SOILS REPORT

DRUMMOND ROAD STRUCTURE

**SUBSURFACE INVESTIGATION FOR  
DRUMMOND ROAD STRUCTURE  
INTERSTATE HIGHWAY PROJECT IN  
SIDNEY, MAINE**

**March 1958**

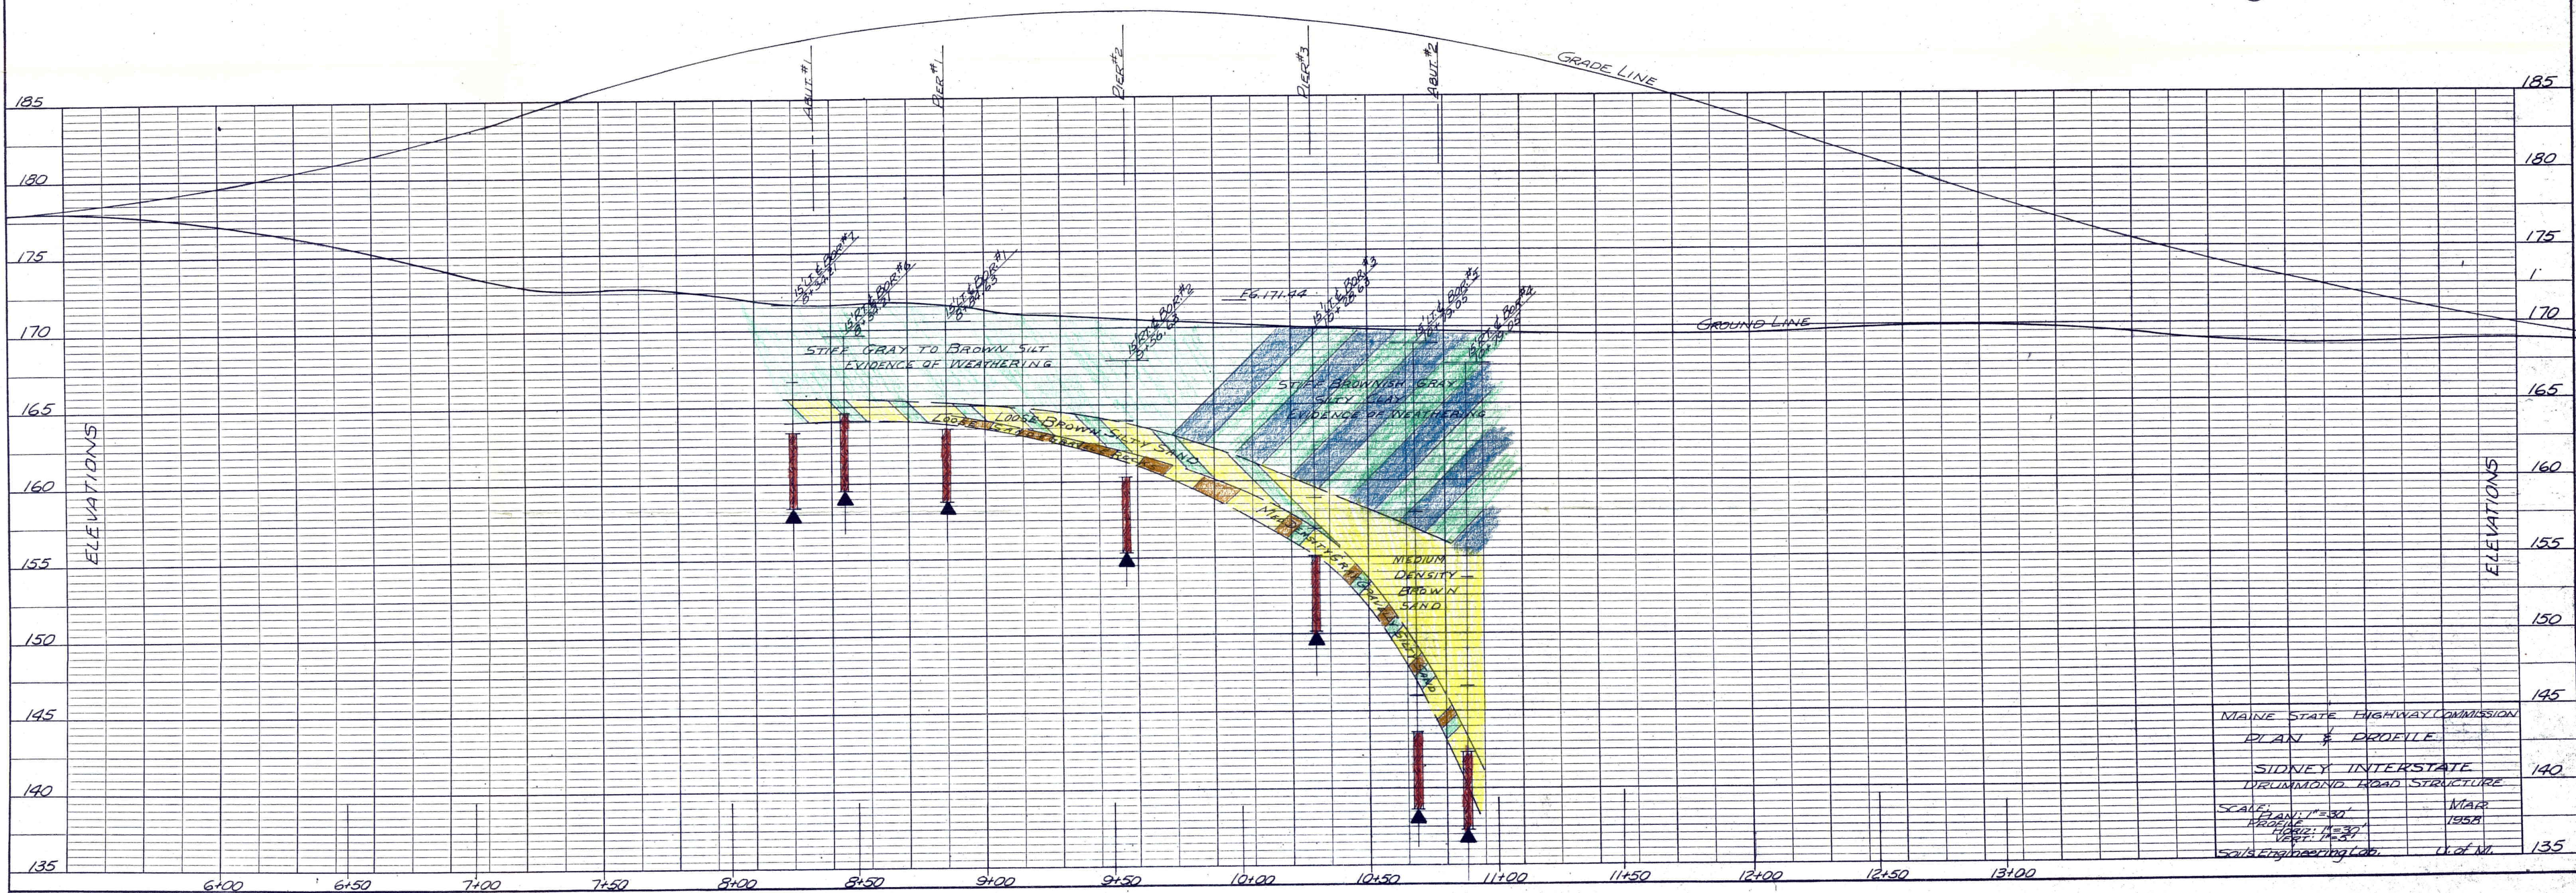
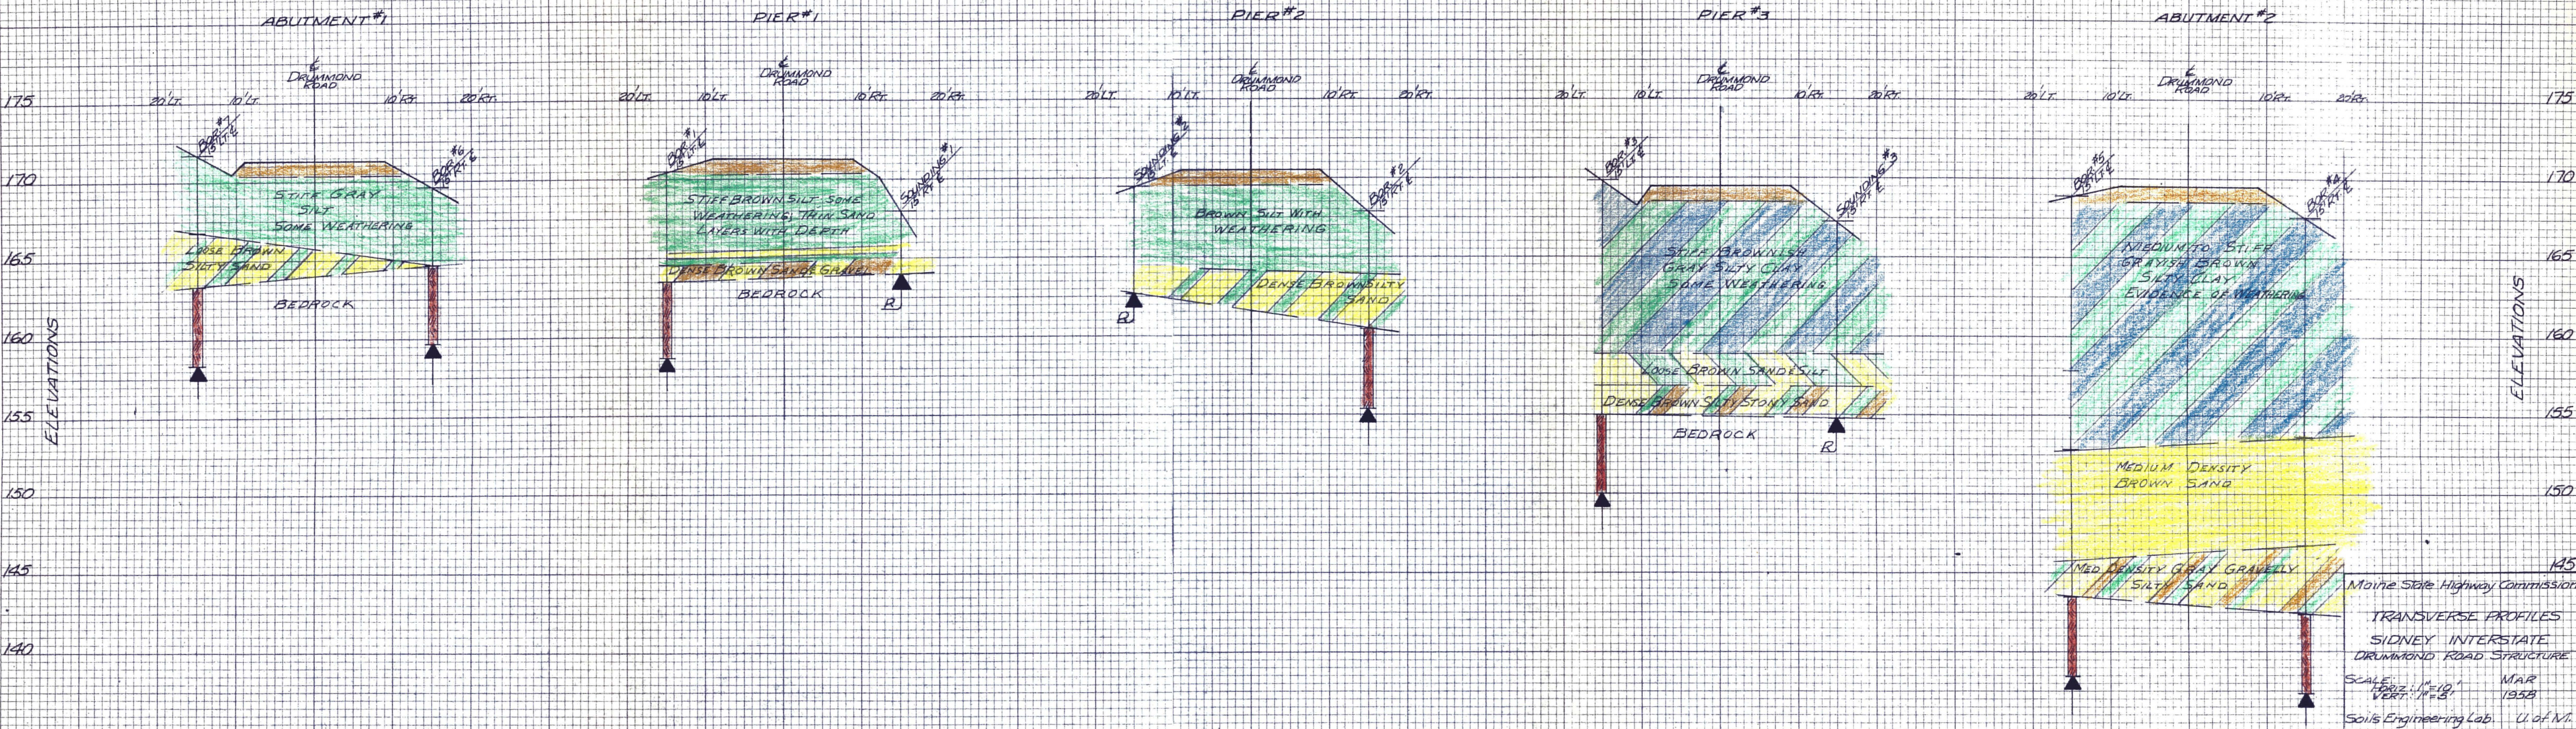
MAINE STATE HIGHWAY COMMISSION  
PLAN & PROFILE  
SIDNEY INTERSTATE  
DRUMMOND ROAD STRUCTURE  
SCALE: PLAN: 1"=30' VERT: 1"=5' DATE: 1958  
SOUTH ENGINEERING CO. 11 of 11

The ledge surface was found within five (5) feet at the surface of Abutment No. 1, and dips gradually to twenty-five (25) feet below the surface under Abutment No. 2. The overburden is divided into three (3) soils. The top and thickest layer is a weathered silty clay. Due to weathering (or drying out) the material is stiff and appears brownish gray in color. A layer of brown silty sand and gray stony silty sand complete the soils with the brown silty sand layer becoming thicker in the same direction as the ledge dips.

Boring No. 3 (Detail Sheet No. 5) and a rod sounding were made at opposite ends of this pier location. The ledge surface, as noted on Sheet No. 2, was encountered almost fifteen (15) feet below the ground surface. The top eleven (11) feet of this overburden is a stiff weathered clay, which under a spread footing pressure of two tons per square foot (2.0 tons/sq. ft.), would consolidate almost two (2) inches. It is therefore recommended that this structure be supported by end bearing (steel or concrete) piles. Because of the normal fluctuation of the ground water table, wooden piles are not recommended.

profile (Sheet 2), the ledge surface was found twenty-seven (27) feet below the ground surface. The overburden consists of a seventeen (17) foot layer of medium to stiff consistent gray weathered silty clay. Underlying this silty clay is a ten (10) foot deposit of granular soil, the top six (6) feet are in a loose density. Since a nineteen (19) foot fill is proposed behind this abutment, and this will necessitate driving any piles through the embankment, some difficulty may be met in driving the piles to the ledge surface. It is believed, however, that piles can be driven through the silty clay in which case they should be continued through the loose brown sand. Jetting may be required. Since the frictional resistance in driving will be high, it is recommended that steel piles be used. Spread footings placed five (5) feet below the ground line with a unit pressure of 3.0 tons per square foot would cause settlement of over two (2) inches.

Because the weathered clay will consolidate slightly under additional loading, and also because of the proximity to a good ledge surface, it is recommended that the bridge structure be supported directly on ledge or at

Since the ledge surface was found between five (5) and nine (9) feet below the surface at Abutment No. 1, and Piers 1 and 2, it is recommended that these three (3) structures be supported directly on the firm durable ledge. At Pier No. 3 and Abutment No. 4, the ledge dips more than fifteen (15) feet below the surface. The overburden is a weathered clay which would

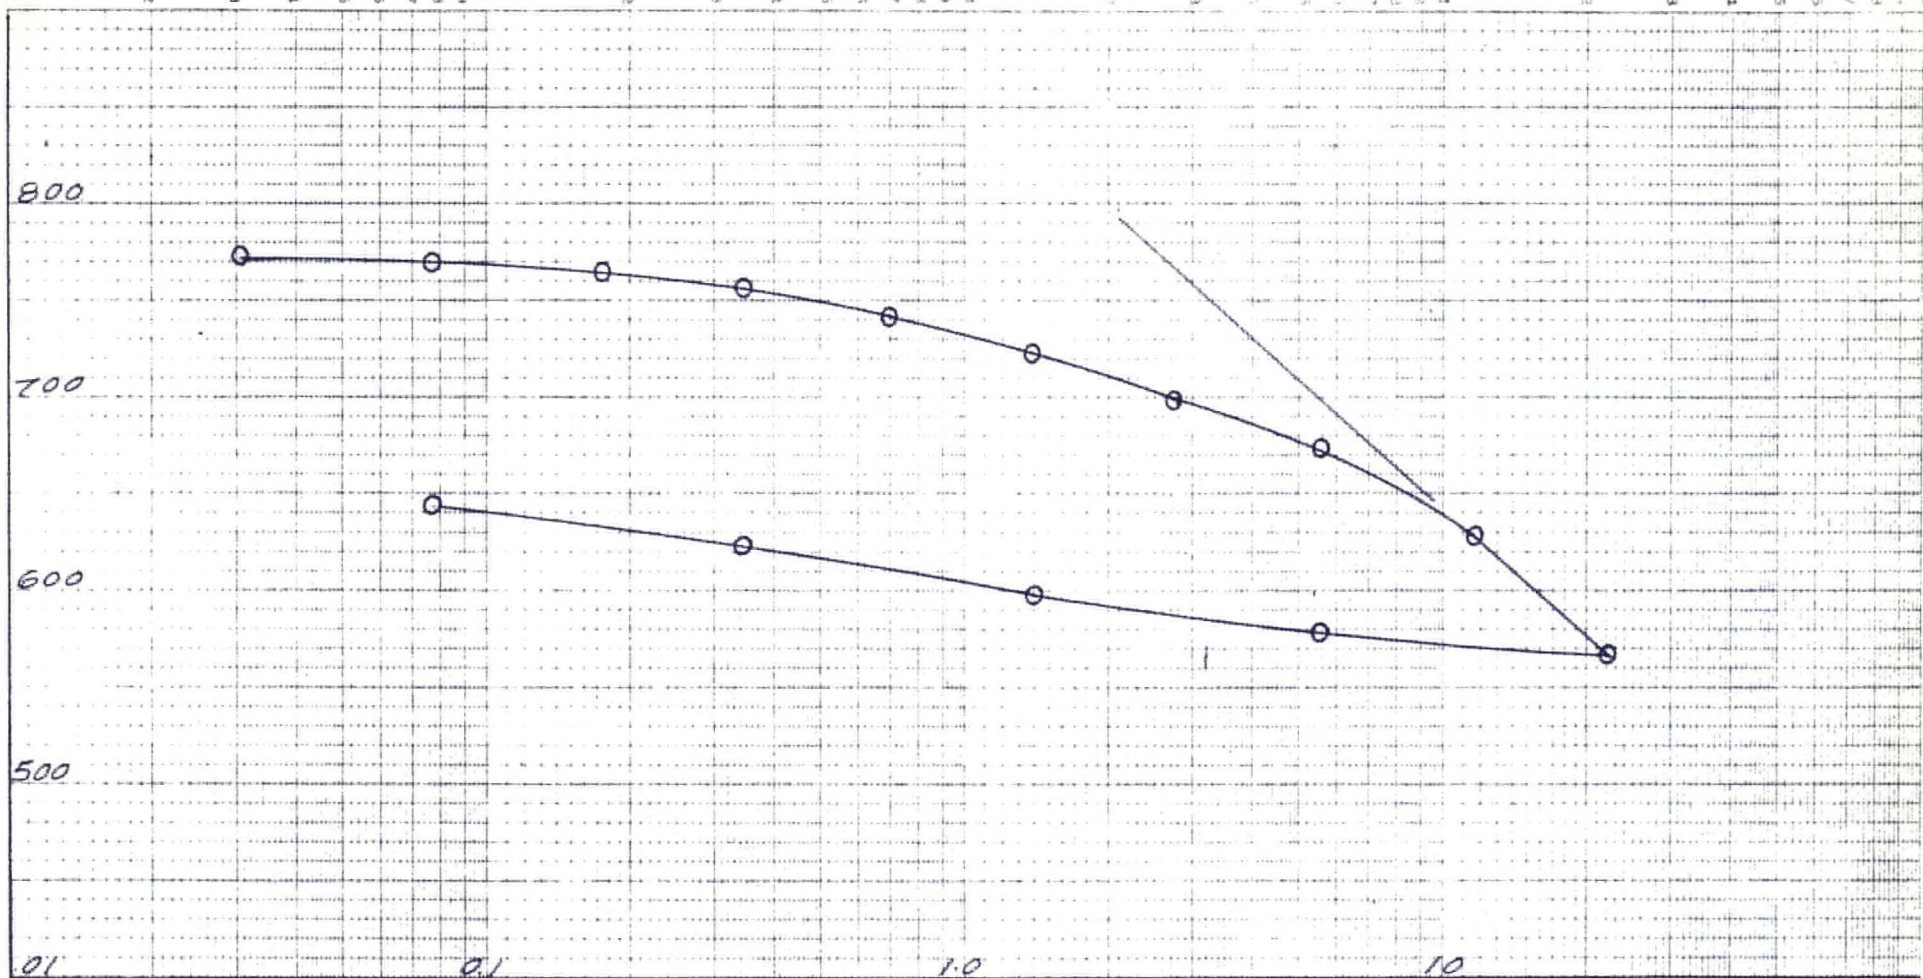
Sheet No. 3

Elevation of Sample 155.96'  
 Thickness of Mineral Matter .4905"  
 Sample Drained Top & Bottom  
 Estimated Effective Pressures  
 a. Existing Overburden .73 Tons/sq. ft.  
 b. Preconsolidation Load  
 1. Apparent Limits 2.10 T/sf to 11.2 T/sf  
 2. Probable Value 4.65 Tons/sq. ft.

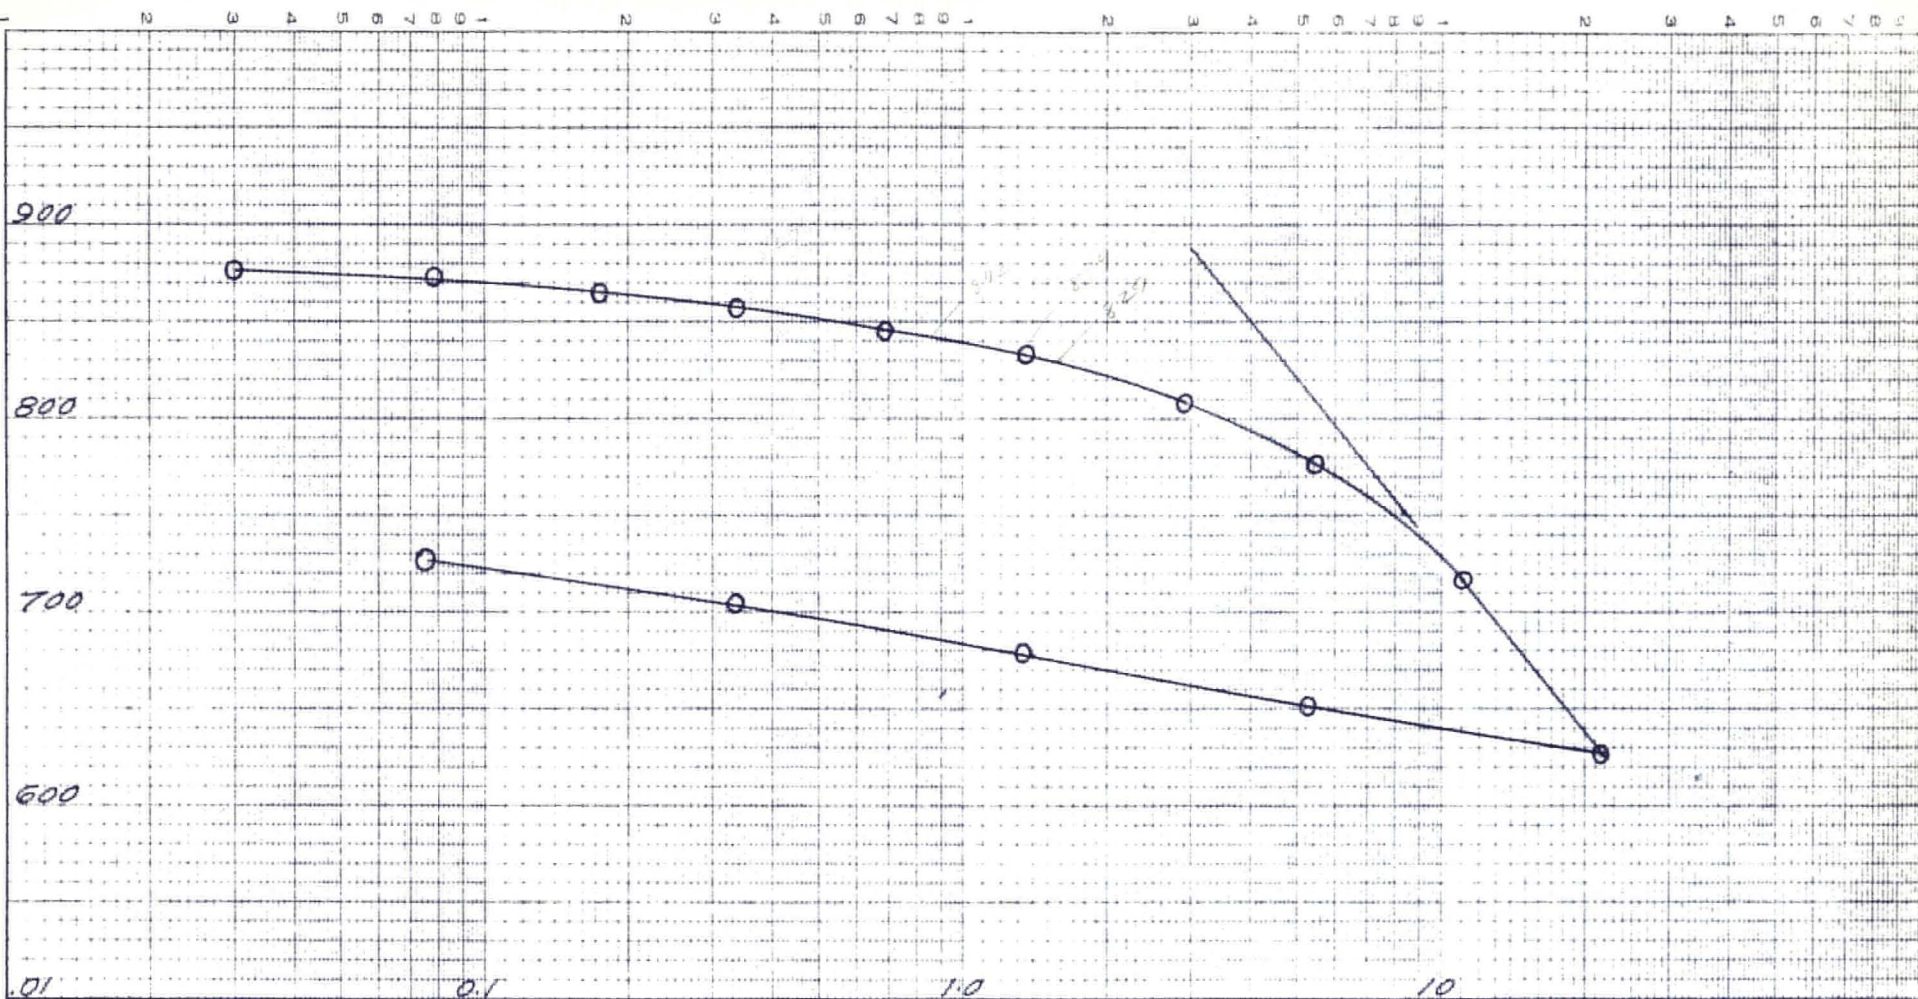
Sheet No. 4

Elevation of Sample 162.26'

Thickness of Mineral Matter .4688"

a. Existing Overburden .41 Tons/sq. ft.

1. Apparent Limits 4.30 T/sf to 9.40 T/sf

2. Probable Value 3.50 Tons/sq. ft.
