SOILS REPORT

SUBSURFACE INVESTIGATION FOR
DENSMORE ROAD STRUCTURE
INTERSTATE HIGHWAY PROJECT
SIDNEY, MAINE

State Highway Commission
Soils Division

May 1958

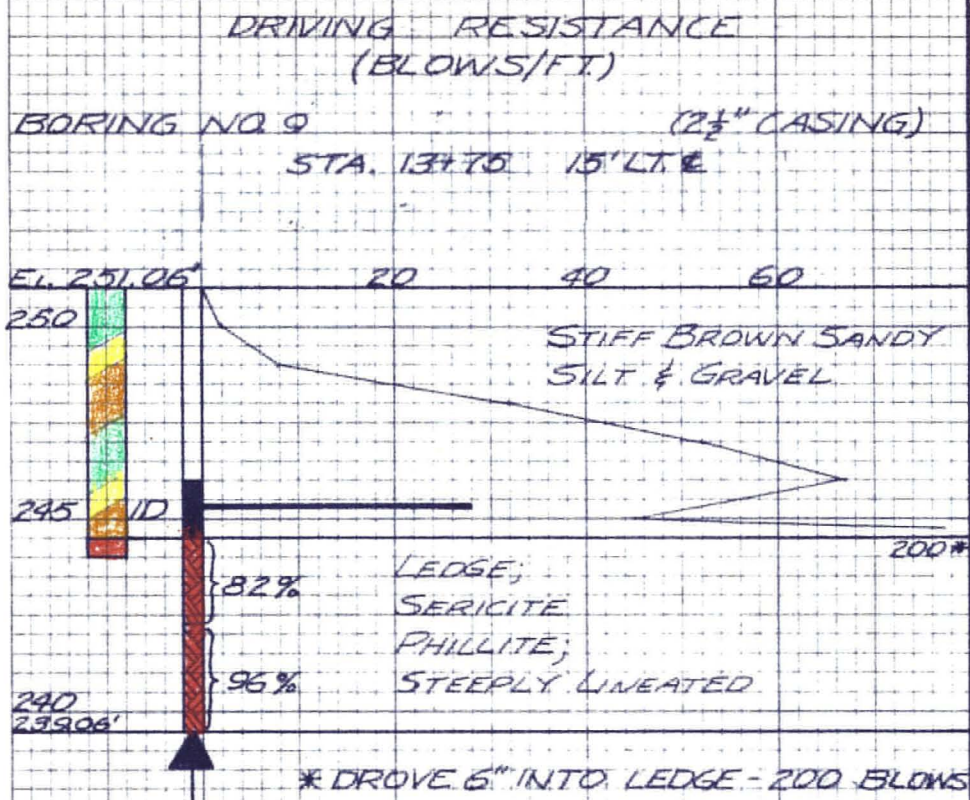
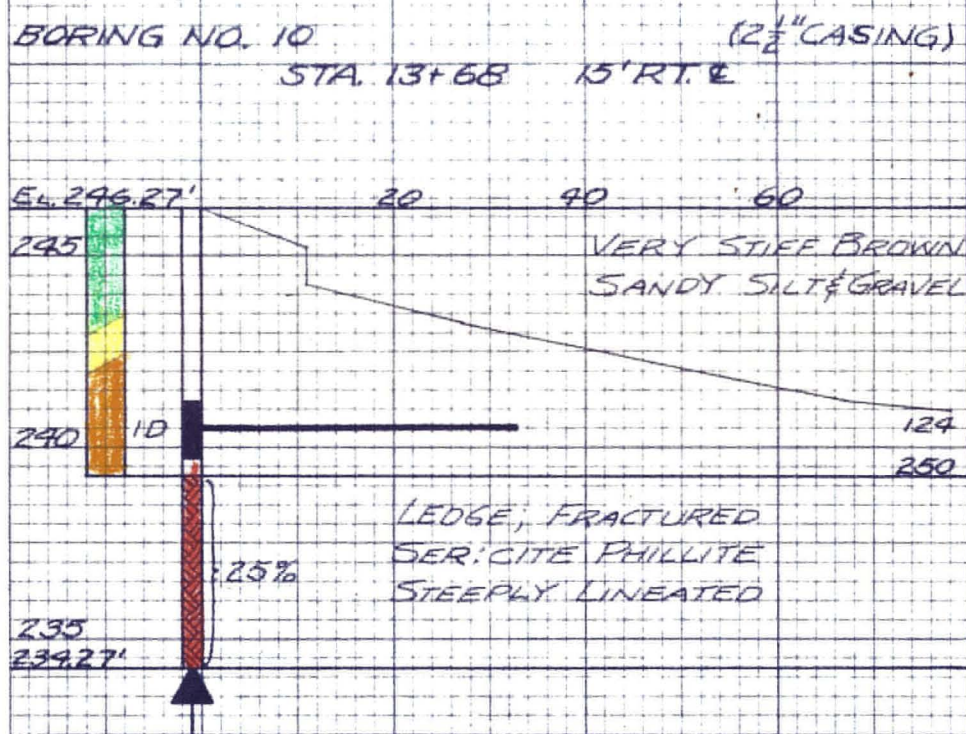
SHEET #10

Borings 7, 8, 9, and 10 (Sheets 9 and 10) and the transverse section (Sheet 4) show the underlying soils in the vicinity of the proposed location of Pier No. 3. These borings were not made on the proposed pier location as the location had not been established at the time the borings were made. The plan showing the fixed location was followed up in the field by two (2)

rod soundings (Soundings 1 and 2), but the location of this pier has since been changed; approximately five (5) feet to the east. The data obtained has been interpolated to show the soils profile at Pier 3 as shown on Sheet 4. Since the ledge surface is but eight (8) feet below the surface, it is recommended that the pier be supported directly on the bedrock. If piles are used, it is believed they can be driven to the ledge surface.

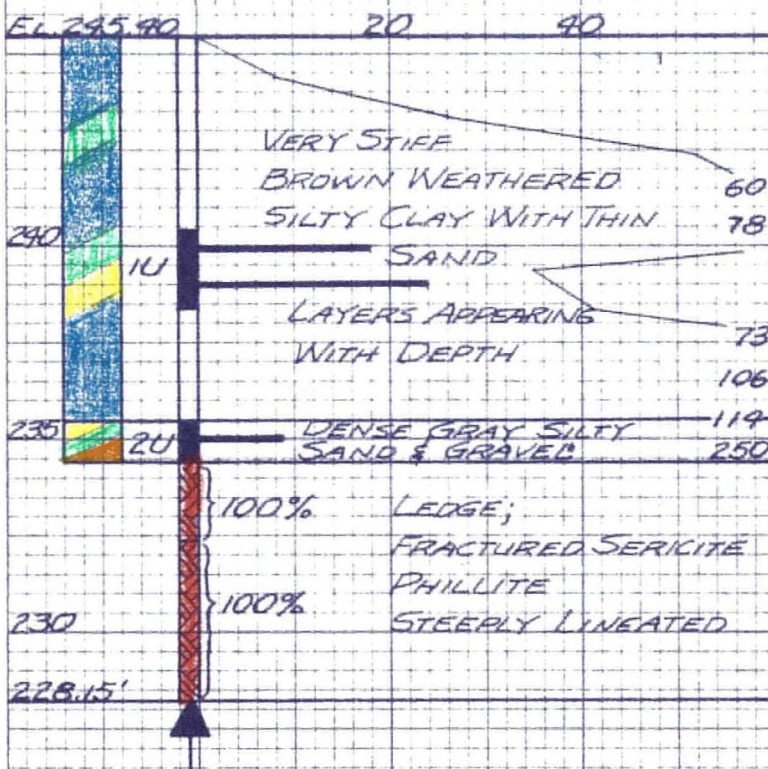
DRIVING RESISTANCE
(BLOWS/FT.)
BORING NO. 14 (4" CASING)
STA. 12+66 15' RT. E

Borings 15 and 16 (Sheets 13 and 14) and the transverse section (Sheet 4) show the existing soils at the proposed site of Abutment No. 1. The ledge surface was noted seventeen (17) feet below the surface with the overburden a weathered clay. Since this clay will consolidate over an inch with a unit pressure of two (2) tons per square foot, it is recommended that the structure be supported by piles. It is believed that with jetting the

Borings 13 and 14 (Sheets 12 and 13) and the transverse section (Sheet 4) show the underlying conditions at the proposed location of Pier No. 1. Since the overburden is stiff clay and will undergo consolidation, and the ledge surface is fourteen (14) feet below the surface, piles are recommended. It is believed that piles can be driven to ledge on the north end to elevation 231.5 and possibly to ledge on the south end with jetting at elevation 232.5.

piles could be driven to the ledge surface (elevation 226-230). If the fill is completed before the abutment is constructed, frictional piles are recommended. It is believed piles driven through the fill may be stopped at elevation 240 and possibly with jetting they might reach the ledge surface.
