# *HISTORIC BRIDGE SURVEY*

## *Metal Truss Re-evaluation*

*April 2019*

*Supplement to Historic Bridge Survey*

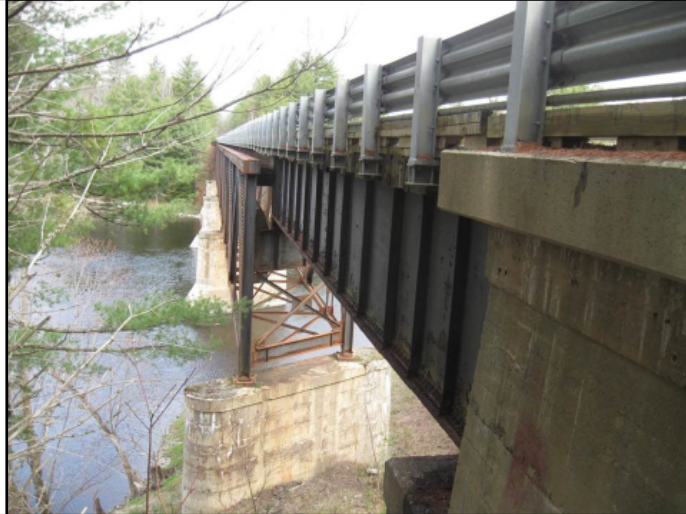
**Bridge Name:** Piscataquis River  
**County:** Piscataquis  
**Priority:** >4

**Feature on:** Trestle Road

**Type:** Truss (Deck)

In 1947 the 1909 bridge was replaced with the existing structure. The pin-connected deck truss was replaced with a Warren deck truss composed of standard built-up sections of

channels, angles, and plates. The bridge includes built-up deck girder approach spans. The bridge likely utilized the same concrete piers and abutments as the previous bridge. As noted by local historian William Sawtell, "Some of the steel on the trestle crystallized, necessitating the renewal of the three center spans."

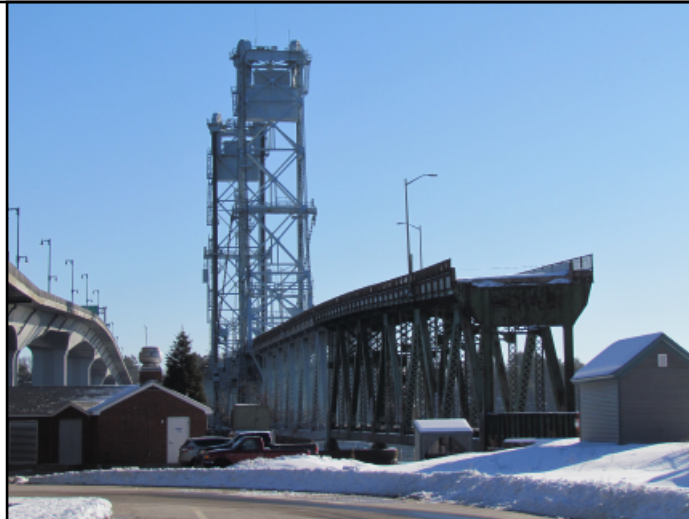
**Bridge #:** 3007      **Bridge Name:** Carlton      **Town:** Bath  
**Region:** 1      **County:** Sagadahoc      **Owner:** MaineDOT  
**NR Eligible:** Yes.      **Priority:** n/a

**Feature on:** Rockland Branch Railroad  
**Type:** Truss (Deck) & Lift Span  
**Superstructure:** Steel  
**Railing type:** Tubular metal pipe with metal bar fill  
**Overall Length:** 2,195'  
**Year Built:** 1926-1927  
**Designer/Builder:** J. A. L. Waddell/McClintic-Marshall/Foundation Company

**Feature under:** Kennebec River  
**Design:** Warren (Riveted)  
**Substructure:** Concrete  
**Number of Spans:** 7  
**Deck Width:** 35'  
**Alteration (Date):** 2000

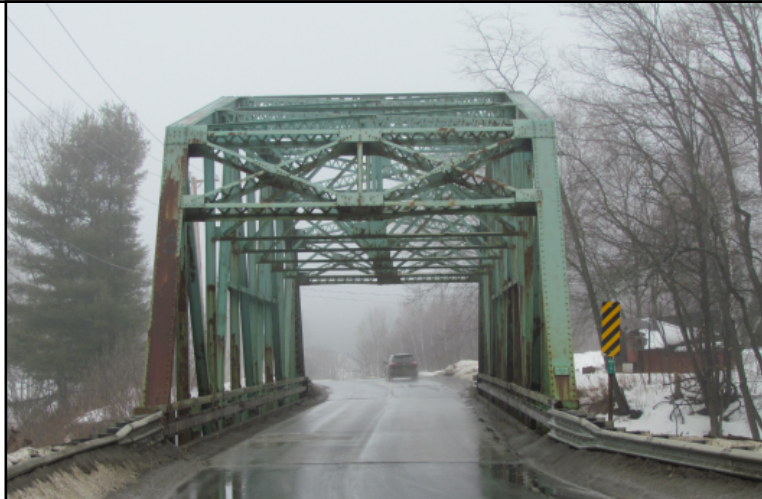
**Bridge #:** 3181      **Bridge Name:** Williams No. 2      **Town:** Chesterville  
**Region:** 3      **County:** Franklin      **Owner:** MaineDOT  
**NR Eligible:** Yes.      **Priority:** 3

**Feature on:** State Route 156      **Feature under:** Wilson Stream  
**Type:** Truss (Thru)      **Design:** Camelback (Riveted)  
**Superstructure:** Steel      **Substructure:** Concrete  
**Railing type:** 2 rail high steel channel      **Number of Spans:** 1  
**Overall Length:** 176'      **Deck Width:** 23'  
**Year Built:** 1937      **Alteration (Date):** n/a  
**Designer/Builder:** MSHC/Pittsburgh-Des Moines Steel Company/Reed & Reed

The truss was constructed in 1937 and has standard built-up chords, portal bracing, and upper laterals. It has rolled section diagonals and verticals. The floorbeams and stringers are rolled steel as well. The Williams #2 Bridge replaced a wooden bridge and provided the crossing with the ability to carry much larger loads. The MSHC raised the bridge elevation slightly from 96' to 100'. The MSHC was able to construct a single-span bridge where a two-span bridge had previously been located.

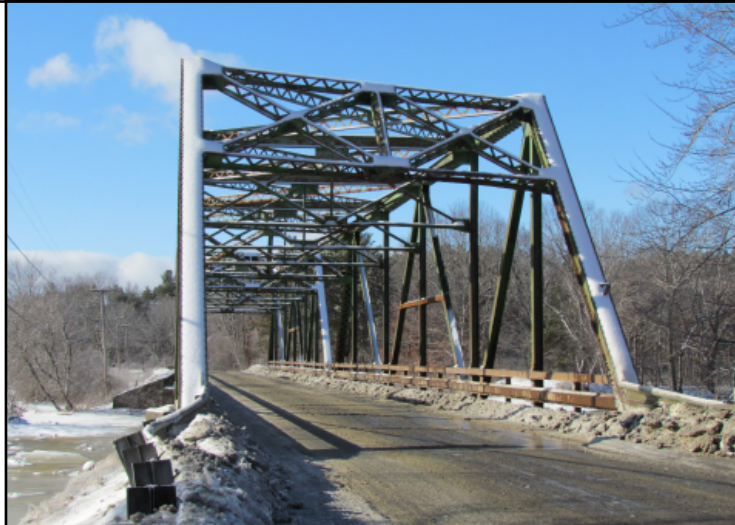
**Bridge #:** 3244      **Bridge Name:** Pleasant River      **Town:** Milo  
**Region:** 4      **County:** Piscataquis      **Owner:** MaineDOT  
**NR Eligible:** Yes.      **Priority:** 4

<b>Feature on:</b> Pleasant Street	<b>Feature under:</b> Pleasant River
<b>Type:</b> Truss (Thru)	<b>Design:</b> Warren (Riveted)
<b>Superstructure:</b> Steel	<b>Substructure:</b> Concrete
<b>Railing type:</b> 2 rail high steel channel	<b>Number of Spans:</b> 2
<b>Overall Length:</b> 309'	<b>Deck Width:</b> 23'
<b>Year Built:</b> 1936	<b>Alteration (Date):</b> n/a
<b>Designer/Builder:</b> MSHC/Harris Structural Steel Company/W. H. McPherson

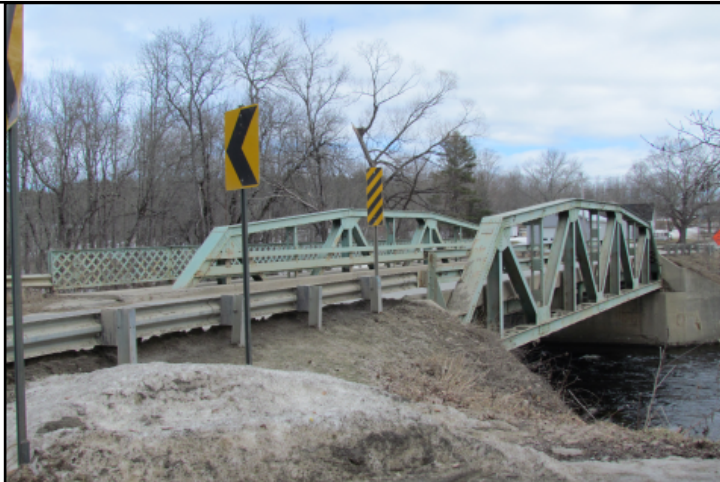
**Bridge #:** 3309      **Bridge Name:** Village      **Town:** Detroit  
**Region:** 4      **County:** Somerset      **Owner:** MaineDOT  
**NR Eligible:** Yes.      **Priority:** 4

<b>Feature on:</b> State Route 69/220	<b>Feature under:</b> East Branch Sebasticook River
<b>Type:</b> Truss (Pony)	<b>Design:</b> Warren (Riveted)
<b>Superstructure:</b> Steel	<b>Substructure:</b> Concrete
<b>Railing type:</b> 2 rail high steel channel; metal lattice railing	<b>Number of Spans:</b> 1
<b>Overall Length:</b> 94'	<b>Deck Width:</b> 23'
<b>Year Built:</b> 1936	<b>Alteration (Date):</b> n/a
<b>Designer/Builder:</b> MSHC/Berlin Construction Company/Edmond Cyr

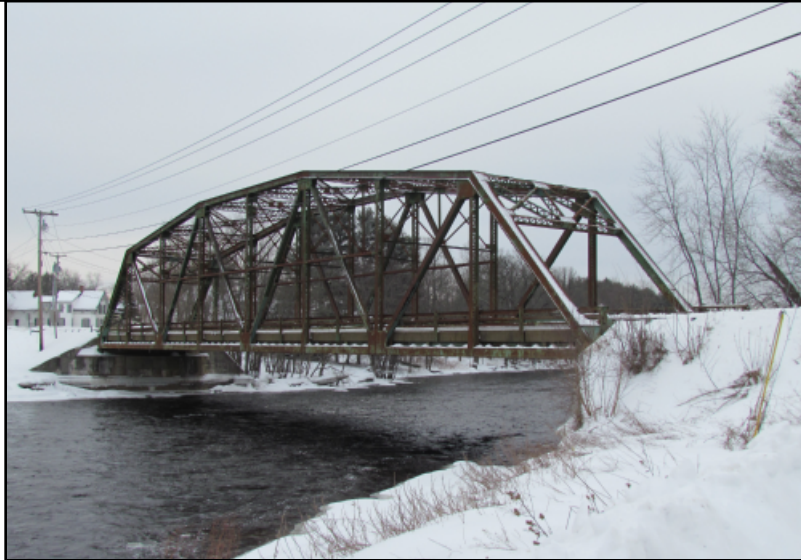
**Bridge #:** 3321      **Bridge Name:** Sebacook      **Town:** Clinton  
**Region:** 2      **County:** Kennebec      **Owner:** MaineDOT  
**NR Eligible:** Yes.      **Priority:** 4

**Feature on:** Pleasant Street      **Feature under:** Sebacook River  
**Type:** Truss (Thru)      **Design:** Warren (Riveted)  
**Superstructure:** Steel      **Substructure:** Concrete  
**Railing type:** 2 rail high steel channel; metal pipe on sidewalk      **Number of Spans:** 1  
**Overall Length:** 190'      **Deck Width:** 23'  
**Year Built:** 1936      **Alteration (Date):** n/a  
**Designer/Builder:** MSHC/American Bridge Company/J. R. Cianchette & Company

The Sebacook Bridge carries Pleasant Street over the Sebacook River. The bridge is located south of Route 11/100 and connects the southern end of Clinton with the rest of the town north of the river. Pleasant Street also connects Clinton to Route 139. The bridge is seated near the upper end of an oxbow in the Sebacook River. The bridge is 1 of 13 Warren Thru trusses in the MaineDOT network.

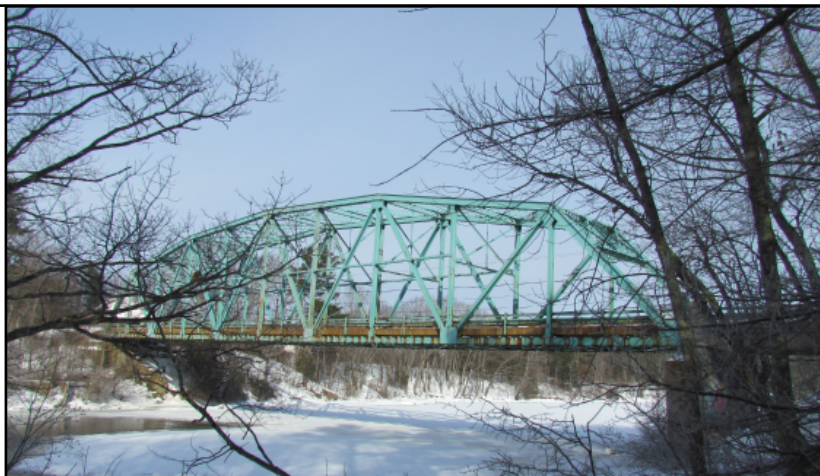
**Bridge #:** 3341      **Bridge Name:** Middle      **Town:** Dresden  
**Region:** 2      **County:** Lincoln      **Owner:** MaineDOT  
**NR Eligible:** Yes.      **Priority:** 3

<b>Feature on:</b> State Route 197	<b>Feature under:</b> Eastern River
<b>Type:</b> Truss (Thru)	<b>Design:</b> Warren (Riveted)
<b>Superstructure:</b> Steel	<b>Substructure:</b> Concrete
<b>Railing type:</b> 2 rail high steel channel	<b>Number of Spans:</b> 1
<b>Overall Length:</b> 296'	<b>Deck Width:</b> 23'
<b>Year Built:</b> 1936	<b>Alteration (Date):</b> n/a
<b>Designer/Builder:</b> MSHC & Fay, Spofford, & Thorndike/Pittsburgh-Des Moines Steel Company/F. W. Carlton

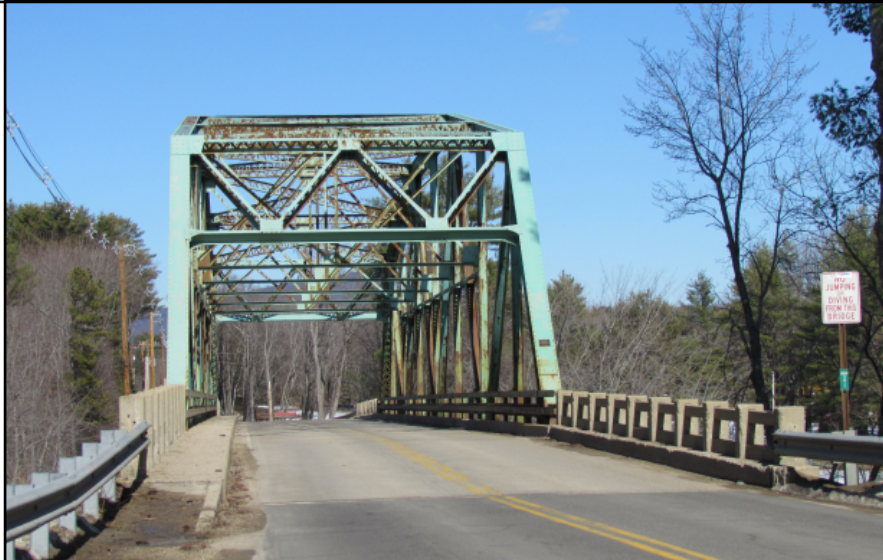
**Bridge Name:** Charles E. Hill  
**County:** Oxford  
**Priority:** 4

**Feature on:** State Route 160  
**Type:** Truss (Thru)  
**Superstructure:** Steel  
**Railing type:** 2 rail high steel channel  
**Overall Length:** 339'  
**Year Built:** 1936  
**Designer/Builder:** MSHC/Harris Structural Steel Company/Wyman & Simpson, Inc.

**Feature under:** Saco River  
**Design:** Warren (Riveted)  
**Substructure:** Concrete  
**Number of Spans:** 1  
**Deck Width:** 26'  
**Alteration (Date):** n/a

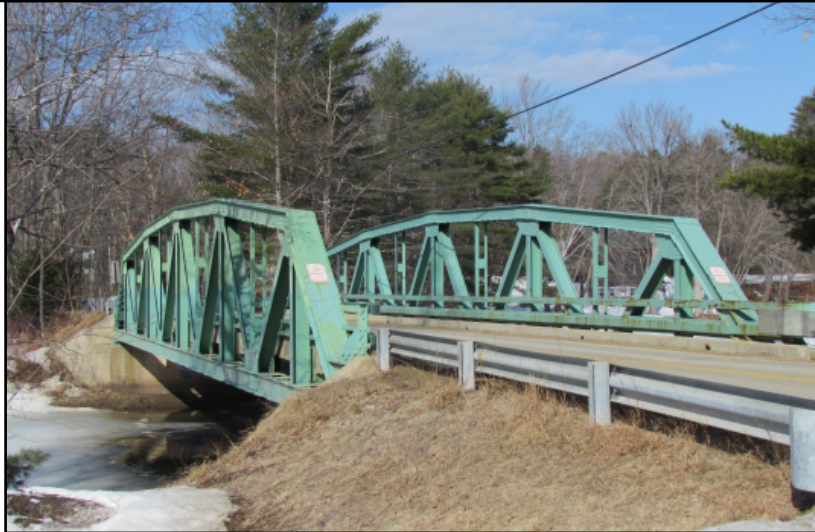
**Bridge #:** 3499      **Bridge Name:** Songo Lock      **Town:** Naples/Casco  
**Region:** 1      **County:** Cumberland      **Owner:** MaineDOT  
**NR Eligible:** Yes.      **Priority:** 4

**Feature on:** State Park Road      **Feature under:** Crooked River  
**Type:** Truss (Pony)      **Design:** Warren (Riveted)  
**Superstructure:** 2 high steel channel      **Substructure:** Concrete  
**Railing type:** Steel      **Number of Spans:** 1  
**Overall Length:** 123'      **Deck Width:** 35'  
**Year Built:** 1937      **Alteration (Date):** n/a  
**Designer/Builder:** MSHC/Lackawanna Steel Construction

The Songo Lock Bridge #3499 spans the Crooked River carrying State Park Road on the town line between Casco and Naples in Cumberland County. It is approximately 800' west of the Songo Lock. State Park Road connects the area around Sebago Lake State Park with State Route 35 (Roosevelt Trail) and State Route 114 as well as different areas of Sebago Lake State Park. The park is located on either side of the Crooked River; users must cross over the Songo Lock Bridge to access one side from the other. Development is sparse in the area with few year-round homes and a few family seasonal camps, likely due to the large privately-owned tracts and the area's flood prone nature. The bridge is 1 of 5 Warren Pony trusses in the MaineDOT network.

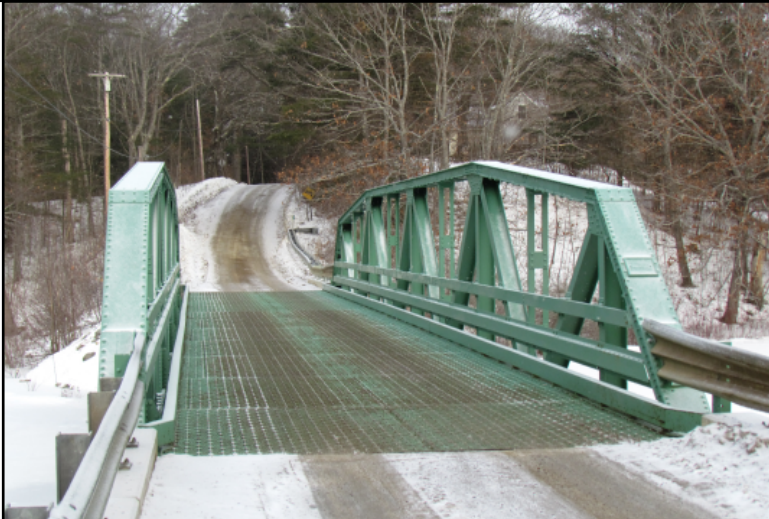
**Bridge #:** 3505      **Bridge Name:** Hathaway      **Town:** Passadumkeag  
**Region:** 3      **County:** Penobscot      **Owner:** MaineDOT  
**NR Eligible:** Yes.      **Priority:** >4

<b>Feature on:</b> Goulds Ridge Road	<b>Feature under:</b> Passadumkeag River
<b>Type:</b> Truss (Pony)	<b>Design:</b> Warren (Riveted)
<b>Superstructure:</b> Steel	<b>Substructure:</b> Concrete/Granite
<b>Railing type:</b> 2 high steel channel	<b>Number of Spans:</b> 1
<b>Overall Length:</b> 109	<b>Deck Width:</b> 14'
<b>Year Built:</b> 1937	<b>Alteration (Date):</b> n/a
<b>Designer/Builder:</b> MSHC/Pan American Bridge Company

The bridge was constructed in 1937, replacing another metal truss bridge. The 109' polygonal top chord Warren Pony truss is supported by concrete capped granite abutments. Traffic is currently carried by a metal grate deck; however this replaced the original concrete deck. In a time of standardization, this bridge did not use AASHTO standards, as evidenced by the narrow deck width (standard at the time was 22').

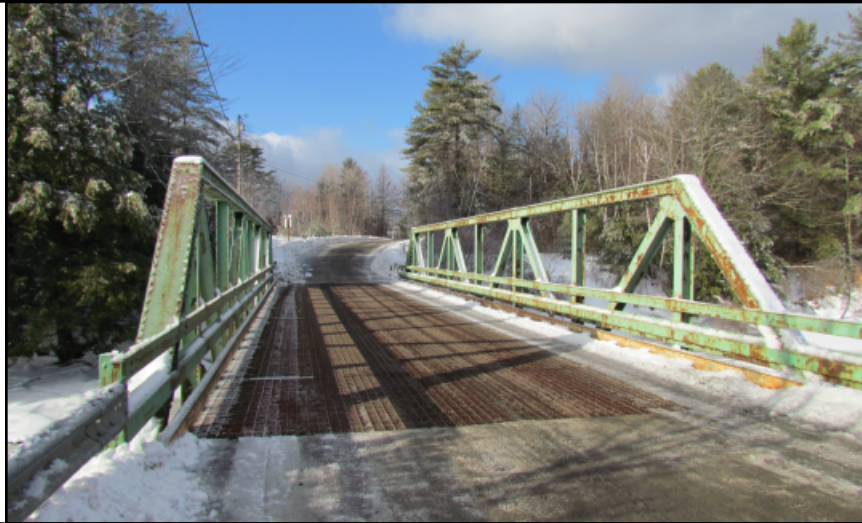
**Feature on:** Back Road

**Type:** Truss (Pony)

Old Covered Bridge #3507 carries Back Road over the Piscataquis River. The area is sparsely developed with Back Road serving as the easterly connector to Guildford versus Route 6 on the western bank of the Piscataquis River. The bridge is located ¼ mile east of the village of Abbot. The Village is oriented around the intersection of State Route 6 and State Route 16. Old Covered Bridge replaced a previous covered wooden truss bridge on the same alignment. There are no other structures near the bridge. The bridge is 1 of 5 Warren Pony trusses in the MaineDOT network.

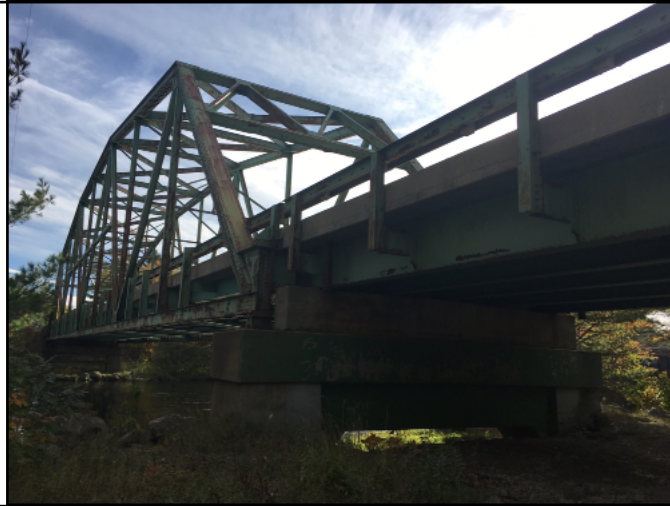
**Bridge #:** 3666      **Bridge Name:** West Branch      **Town:** T3 Indian Purchase  
**Region:** 5      **County:** Penobscot      **Owner:** MaineDOT  
**NR Eligible:** Yes.      **Priority:** 3

<b>Feature on:</b> State Route 11	<b>Feature under:</b> Penobscot River
<b>Type:</b> Truss (Thru)	<b>Design:</b> Parker (Riveted)
<b>Superstructure:</b> Steel	<b>Substructure:</b> Concrete
<b>Railing type:</b> 1 high steel channel	<b>Number of Spans:</b> 3
<b>Overall Length:</b> 369'	<b>Deck Width:</b> 26'
<b>Year Built:</b> 1948	<b>Alteration (Date):</b> n/a
<b>Designer/Builder:</b> MSHC/American Bridge Company

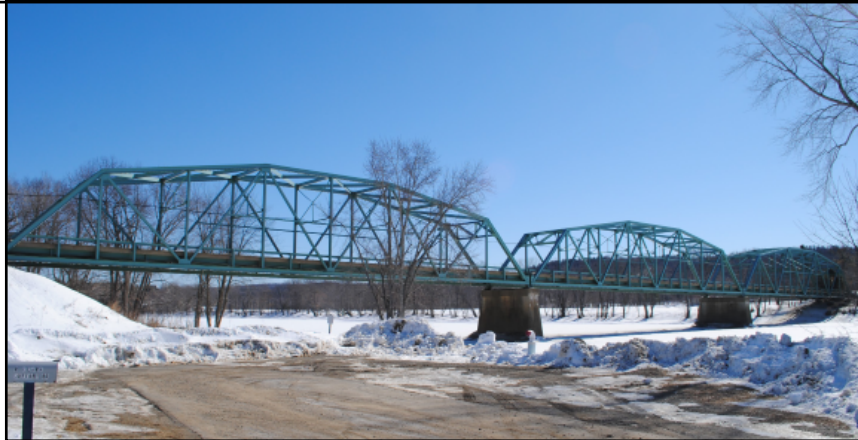
**Bridge #:** 3790      **Bridge Name:** Penobscot River      **Town:** Chester/Lincoln  
**Region:** 5      **County:** Penobscot      **Owner:** MaineDOT  
**NR Eligible:** Yes.      **Priority:** 3

**Feature on:** Chester Road      **Feature under:** Penobscot River  
**Type:** Truss (Thru)      **Design:** Warren (Riveted)  
**Superstructure:** Steel      **Substructure:** Concrete  
**Railing type:** 1 high steel channel      **Number of Spans:** 3  
**Overall Length:** 610'      **Deck Width:** 23.6  
**Year Built:** 1950      **Alteration (Date):** 1983  
**Designer/Builder:** MSHC/Lackawanna Steel Construction Corporation

The Penobscot River Bridge #3790 carries Chester Road over the Penobscot River connecting Chester and Lincoln. It also connects US Route 2 in Lincoln to State Route 116 in Chester, where it diverts from its route along the Penobscot River to follow a northerly route connecting to Medway and Route 11. The bridge is comprised of three 200' long spans of rolled section diagonals, verticals and top laterals; built-up members are limited to the section chords and plate. Of the remaining 32 truss bridges in the state, this is the first to extend the use of rolled section to additional members than the verticals and diagonals thereby further reducing construction time in the field as rolled members did not require any further action in the field (unlike built-up members). The bridge is 1 of 13 Warren Thru trusses in the MaineDOT network.

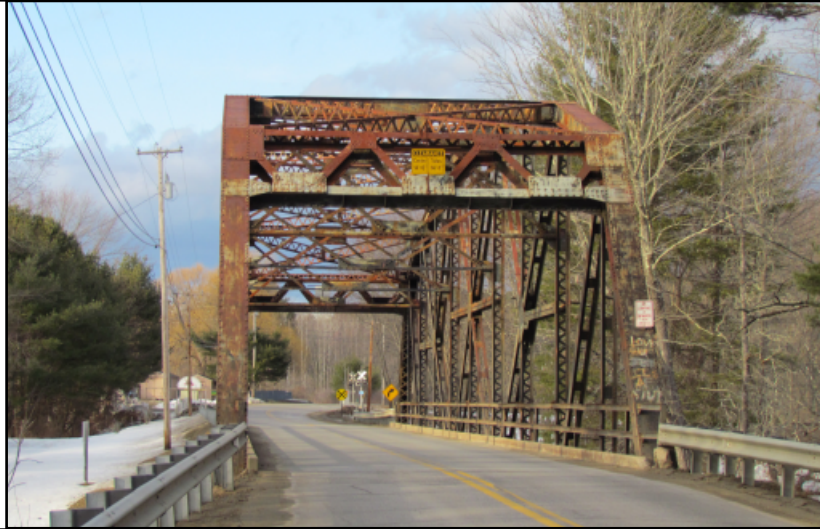
**Feature on:** State Route 106

**Type:** Truss (Thru)

Constructed in 1922, it replaced a narrow stringer bridge with wood rails. A railroad bridge, also a Pennsylvania truss, is located approximately 150' east of the Stinchfield Bridge. The railroad bridge is not owned by MaineDOT. The bridge was 1 of 7 identified as constructed by the MSHC from 1921 to 1929. It is the only remaining example of a Pennsylvania truss in the MaineDOT network. While the portal bracing was increased (1974 or 1988) to allow for taller vehicles, the bridge retains its integrity.

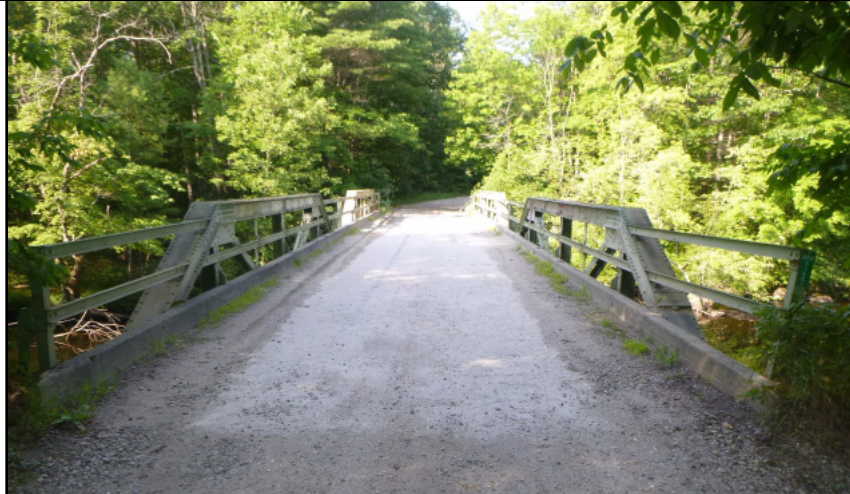
**Bridge Name:** Nason's Mill  
**County:** Cumberland  
**Priority:** >4

**Feature on:** Millturn/Salt Pond Road  
**Type:** Truss (Pony)  
**Superstructure:** Steel  
**Railing type:** Steel channel  
**Overall Length:** 111'  
**Year Built:** 1923  
**Designer/Builder:** MSHC/United Construction Company

**Feature under:** Little Ossipee River  
**Design:** Warren (Riveted)  
**Substructure:** Concrete  
**Number of Spans:** 2  
**Deck Width:** 35'  
**Alteration (Date):** n/a

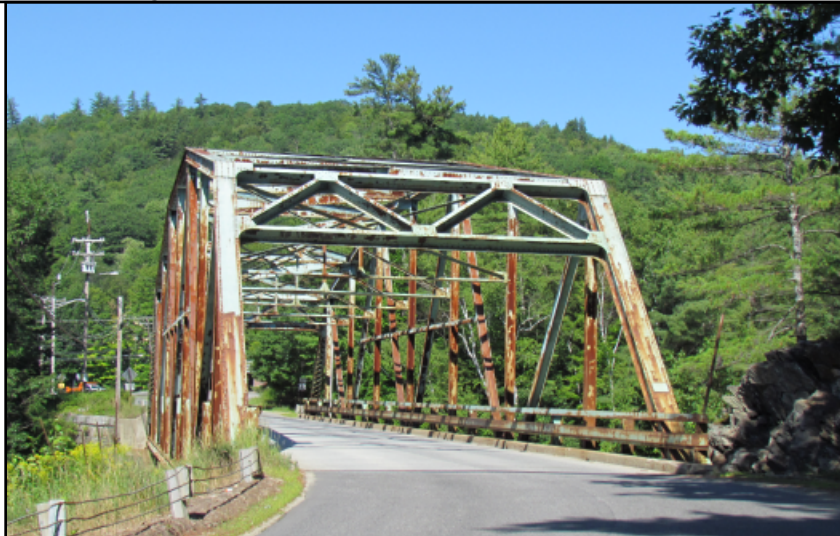
**Feature on:** South Rumford Road

**Feature under:** Androscoggin River

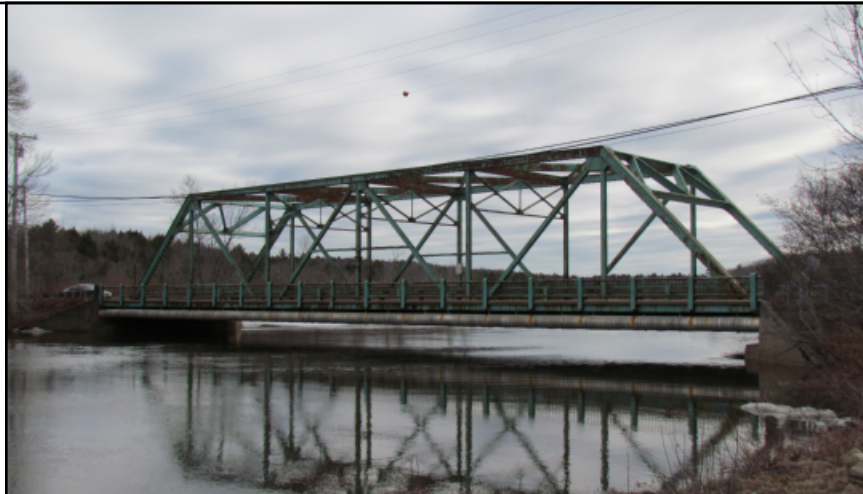
**Bridge #:** 5190      **Bridge Name:** Brooklyn      **Town:** Bowdoinham  
**Region:** 2      **County:** Sagadahoc      **Owner:** MaineDOT  
**NR Eligible:** Yes.      **Priority:** 3

<b>Feature on:</b> State Route 24	<b>Feature under:</b> Cathance River
<b>Type:</b> Truss (Thru)	<b>Design:</b> Warren (Riveted)
<b>Superstructure:</b> Steel	<b>Substructure:</b> Concrete
<b>Railing type:</b> Two high steel channel	<b>Number of Spans:</b> 1
<b>Overall Length:</b> 156'	<b>Deck Width:</b> 25.9'
<b>Year Built:</b> 1953	<b>Alteration (Date):</b> 2000
<b>Designer/Builder:</b> MSCH/Herbert C. Callahan

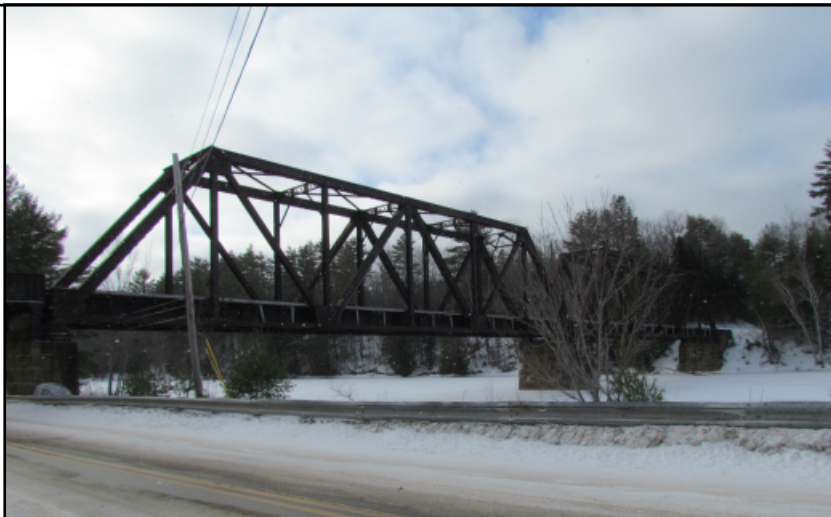
**Bridge #:** 7766<sup>1</sup>      **Bridge Name:** Madawaska #133.14      **Town:** Grindstone Township  
**Region:** 5      **County:** Penobscot      **Owner:** MaineDOT  
**NR Eligible:** Yes.      **Priority:** 4

**Feature on:** Bangor & Aroostook Railroad      **Feature under:** State Route 11 & East Branch Penobscot River  
**Type:** Truss (Thru)      **Design:** Warren (Riveted)  
**Superstructure:** Steel      **Substructure:** Granite/Concrete  
**Railing type:** 2 rail high steel channel      **Number of Spans:** 2  
**Overall Length:** 330'      **Deck Width:** 17.4'  
**Year Built:** 1925      **Alteration (Date):** 1947  
**Designer/Builder:** Bangor & Aroostook Railroad

The Madawaska #133.14 Bridge carries the Bangor and Aroostook (B&A) Railroad over the East Branch of the Penobscot River. Grindstone Bridge #0814 is the eastern approach span to Madawaska #133.14 and carries the rail line over Route 11. The approach span is a 40' girder-floorbeam bridge. Grindstone Township was first known as Plantation No. 1 in Penobscot County. The township has historically been sparsely populated with 66 inhabitants in 1870 and 97 in 1880. The township remains sparsely developed today and is largely covered with forest lands. The Madawaska #133.14 Bridge is 1 of 13 Warren Thru trusses in the MaineDOT network.
