# **Preliminary Design Report**

Ticonic Bridge #2854 over Kennebec River

Waterville-Winslow, Maine

2313800 WIN 023138.00

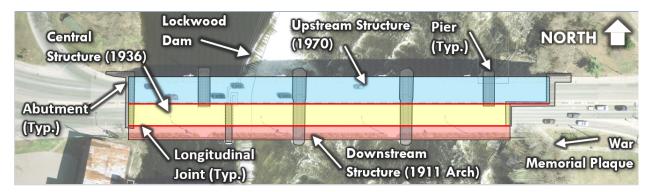
Figure 1 Ticonic Bridge Existing Conditions

The combined curb-to-curb width of the bridge is 62'-0" including a 3'-0" raised median between the two steel structures with an out-to-out width of 86'-0". An 8'-0" sidewalk and a 7'-0" esplanade are located on the concrete arch and extend along the eastbound lanes of traffic. On the upstream side of the structure a 6'-0" sidewalk runs along the westbound lanes of traffic. A war memorial plaque is mounted within the railing system mounted atop the southeast wingwall of the existing structure. Bridge mounted utilities include electrical, communication, cable, water, and conduit for bridge mounted light fixtures. Aerial utilities are located in the adjacent intersections but are not present across the bridge. Pan-Am Railways operates two railroad tracks that pass through the adjacent Winslow intersection. South of the bridge the railroad tracks run parallel and to the east of Bay Street. At the intersection east of the bridge the tracks extend northwest through the intersection, crossing the intersection at an angle, and continue across the Kennebec River. The railroad bridge is approximately 200' north of the Ticonic Bridge at the east riverbank.

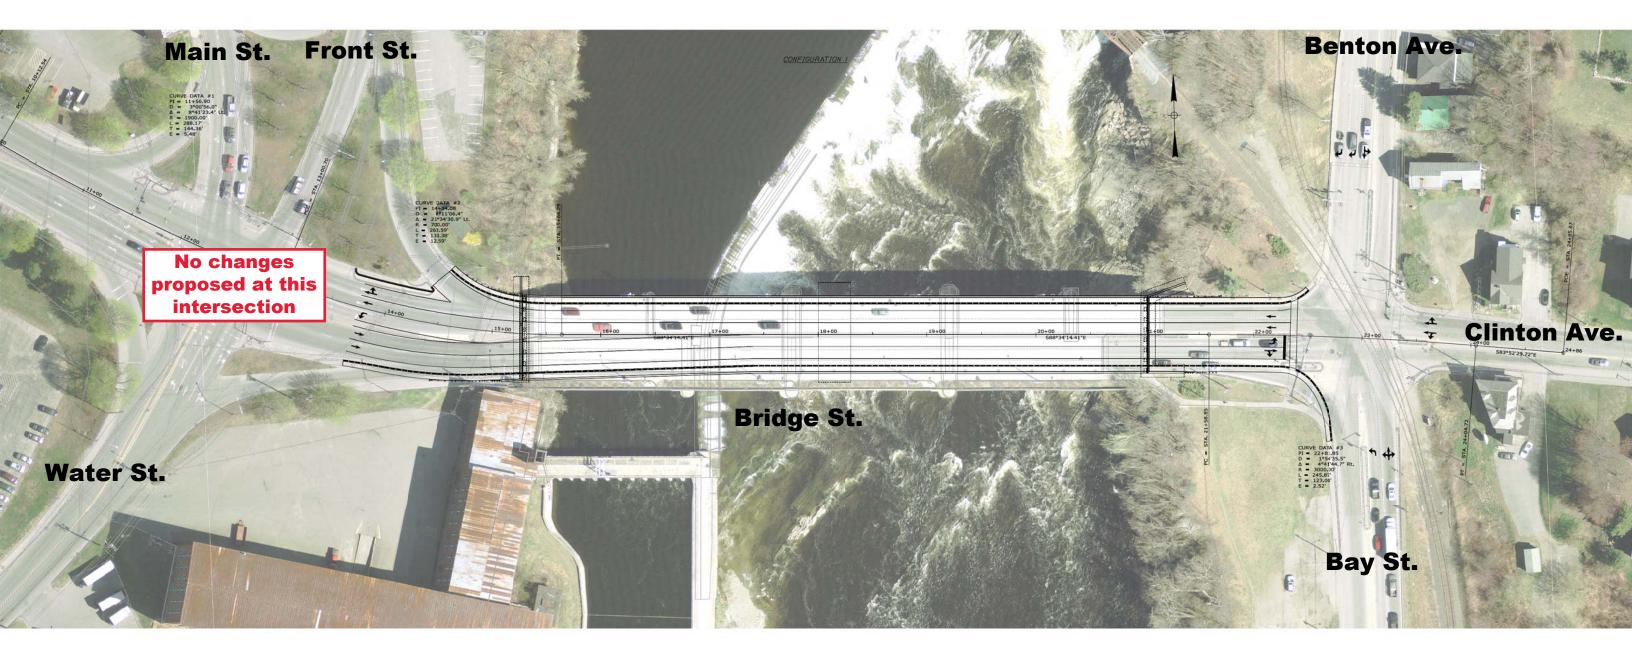
**Configuration 1 - Four lane bridge, flared at Waterville approach**

- WB across bridge remains two lanes
- EB approach at Winslow intersection reduced to two lanes (dedicated left turn lane with through/right)
- Remaining legs of Winslow intersection unchanged

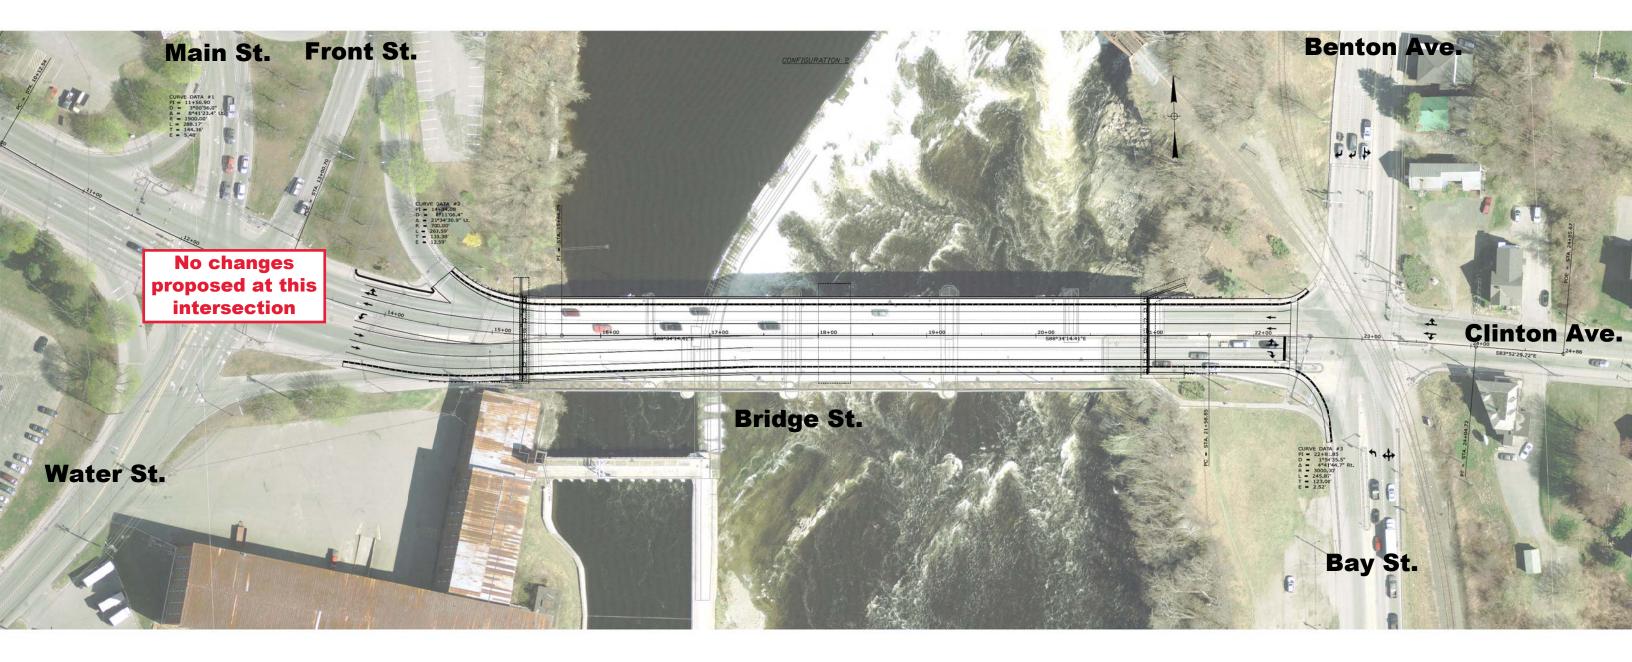
**Configuration 2 - Four lane bridge, flared at Waterville approach**

- WB across bridge remains two lanes
- EB approach at Winslow intersection reduced to two lanes (through/left lane with dedicated right)
- Remaining legs of Winslow intersection unchanged

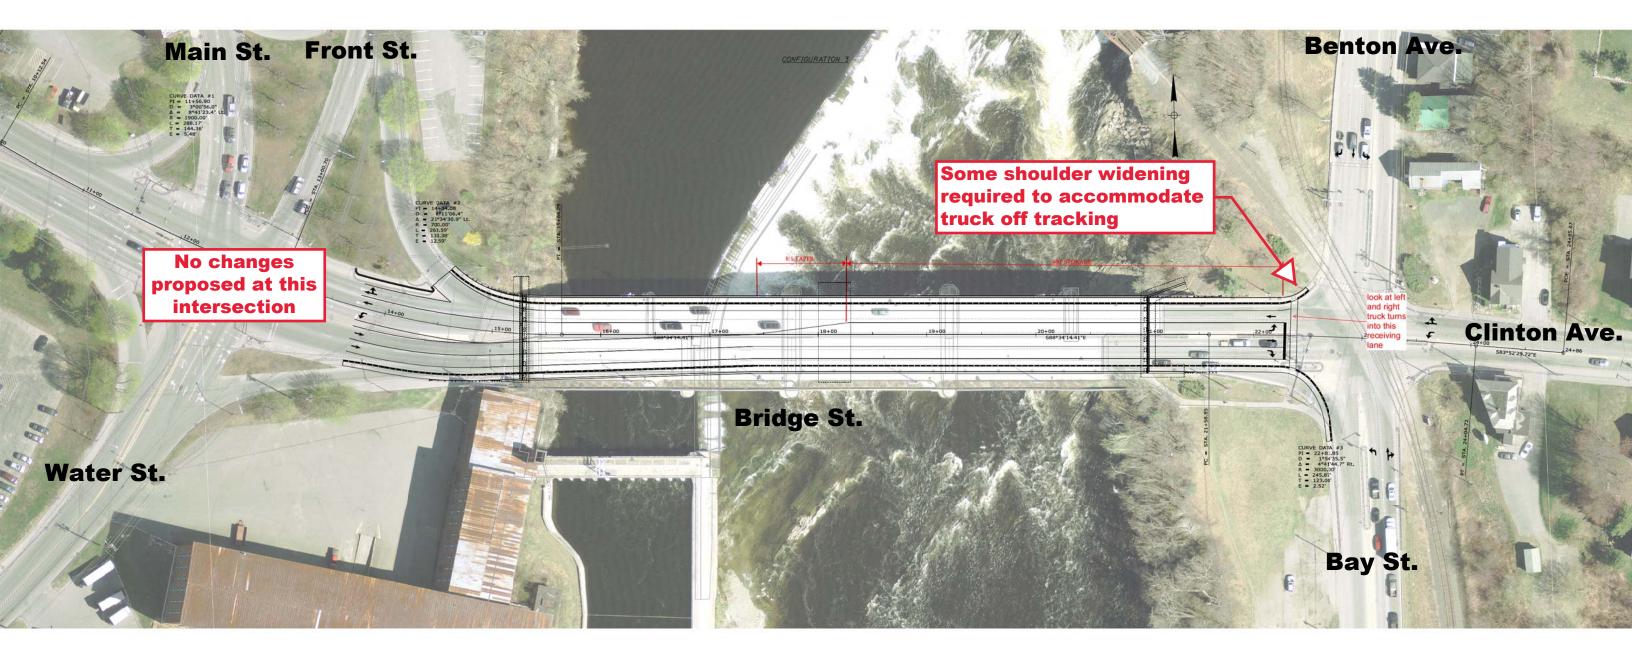
**Configuration 3 - Four lane bridge, flared at Waterville approach**

- WB across bridge reduced to a single lane on Winslow side
- EB approach at Winslow intersection remains three lanes (separate left, through and right turn lanes)
- Remaining legs of Winslow intersection changed to accommodate single WB lane on bridge approach

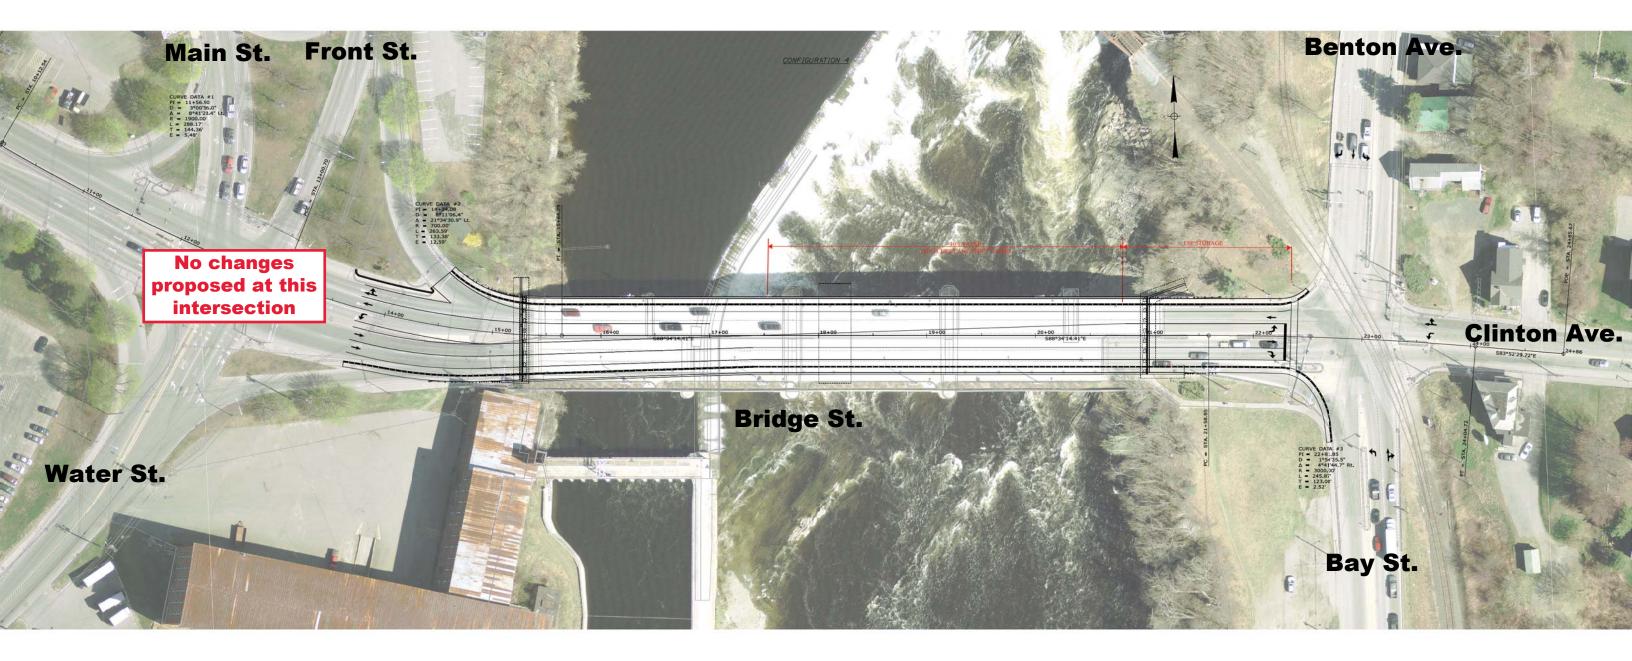
**Configuration 4 - Four lane bridge, flared at Waterville approach**

- This is a variation of Configuration 3 with a change to how the left turn lane for Bridge St EB develops

## This option is not suggested for construction

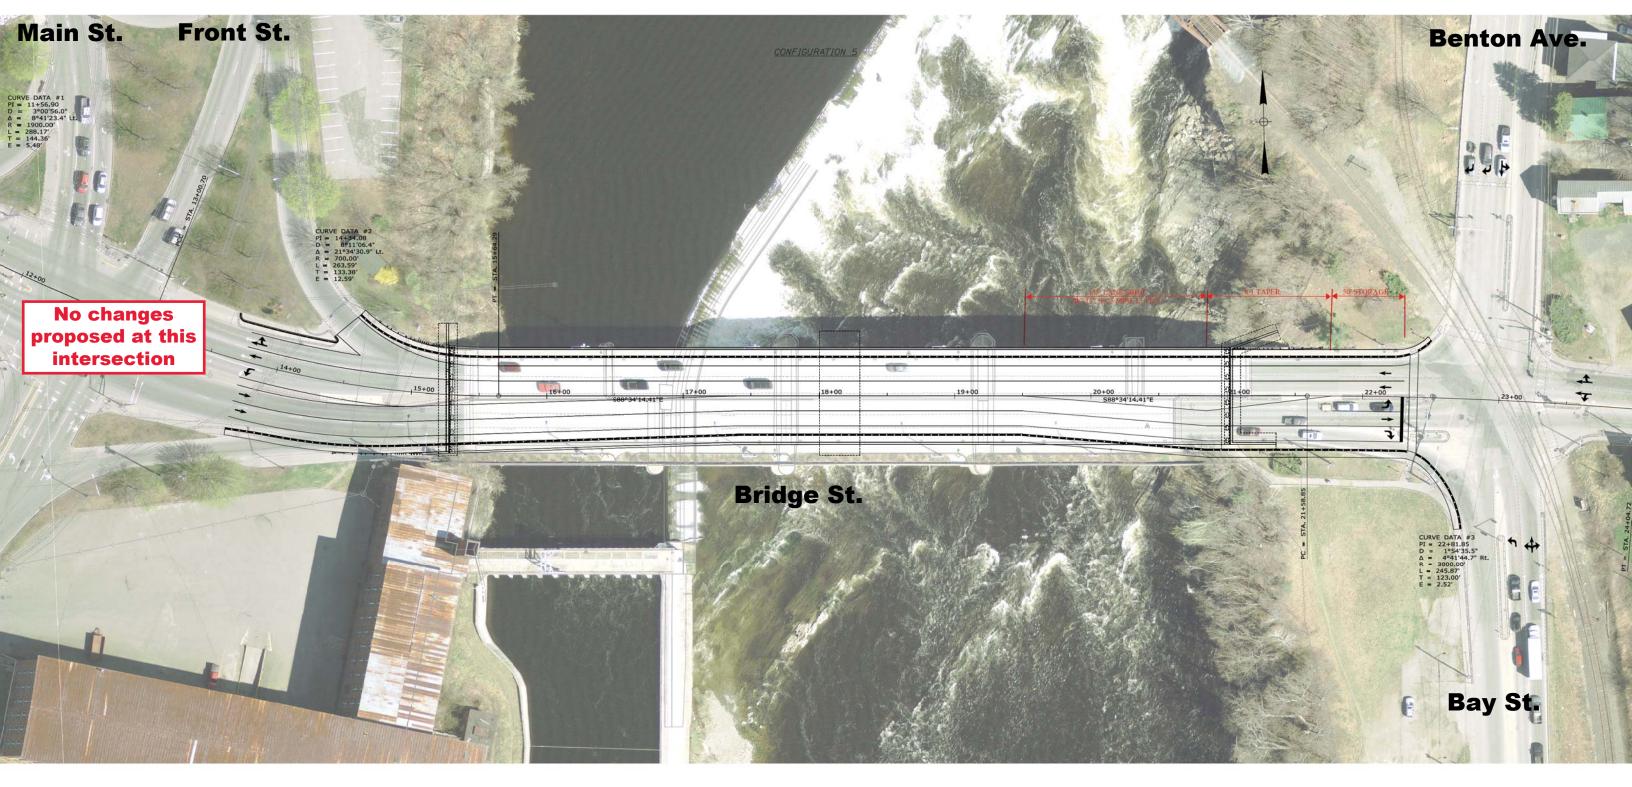
**Configuration 5 - Four lane bridge, flared at Waterville and Winslow approach** - This option allows for five lanes at the EB approach to the Winslow intersection with a four lane bridge

> This option is not suggested for construction whereas building a five lane bridge would likely be preferable to building a bridge with flares at both ends.

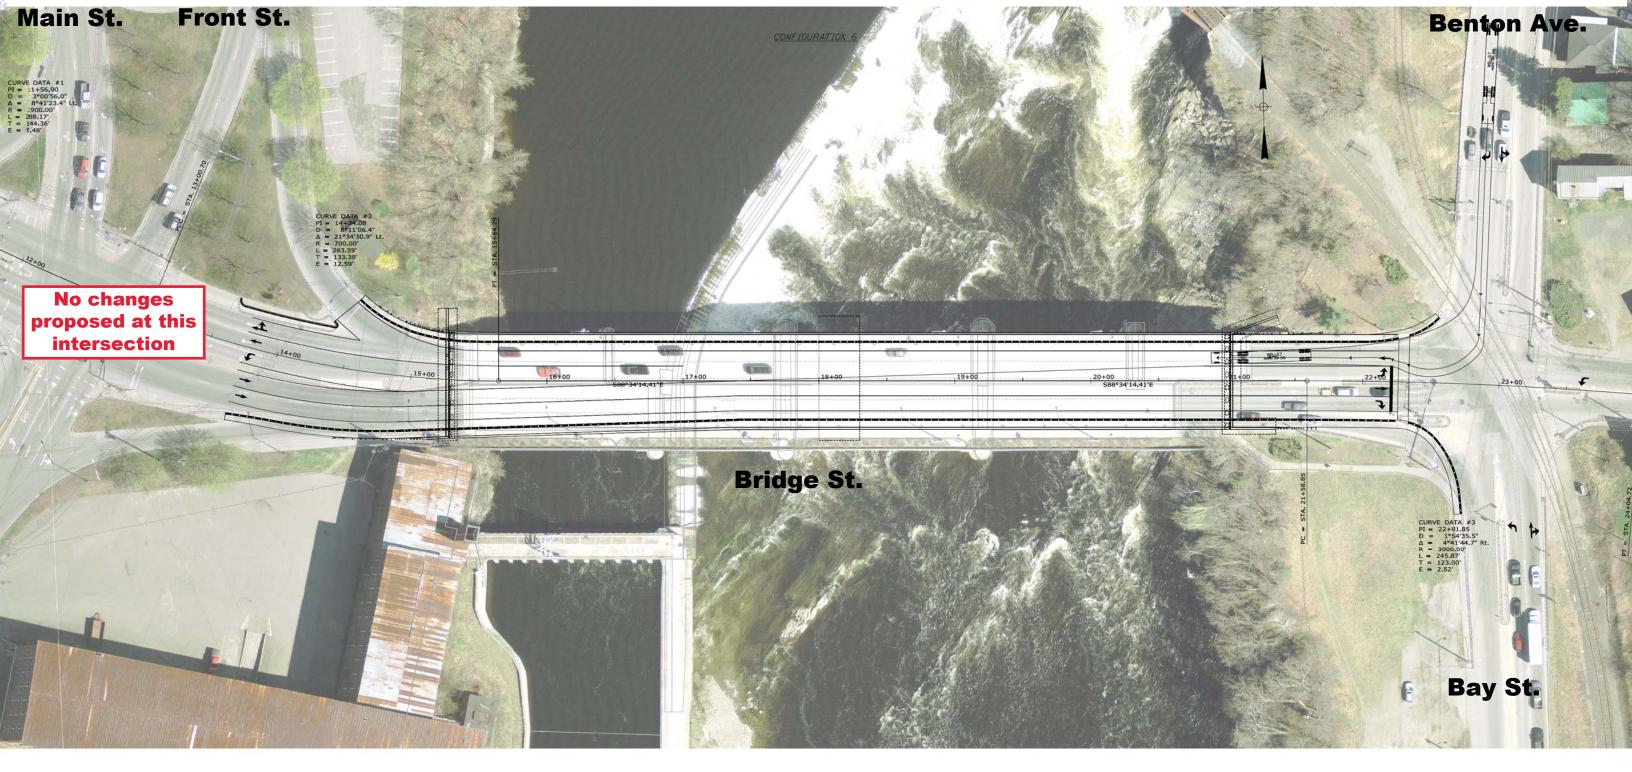
**Configuration 6 - Four lane bridge, flared at Waterville approach**

- This is a variation of Configuration 3 with a change to the SB leg of the Winslow approach to avoid shoulder widening
- WB across bridge reduced to a single lane on Winslow side
- EB approach at Winslow intersection remains three lanes (separate left, through and right turn lanes) - Remaining legs of Winslow intersection changed to accommodate single WB lane on bridge approach.

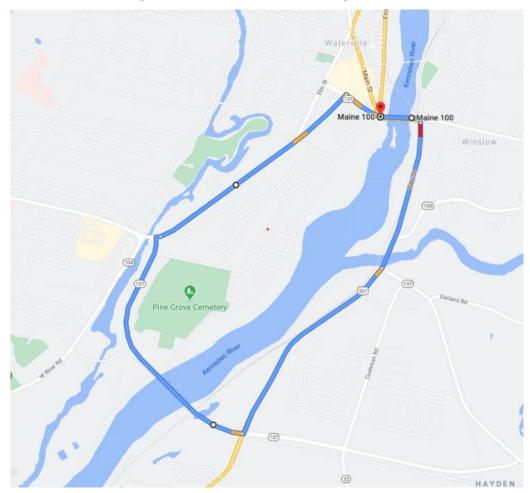
Figure 1 – Potential Detour for Bridge Closure

- 2 lane bridge with 1 lane in each direction and intersection modification to removal dual approaches (included for reference).
- 2 lane bridge with 2 lanes eastbound and intersection modifications to the Winslow intersection to prevent vehicles from entering the bridge. A preliminary detour for westbound traffic is shown below. The detour route has not been operationally evaluated.

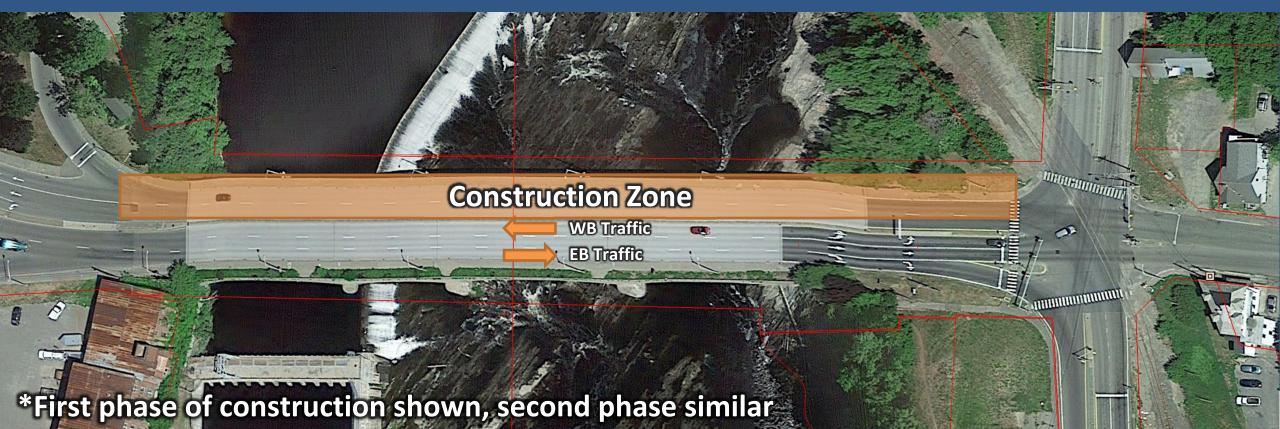
- Option 1:
  - Traffic limited to one lane of traffic in each direction
  - Occasional short-term bridge closures for key activities (e.g. demolition, girder erection)
  - Two construction phases, longest overall duration

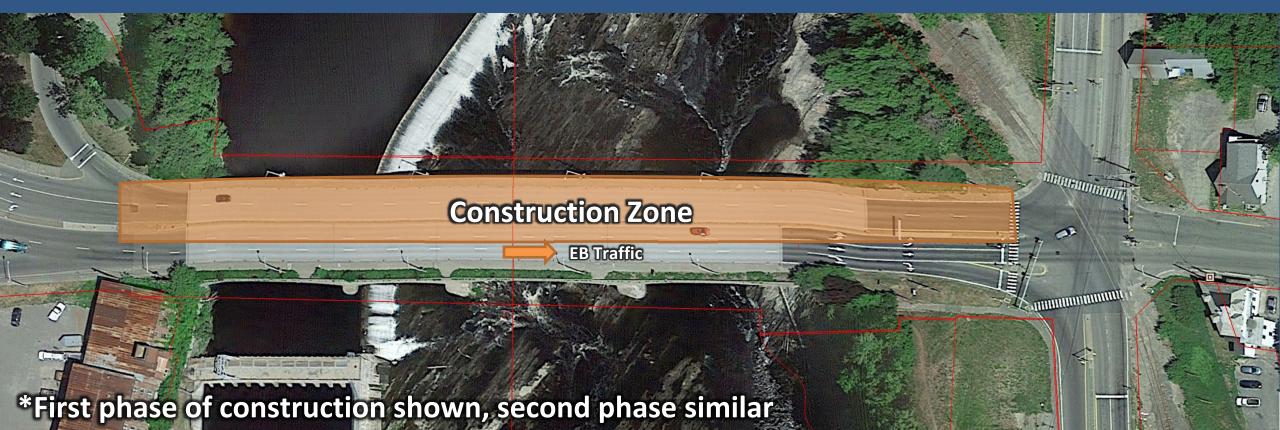
- Option 2a:
  - Traffic limited to one lane in eastbound direction only. Westbound traffic detoured.
  - Improved worker safety, more efficient construction operations
  - Two construction phases, duration slightly shorter than Option 1.

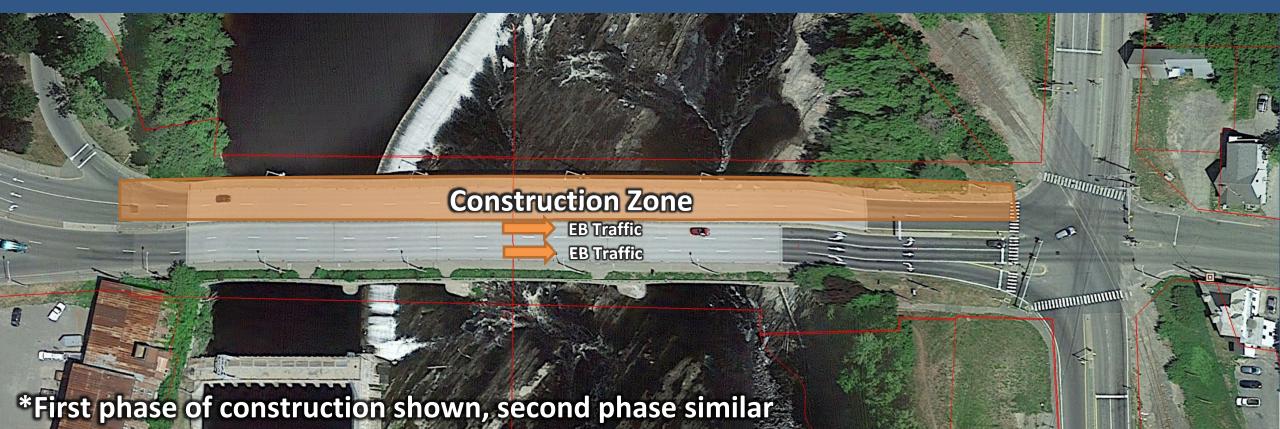
- Option 2b:
  - Traffic limited to one lane in eastbound direction only. Westbound traffic detoured.
  - Improved worker safety, more efficient construction operations
  - Two construction phases, duration slightly shorter than Option 1.
