# Coastal Erosion Assessment for Maine FIRMs and Map Modernization Plan

Stephen M. Dickson, Ph.D.  
State Marine Geologist  
Maine Geological Survey  
Department of Conservation  
22 State House Station  
Augusta, ME 04333-0022

W. Louis Sidell, Jr. CFM  
State Floodplain Management Coordinator  
Maine Floodplain Management Program  
State Planning Office  
38 State House Station  
Augusta, ME 04333-0038

July 2, 2003

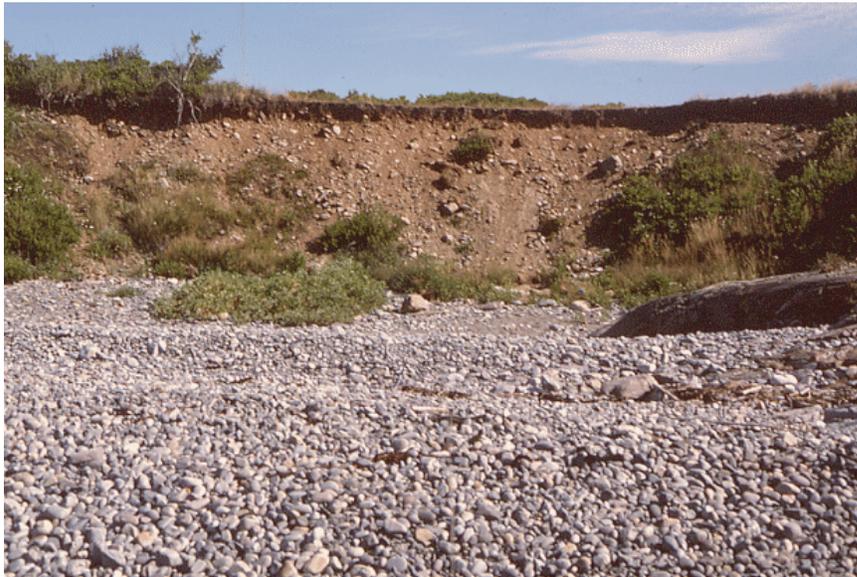
Bluff erosion and gravel beach formation at Fletcher Neck in Biddeford. Maine Geological Survey file photo.

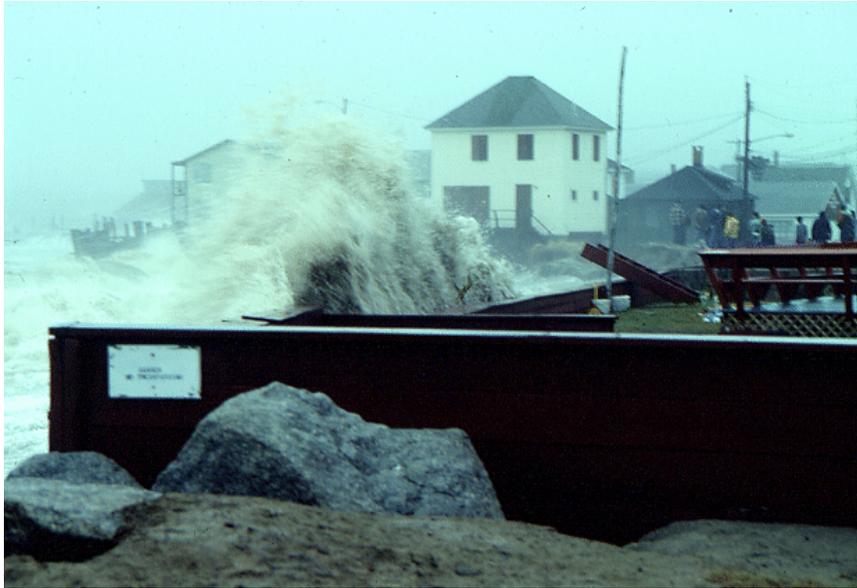
Storm wave impact on a wooden sea wall at Camp Ellis in Saco. Photo by S. M. Dickson.

Seawalls also alter the rate of sand transport along the beach. By causing increased wave reflection, the amount of sand resuspended in the water in front of a seawall can increase and lead to more sand being carried in an alongshore direction, away from the beach profile. The increase in alongshore-sand transport can be 10 times that which occurs in a natural beach and dune system. Seawalls can significantly alter the local sand budget of beaches. An effect of seawalls can be to *alter the orientation of the shoreline* and thus the way waves break and run up the beach and cause coastal flooding.

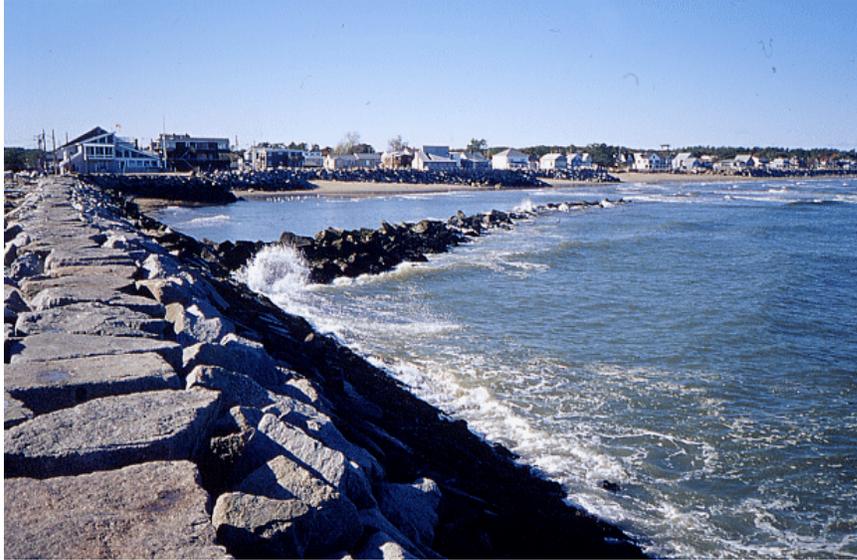
The north jetty/breakwater of the Saco River. The community of Camp Ellis (City of Saco) is in the background. Photo by S. M. Dickson.

**b. Jetties.** Jetties are engineered structures that flank tidal channels adjacent to beaches. They are installed to stop natural shoreline change where beaches meet a tidal inlet in order to provide better navigation. Maine has jetties on both shores of the Webhannet River (Wells), on both shores of the Kennebunk River, and both shores of the Saco River. There is only one jetty at the southern side of the Scarborough River. Within the estuary, both shores of the Goosefare Brook (Saco and Old Orchard Beach) are also stabilized. All of the major jetties at rivers in Maine have significantly altered local sand budgets and shoreline change.

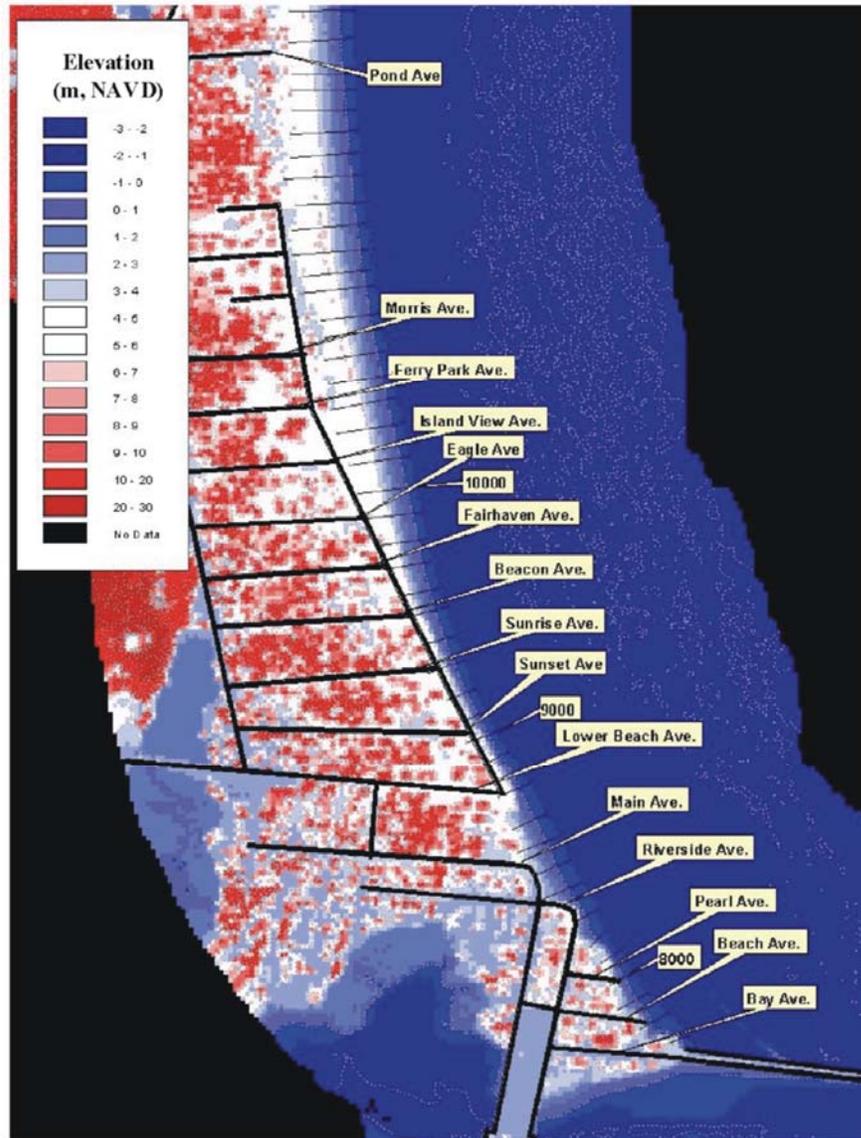
LIDAR topography from NOAA of the Camp Ellis region used to generate beach profiles and evaluate the elevation of dunes relative to base flood elevations. Graphic by P. A. Slovinsky, Maine Geological Survey. See Slovinsky and Dickson (2003) for more applications of this data.

Repeated LIDAR surveys have been used to measure shoreline change and to calculate erosion rates. Since the data have a vertical (as well as horizontal) component, equal elevation contours can be delineated and changes at a particular elevation mapped. This allows several shoreline proxies, such as mean sea level (MSL) and mean high water (MHW), can be extracted from the data. Temporal changes to dune ridge elevations can also be analyzed so trends relative to floodplain elevations can also be computed (e.g. is the frontal dune ridge getting lower over time; will the dune ridge remain above the V-Zone FHA in the next 10 years?).

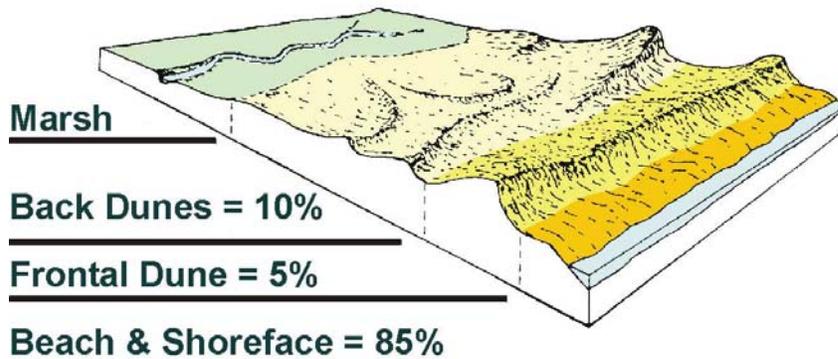
**Wells Embayment Sand Budget**

**Storage - Where does it reside?**

**Dunes = 13,000,000 cubic yards**  
**Shoreface = 75,000,000 cubic yards**

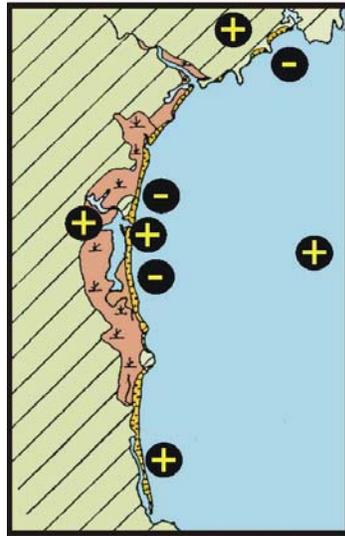
## Wells Embayment Sand Budget

Up to **2,000,000** cubic yards of beach and channel sand have been moved in **40** years as a result of human activity related to harbor and river dredging and jetty construction.

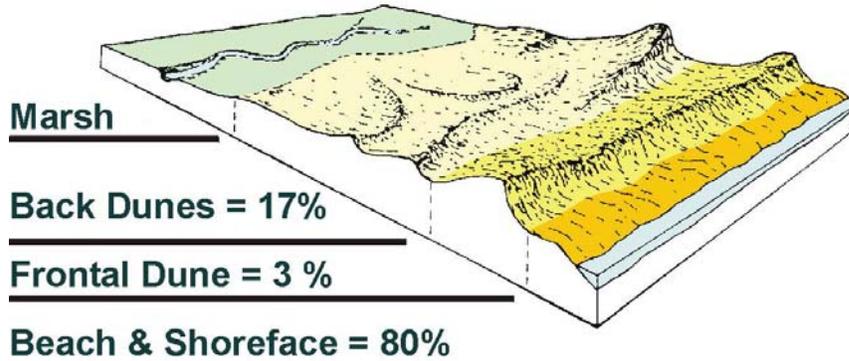
## Saco Bay Sand Budget

Storage - Where does it reside?

**Dunes = 20,000,000 cubic yards**

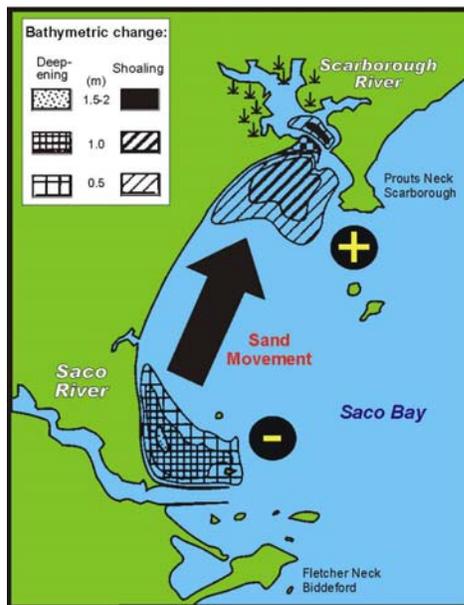
**Saco Bay Sand Budget**

About 4,000,000 cubic yards of beach sand moved north in 100 years (1859-1955) from the vicinity of the Saco River jetty to the Scarborough River tidal inlet. This is about 3 times the pre-jetty transport rate and also about 3 times the sand resupply rate of the Saco River.

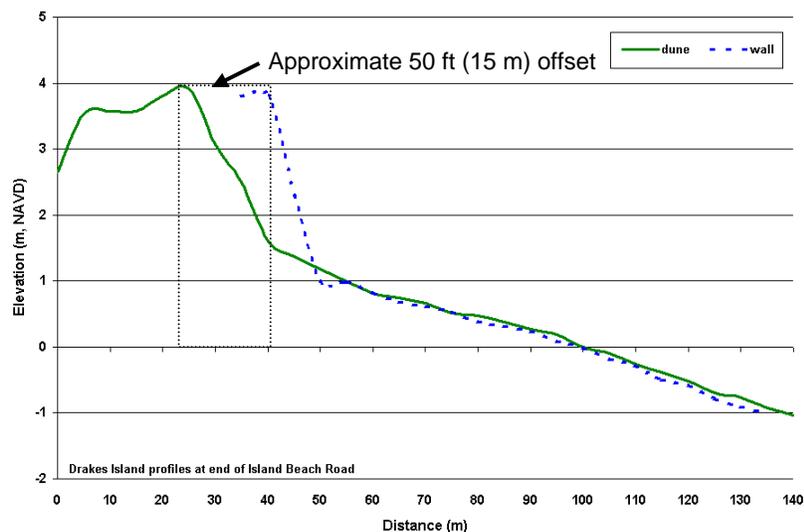
Apparent shoreline offset between beach profiles 200 feet apart along Drakes Island Beach in Wells is shown in the figure above. A “stabilized” profile at the end of Island Beach Road (blue dashed) includes a seawall protecting a home in the frontal dune. The second, a “natural” profile from approximately 200 feet north, includes only sand dune. There is an approximate 15 m offset between the crests of the two profiles, indicating that the shoreline, in absence of the seawall, would most likely be located approximately 50 ft landward. Maine Geological Survey graphic by P. A. Slovinsky.

Lastly, the Maine Geological Survey has explored new methods of estimating how much shoreline recession would have occurred in a particular location if seawalls had not been built. The approach is new and holds promise to overcome some of the difficulties present with historical photo analysis along a shoreline with seawalls. Using LIDAR topographic profiles from a natural dune system that most closely represents the beach in a particular area, the profile can be matched throughout its mid- to low-tide levels to those in adjacent beaches with seawalls. By matching the lower portion of beach profiles, the offset in the upper profiles can be examined. This offset can project the landward position of the frontal dune in an area that has been fixed due to seawalls and development. This concept is illustrated with data from Wells Beach in the figure below. The apparent offset is on the order of 50 feet (15 m) and represents what erosion would have taken place without the coastal engineering structure. This offset can be used, along with the age of the seawall, to determine an erosion rate. Since most seawalls in Maine were built in the 1940s and 1950s, the time frame for calculating this proxy for shoreline erosion is on the order of half a century, or about equivalent to the period for which aerial photographs have been available.

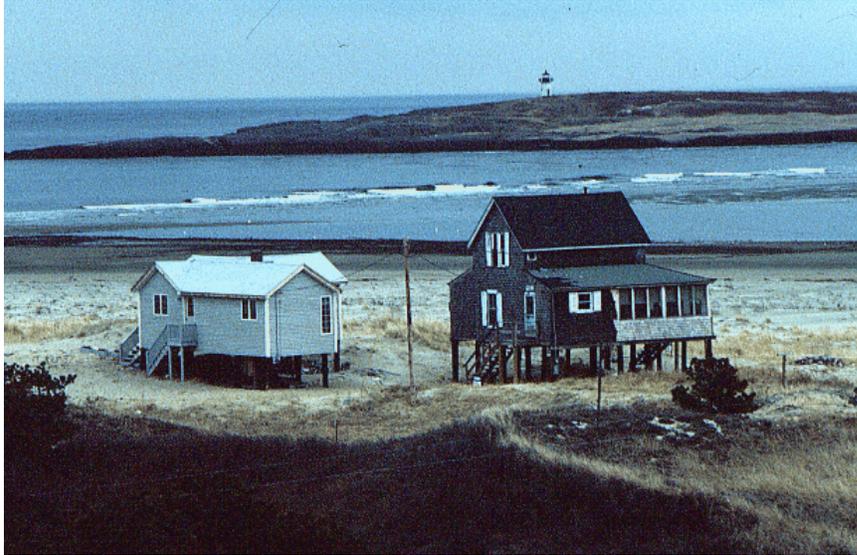
Two homes on Hunnewell Beach that were damaged by erosion and flooding and subsequently moved landward and elevated on posts. Photo by S. M. Dickson.

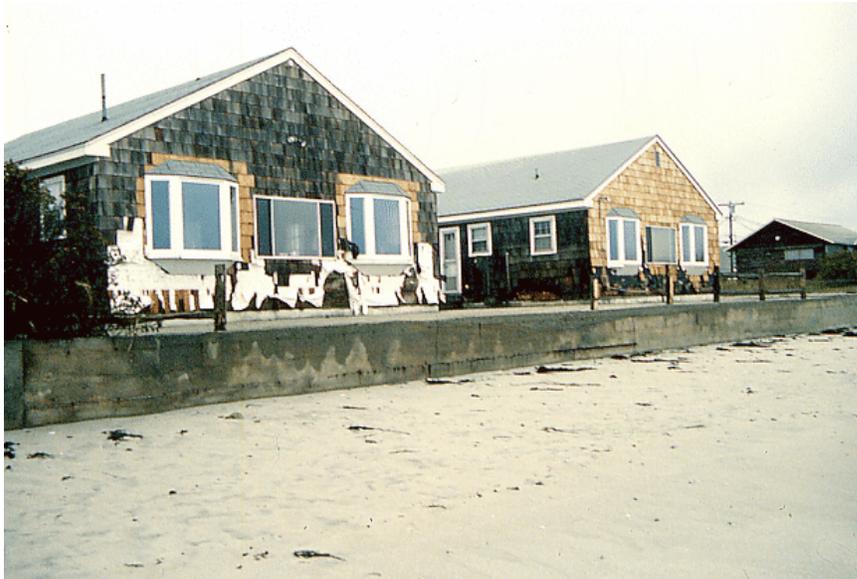
Higgins Beach after the 1991 Perfect Storm. Coastal flooding overtopped the seawall and waves damaged several homes. Photo by S. M. Dickson, 11/01/91.

**2. Higgins Beach.** In Scarborough, Higgins Beach is an isolated beach and dune system fronting the Spurwink River marsh. The tidal inlet is down drift from the beach and sand has continued to prograde in the form of a spit and dune system over the last century. Net sand transport is northeast toward the inlet. The local sand budget has no new supply of sand to the beach system so sediment removed from the southwest end of the beach is not replaced. This net loss of sand was documented by Timson and Lerman (1980) in the Higgins Beach Management Plan. For the plan, shoreline recession rates were calculated using historical shoreline positions and range from 1 to over 5 feet per year along the beach. Nelson (1979) determined the erosion rate of 1 to 1.5 feet per year over most of its length with greater variability at the spit end. The dunes are densely developed and properties have been destroyed by erosion. Chronic erosion has resulted in many seawalls being built along the frontal dune. Many of these shoreline stabilization structures are not as high as the 100-year coastal floodplain and waves can overtop the walls and reach some structures. The October 1991 "Perfect" Storm caused property damage due to wave action in the dunes. **FIRM 230052, Panel 22** was last mapped in 1992. In this analysis an average erosion rate for the FIRM was 2 feet per year; however, this analysis may underestimate the need for remapping this panel if erosion has proceeded at a faster rate in the last decade.

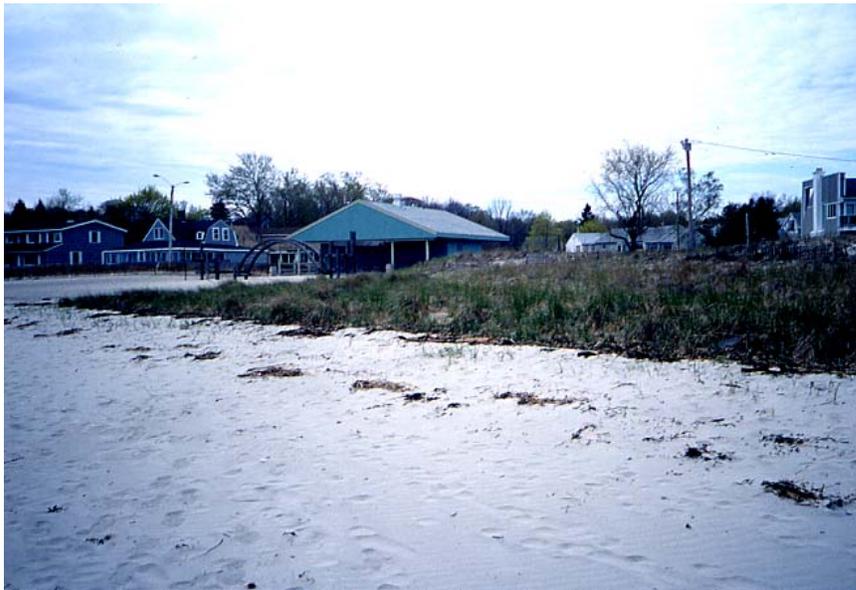
Willard Beach, South Portland has a dune management plan that has helped restore the frontal dune in the last few years. Photo by S. M. Dickson, 05/07/02.

**3. Willard Beach.** An arcuate pocket beach in Simonton Cove in South Portland is known as Willard Beach. This urban setting has dense residential development in coastal sand dunes. Beach erosion, perhaps due to poor dune management over the last century, was studied by the U.S. Army Corps of Engineers (1982) with the goal of reducing beach loss and property damage. The Corps estimated an erosion rate of 0.65 to 1.0 feet per year using historical shoreline positions. The Corps report also determined that the beach profile may have become steeper from 1853 to 1941. This change in nearshore elevations may be indicative of a negative sediment budget for the cove. For planning purposes, this report followed the guidance of the Corps report and assumed a 1 foot per year erosion rate. In the last two years there has been a concerted effort by the local community to restore the frontal dunes to preserve the beach and protect development. Dunes are currently getting higher and wider as a result of this effort. The Maine Geological Survey is currently in the process of creating a map of the coastal sand dune system for Willard Beach and the City of South Portland has adopted a beach and dune management plan. **FIRM 230053, Panel 9** was last mapped 18 years ago in 1985 and current conditions are quite different along the beach profile and in the elevation of the dunes.

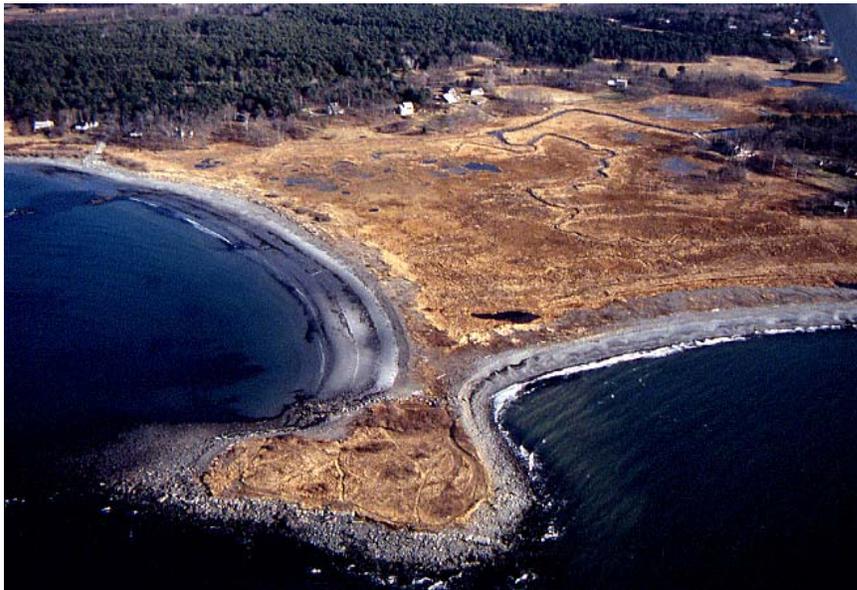
Crescent Beach (left) and Seapoint Beach in Kittery is a mixed sand and gravel beach. Dune washover is common in large storms and shoreline change is probably episodic rather than gradual. Photo by S. M. Dickson.

**4. Gerrish and Cutts Islands.** A double beach and dune tombolo system connects a small rock ledge to Gerrish and Cutts Islands in Kittery. Seapoint Beach is on the northern side and connects to Cutts Island while Crescent Beach connects to Gerrish Island. Both Seapoint and Crescent Beaches are part of the Coastal Barrier Resources System Unit A09. These two beaches are exposed to high wave energy and, based on the presence of overwash deposits of sand and gravel, are likely to be transgressive and experiencing shoreline recession (Nelson, 1979). Nelson noted that the ridges were over topped by the January 9 and February 7, 1978 storms. Additional shoreline areas have gravel beaches and storm berms that are prone to shoreline recession in AO-Zone flood hazard areas. **FIRM 230171, Panels 3 and 6** were last mapped in 1986. The relatively undeveloped shoreline along the coastal barrier makes this area less in need of remapping than some other areas with more coastal development adjacent to eroding shorelines. It does serve to show how the shoreline of a mixed sand and gravel beach system responds episodically to large storms with coastal flooding.

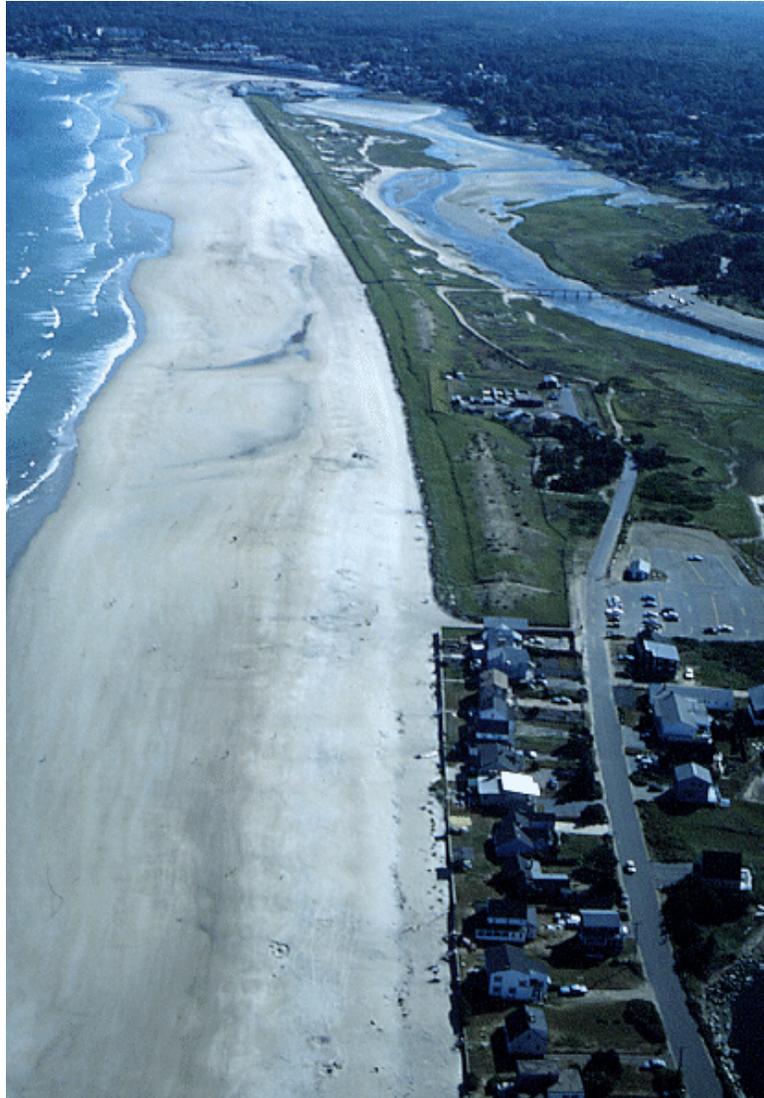
Ogunquit Beach and River (top) and Moody Beach (Wells, foreground with houses). The sewer treatment plant is in the dunes above the parking lot and behind a metal seawall in the artificial frontal dune. Photo by S. M. Dickson.

**9. Ogunquit Beach.** At the southern end of the Wells Embayment, Ogunquit Beach forms a long, linear beach and dune system with a large spit at the mouth of the Ogunquit River tidal inlet. Dunes along this beach are primarily artificial and were built in 1974 and 1975 by the Department of Agriculture's Soil Conservation Service. The dunes are cored with gravel and sand imported from an upland source. The top elevation of the dune exceeds the floodplain height and the seaward slope of the dunes is unnaturally steep. Near the middle of the beach, the Ogunquit sewer treatment plant is positioned behind a metal (sheet pile) seawall buried in the artificial dune. The treatment plant has a pipeline buried in the dunes and beneath the beach that extends out to sea where there is an ocean outfall of the treated effluent. Behind the dunes is an extensive back barrier salt marsh system. Erosion has removed part of the frontal dune in the last decade, although there are periods of dune accretion as a result of a relatively successful dune management plan by the Town of Ogunquit. Nelson (1979) found no significant erosional or accretional trend, although the data are strongly influenced by the dike construction in the 1970s. All of Ogunquit Beach is Unit ME-20P in the Coastal Barrier Resources System. **FIRM 230632, Panel 3** was last mapped in 1992.

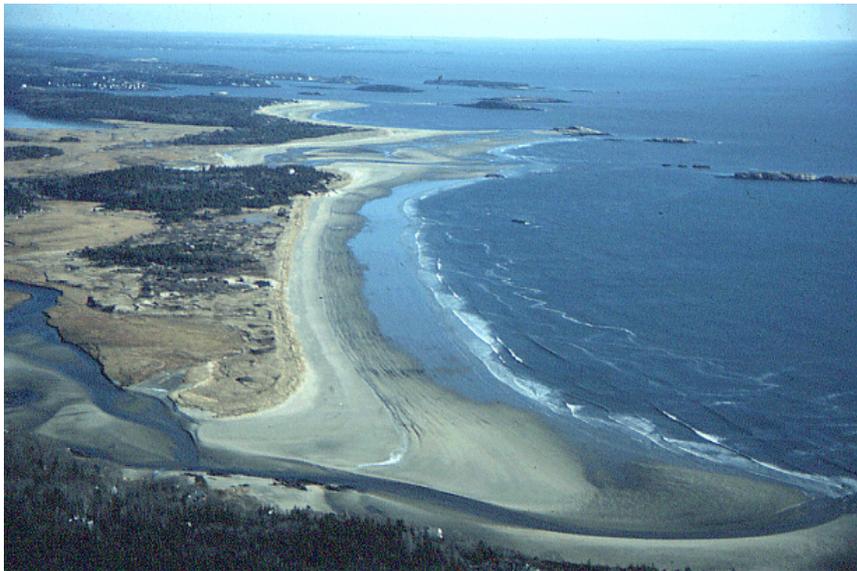
Small Point (Seawall) Beach and the Little River inlet is in the foreground and Popham and Hunnewell Beaches are in the background on the far side of the Morse River inlet. Photo by S. M. Dickson.

**11. Head Beach and Small Point Beach.** Small Point Beach, also known as Seawall Beach is a large natural barrier beach and dune system that fronts the Little River and Morse River tidal inlets and salt marshes. This dune system, like those at Reid State Park, has a linear shoreline and a large and wide frontal dune ridge. Nelson (1979) reported a long-term erosion rate of 1 to 1.5 feet per year and documented significant erosion (30 to 50 feet) of the frontal dune as a result of the large storms in the winter of 1978. Measurements of beach profiles have shown that a winter northeaster can lower the Small Point (Seawall) Beach profile by as much as 3 feet during a storm (Jones, 2000) so flood hazard calculations based on topographic profiles do need to anticipate brief vertical changes to the beach. Small Point Beach is part of Coastal Barrier Resources System Units ME-16 and 17. Head Beach is west of Small Point Beach and on the west side of the Small Point peninsula. This beach is a sandy pocket barrier beach with a salt marsh and tidal bay on the back side. The dunes are relatively undeveloped and minimally managed to control pedestrian traffic through the dunes. Head Beach is part of Coastal Barrier Resources System Units ME-A05B. **FIRM 230120, Panel 11** was last mapped in 1992.

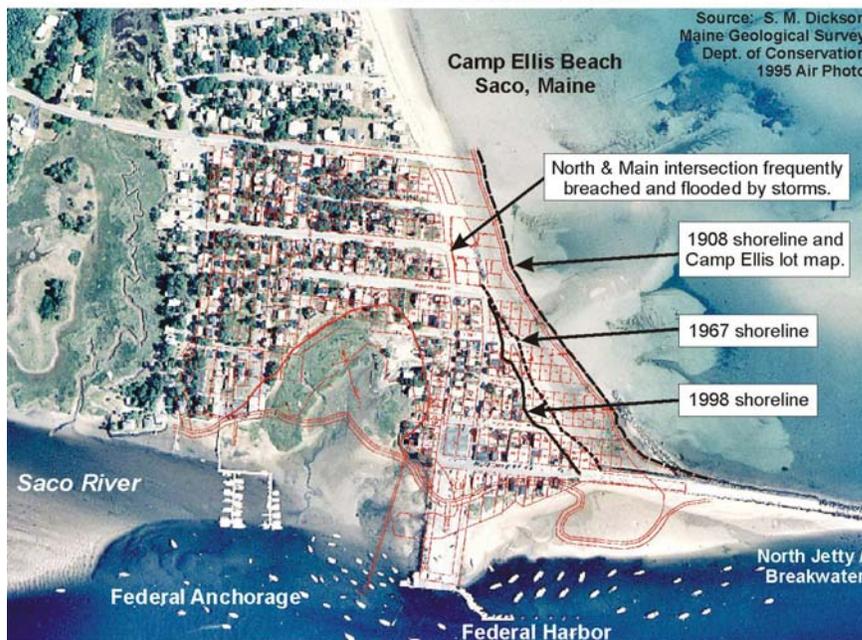
### Past Shoreline Positions

Over 30 properties have been lost in less than 100 years. Historical lot map modified from Appendix E of the Saco Bay Regional Beach Management Plan, 2000. Shorelines mapped in 1998 by the Saco Bay Beach Erosion Committee. Historic shoreline positions (black lines) and tax map lots (red) superimposed on a 1995 air photograph of Camp Ellis Beach in the City of Saco where the U.S. Army Corps of Engineers in conducting a Section 111 mitigation study.

This area is currently under investigation by the U.S. Army Corps of Engineers, New England District, as part of a Section 111 (Rivers and Harbors Act) study for mitigation of erosion caused by the federal jetty. Details about the history of the area can be found in Slovinsky and Dickson (2003). **FIRM 230155, Panel 29** was last mapped in 1998. The Kinney Shores section of Saco (**FIRM 230155, Panel 27**) has a lower erosion rate of about 1 foot per year with a net shoreline change of about 5 feet since the last FIRM was produced. Anticipated federal action to modify the jetty and to nourish the beach with sand may result in a significant alteration of the shoreline configuration on Panel 29 in the next 5 years.

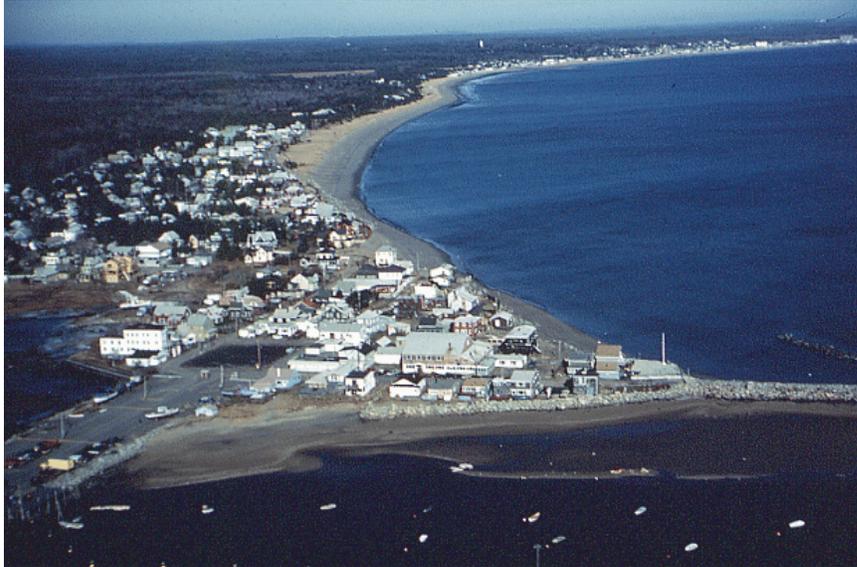
Saco Bay and the Saco River mouth in the vicinity of Camp Ellis. The north jetty/breakwater is in the right foreground. Photo by S. M. Dickson.

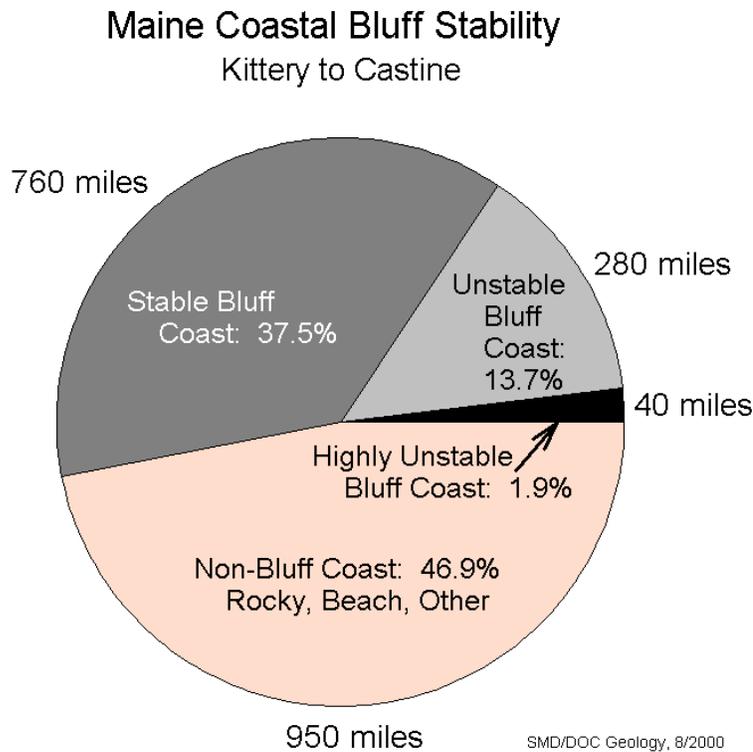
In addition to the chronic erosion that is common on the face of many bluffs, there is another process of internal mass movement of the land that places some structures at risk. Landslides, formed by the internal failure of sediments, tend to occur in areas where the sediments are (a) made of clay, (b) the clay thickness exceeds 20 feet, and (c) there is water saturating the ground. Factors that lead to landslides are described on the MGS Coastal Landslides map series (Dickson, 2001c) and include the slope of the bluff face, types of vegetation, depth to bedrock, sediment type, ground water level, weathering, and earthquakes. Land use that affects vegetation, surface or groundwater levels, and buildings that load the ground all can contribute to increase or decrease landslide risk.

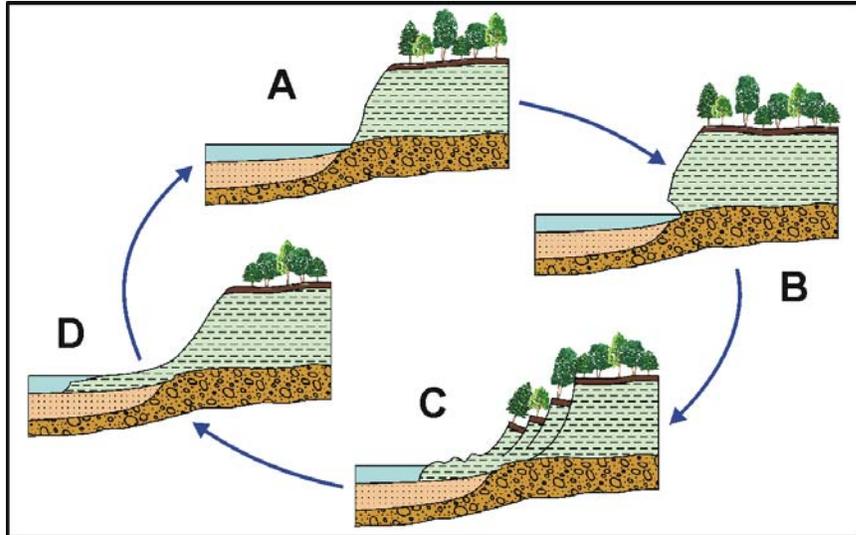
The cycle of bluff erosion by marine processes (A to B) with wave undercutting and oversteepening of the bluff toe. In areas where the bluff is composed of clay with a thickness of 20 feet or more (C) there is a risk of internal failure and down slope movement in the form of a landslide. Tides and waves rework slumped deposits (D). In all areas with chronic bluff erosion and or landslides, the shoreline continues in a net landward direction and results in erosion hazards to bluff-top structures. Source: MGS Coastal Landslide Map series (Dickson, 2001c).

Shoreline engineering is sometimes used to stabilize the shoreline at the base of bluffs. This effort has been successful in some locations and not in others. In order to reduce the risk of landslides, bluffs are sometimes graded to a lower slope in order to relieve the earth load within the sediments. The MGS map products provide an indication of which areas are vulnerable to bluff erosion and landslides. The risk to property from landslides is very real and the timing of failure is difficult to predict.

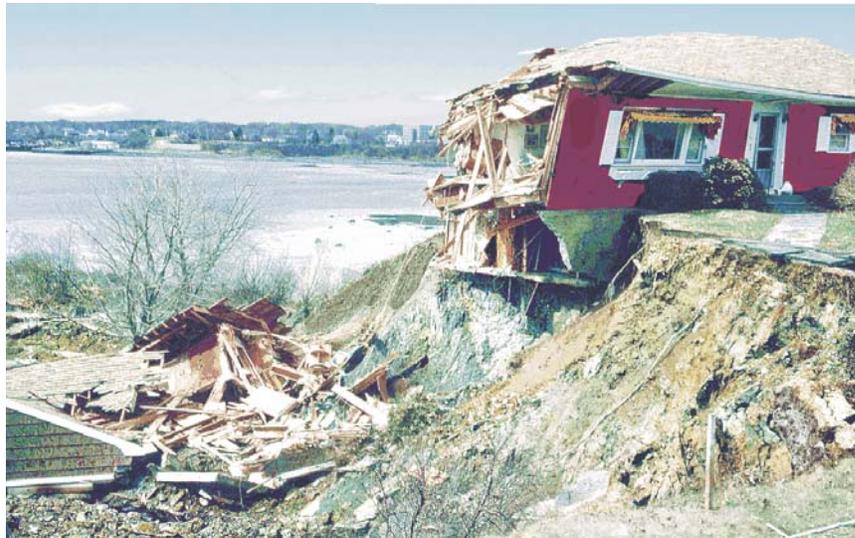
Landslide damage in Rockland, Maine in 1996. See Berry et al., (1996) and MGS (1997) for more information on the 1996 landslide. MGS file photo.
