Geologic Site of the Month
February, 2006

***Dune Restoration at Willard Beach in Simonton Cove
South Portland, Maine***

Text by
Stephen M. Dickson

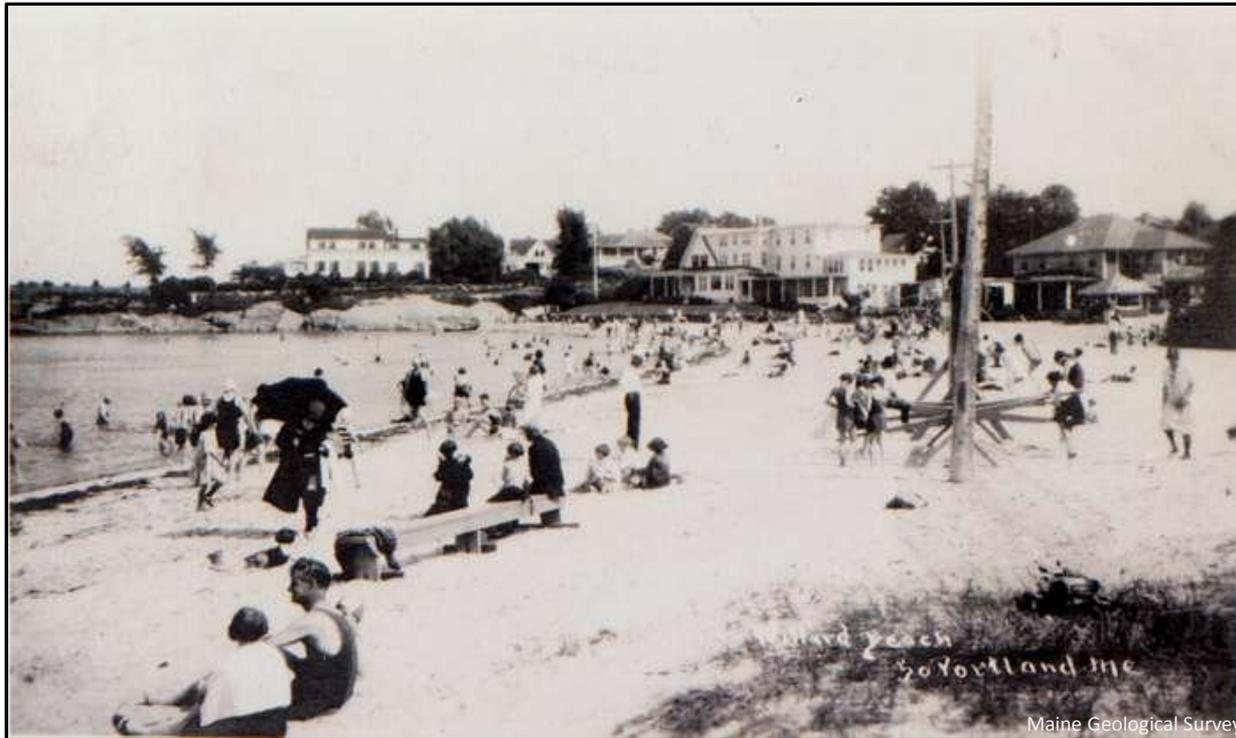
Figure 3. An antique photograph of the central portion of Willard Beach indicates a level of recreational use that is similar to that of today. The seaward edge of the frontal dune vegetation is visible in the foreground and would continue past the utility pole and playground if left undisturbed by people. The Willard Haven Inn is in the background.

In Figure 3 the vestiges of a dune can be seen in the foreground. Some of the buildings were built on posts and it appears that wave action could reach them in storms due to the lack of a frontal dune (Figure 4).

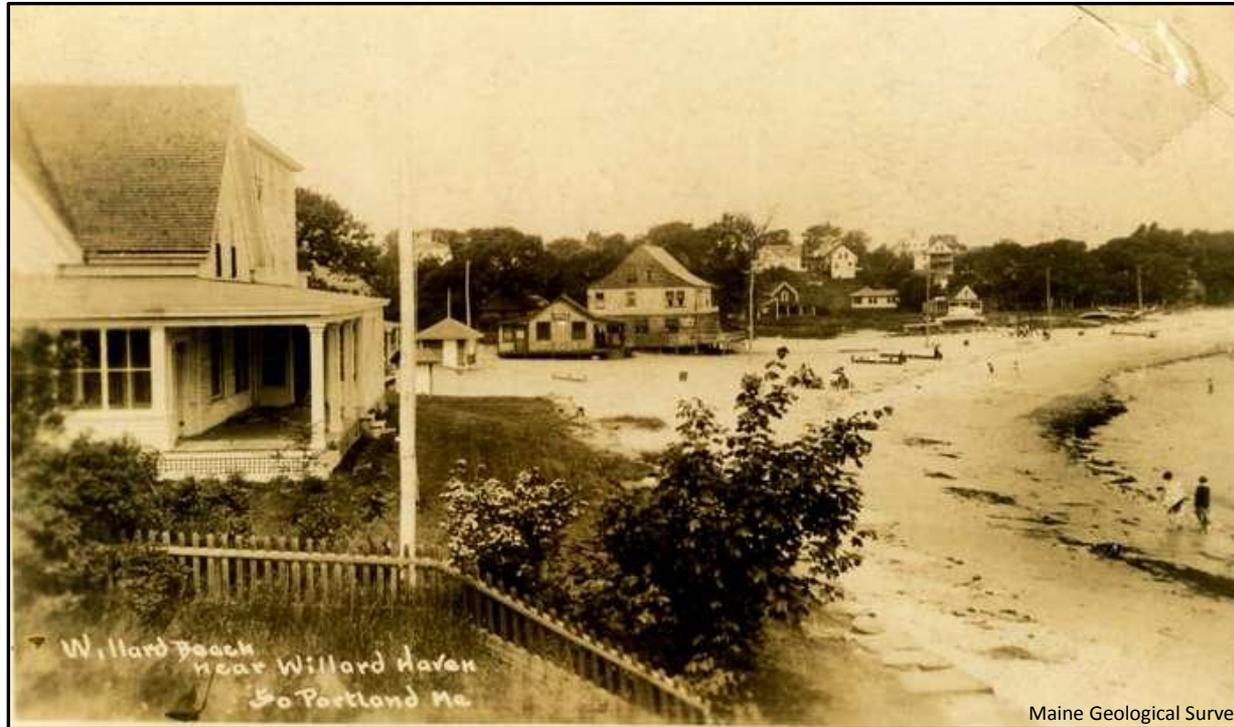
Figure 4. Antique photograph of Willard Beach from the southwest end looking northeast toward Spring Point. Notice how several buildings are built on posts directly over sand that slopes down toward the beach. This grade is probably a result of wave action across the sand surface. These structures could have been better protected if the dunes had been allowed to grow dune grass and trap sand. A higher dune would have limited the inland reach of storm waves.

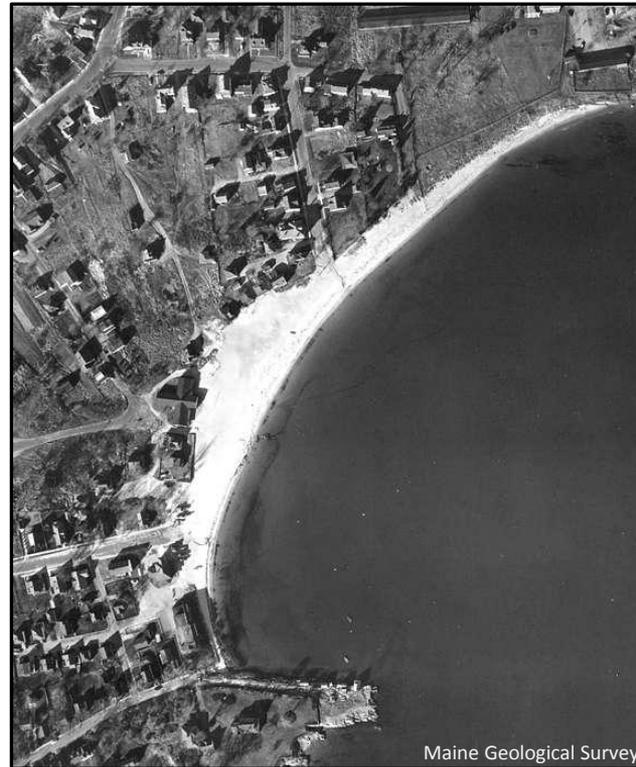
Photo No. PWN-2-3 courtesy of L. K. Fink, Jr

Figure 5. A vertical air photo of Willard Beach taken December 1, 1956. In the low angle winter sun, shadows fall on parts of the dunes. The open sandy beach extends up to the front of many homes (see details in Figures 6-8). The ground does not appear to be snow-covered, so light tones are sand.

Residential development has fringed Willard Beach for generations and a strong sense of community exists there today. In 1956, development consisted primarily of single-family homes (Figure 5), many of which were close to the beach and not protected behind sand dunes (Figure 6-8).

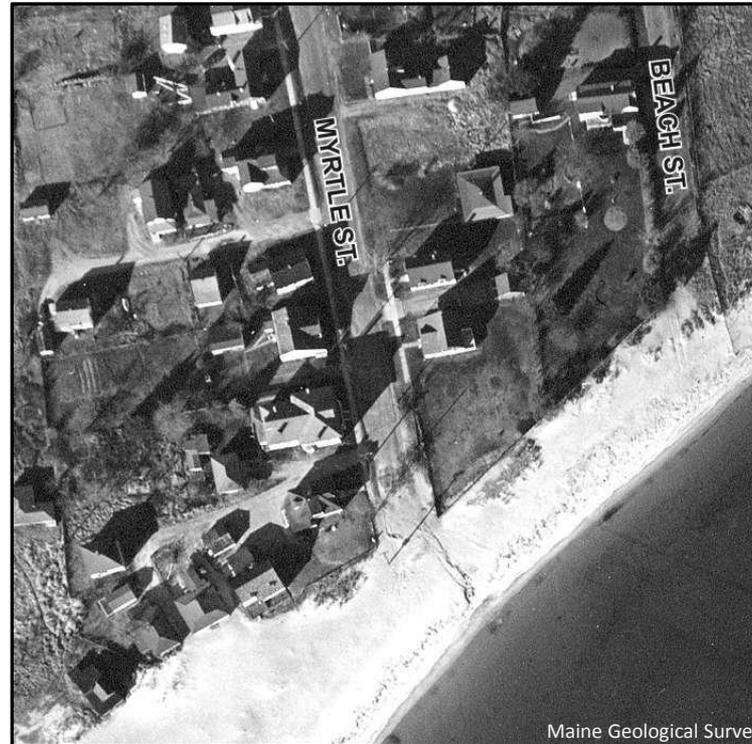
Photo No. PWN-2-3 courtesy of L. K. Fink, Jr

Figure 6. A detailed view of Figure 5 at the northeastern end of the beach near Myrtle and Beach Streets in 1956. Note the irregular appearance of the seaward dune edge in front of the houses and end of the streets. Some of the irregular dunes are due to human activity and some are due to storm erosion. At the upper right corner of the photo the dunes appear less disturbed. This trend appears also in Figure 5 along what is now the SMCC campus.

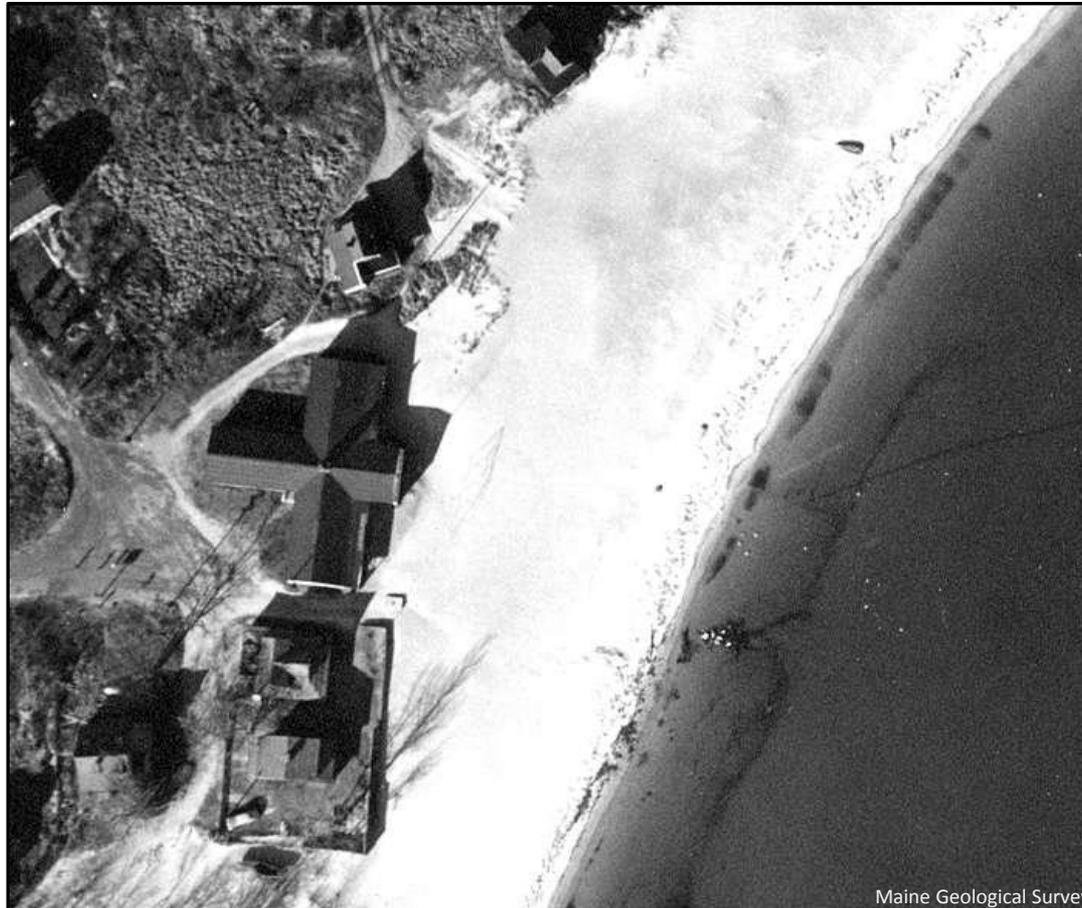
Photo No. PWN-2-3 courtesy of L. K. Fink, Jr

Figure 7. A close-up view of Figure 5 in the central section of Willard Beach in 1956 near Willow Street and Franklin Terrace. Note the boat on the beach near where the high-tide line would be. Vehicle traffic probably led to the loss of natural vegetation and relief landward of the high-tide line.

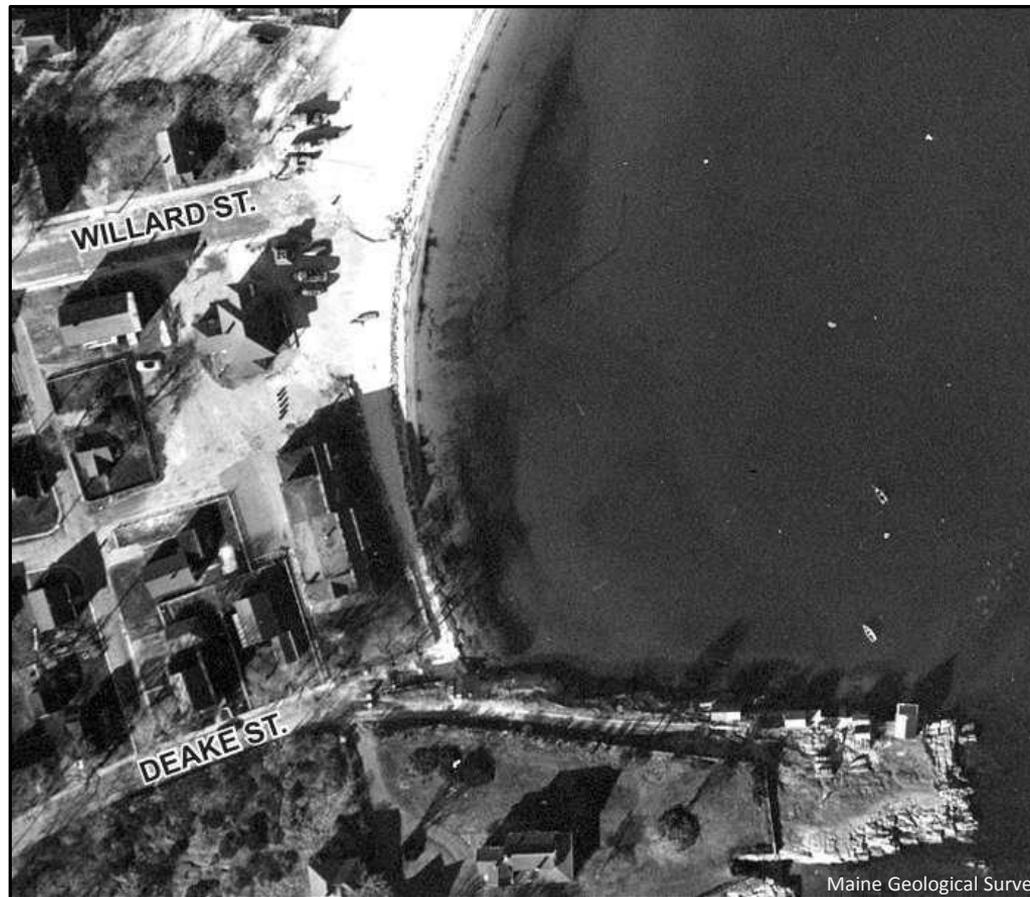
Photo No. PWN-2-3 courtesy of L. K. Fink, Jr

Figure 8. A detailed view of Figure 5 at the southwestern end of the beach near Willard and Deake Streets. Several boats are visible (some in shadows) near the end of Willard Street. The beach is narrow where it meets Deake Street, in part perhaps due to a seawall and in part due to the presence of the bedrock headland.

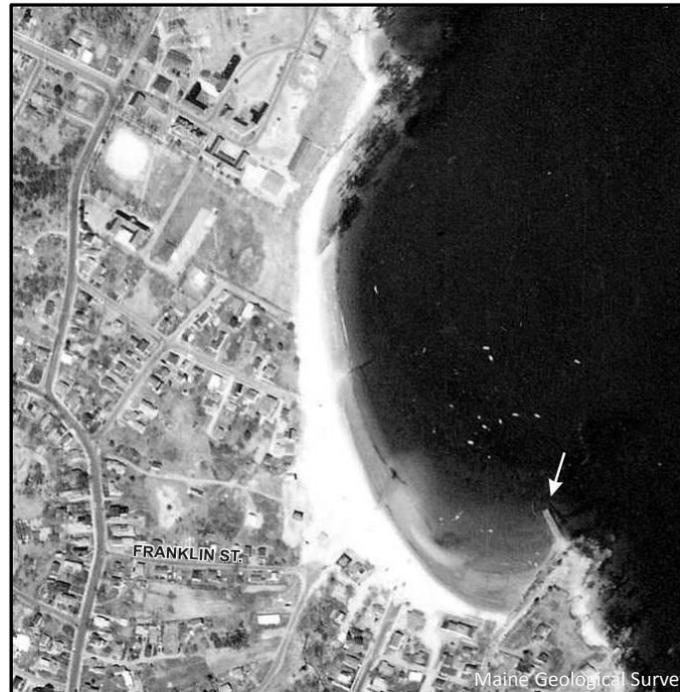
Figure 9. In this photo from 1964 the tide appears lower and thus the intertidal portion of beach is wider. Boats can be seen moored in the cove.

Willard Beach in 1964 appears quite similar to 1956 with a large open expanse of sand and few dunes (Figure 9). On the lower beach profile, structures associated with pipe outfalls can be seen. The large building at the end of Franklin Street (with a t-shaped roof) was removed in 1967 and a smaller structure built in 1976 sits in its place surrounded by open sand. A rock breakwater (known as the wharf jetty) extends from the bedrock headland southern end of the cove. Timson (1977) concluded that the wharf jetty had no significant influence on beach erosion.

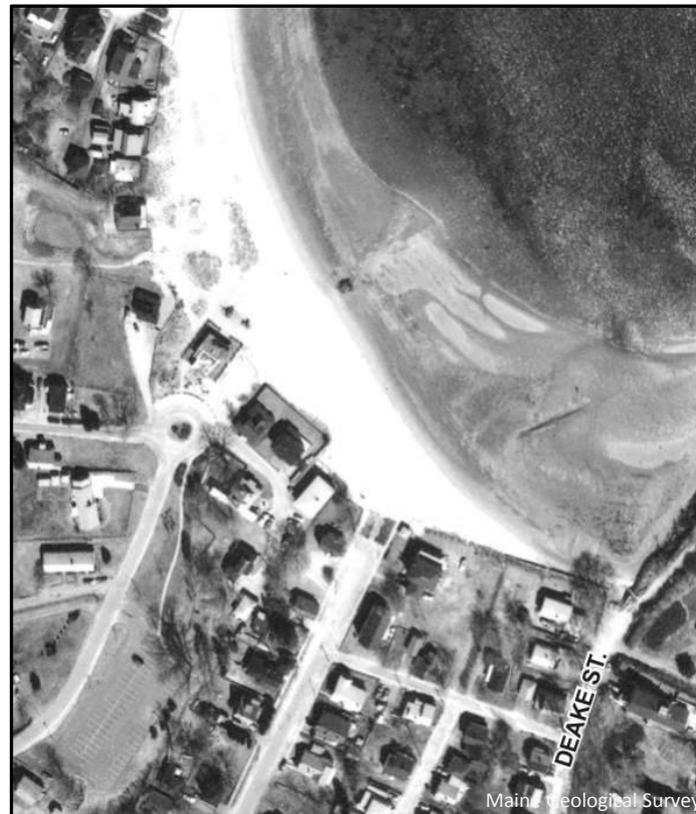
Figure 10. The central and southern section of Willard Beach in 1986. The dry beach (white sand) at the southern end of the beach near Deake Street is absent, suggesting that the high tide reaches the seawall.

By 1986 sand dunes with sparse vegetation had begun to build seaward of some homes (Figure 10-11). The bathhouse facility next to the traffic circle is partially surrounded by dune vegetation. These incipient dunes probably trapped sand and benefited from fewer people walking or driving across them.

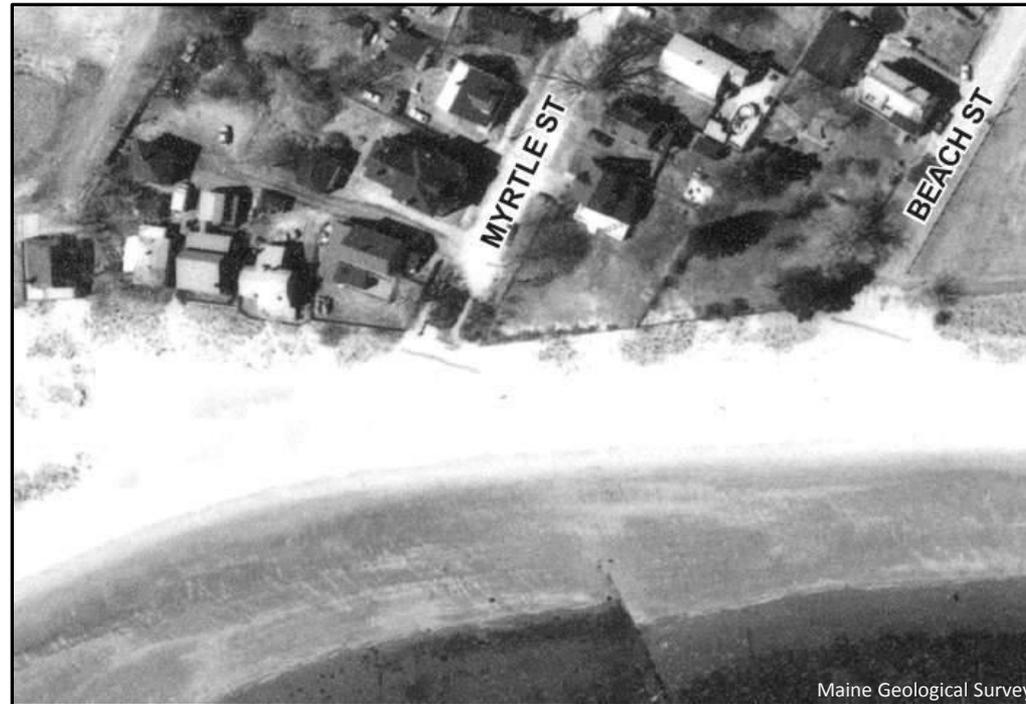
Figure 11. Willard Beach near Beach and Myrtle Streets in 1986. A pipeline running across the lower beach causes an offset in the water line. Incipient frontal dunes are forming seaward of several houses and fence lines. Access points from the streets appear to have sand fencing to control foot traffic and to trap wind-blown sand.

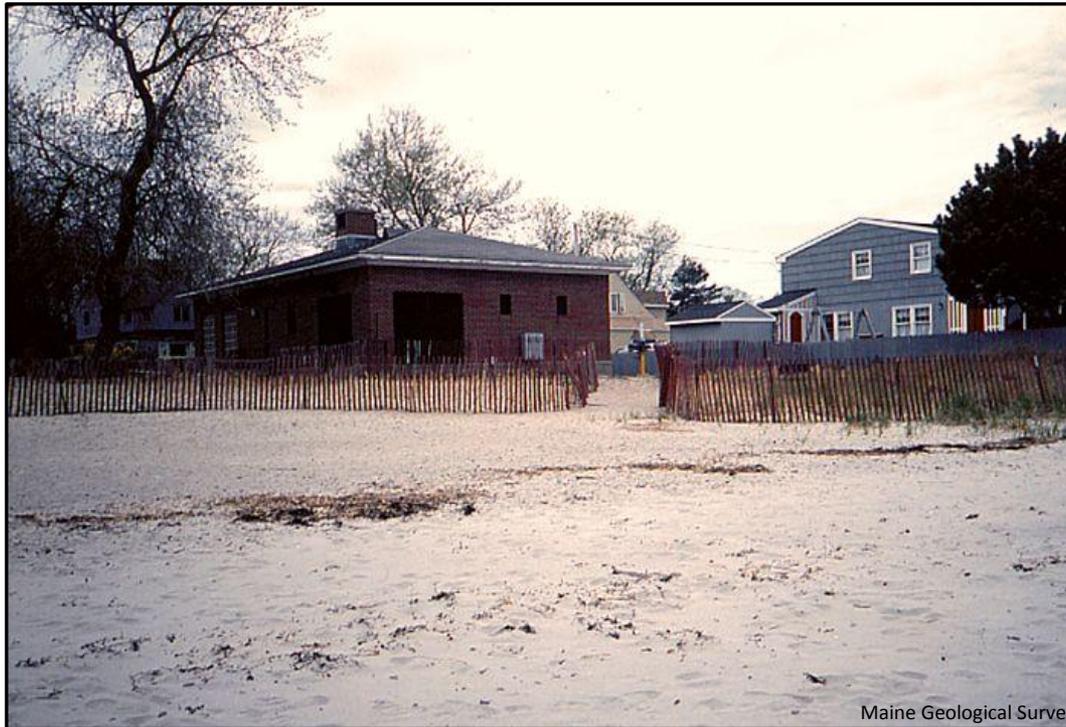
Figure 17. A May 7, 2002 photo of an entrance path to Willard Beach next to the sewer pumping station. See Figure 18 for the change in beach grass over one summer growing season.

In Figure 17 sand fencing has been placed seaward from the edge of dune vegetation from the prior year. Through the growing season, rhizomes (roots) of American beach grass will extend beyond the fence and propagate over the sand. New shoots of the grass will trap sand and lead to higher dune elevations. Foot traffic and erosion by storms will break the stems and limit the seaward growth of the vegetation.

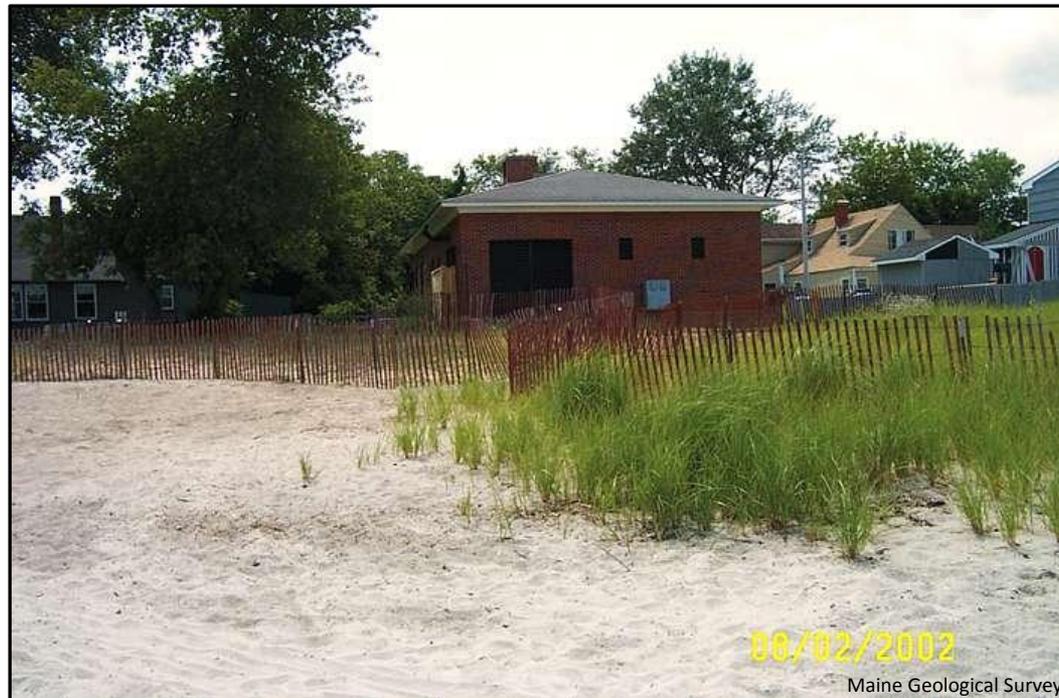
Figure 18. An August 2, 2002 photo of the growing frontal dune in the vicinity of the sewer pumping station.

In Figure 18 American beach grass has extended roots beyond the sand fencing to propagate on the open sand and begin to restore a frontal dune. Sand fencing limits foot traffic to narrow paths through the frontal dune and also traps wind-blown sand. The combination of fencing and vegetation results in the frontal dune ridge building higher over time and increasing in sand volume. This volume is helpful in providing a protective (sacrificial) buffer for storm erosion and also helps limit inland flooding from coastal storm surges.

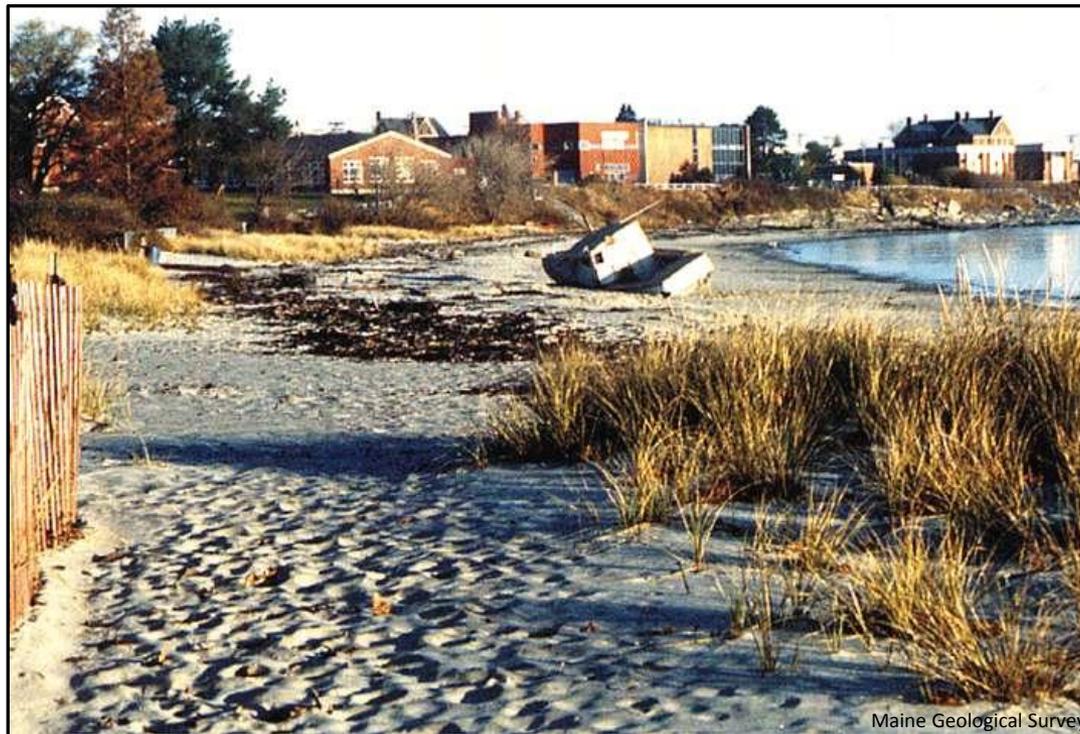
Figure 19. A November 4, 1988 photo of Willard Beach with a stranded lobster boat. In some cases, seaweed is hauled back to the water where it releases its sand on the intertidal or subtidal beach profile, then floats back to Casco Bay.

Through beach cleanup efforts, citizens and the city remove debris that strands on the beach (with the exception of seaweed; Figure 19). Water quality is tested regularly in the summer as part of the Maine Healthy Beaches program to advise swimmers about unsafe conditions if they arise. The City of South Portland maintains the recreation facilities and manages beach cleanups and litter removal.
