Geologic Site of the Month
January, 1998

WWII Rockets Removed from Beach at Reid State Park

Text by
Stephen M. Dickson

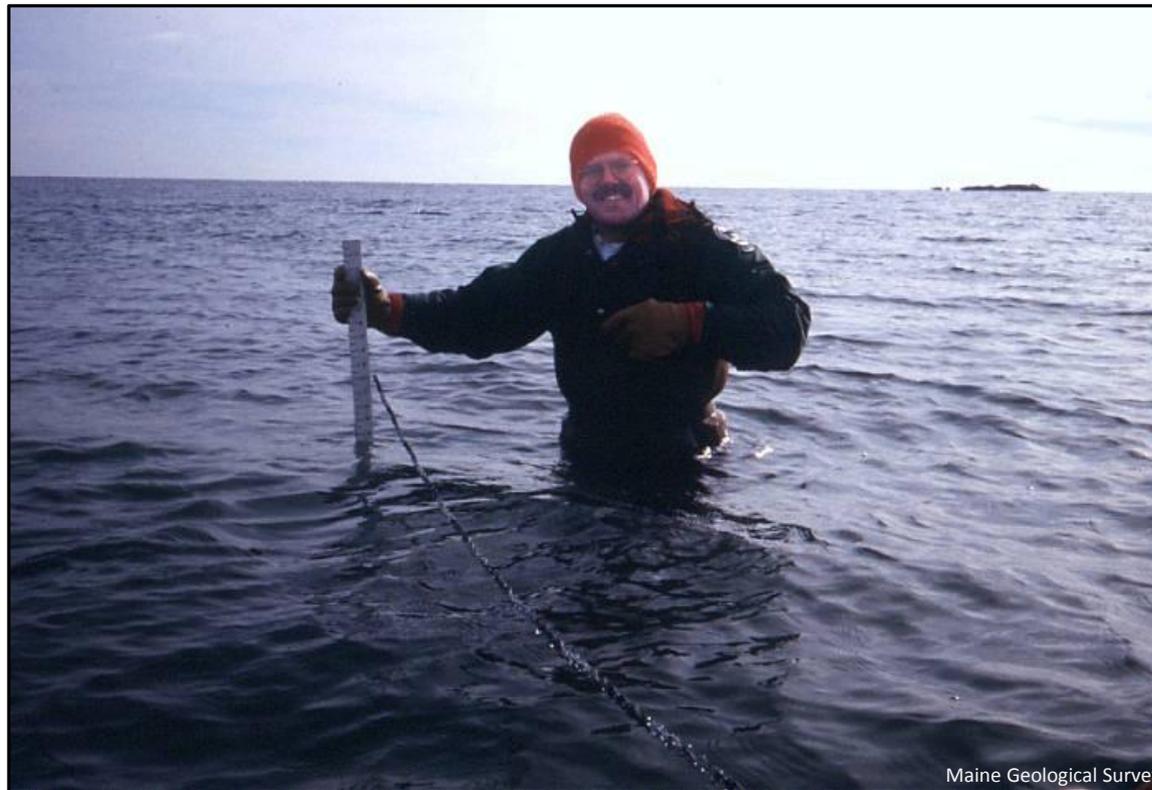
Figure 1. Robert Johnston doing beach profiling at Reid State Park.

Geologists Steve Dickson and Robert Johnston (Figure 1) of the Maine Geological Survey recorded beach elevations through the summer and fall of 1997. Beach profiles were made out to wading depth. Profiles were used to monitor the amount of sand burying the ordnance as a measure of safety for park visitors and to plan a cleanup effort for the fall.

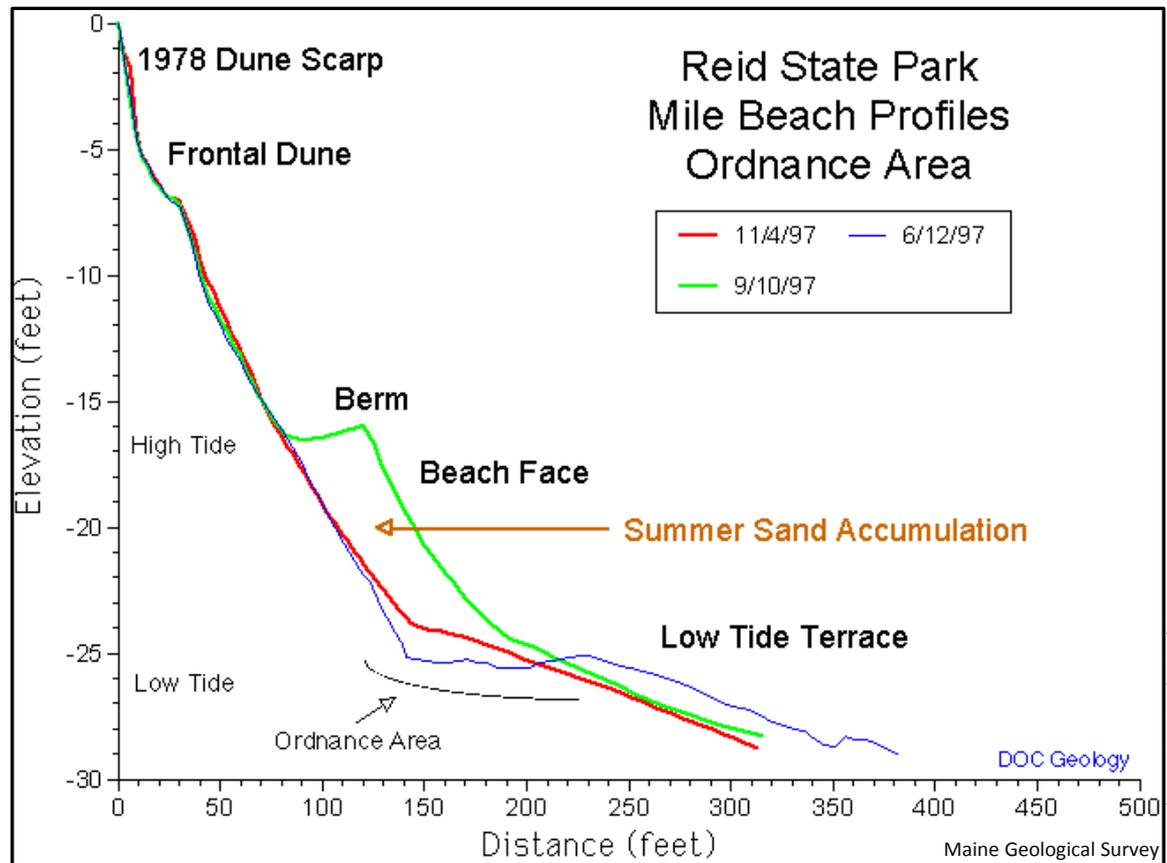
Figure 2. Beach profiles for Mile Beach showing summer sand accumulation.

As fall storm waves eroded the summer beach, sand on the beach shifted offshore and resulted in a lower beach profile (Figure 2).

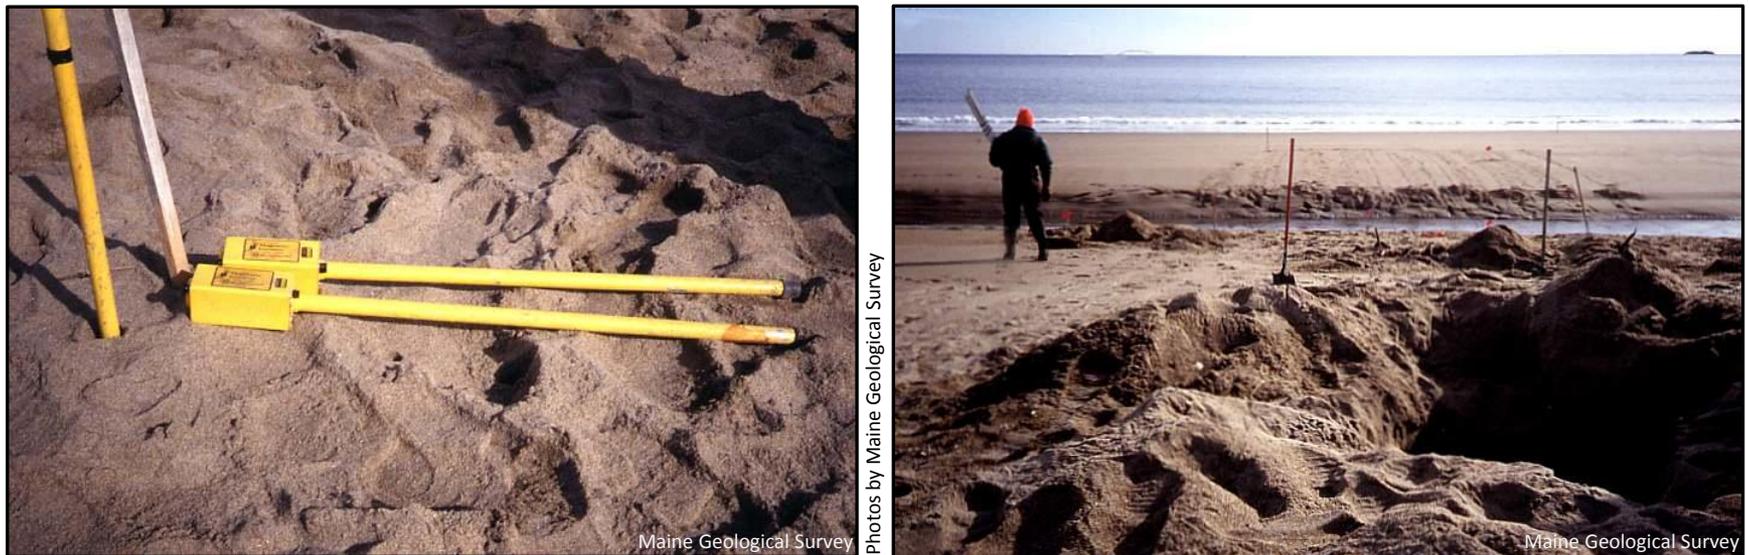
Figure 3. (Left) Metal detectors on the beach. (Right) Digging for ordnance with shovels.

A summer accumulation of sand, in the form of a 40-foot wide berm, disappeared in October and created conditions ideal for cleanup of the WWII debris. The resulting "winter" beach profile left little sand over the ordnance and allowed cleanup crews easier detection with metal detectors and digging with shovels (Figure 3).

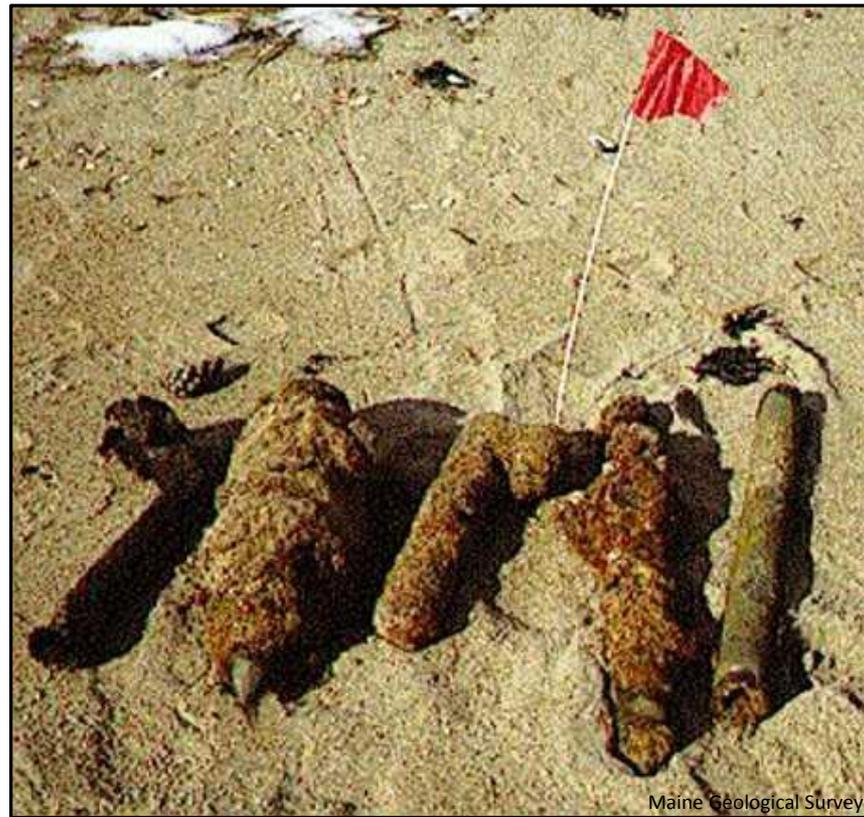
Figure 4. Warheads removed from beach.

Twenty-eight larger 5 inch warheads (shells) were removed from the beach (Figure 4). No live ordnance was found and there were only traces of rocket propellant detected. Between last winter and the end of the cleanup operation over 200 pieces were removed from Mile Beach.

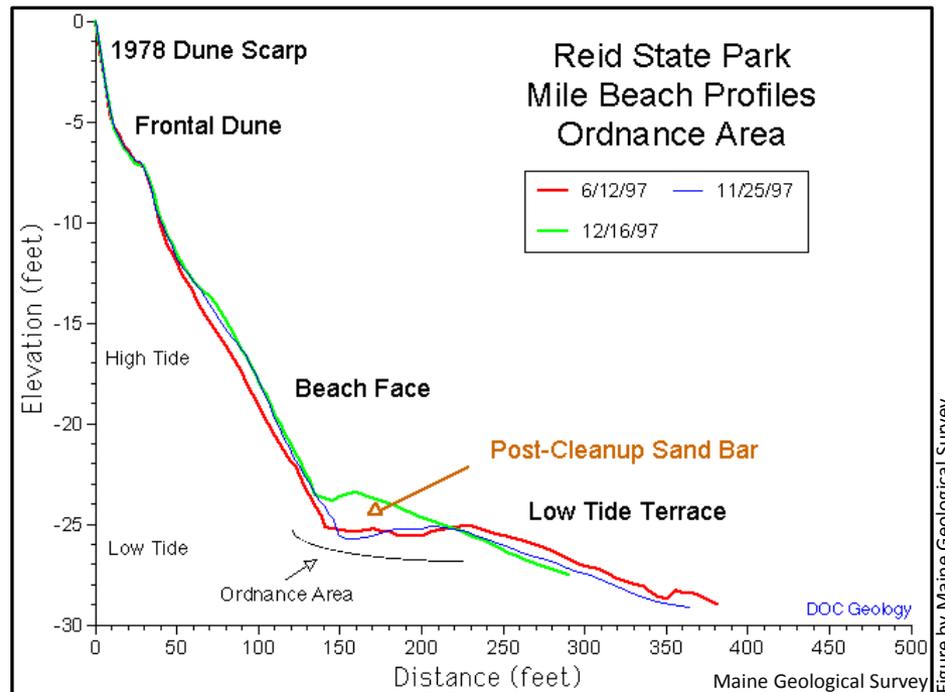
Figure 5. Graph of beach profiles for Mile Beach showing the effect of cleanup.

Several interesting results came from the beach surveys as shown in the beach profiles (Figure 5) and in photos of the beach (Figure 6). Comparison of beach profiles from June through December 1997 (not all shown in the graph) indicated that the cleanup effort occurred during a period with the least amount of sand on the beach in that time period. A week after the completion of the work (December 16), the low tide terrace had gained a large volume of sand which would have buried the ordnance under as much as two more feet of sand. It is apparent that the cleanup effort occurred at an optimal time.

- The profile variability seen on the beach face is natural and due to beach cusp formation, movement, and degradation. Beach cusps are curves in the beach elevation that form parallel to the water line and shift with different kinds of surf.
- The surveys did not detect any permanent alteration of the beach profiles or damage to the beach from the ordnance removal process.
- The berm that forms in summer buries ordnance several feet further below sand and helps protect summer park users from any remaining sharp metal rocket fragments.

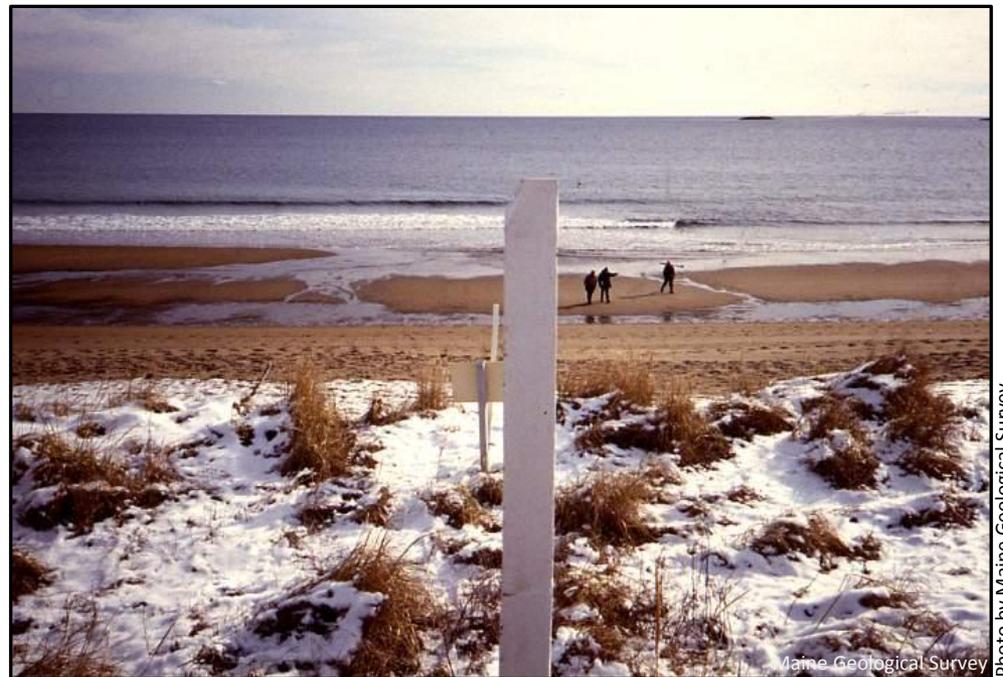
Figure 6. View of the beach after cleanup.
