Virtual Tour of Maine's Geologic Hazards

Introduction

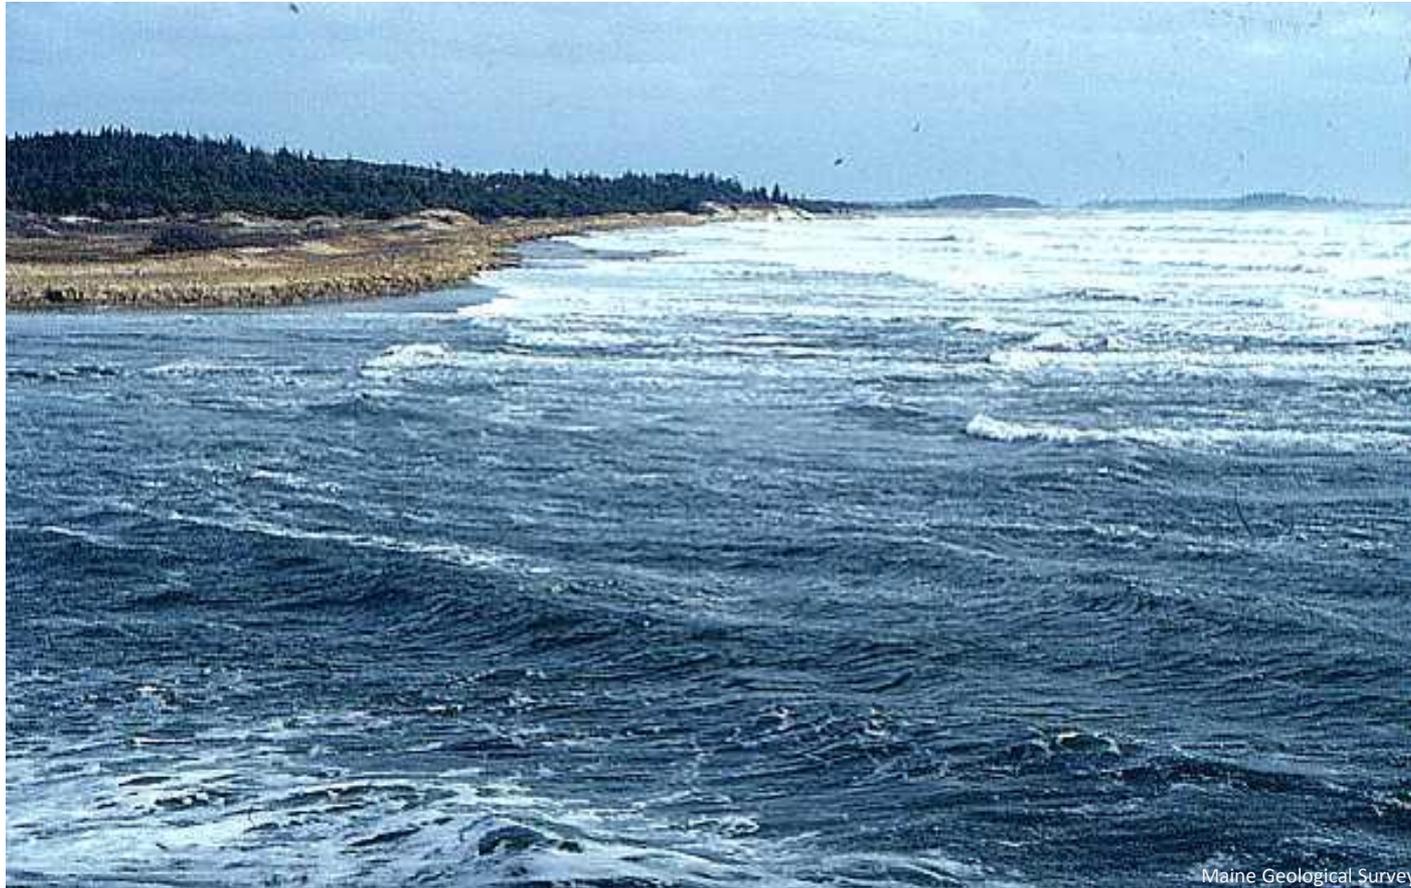
A four-day northeaster in December 1992 resulted in a coastal storm surge of less than 2 feet yet it produced an erosional cut in the dunes at Seawall Beach, Phippsburg (shown in next slide).

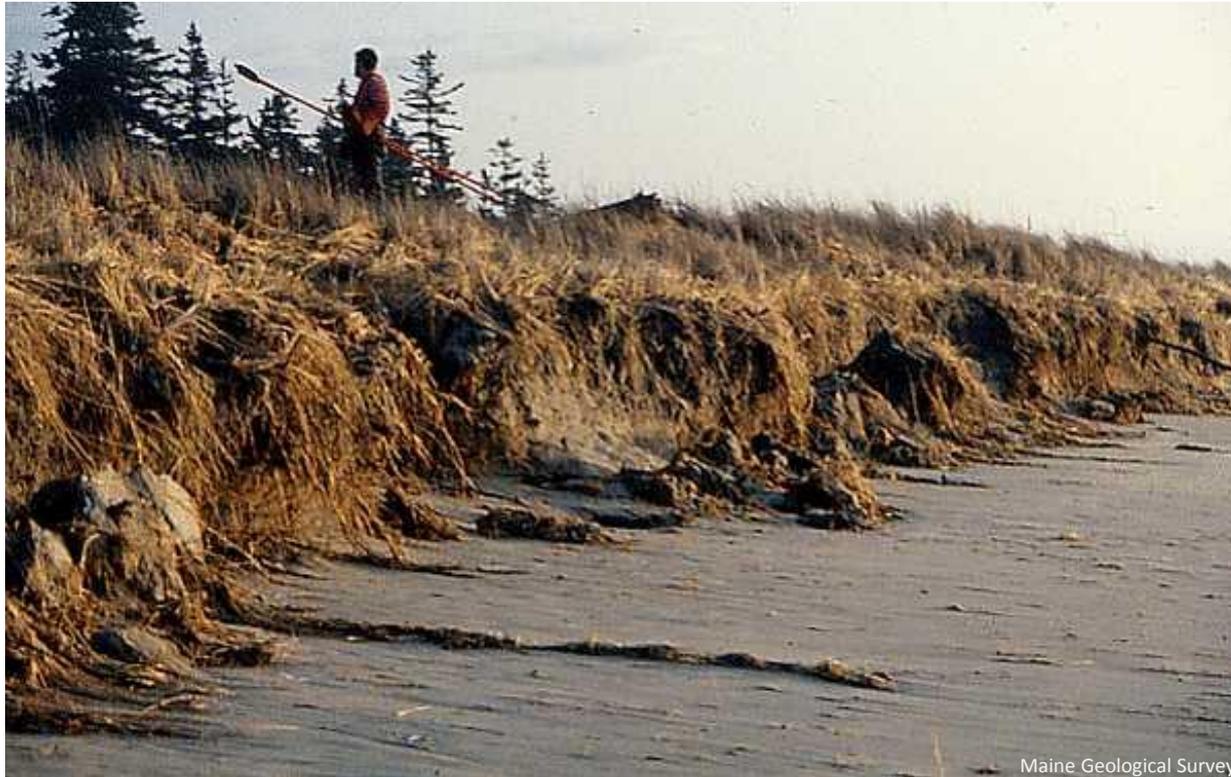
A four-day northeaster in December 1992 resulted in a coastal storm surge of less than 2 feet (shown in previous slide) yet it produced an erosional cut in the dunes at Seawall Beach, Phippsburg. Northeasters commonly produce frontal dune erosion and scarp formation. Note the person standing on top of the scarp for scale. Dune scarps from major storms can take years to return to the pre-storm condition.

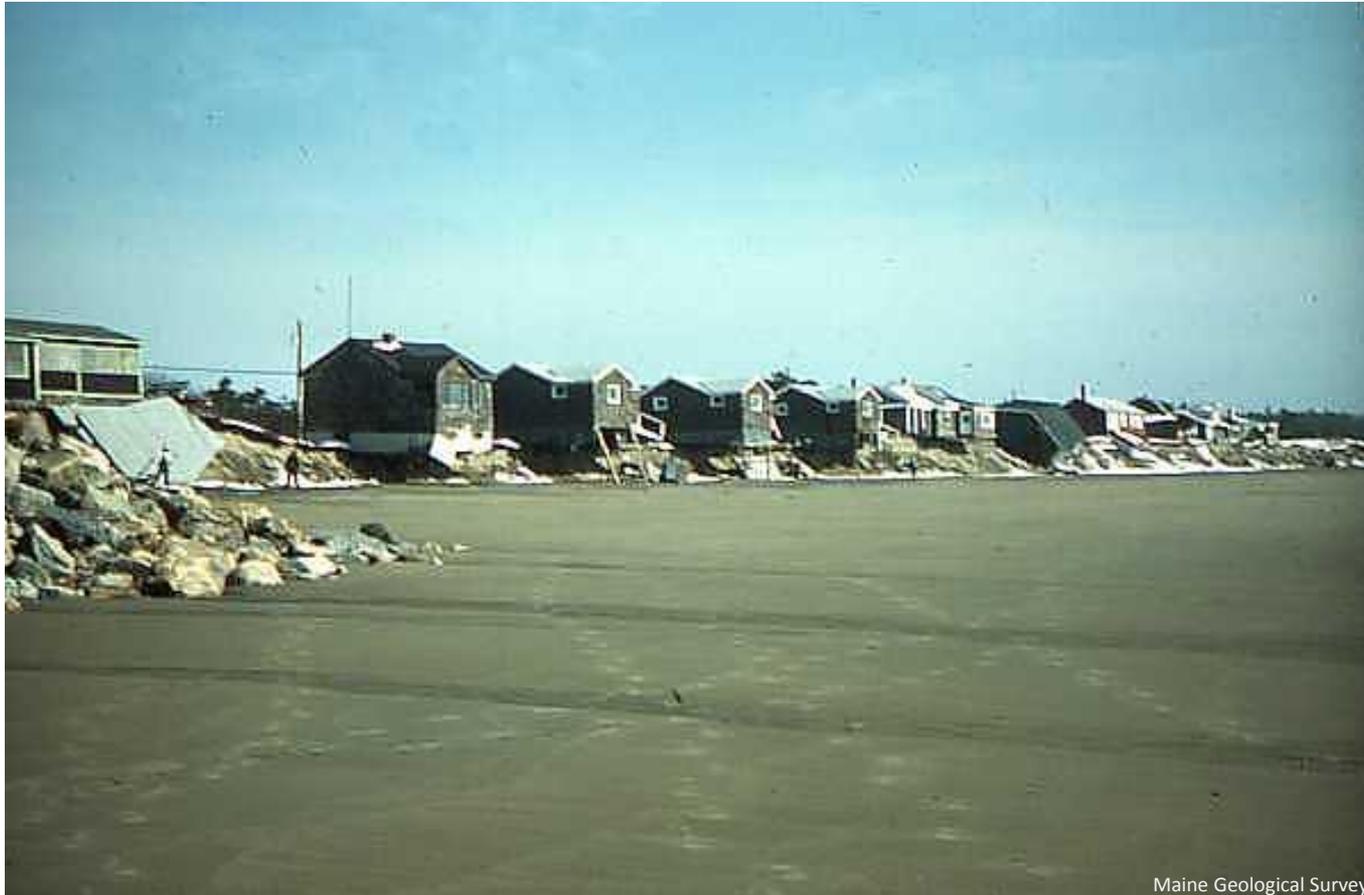
At the location shown in the previous slide, a row of cottages was undermined by coastal erosion on Popham Beach in 1976.

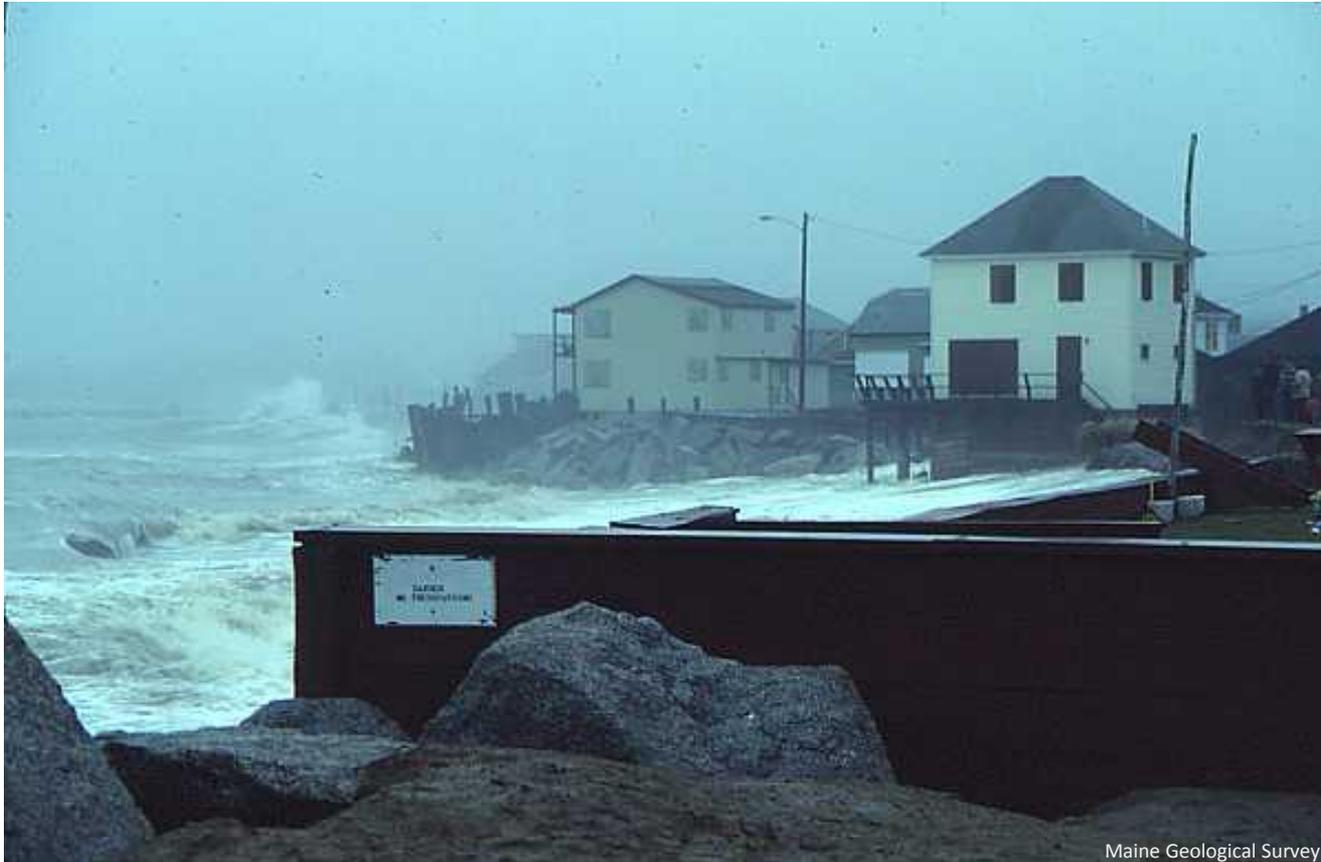
Engineered structures such as seawalls provide some short-term protection from coastal erosion, but over time, sea-level rise and the pounding surf will undermine the structures. Photo of Camp Ellis, winter 1986.

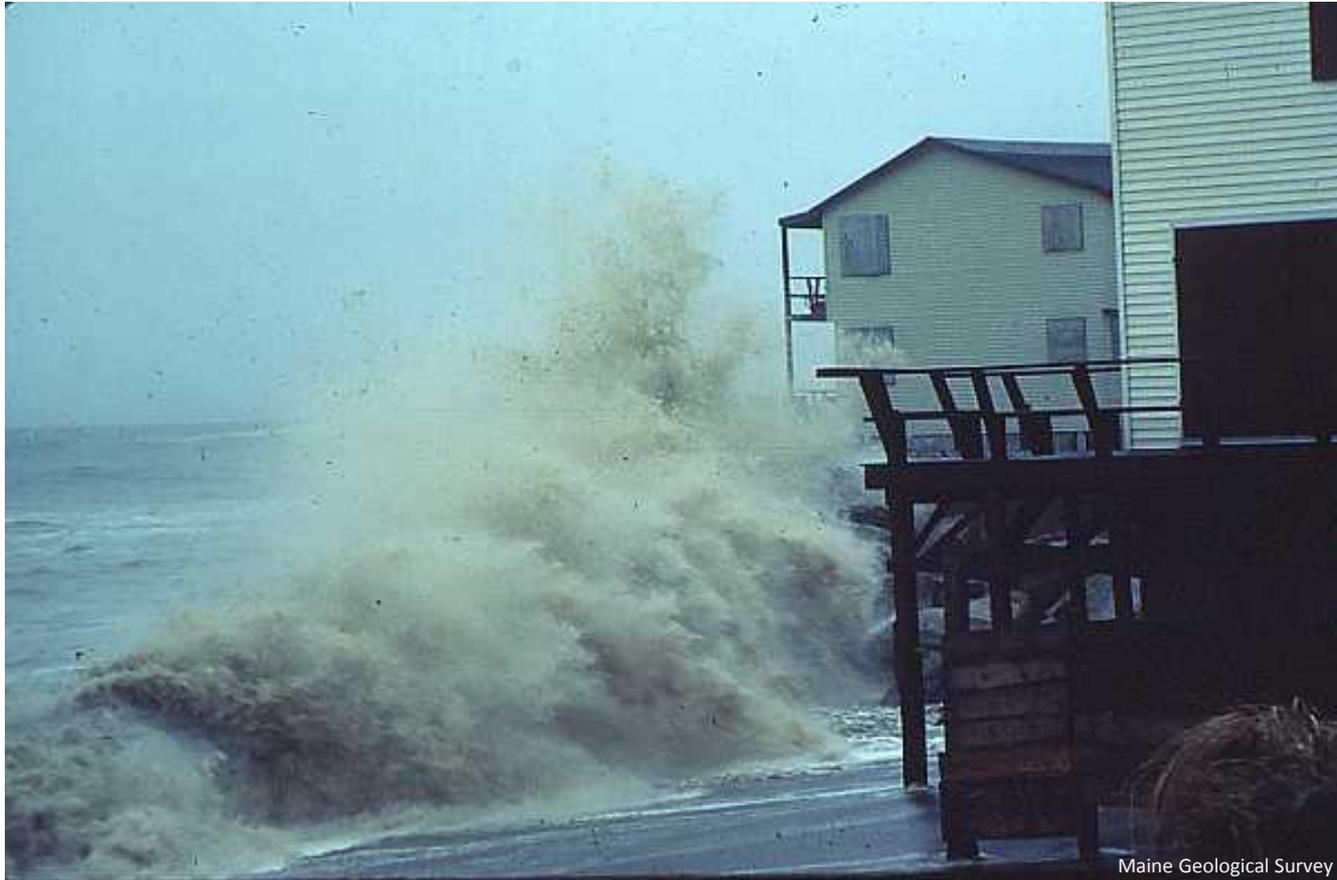
The destructive power of coastal surf is seen in this photo of Camp Ellis during the winter of 1986.

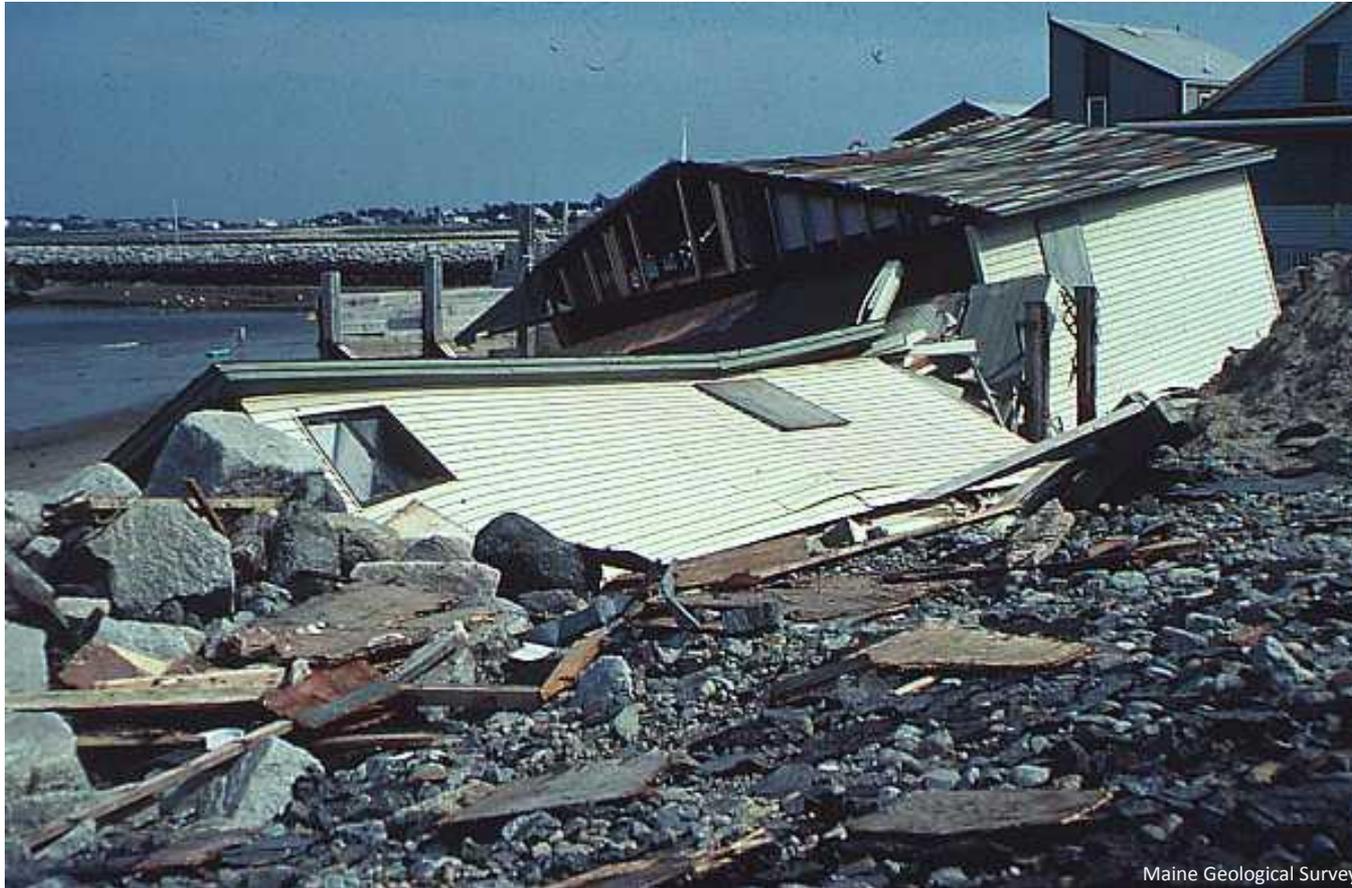
When engineered protective structures are breached by ocean waves, erosion is often rapid and devastating as shown in this photo of a ruined house at Camp Ellis in 1991.

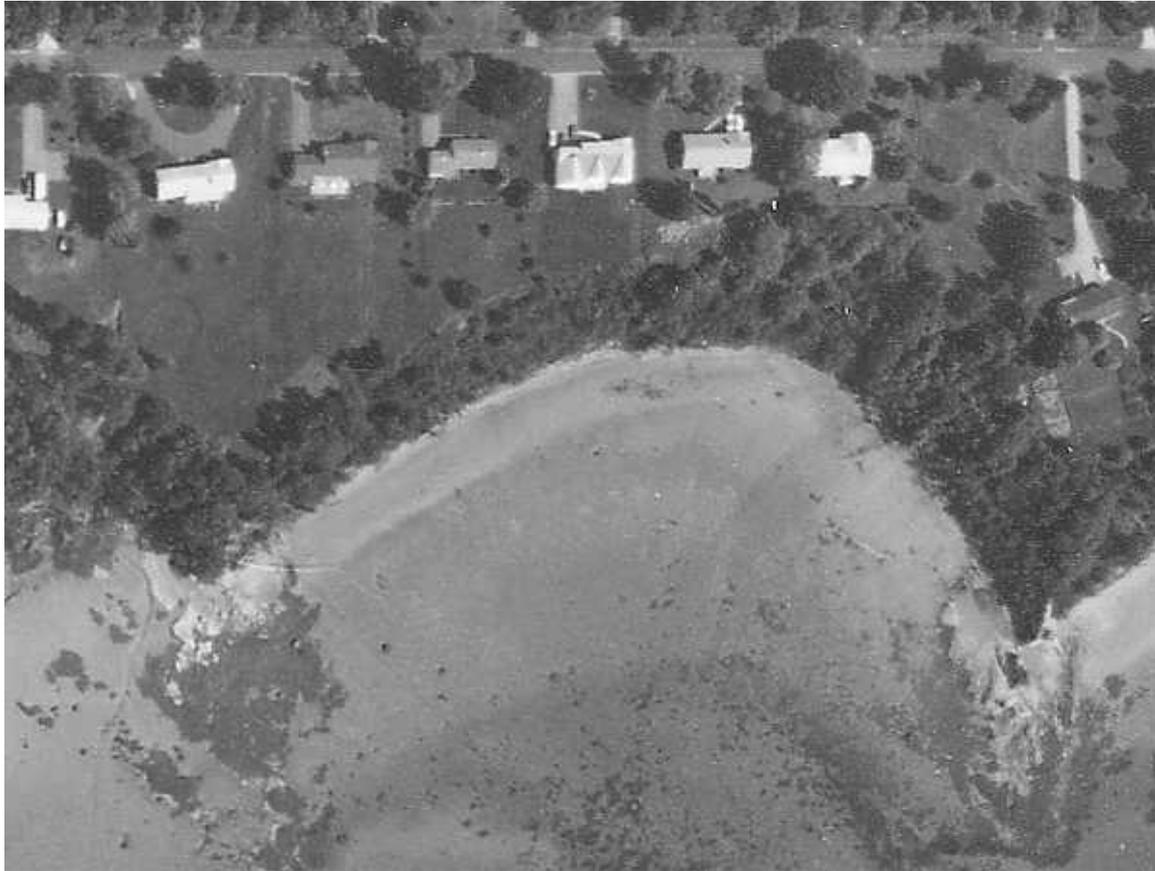
View of the north shore of Rockland Harbor in 1992. Note the well vegetated coastal bluff and the arcuate shape of the shoreline which is "pinned" by bedrock outcrops at either end.

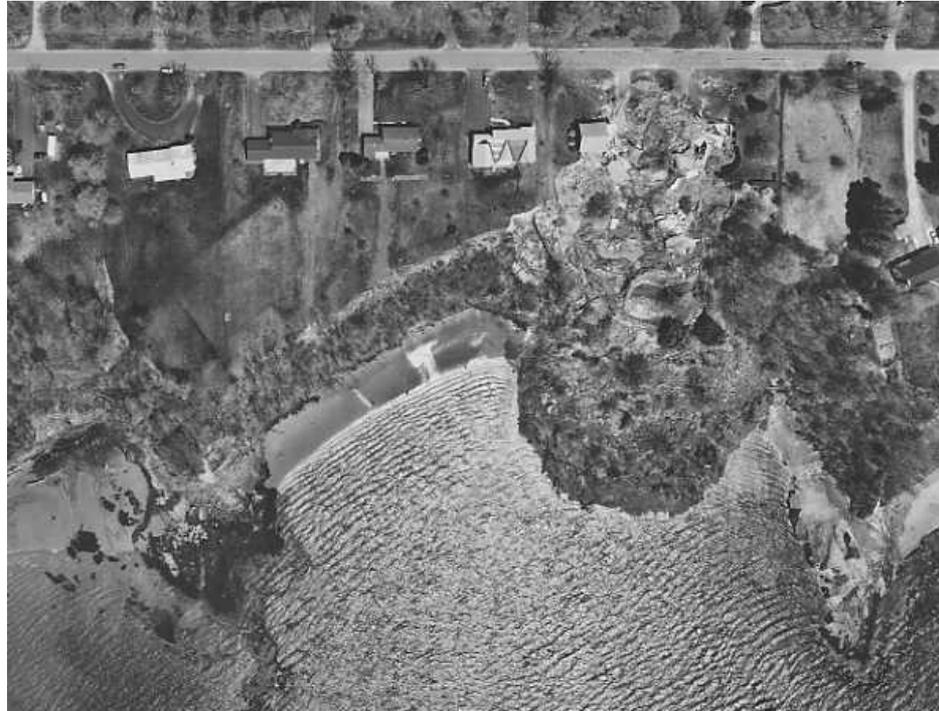
Early in the morning of April 16, 1996, a clay bluff failed on the north shore of Rockland Harbor. This landslide formed a new scarp about 200 feet landward of the original top of the bluff in just a few hours and destroyed two homes. The slide occurred along a steep bluff adjacent to Samoset Road. The bluff top was about 50 feet (15 m) above sea level and the base of the bluff slope ended at the high water mark. Slumping of the bluff occurred progressively in a series of discrete landslide events. When it was over, the slide had moved horizontally over 400 feet (120 m) onto the mudflats of the intertidal zone and had disturbed a total area of 3.5 acres (1.4 hectares).

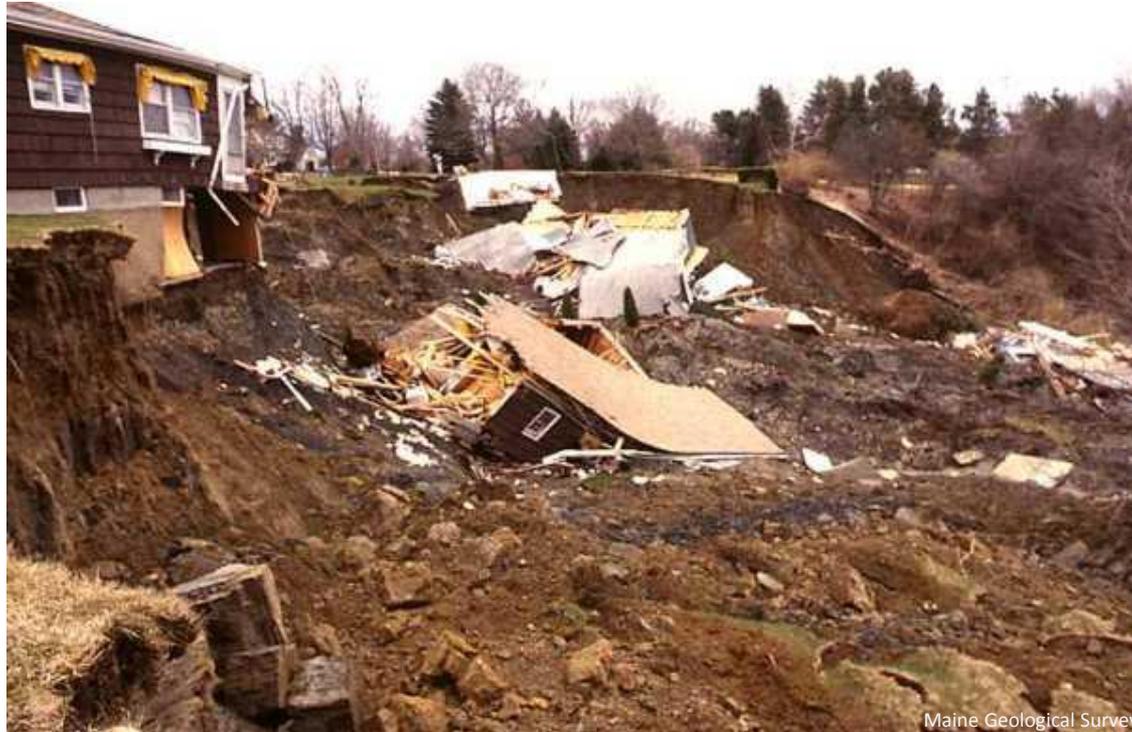
For a month following the major slide event, smaller blocks continued to fall from the steep landward slopes. These continued slope failures resulted in enlargement of the affected area by landward progression of the vertical scarp. By landward retreat, the main scarp moved to within 15 feet (5 m) of a sewer main on the seaward side of Samoset Road. The total cost in terms of lost property value and cost to the city for emergency activities, evaluation of the two homes destroyed and loss of land, clean up, and engineered stabilization was approximately \$710,000.

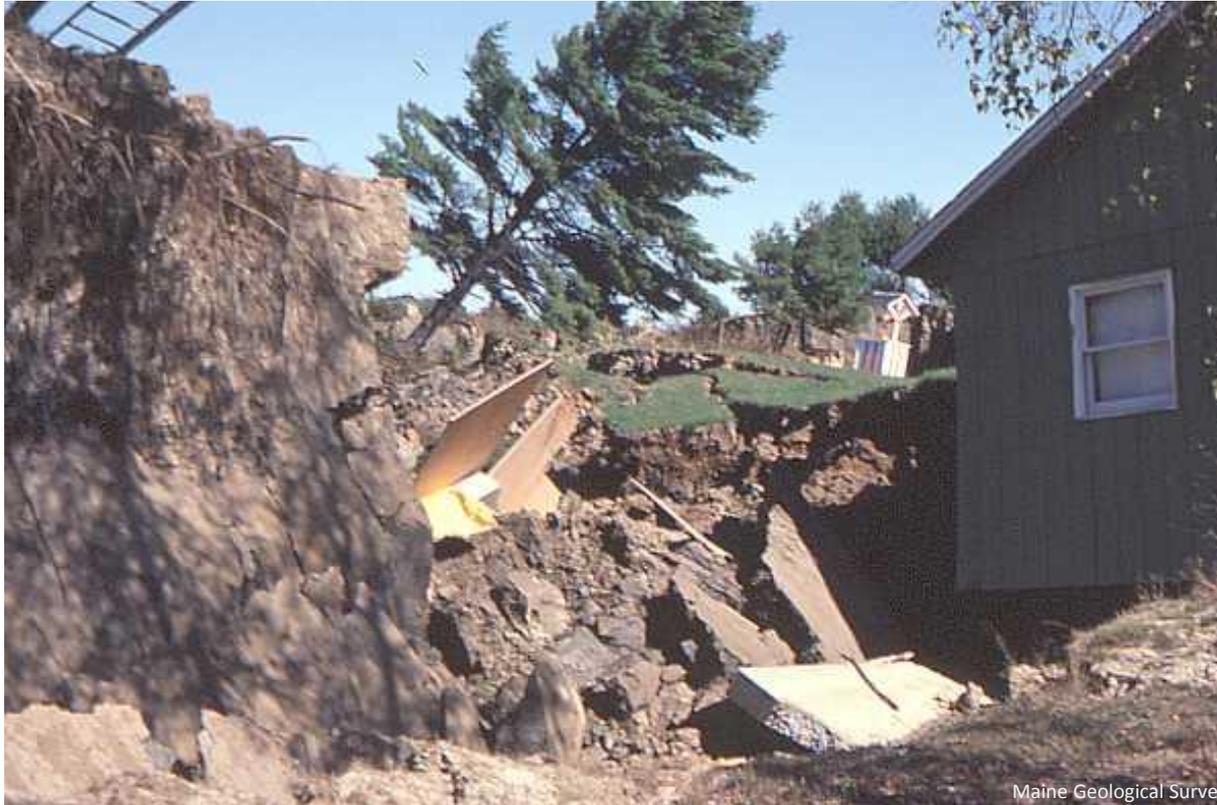
On September 28, 1983, a landslide occurred in a bluff of marine sediments at the confluence of the Stroudwater River and Indian Camp Brook in Gorham. Seven acres (3 hectares) of land slid to the south and southwest into the river and the brook, taking with it a house and garage, several vehicles, a tank truck, and a well drilling rig. The total area affected by the slide was about 12 acres (5 hectares).

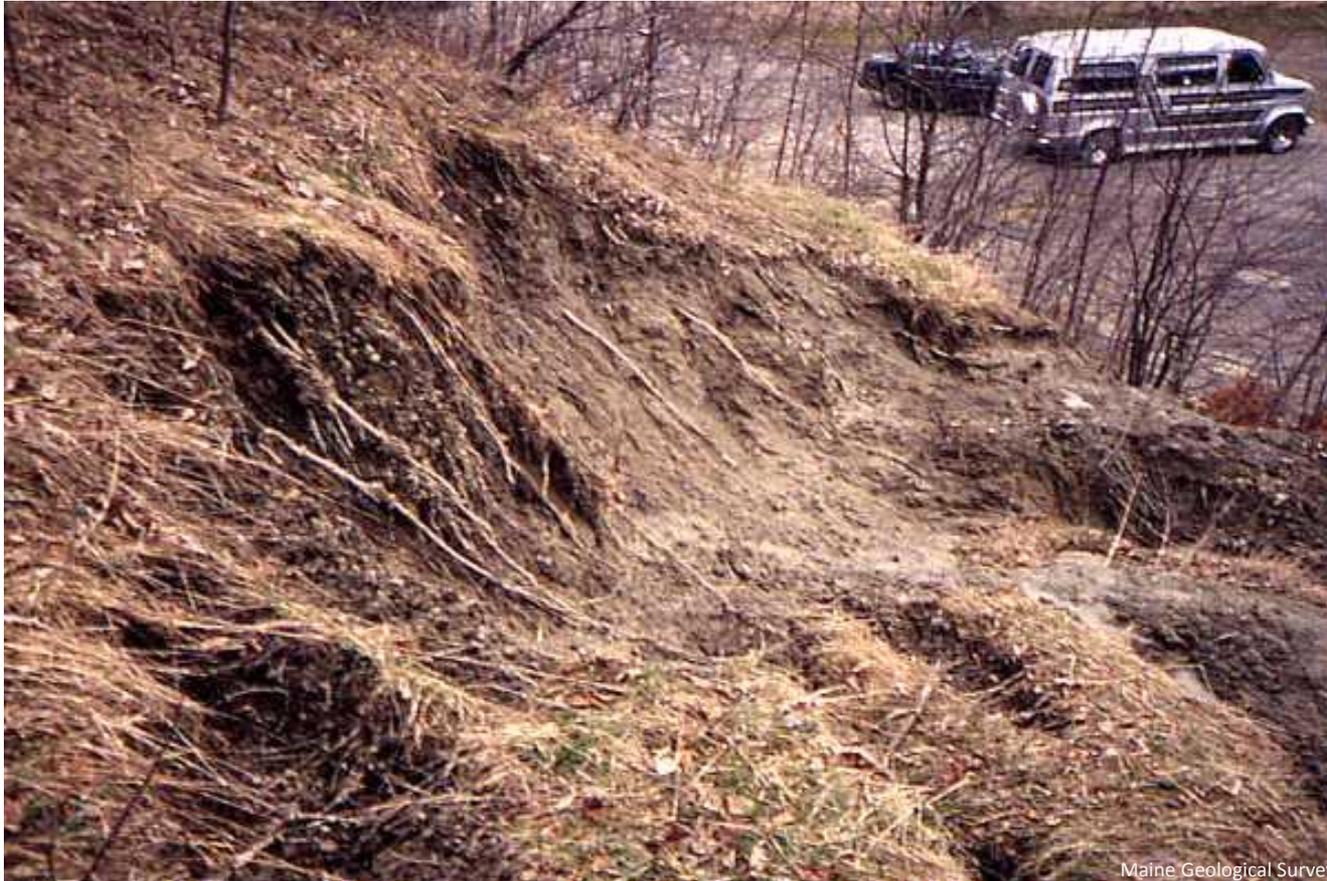
Not all landslides are as catastrophic as the ones that occurred in Rockland and Gorham. Many small landslides and slumps occur every year in clay soils in many parts of the state. The small landslide shown occurred in a clay slope in Augusta.

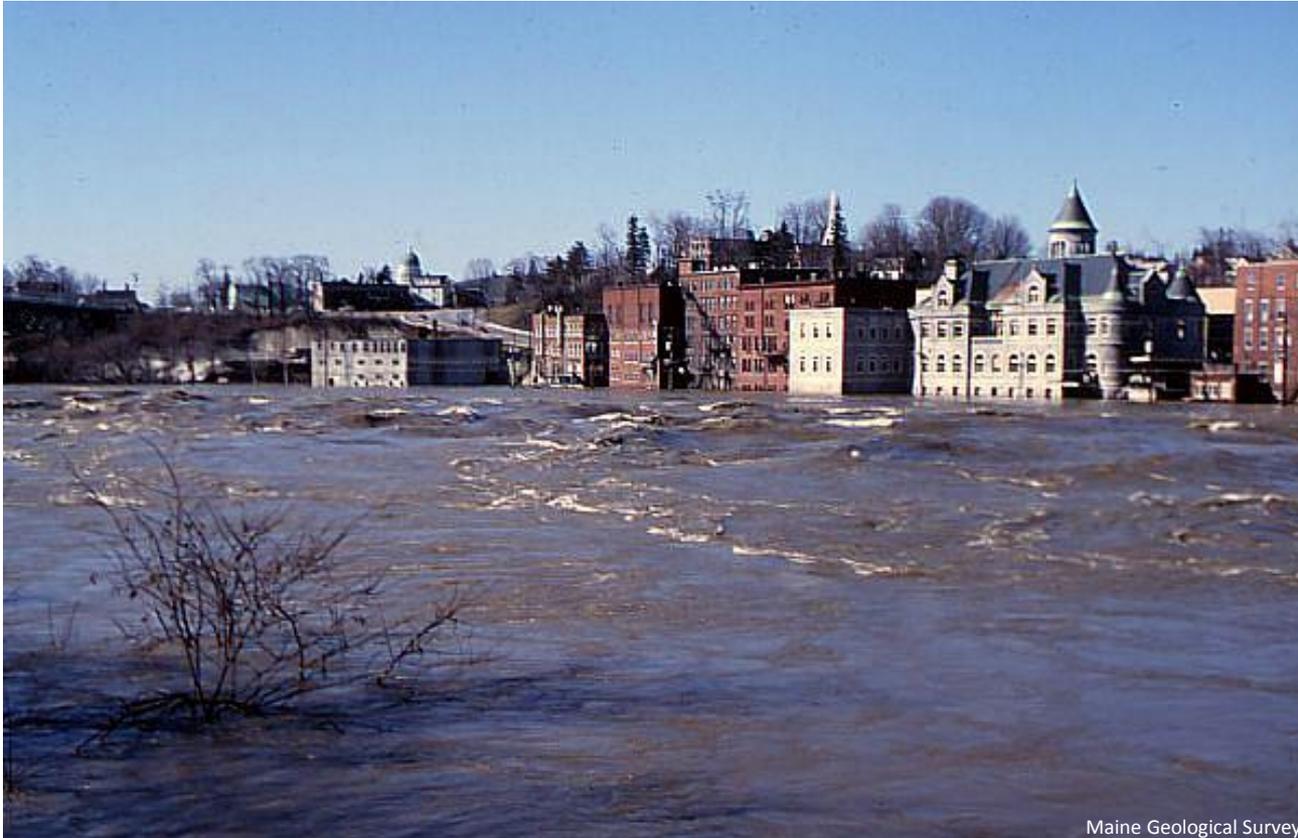
Kennebec River, April Fool's Day flood, 1987, downtown Augusta. A spring storm released an average of 4-8 inches of rain on snowpack that contained an average of 5-7 inches of water equivalent. The flood crest at Augusta was 21 feet above flood stage. This was the most devastating flood of record in Maine, with damage estimated at \$100 million.

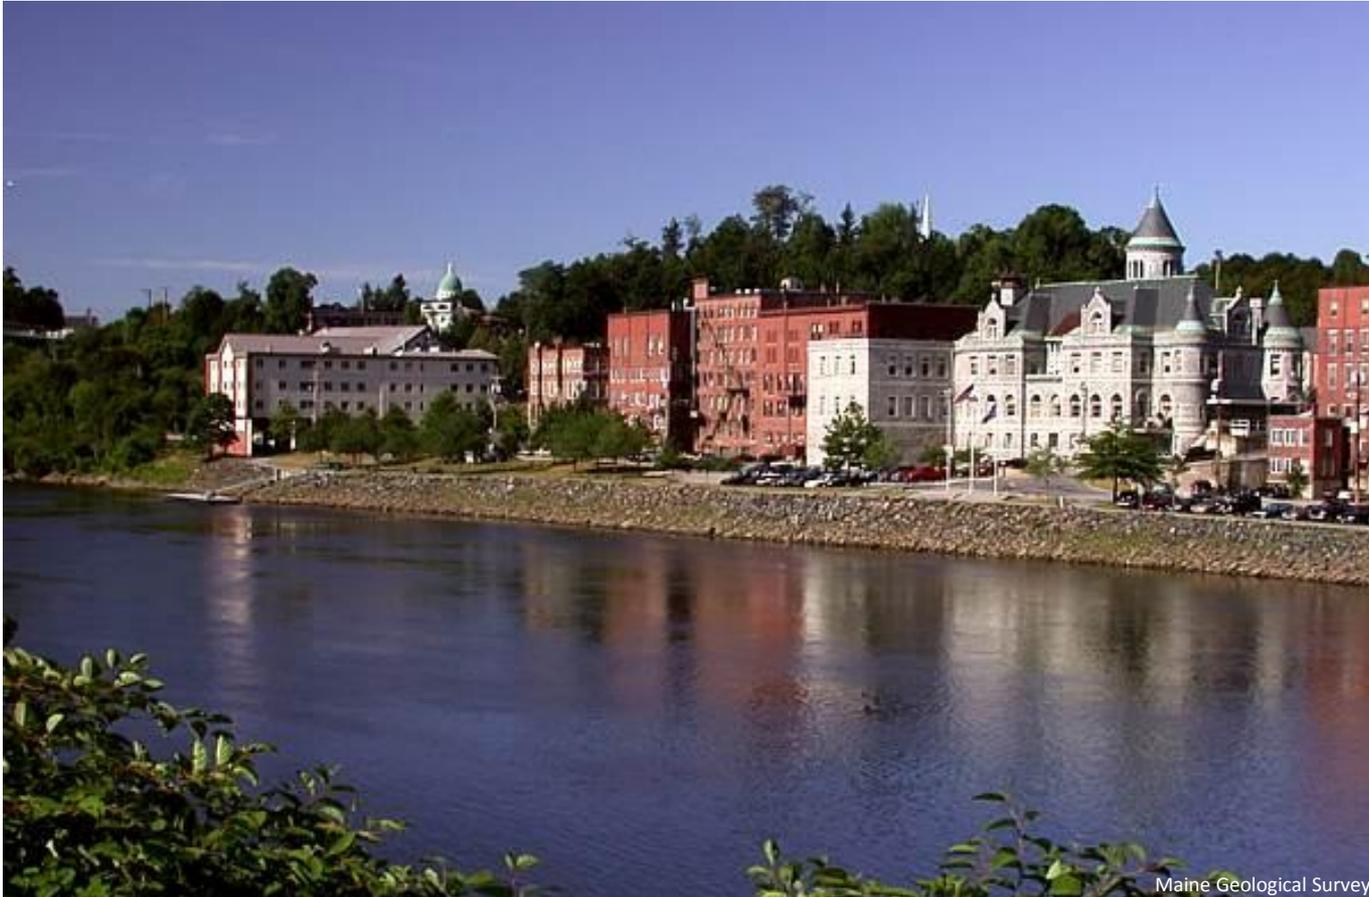
View of downtown Augusta with the Kennebec River at its normal water level.

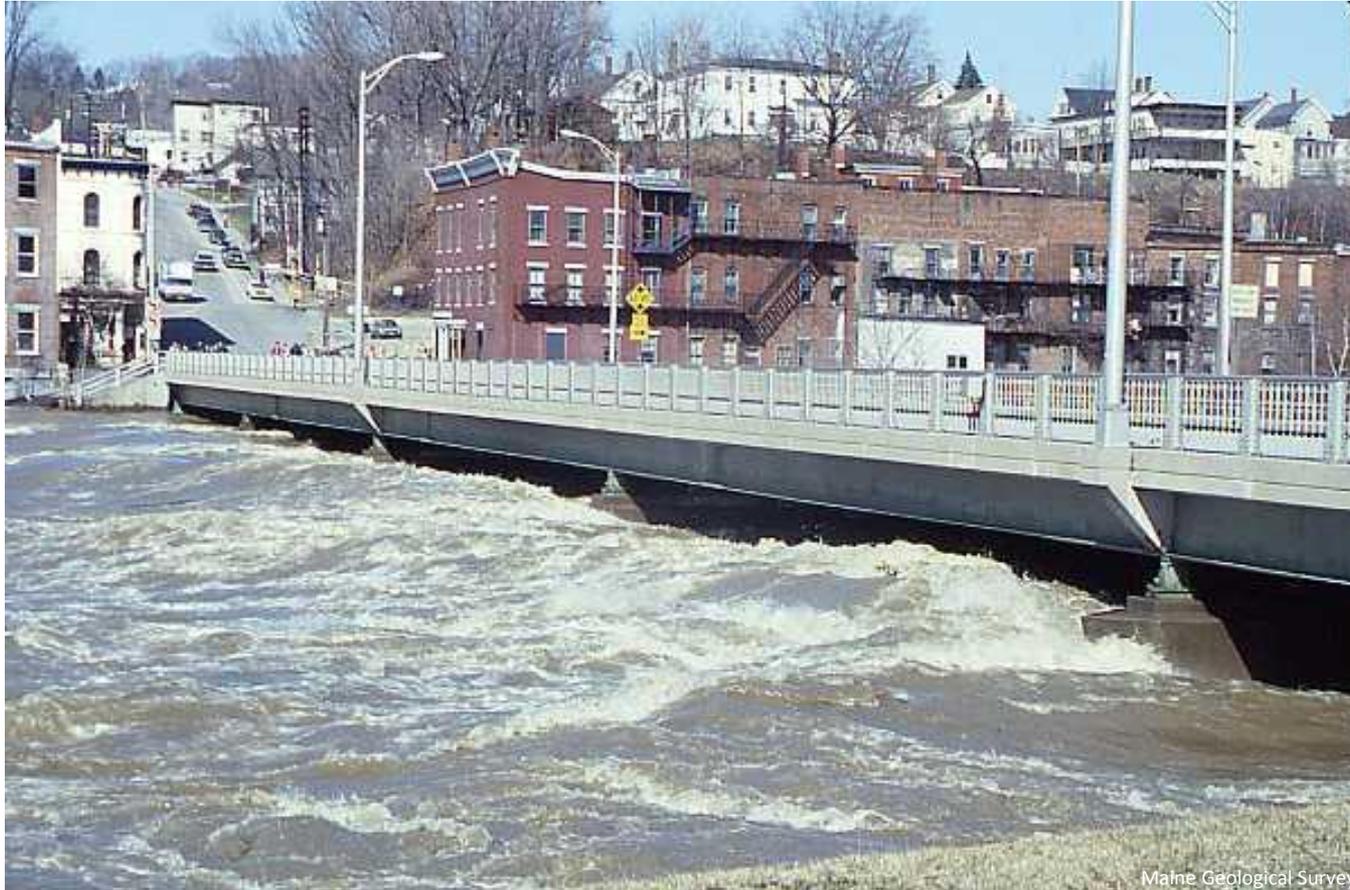
View of the Calumet Bridge at Old Fort Western during the Kennebec River flood of April 1987.

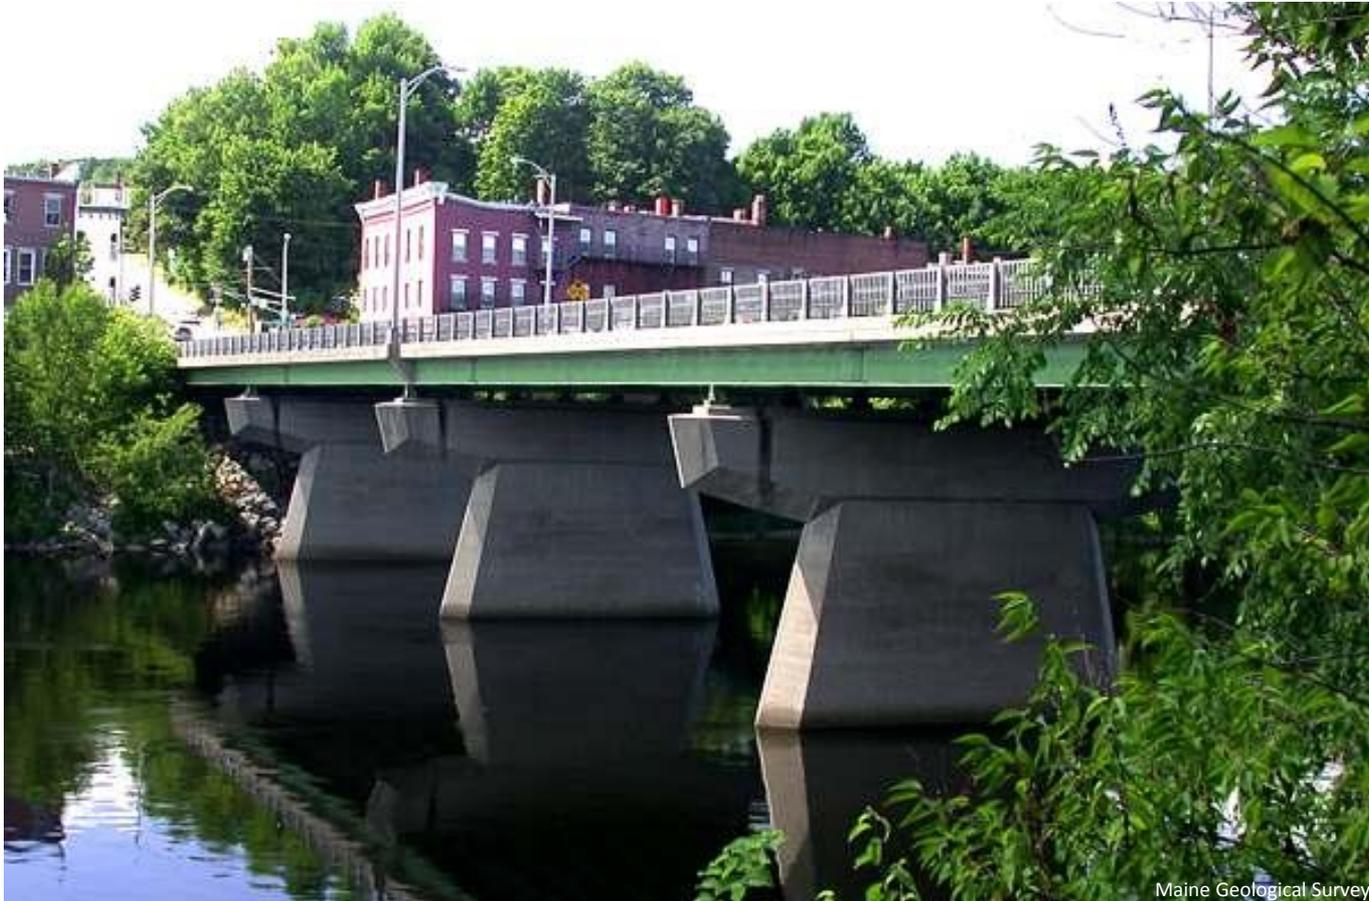
View of the Calumet Bridge at Old Fort Western with the Kennebec River at its normal water level.

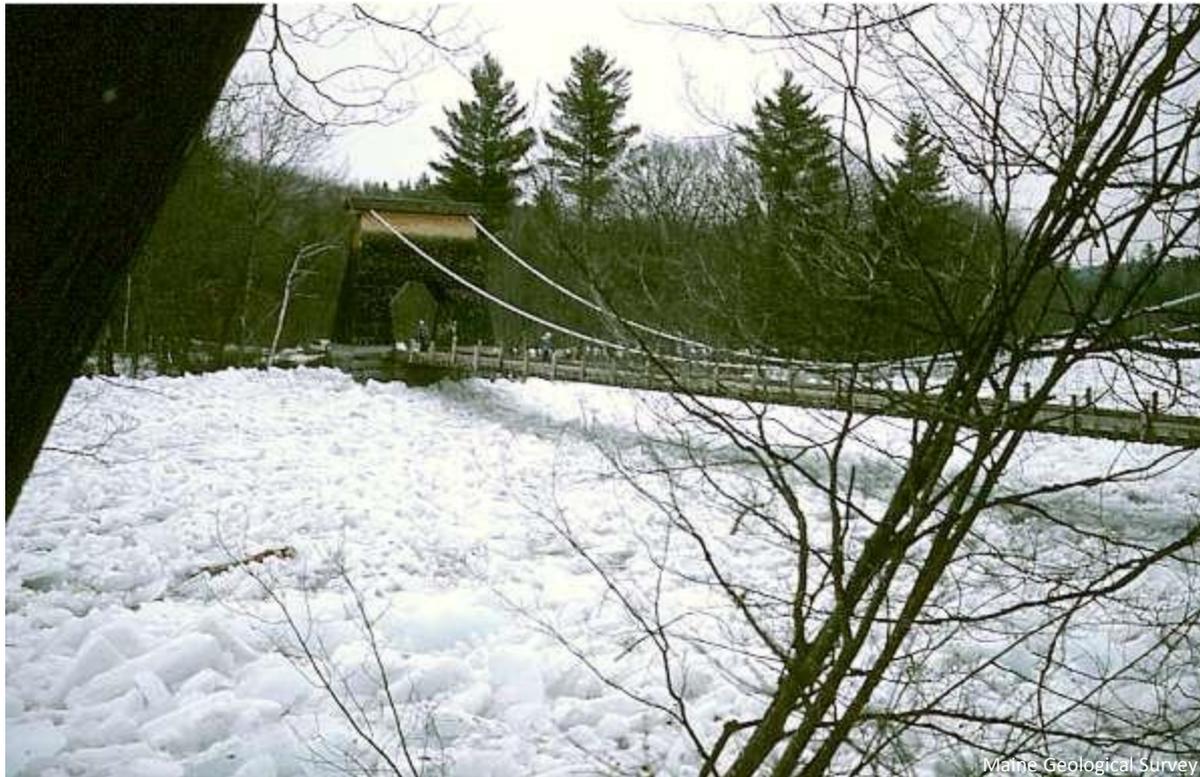
Floods in Maine are often caused by a combination of heavy rains and resulting snowmelt in the spring. Ice jams during late winter-early spring may also be a contributing factor when ice floes on rivers meet at a constriction or obstruction in the river valley causing backwater flooding. The ice jam shown occurred in February 1995 at the Wire Bridge over the Carrabassett River in New Portland, Maine.

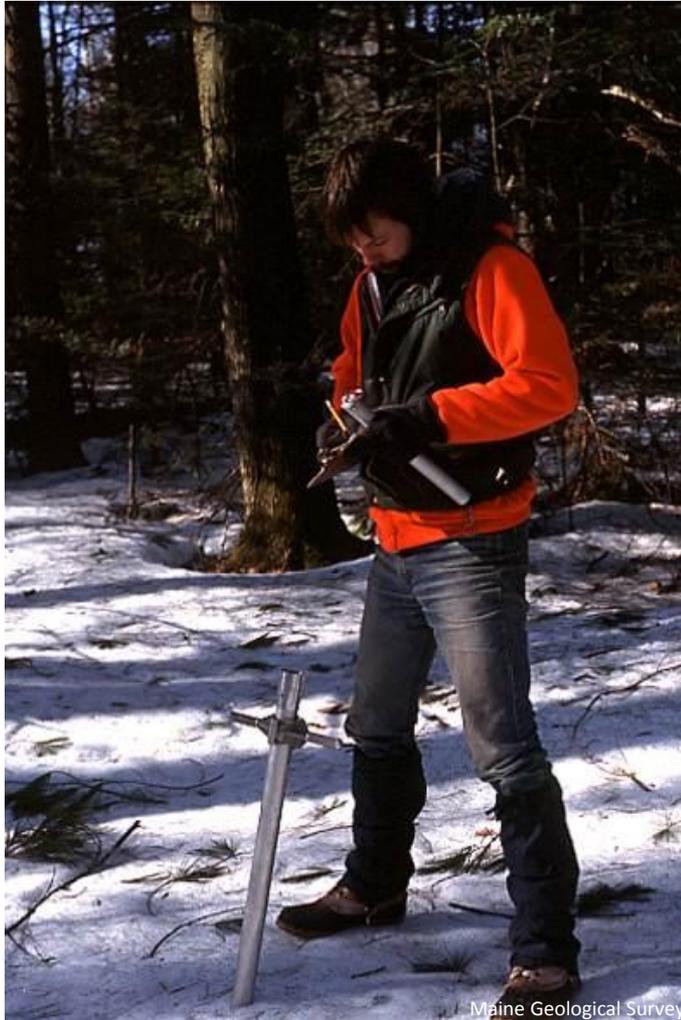
The Maine Geological Survey conducts bi-weekly snow surveys in late winter and early spring to provide information to the National Weather Service for use in preparing flood-potential statements, and to State and local emergency management officials for use in flood awareness efforts.

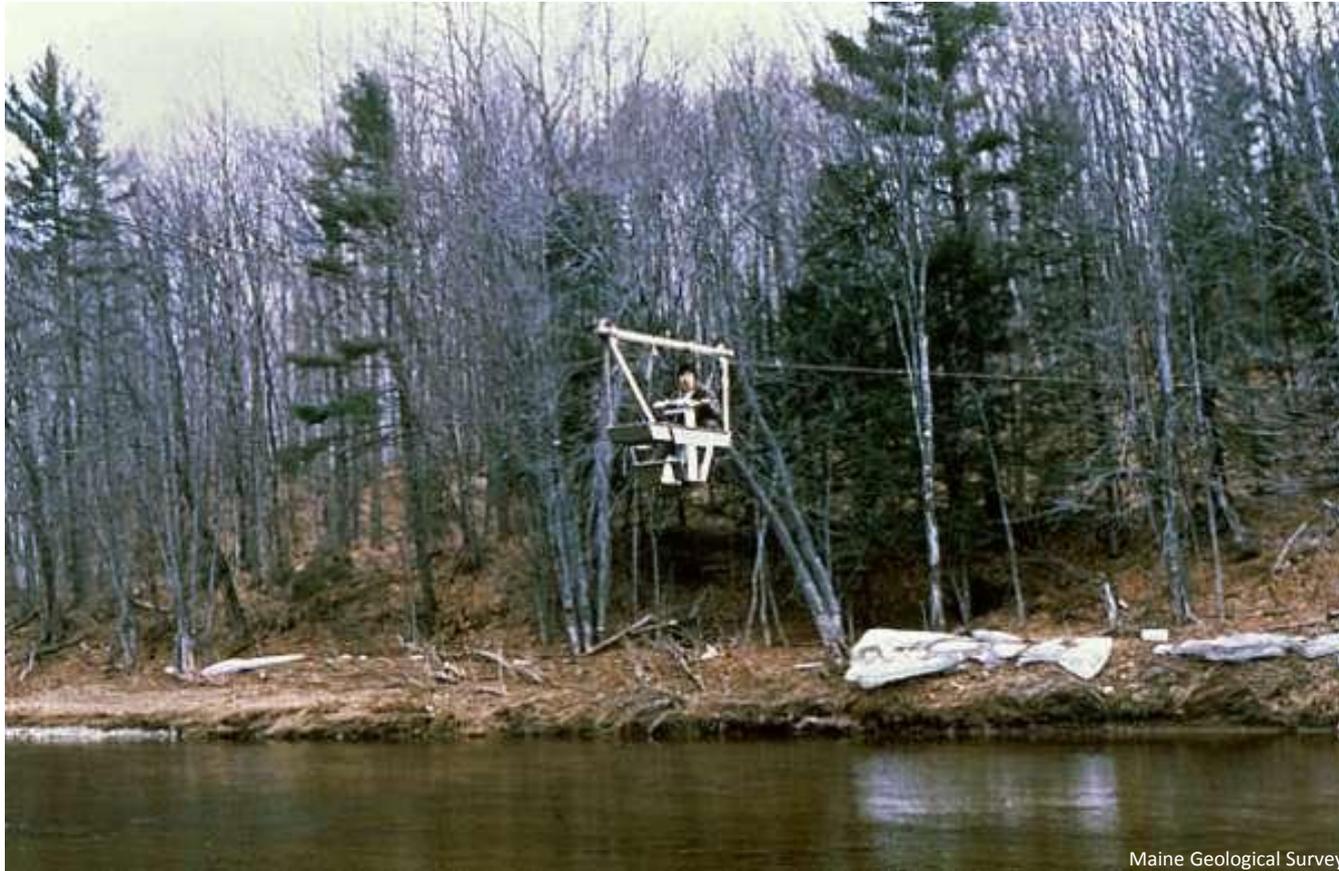
The U.S. Geological Survey maintains a network of stream-gaging stations in Maine to monitor streamflow across the state. Real-time observations of streamflow are available on the USGS website. The photo shows a cable way for surface water monitoring in Waterville.
