# Beach Dynamics of Sebago Lake

A Report on the Results of Beach Profiling

by Robert A. Johnston and Martha N. Mixon

Open-File 98-122

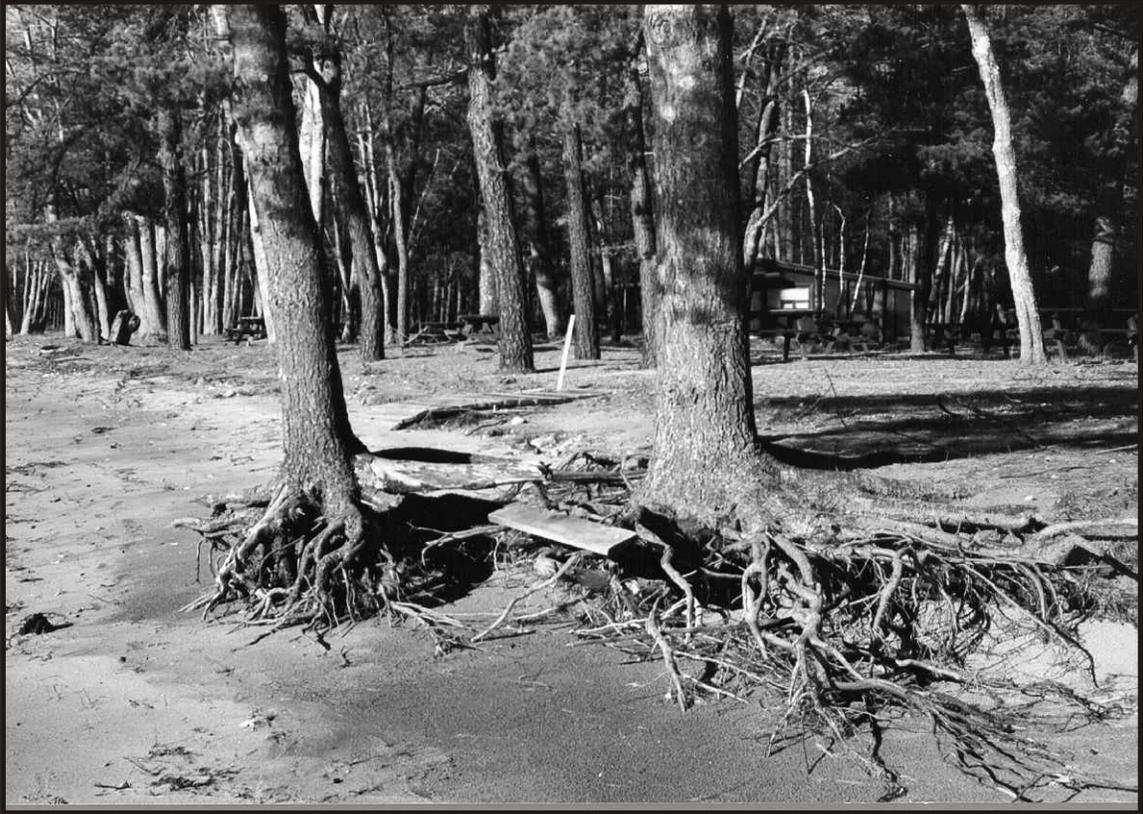
Figure 2. Tree roots continue to be exposed at Songo Beach, December 1996 (photo by Robert Johnston).

Beginning in 1990, the Maine Department of Conservation, Bureau of Parks and Recreation, raised concerns that S. D. Warren's water level management plan was increasing erosion at Sebago Lake State Park. In the late 1980's tree roots were exposed along Songo Beach (Figure 2). The exposed roots suggested that sand had been lost from the upper beach due to the higher water levels. The Bureau of Parks and Recreation asked the Maine Geological Survey (both agencies are in the Department of Conservation) to look at the erosion problem. As a result, the Survey established a network of beach profile stations along the sand beaches in the park. Ten stations were established in the fall of 1990 on Cub Cove, Songo, Naples, and Witch Cove beaches (Figure 3). In the summer of 1991, two more sites were added at Halls (Tasseltop) Beach, just south of Browns Point in Raymond (Figure 3). Dickson and Johnston (1994) published an open-file report based on the monitoring of these twelve sites during the open-water season.

While lake levels were at or near this full pond level, a low pressure system tracking up the St. Lawrence River valley brought strong southerly winds to the lake on November 8th and 9th (FEMA, 1996). The combination of the strong southerly winds and a high lake level allowed waves to reach and erode the upper beach areas, exposing tree roots and toppling trees along the shoreline at the Songo and Frye Island sites (Figure 2).

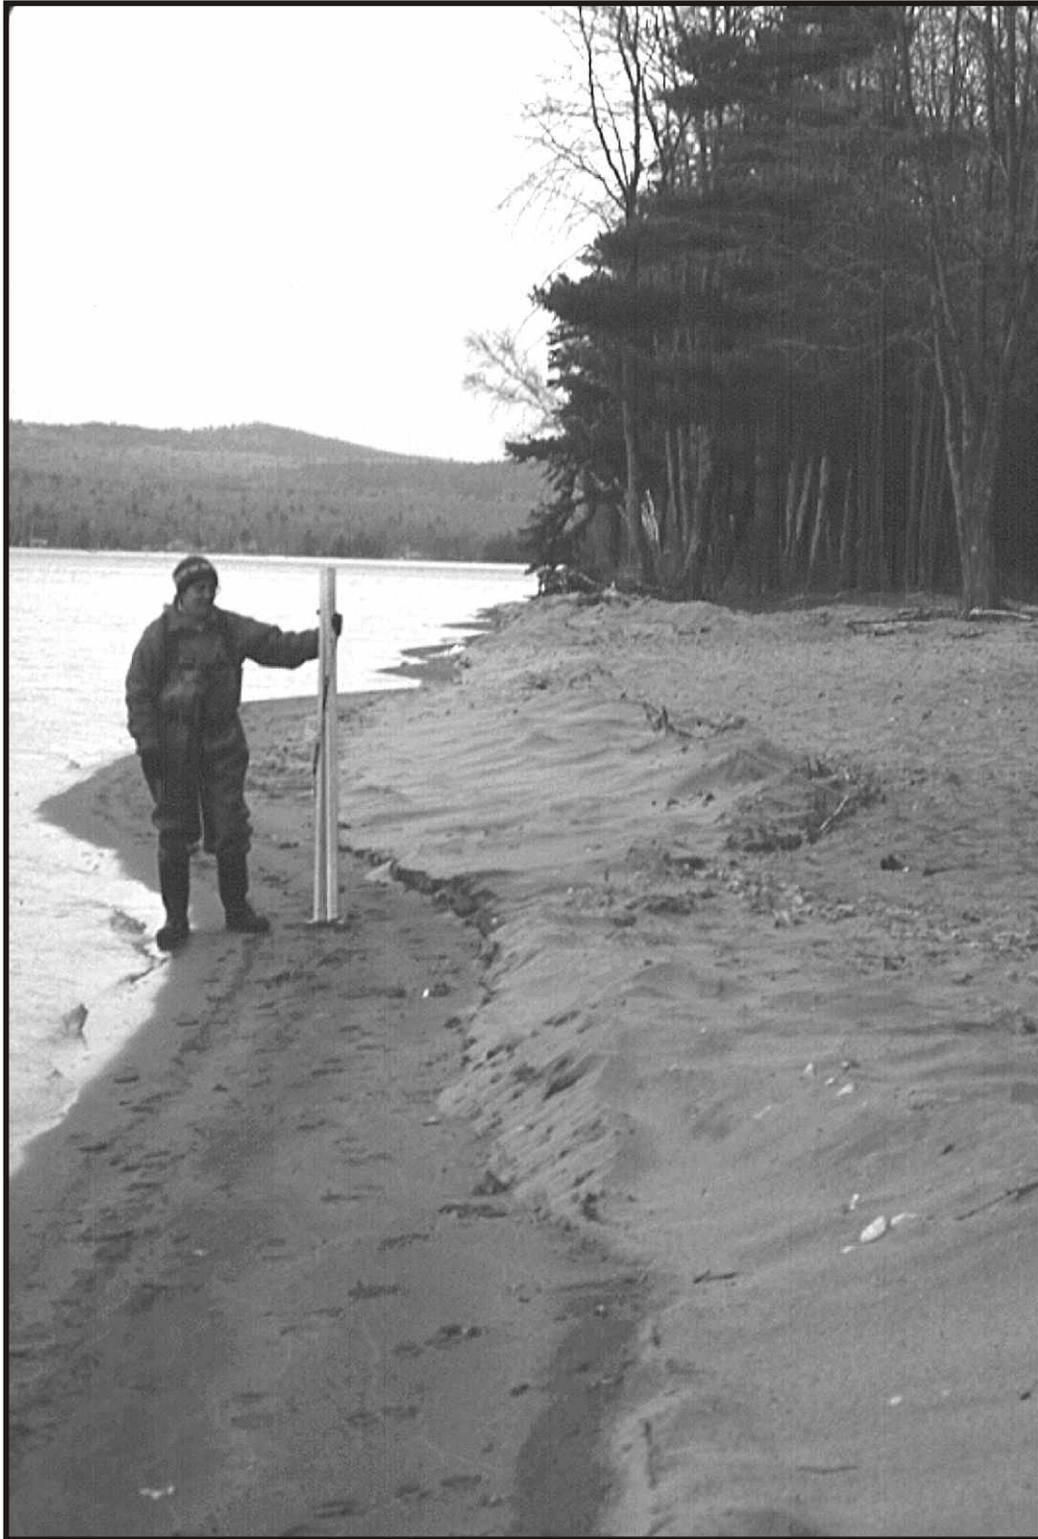
Figure 22. Photograph of spring 1997 ice ridge, Songo Beach (photo by Robert Johnston).

A large ice-push ridge was present in the spring of 1997 (see April 9, 1997 profile, and Figure 22). The long, sinuous ridge extended discontinuously for most of the length of Songo Beach on that date.

An ice push ridge was documented on April 6, 1996 and was reworked by April 18 (Figure 22).
