A Pilot Study: Railroad Right of Way Herbicides and Maine's Surface and Ground Water

The following is a summary of a pesticide and railroad right of way (ROW) pilot study, conducted by the Maine Board of Pesticides Control (BPC) during the summer of 2003.

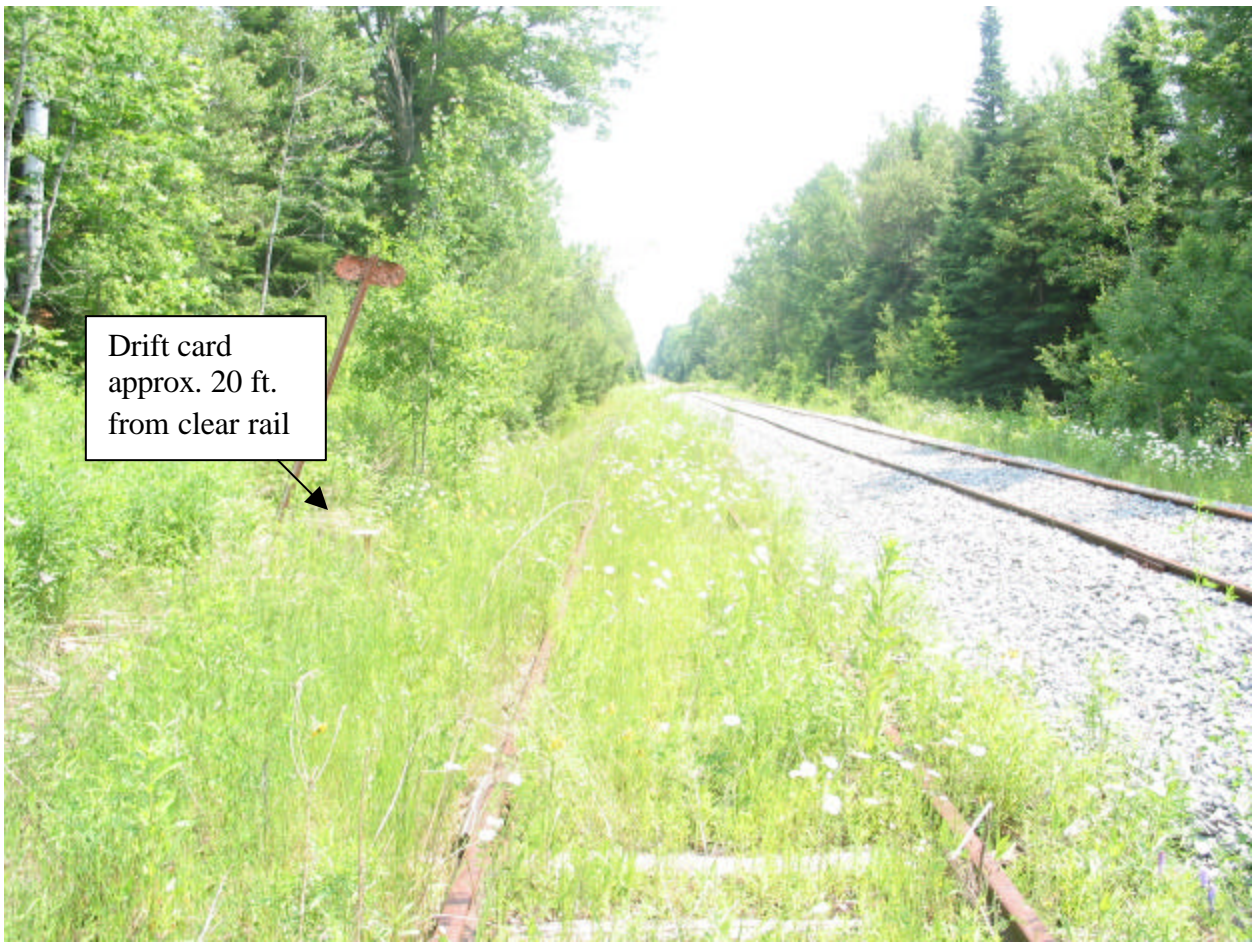
Figure 1. Burnham southernmost site
N44°39'11.1"
W69°23'09.2"

Sample 030624HPJ03 was positive for imazapyr with 384.8 micrograms on the drift card. This sample was taken in the town of Burnham, not near a water body. It was intended that this card be placed 10 feet away from the spray zone to get an idea of any drift that may be occurring when spray crews are not using precautions for water. Due to the double tracks however, more area was sprayed than was anticipated, and the card was directly sprayed with the glyphosate/imazapyr mixture when the spray truck's booms were lifted (see Figures 1 and 2). This sample may be useful in the future as a quick comparison to other cards with positive detections that may show lesser degrees of herbicide residue.

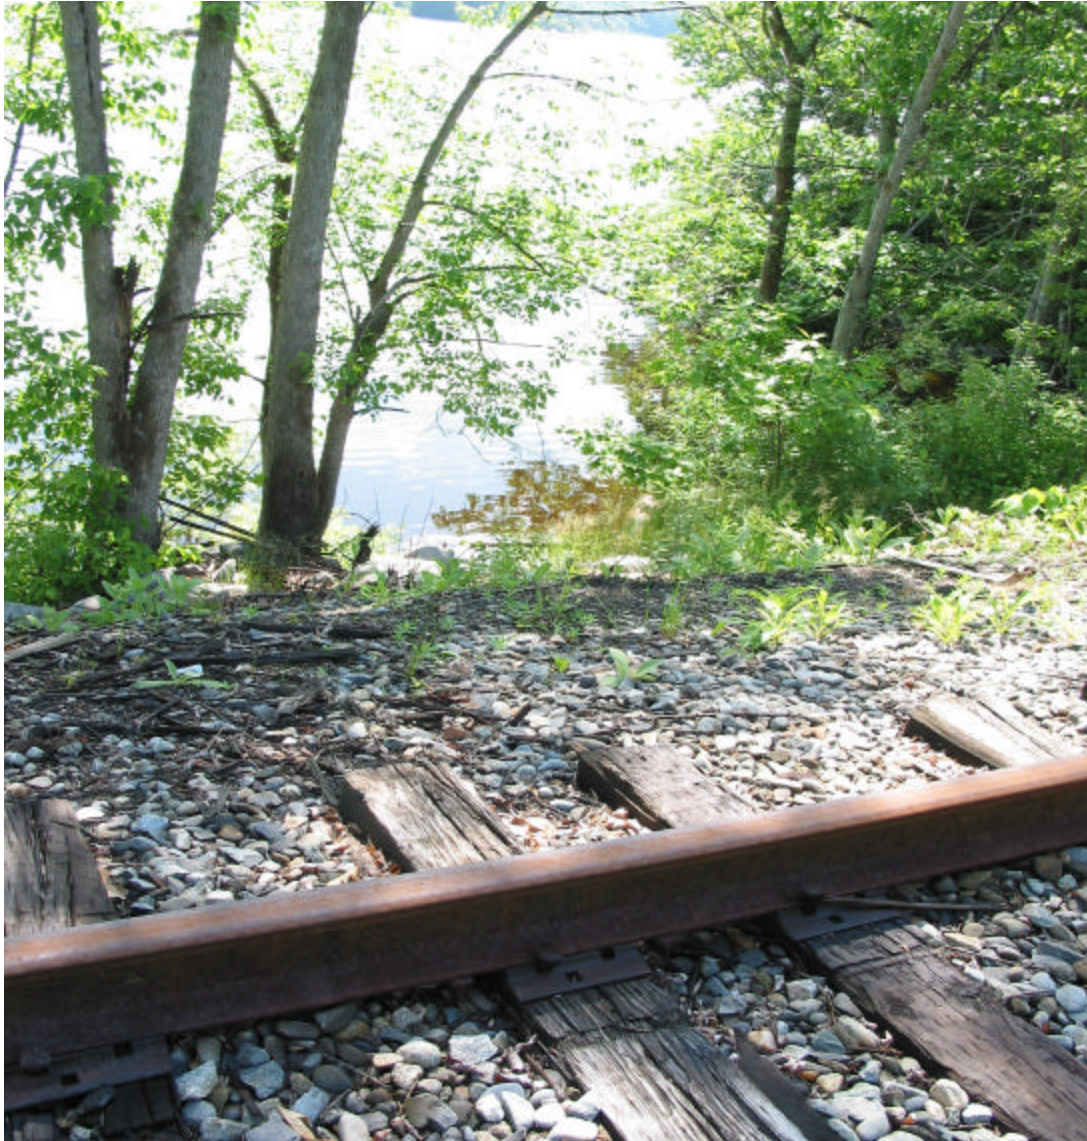
Figure 3. Kennebec River sampling site

Initially, the lab reported a positive detection for imazapyr on the drift card at the Kennebec River site. However, the lab later realized that an error had been made. When rechecking the chromatograms, it was discovered that there was an artifact peak which eluted before imazapyr would have.

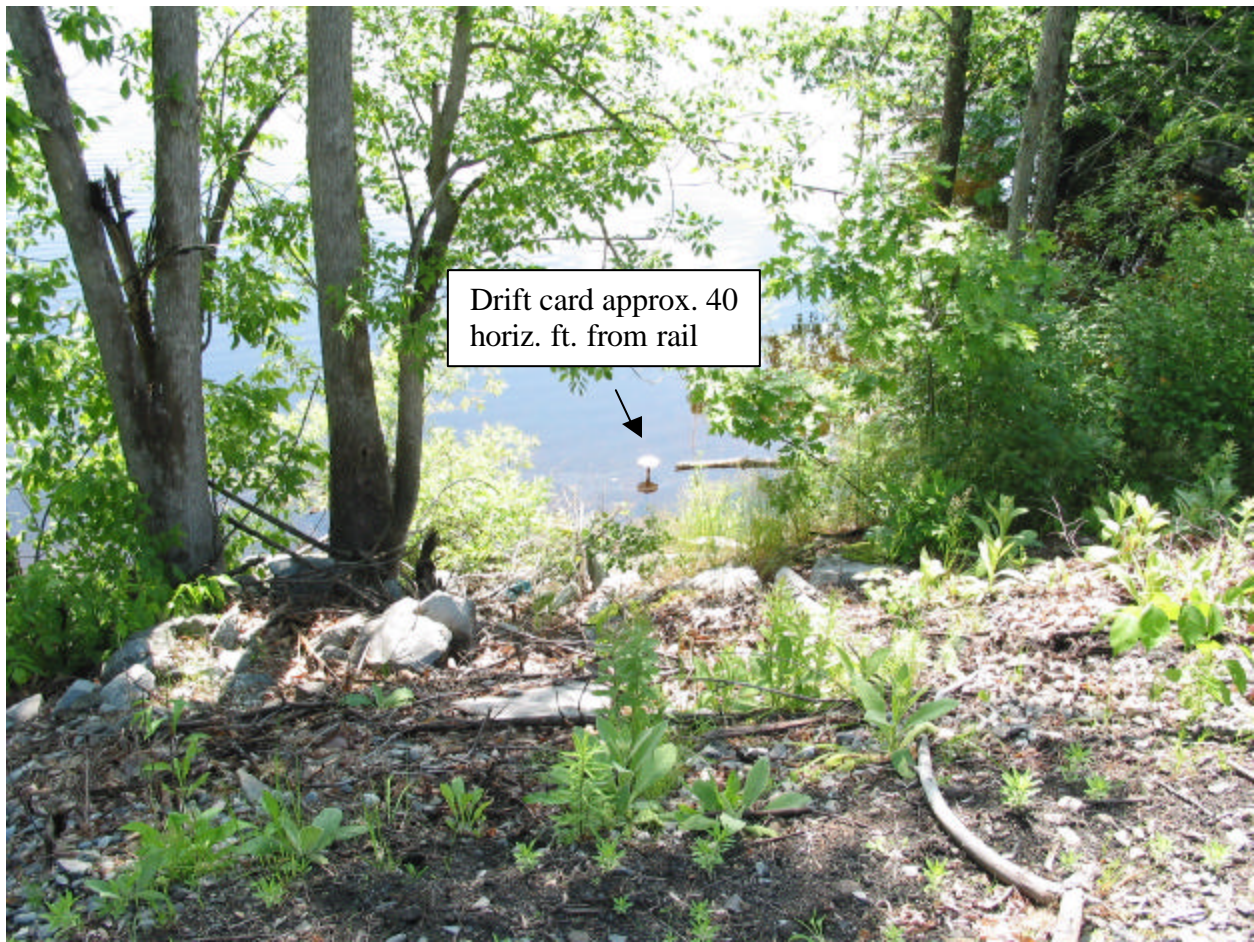
Figure 4. Kennebec River sampling site looking down slope from tracks

Drift card approx. 40
horiz. ft. from rail

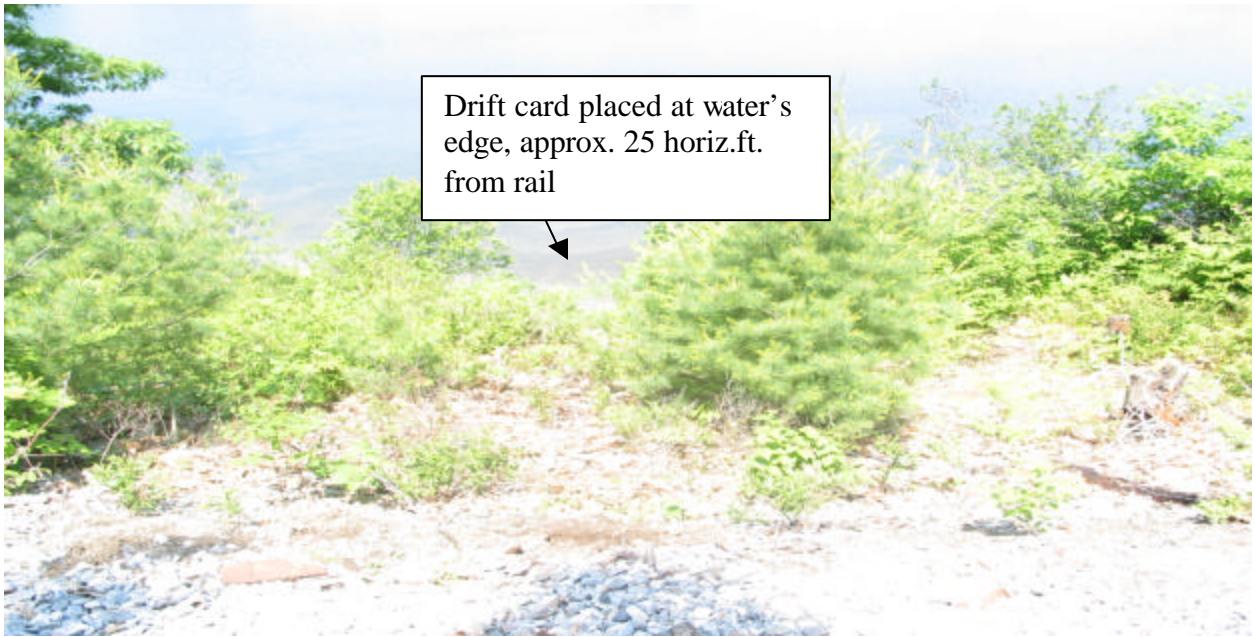
Figure 6. Damariscotta Lake northernmost site (picture taken from tracks)
N44°06'16.9"
W69°28'18.1"

Drift card placed at water's edge, approx. 25 horiz.ft. from rail

An attempt was also made to detect potential herbicide residues by collecting water samples at two of the Damariscotta Lake sites after significant rain events (see Figures 6 and 7). The plan was to sample after one inch of rainfall was received within a 24 hour period, but the staff experienced difficulty obtaining accurate rainfall information (see the Discussion and Conclusions section of this paper). After about a month and a half of very little rain since the herbicide application in June, two water samples were collected on Monday, August 4 after the area reportedly received almost 2 inches of rain the preceding Friday night and Saturday. It is expected that close to 48 hours elapsed from the end of that rain event to the time of sampling. Two more water samples were collected on August 12 after an undetermined amount of rain.
