07018 Stone Beachfront Protection  
Prouts Neck; Scarborough, Maine

**Application for  
NRPA Coastal Sand Dune Permit**  
March 14, 2008

**Stone Beachfront Protection**  
Prouts Neck; Scarborough, Maine

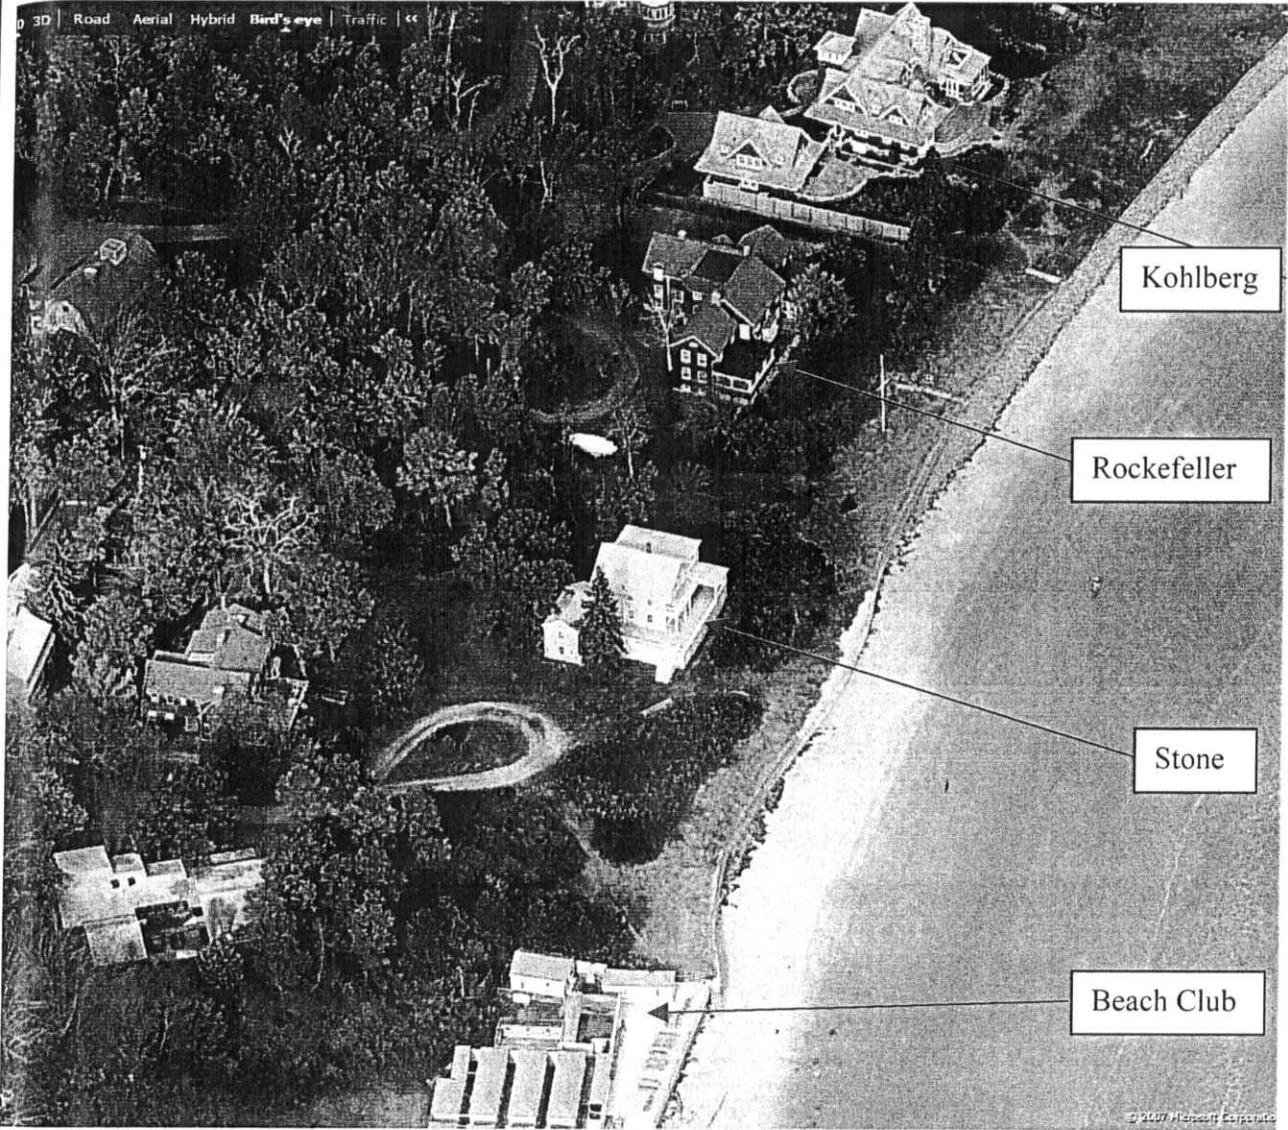
Pre Storm Aerial Photo from Google Earth

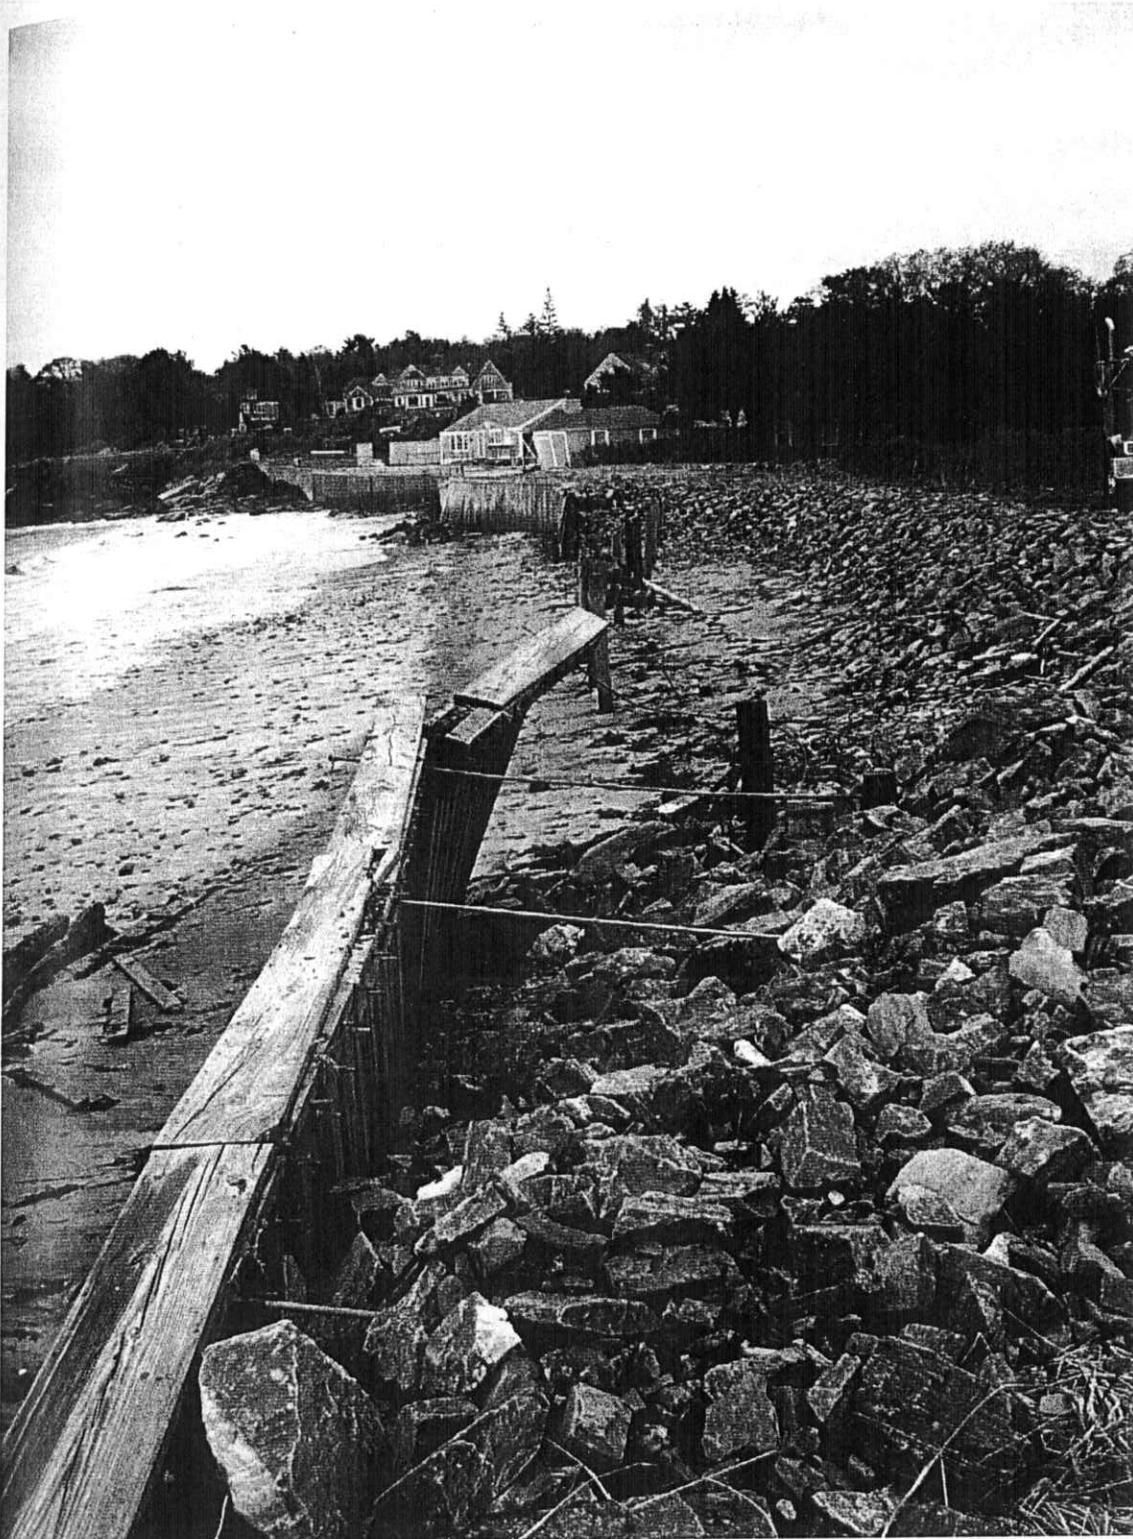
April 07 storm damage. Looking across Stone property towards the Prouts Neck Beach Club.

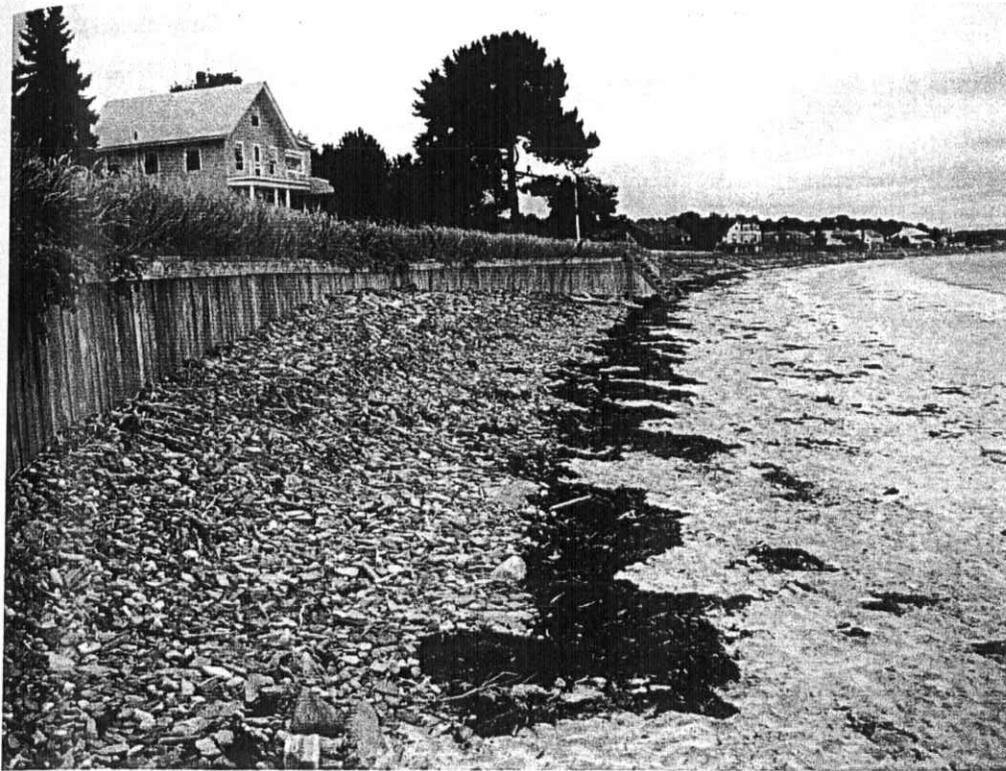
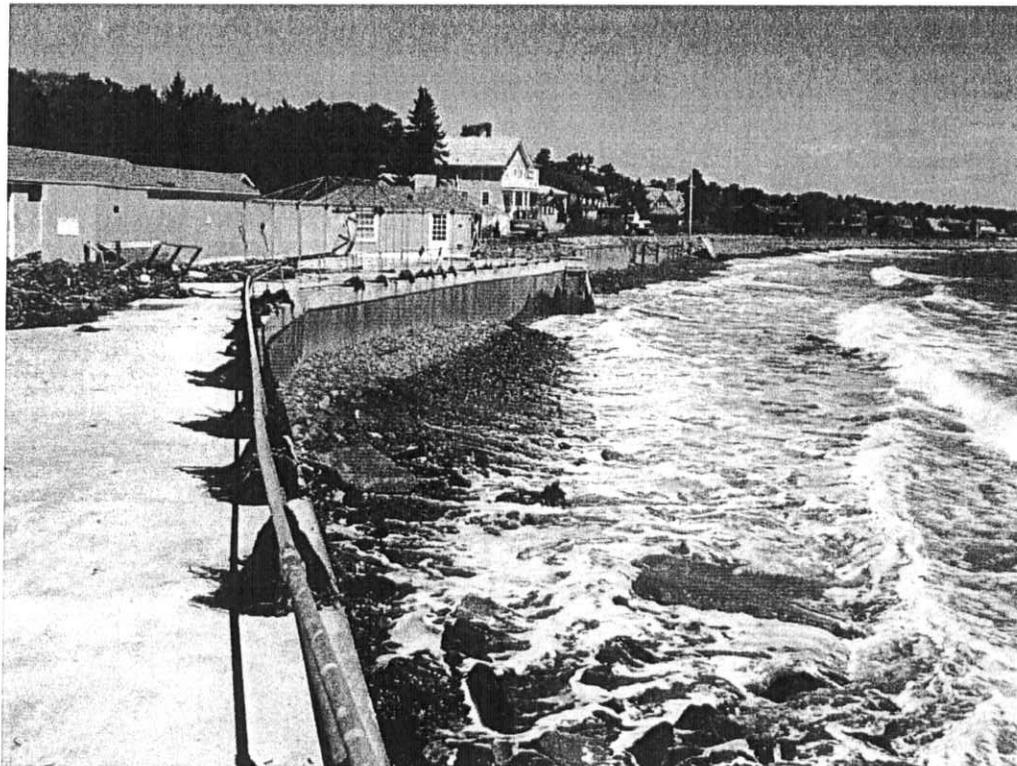
Pre-storm damage condition of Stone property above. Note 'bump' in horizontal wall alignment. Contrast with April 2007 damage below. Note that the Prouts Neck Beach Club wall was replaced in 2006.

The horizontal alignment of the revetment is based on the location of the timber bulkhead that it replaces. As shown on plan sheet C-3 Proposed Plan and Profile, the proposed wall alignment is 'smoothed out' to eliminate a 'bump' in the previous wall location. Based on observation, this anomaly served to promote scour at this location of the wall. By reconstructing the wall on the gradual alignment shown, the tendency for localized storm scour is reduced or eliminated. The net effect is to balance upland loss with gain on the new wall alignment.

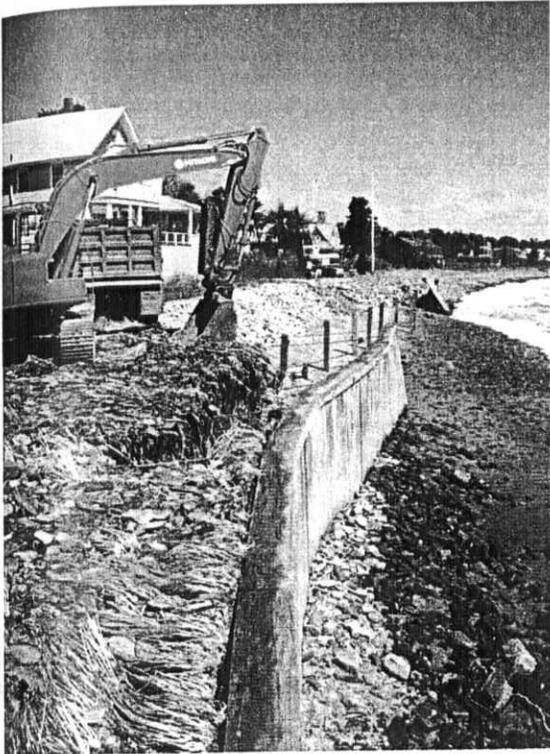
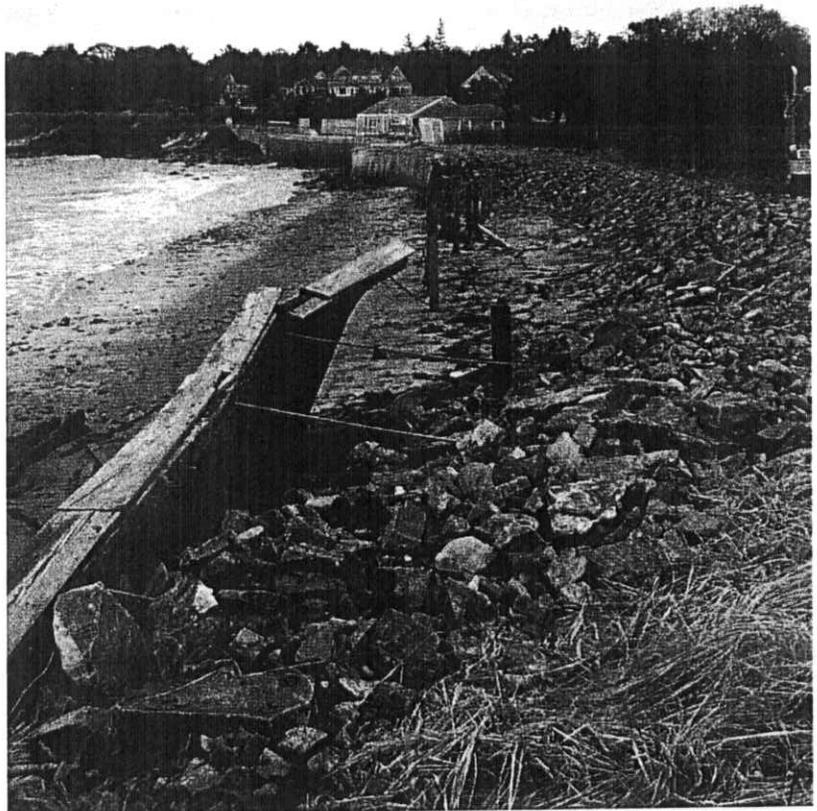
Close up of April 2007 storm damage.

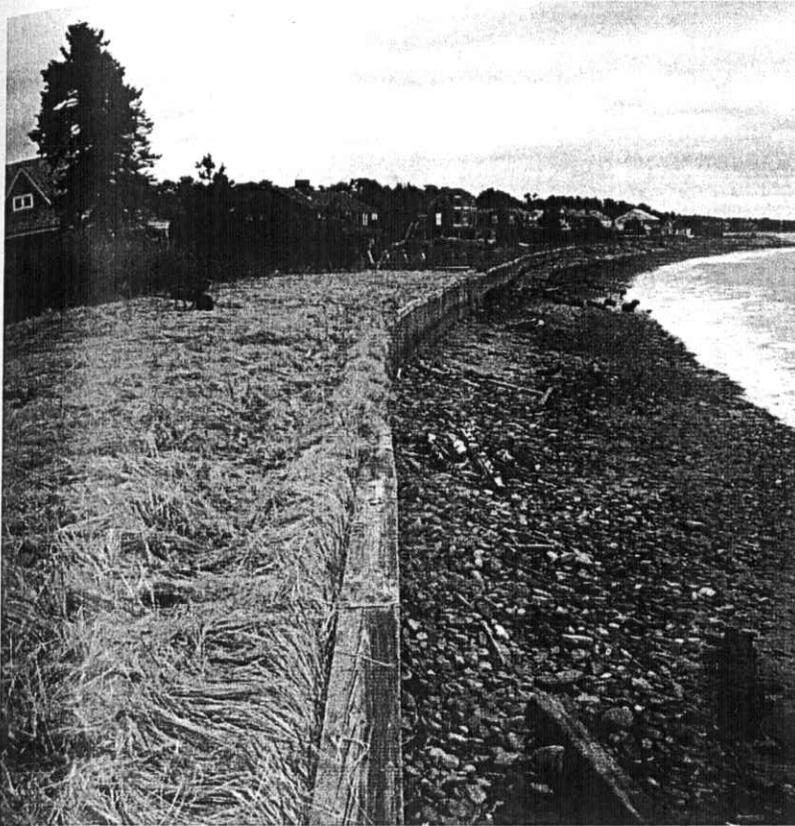
Replacement of Dune Grass on Rockefeller Property. Kohlberg property beyond.

Dune grass is planted to stabilize the ground surface and to provide a natural buffer above the revetment.
