**Re: NRPA Permit Application Amendment | Proposed Utility Connection | MRC-Fiberight Waste Processing and Recycling Facility | Hampden, Maine**

CES is assisting the MRC with the design and permitting of a proposed utility connection for a solid waste processing and recycling facility in Hampden, Maine. Enclosed please find an Amendment to the NRPA Permit Application submitted for the proposed utility connection associated with the MRC-Fiberight Solid Waste Processing Facility (the Facility), a NRPA Permit by Rule (PBR) for a stream crossing (check included), and minor revisions to the site plan. This submittal is an Amendment to the permit application #L26497-TG-A-N submitted previously for the Facility on June 24, 2015.

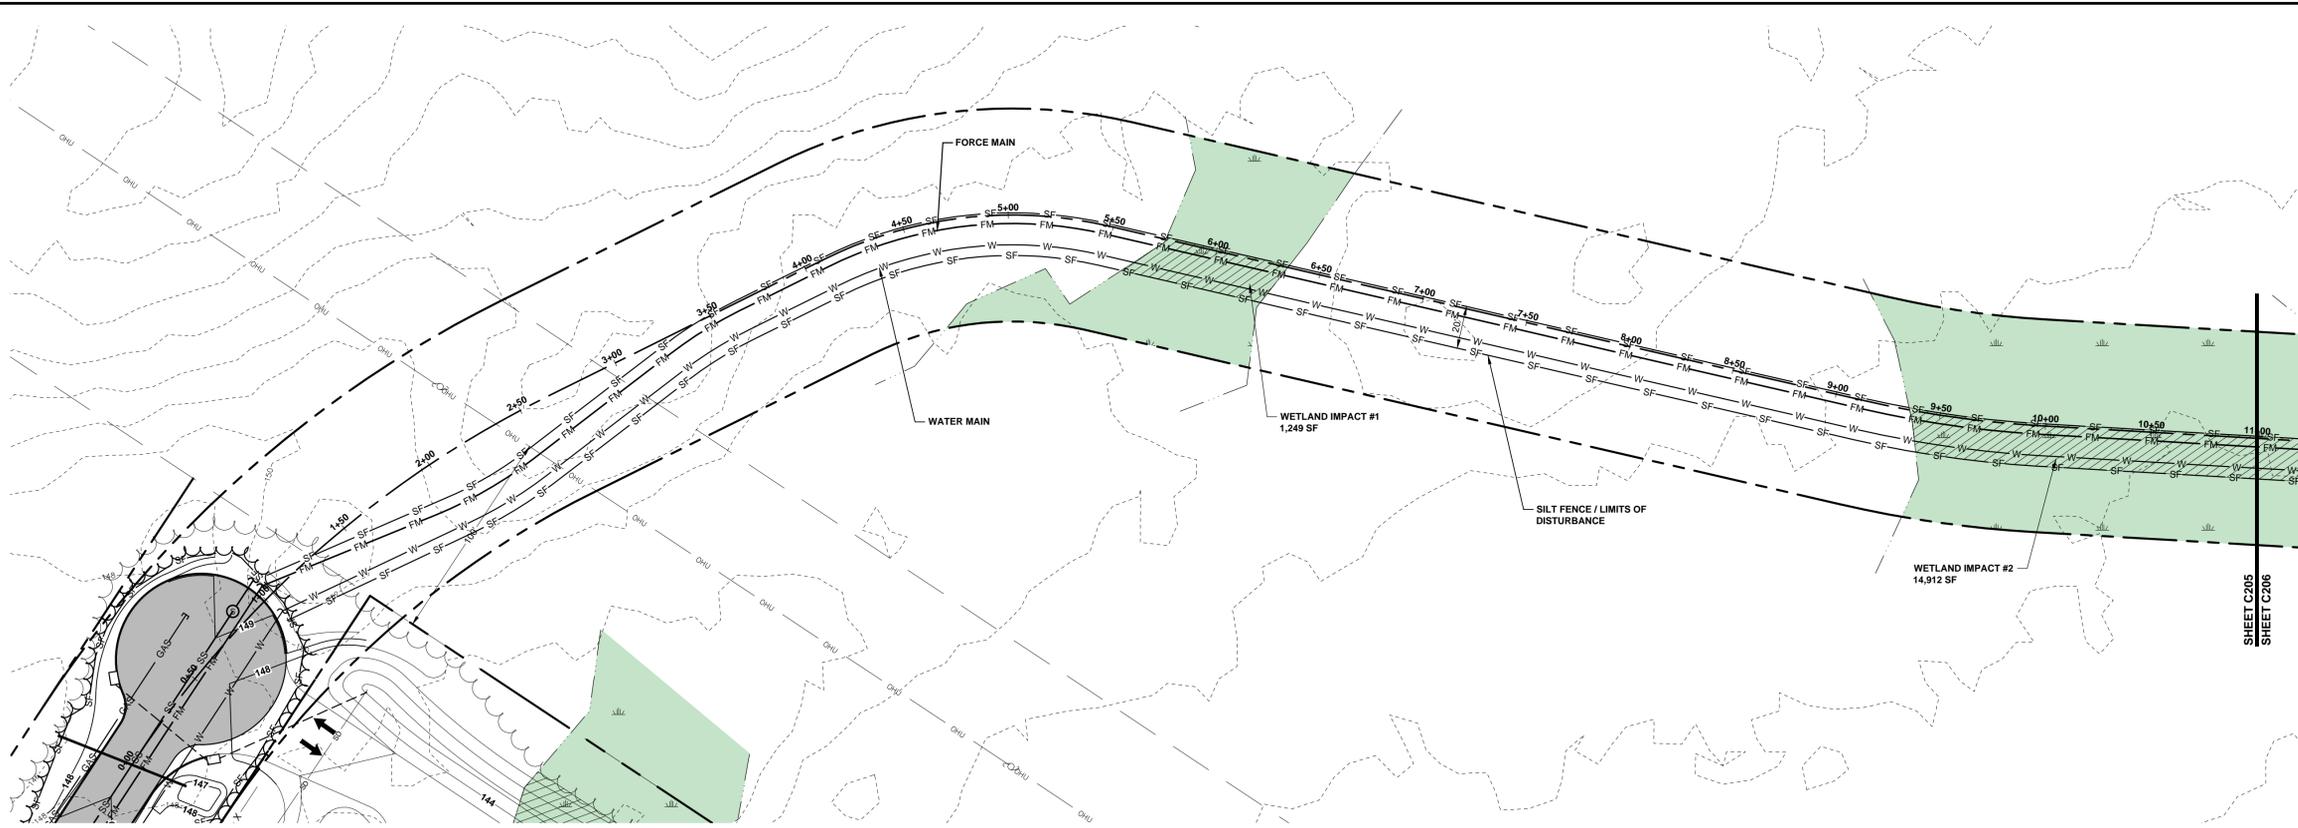
**PLAN - STA: 0+00 TO 11+00**  
SCALE: 1"=40'

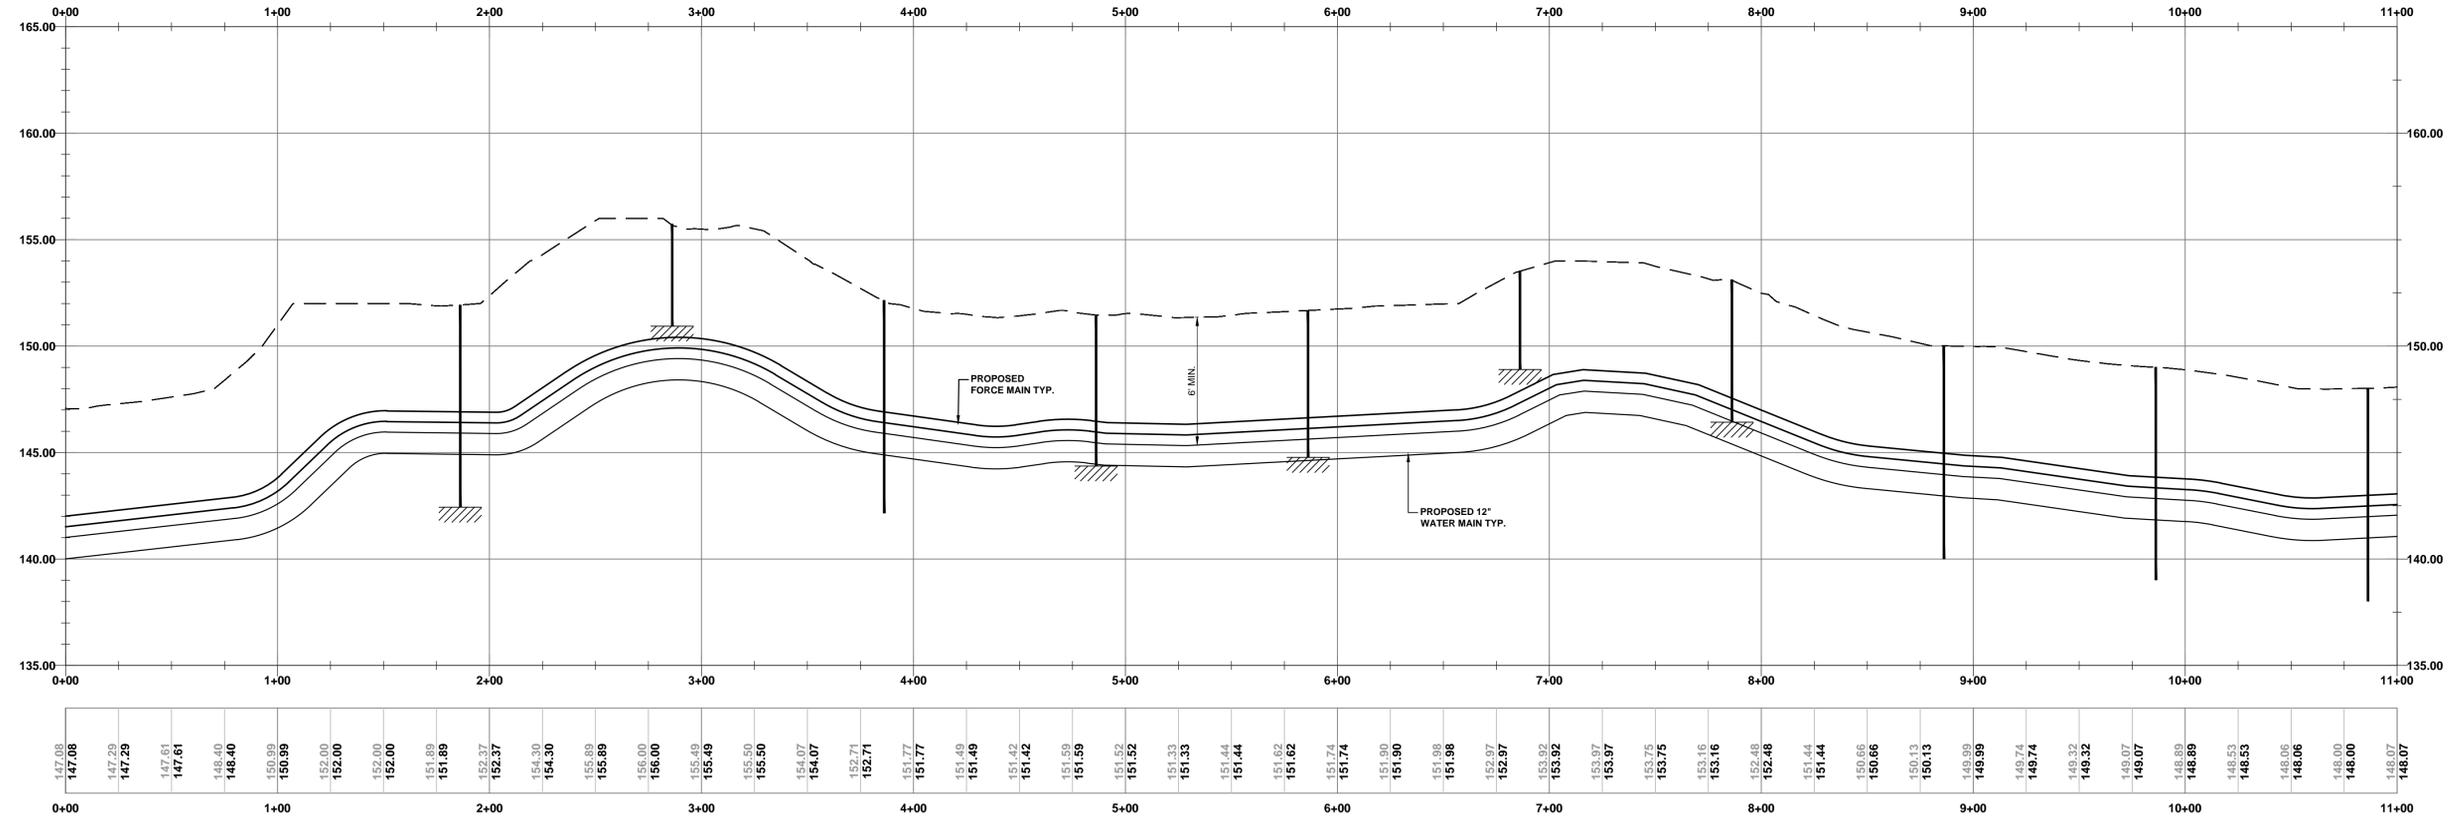
**PROFILE - STA: 0+00 TO 11+00**  
SCALE: H: 1"=40'  
V: 1"=4'

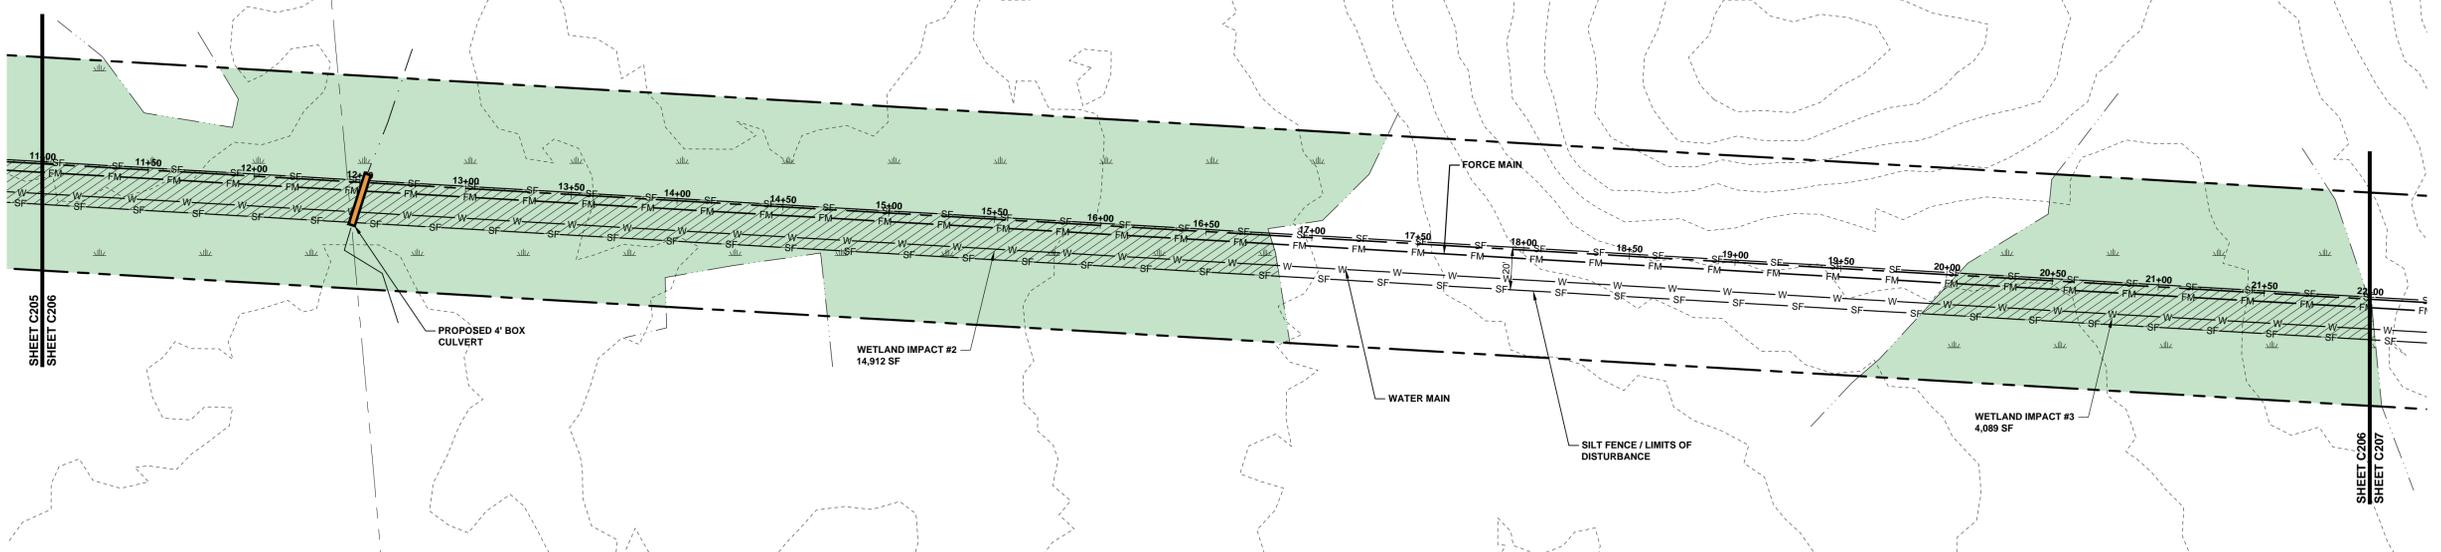
**PLAN - STA: 11+00 TO 22+00**  
SCALE: 1"=40'

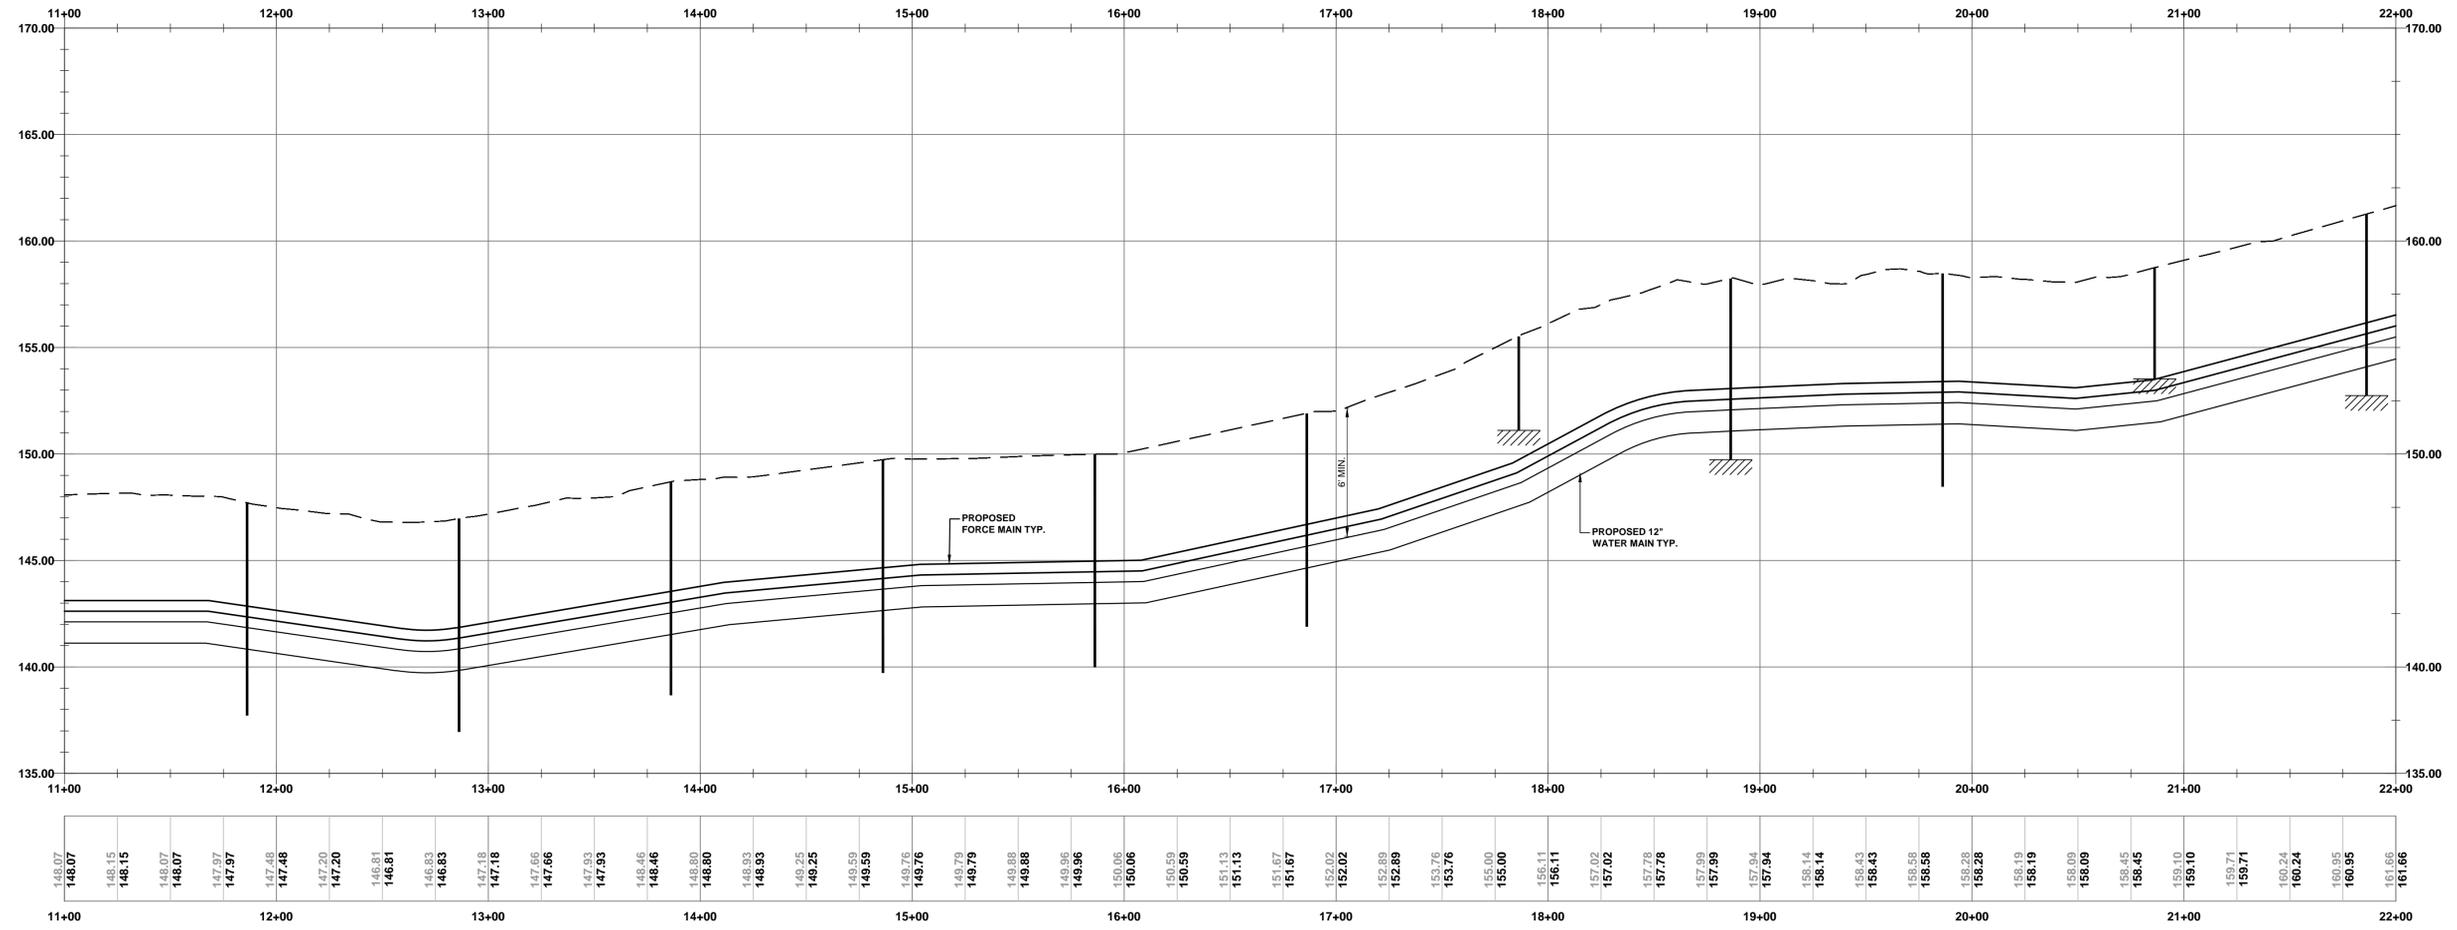
**PROFILE - STA: 11+00 TO 22+00**  
SCALE: H: 1"=40'  
V: 1"=4'

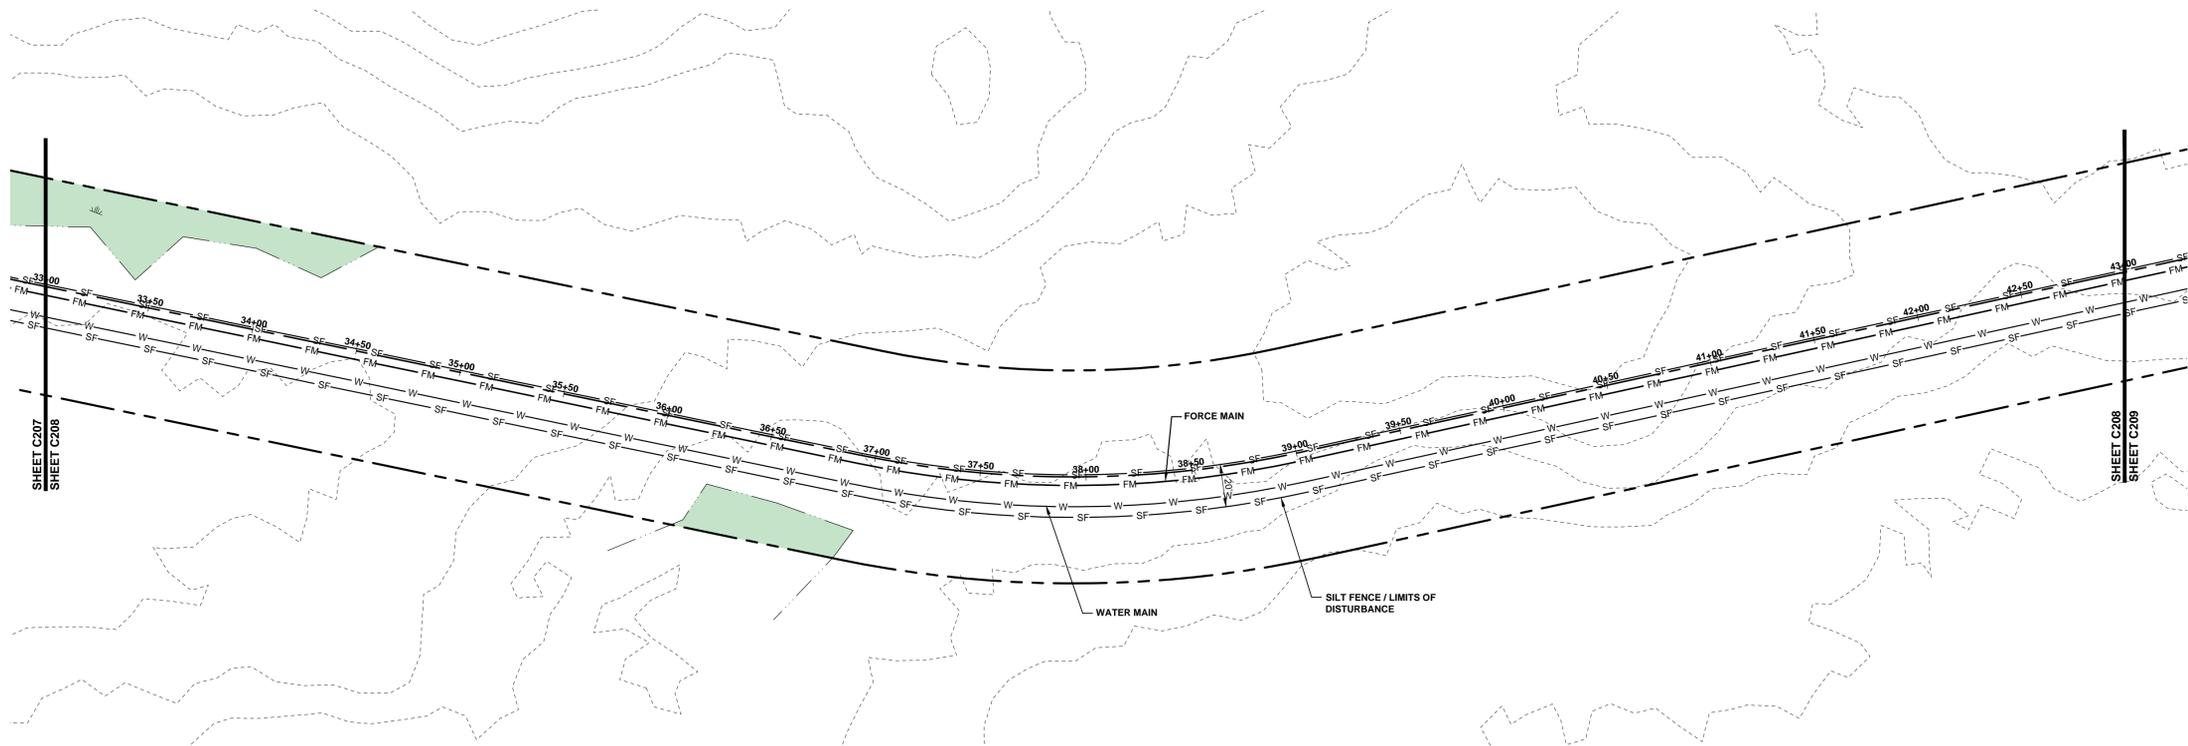
**PLAN - STA: 33+00 TO 43+00**  
SCALE: 1"=40'

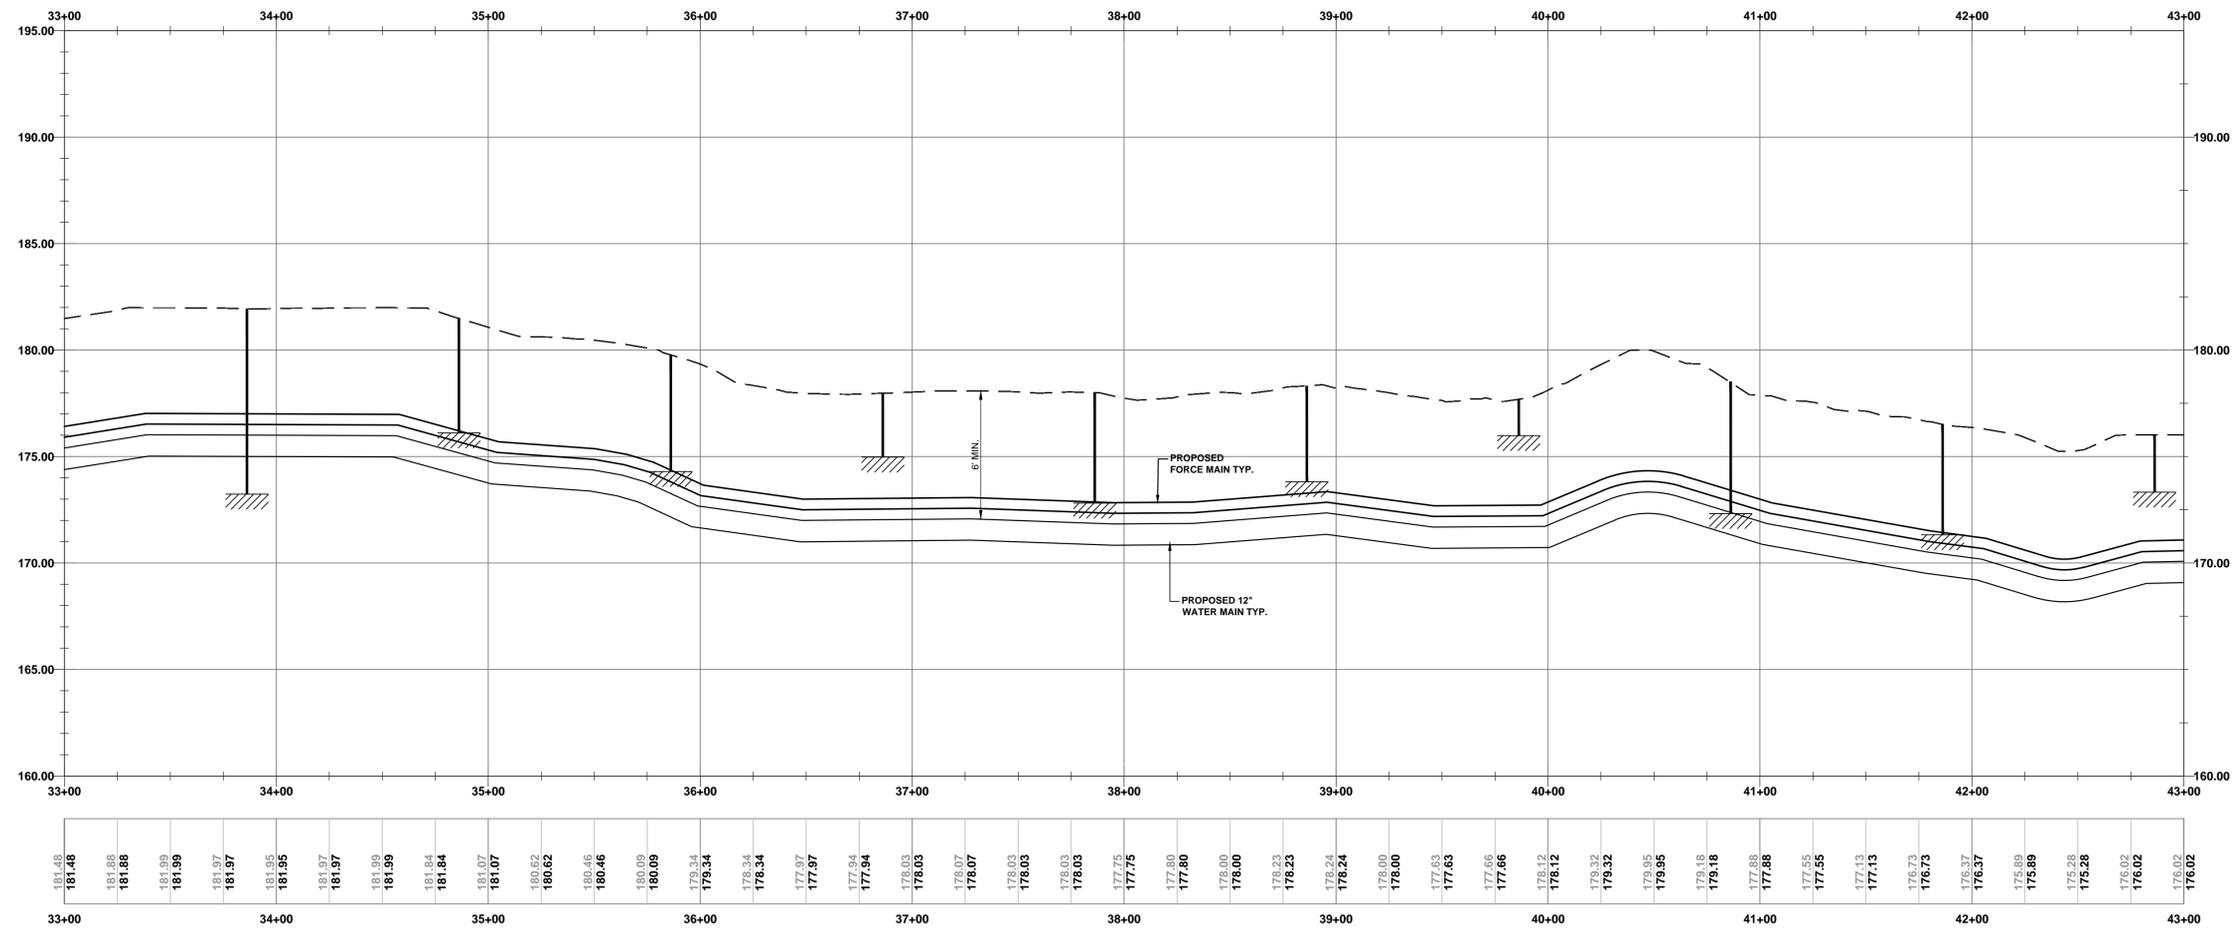
**PROFILE - STA: 33+00 TO 43+00**  
SCALE: H: 1"=40'  
V: 1"=4'

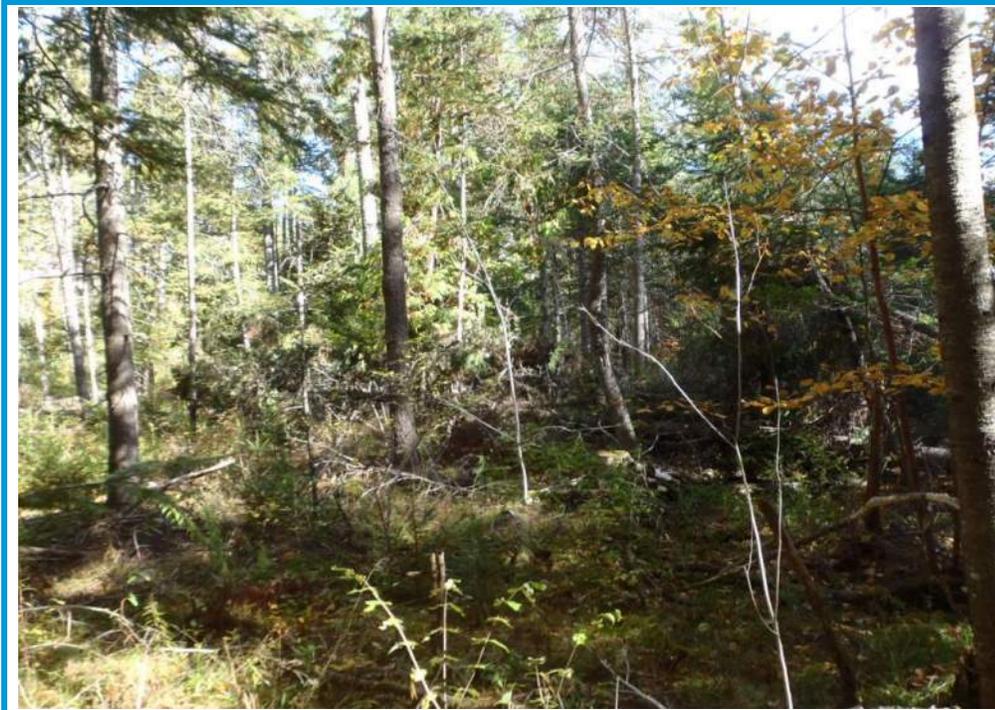
**Photo No. 1**

**Description:**  
View of Wetland  
15AU-1, a red maple-  
balsam fir forested  
wetland.

Wetlands on the Site are dominated by forested freshwater red maple – balsam fir wetlands. In the western portion of the Site, these wetlands are seasonally saturated forested wetlands (PFO1&4E), such as Wetland 15AU-1 and Wetland 15AU-3. In these wetlands, the tree stratum is dominated by red maple, balsam fir, and cedar (*Thuja occidentalis*). The shrub stratum is dominated by the species noted in the tree stratum, and also by speckled alder (*Alnus incana*) and quaking aspen (*Populus tremuloides*). The herb stratum is sparse to moderate cover, with bracken fern (*Pteridium aquilinum*), horsetail (*Equisetum* sp.), sensitive fern (*Onoclea sensibilis*), and dwarf raspberry (*Rubus pubescens*) present. Greater than 50 percent of the dominant vegetation across all strata is currently listed as having a regional wetland indicator status of facultative or wetter (Vegetation Indicator 2). Soils in these wetlands consisted of a depleted silt loam horizon underlain by a depleted and mottled silt loam horizon. In some areas, a thin horizon of organic soil or mucky mineral soil covered the surface. These soils met the requirements of Hydric Soil Indicator F3, Depleted Matrix. Evidence of hydrology in this wetland consisted of pit and mound microtopography, water stained leaves, and thin muck surface (Hydrology Indicators D4, B9, and C7).

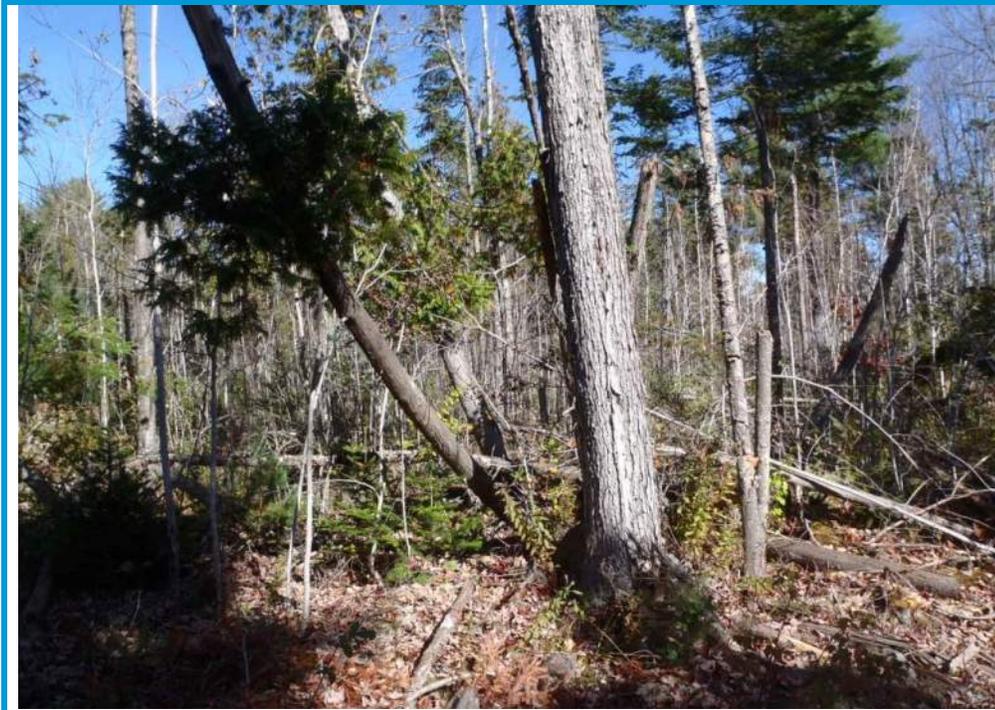
**Photo No. 3**

**Description:**  
 View of Wetland  
 15AU-2.

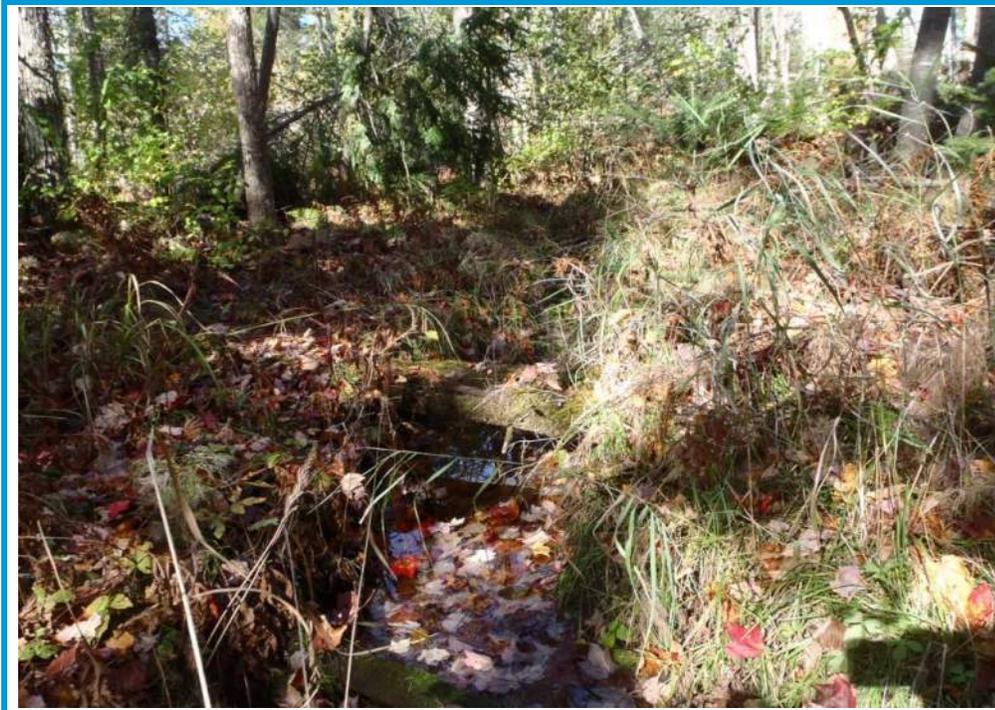
**Photo No. 5**

**Description:**  
 View of intermittent stream 15AU-2 S1, which is located within Wetland 15AU 2.

The proposed stream crossing involves crossing an approximately 24" wide intermittent stream channel. A four foot wide by two foot high box culvert will be installed to provide greater than a 1.2 times bank full width opening. This opening has been sized based on the natural stream bank-full width observed downstream of the disturbed area. Construction is expected to occur in late Summer 2016 (July 15-October 1) during periods of low water, and will adhere to all standards and conditions outlined under Section 10 of Chapter 305 – Permit by Rule Standards and the current Erosion and Sediment Control BMPS.

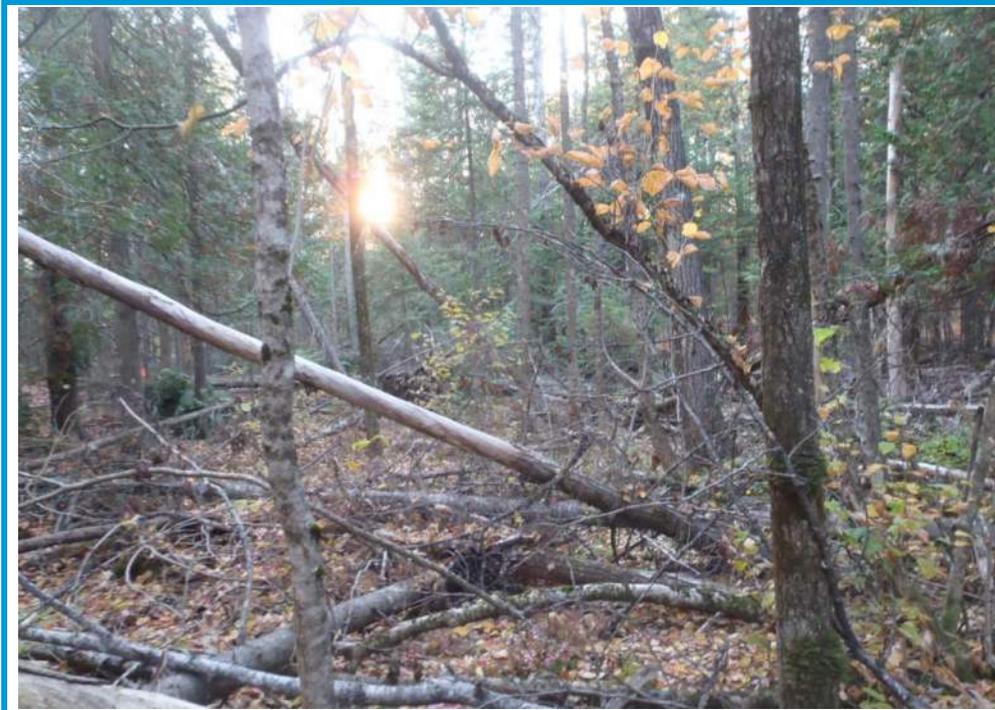
Photo No. 7

Description:  
View of Wetland  
15AU-4, a forested  
swale wetland.

Wetland drainages such as Wetland 15AU-4 are located in areas of the Site where soils are stony and shallow to bedrock. Vegetation and soils characteristics are similar to what was noted above. Indicators of hydrology in these wetland drainages consisted of saturation, drainage patterns, and pit and mound microtopography (Hydrology Indicators A3, B10, and D4).

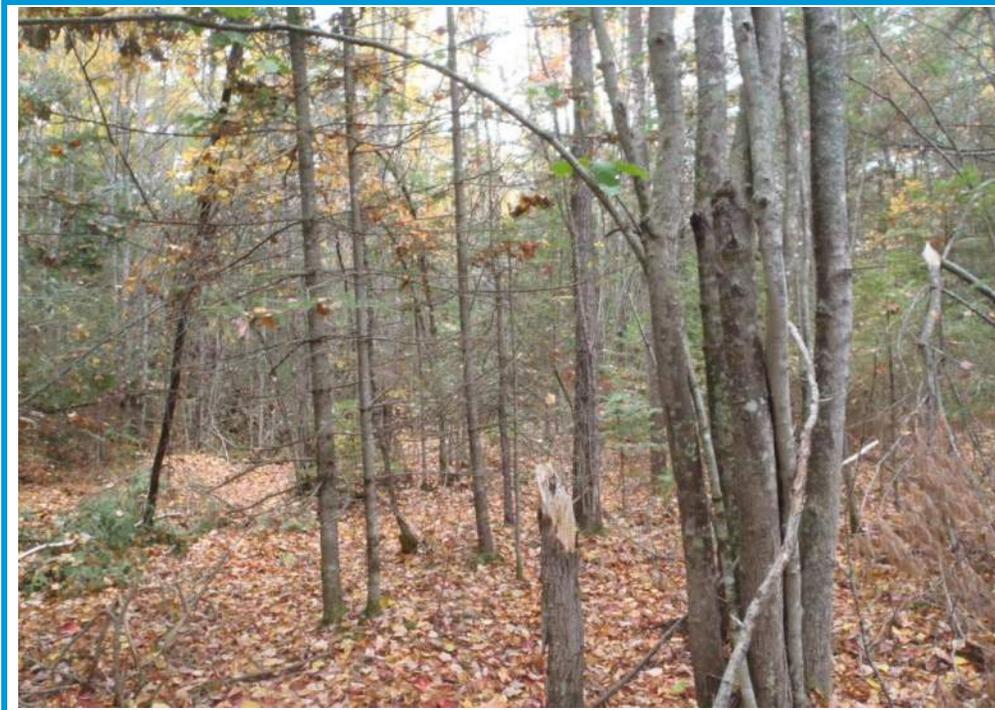
**Photo No. 9**

**Description:**  
 View of Wetland  
 15AU-6, a red maple  
 and balsam fir  
 seasonally inundated  
 forested wetland.

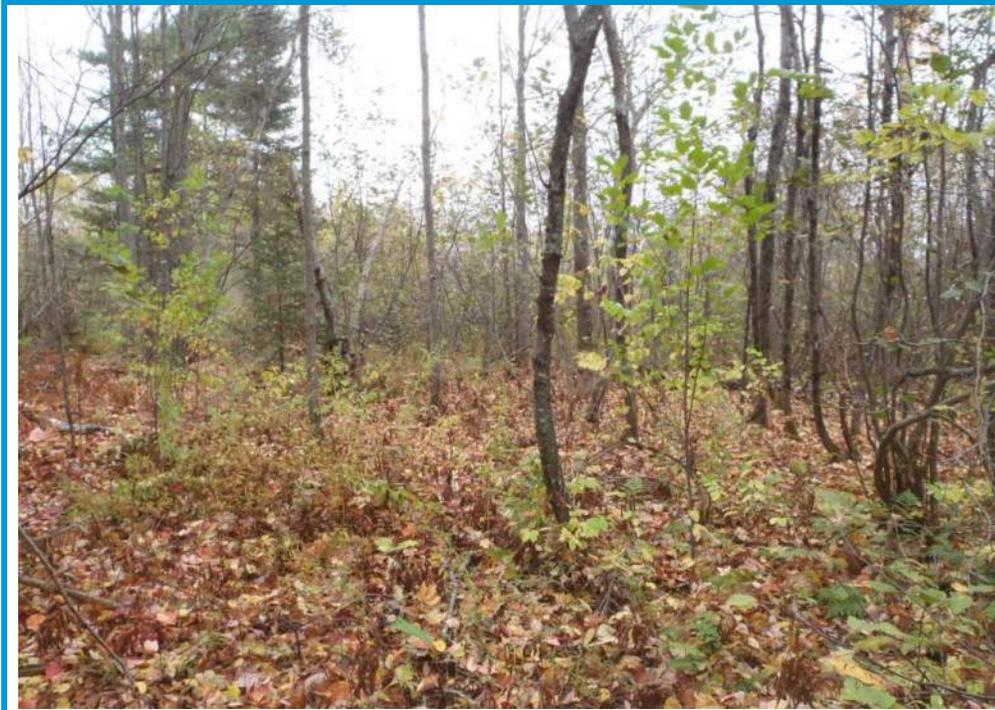
**Photo No.** 11

**Description:**  
View of forested  
portion of Wetland  
15AU-8.

Wetland 15AU-8 is located in the eastern portion of the Site and is a deciduous forested and scrub shrub freshwater wetland (PFO1 and PSS1) which is different from the wetlands noted above. In the forested portions, the tree stratum is dominated by red maple and quaking aspen with grey birch and black cherry (*Prunus serotina*) also present. The shrub stratum of both the forested and scrub-shrub wetland is dominated by speckled alder, Morrow's honeysuckle, and winterberry with glossy false buckthorn also present. The herb stratum in the forested wetland is relatively sparse, with meadowsweet (*Spiraea latifolia*) and bunchberry (*Cornus canadensis*) dominant. In the scrub-shrub portions of this wetland, the herbaceous layer is abundant and dominated by Canada goldenrod (*Solidago canadensis*), dwarf raspberry and sensitive fern. Greater than 50 percent of the dominant vegetation across all strata is currently listed as having a regional wetland indicator status of facultative or wetter (Vegetation Indicator 2). Soils in these wetlands consisted of a depleted silt loam horizon underlain by a depleted and mottled silt loam horizon. In some areas, a thin horizon of organic soil or mucky mineral soil covered the surface. These soils met the requirements of Hydric Soil Indicator F3, Depleted Matrix. Evidence of hydrology in this wetland consisted of pit and mound microtopography, water stained leaves, drainage patterns, and thin muck surface (Hydrology Indicators D4, B9, B10 and C7).

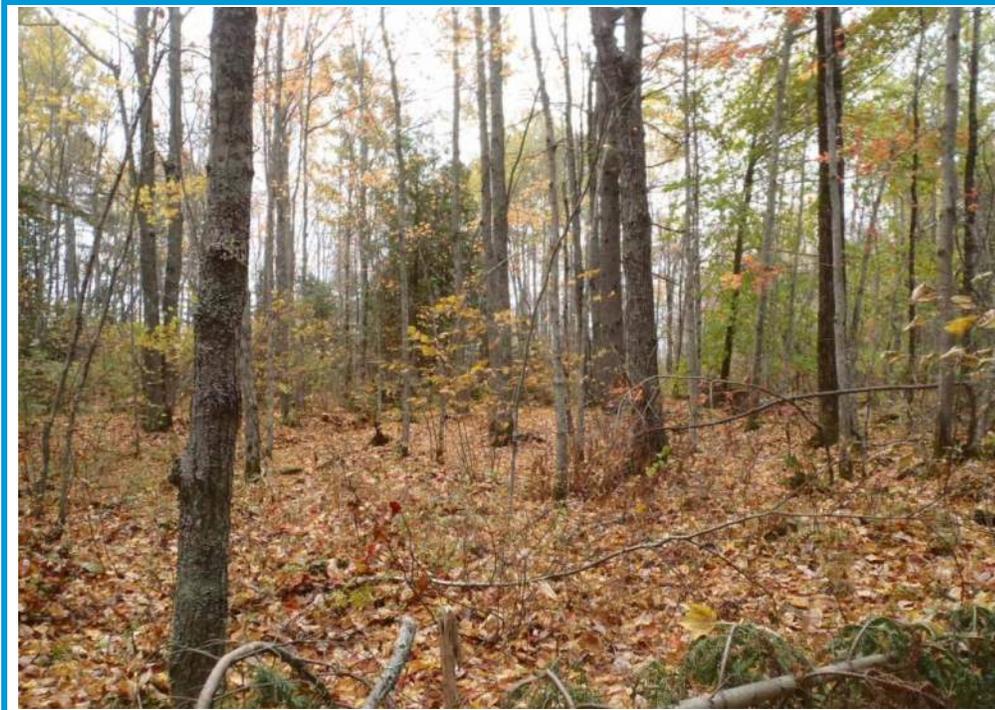
**Photo No. 13**

**Description:**  
 View of Wetland  
 15AU-9, a red maple  
 and balsam fir  
 seasonally inundated  
 forested wetland.
