**Re: Phase I Environmental Site Assessment
Former Chinet Groundwood Mill
69 Kennebec Street, Shawmut Village, Fairfield, Maine**

**PHASE I
ENVIRONMENTAL SITE ASSESSMENT**

**CHINET GROUNDWOOD MILL
69 KENNEBEC STREET
SHAWMUT VILLAGE, FAIRFIELD, MAINE**

**JANUARY 28, 2016
JN: 10193.040-01**

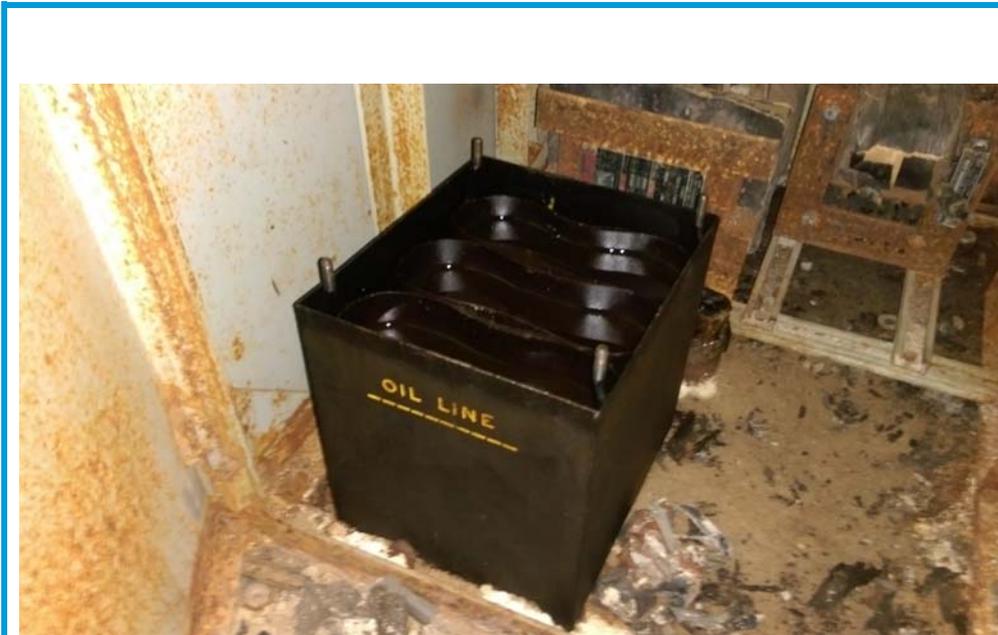
Photo No. 7

- ◆ Five open containers of oil and an oil-filled electrical transformer were observed in the first floor electrical room. The PCB content (if any) of the oil is unknown.

Description:
 View of a typical open oil container located in the electrical room on the first floor of the mill building.
