**Phase I Environmental Site Assessment
Former Naval Facility
Building 85 Complex and Wullenweber Circulatory Disposed Antenna Array
Corea, Maine**

CEG Project # 1014-257-00

July 2015

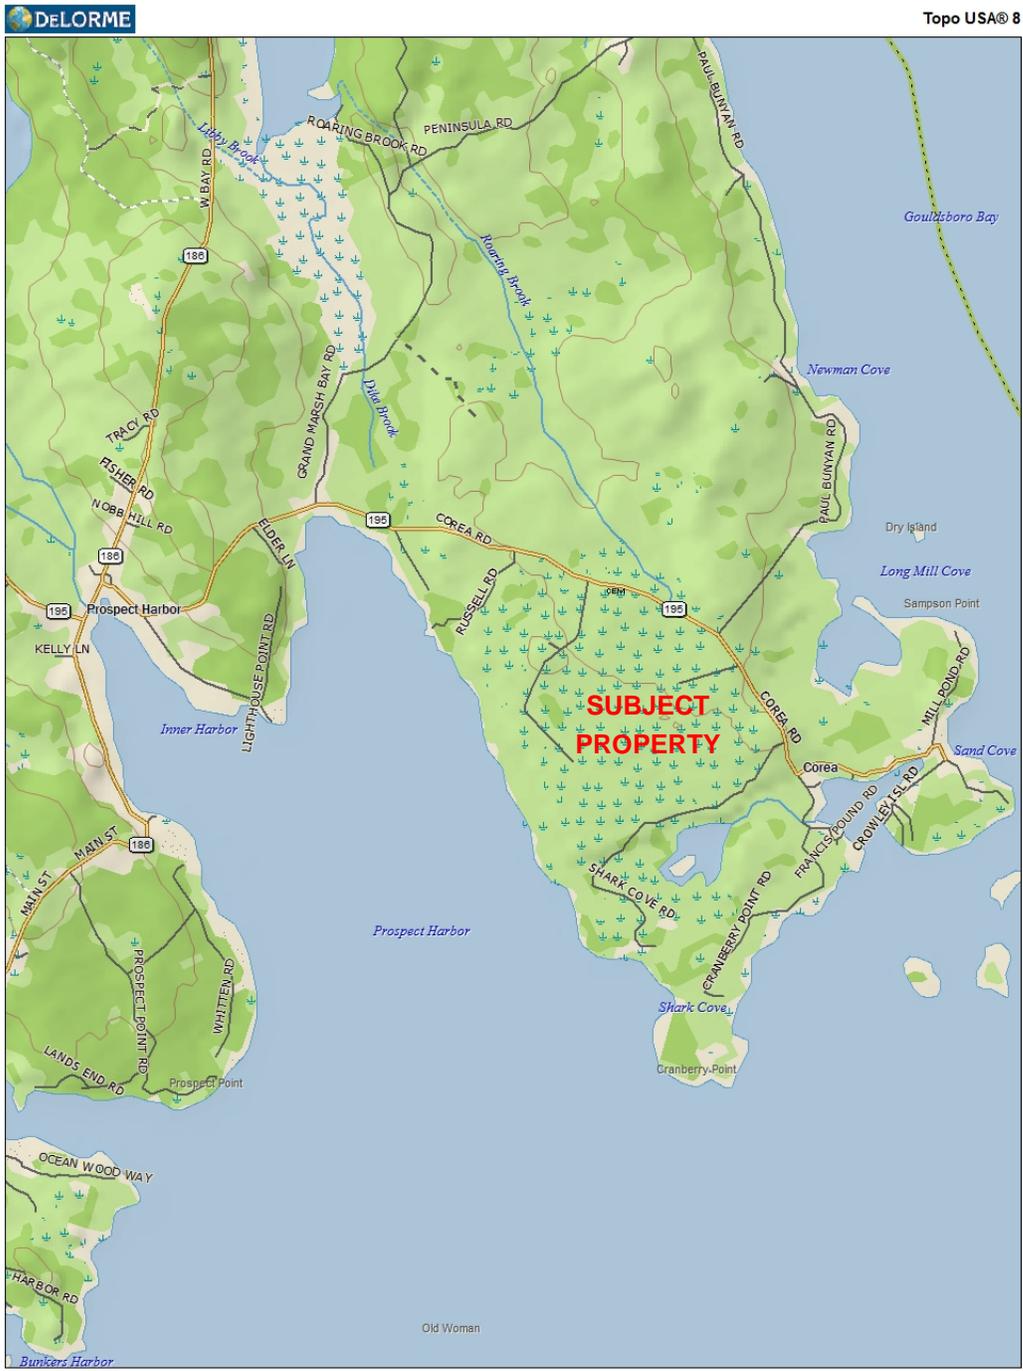
The following is a portion of the United States Geological Survey (USGS) topographic map obtained from the Maine Region 3, Delorme TopoQuads program, dated 1999.

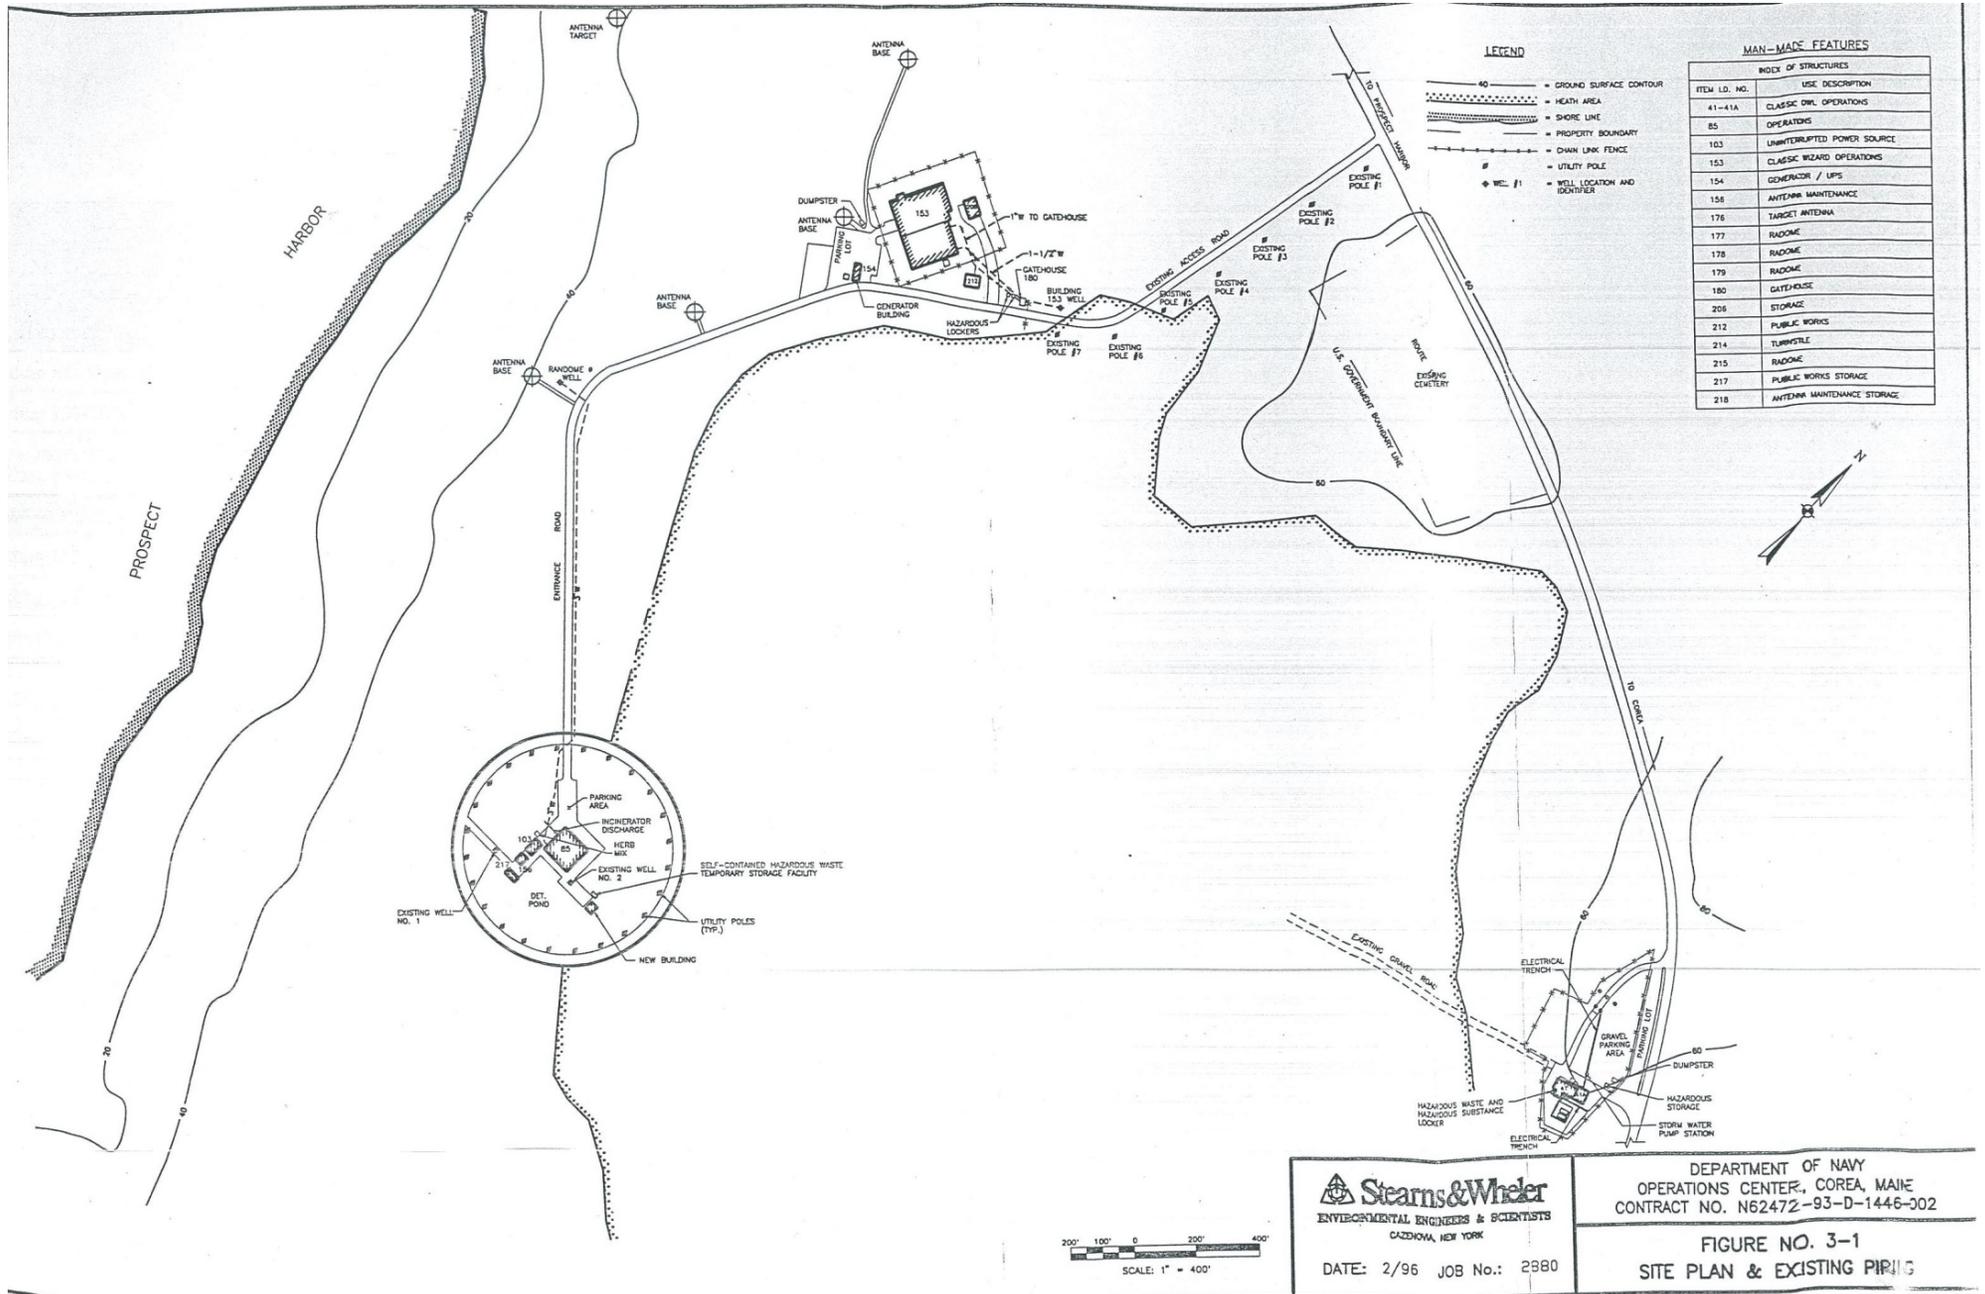
Figure 3
1996 Site Plan by Stearns & Wheeler

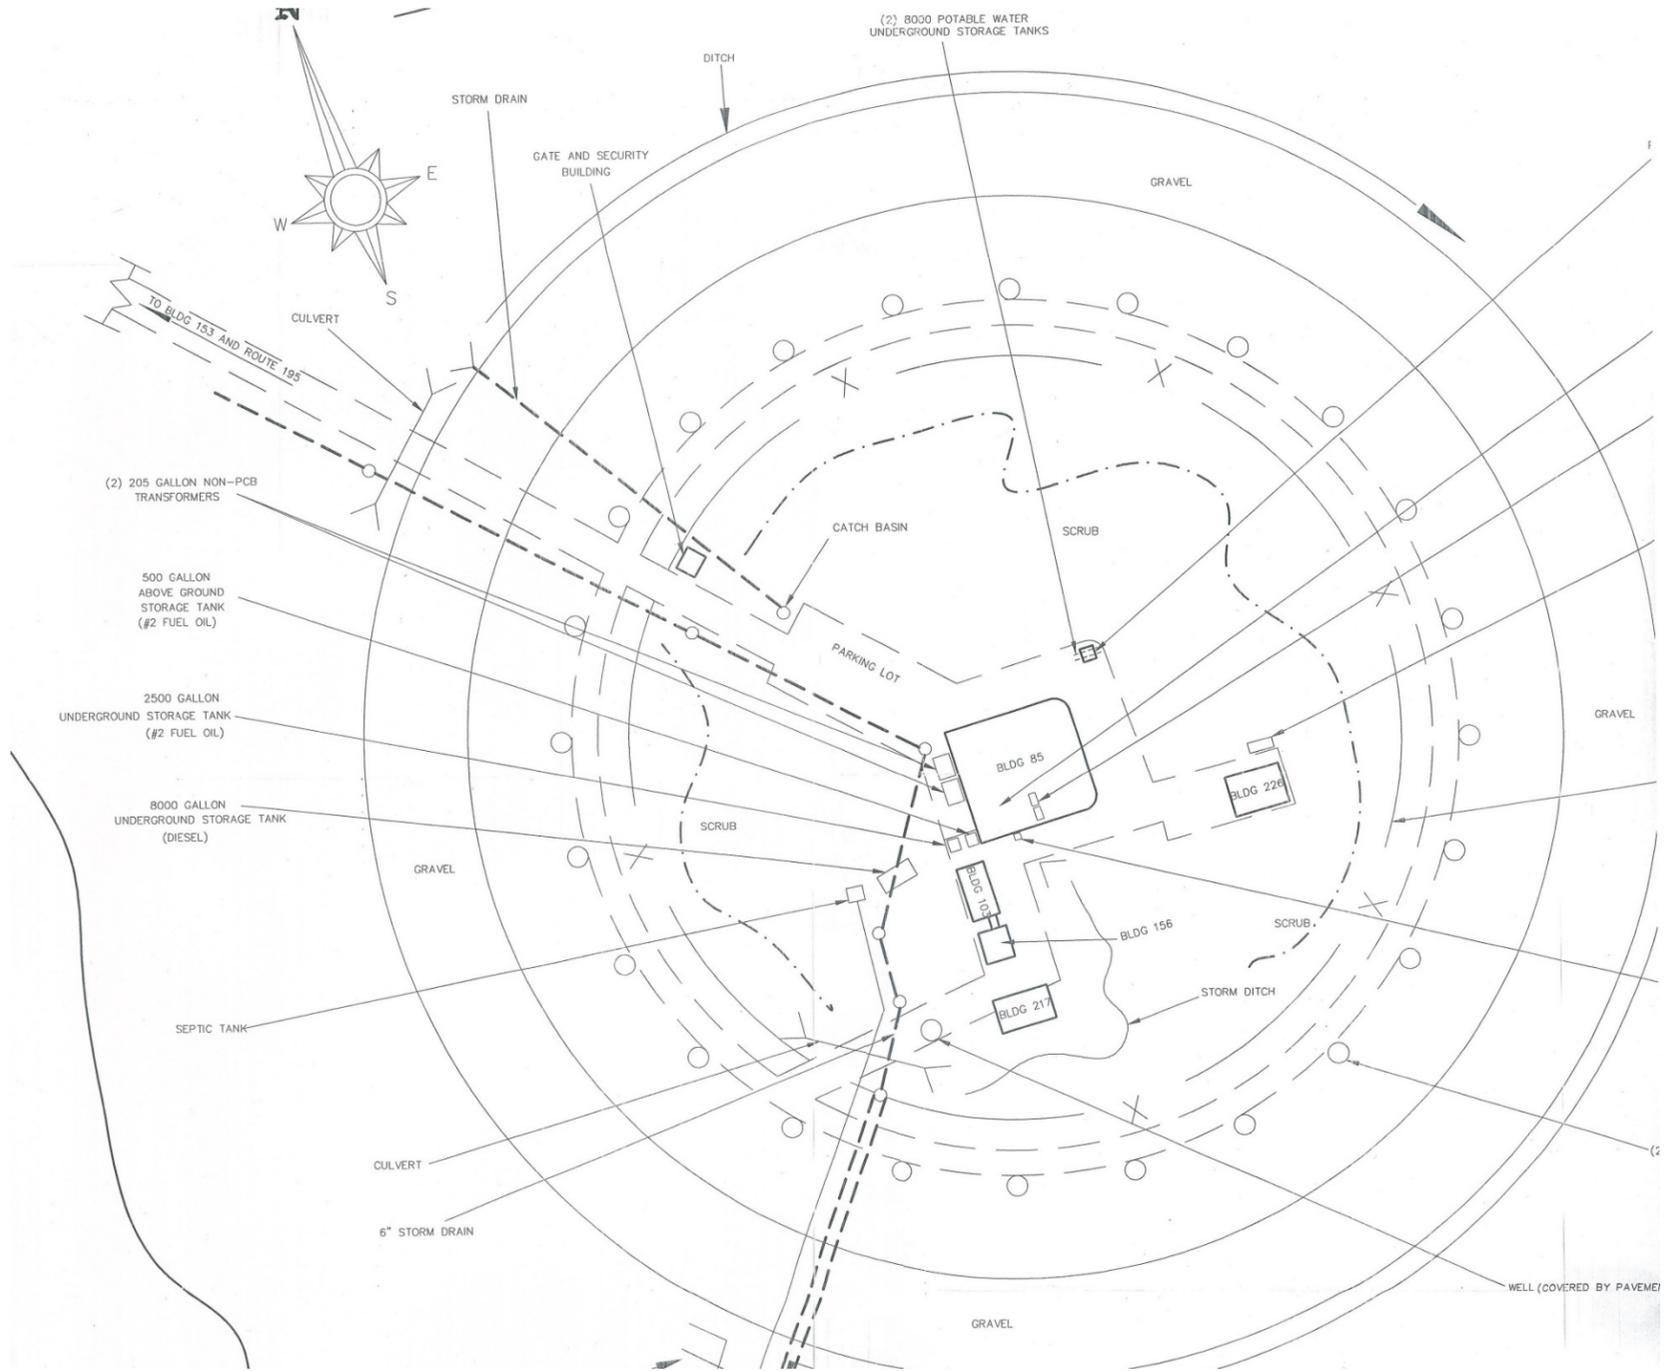
Figure 5

Detail of Wullenweber CDAA and Building Complex 85

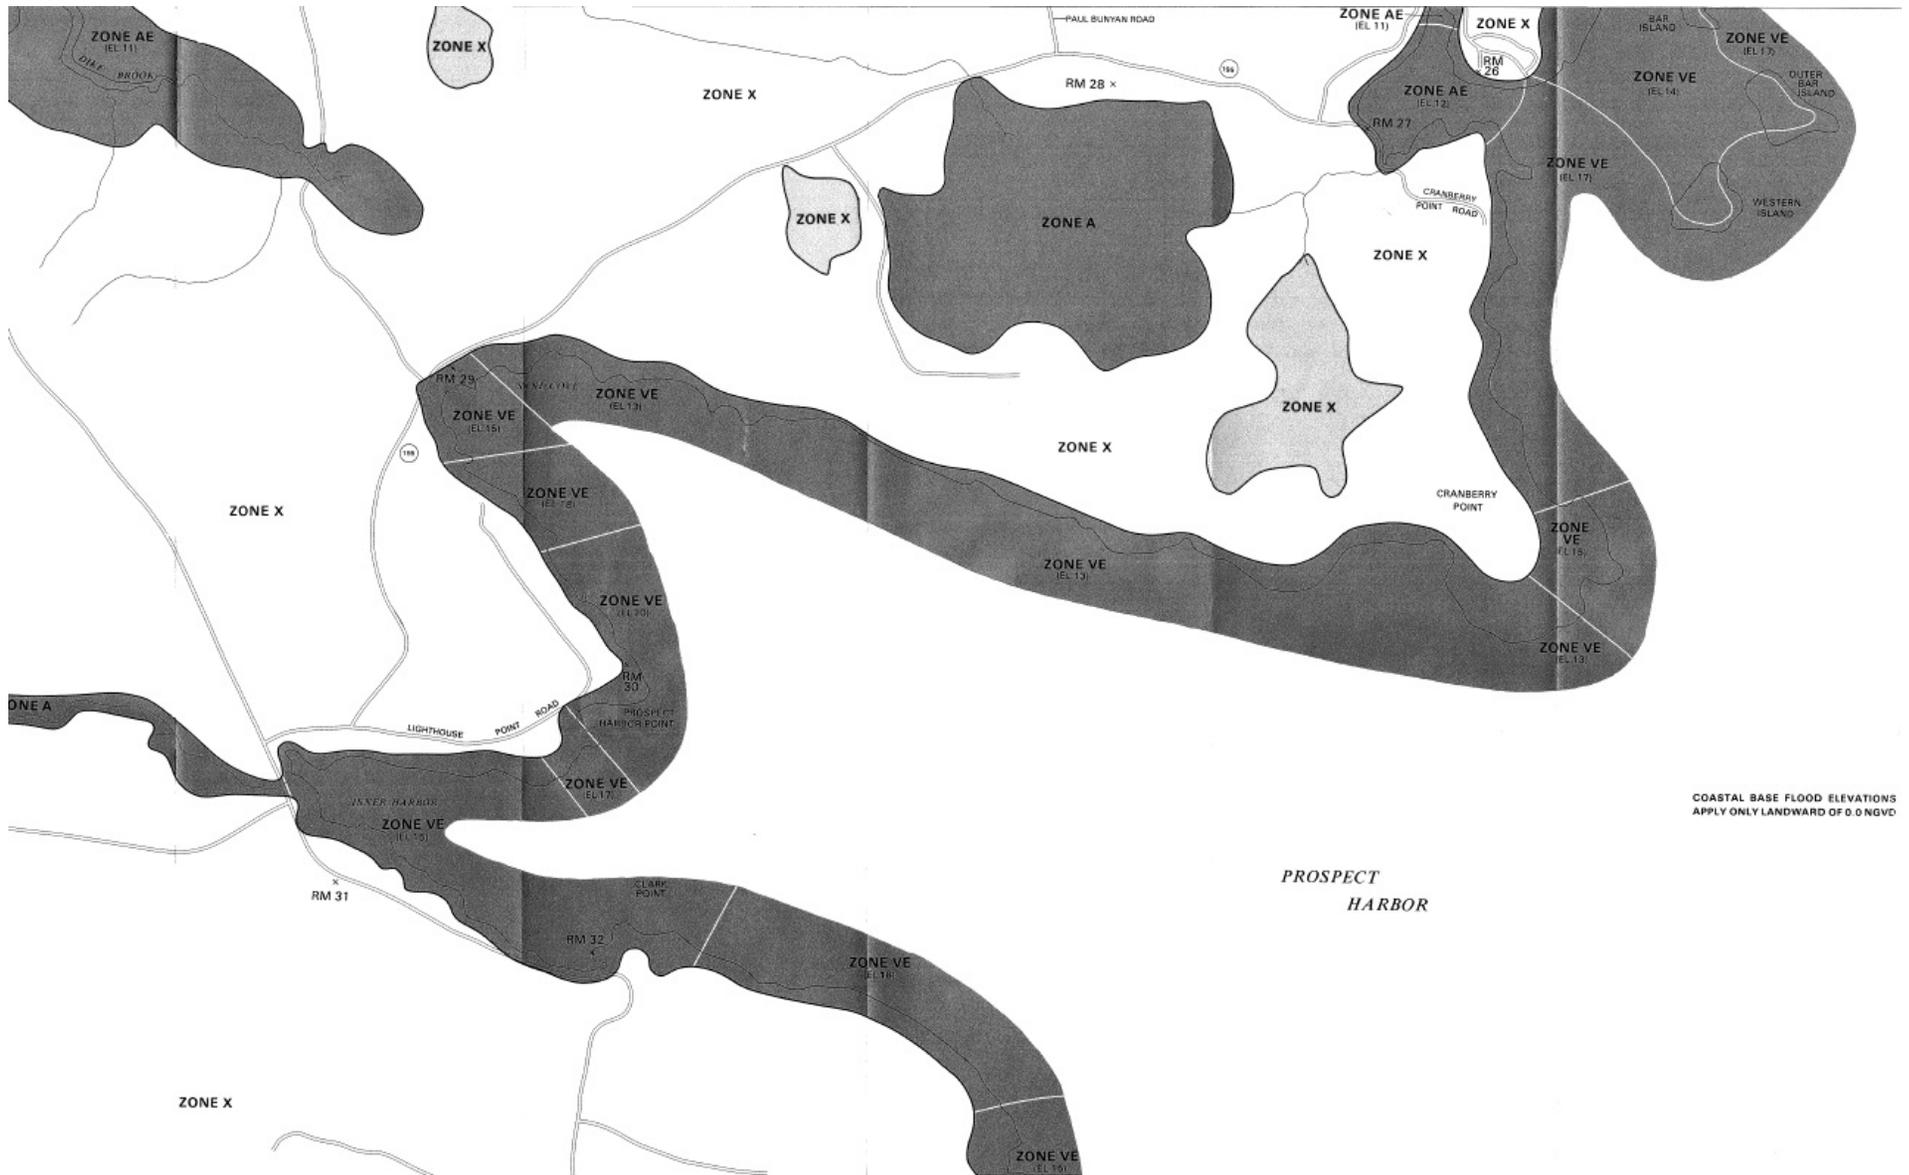
Figure 6
FEMA Flood Map

Flood Zone	(FEMA) 100-year flood plain panel for Hancock County Panel 230283 0020 B	Area designated with no base flood elevation (a), 500 year flood plain area (X), and coastal flooding with base elevation of 13 feet (VE) (Figure 6, Appendix A).
Drinking Water Source	Maine Public Water Resource Information System, MEDEP EGAD	Nearest public water supply well approximately 1.8 miles northwest of Subject Property across Prospect Harbor.
Sand & Gravel (S&G) Aquifer	MGS Hartland Quadrangle 2001, open File No. 01-86	Nearest sand & gravel aquifer is approximately 5 miles northeast of Subject Property

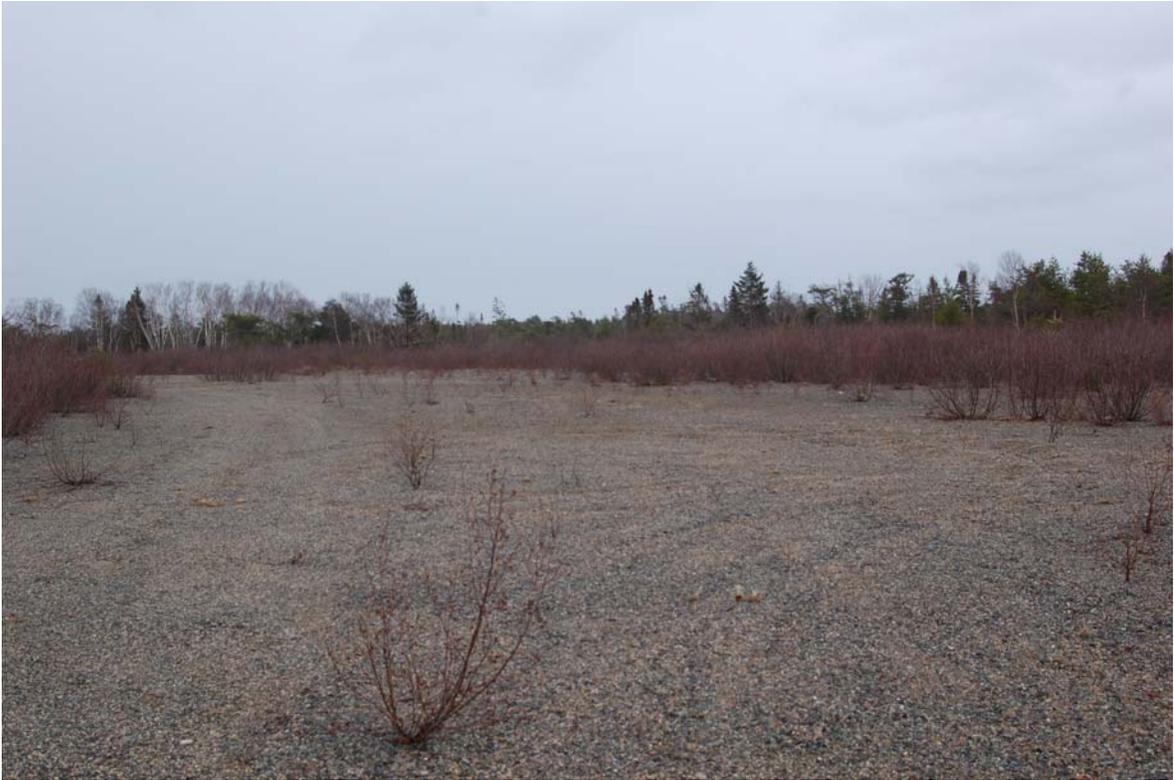
REC#2: There are large areas within the former Wullenweber CDAA that contain no plant life. The cause of this could be related to geotextile located directly below the surface, excessive amounts of herbicides, or another unrelated reason.

Photograph 7 Wellenweber CDAA vegetation.

CEG recommends that these RECs be assessed as part of a Phase II ESA.

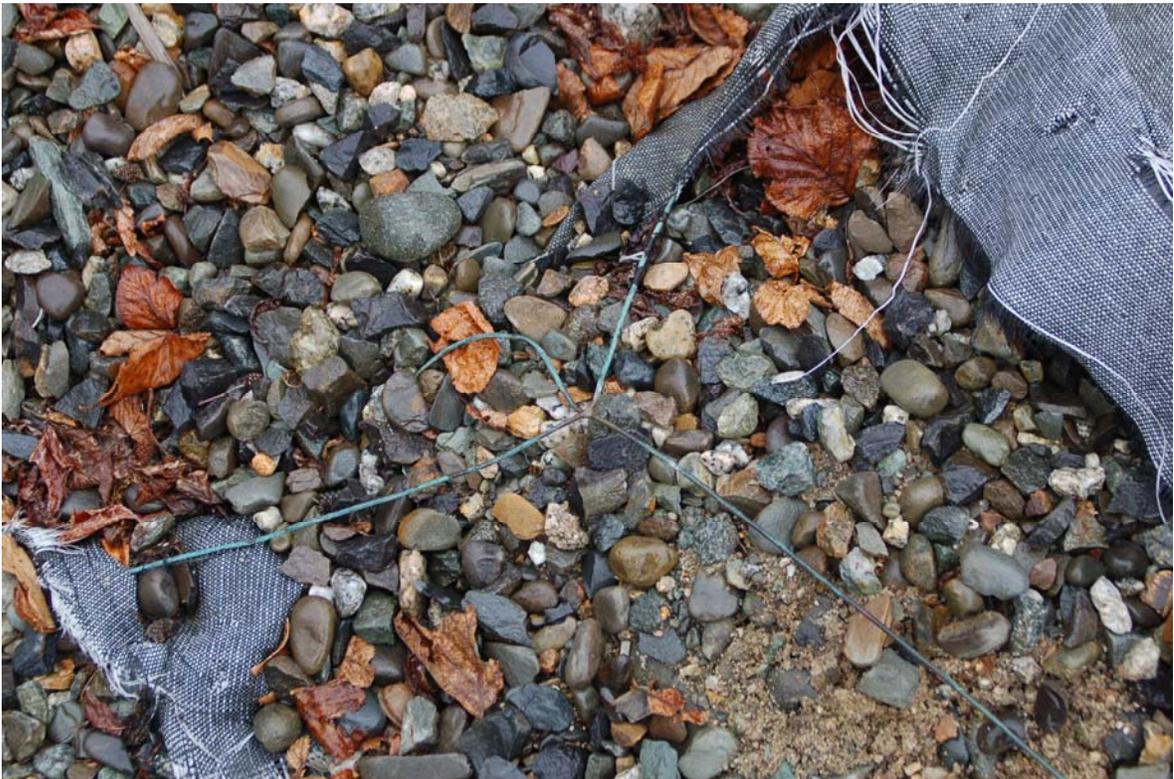
Photograph 8 Wellenweber CDAA wire, geotextile and surface soil

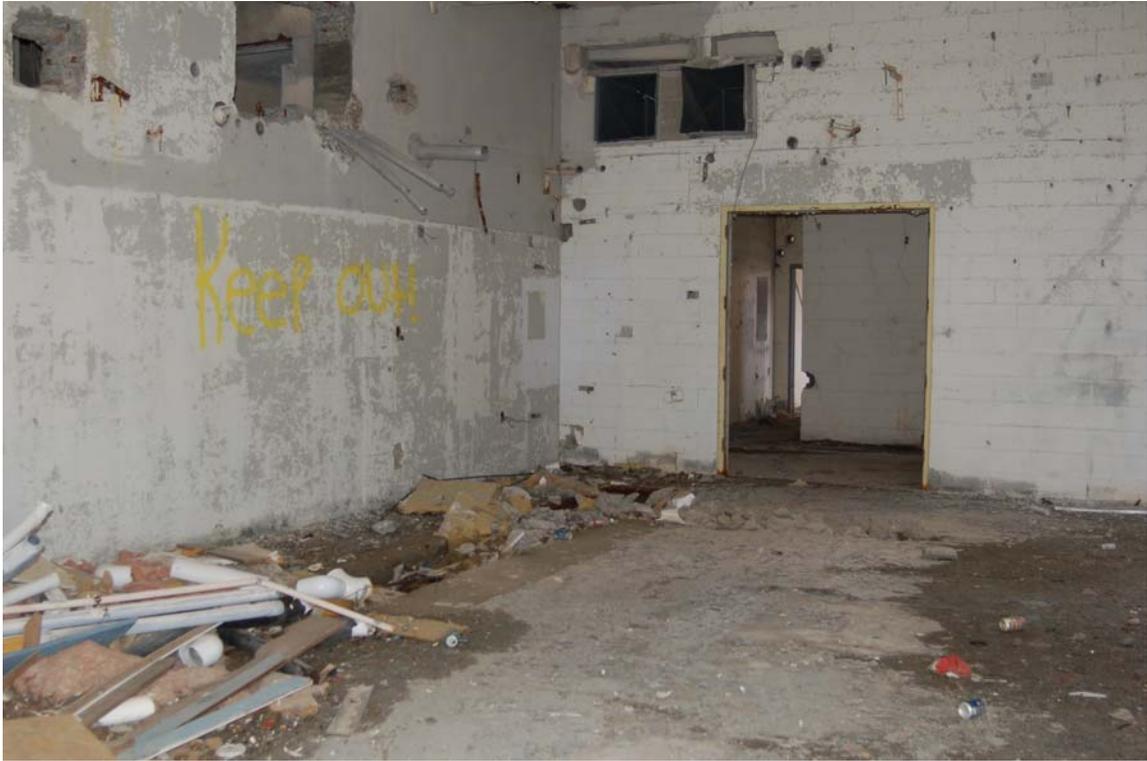
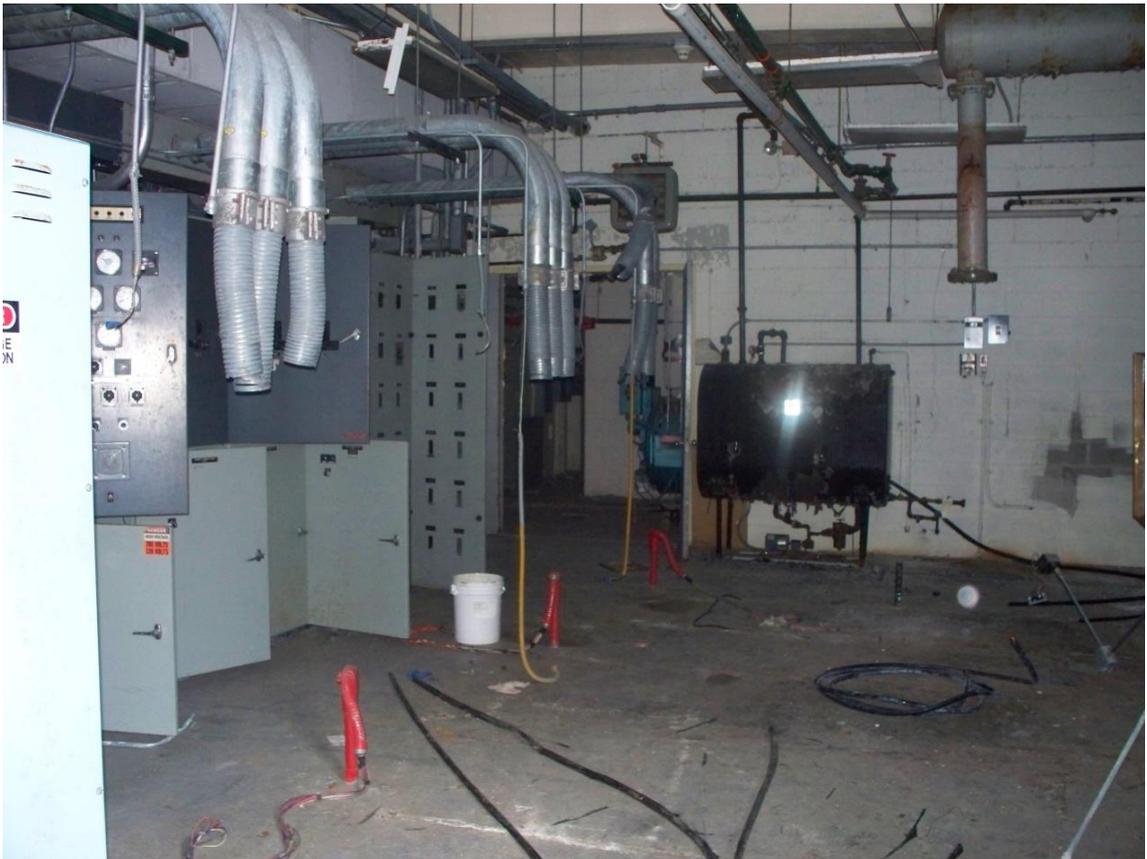
The buildings have been heavily vandalized. Metal appears to have been the target of most of the vandalism. Therefore, any metal object or part that could be removed was stolen. This included fences, aboveground storage tanks, compressed gas cylinders, manhole covers, wires, pieces of equipment, and piping. To access the metal, floors were removed, ceiling tiles were removed, and massive amounts of fiber glass insulation were moved and discarded into large piles amongst the building interiors. Sheetrock in many of the buildings was broken as well as many of the glass windows. Other parts of equipment including air filters, eye wash stations, and paper were scattered throughout the buildings and the grounds. It was difficult to view some areas due to the amount of material that was piled into certain areas.

Photographs 9 &10 Interior of Building #85 same location in 2010 and 2015!

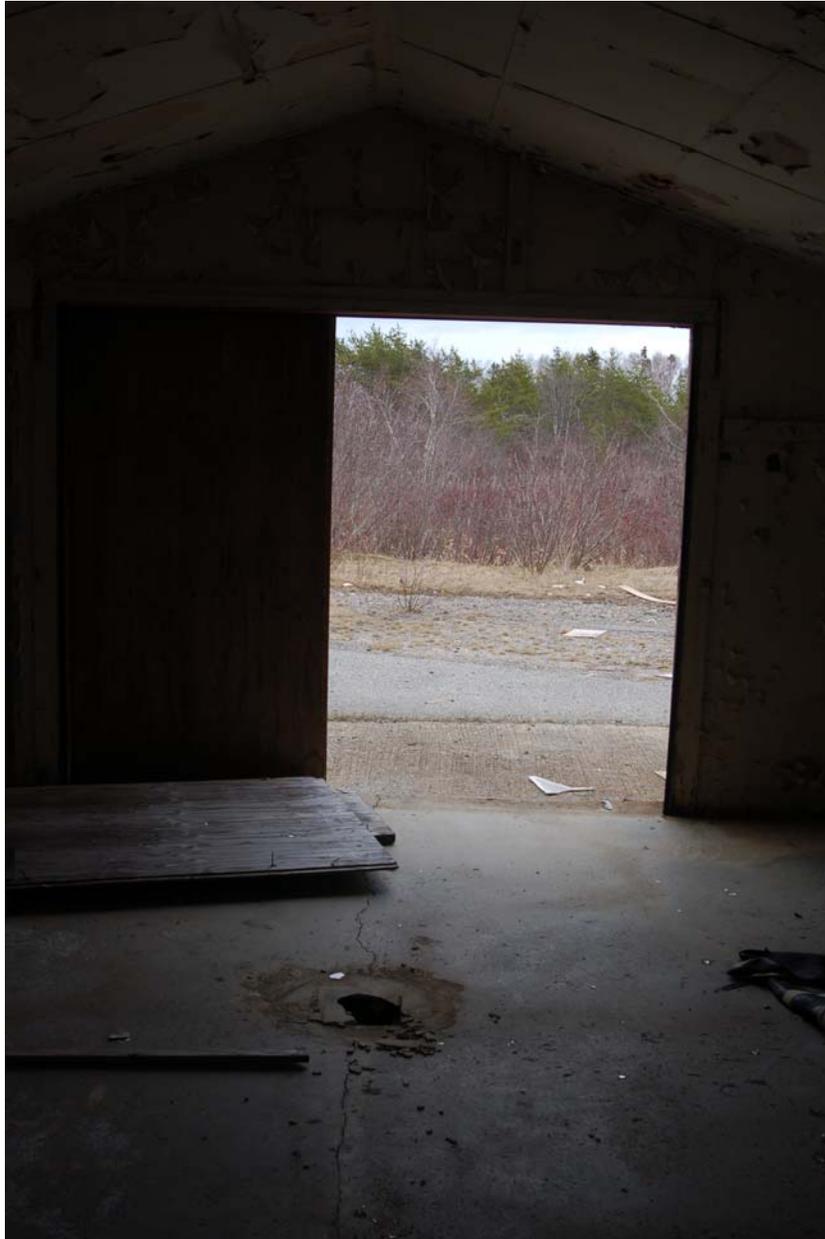
Photograph 11 Floor drain in Building #156 looking southeast.

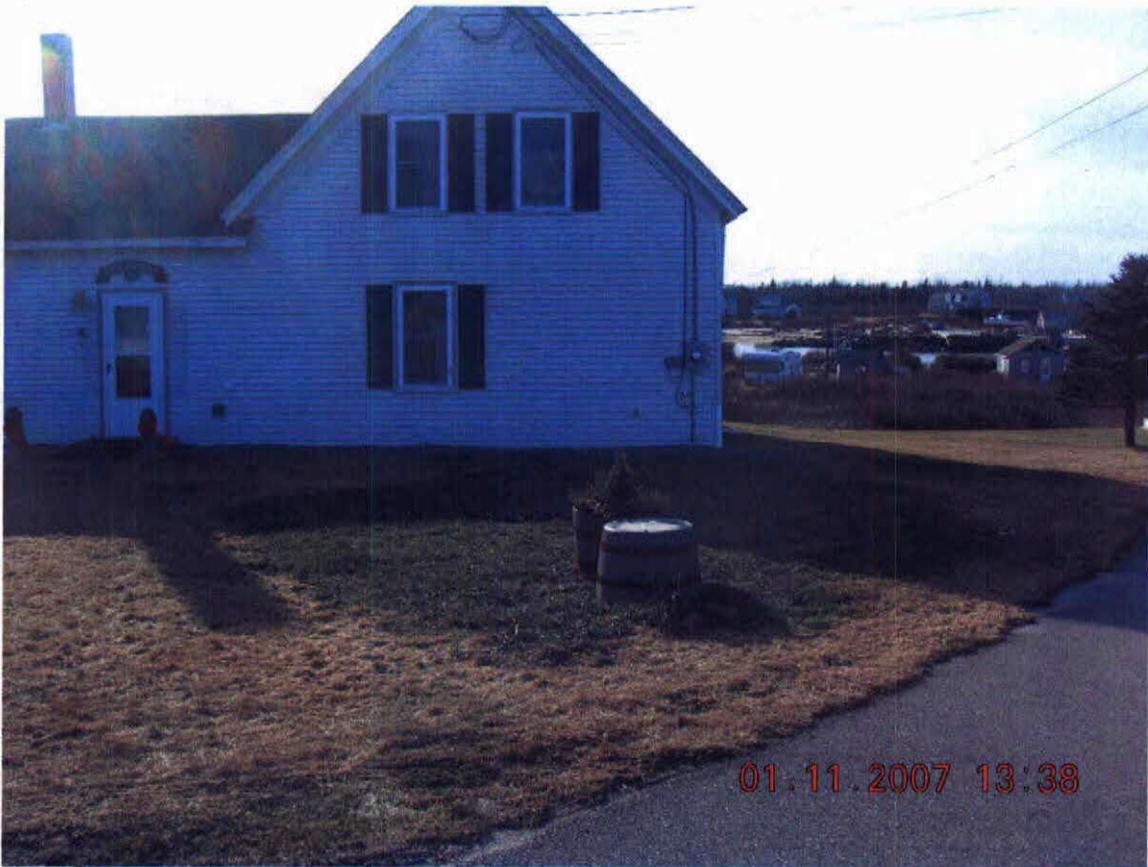
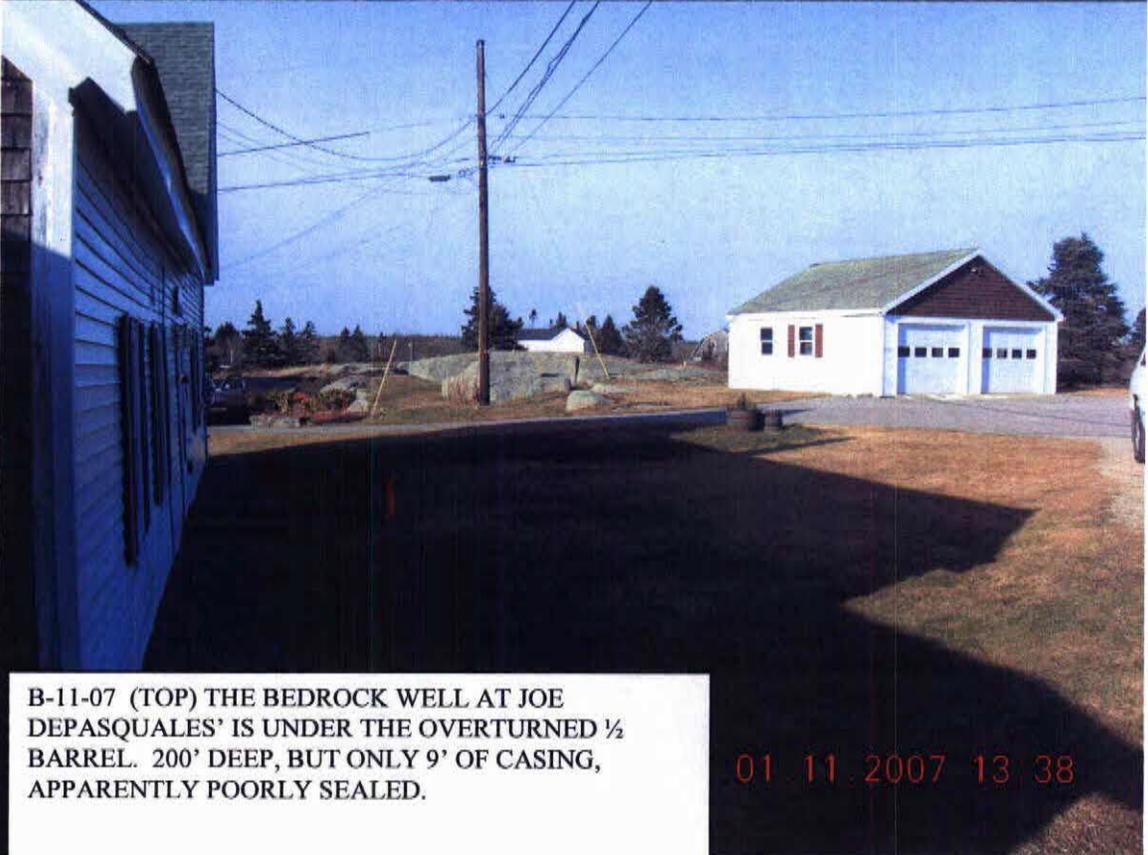
B-11-2007

B-11-07 (TOP) THE BEDROCK WELL AT JOE DEPASQUALES' IS UNDER THE OVERTURNED ½ BARREL. 200' DEEP, BUT ONLY 9' OF CASING, APPARENTLY POORLY SEALED.

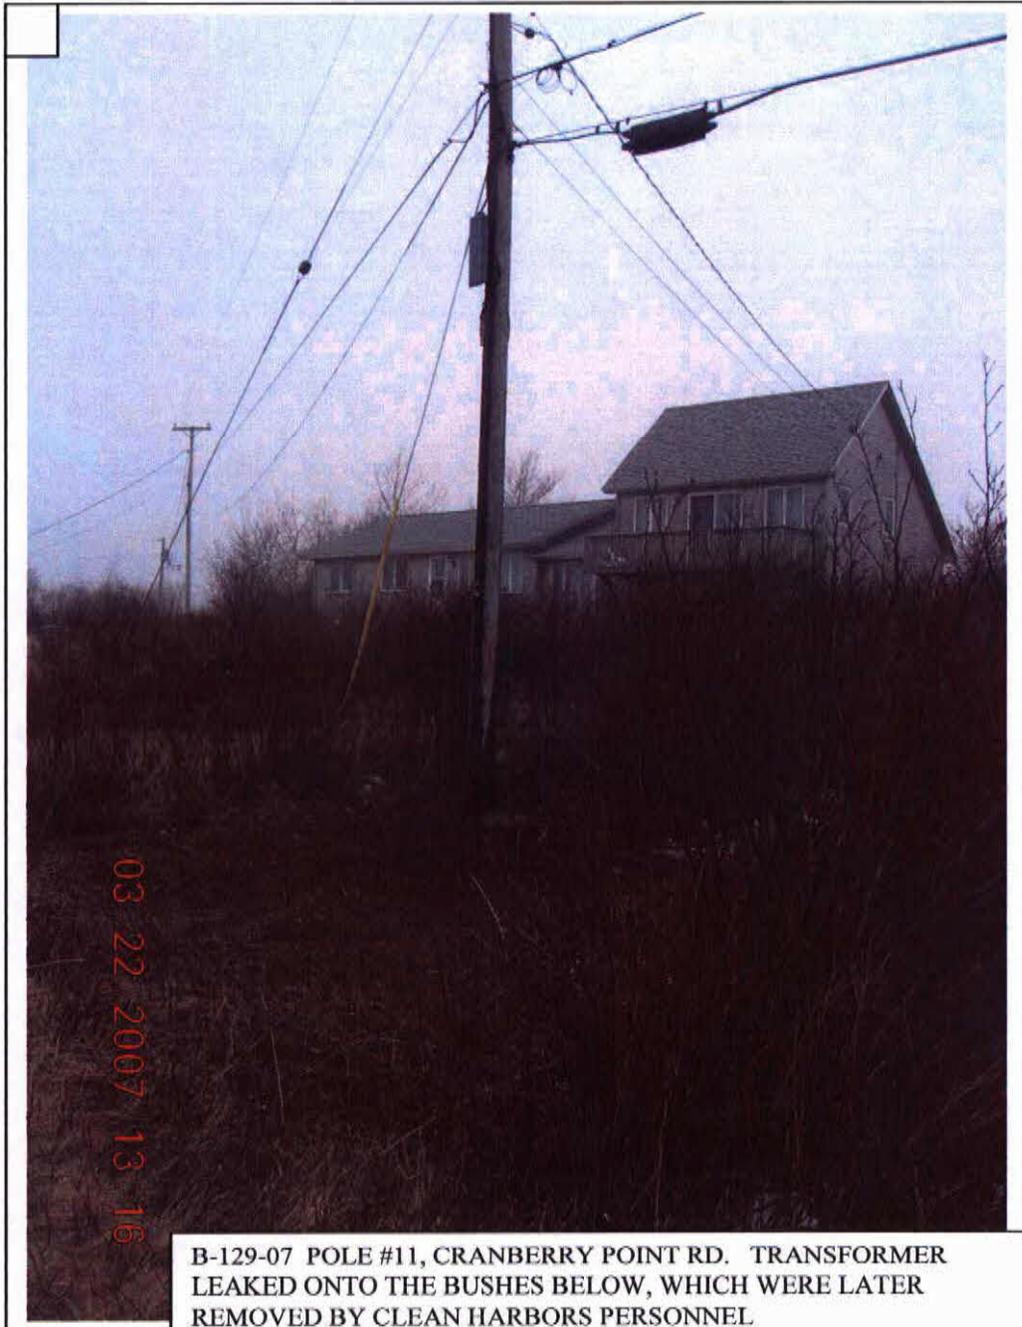
Salt water spray rusted out the transformer atop pole #11 on the Cranberry Point Road, which caused the failure of the transformer and the contamination of the bushes under it. See Bangor Hydro-Electric Company's attached report.

B-129-07 POLE #11, CRANBERRY POINT RD. TRANSFORMER
LEAKED ONTO THE BUSHES BELOW, WHICH WERE LATER
REMOVED BY CLEAN HARBORS PERSONNEL
