# Canton Mountain Wind Project

Canton and Dixfield,  
Oxford County, Maine

## RESOURCE SURVEY REPORT

**November 2011**

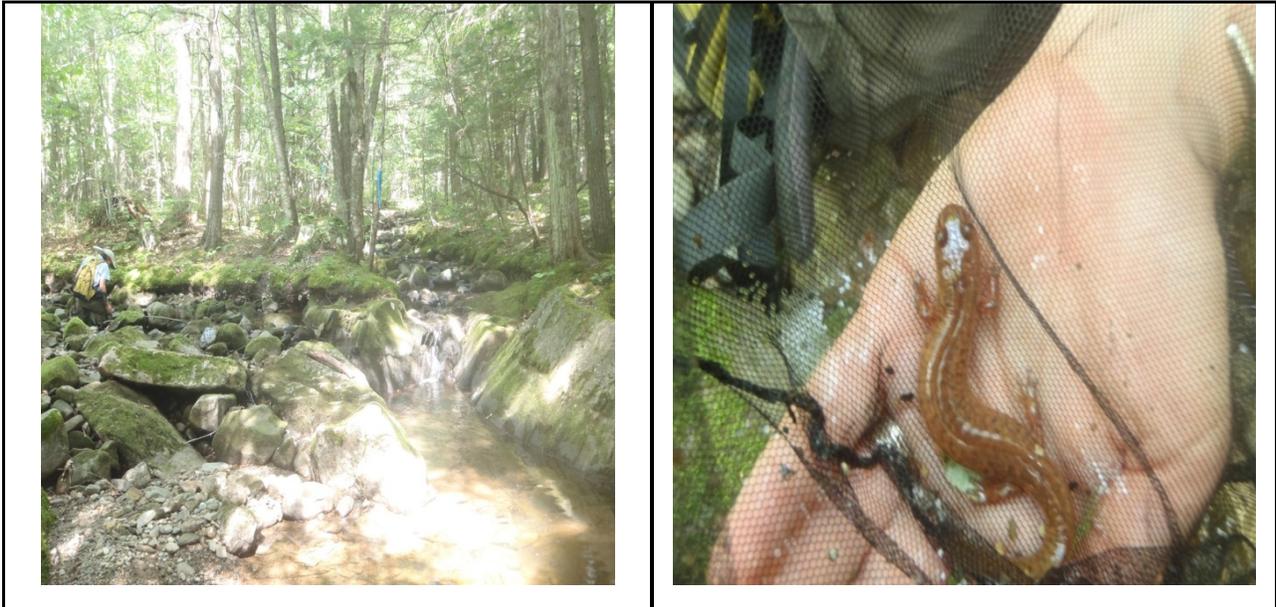
Three adult NSS were found in Ludden Brook. Two were located just upstream from Ludden Brook's confluence with an unnamed perennial tributary (Stream ID CASBW8), on the east side of Ludden Lane, and just south of the northernmost Ludden Lane crossing of Ludden Brook. A third NSS was located in Ludden Brook south of Dunn Cemetery adjacent to Ludden Lane and just downstream from the confluence of Ludden Brook and Fletcher Brook. In total, four timed surveys for NSS were completed within suitable NSS habitats within Ludden Brook. Each of these were ½ hour surveys conducted by a team of two biologists. Representative photographs of two of the NSS are provided below, the third individual escaped prior to being photographed but was positively identified by two biologists.

Photo 1. Facing upstream at confluence of Ludden Brook and perennial tributary (field ID CASBW8) at habitat type from which two NSS were observed (8/12/2010).

Photo 2. Adult NSS found within Ludden Brook (8/12/2010).

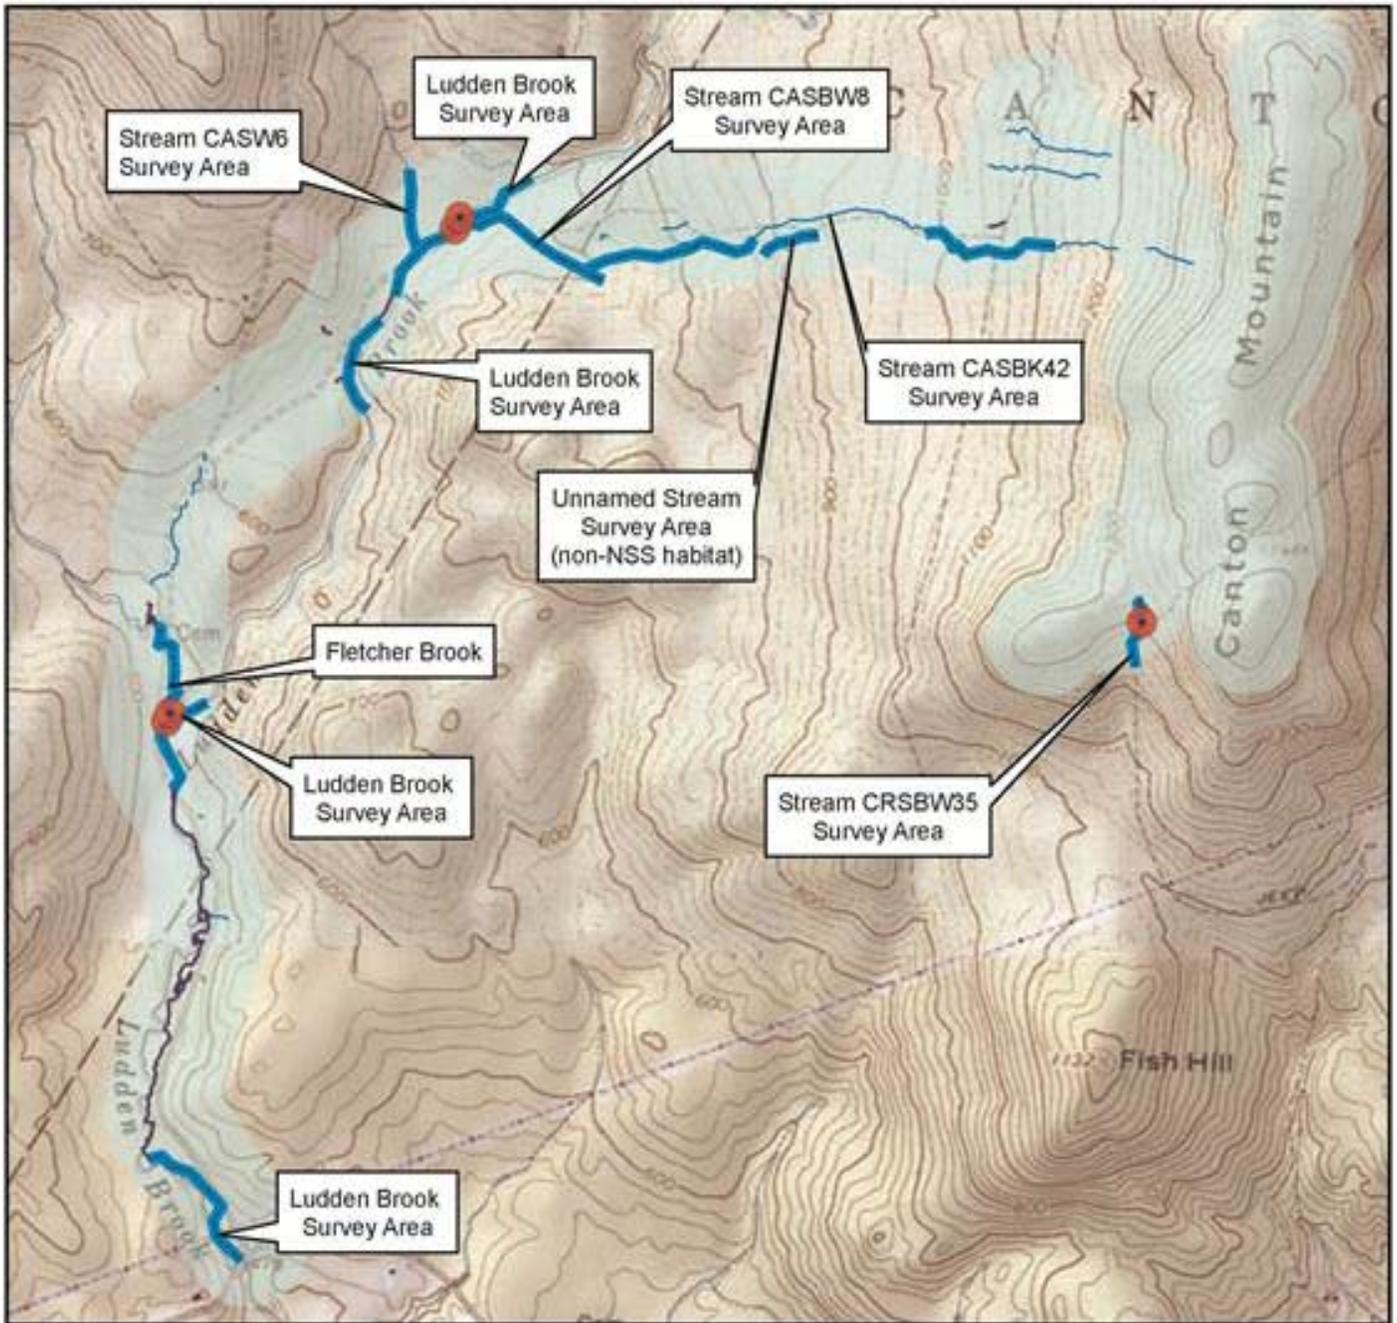
**Figure 4-1. Northern Spring Salamander Survey Limits and Results**

Five adult NSS were identified during the summer 2010 surveys. Three NSS were identified in Ludden Brook, one was located in Fletcher Brook just upstream from the confluence of Fletcher Brook and Ludden Brook, and one was located in an unnamed perennial stream on the southern end of the Canton Mountain ridgeline (see Figure 4-1). As requested by Maine DIFW, Maine Rare Animal Reporting Forms were filled out for the five NSS observed and are included in Appendix F.

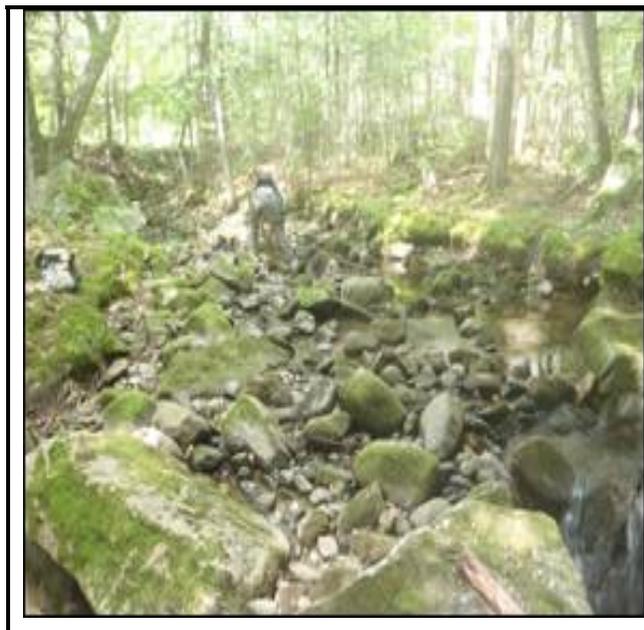
Photo 3. Habitat in Ludden Brook from which a NSS was observed (8/12/2010).

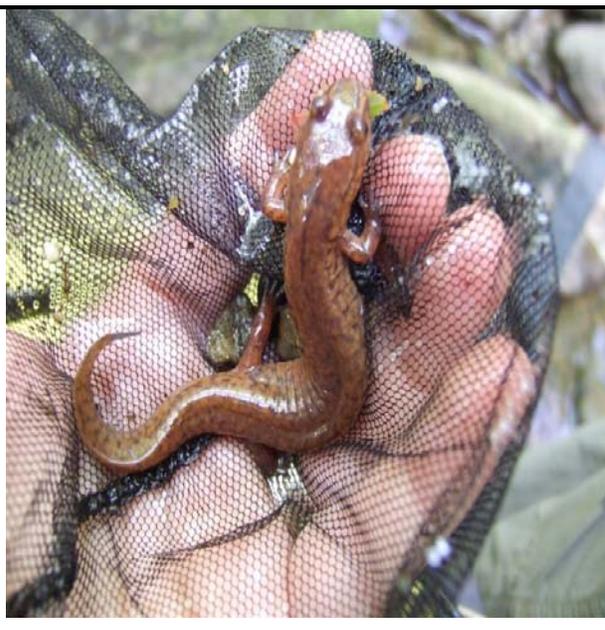
Photo 4. Adult NSS located in Ludden Brook (8/12/2010).

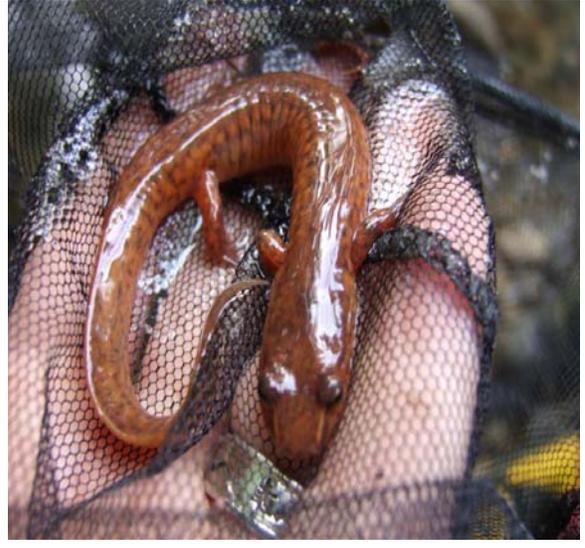
Photo 6. Adult NSS found within Fletcher Brook (8/13/2010).

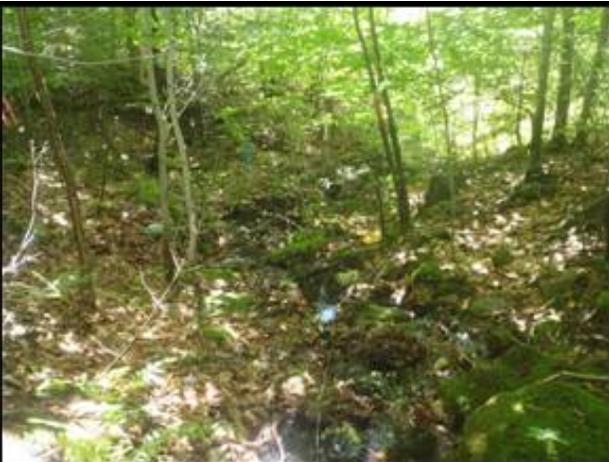
Photo 7. Facing downstream at CRSBW35 near where an adult NSS was located (8/26/2010).

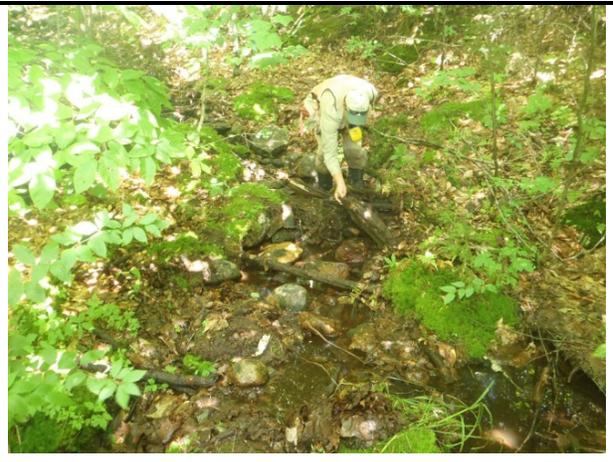
Photo 8. Facing upstream at CRSBW35 to habitat where an adult NSS was located (8/26/2010).

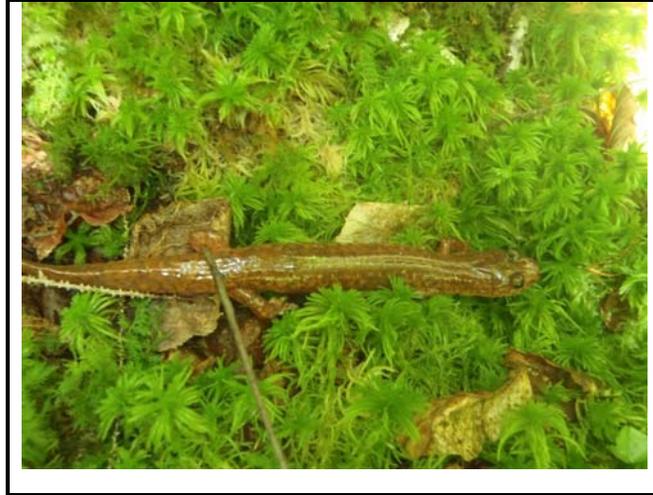
Photo 9. Adult NSS found within CRSBW35 (8/26/2010)

The stream flows generally to the south. The average width is approximately 2 to 4 feet and even though the gradient is somewhat steep, the stream flow is marginal and slow, with several shallow (2-6") debris-filled pools where organics accumulate behind roots and stones. The substrate is a complex of bedrock and sandy materials with a surface of cobbles. Approximately 150 feet south of where the NSS was located, the stream becomes steeper, and in many places is scoured to bedrock. Biologists followed the stream downslope approximately 500 feet from where the NSS was observed, and no larger streams or NSS habitats were observed.

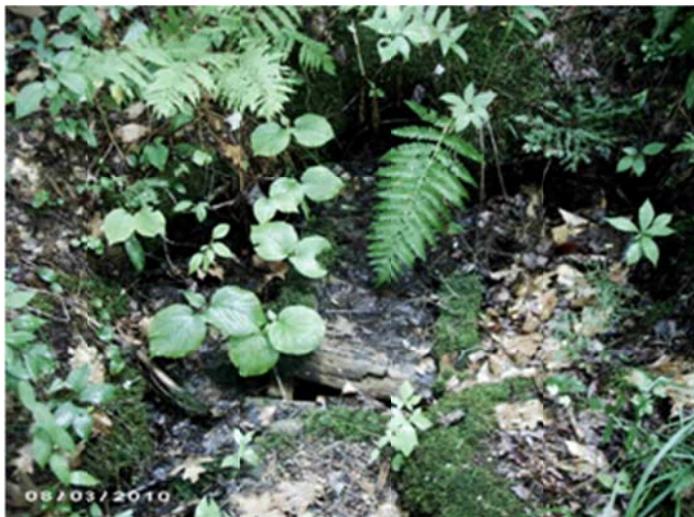
**Photo No.:** 2  
**Plan ID:** AW8  
**Field ID:** CAWBK15  
**Date:** August 3, 2010  
**Photographer:** Rodney Kelshaw

**Comments:**  
Wetland is located near a spring (mapped separately as CA) on a sideslope with a narrow swale spillway. Classification of this wetland is PFO4/PEM1. Photo looking east.

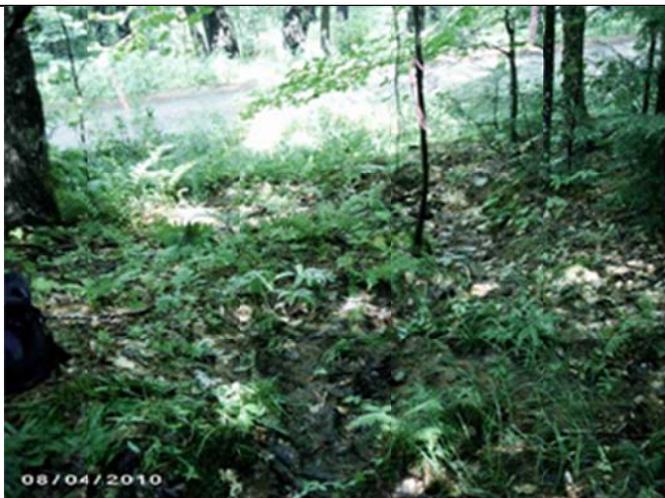
**Photo No.:** 1  
**Plan ID:** AW10  
**Field ID:** CAWBK17  
**Date:** August 4, 2010  
**Photographer:** Rodney Kelshaw

**Comments:**  
FO1/PEM1 wetland located on a narrow sideslope seep. Photo taken looking west.

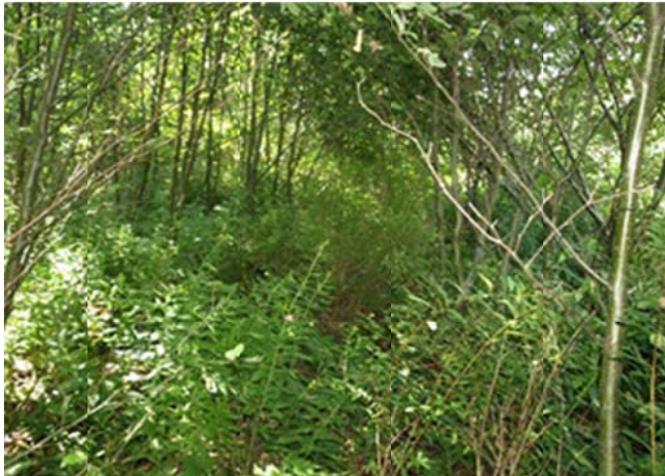
**Photo No.:** 2  
**Plan ID:** AW30  
**Field ID:** CAWBW10  
**Date:** August 10, 2010  
**Photographer:** Heather Storlazzi Ward

**Comments:**  
A PSS1E wetland. Photo was taken looking south.

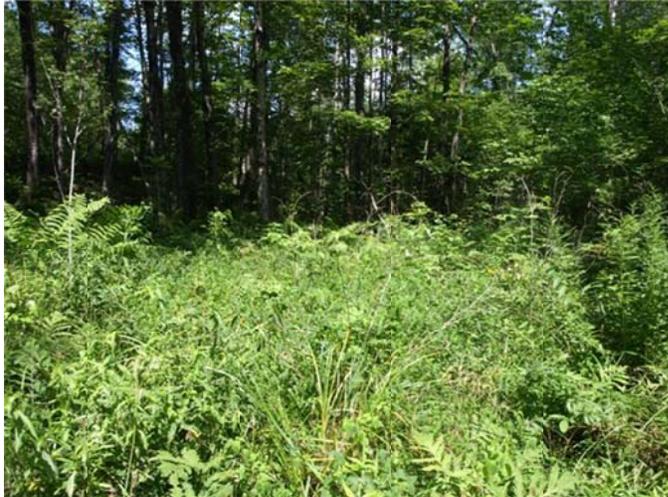
**Photo No.:** 2  
**Plan ID:** AW32  
**Field ID:** CAWBW11  
**Date:** August 10, 2010  
**Photographer:** Heather Storlazzi Ward

**Comments:**  
A PEM1E with a small component of PFO1E wetland with a small component of PFO1E. Photo was taken looking northeast.

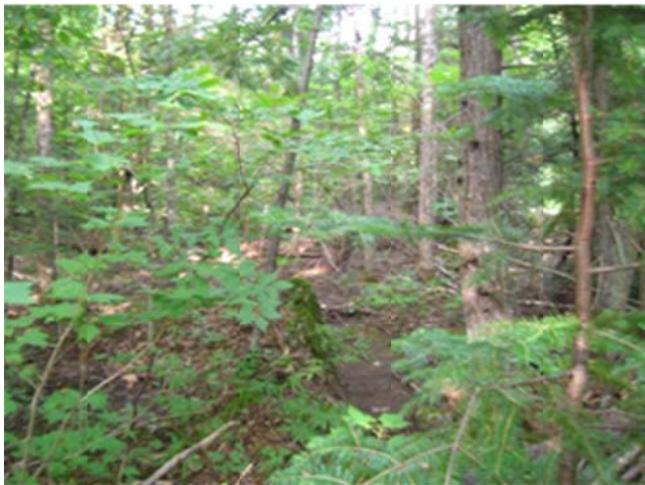
**Photo No.:** 1  
**Plan ID:** AW36  
**Field ID:** CAWBW14  
**Date:** August 10, 2010  
**Photographer:** Heather Storlazzi Ward

**Comments:**  
A PFO1 wetland. Photo was taken looking north.

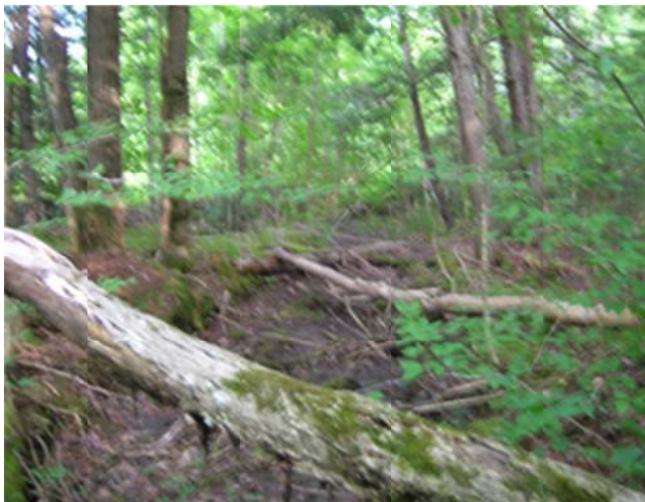
**Photo No.:** 2  
**Plan ID:** AW36  
**Field ID:** CAWBW14  
**Date:** August 10, 2010  
**Photographer:** Heather Storlazzi Ward

**Comments:**  
A PFO1. Photo was taken looking south.

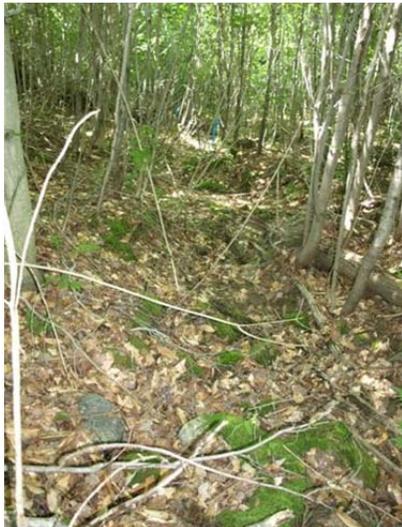
**Photo No.:** 20  
**Plan ID:** AS62  
**Waterbody:** CRSBW28  
**Date:** August 12, 2010  
**Photographer:** Heather Storlazzi Ward

**Comments:** A westerly flowing intermittent stream that has an average bank width of 3-5 feet. Photo taken looking west.

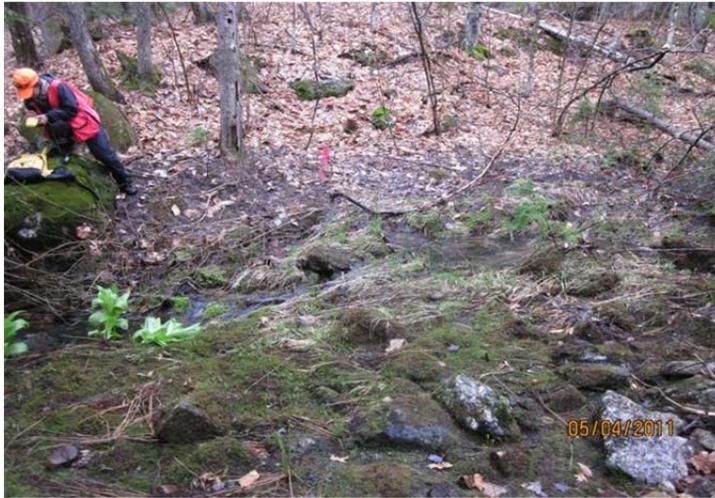
**Photo No.:** 1  
**Plan ID:** 1BVP  
**Vernal Pool:** CA\_34\_BVP\_BA504  
CA\_34\_BVP\_BA523  
**Date:** May 4, 2011  
**Photographer:** David Brenneman

**Comments:** Natural depression in rocky oxbow of Ludden Brook. No egg masses were present at time of survey. Facing north. Needs a revisit (was revised on 05.23.11).

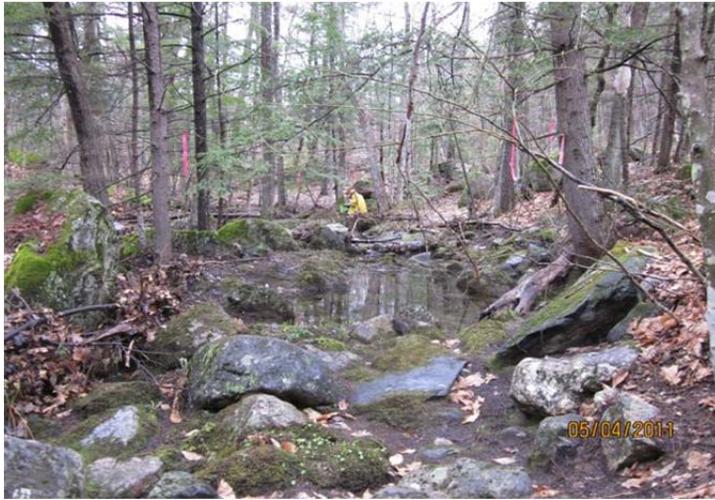
**Photo No.:** 1  
**Plan ID:** 2NVP  
**Vernal Pool:** CA\_33NVP\_BA504  
CA\_33NVP\_BA523  
**Date:** May 4, 2011  
**Photographer:** Lauren Leclerc

**Comments:** Natural vernal pool in rocky oxbow of Ludden Brook containing one spotted salamander egg mass. Facing northeast. Needs a revisit (was revised on 11.23.11).

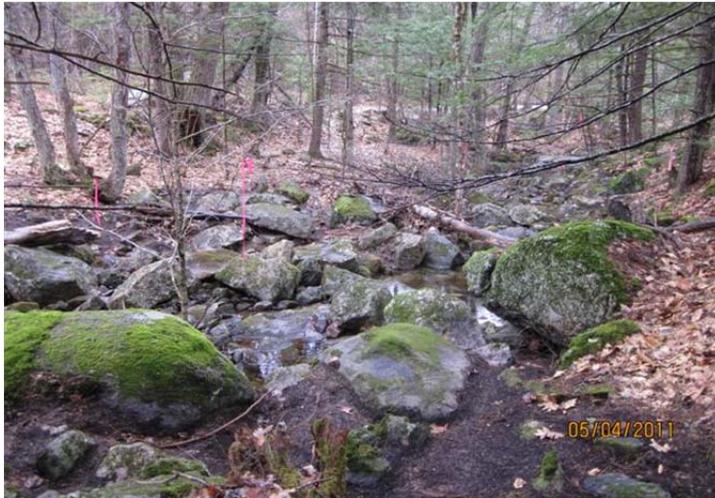
**Photo No.:** 1  
**Plan ID:** 3BVP  
**Vernal Pool:** CA\_32\_BVP\_BA504  
CA\_32\_BVP\_BA523  
**Date:** May 4, 2011  
**Photographer:** David Brenneman

**Comments:** Natural vernal pool in rocky oxbow of Ludden Brook. No egg masses were present at time of survey. Facing southeast. Needs a revisit (was revised on 11.23.11).

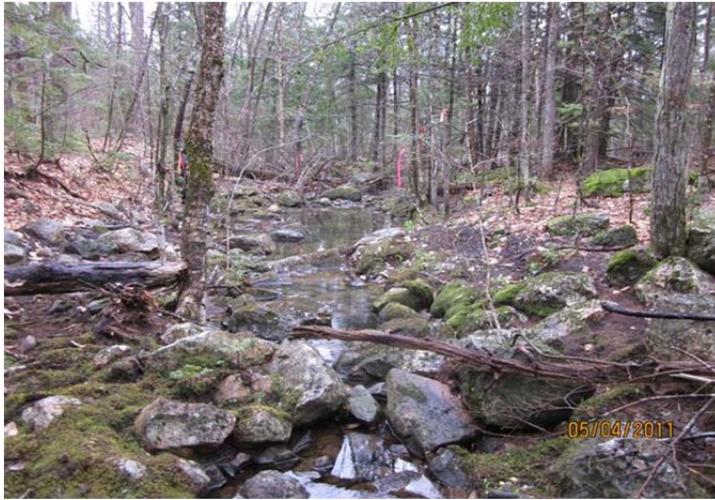
**Photo No.:** 1  
**Plan ID:** 4NVP  
**Vernal Pool:** CA\_31NVP\_BA504  
CA\_31NVP\_BA523  
**Date:** May 4, 2011  
**Photographer:** David Brenneman

**Comments:** Natural vernal pool in rocky oxbow of Ludden Brook containing two spotted salamander egg masses. Looking southeast. Needs a revisit (was revised on 11.23.11).

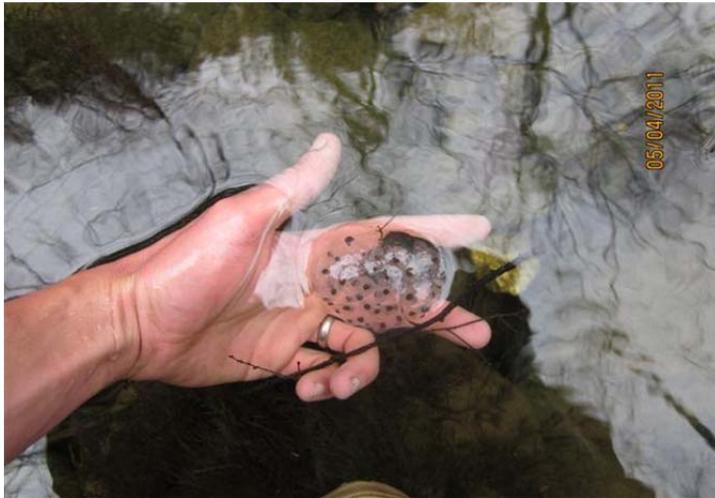
**Photo No.:** 5  
**Plan ID:** 4NVP  
**Vernal Pool:** CA\_31NVP\_BA504  
CA\_31NVP\_BA523  
**Date:** May 4, 2011  
**Photographer:** David Brenneman  
**Comments:** Spotted salamander egg mass.

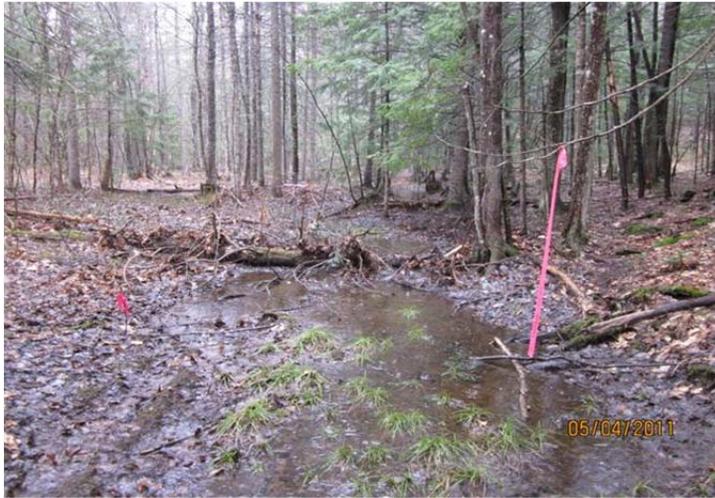
**Photo No.:** 1  
**Plan ID:** 5NVP  
**Vernal Pool:** CA\_35NVP\_BA504  
CA\_35NVP\_BA523  
**Date:** May 4, 2011  
**Photographer:** Lauren Leclerc

**Comments:** Natural pool in forested wetland containing one spotted salamander egg mass. Possible historic stream channel filled in with soil and leaf litter. Looking northeast. Needs a revisit (was revisited on 11.23.11).

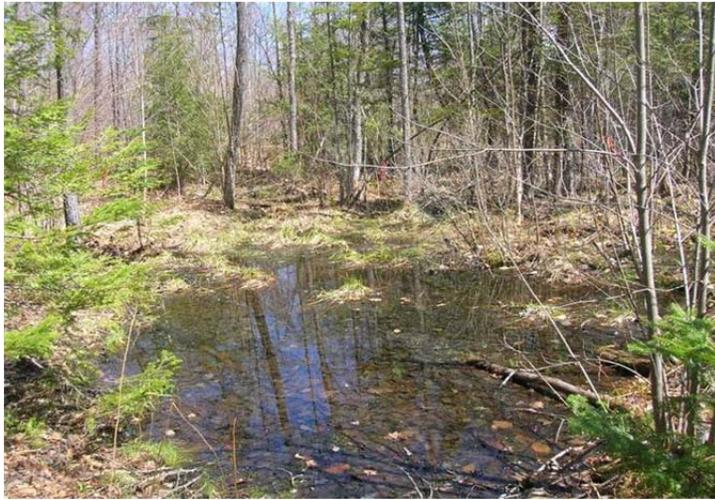
**Photo No.:** 1  
**Plan ID:** 6NVP  
**Vernal Pool:** CA\_3NVP\_BA415  
CA\_3NVP\_BA506  
**Date:** April 15, 2010  
**Photographer:** David Brenneman

**Comments:** Looking east at natural vernal pool. No wood frog egg masses found at time of survey. Fourteen spotted salamander egg masses found. Should have a revisit (was revised on 5.06.10).

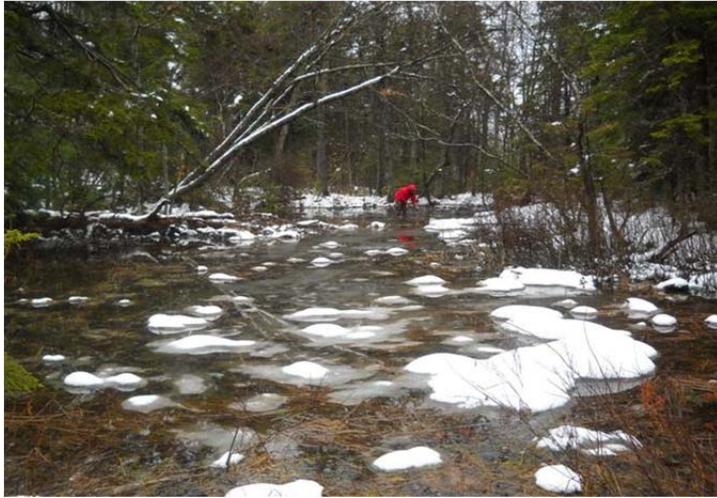
**Photo No.:** 1  
**Plan ID:** 7NVP  
**Vernal Pool:** CR\_2NVP\_BA418  
CR\_2NVP\_BA506  
**Date:** April 18, 2010  
**Photographer:** Heather Storlazzi-Ward

**Comments:** Looking northeast at natural vernal pool containing five wood frog egg masses and four spotted salamander egg masses.

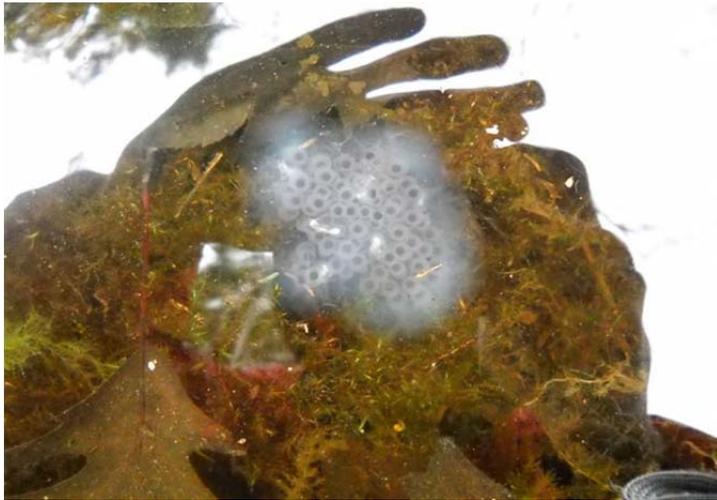
**Photo No.:** 5  
**Plan ID:** 7NVP  
**Vernal Pool:** CR\_2NVP\_BA418  
CR\_2NVP\_BA506  
**Date:** April 18, 2010  
**Photographer:** Heather Storlazzi-Ward  
**Comments:** Spotted salamander egg mass.

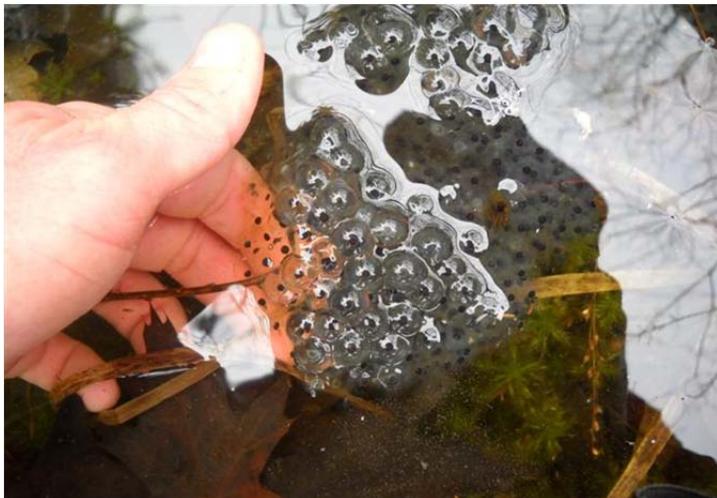
**Photo No.:** 6  
**Plan ID:** 7NVP  
**Vernal Pool:** CR\_2NVP\_BA418  
CR\_2NVP\_BA506  
**Date:** April 18, 2010  
**Photographer:** Heather Storlazzi-Ward  
**Comments:** Wood frog egg mass.

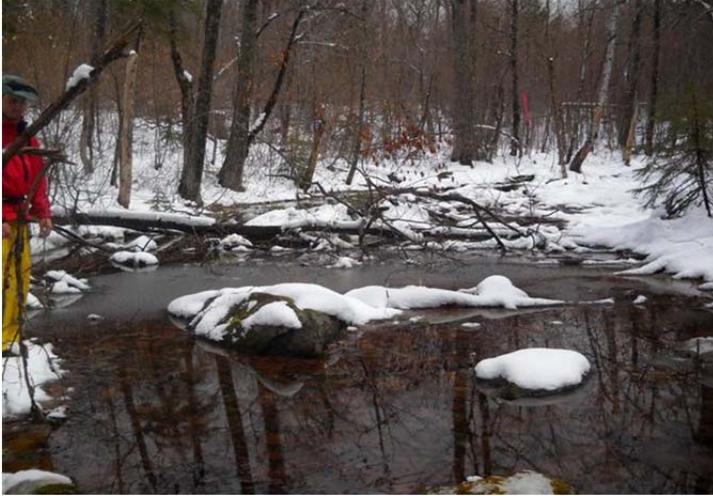
**Photo No.:** 1

**Comments:** Looking east at natural vernal pool with spotted salamander egg masses.

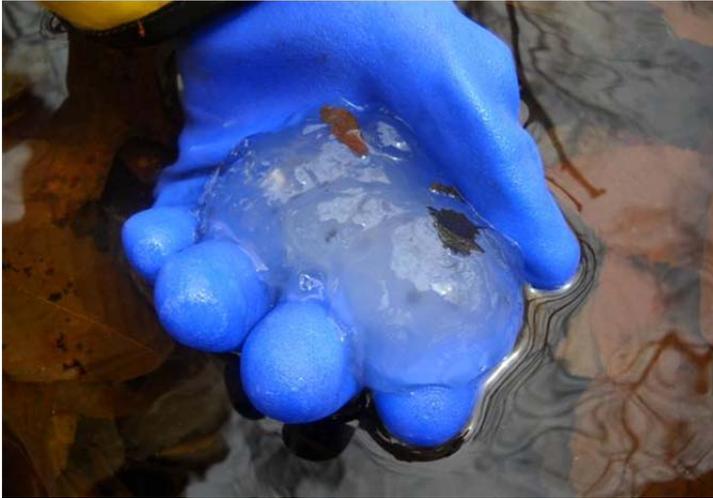
**Photo No.:** 5  
**Plan ID:** 8NVP  
**Vernal Pool:** CR\_1NVP\_BA418  
CR\_1NVP\_BA506  
**Date:** April 18, 2010  
**Photographer:** Heather Storlazzi-Ward  
**Comments:** Spotted salamander egg mass.

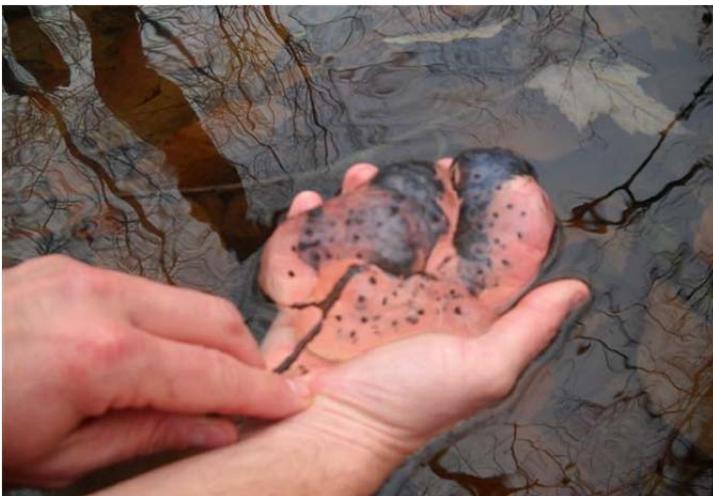
**Photo No.:** 6  
**Plan ID:** 8NVP  
**Vernal Pool:** CR\_1NVP\_BA418  
CR\_1NVP\_BA506  
**Date:** April 18, 2010  
**Photographer:** Heather Storlazzi-Ward  
**Comments:** Spotted salamander egg mass.

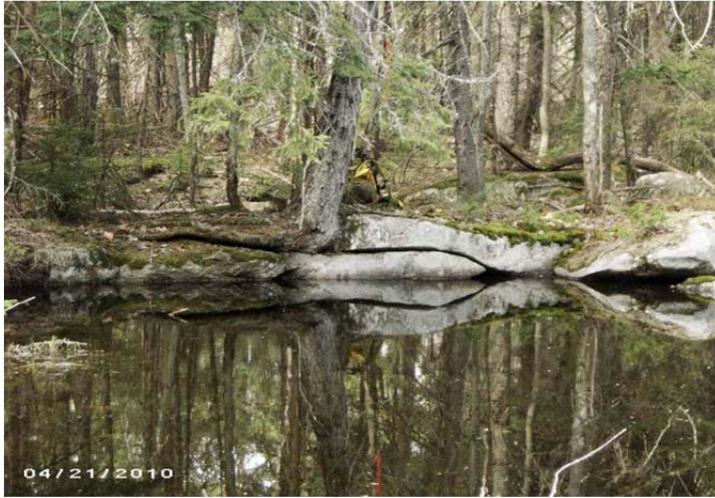
**Photo No.:** 1  
**Plan ID:** 9PSVP  
**Vernal Pool:** CR\_11SVP\_BA421  
CR\_11SVP\_BA506  
**Date:** April 21, 2010  
**Photographer:** Rodney Kelshaw

**Comments:** Appears to be a natural depression in the landscape that has been enhanced. Pool found in historic quarry area (with apparent cut stone) at ridge top. Significant numbers of wood frog egg masses found. Raptor survey crew said that pool was iced over 1 week prior. Needs further visit for spotted salamanders. Photo facing north.

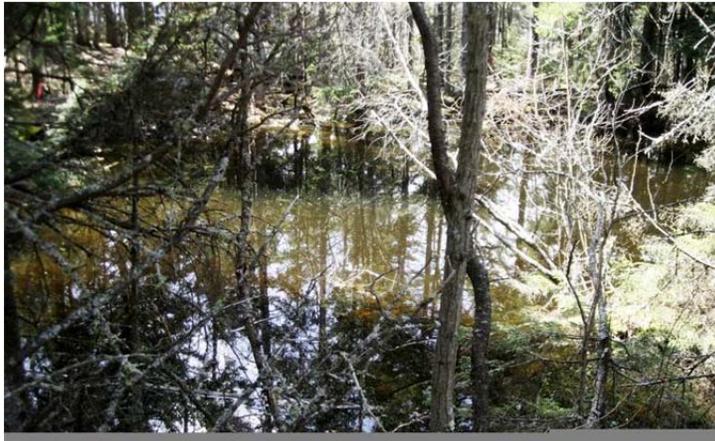
**Photo No.:** 2  
**Plan ID:** 9PSVP  
**Vernal Pool:** CR\_11SVP\_BA421  
CR\_11SVP\_BA506  
**Date:** April 21, 2010  
**Photographer:** Rodney Kelshaw

**Comments:** Facing east.

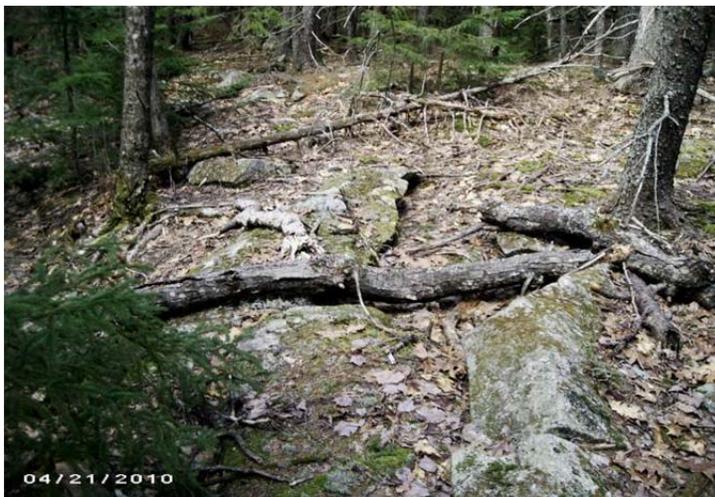
**Photo No.:** 3  
**Plan ID:** 9PSVP  
**Vernal Pool:** CR\_11SVP\_BA421  
CR\_11SVP\_BA506  
**Date:** April 21, 2010  
**Photographer:** Rodney Kelshaw

**Comments:** Granite slabs found around pool.

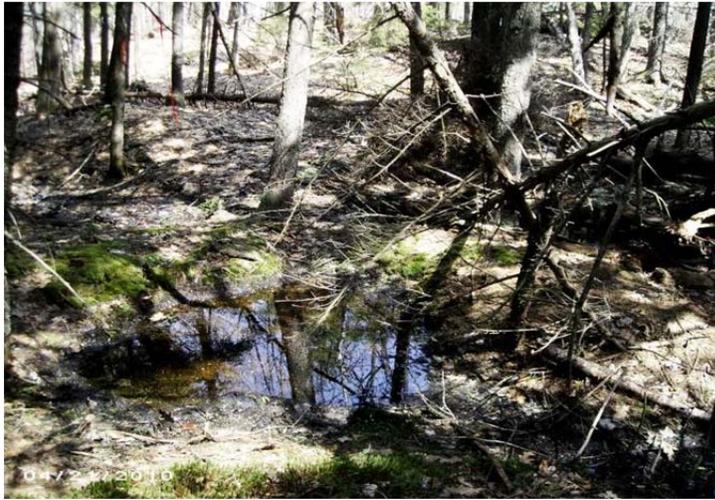
**Photo No.:** 4  
**Plan ID:** 9PSVP  
**Vernal Pool:** CR\_11SVP\_BA421  
CR\_11SVP\_BA506  
**Date:** April 21, 2010  
**Photographer:** Rodney Kelshaw

**Comments:** Isolated depression adjacent to pool appears to be connected at high water (see notes and sketch, GPS center point flag 7 taken here).

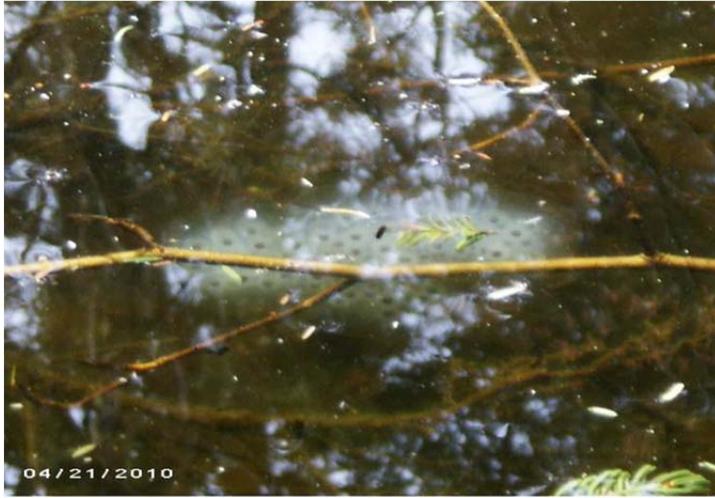
**Photo No.:** 7  
**Plan ID:** 9PSVP  
**Vernal Pool:** CR\_11SVP\_BA421  
CR\_11SVP\_BA506  
**Date:** April 21, 2010  
**Photographer:** Rodney Kelshaw  
**Comments:** Spotted salamander egg mass.

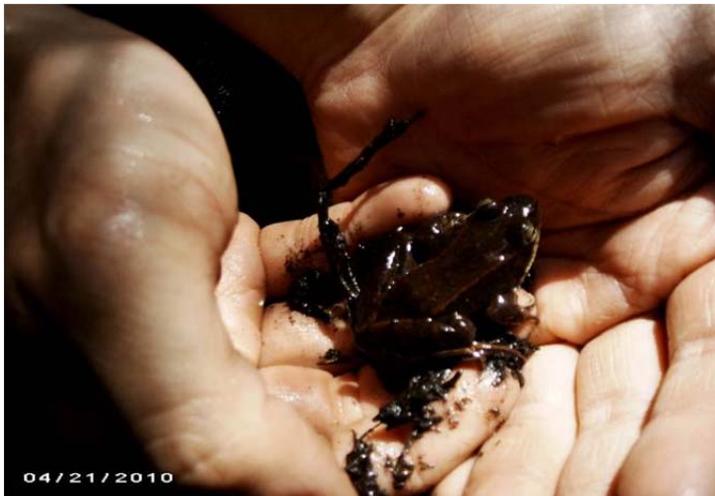
**Photo No.:** 9  
**Plan ID:** 9PSVP  
**Vernal Pool:** CR\_11SVP\_BA421  
CR\_11SVP\_BA506  
**Date:** April 21, 2010  
**Photographer:** Rodney Kelshaw  
**Comments:** Wood frog adult found in pool.

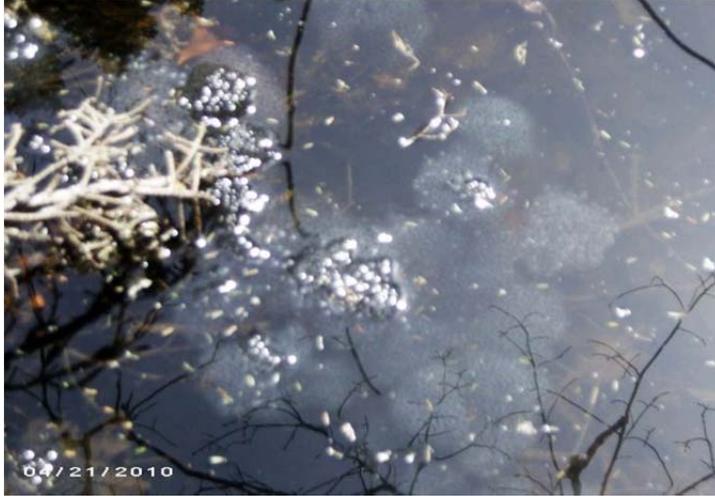
**Photo No.:** 10

**Comments:** Wood frog egg masses.

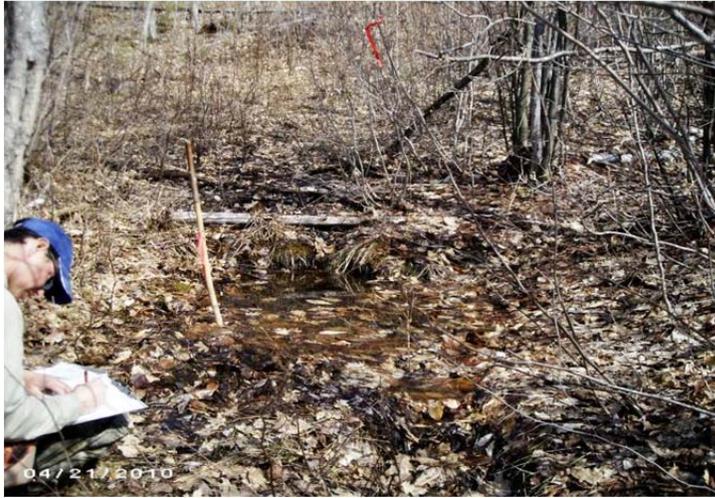
**Photo No.:** 1  
**Plan ID:** 10 BVP  
**Vernal Pool:** CR\_13BVP\_BA421  
CR\_13BVP\_BA506

**Comments:** Facing east at small natural pool. Small drainage exiting pool.

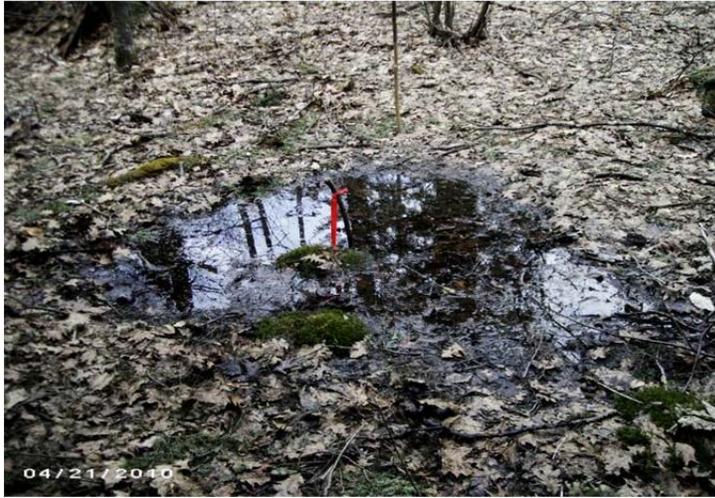
**Photo No.:** 1  
**Plan ID:** 11BVP  
**Vernal Pool:** CR\_10BVP\_BA421  
CR\_10BVP\_BA506  
**Date:** April 21, 2010  
**Photographer:** Rodney Kelshaw

**Comments:** Small natural feature on ridge plateau. Narrow drainage from CR\_11VP\_BA421. No egg masses found. Photo facing east.

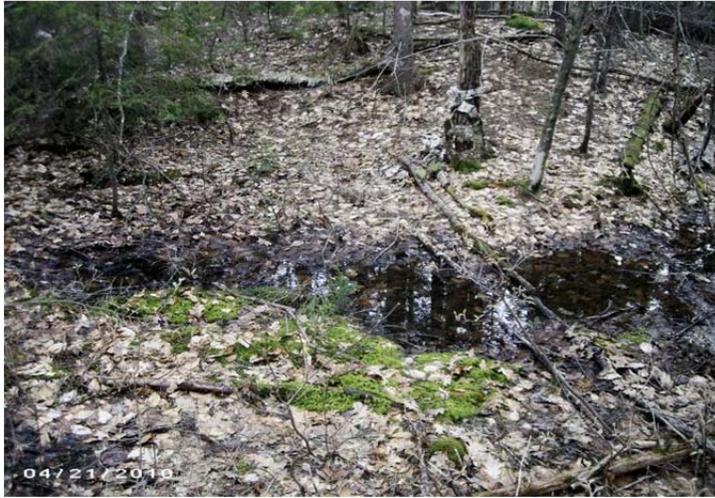
**Photo No.:** 1  
**Plan ID:** 12BVP  
**Vernal Pool:** CR\_8BVP\_BA421  
CR\_8BVP\_BA507  
**Date:** April 21, 2010  
**Photographer:** Rodney Kelshaw

**Comments:** Facing east at pool complex. Natural feature lacking vegetation. No egg masses present at time of survey.

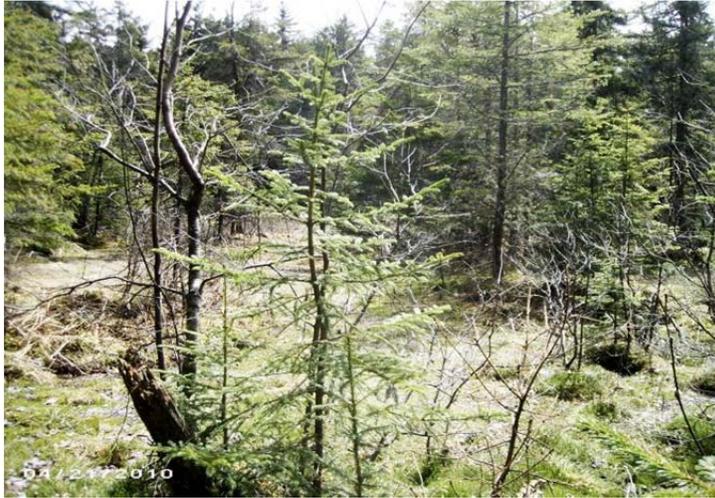
**Photo No.:** 1  
**Plan ID:** 14NVP  
**Vernal Pool:** CR\_7NVP\_BA421  
CR\_7NVP\_BA507  
**Date:** April 21, 2010  
**Photographer:** Rodney Kelshaw

**Comments:** Kettle bog on top of ridge. Pools “ringing” outer boundary of bog with raised sphagnum mound in center. Photo facing east. No egg masses found in bog at time of survey.

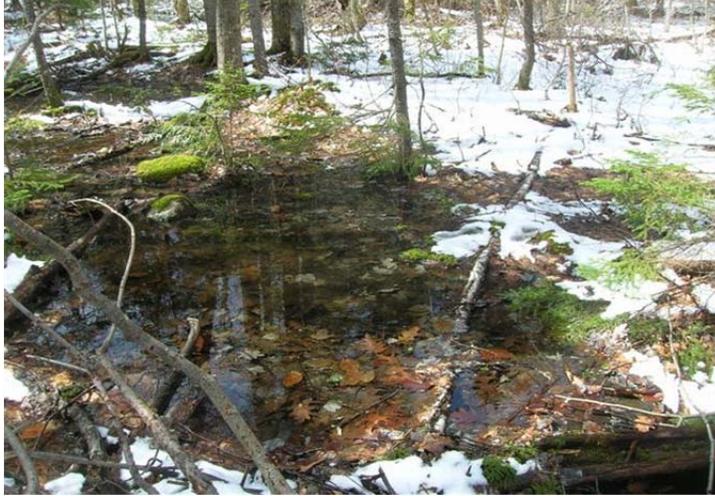
**Photo No.:** 1  
**Plan ID:** 15BVP  
**Vernal Pool:** CR\_4BVP\_BA419  
CR\_4BVP\_BA507  
**Date:** April 19, 2010  
**Photographer:** Rodney Kelshaw

**Comments:** Looking east at natural pool complex. No egg masses found.

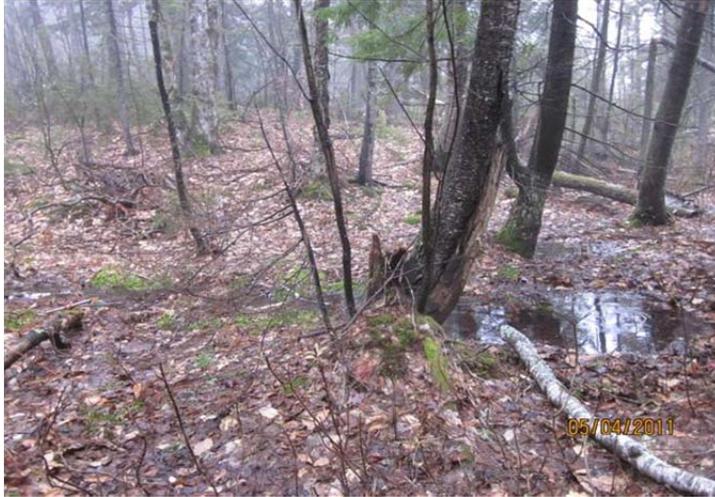
**Photo No.:** 1  
**Plan ID:** 16BVP  
**Vernal Pool:** CR\_14BVP\_BA504  
CR\_14BVP\_BA523  
**Date:** May 4, 2010  
**Photographer:** Lauren Leclerc

**Comments:** Small pool in natural drainage swale. No egg masses were present at time of survey. Looking north. Needs a revisit (revised on 05.23.10).

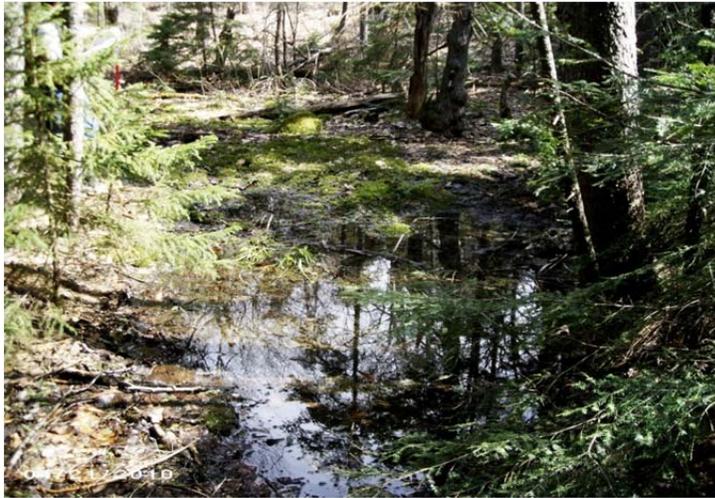
**Photo No.:** 1  
**Plan ID:** 17BVP  
**Vernal Pool:** CR\_5BVP\_BA421  
CR\_5BVP\_BA507  
**Date:** April 21, 2010  
**Photographer:** Rodney Kelshaw  
**Comments:** Looking north at shallow natural pool. No egg masses present.

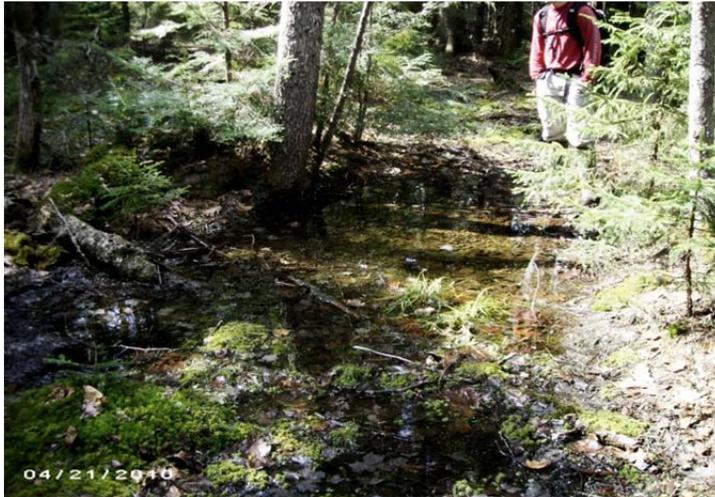
**Photo No.:** 2  
**Plan ID:** 17BVP  
**Vernal Pool:** CR\_5BVP\_BA421  
CR\_5BVP\_BA507  
**Date:** April 21, 2010  
**Photographer:** Rodney Kelshaw  
**Comments:** Looking south.

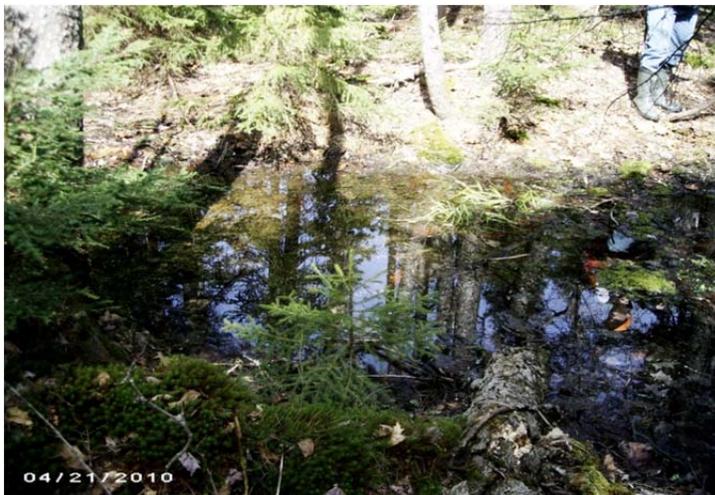
**Photo No.:** 3  
**Plan ID:** 17BVP  
**Vernal Pool:** CR\_5BVP\_BA421  
CR\_5BVP\_BA507  
**Date:** April 21, 2010  
**Photographer:** Rodney Kelshaw  
**Comments:** Looking west.

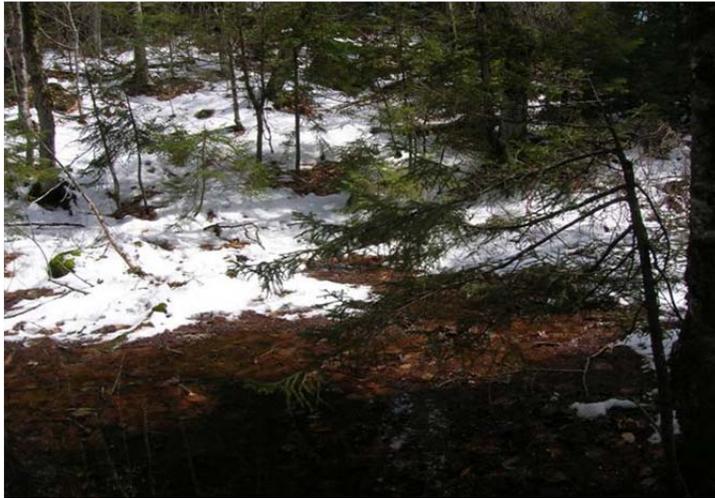
**Photo No.:** 1  
**Plan ID:** 18BVP  
**Vernal Pool:** CR\_3BVP\_BA419  
CR\_3BVP\_BA507  
**Date:** April 19, 2010  
**Photographer:** David Brenneman  
**Comments:** Looking east at natural vernal pool lacking egg masses.

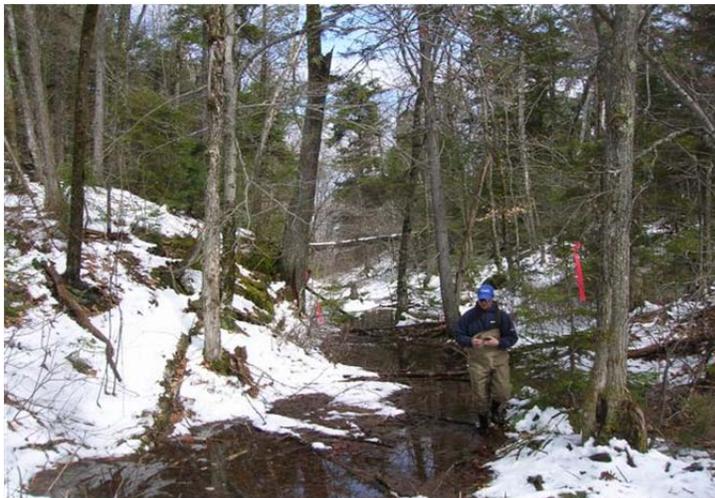
**Photo No.:** 2  
**Plan ID:** 18BVP  
**Vernal Pool:** CR\_3BVP\_BA419  
CR\_3BVP\_BA507  
**Date:** April 19, 2010  
**Photographer:** David Brenneman  
**Comments:** Looking north.

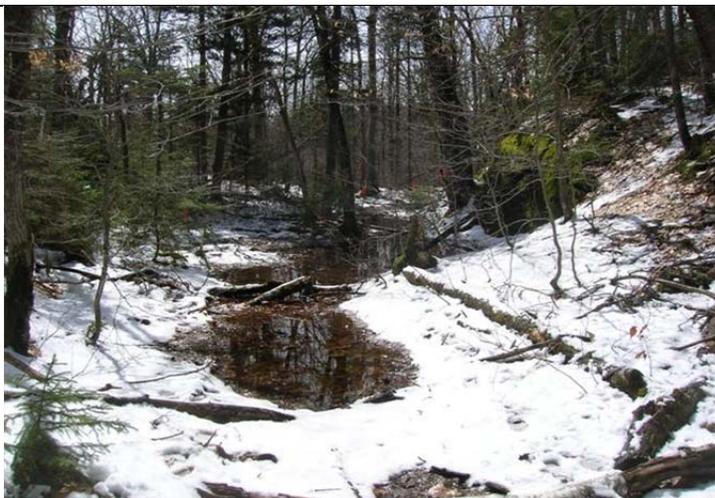
**Photo No.:** 3  
**Plan ID:** 18BVP  
**Vernal Pool:** CR\_3BVP\_BA419  
CR\_3BVP\_BA507  
**Date:** April 19, 2010  
**Photographer:** David Brenneman  
**Comments:** Looking south.

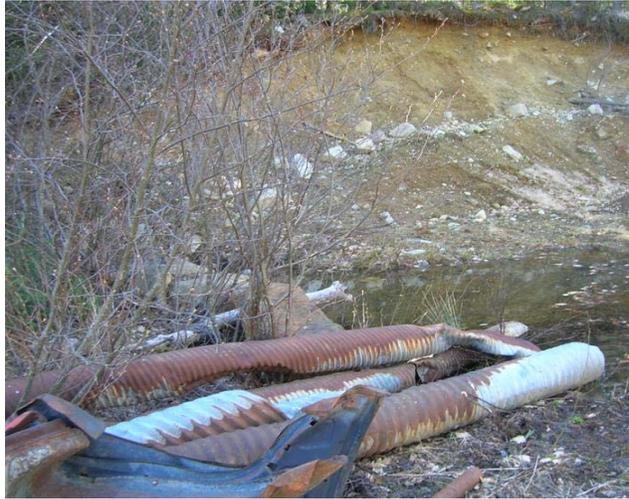
**Photo No.:** 1  
**Plan ID:** 1CP  
**Vernal Pool:** CA\_1CP\_BA415  
**Date:** April 15, 2010  
**Photographer**  
: David Brenneman  
**Comments:** Pool in hillside excavation area looking east. Contained a single egg mass.

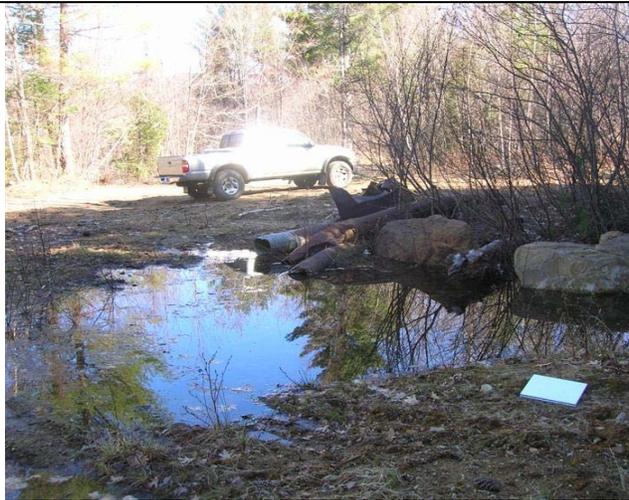
**Photo No.:** 2  
**Plan ID:** 1CP  
**Vernal Pool:** CA\_1CP\_BA415  
**Date:** April 15, 2010  
**Photographer**  
: David Brenneman  
**Comments:** Pool looking north.

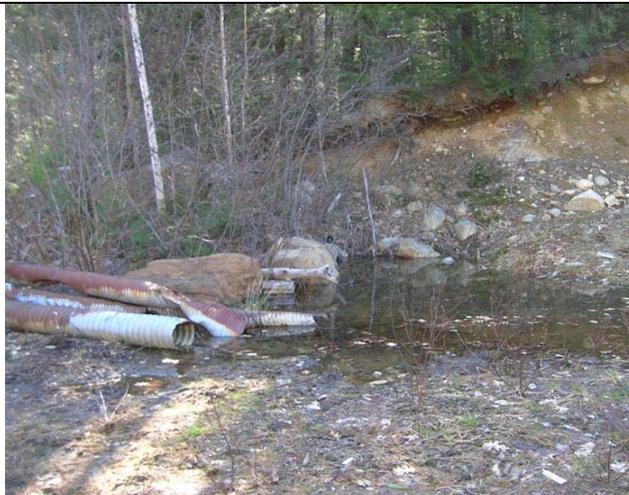
**Photo No.:** 3  
**Plan ID:** 1CP  
**Vernal Pool:** CA\_1CP\_BA415  
**Date:** April 15, 2010  
**Photographer**  
: David Brenneman  
**Comments:** Looking south.

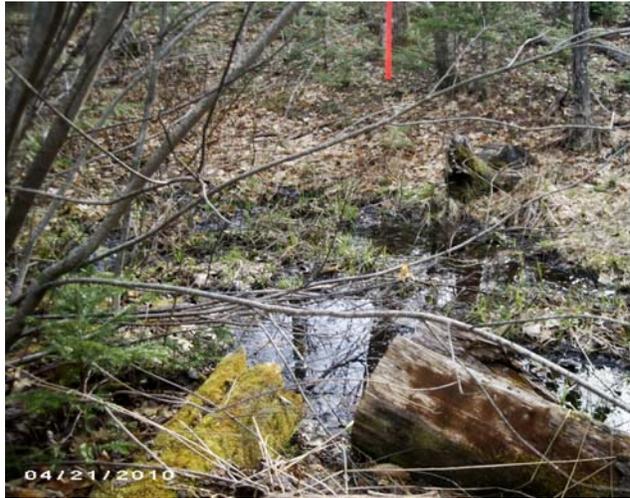
**Photo No.:** 1  
**Plan ID:** 2CP  
**Vernal Pool:** CA\_17CP\_BA421  
**Date:** April 21, 2010  
**Photographer :** Rodney Kelshaw  
**Comments:** Facing west at old skidder ruts in wetland.
