# Canton Mountain Wind Project

Canton and Dixfield,  
Oxford County, Maine

## RESOURCE SURVEY REPORT

**November 2011**

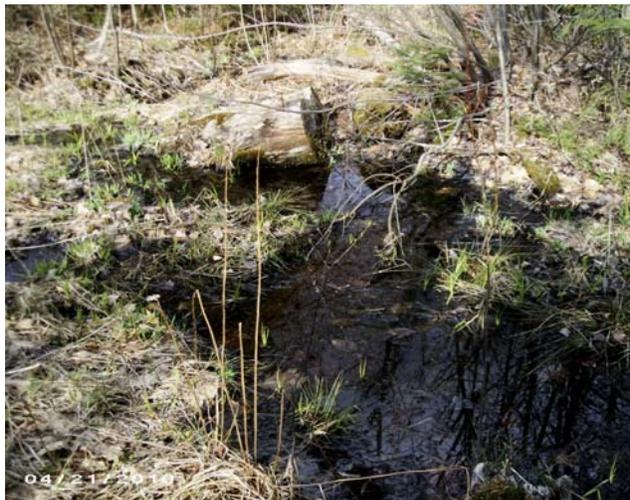
**Photo No.:** 2  
**Plan ID:** 2CP  
**Vernal Pool:** CA\_17CP\_BA421  
**Date:** April 21, 2010  
**Photographer :** Rodney Kelshaw  
**Comments:** Facing east.

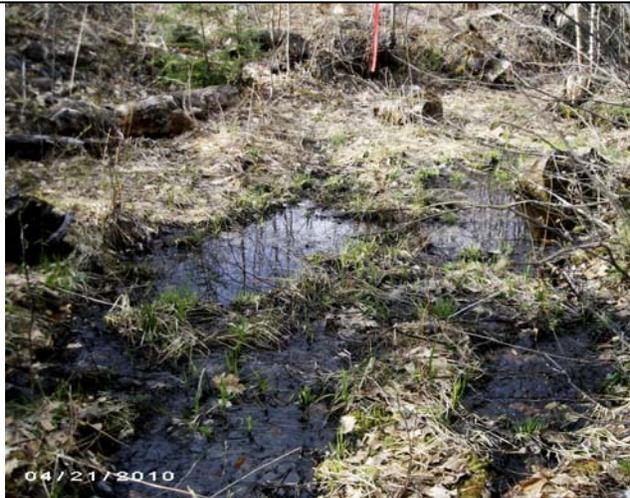
**Photo No.:** 3  
**Plan ID:** 2CP  
**Vernal Pool:** CA\_17CP\_BA421  
**Date:** April 21, 2010  
**Photographer :** Rodney Kelshaw  
**Comments:** Facing north.

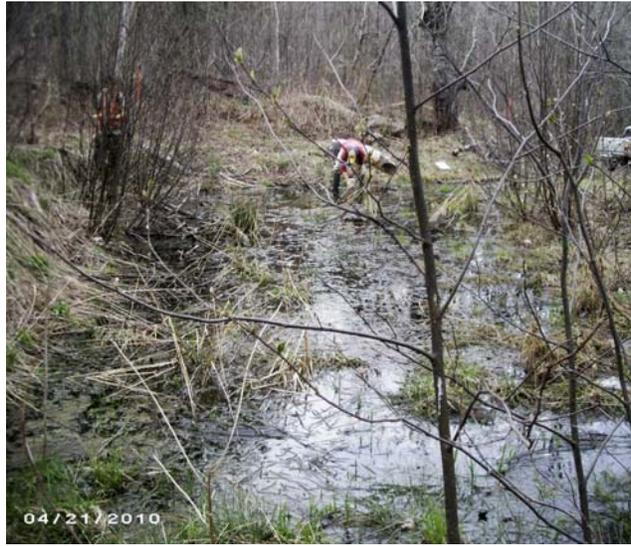
**Photo No.:** 1  
**Plan ID:** 3CP  
**Vernal Pool:** CA\_18CP\_BA421  
**Date:** April 21, 2010  
**Photographer :** Rodney Kelshaw  
**Comments:** “Borrow pit” along Ludden Road, facing east.

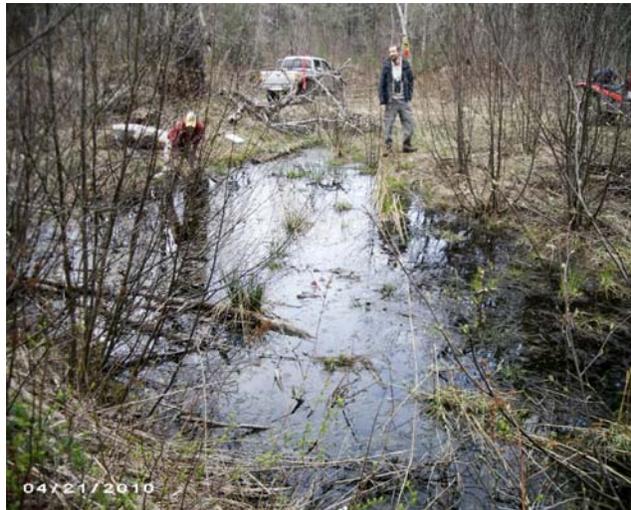
**Photo No.:** 2  
**Plan ID:** 3CP  
**Vernal Pool:** CA\_18CP\_BA421  
**Photographer :** Rodney Kelshaw  
**Comments:** Facing south.

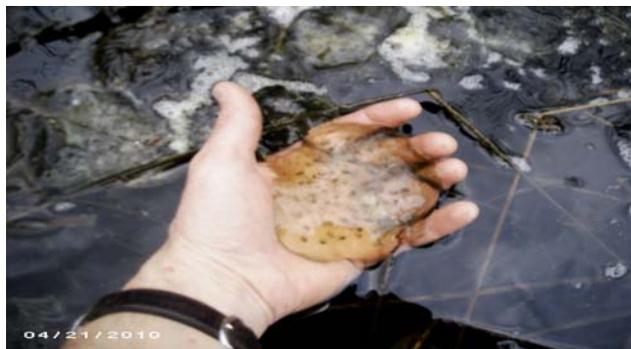
**Photo No.:** 3  
**Plan ID:** 3CP  
**Vernal Pool:** CA\_18CP\_BA421  
**Photographer :** Rodney Kelshaw  
**Comments:** Spotted salamander egg mass in pool.

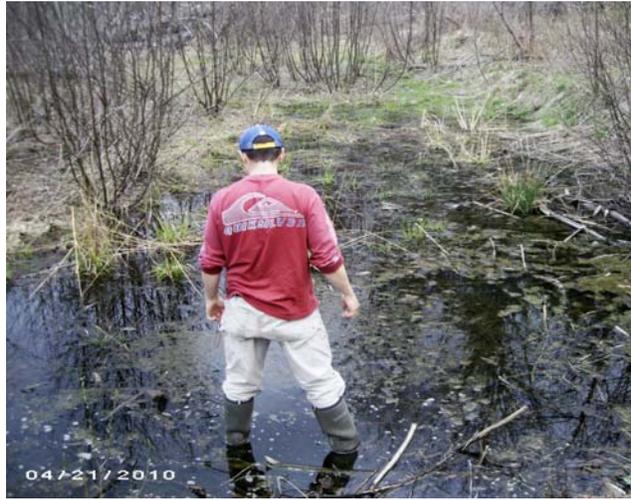
**Photo No.:** 4  
**Plan ID:** 3CP  
**Vernal Pool:** CA\_18CP\_BA421  
**Photographer :** Rodney Kelshaw  
**Comments:** Skidder ruts in wetland at access road boundary. No egg masses found. Photo facing east.

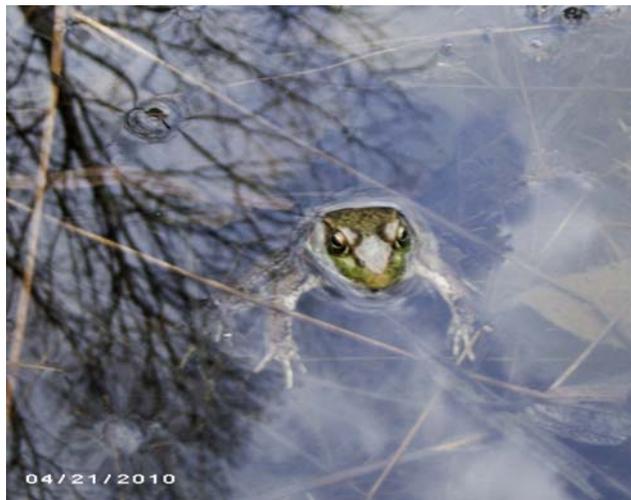
**Photo No.:** 5  
**Plan ID:** 3CP  
**Vernal Pool:** CA\_18CP\_BA421  
**Photographer :** Rodney Kelshaw  
**Comments:** Adult green frog in pool.

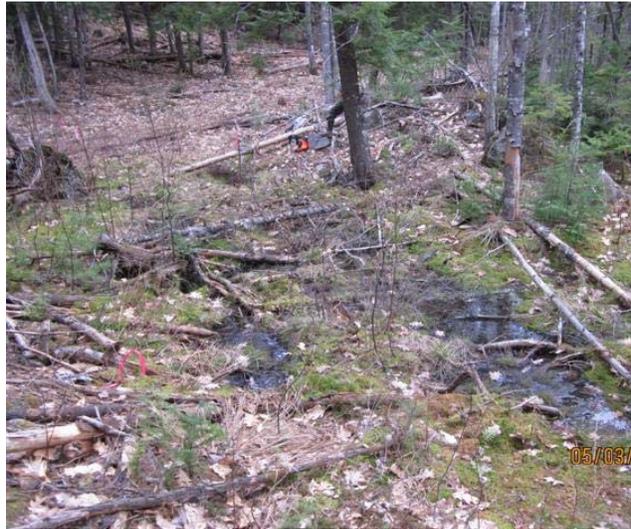
**Photo No.:** 1  
**Plan ID:** 4CP  
**Vernal Pool:** CA\_29CP\_BA503  
**Date:** May 3, 2011  
**Photographer :** Lauren Leclerc  
**Comments:** Ruts from logging activity in forested swale. No egg masses were present at time of survey. Looking north.

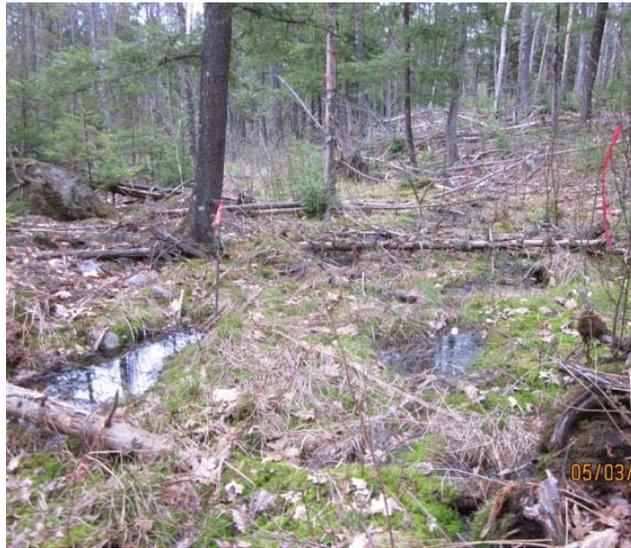
**Photo No.:** 2  
**Plan ID:** 4CP  
**Vernal Pool:** CA\_29CP\_BA503  
**Photographer :** Lauren Leclerc  
**Comments:** Looking east.

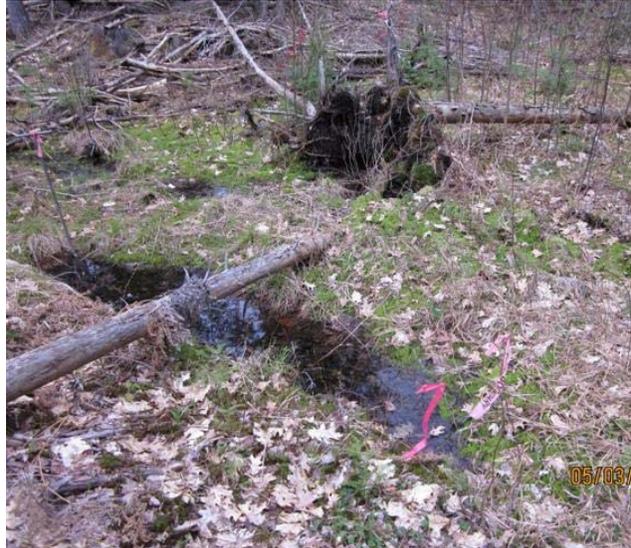
**Photo No.:** 3  
**Plan ID:** 4CP  
**Vernal Pool:** CA\_29CP\_BA503  
**Photographer :** Lauren Leclerc  
**Comments:** Looking south.

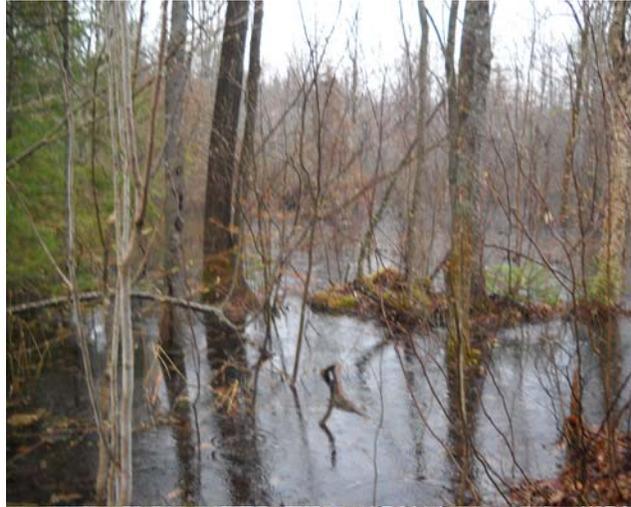
**Photo No.:** 1  
**Plan ID:** 5ABA  
**Vernal Pool:** CA\_1ABA\_BA416  
**Date:** April 16, 2010  
**Photographer:** Heather Storlazzi-Ward  
**Comments:** Looking east at beaver flowage. Area completely floods access road. Most egg masses were found to the east of the access road.

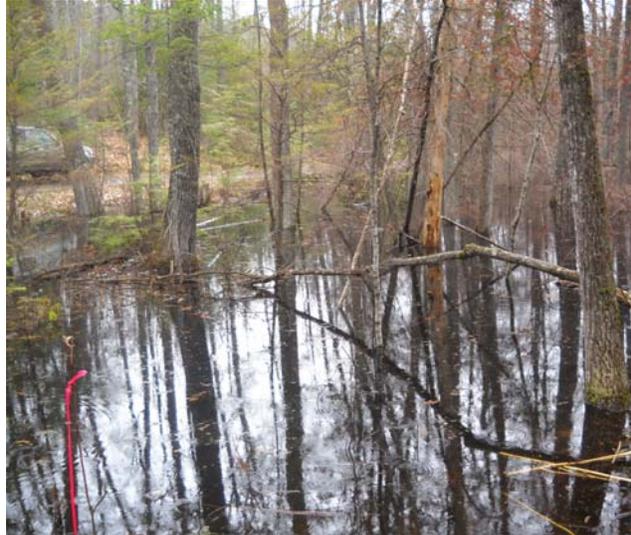
**Photo No.:** 2  
**Plan ID:** 5ABA  
**Vernal Pool:** CA\_1ABA\_BA416  
**Photographer:** Heather Storlazzi-Ward  
**Comments:** Looking north at beaver flowage.

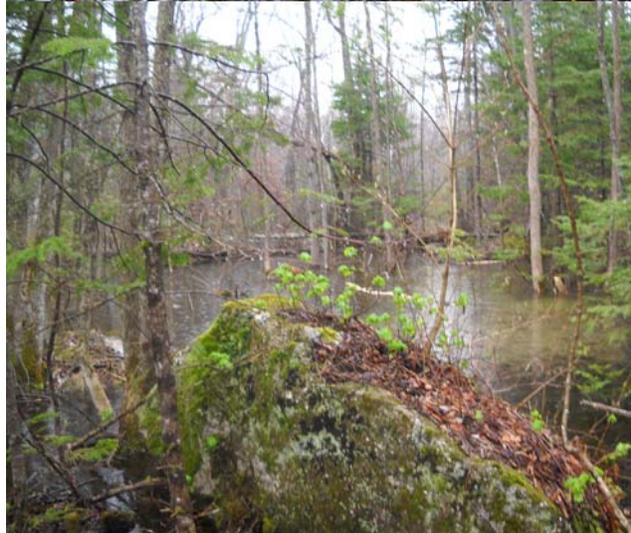
**Photo No.:** 3  
**Plan ID:** 5ABA  
**Vernal Pool:** CA\_1ABA\_BA416  
**Photographer:** Heather Storlazzi-Ward  
**Comments:** Looking south at beaver flowage.

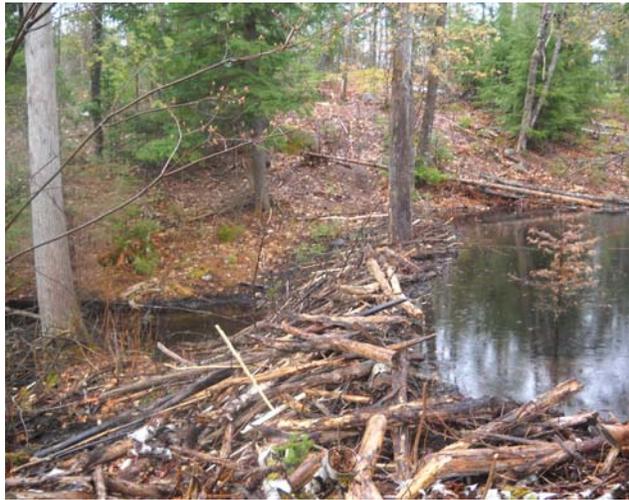
**Photo No.:** 4  
**Plan ID:** 5ABA  
**Vernal Pool:** CA\_1ABA\_BA416  
**Photographer:** Heather Storlazzi-Ward  
**Comments:** Looking southeast at beaver dam.

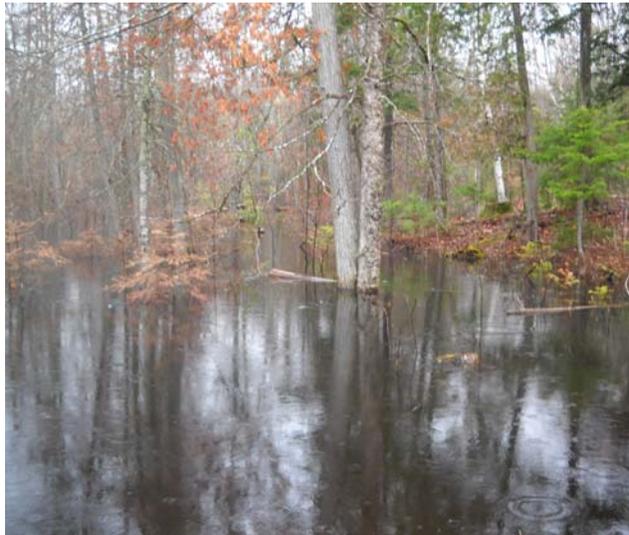
**Photo No.:** 5  
**Plan ID:** 5ABA  
**Vernal Pool:** CA\_1ABA\_BA416  
**Photographer:** Heather Storlazzi-Ward  
**Comments:** Looking east at beaver flowage.

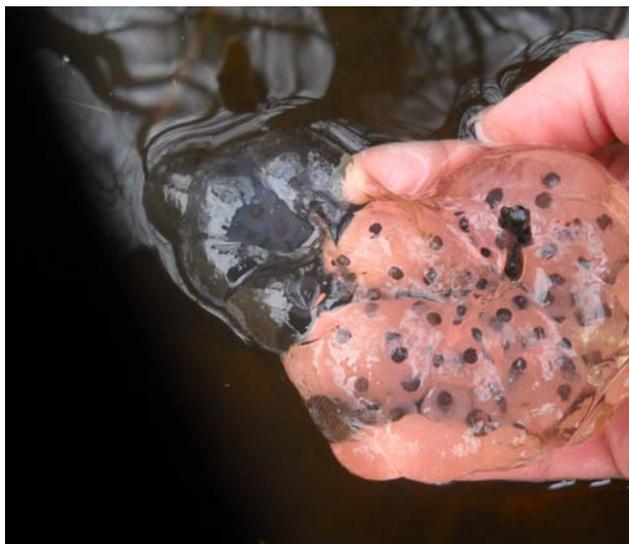
**Photo No.:** 6  
**Plan ID:** 5ABA  
**Vernal Pool:** CA\_1ABA\_BA416  
**Photographer:** Heather Storlazzi-Ward  
**Comments:** Spotted salamander egg mass.

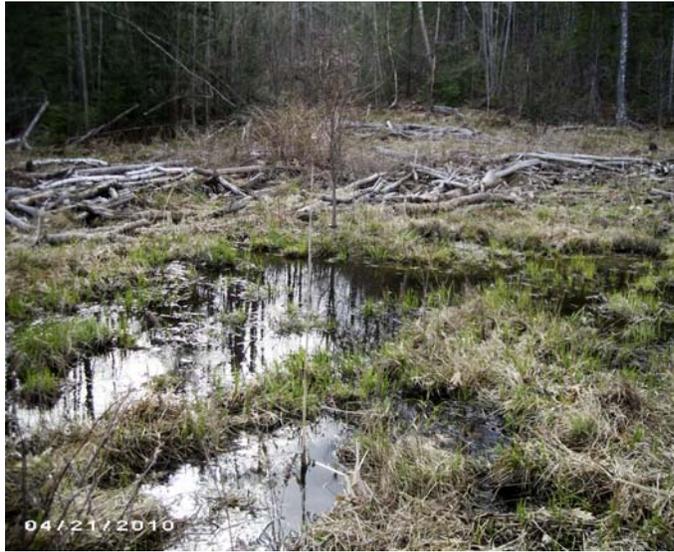
**Photo No.:** 1  
**Plan ID:** 6CP  
**Vernal Pool:** CA\_16CP\_BA421  
**Date:** April 21, 2010  
**Photographer:** Rodney Kelshaw  
**Comments:** Pool complex in wetland feature that was used as a log landing. No egg masses found at time of survey. Photo facing west.

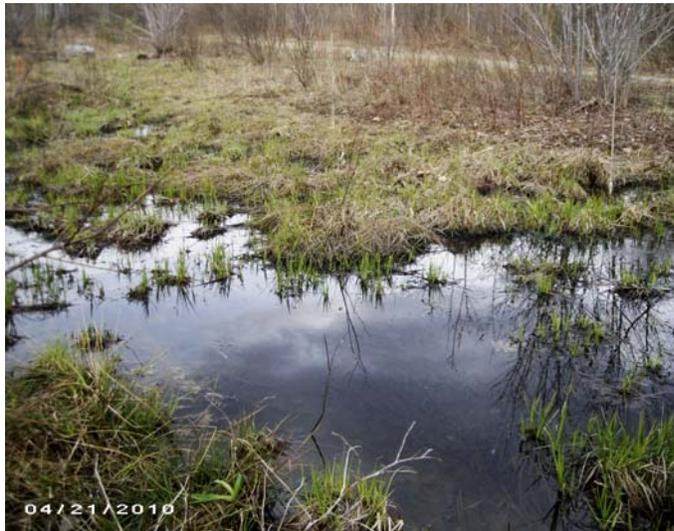
**Photo No.:** 2  
**Plan ID:** 6CP  
**Vernal Pool:** CA\_16CP\_BA421  
**Photographer:** Rodney Kelshaw  
**Comments:** Facing east.

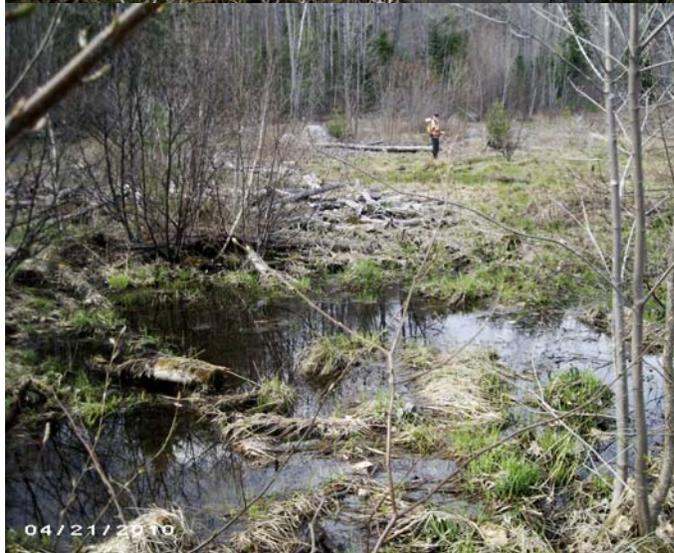
**Photo No.:** 3  
**Plan ID:** 6CP  
**Vernal Pool:** CA\_16CP\_BA421  
**Photographer:** Rodney Kelshaw  
**Comments:** Facing north.

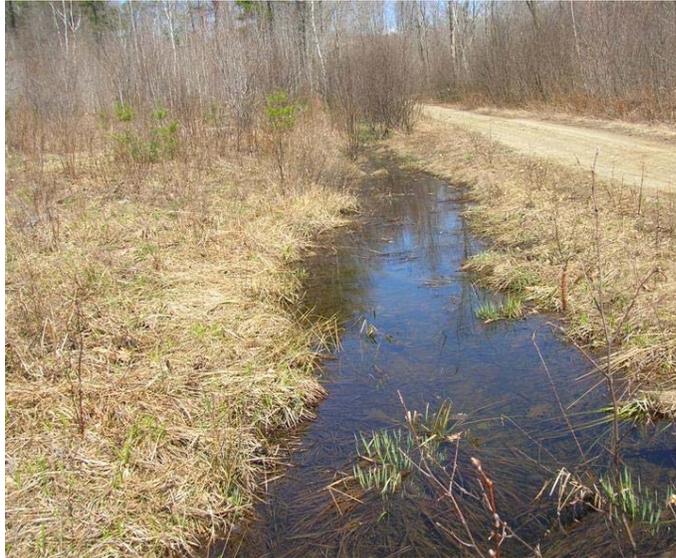
**Photo No.:** 1  
**Plan ID:** 7CP  
**Vernal Pool:** CA\_4CP\_BA415  
**Date:** April 15, 2010  
**Photographer:** David Brenneman  
**Comments:** Looking northeast at ditch along access road with four spotted salamander egg masses.

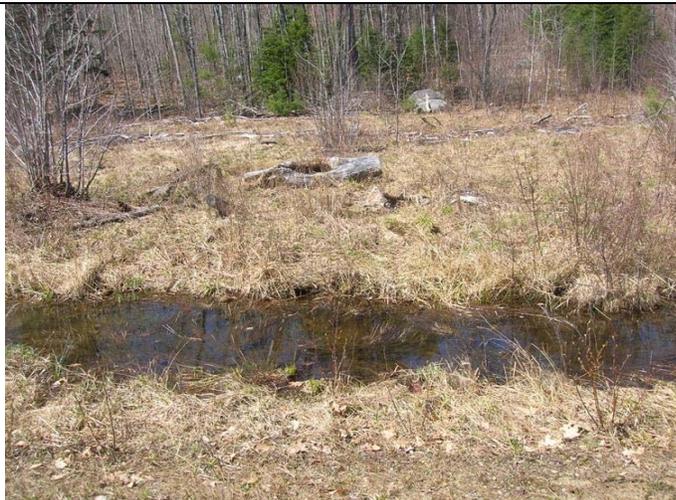
**Photo No.:** 2  
**Plan ID:** 7CP  
**Vernal Pool:** CA\_4CP\_BA415  
**Date:** April 15, 2010  
**Photographer:** David Brenneman  
**Comments:** Looking northwest.

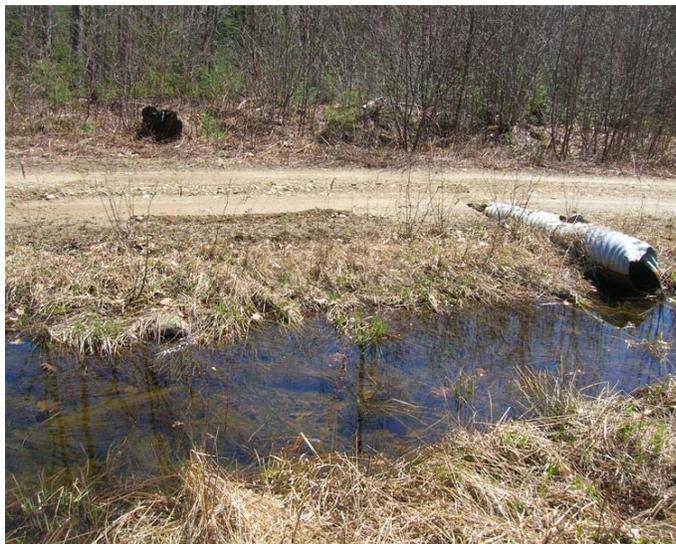
**Photo No.:** 3  
**Plan ID:** 7CP  
**Vernal Pool:** CA\_4CP\_BA415  
**Date:** April 15, 2010  
**Photographer:** David Brenneman  
**Comments:** Looking southeast.

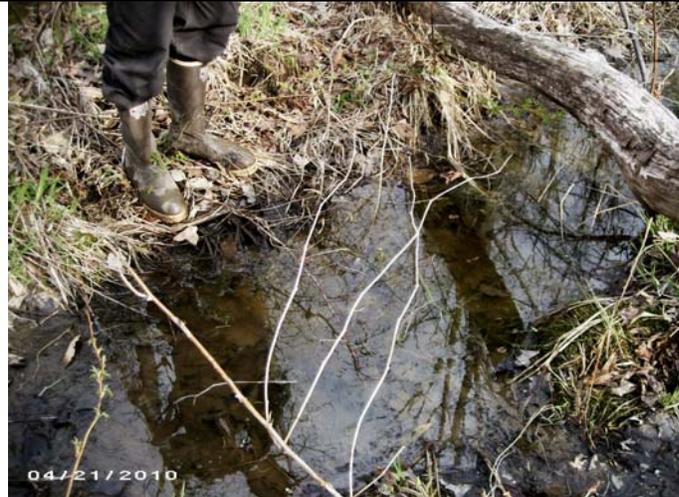
**Photo No.:** 1  
**Plan ID:** 8CP  
**Vernal Pool:** CA\_15CP\_BA421  
**Date:** April 21, 2010  
**Photographer:** Rodney Kelshaw  
**Comments:** Skidder ruts in wetland at access road boundary. No egg masses found. Photo facing east.

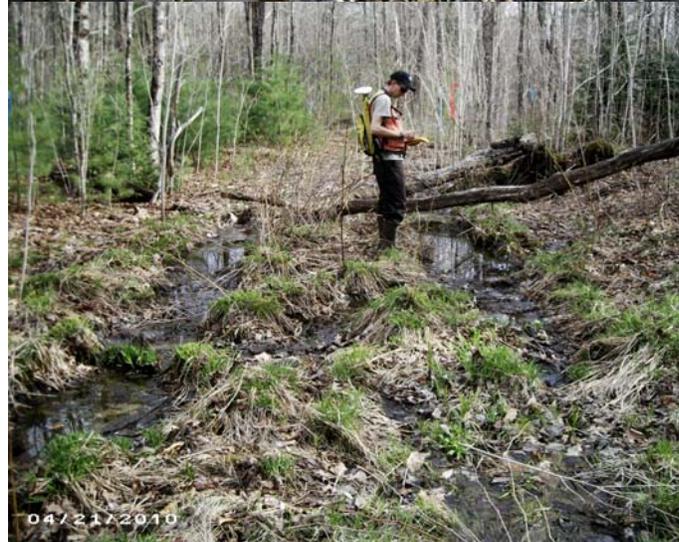
**Photo No.:** 2  
**Plan ID:** 8CP  
**Vernal Pool:** CA\_15CP\_BA421  
**Date:** April 21, 2010  
**Photographer:** Rodney Kelshaw  
**Comments:** Facing south.

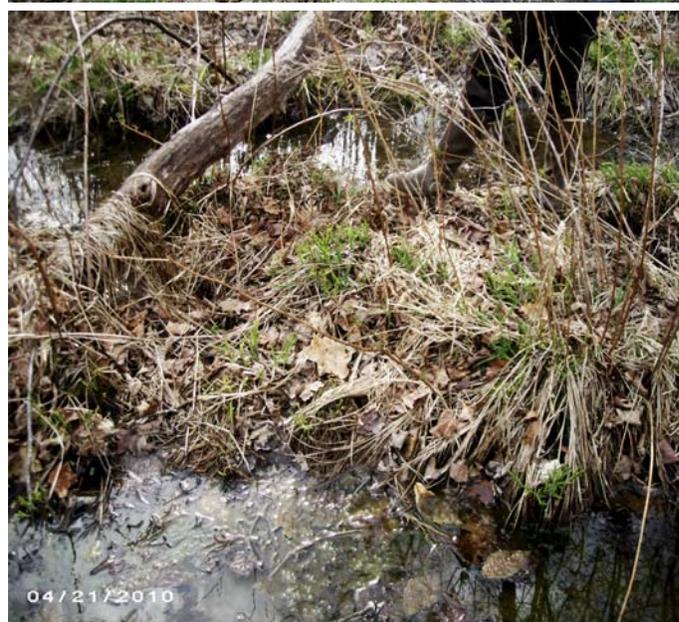
**Photo No.:** 3  
**Plan ID:** 8CP  
**Vernal Pool:** CA\_15CP\_BA421  
**Date:** April 21, 2010  
**Photographer:** Rodney Kelshaw  
**Comments:** Facing west.

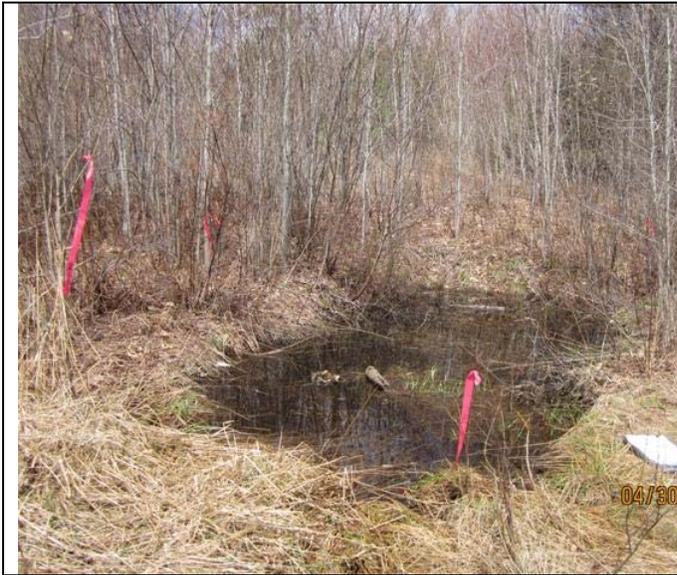
**Photo No.:** 1  
**Plan ID:** 9CP  
**Vernal Pool:** CA\_19CP\_BA430  
**Date:** April 30, 2011  
**Photographer:** Lauren Leclerc  
**Comments:** Naturalized historic borrow area along road containing eight spotted salamander egg masses. Part of pool was outside of survey area. Looking north.

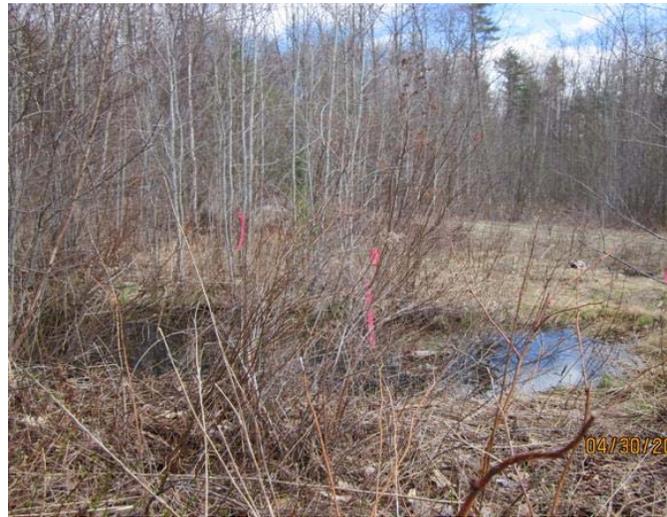
**Photo No.:** 2  
**Plan ID:** 9CP  
**Vernal Pool:** CA\_19CP\_BA430  
**Date:** April 30, 2011  
**Photographer:** Lauren Leclerc  
**Comments:** Looking east.

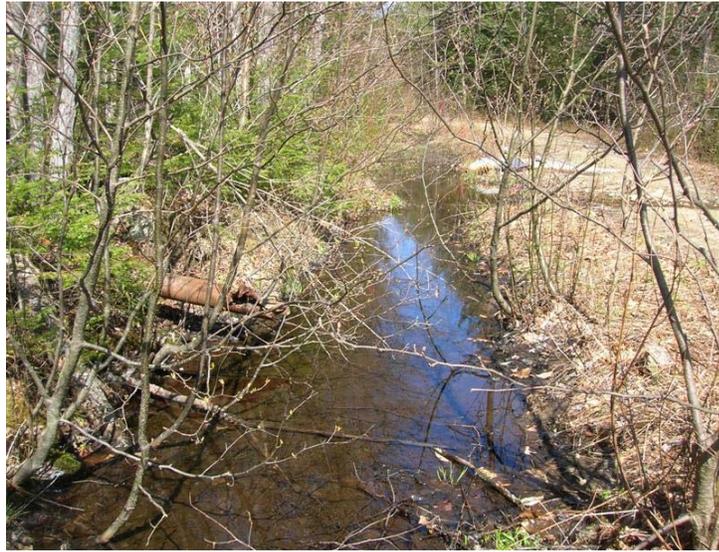
**Photo No.:** 1  
**Plan ID:** 10CP  
**Vernal Pool:** CA\_5CP\_BA415  
**Date:** April 15, 2010  
**Photographer:** David Brenneman  
**Comments:** Looking east at road ditch in wetland. Water in ditch is dammed by road.

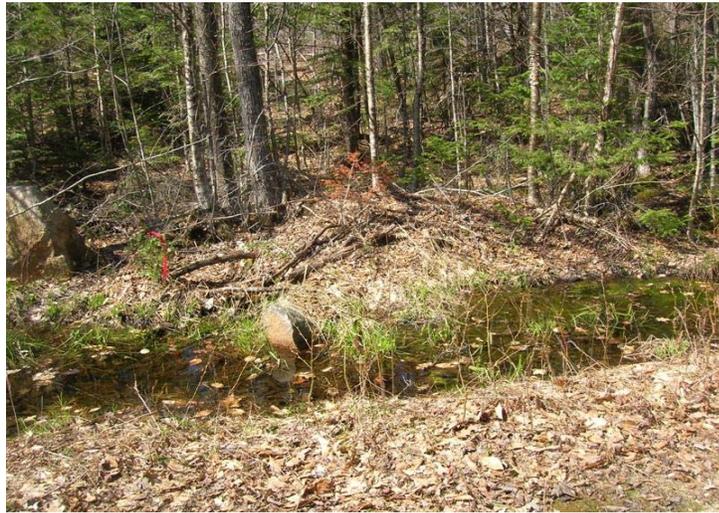
**Photo No.:** 2  
**Plan ID:** 10CP  
**Vernal Pool:** CA\_5CP\_BA415  
**Date:** April 15, 2010  
**Photographer:** David Brenneman  
**Comments:** Looking north.

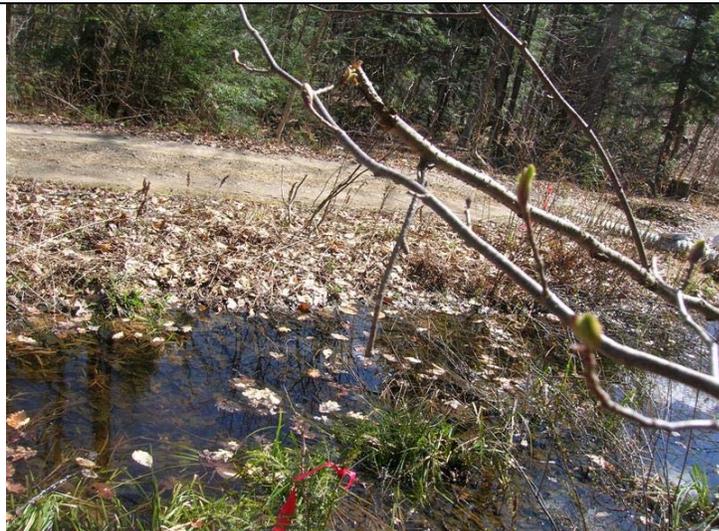
**Photo No.:** 3  
**Plan ID:** 10CP  
**Vernal Pool:** CA\_5CP\_BA415  
**Date:** April 15, 2010  
**Photographer:** David Brenneman  
**Comments:** Looking south.

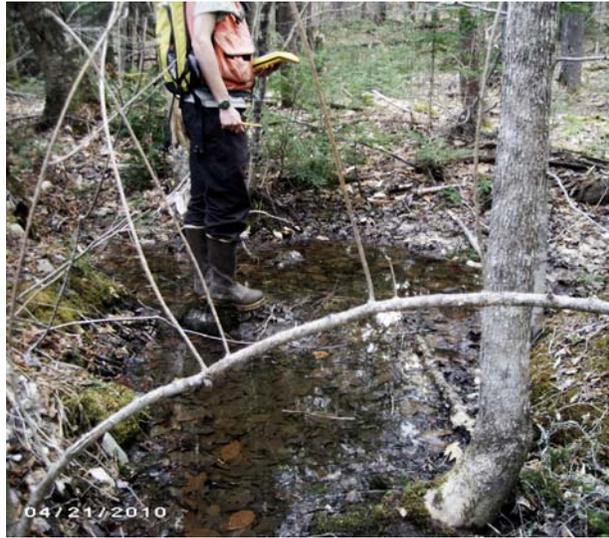
**Photo No.:** 1  
**Plan ID:** 11CP  
**Vernal Pool:** CA\_14CP\_BA421  
**Date:** April 21, 2010  
**Photographer:** Rodney Kelshaw  
**Comments:** Pool in wetland adjacent to berm and road ditch. Photo facing east.

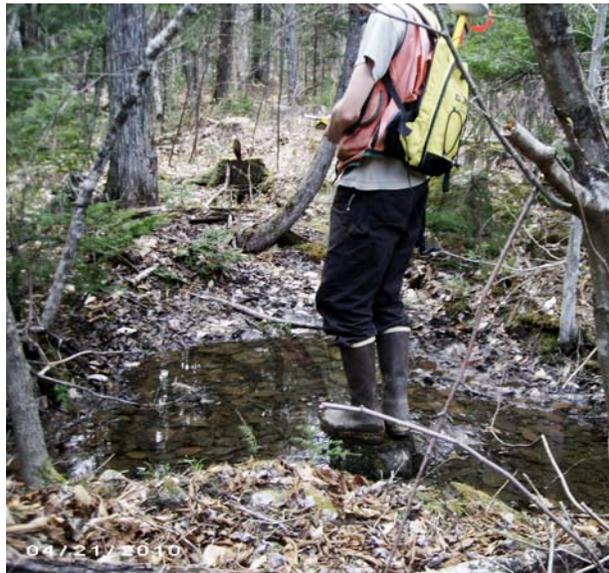
**Photo No.:** 2  
**Plan ID:** 11CP  
**Vernal Pool:** CA\_14CP\_BA421  
**Date:** April 21, 2010  
**Photographer:** Rodney Kelshaw  
**Comments:** Facing north.

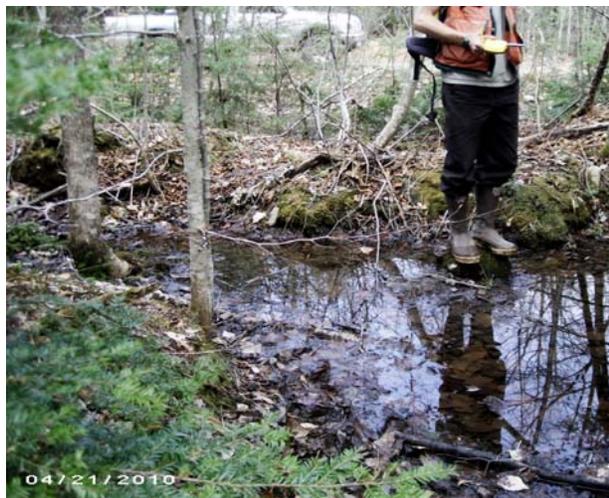
**Photo No.:** 3  
**Plan ID:** 11CP  
**Vernal Pool:** CA\_14CP\_BA421  
**Date:** April 21, 2010  
**Photographer:** Rodney Kelshaw  
**Comments:** Facing south.

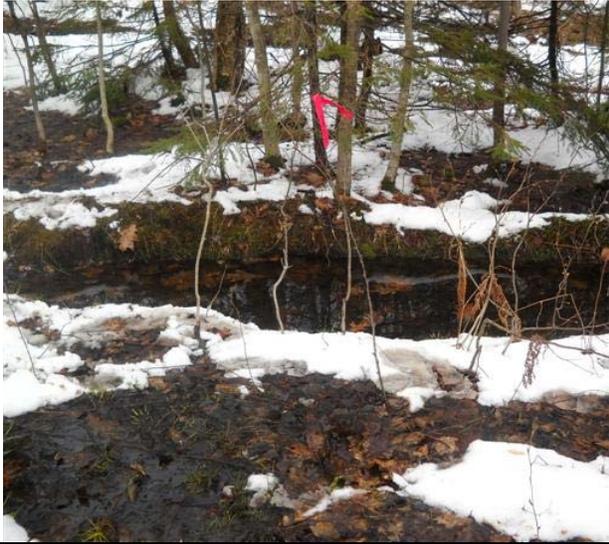
<p><b>Photo No.:</b> 1</p> <p><b>Plan ID:</b> 12CP</p> <p><b>Vernal Pool:</b> CR_1CP_BA418</p> <p><b>Date:</b> April 18, 2010</p> <p><b>Photographer:</b> Heather Storlazzi-Ward</p> <p><b>Comments:</b> Looking east at pool 1 in skidder rut complex.</p>

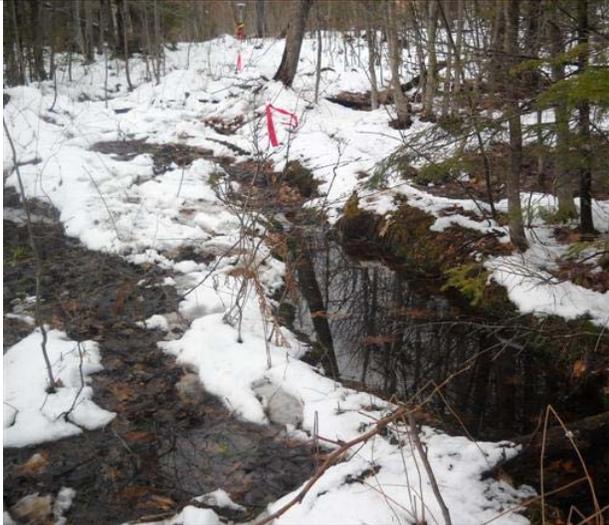
<p><b>Photo No.:</b> 2</p> <p><b>Plan ID:</b> 12CP</p> <p><b>Vernal Pool:</b> CR_1CP_BA418</p> <p><b>Date:</b> April 18, 2010</p> <p><b>Photographer:</b> Heather Storlazzi-Ward</p> <p><b>Comments:</b> Looking north at pool 1.</p>

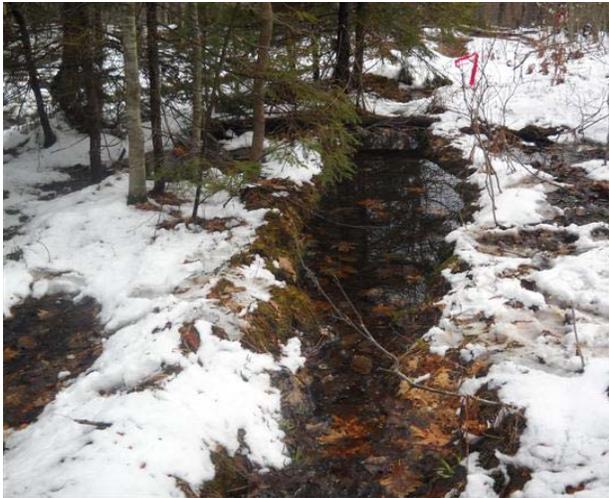
<p><b>Photo No.:</b> 3</p> <p><b>Plan ID:</b> 12CP</p> <p><b>Vernal Pool:</b> CR_1CP_BA418</p> <p><b>Date:</b> April 18, 2010</p> <p><b>Photographer:</b> Heather Storlazzi-Ward</p> <p><b>Comments:</b> Looking south at pool 1.</p>

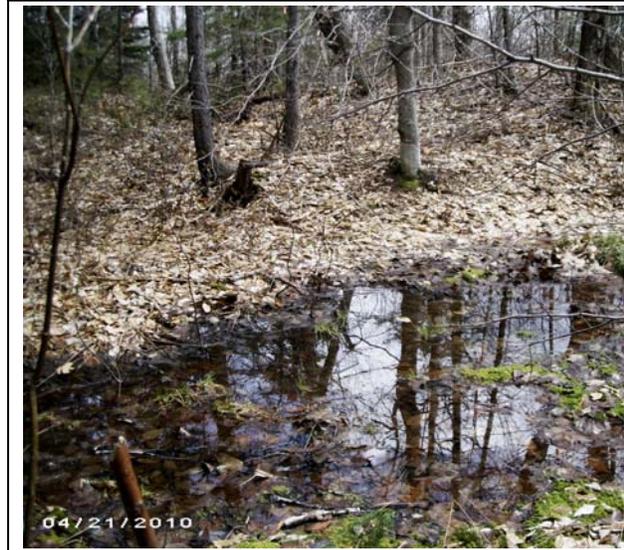
**Photo No.:** 1  
**Plan ID:** 13CP  
**Vernal Pool:** CR\_9CP\_BA421  
**Date:** April 21, 2010  
**Photographer:** Rodney Kelshaw  
**Comments:** Re-naturalizing skid trail with a complex of pools in approximately 15 year old harvest area. No egg masses found.

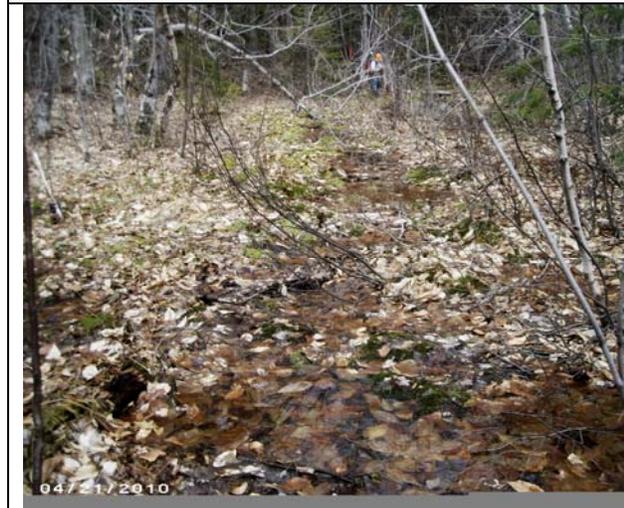
**Photo No.:** 2  
**Plan ID:** 13CP  
**Vernal Pool:** CR\_9CP\_BA421  
**Date:** April 21, 2010  
**Photographer:** Rodney Kelshaw  
**Comments:** Facing north.

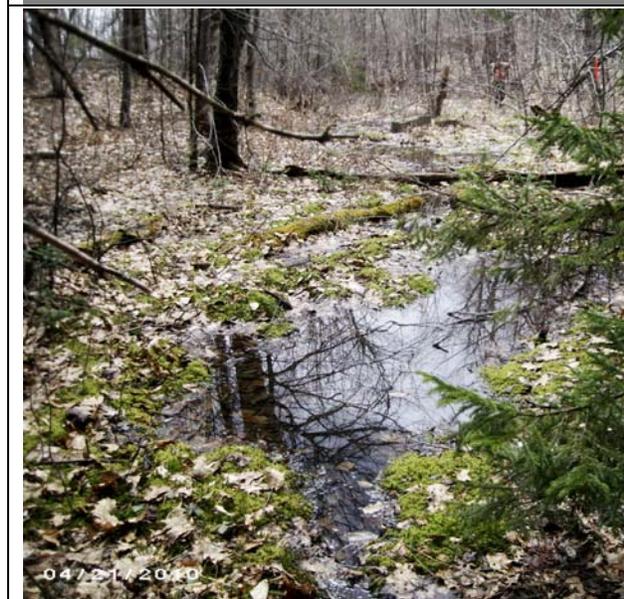
**Photo No.:** 3  
**Plan ID:** 13CP  
**Vernal Pool:** CR\_9CP\_BA421  
**Date:** April 21, 2010  
**Photographer:** Rodney Kelshaw  
**Comments:** Facing south.

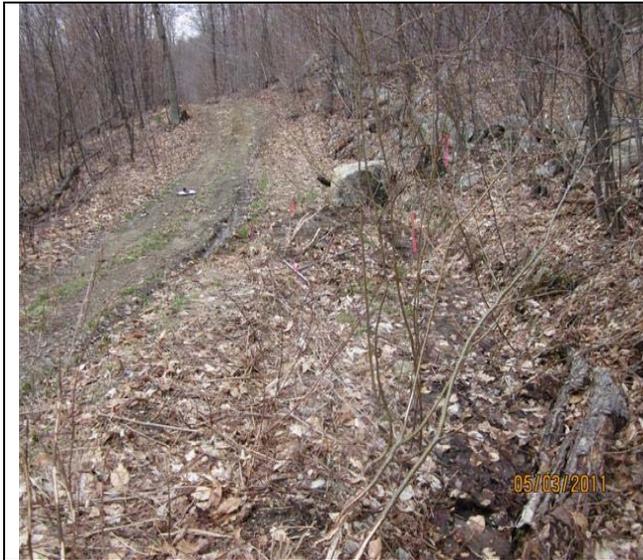
**Photo No.:** 1  
**Plan ID:** 14CP  
**Vernal Pool:** CA\_28CP\_BA503  
**Date:** May 3, 2011  
**Photographer:** Lauren Leclerc  
**Comments:** Small excavation adjacent to gravel road. No egg masses were present at time of survey. Looking north.

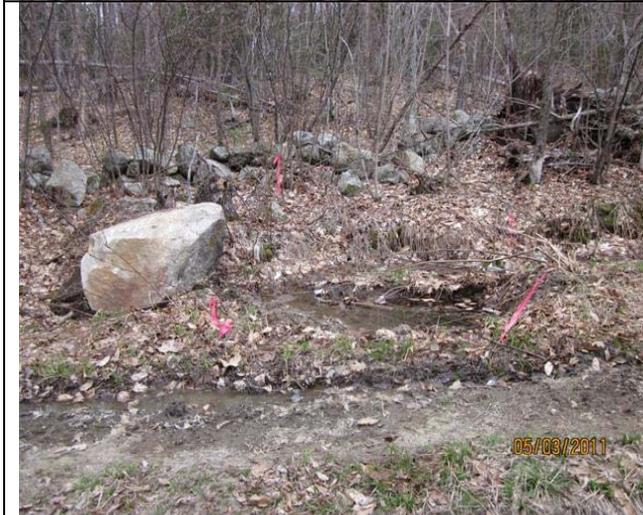
**Photo No.:** 2  
**Plan ID:** 14CP  
**Vernal Pool:** CA\_28CP\_BA503  
**Date:** May 3, 2011  
**Photographer:** Lauren Leclerc  
**Comments:** Looking east.

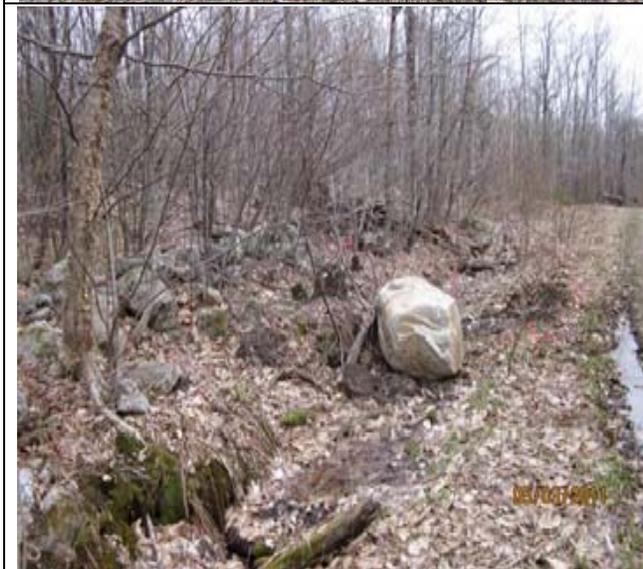
**Photo No.:** 3  
**Plan ID:** 14CP  
**Vernal Pool:** CA\_28CP\_BA503  
**Date:** May 3, 2011  
**Photographer:** Lauren Leclerc  
**Comments:** Looking west.

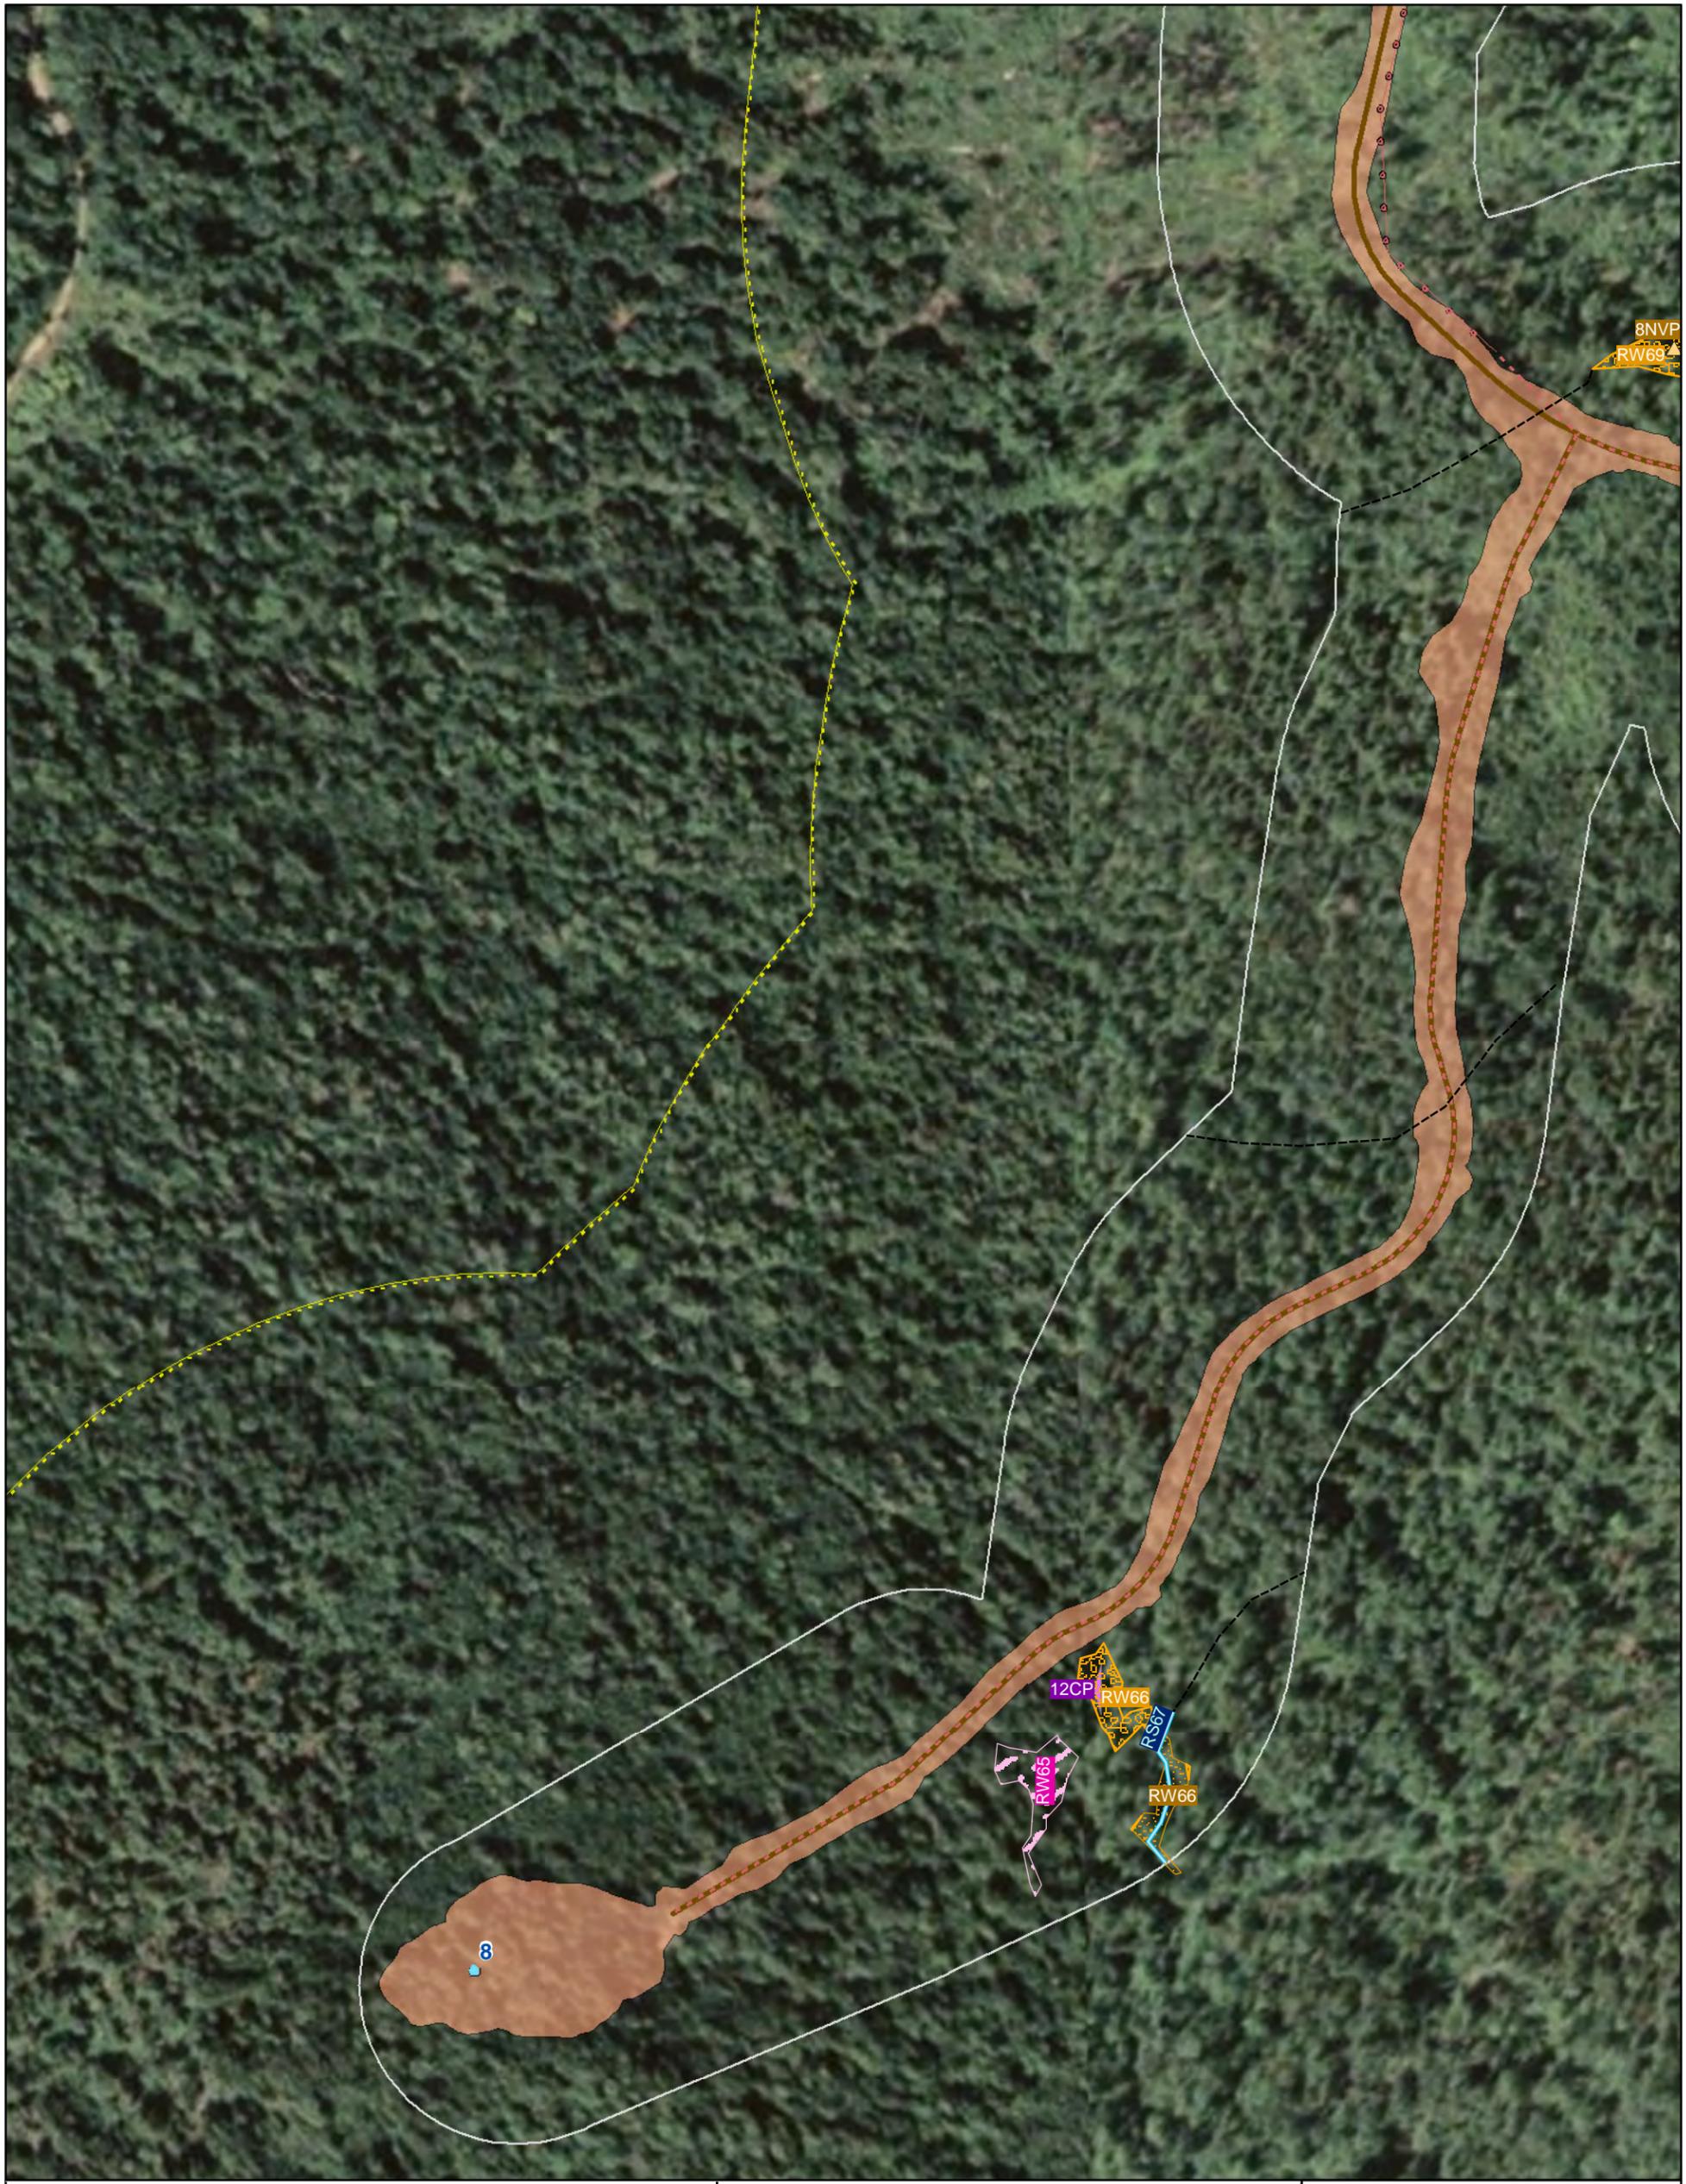
**MAP 06**

**Water Resources**
