# Canton Mountain Wind Project

Canton and Dixfield,  
Oxford County, Maine

## RESOURCE SURVEY REPORT

**November 2011**

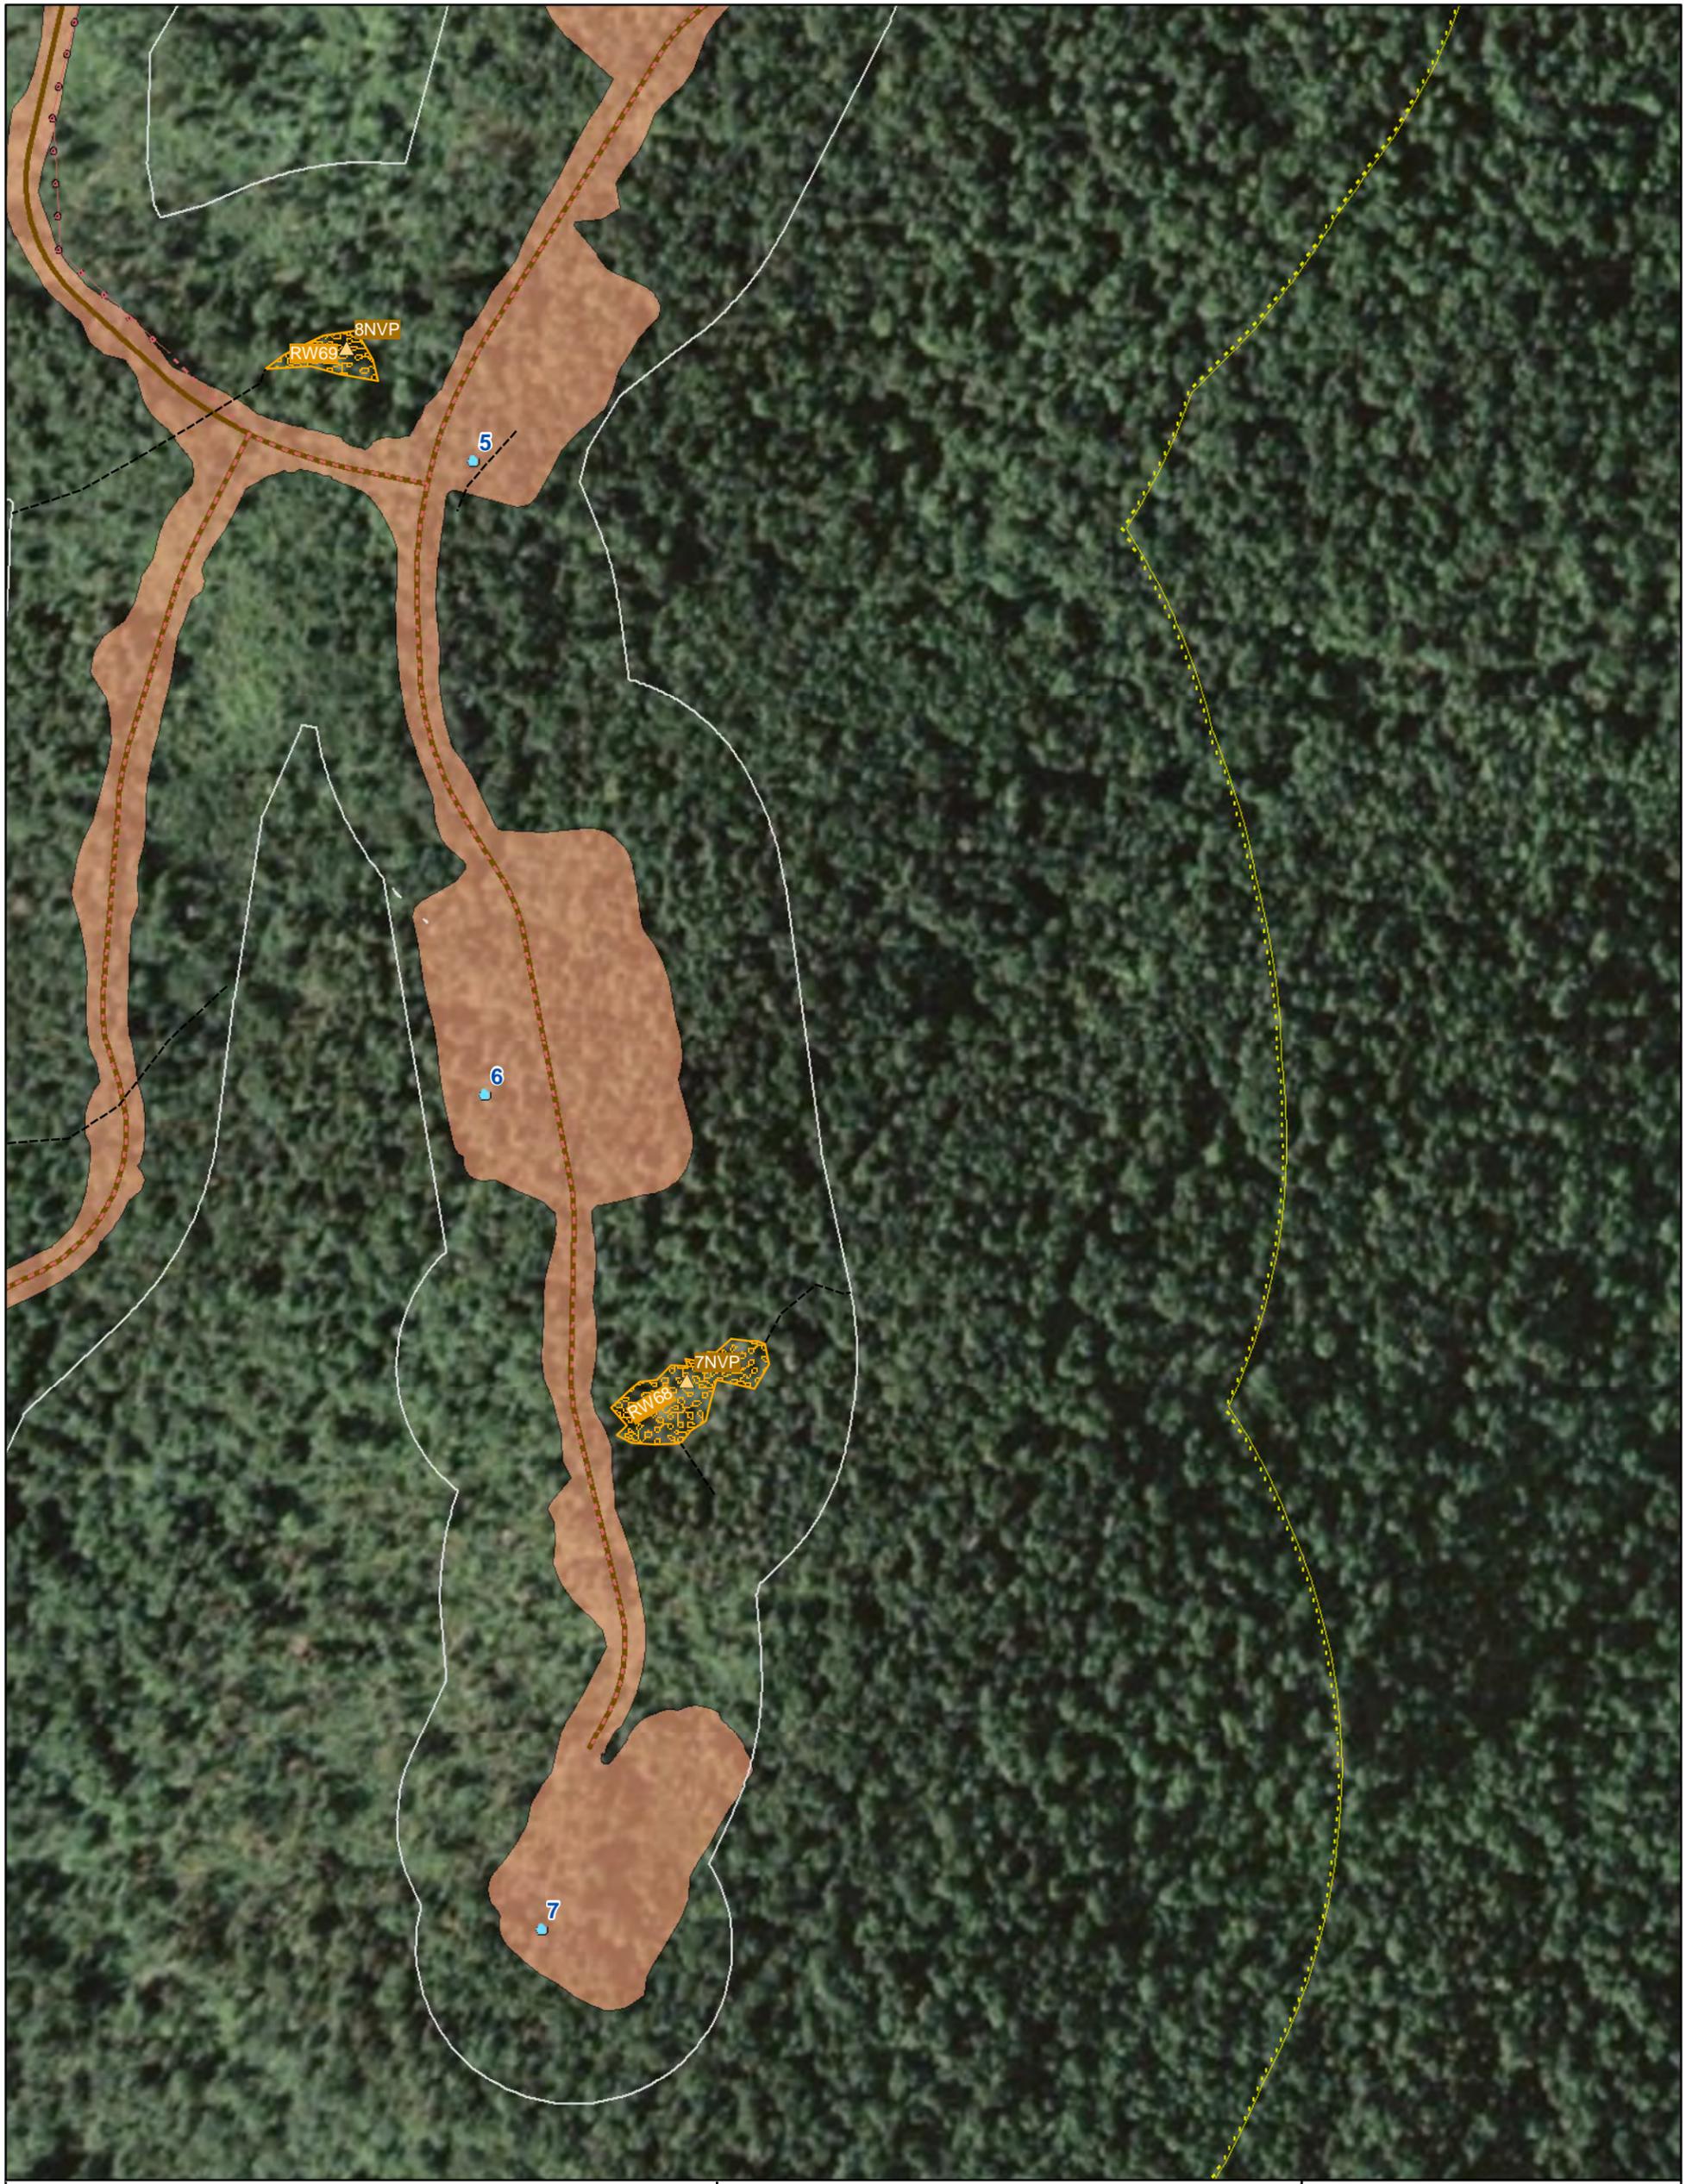
**MAP 07**

**Water Resources**
