RE: RFP# 201601017 - Stream Crossing Public Infrastructure Improvements
Coleman Pond Outlet/Slab City Road - Lincolnville, ME

Maine Department of Environmental Protection Request for Proposals for Stream Crossing Public Infrastructure Improvement Projects Proposal Application Form - 2016 RFP# 201601017

Restoration Plan Summary

Coleman Pond Outlet Brook Site #11982, Slab City Road, Lincolnville, Maine

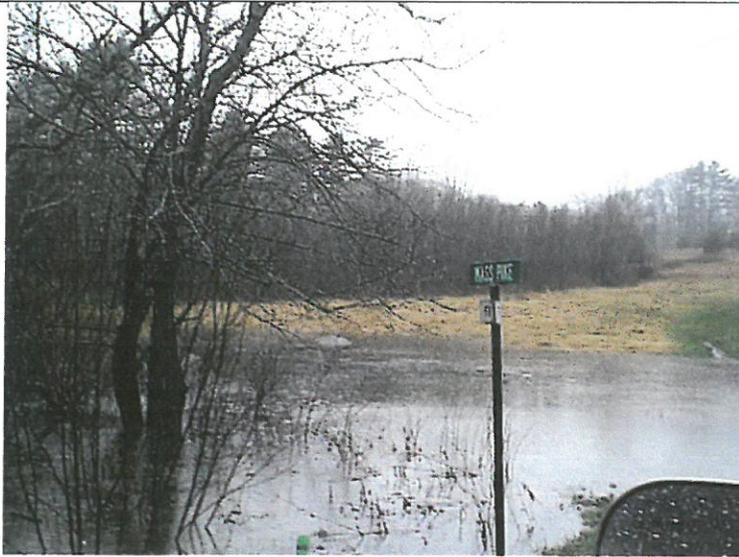
Mass Pike (flooded, April 2005)

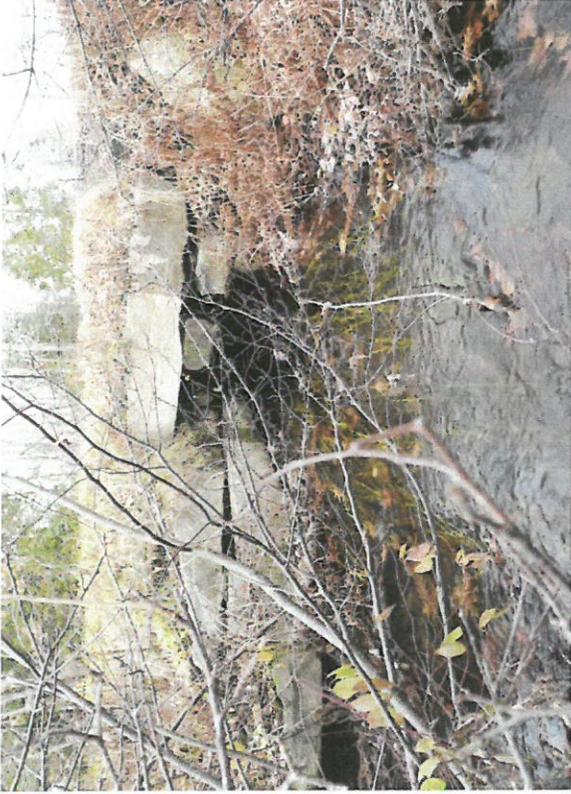
Inlet Photo

Crossing #11982 consists of one round 4' diameter corrugated metal culvert, providing insufficient capacity for the outlet stream of Coleman Pond, and presenting a barrier to aquatic organism passage. The stream has recently undergone restoration, with a new pool and weir fishway built in 2013 to provide access to alewife in particular, but which could be used by wild Eastern brook trout (resident or sea-run). At high flows, as when alewife migrate in spring to Coleman Pond, this crossing can present high velocities to returning fish. To restore the ability of this crossing to pass expected flood discharges while also improving aquatic organism passage, the crossing needs a substantially larger capacity structure. The new structure should have a natural bottom, be set at an appropriate stream bed elevation, and be sized to handle 100-year peak flows. An open-bottom structure of sufficient width will allow the stream bed to adjust naturally to accommodate movement of sediment and natural materials through the structure. An appropriate structure for the site is an open-bottom metal arch on concrete block footings. Removing this barrier to aquatic organism passage will better ensure alewife access to Coleman Pond, as well as to 0.17 miles of brook trout habitat.
