HOLTRACHEM MANUFACTURING  
 ORRINGTON, MAINE  
 SITE INVESTIGATION

WELL POINT LOCATIONS  
 LANDFILL #2

MDEP Site Inspection Figure 2.

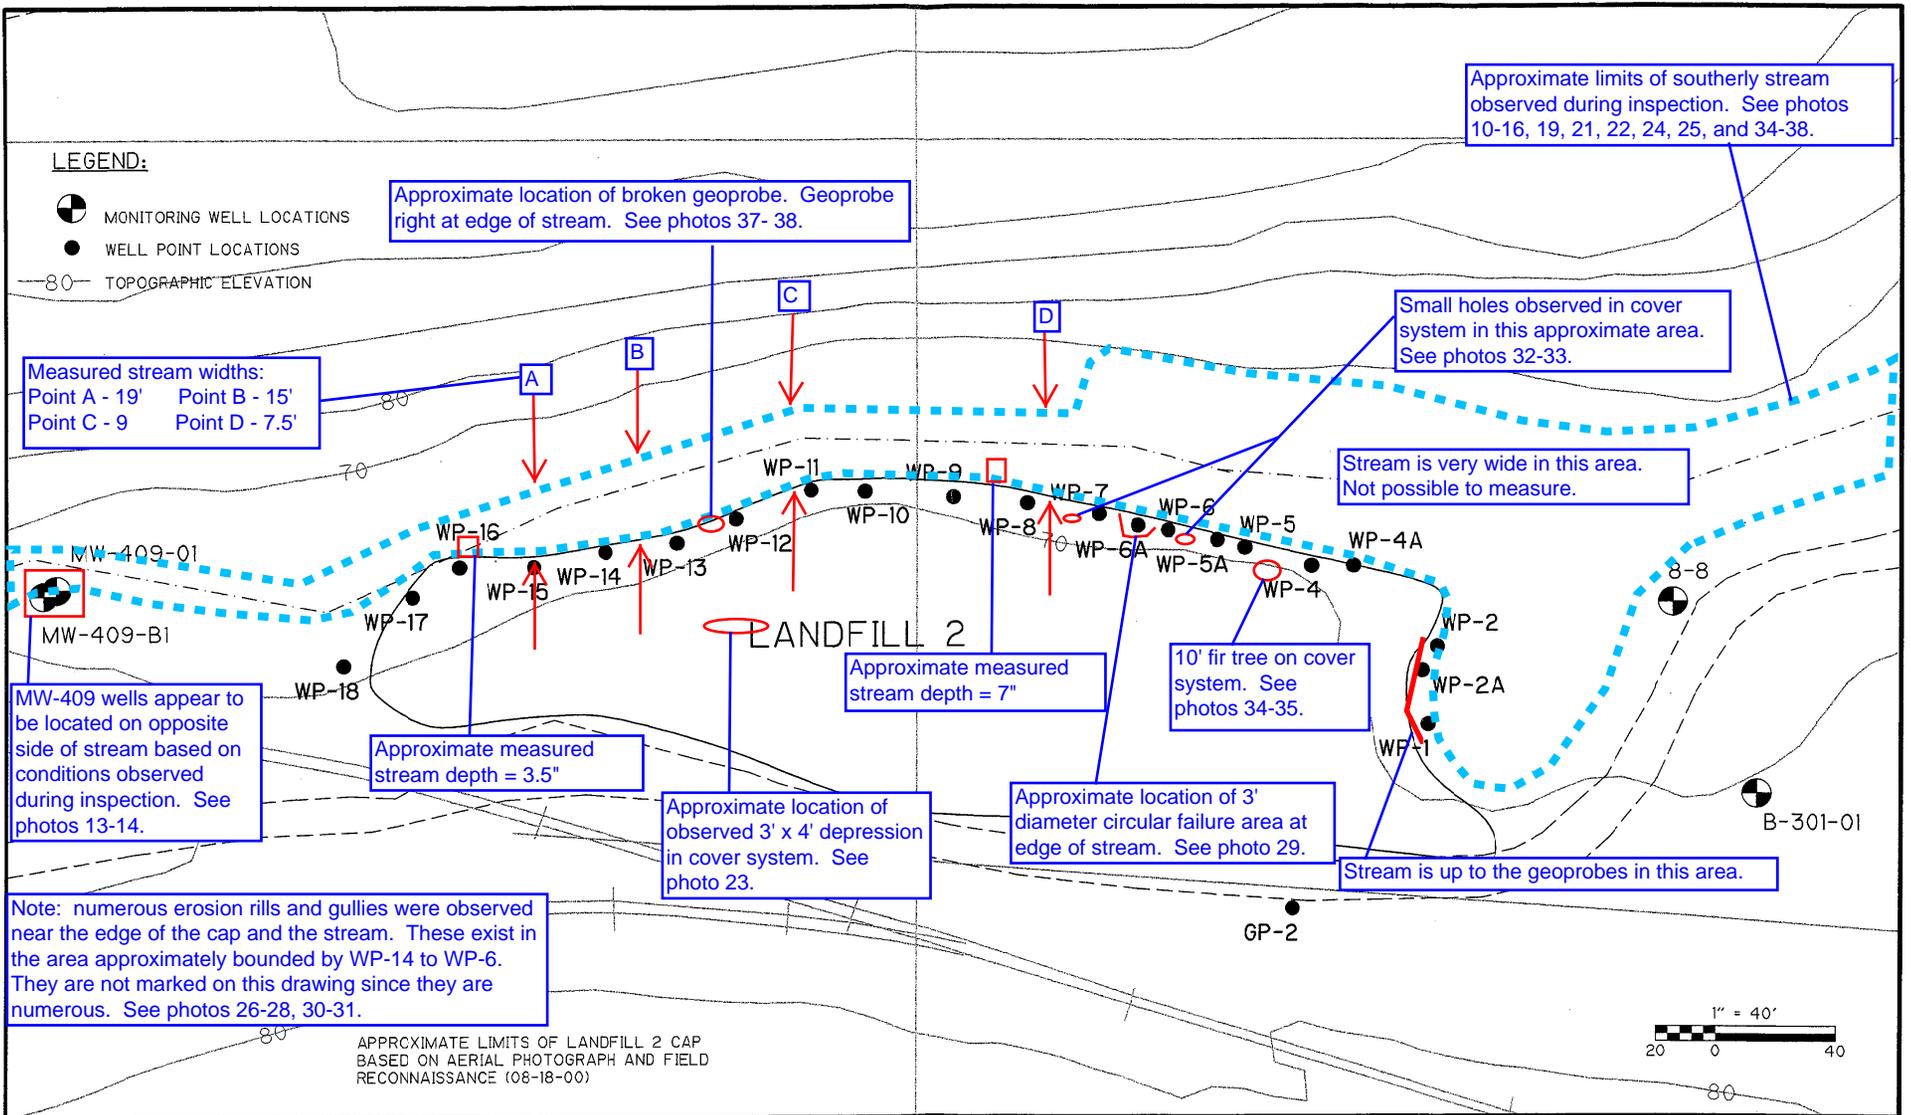
FIGURE 2

Approximate WP Location	Observed Distance from WP to Stream Edge
16	1'-5"
15	1'-5"
13/14	0'
9	2'-8"
8	1'-6"
2	0'
2A	0'
1	0'

Note: WP references are approximate since they are not field labeled and MDEP estimated locations in the field from this base map.

Notes recorded by David Burns (MDEP) during a Mallinckrodt Landfill 1-5 site inspection on 4/1/10. Accompanied by Fred Lavallee and Stacy Ladner (MDEP) as well as Dave Tonini (CDM). Basemap taken from Joint-017 for BEP Hearing. Photo references are to photos taken by D. Burns during the inspection.
