**IMPLEMENTATION OF A SEALED DOUBLE-RING
INFILTROMETER TO EVALUATE THE LONG-TERM
HYDRAULIC PERFORMANCE OF THE BARRIER SOIL
LAYER COMPONENT OF A COMPOSITE LANDFILL
COVER SYSTEM - NORRIDGEWOCK, MAINE**

Bureau of Remediation and Waste Management
Division of Technical Services
Solid Waste Engineering Unit

May 2005

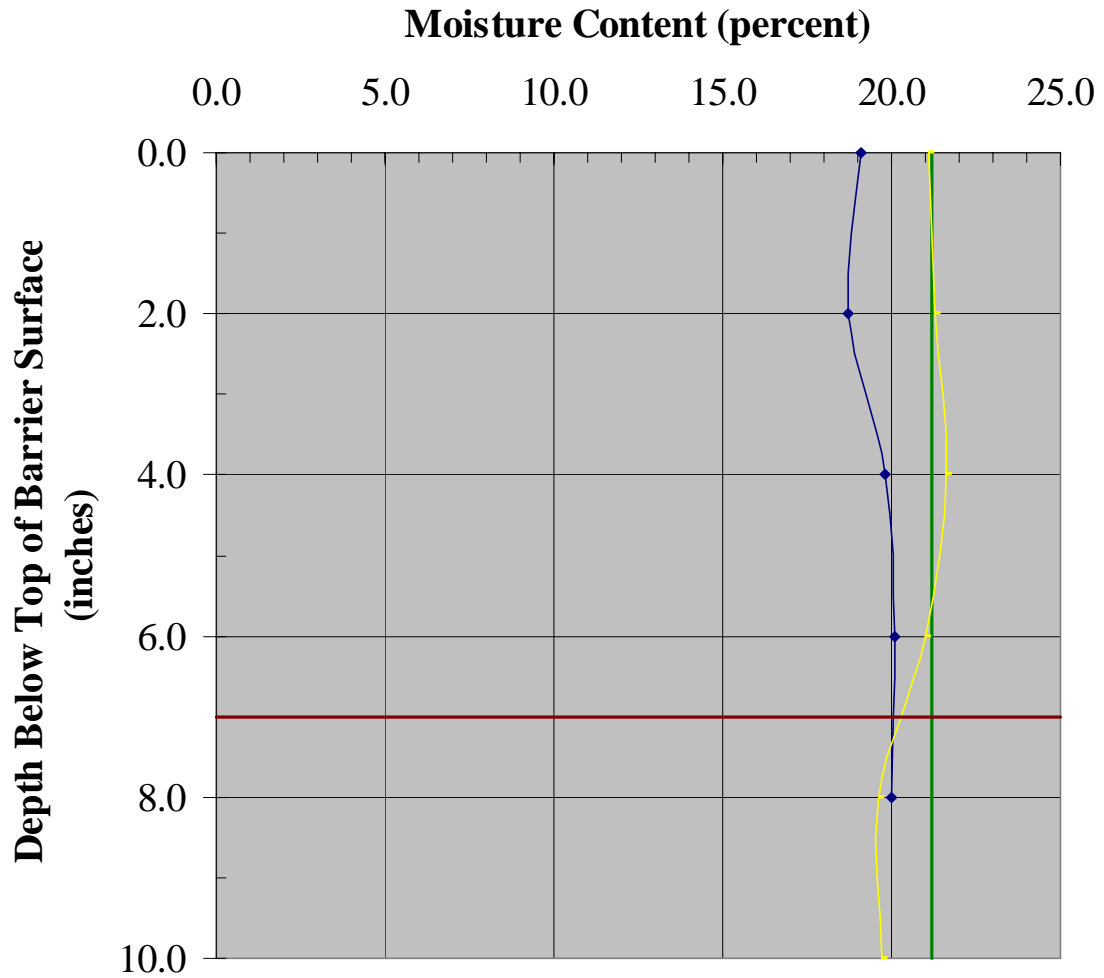
Figure 3
Water Content Distribution - WMDSM 02

Water content versus depth profiles at two inch intervals were evaluated before and after each of the SDRI tests (samples WM02A, WM06, WM03A, and WM05) to determine the depth of the wetting front. The depth of the wetting front is needed to determine the hydraulic gradient and, subsequently, calculate the hydraulic conductivity. Prior to the testing, the water content at WMDSM02 ranged from 18.7 to 20.1 percent with an average of 19.5 percent and the water content at WMDSM03 ranged from 20.6 to 23.4 percent with an average of 21.6 percent. The before and after profiles are presented graphically on Figures 3 and 4 and summarized in Table II.

◆ WMDSM 02 (Before Test - June 2003) — Average As-Placed Water Content (1993)
— WMDSM 02 (After Test - August 2003) — Depth to Wetting Front

The final calculated hydraulic conductivity for WMDSM02 was 4.9×10^{-6} cm/sec based on an estimated steady state infiltration rate of 1.3×10^{-5} cm/sec and an estimated gradient of 2.38. Two laboratory measurements conducted on a tube sample taken from within the area of the inner ring following its removal indicated hydraulic conductivities of 3.4×10^{-8} and 1.9×10^{-8} cm/sec respectively. The 1993 and 2003 hydraulic conductivity data are compared graphically with respect to depth on Figure 10. Figure 11 depicts the range of measurements over time. The water content of the barrier soil layer measured prior to the test (ten years following construction) averaged 19.5 percent.

Based on our observation of its condition and the water content profile taken before the test, it is readily apparent that the barrier soil layer at WMDSM02 maintained its moisture properties over the ten year period following its installation. The average moisture content from the water content profile of 19.5 percent is essentially the same as the average of 19.9 percent reported at the time of construction (the measured moisture content in the vicinity of the SDRI set-up averaged 21.2 percent).

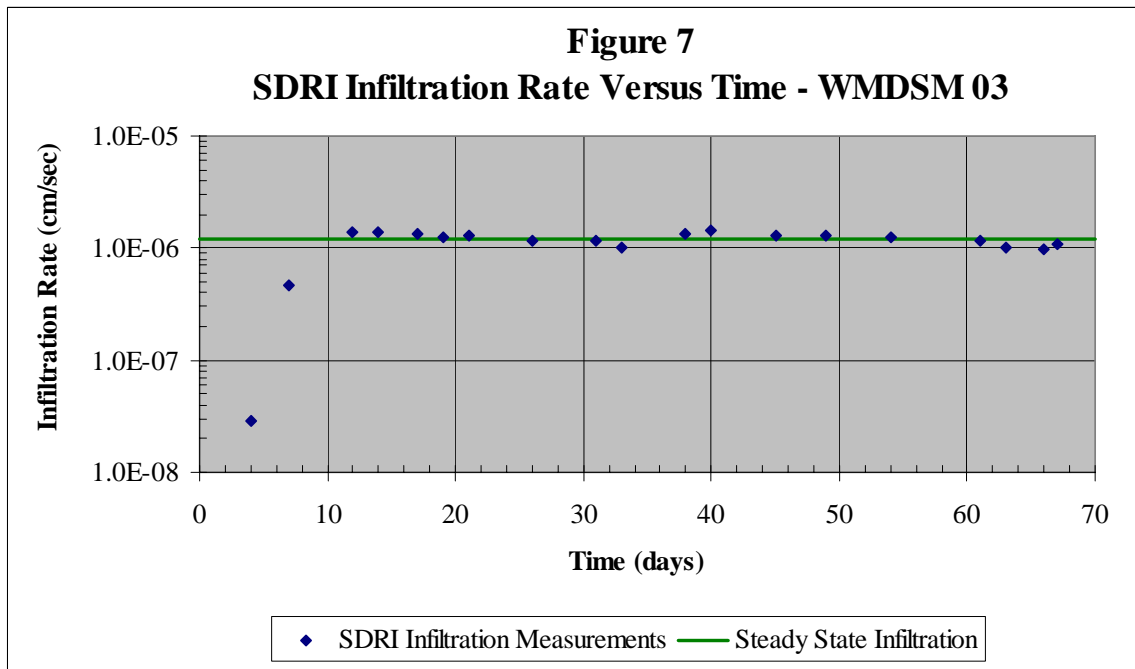
The SDRIs were installed during the period from June 2 through June 5, 2003 by Technical Services personnel with assistance from HES. Both tests were run for 67 days from June 6 through August 12, 2003. A total of 14 measurements were taken from WMDSM02 and 19 measurements from WMDSM03. The resulting infiltration rates were found to be 1.3×10^{-5} cm/sec at WMDSM02 and 1.2×10^{-6} cm/sec at WMDSM03. After interpreting the water content profiles, hydraulic conductivity values of 4.9×10^{-6} and 4.2×10^{-7} cm/sec respectively were calculated. The data is presented graphically on Figures 6 and 7 and summarized in Table V.

Readings continue until the infiltration rate reaches a steady state. Data taken for the individual readings at WMDSM02 and WMDSM03 are included in Appendix D. The infiltration rates are graphically presented on Figures 6 and 7. It is noteworthy that, as can be seen on Figure 6, there is significant scatter in the data for WMDSM 02 indicating instabilities in the system.

A total of 14 successful readings were recorded between June 20 and August 12. A steady state infiltration rate of 1.3×10^{-5} cm/sec was estimated. Due to scatter in the data a steady state infiltration rate could only be approximated.

The third reading was recorded on June 18 and showed a loss of 16.72 pounds over a period of just over five days, converting to an infiltration rate of about 1.2×10^{-6} cm/sec. From there the infiltration rate remained steady for 17 readings over the next 55 days. A steady state infiltration rate is clearly discernable on Figure 7. The last reading was taken on August 12.

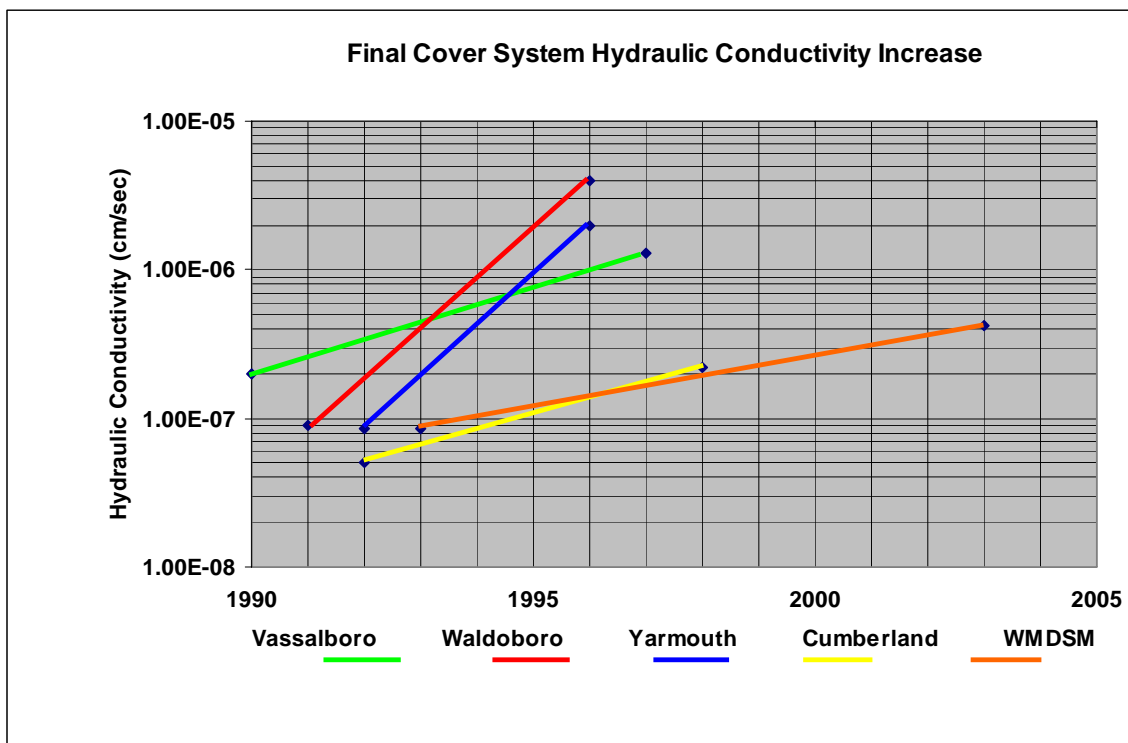
Figure 14a graphically depicts the measured change in hydraulic conductivity over time for each of the five barrier soil layers studied using the SDRI since 1993. Visually, the WMDSM barrier soil layer (represented by the orange line), overlain by a geomembrane, has undergone the least amount of hydraulic degradation, if any appreciable degradation has in fact occurred. As discussed previously there is no as-built hydraulic conductivity data from the vicinity of the SDRI set-up due to the test pad approach used to guide construction of the barrier soil layer. The SDRI derived hydraulic conductivity falls within the range of values measured within the test pad in 1993 and may in fact reflect as-placed conditions at the test site. It should be noted that the SDRI data from WMDSM depicted on Figure 14a is limited to that collected at WMDSM03.

The other four barrier soil layers were not overlain by a geomembrane. SDRI tests at Waldoboro and Yarmouth (red and blue lines respectively) revealed very similar trends of significant hydraulic degradation. Vassalboro (green line) also showed significant degradation, although not to the extent of Waldoboro and Yarmouth. The barrier soil layer at Vassalboro was constructed of a glacial till material which, by its nature, is not subject to the same degree of moisture loss and cohesive desiccation as the silty clay materials used at the other sites^{1,2,9,10}.

The findings from the Cumberland site (yellow line) would appear to contradict a conclusion that an overlying geomembrane is required to maintain the barrier soil layer moisture. In reviewing the data⁶ from the 1998 SDRI test, however, it is noted that it took in excess of 60 days to achieve a steady state infiltration rate indicating that the hydraulic performance may have been controlled by the lower silty clay strata (the upper soils may have been degraded). Conversely, the 2003 WMDSM SDRI reached steady state in less than twelve days indicating a consistent condition throughout the profile. As discussed in a previous report¹, we believe that, with time, degradation will progress through the entire profile of the Cumberland barrier soil layer resulting in a hydraulic performance similar to what was measured at Waldoboro and Yarmouth.
