Maine Statewide Bacteria TMDL: APPENDIX I Freshwaters

August 2009
Report #: DEPLW-1003

Freshwater Rivers & Streams

FB Environmental Associates, Inc.

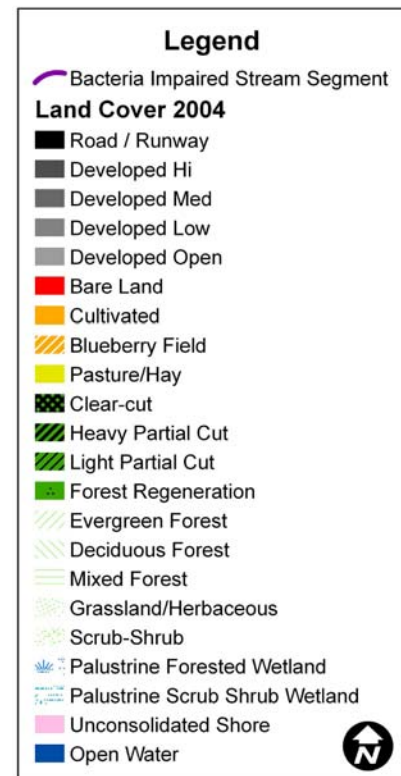
Land Cover in Nasons Brook Watershed

Figure 13: Nasons Brook watershed land cover map and statistics

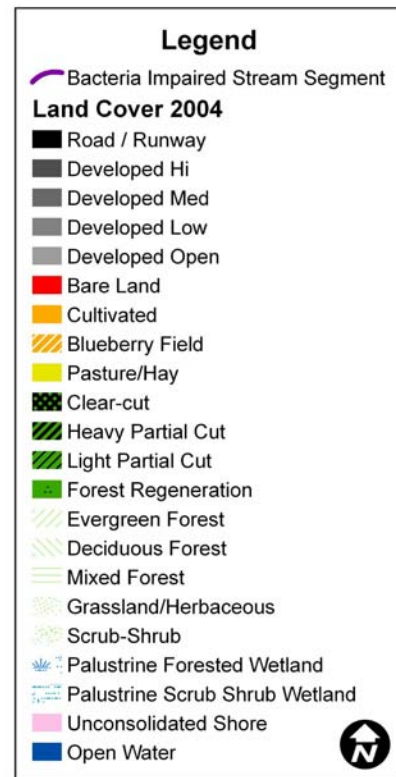
Land Cover in Unnamed Brook Camden Watershed

Figure 29: Unnamed Brook in Camden watershed land cover map and statistics.

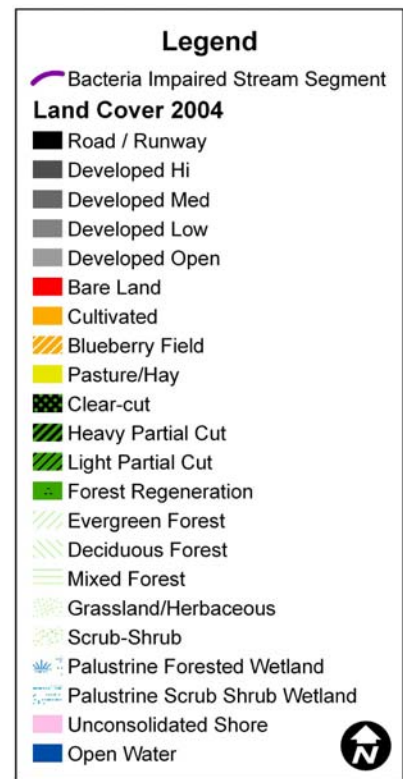
Land Cover in Thatcher Brook Watershed

Figure 89: Thatcher Brook watershed land cover map and statistics.
