**FINAL GEOTECHNICAL DESIGN REPORT
KENNEBUNK BRIDGE
MAINE DOT PIN 15098.00
KENNEBUNK, MAINE**

August 2010
File No. 09.0025597.10

Re: Final Geotechnical Design Report
Kennebunk Bridge Replacement
Kennebunk, Maine

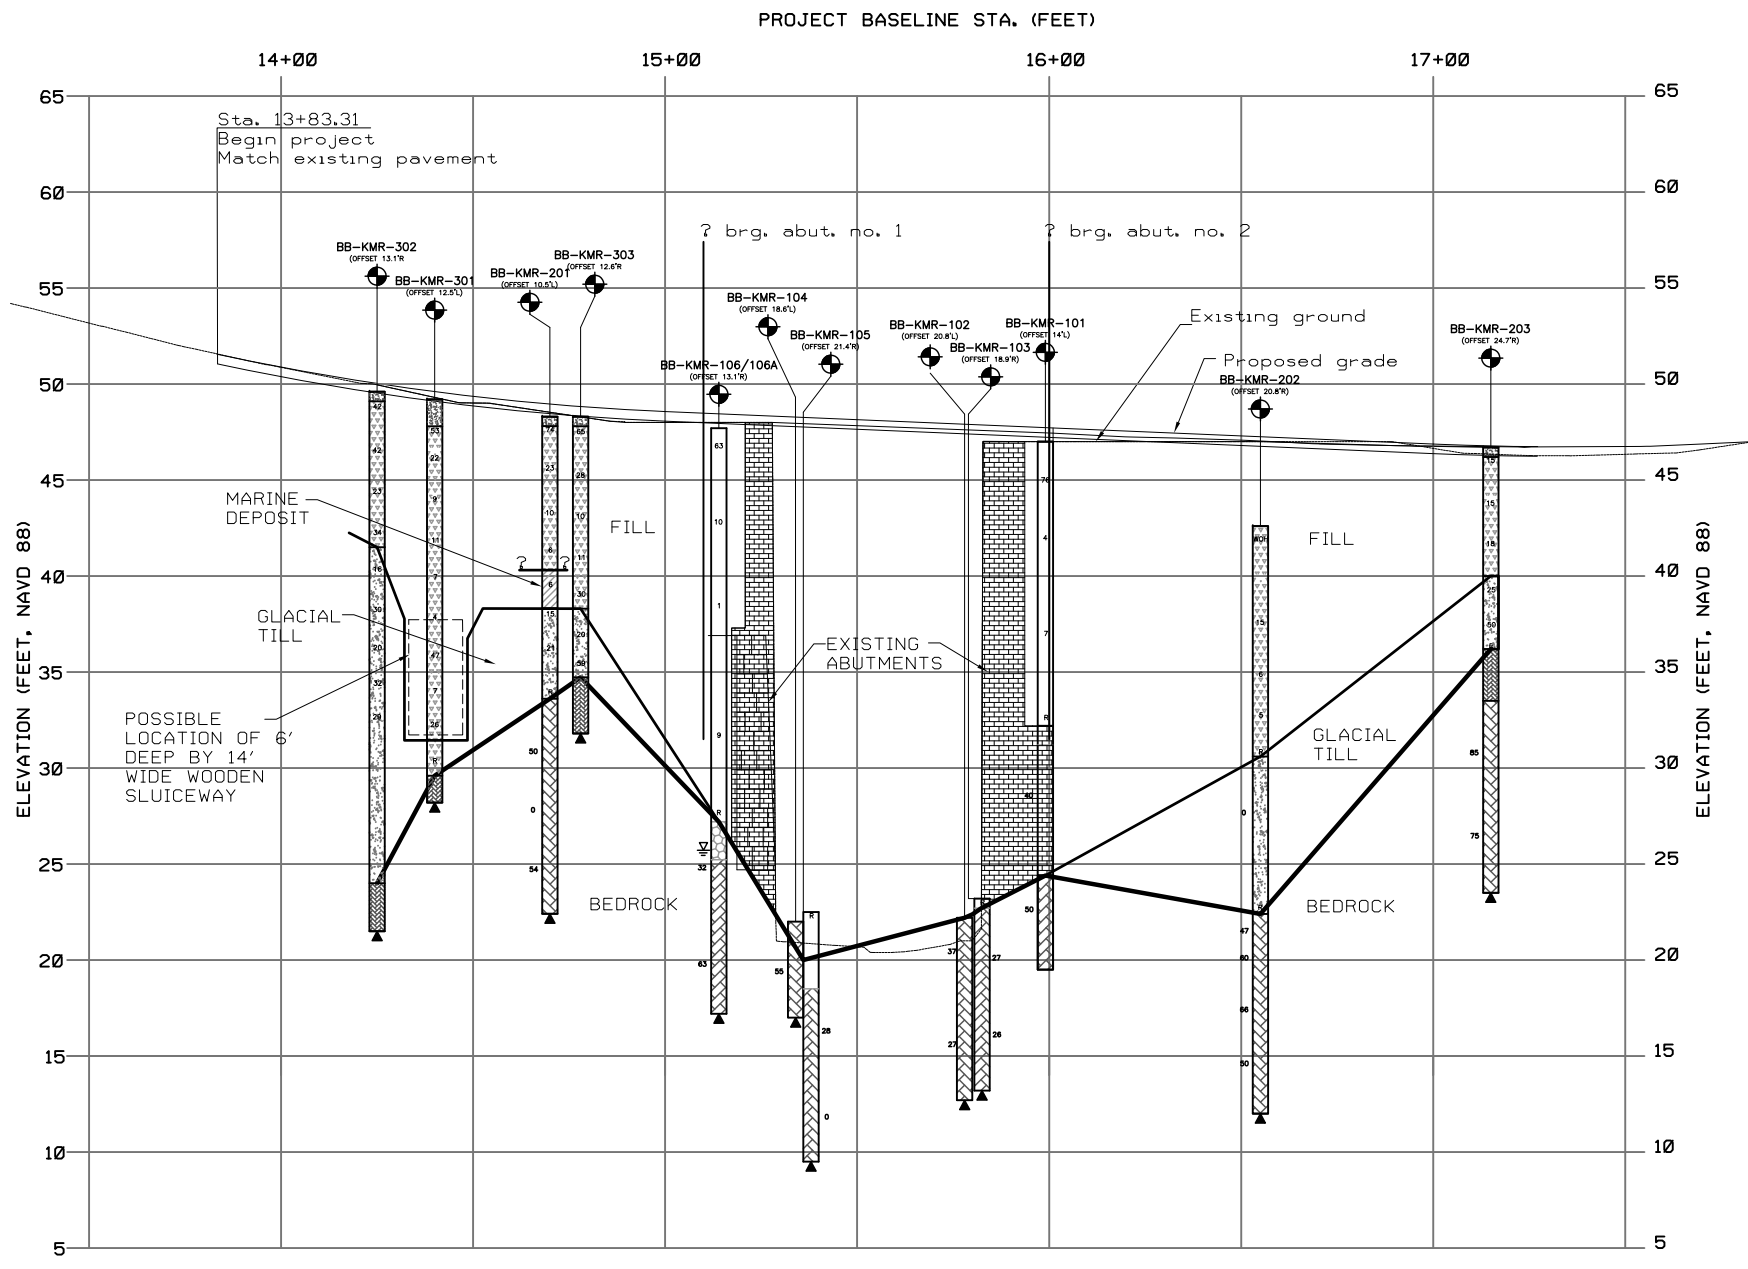
1) THIS GENERALIZED INTERPRETIVE SOIL PROFILE IS INTENDED TO CONVEY TRENDS IN SUBSURFACE CONDITIONS. THE BOUNDARIES BETWEEN STRATA ARE APPROXIMATE AND IDEALIZED, AND HAVE BEEN DEVELOPED BY INTERPRETATIONS OF WIDELY SPACED EXPLORATIONS AND SAMPLES. ACTUAL SOIL TRANSACTIONS MAY VARY AND ARE PROBABLY MORE ERRATIC. FOR MORE SPECIFIC INFORMATION REFER TO THE EXPLORATION LOGS.

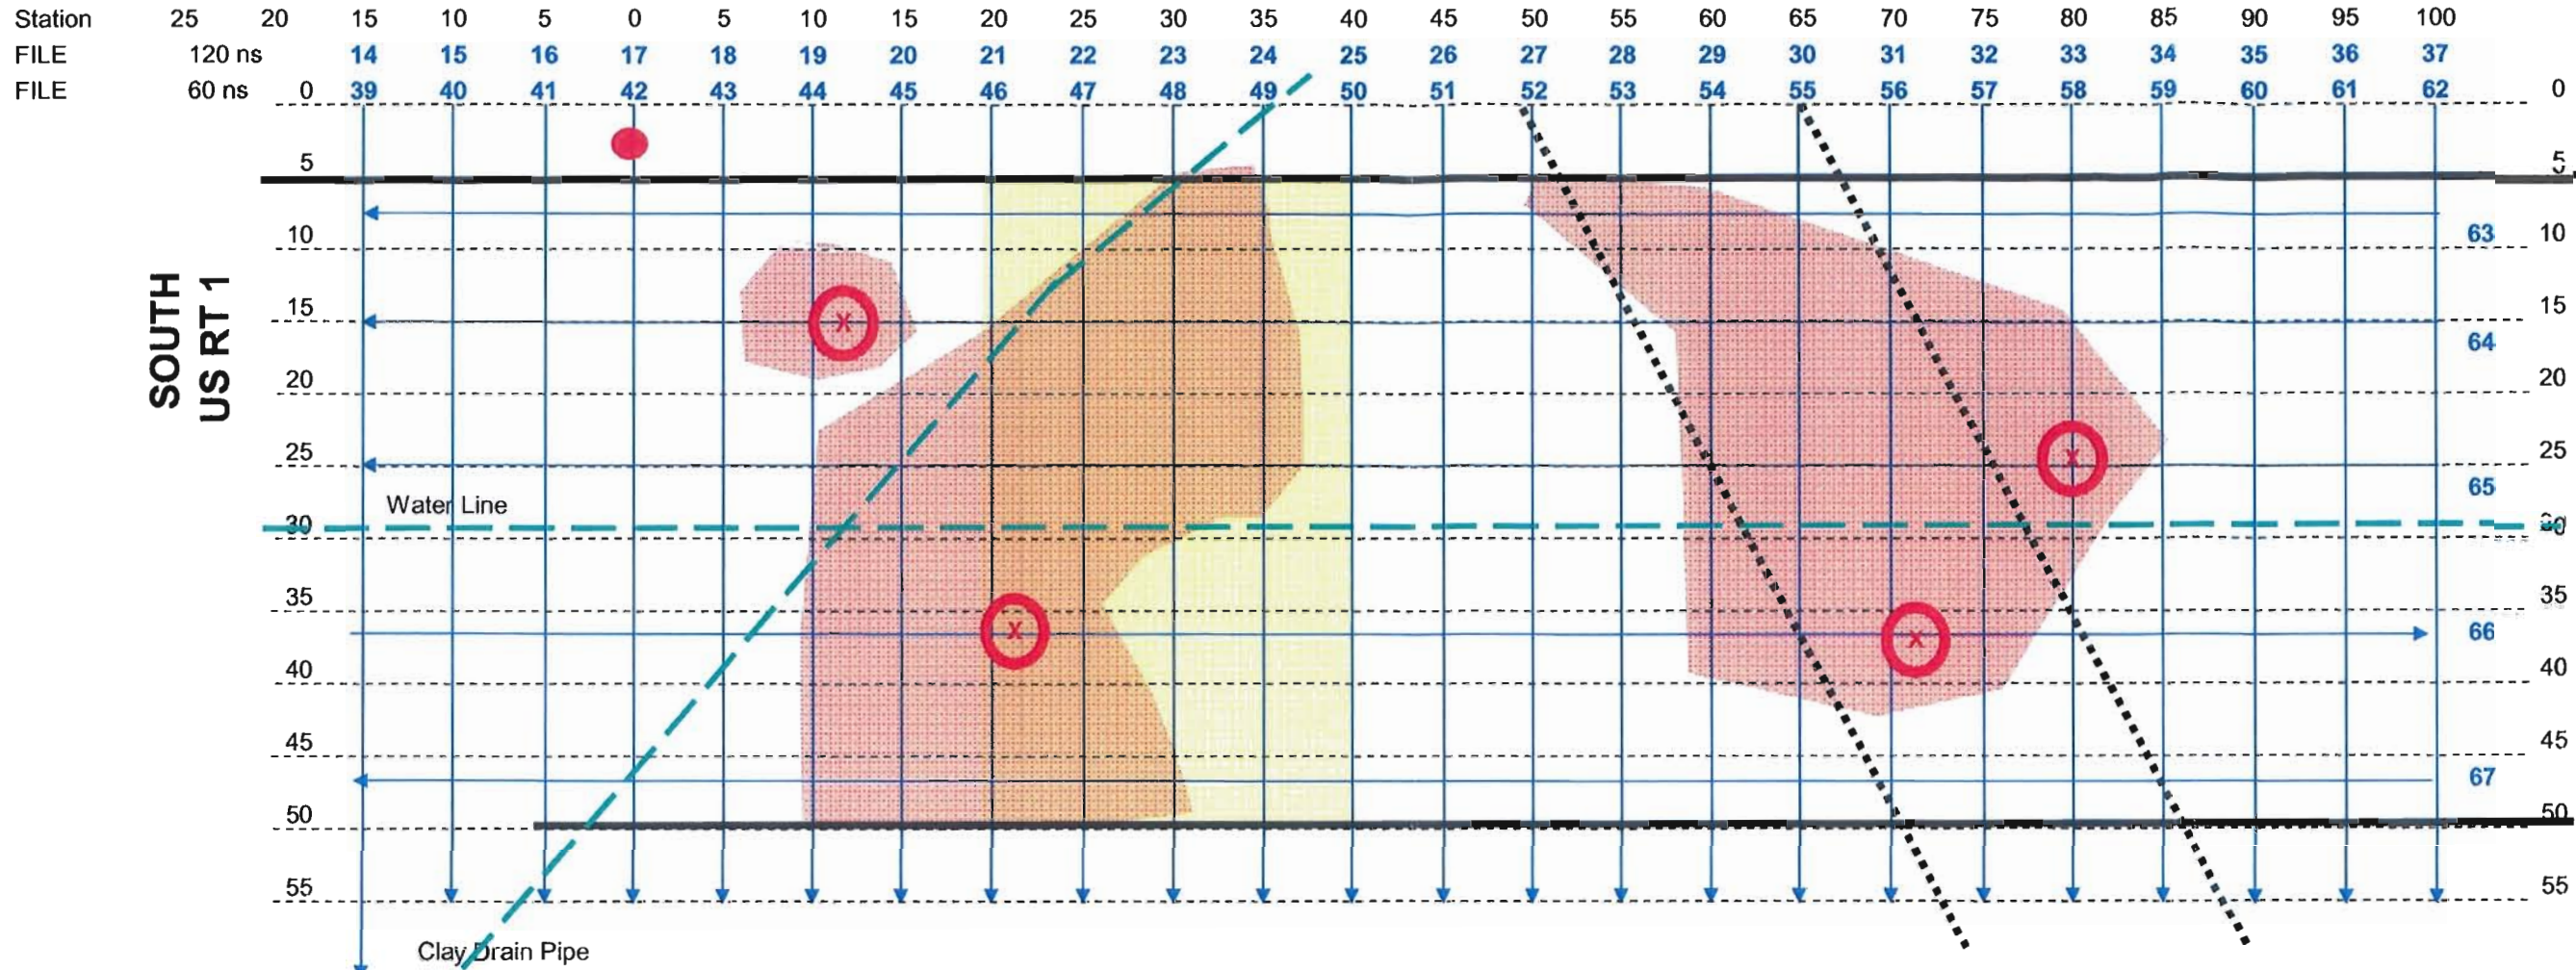
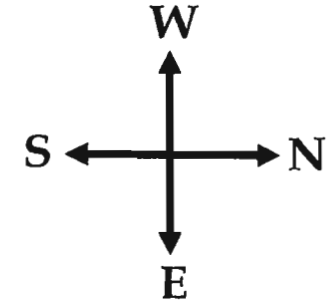
GPR SINKHOLE INVESTIGATION US RT 1 KENNEBUNK, MAINE FOR KENNEBUNK PUBLIC WORKS By NDT CORPORATION		INTERPRETATION OF GPR RESULTS	
		Oct. 2004	Figure 3

- Fire Hydrant
- Asphalt Patch
- Approximate Location of Water line and clay drain pipe
- X Recommended Areas for Split Spoon Probing
- Possible Location of Buried Sluiceway
- GPR Data indicative of Settlement or Filled Sinkhole

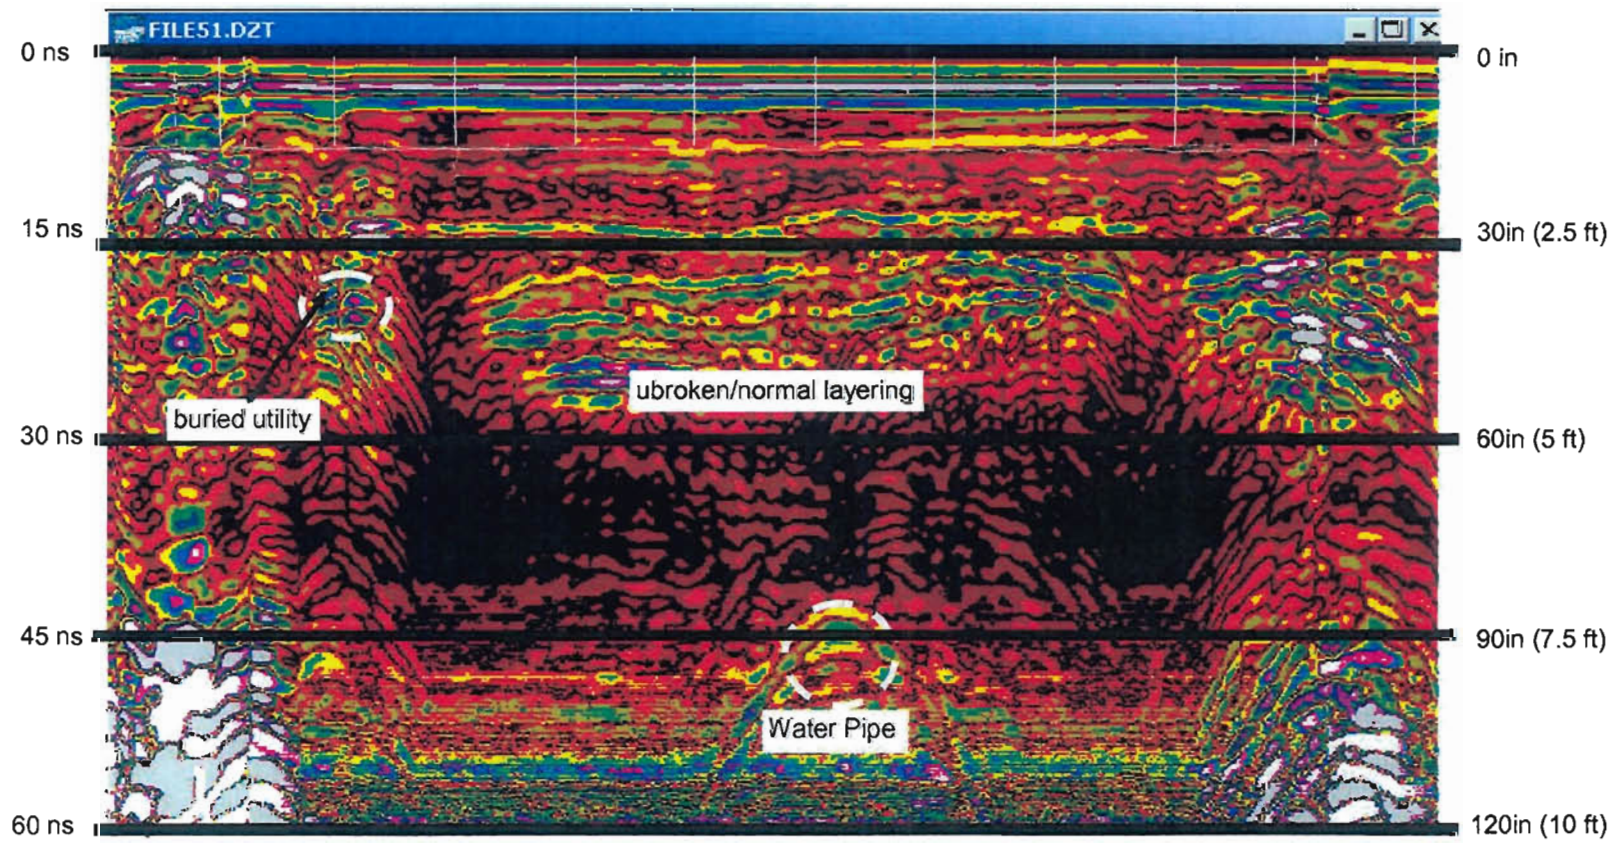
GPR SINKHOLE INVESTIGATION US RT 1 KENNEBUNK, MAINE FOR KENNEBUNK PUBLIC WORKS By NDT CORPORATION		ANNOTATED GPR RECORDS	
		Oct. 2004	Figure 4

**File 58 West to East Cross Line
80 Feet North of Hydrant**

**File 51 West to East Cross Line
45 Feet North of Hydrant**

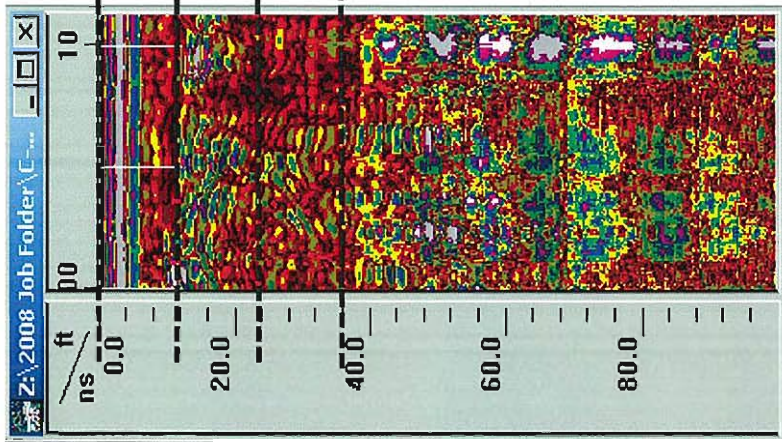
WING WALL RECORD

36 NANOSECONDS
 APPROXIMATELY 6 +/- FEET
 3 TIERS OF 2 +/- FT BLOCKS

Figure 3 is a compilation of the wall, abutment and street GPR results. Figure 4 has an annotated wall and abutment GPR record.

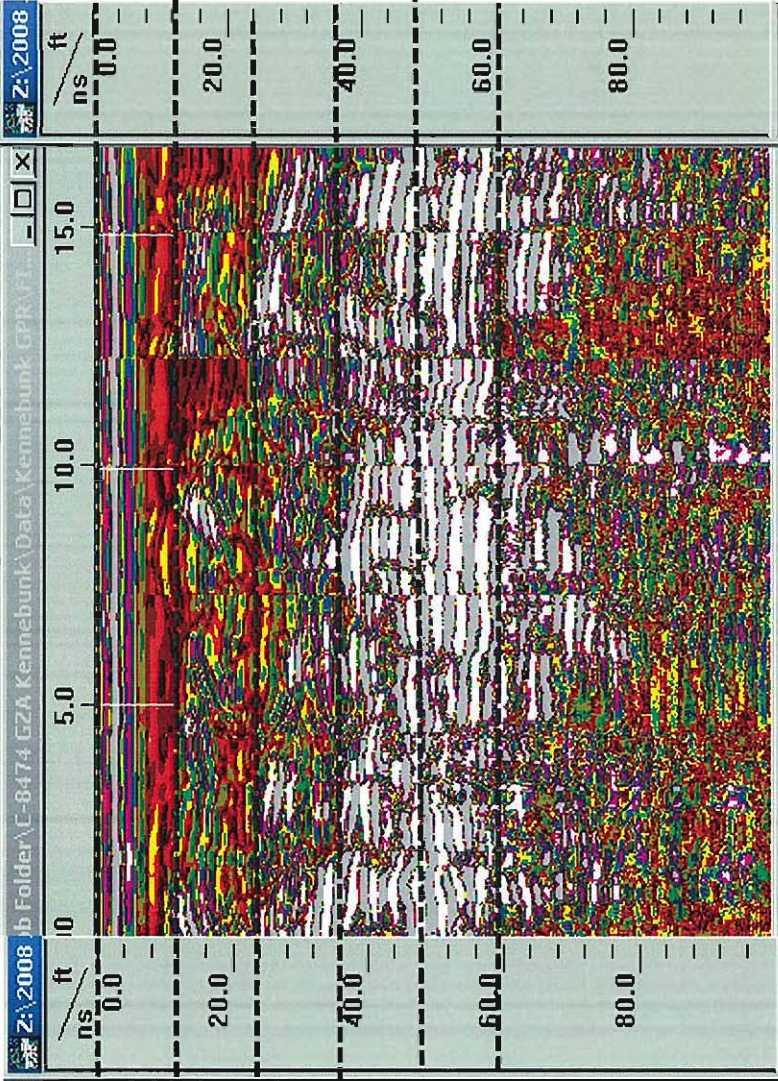
ABUTMENT FACE RECORD

48-60 NANOSECONDS
 APPROXIMATELY 8-10 +/- FEET
 4-5 TIERS OF 2 +/- FT BLOCKS

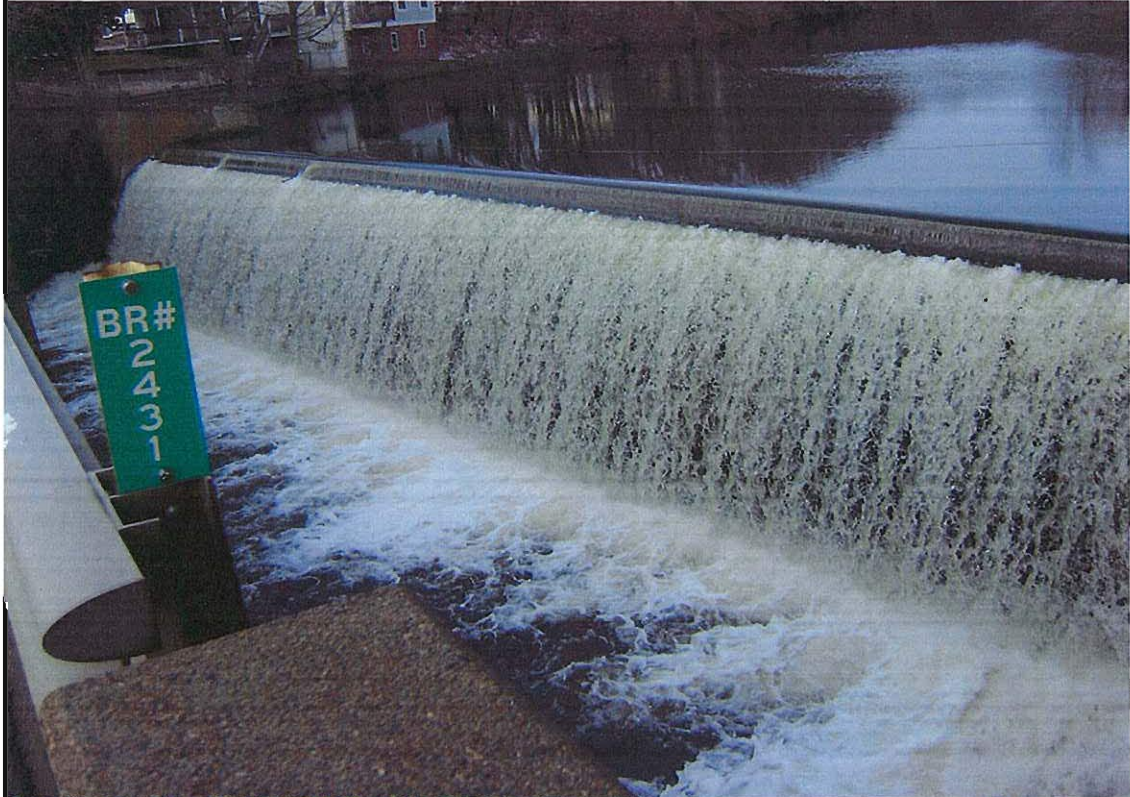
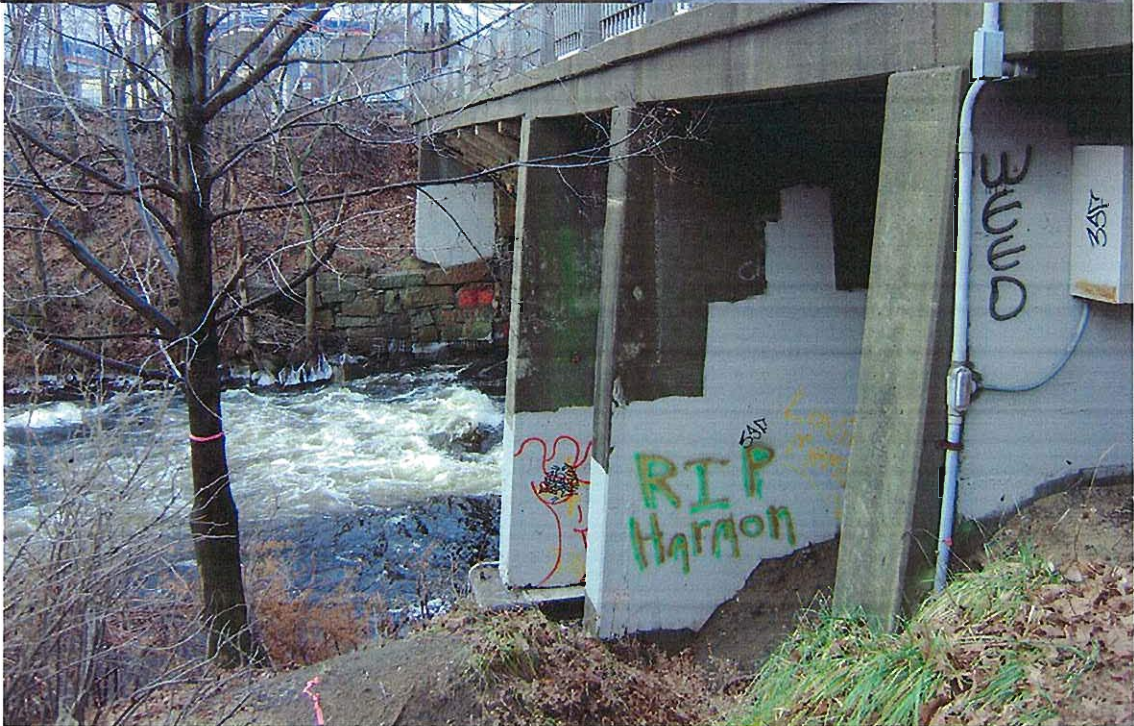
Photos

GROUND PENETRATING RADAR
US RT 1 MASONRY BRIDGE
OVER THE MOUSAM RIVER
Prepared for
GZA GEOENVIRONMENTAL, INC
KENNEBUNK, MAINE
by
NDT Corporation

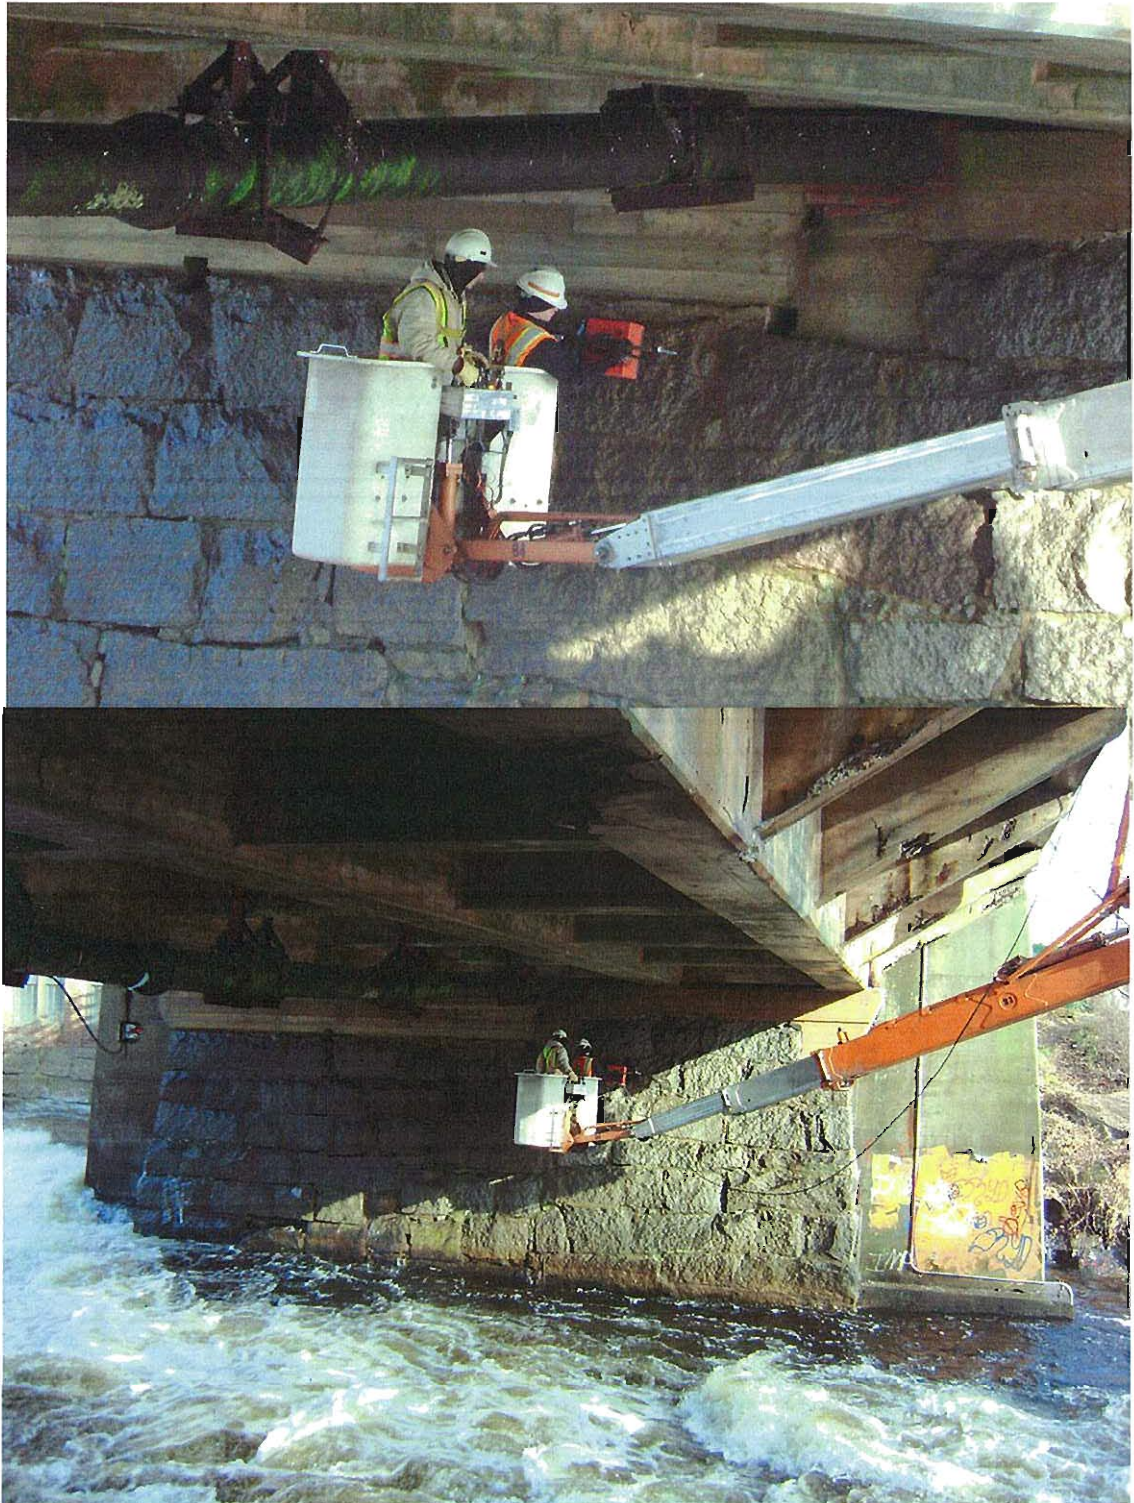
Photos

GROUND PENETRATING RADAR
US RT 1 MASONRY BRIDGE
OVER THE MOUSAM RIVER
Prepared for
GZA GEOENVIRONMENTAL, INC
KENNEBUNK, MAINE
by
NDT Corporation

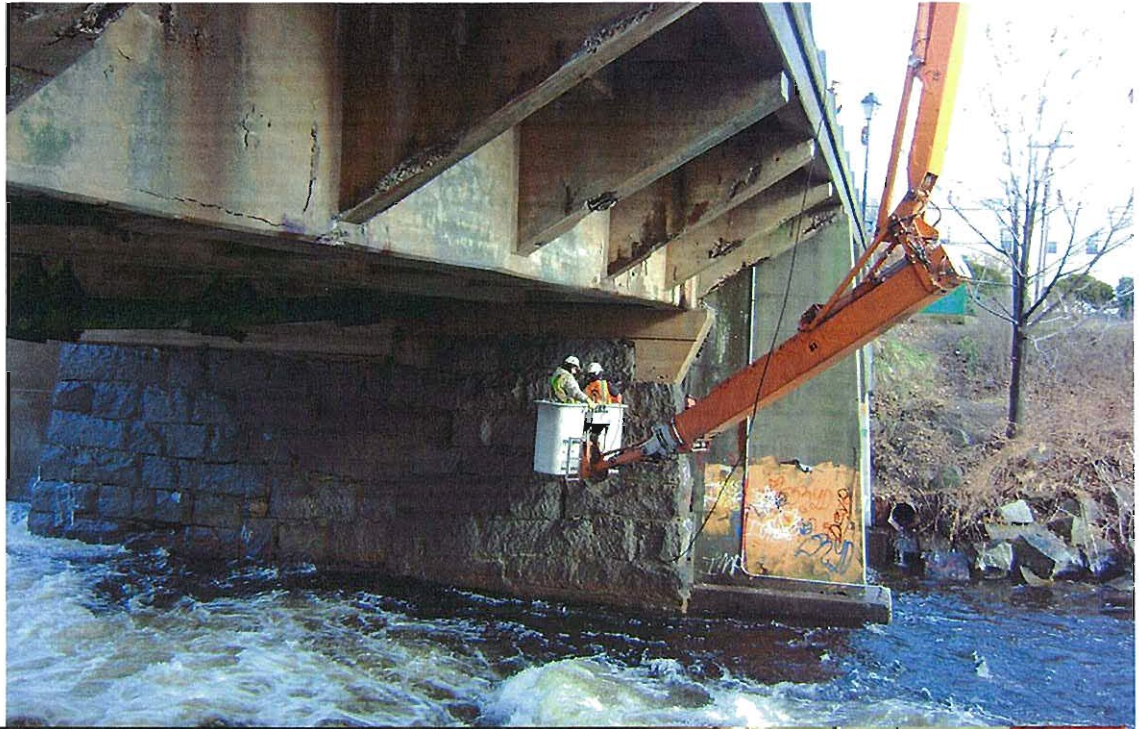
Photos

GROUND PENETRATING RADAR
US RT 1 MASONRY BRIDGE
OVER THE MOUSAM RIVER
Prepared for
GZA GEOENVIRONMENTAL, INC
KENNEBUNK, MAINE
by
NDT Corporation

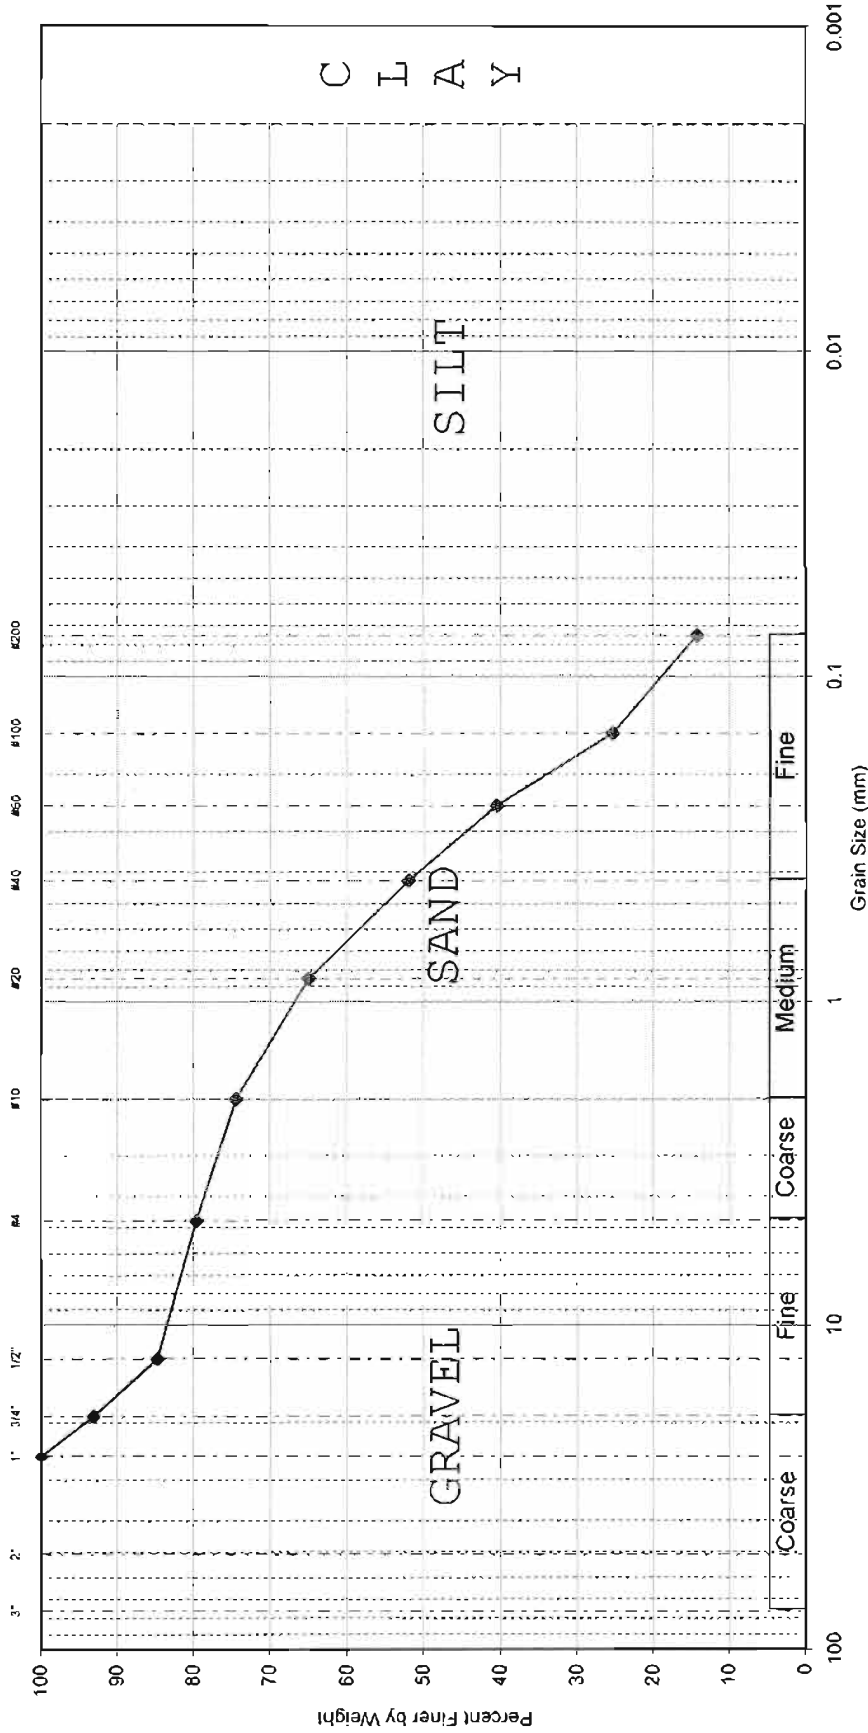
Gravel 20.4% Sand 65.4% Fines 14.2%

Lab #	Exploration	Sample	Depth (ft)	Description	WC	LL	PL	PI
4	BB-KMR-106A	4D	15-17'	Brown Silty Sand with Gravel (SM)	16.5

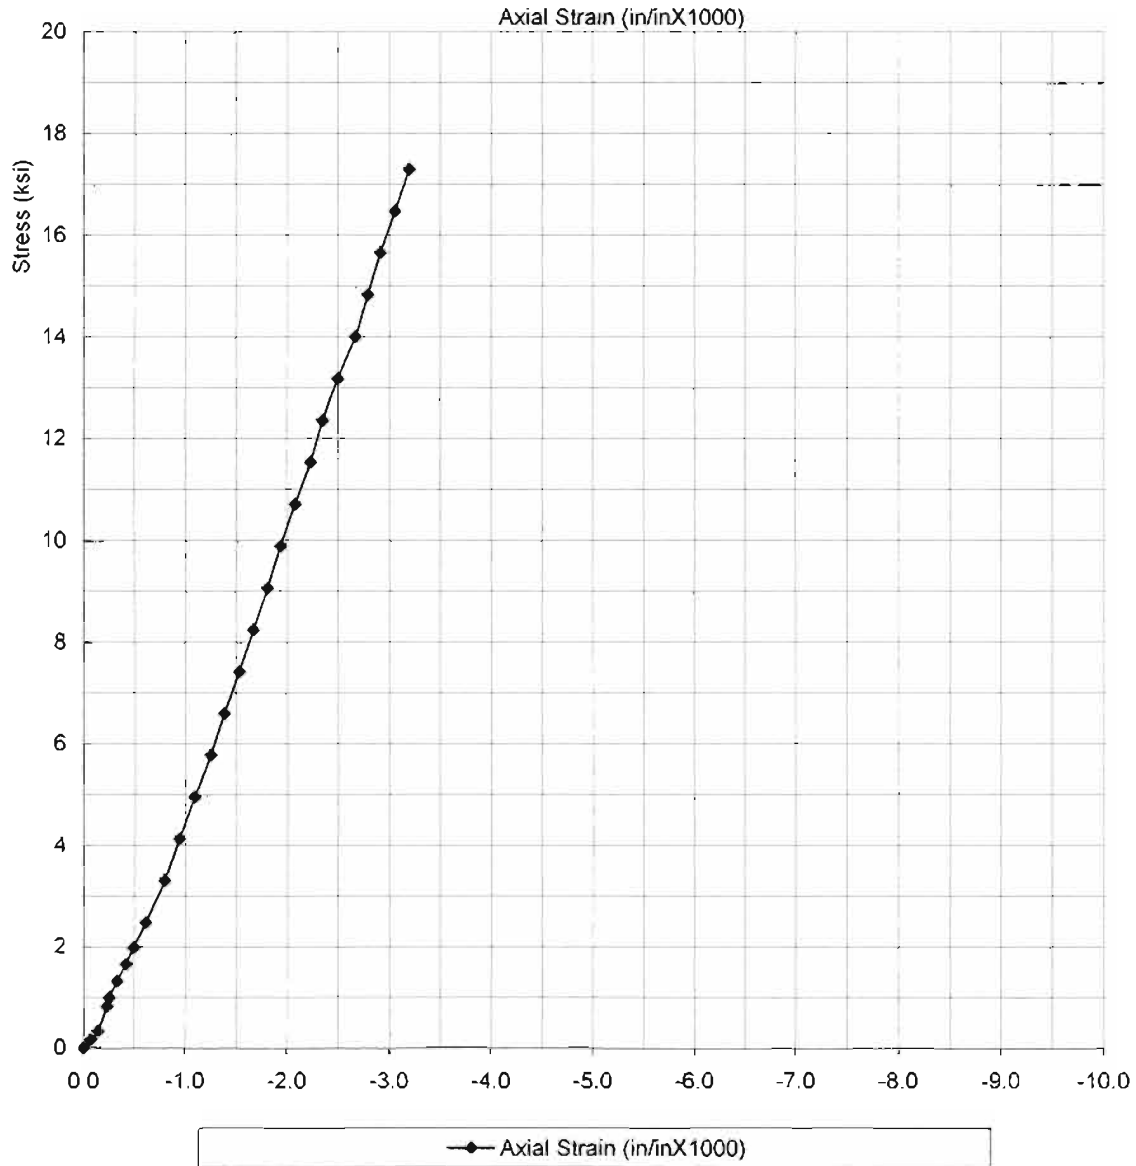
Boring No. BB-KMR-103
Sample No. R1
Depth: 25.5-25.9'

Rock Testing

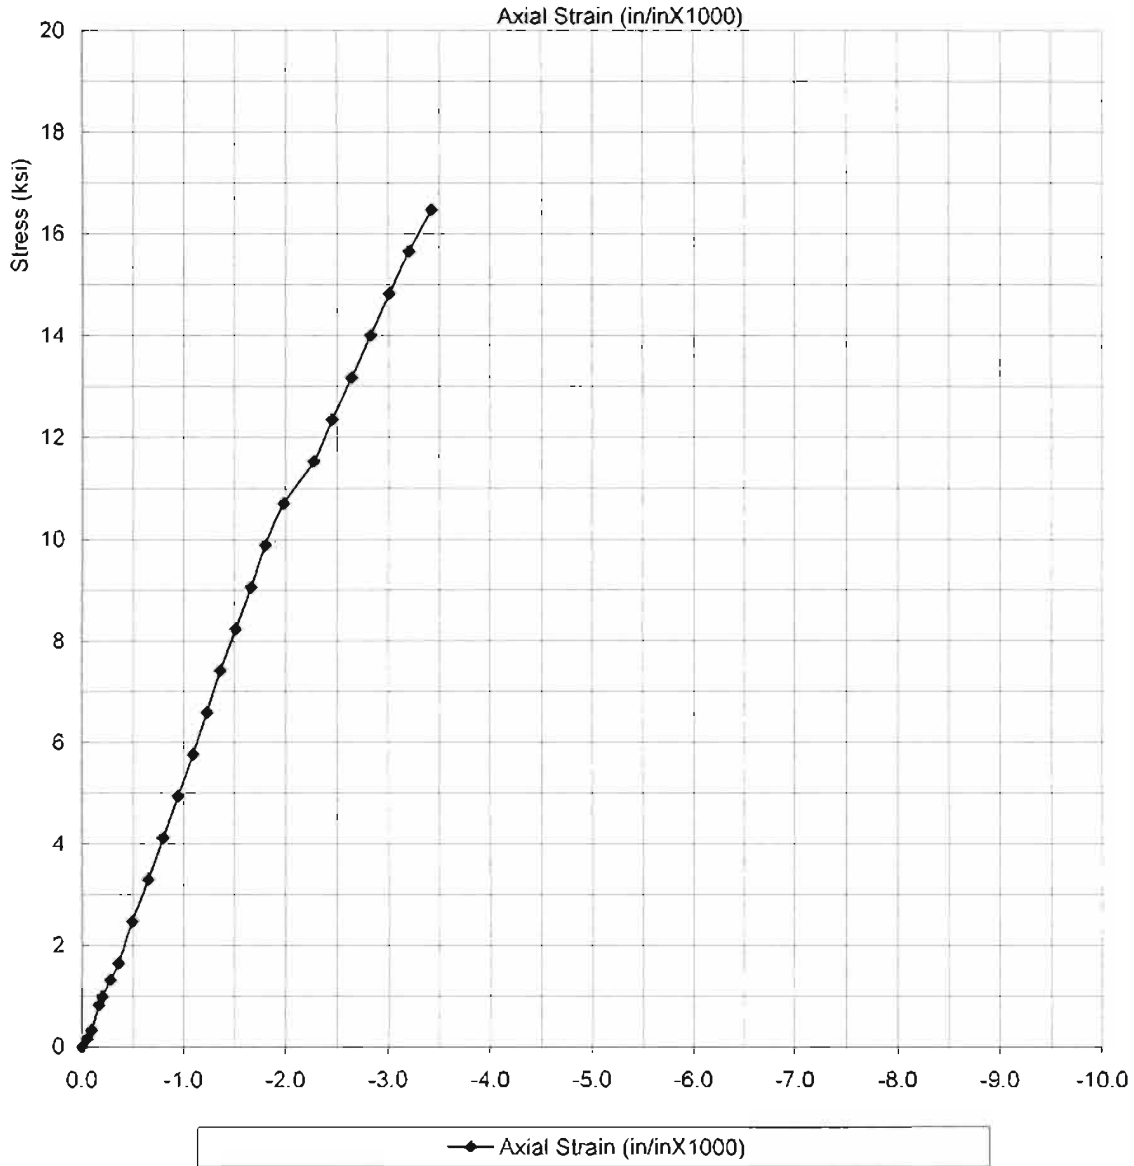
Boring No. BB-KMR-102
Sample No. R1
Depth: 29.9-30.3'

Rock Testing

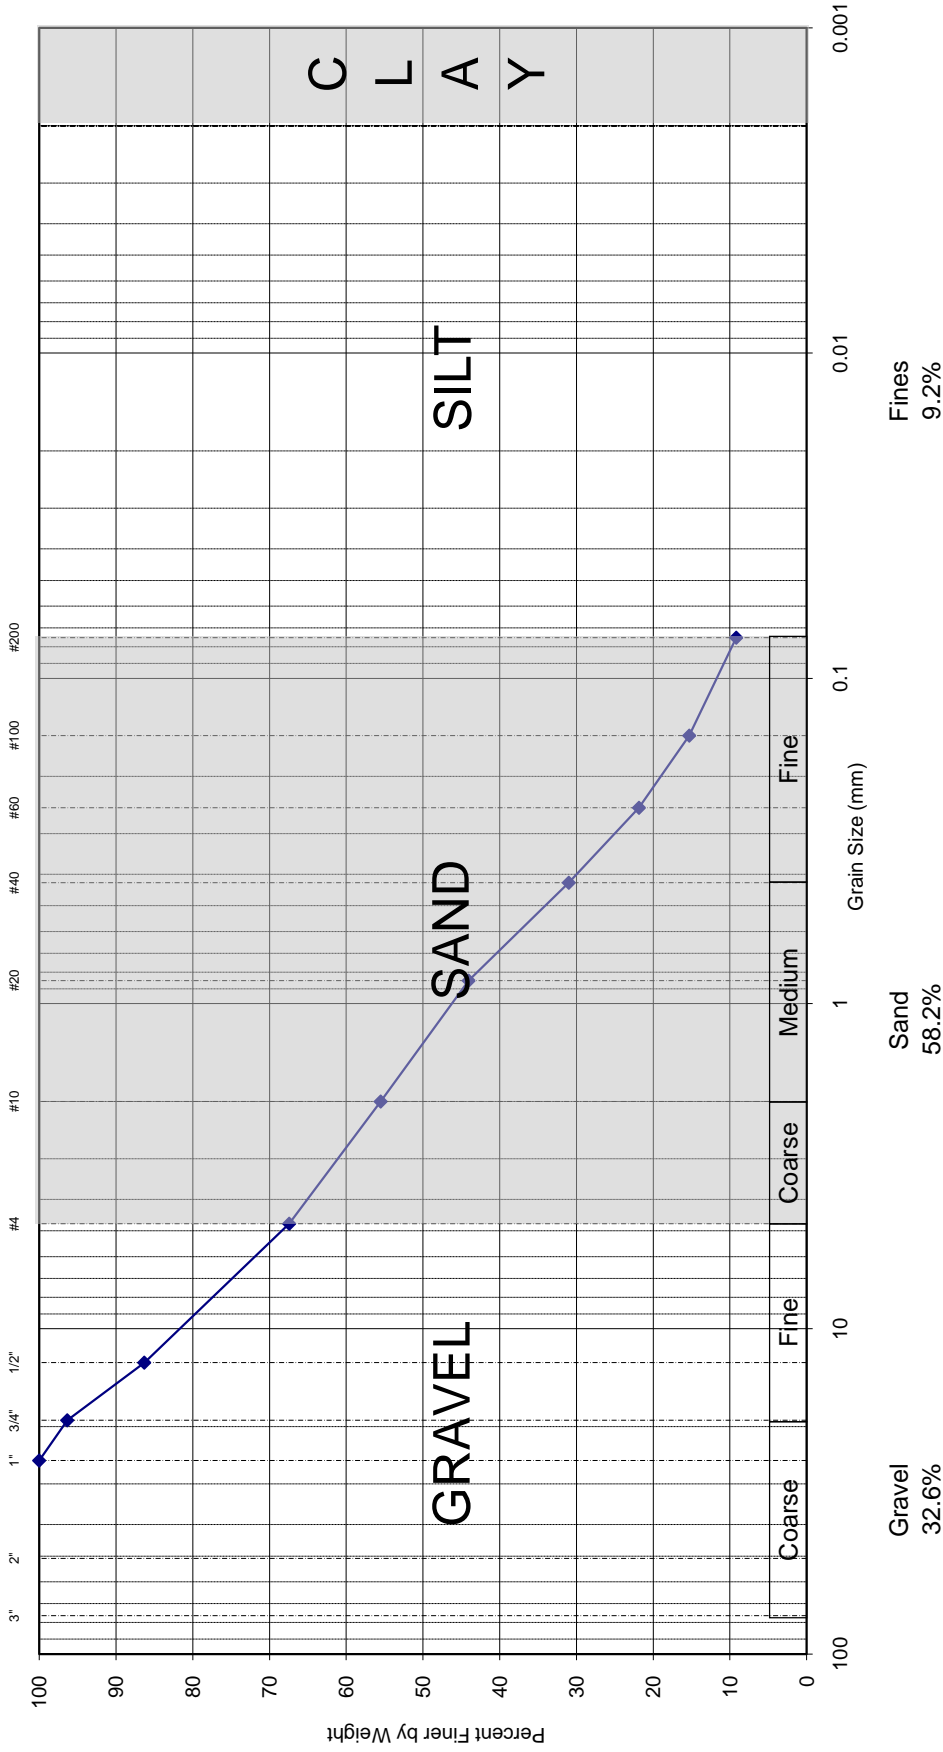
Lab #	Exploration	Sample	Depth (ft)	Description	WC	LL	PL	PI
1	BB-KMR-201	1D	0.5-2.0'	Brown Poorly-graded Sand with Silt and Gravel (SP-SM)

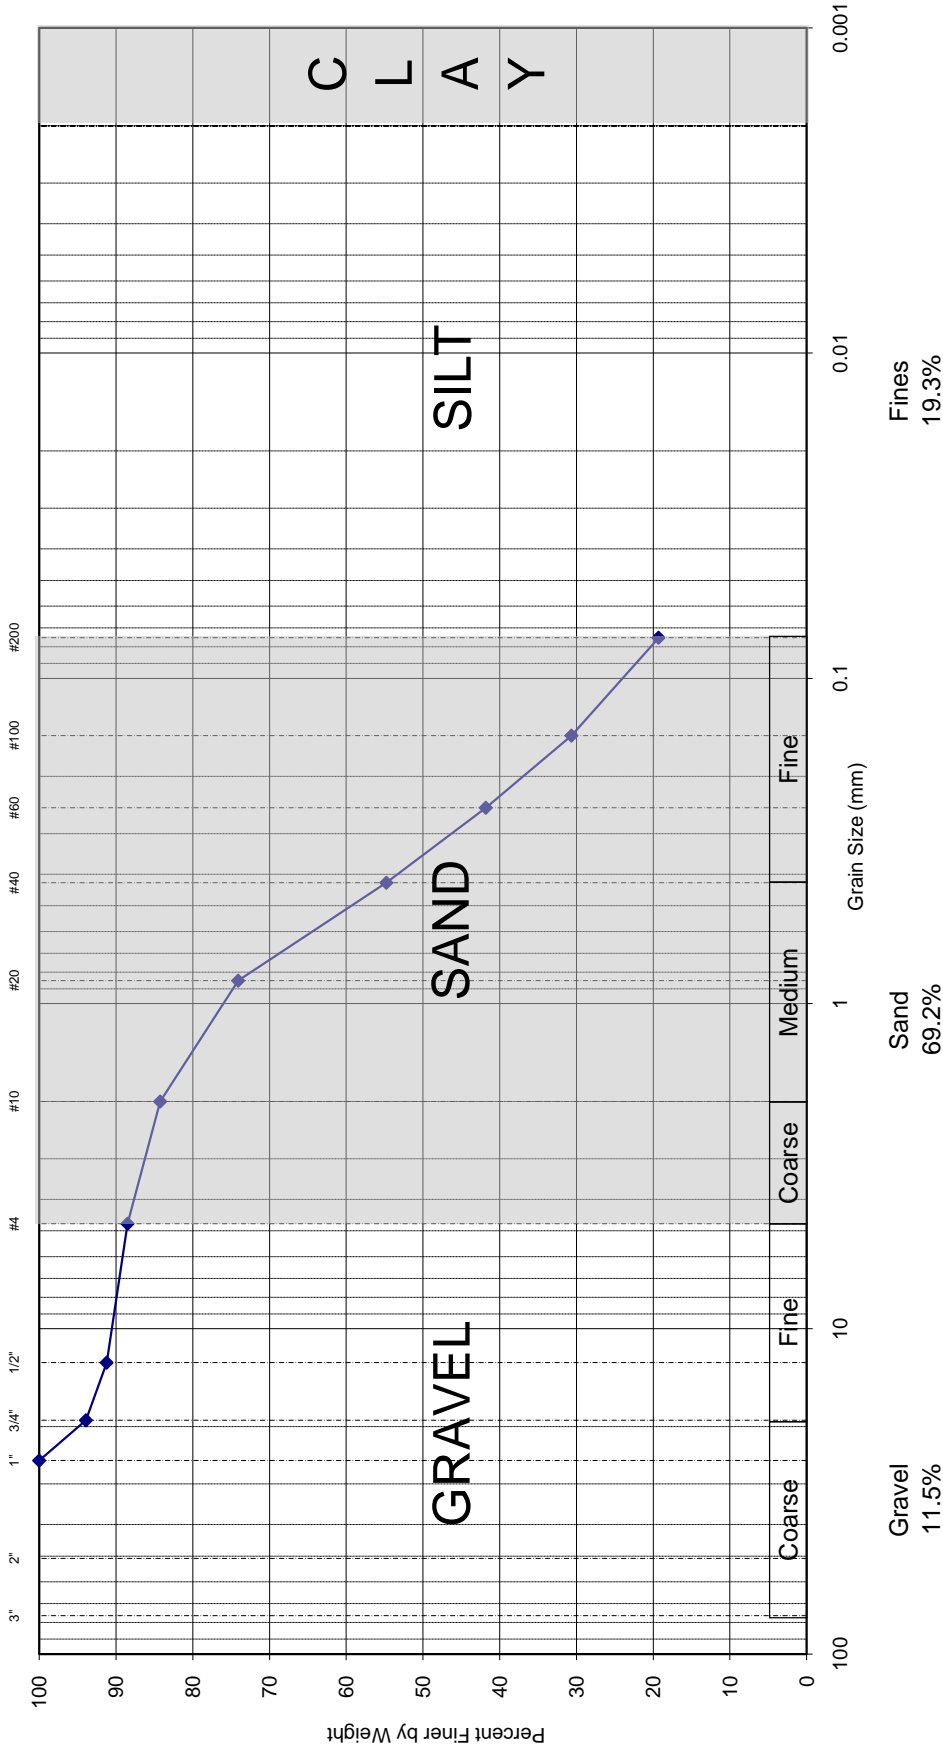
Lab #	Exploration	Sample	Depth (ft)	Description	WC	LL	PL	PI
2	BB-KMR-201	4D	6-8'	Brown Silty Sand (SM)

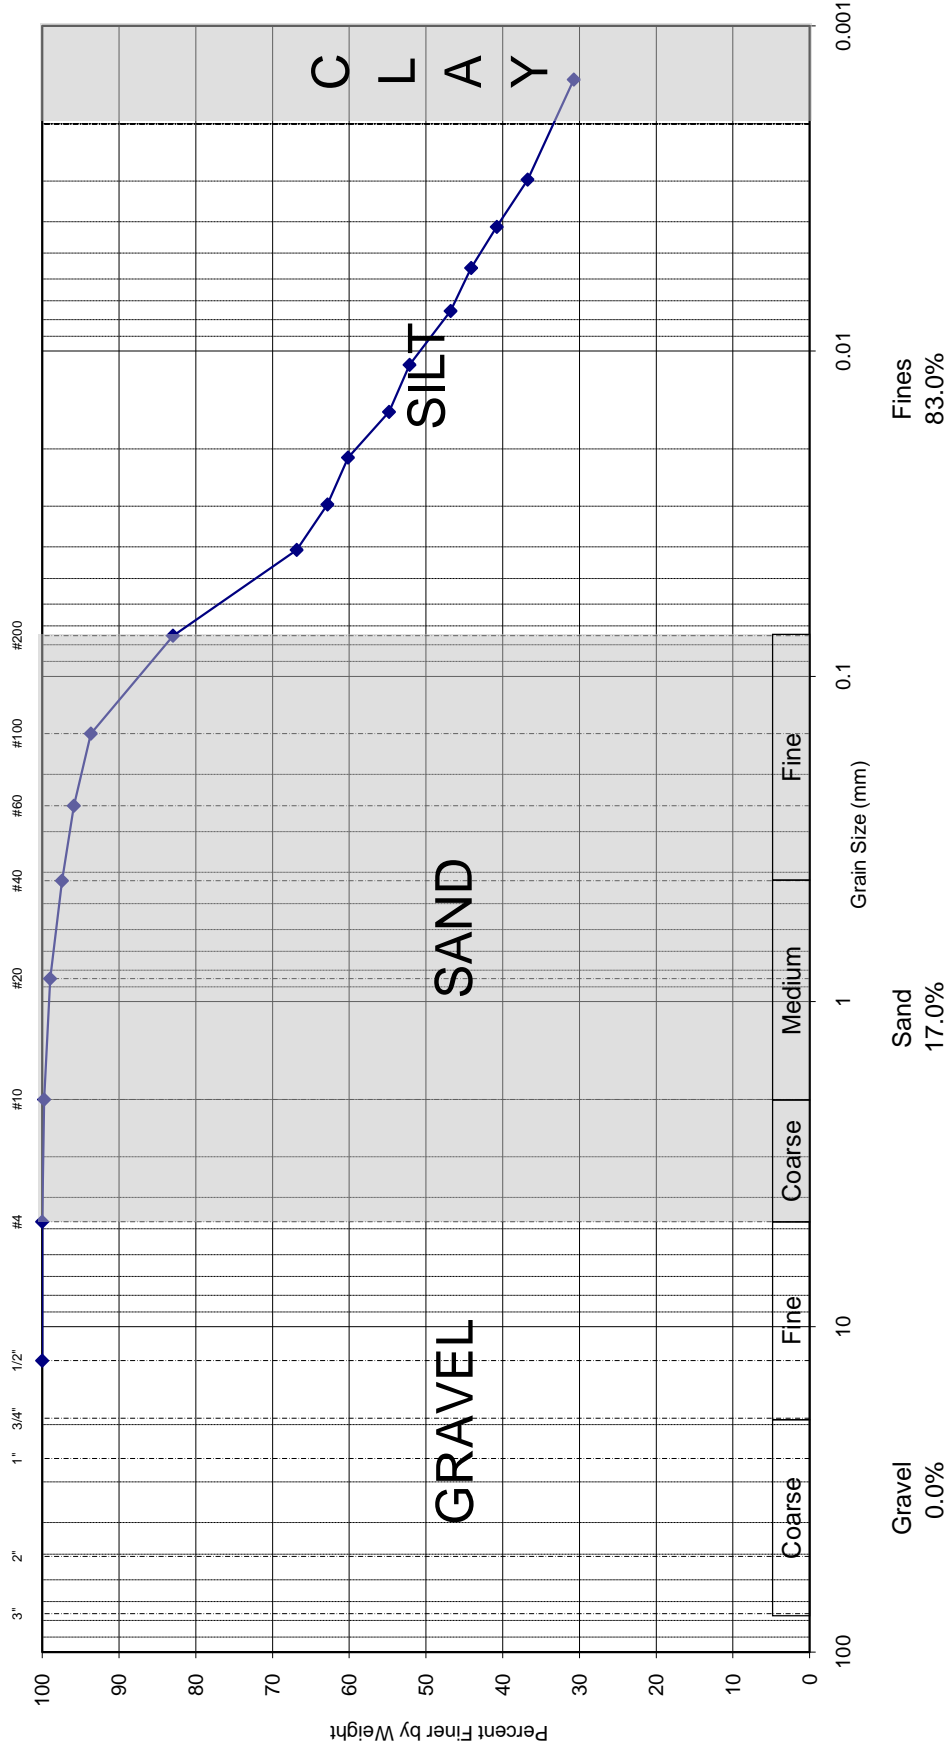
Lab #	Exploration	Sample	Depth	Description	WC	LL	PL	PI
3	BB-KMR-201	5D	8-10'	Brown Lean Clay with Sand (CL)

Fines
83.0%

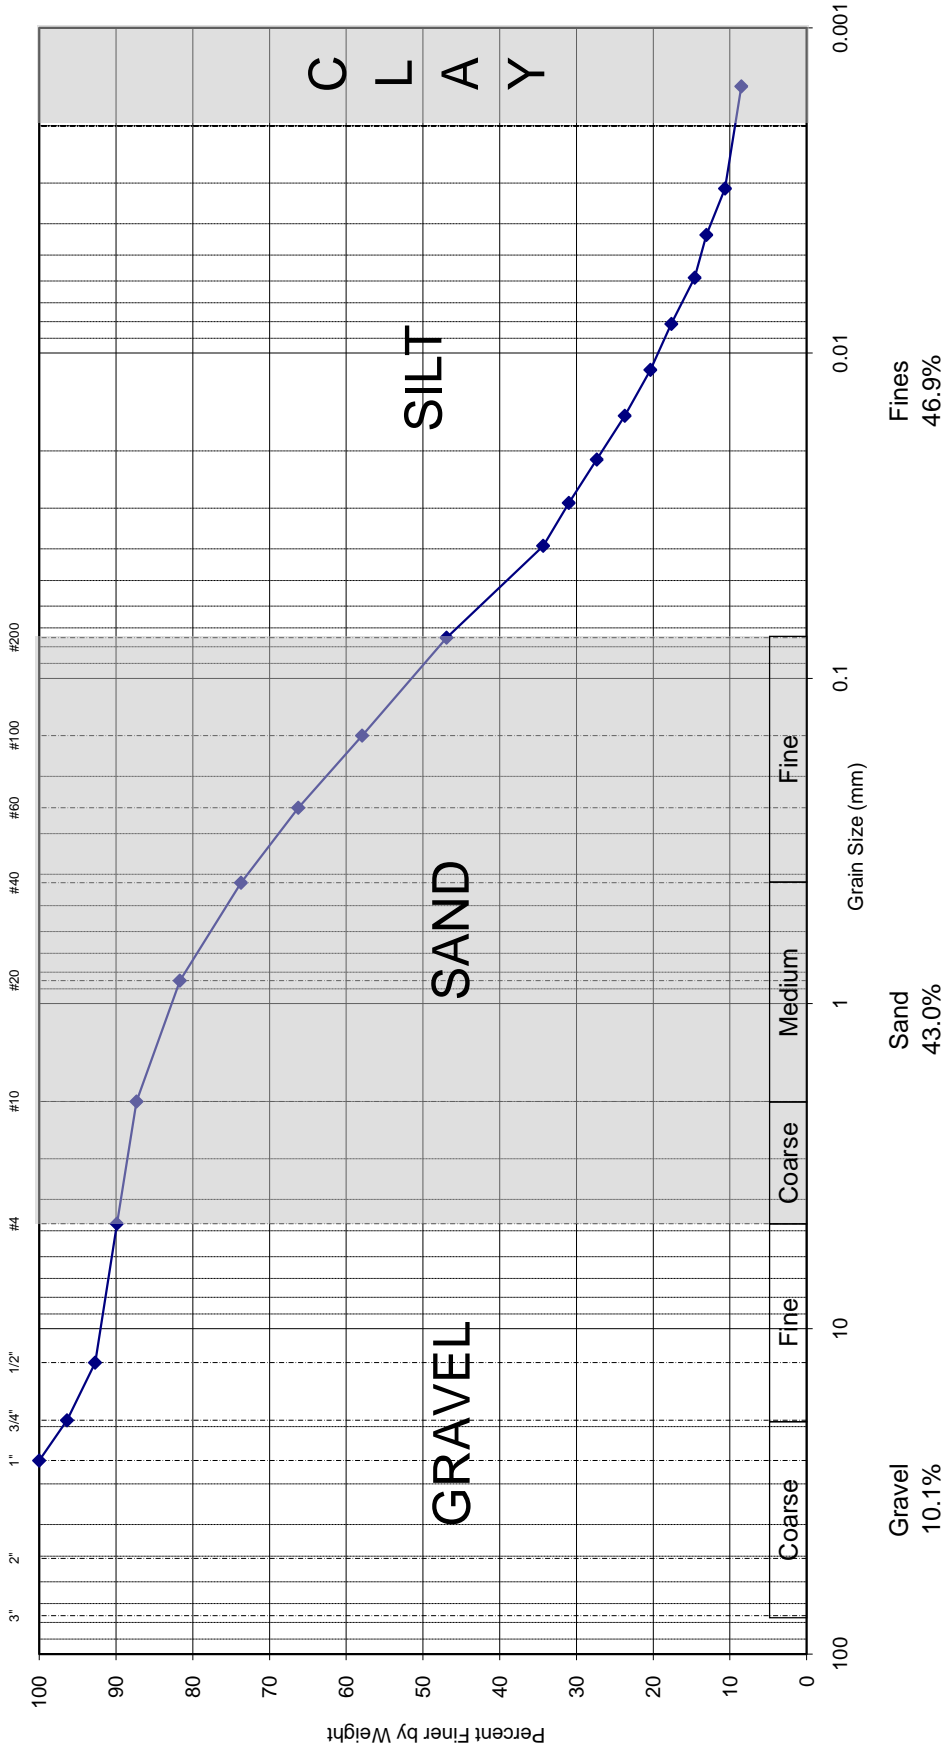
Lab #	Exploration	Sample	Depth	Description	WC	LL	PL	PI
4	BB-KMR-201	6D	10-12'	Brown Sandy Silt (ML)

Fines
46.9%
