**FINAL GEOTECHNICAL DESIGN REPORT
KENNEBUNK BRIDGE
MAINE DOT PIN 15098.00
KENNEBUNK, MAINE**

August 2010
File No. 09.0025597.10

Re: Final Geotechnical Design Report
Kennebunk Bridge Replacement
Kennebunk, Maine

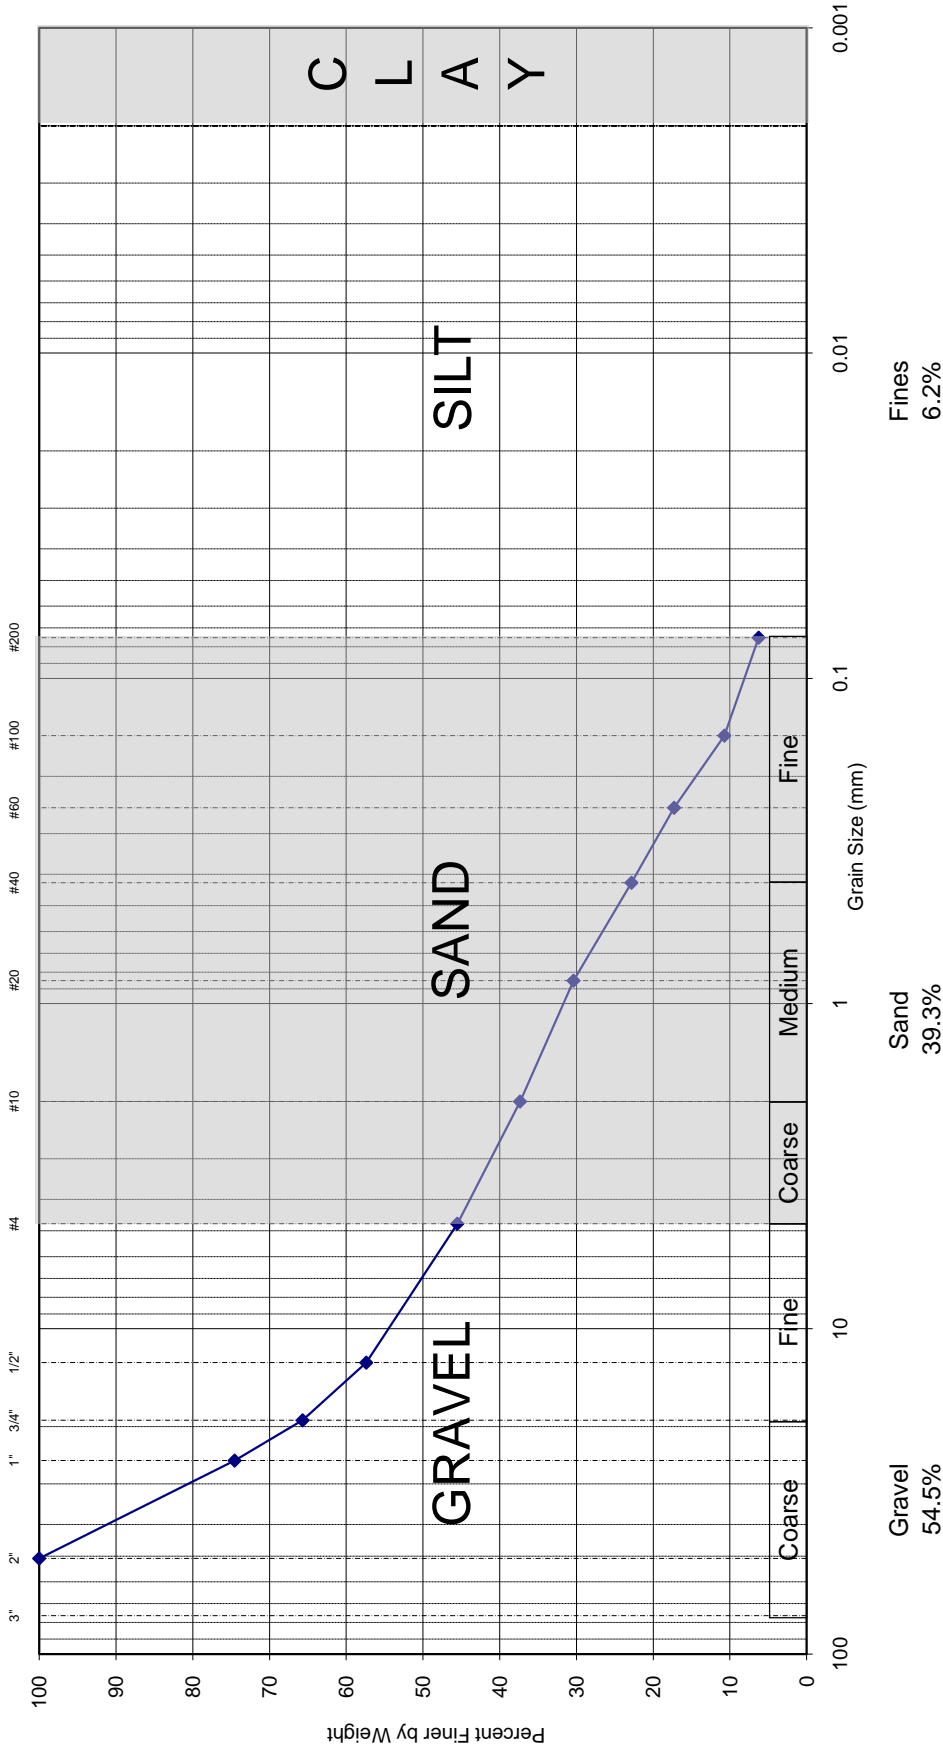
Lab #	Exploration	Sample	Depth (ft)	Description	WC	LL	PL	PI
5	BB-KMR-202	4D	9-11'	Brown Poorly-graded Gravel with Silt and Sand (GP-GM)

Fines
6.2%

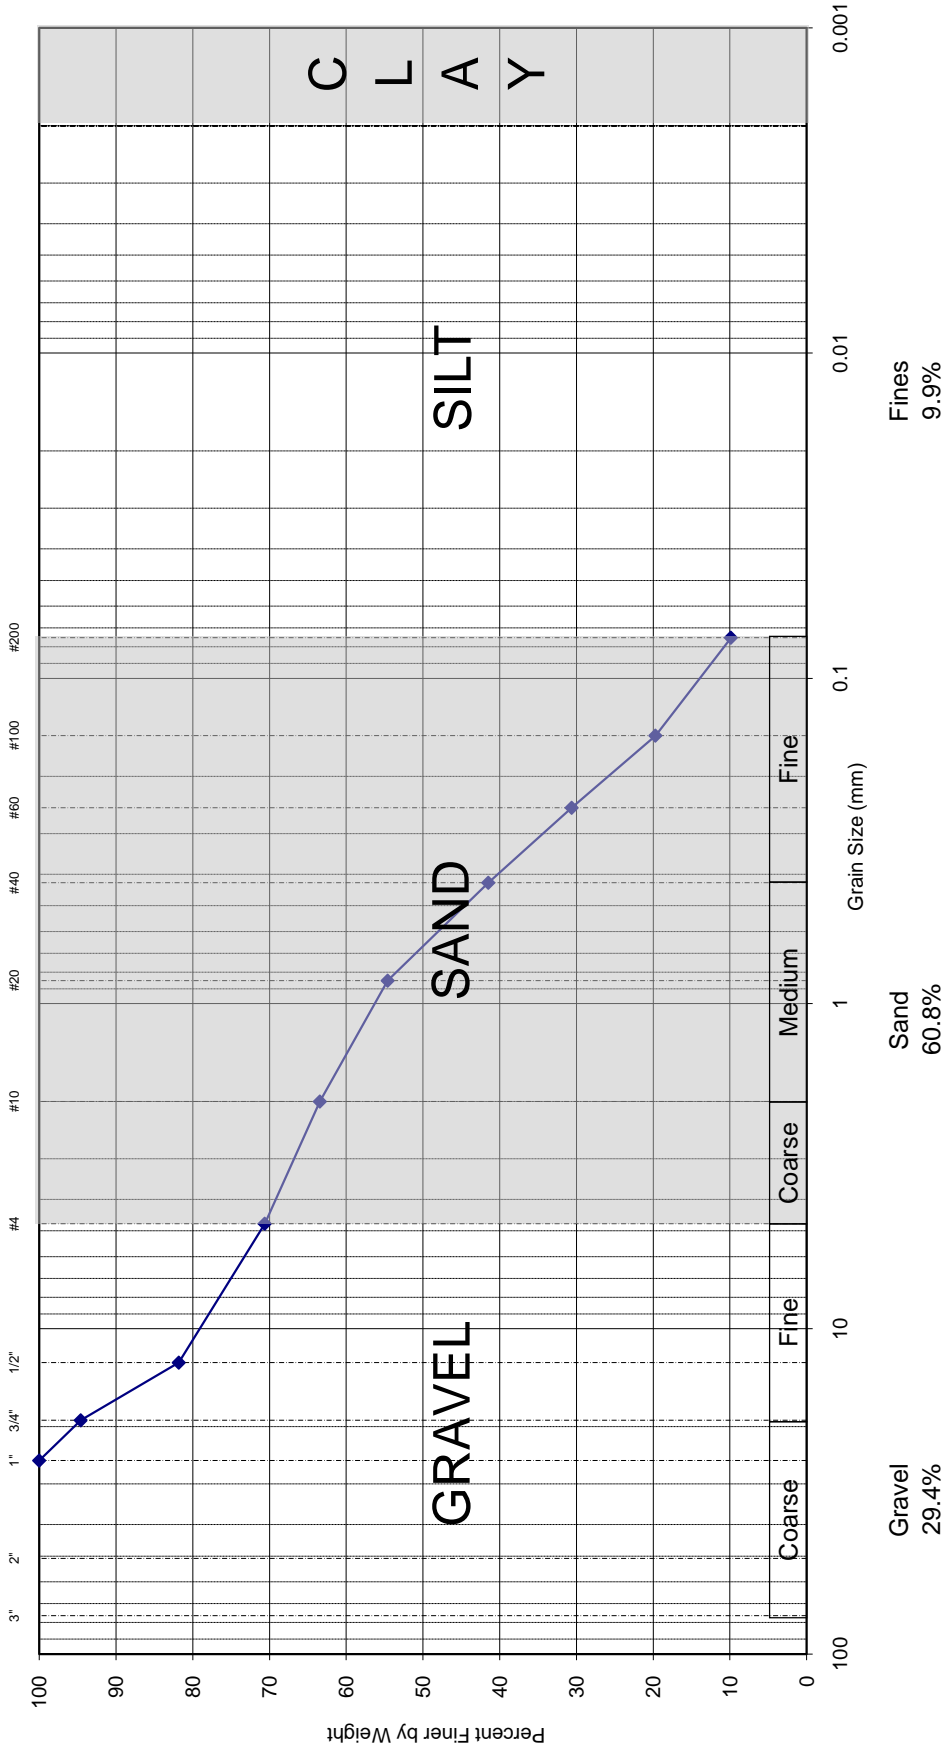
Lab #	Exploration	Sample	Depth (ft)	Description	WC	LL	PL	PI
6	BB-KMR-203	1D	0.5-2.0'	Brown Poorly-graded Sand with Silt and Gravel (SP-SM)

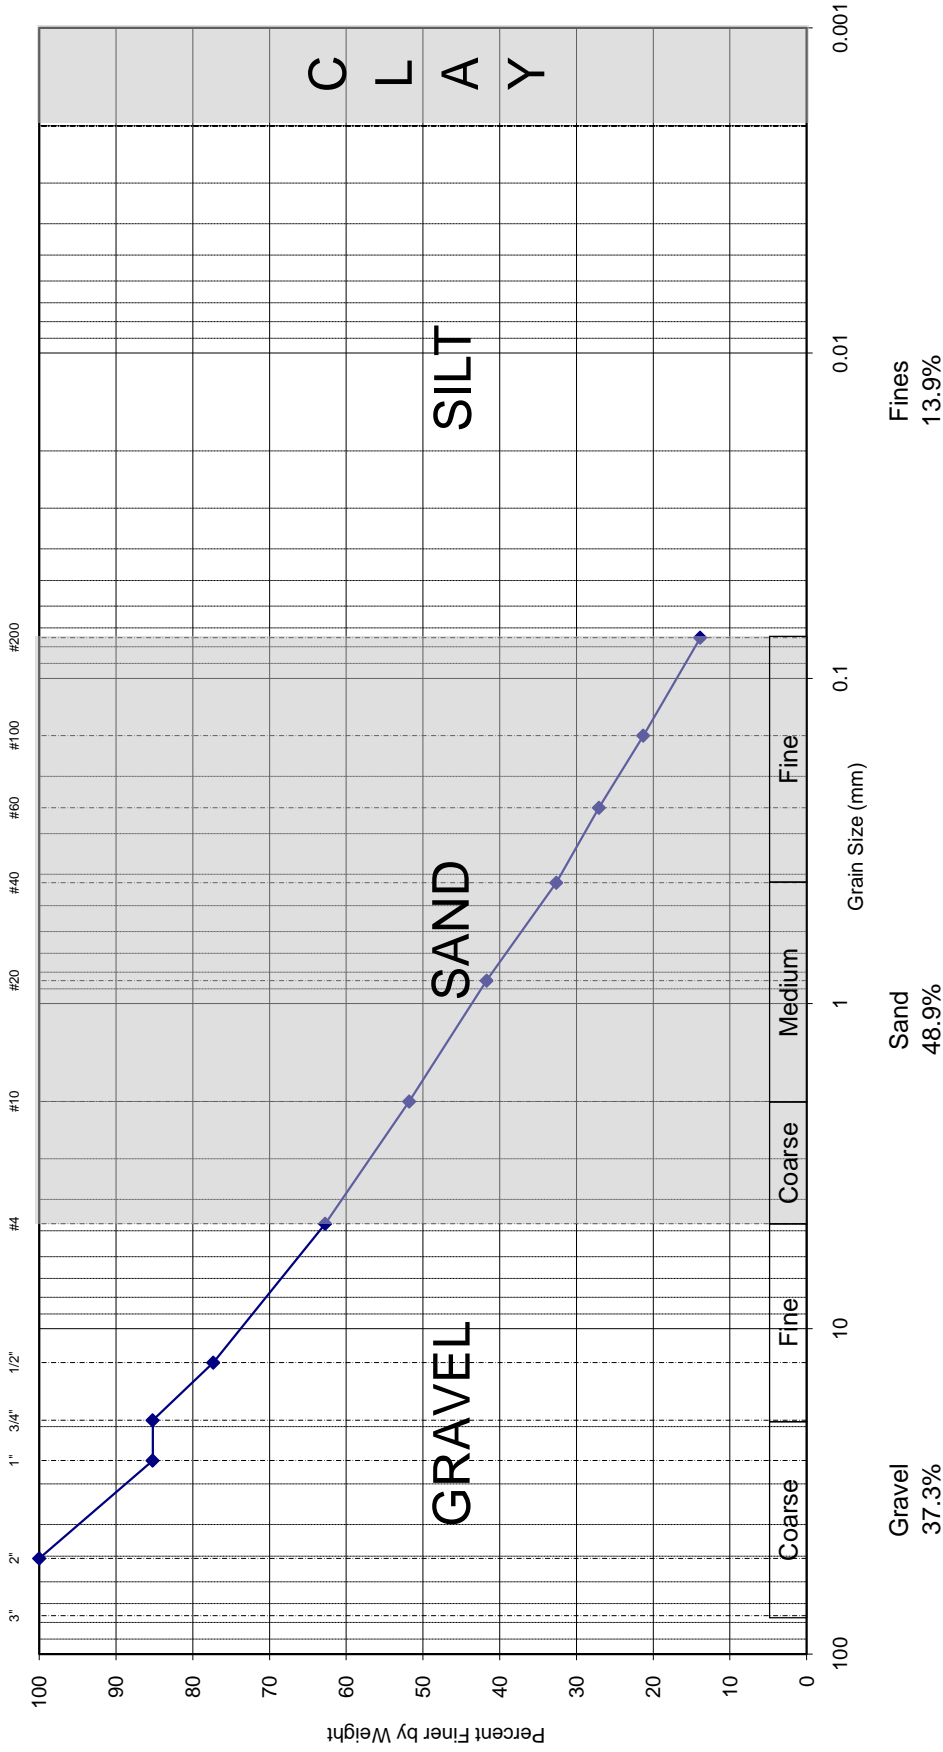
Lab #	Exploration	Sample	Depth (ft)	Description	WC	LL	PL	PI
7	BB-KMR-203	3D	4-6'	Brown Silty Sand with Gravel (SM)

Fines
13.9%

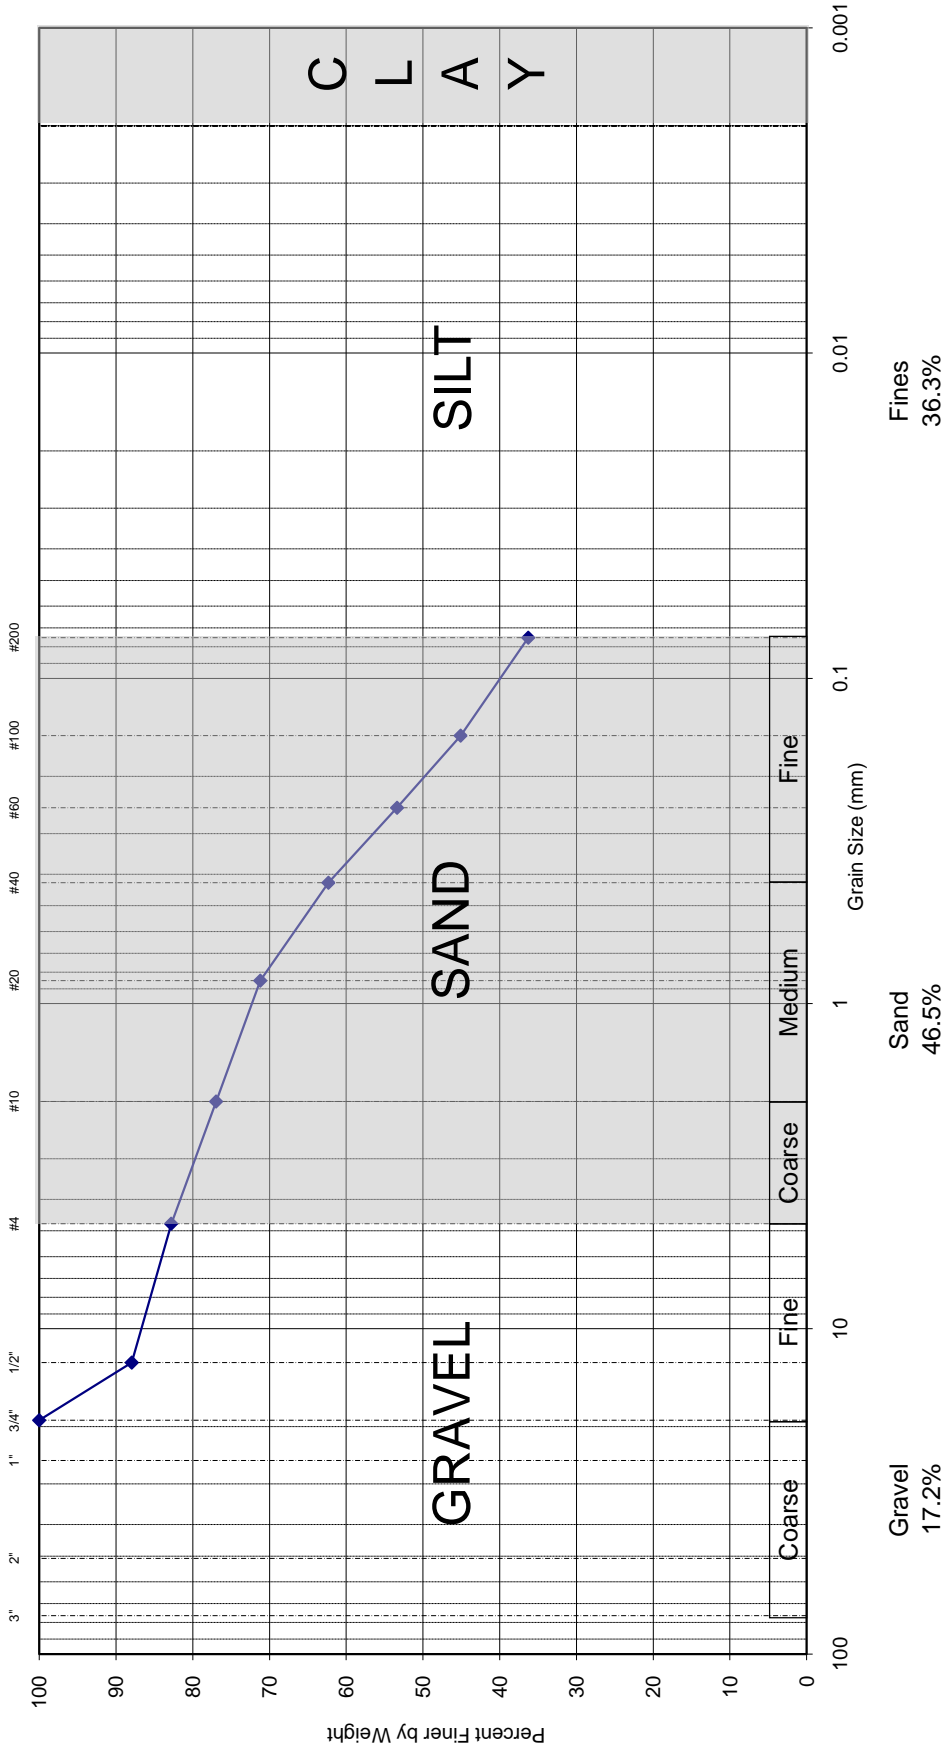
Lab #	Exploration	Sample	Depth (ft)	Description	WC	LL	PL	PI
9	BB-KMR-301	6D	11-13'	Brown Silty Sand with Gravel (SM)

Fines
36.3%

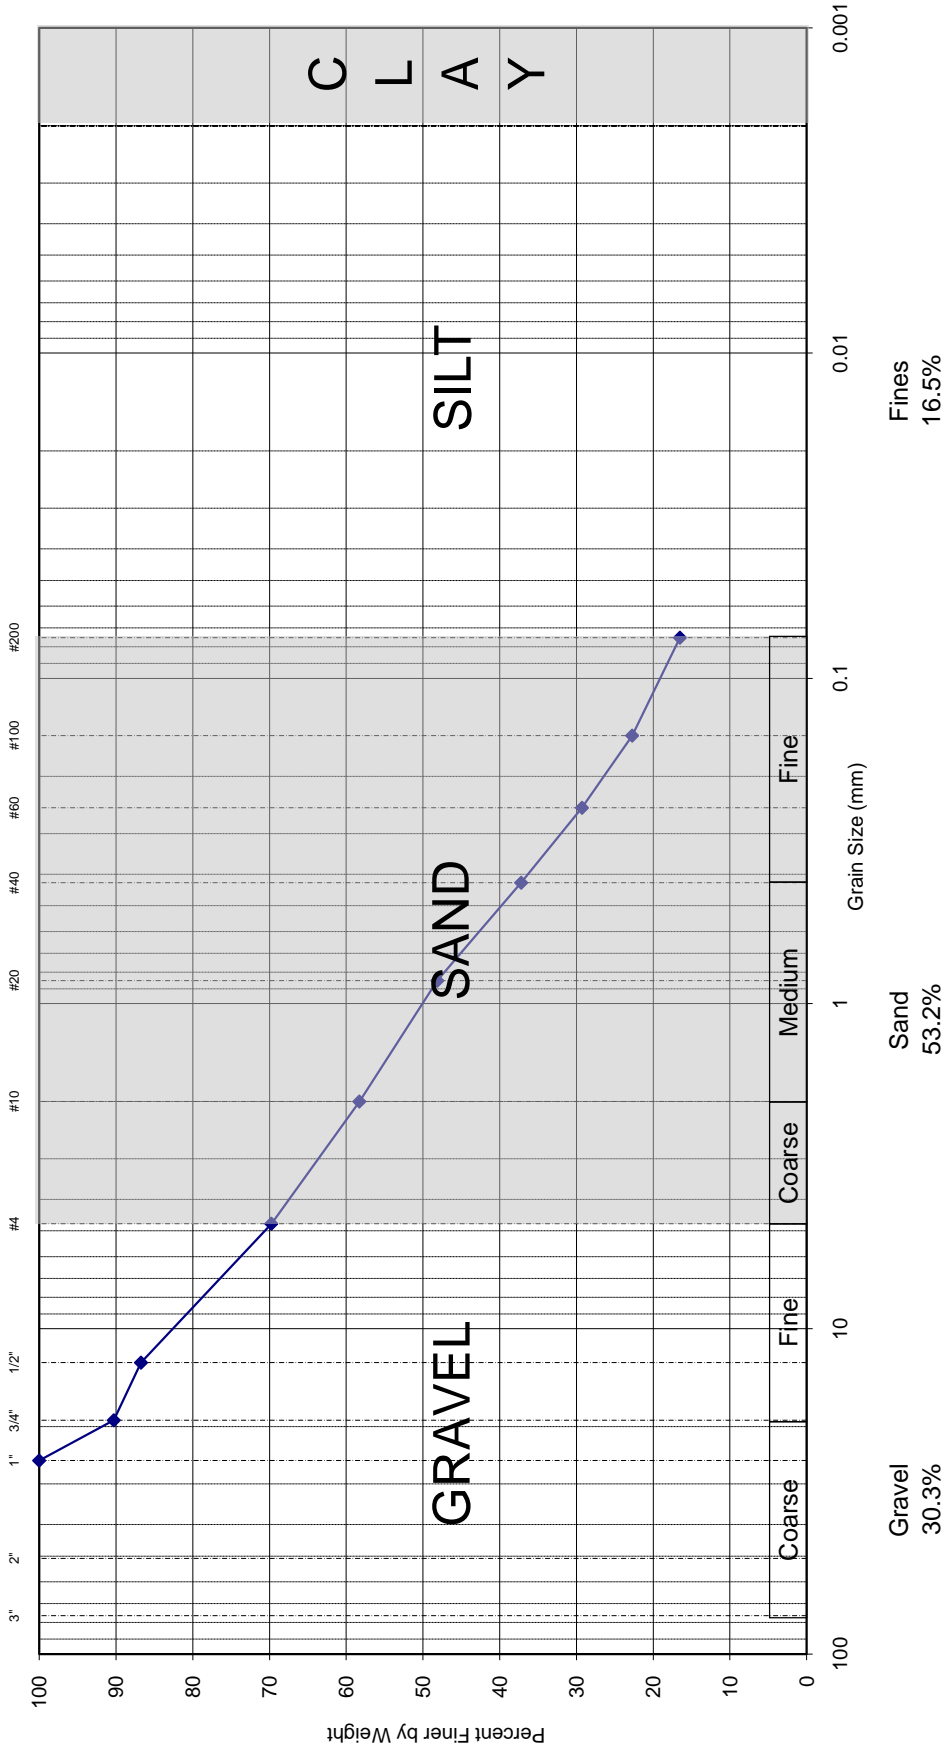
Lab #	Exploration	Sample	Depth (ft)	Description	WC	LL	PL	PI
10	BB-KMR-301	8D	15-17'	Gray-brown Silty Sand with Gravel (SM)

Fines
16.5%

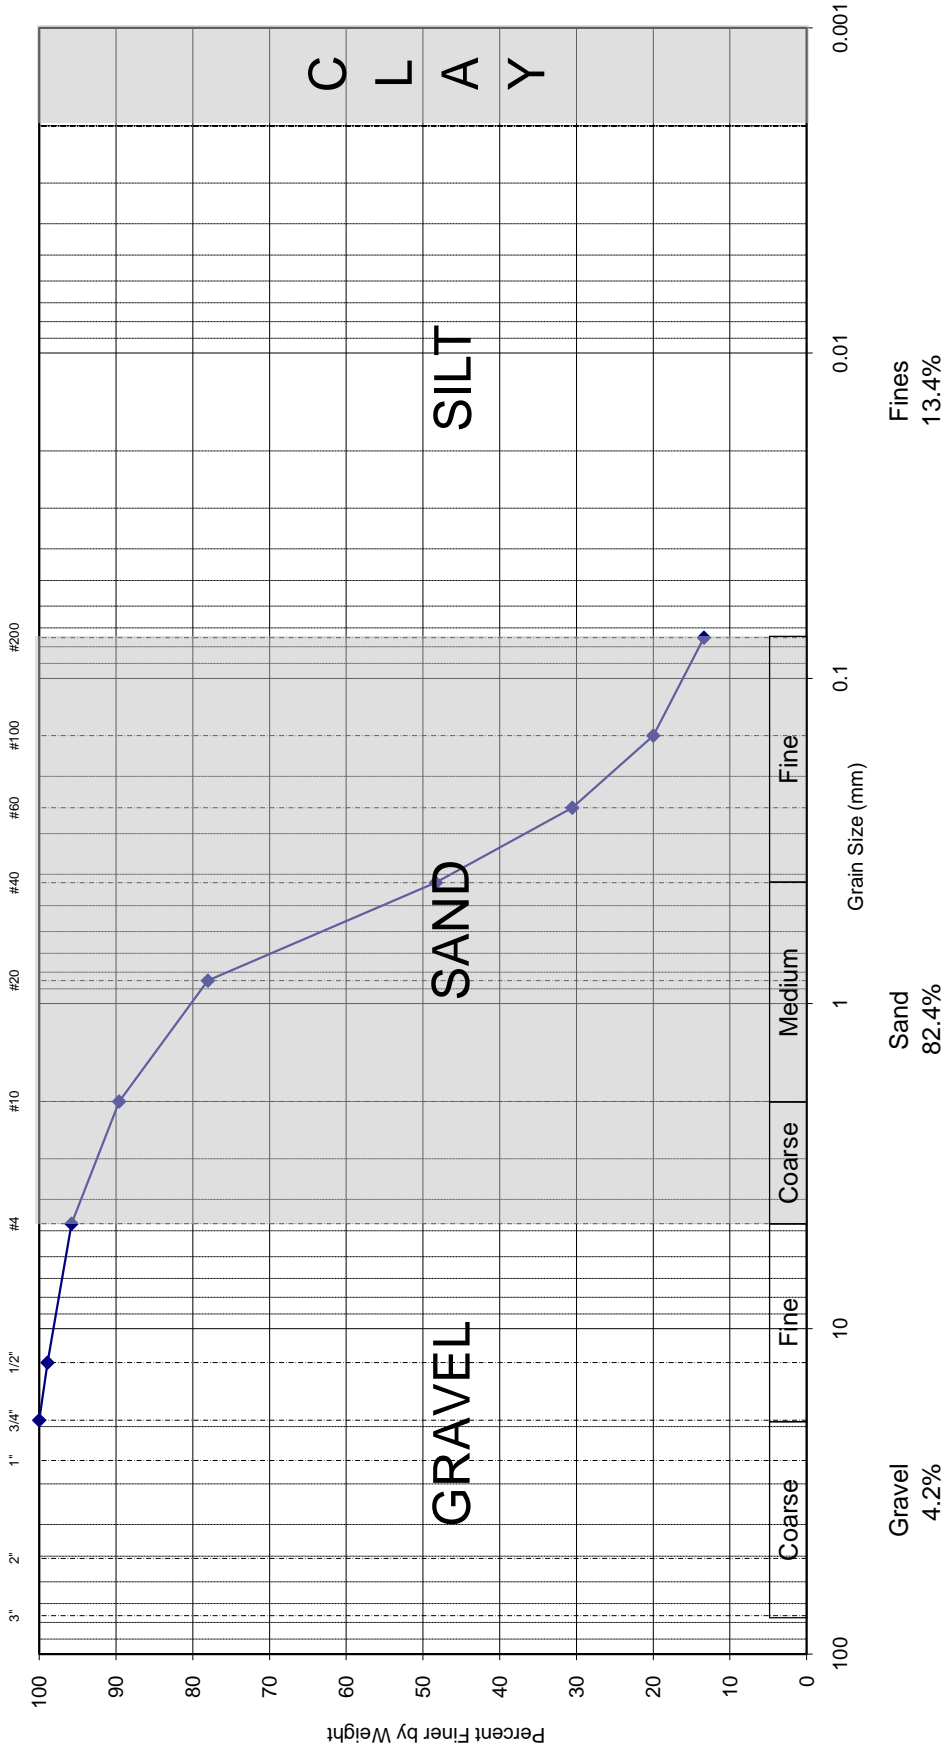
Lab #	Exploration	Sample	Depth (ft)	Description	WC	LL	PL	PI
11	BB-KMR-301	9D	17-19'	Brown Silty Sand (SM)

Fines
13.4%

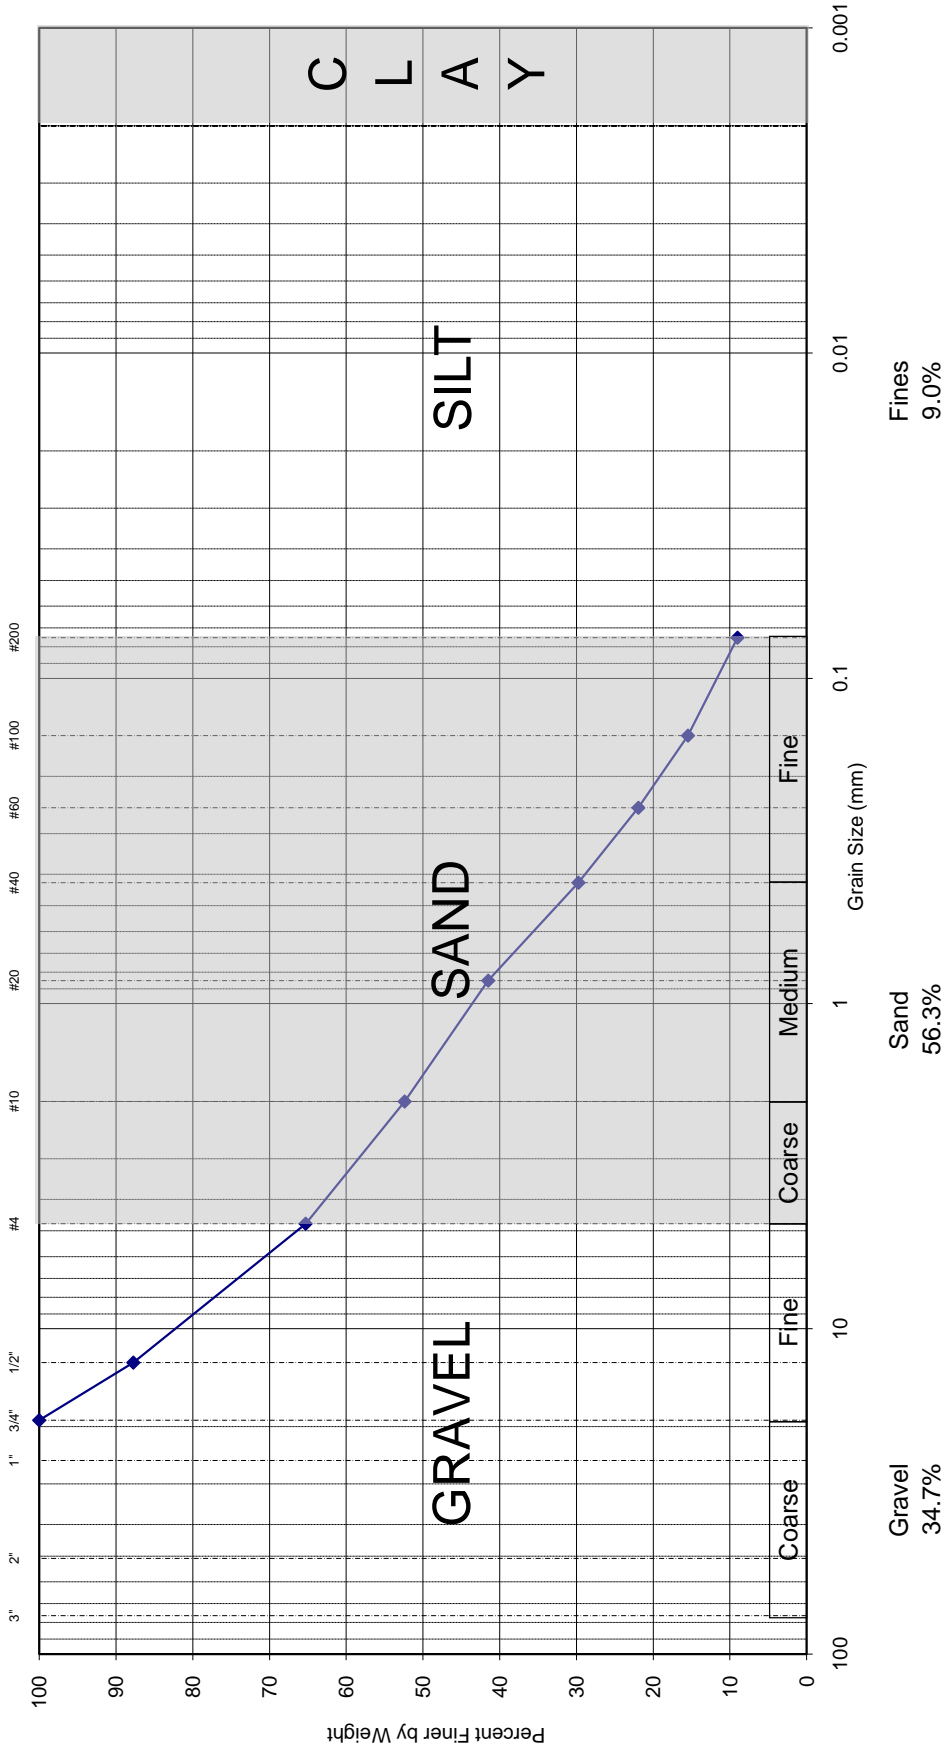
Lab #	Exploration	Sample	Depth (ft)	Description	WC	LL	PL	PI
12	BB-KMR-302	1D	0.5-2.0'	Brown Poorly-graded Sand with Silt and Gravel (SP-SM)

Fines
9.0%

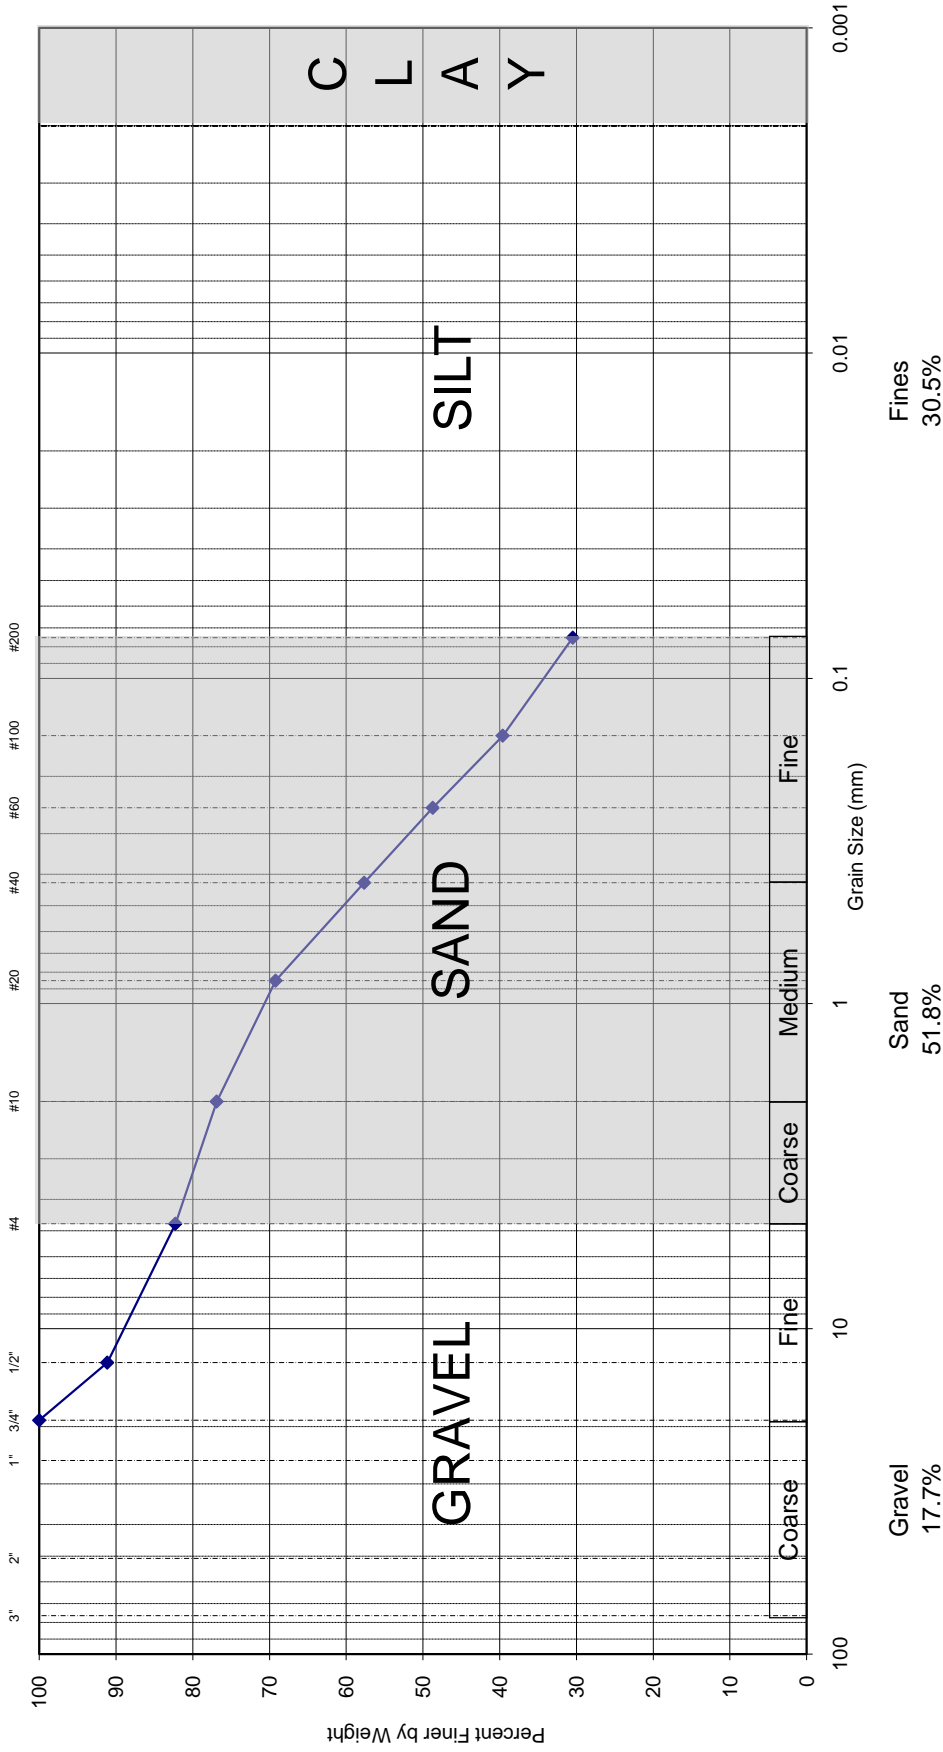
Lab #	Exploration	Sample	Depth (ft)	Description	WC	LL	PL	PI
13	BB-KMR-302	4D	6-8'	Brown Silty Sand with Gravel (SM)

Fines
30.5%

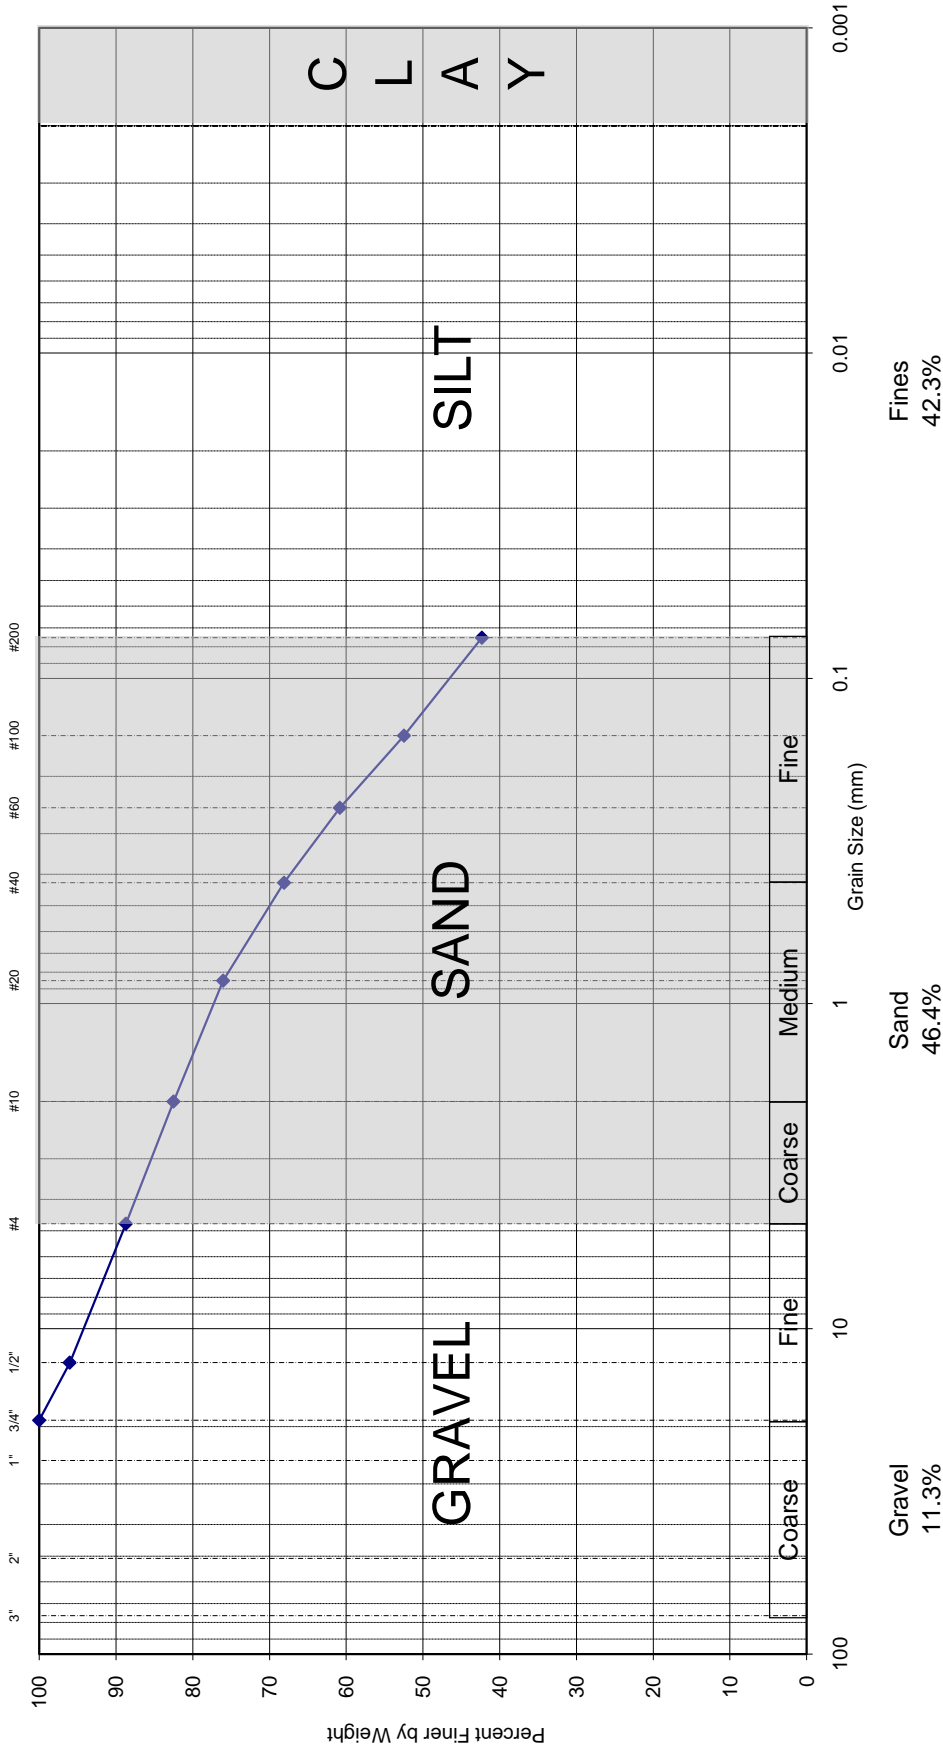
Lab #	Exploration	Sample	Depth (ft)	Description	WC	LL	PL	PI
14	BB-KMR-302	6D	10-12'	Brown Silty Sand (SM)

Fines
42.3%

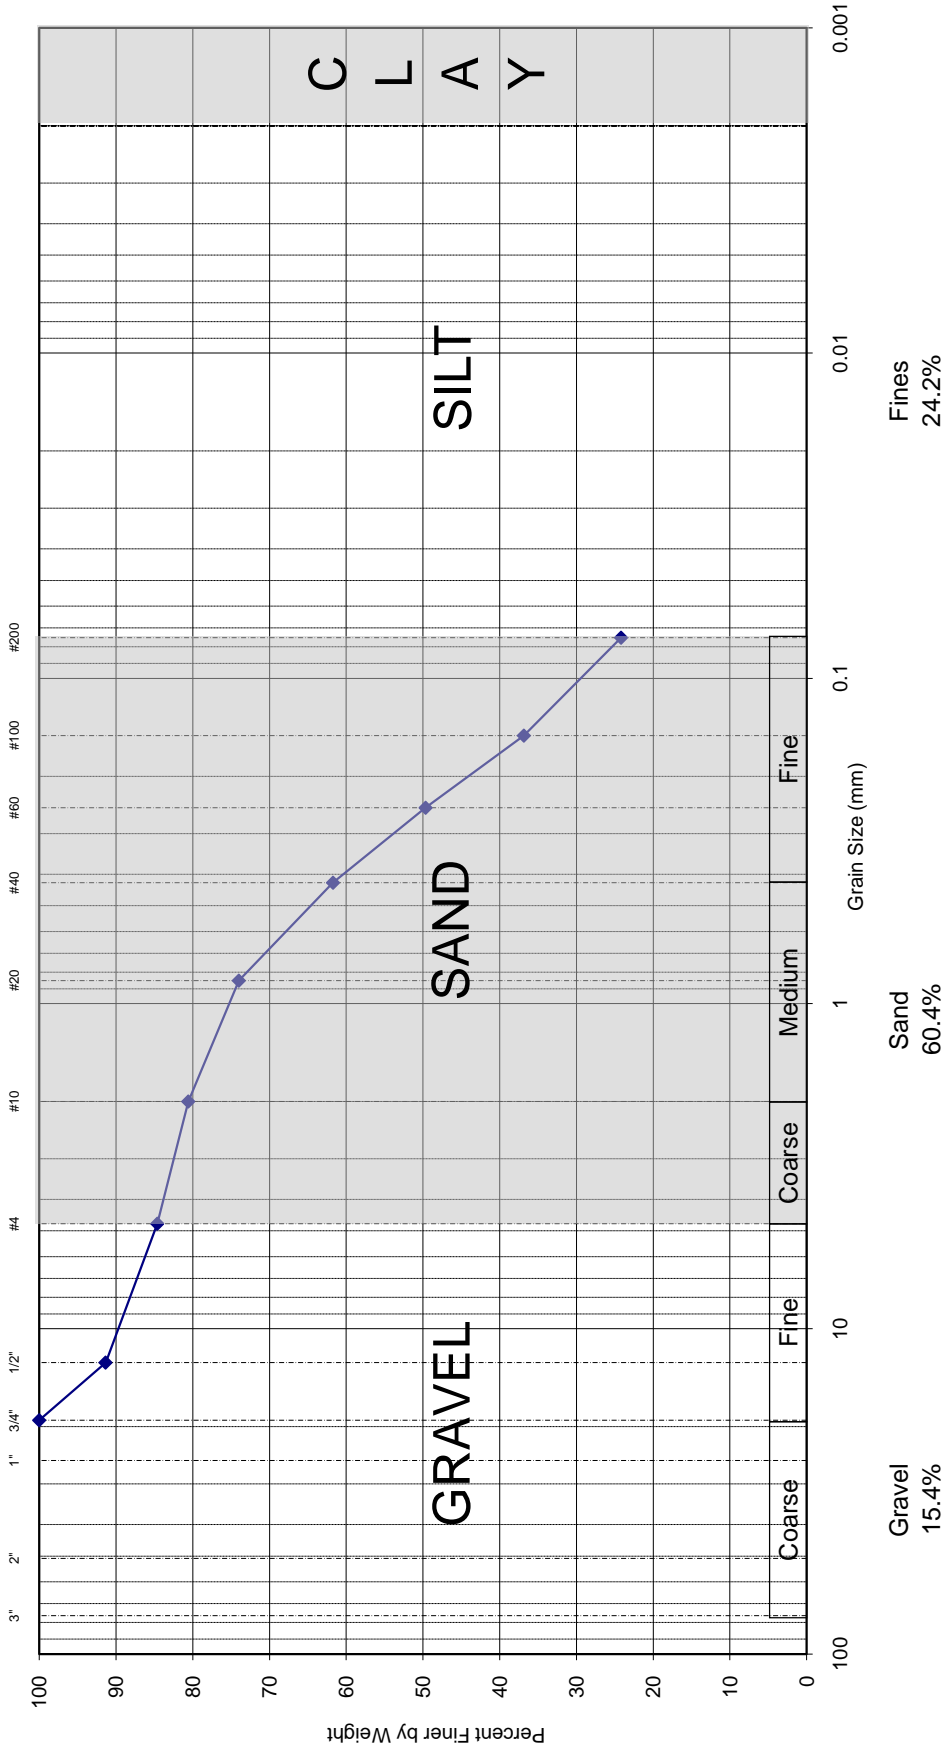
Lab #	Exploration	Sample	Depth (ft)	Description	WC	LL	PL	PI
15	BB-KMR-303	4D	6-8'	Brown Silty Sand with Gravel (SM)

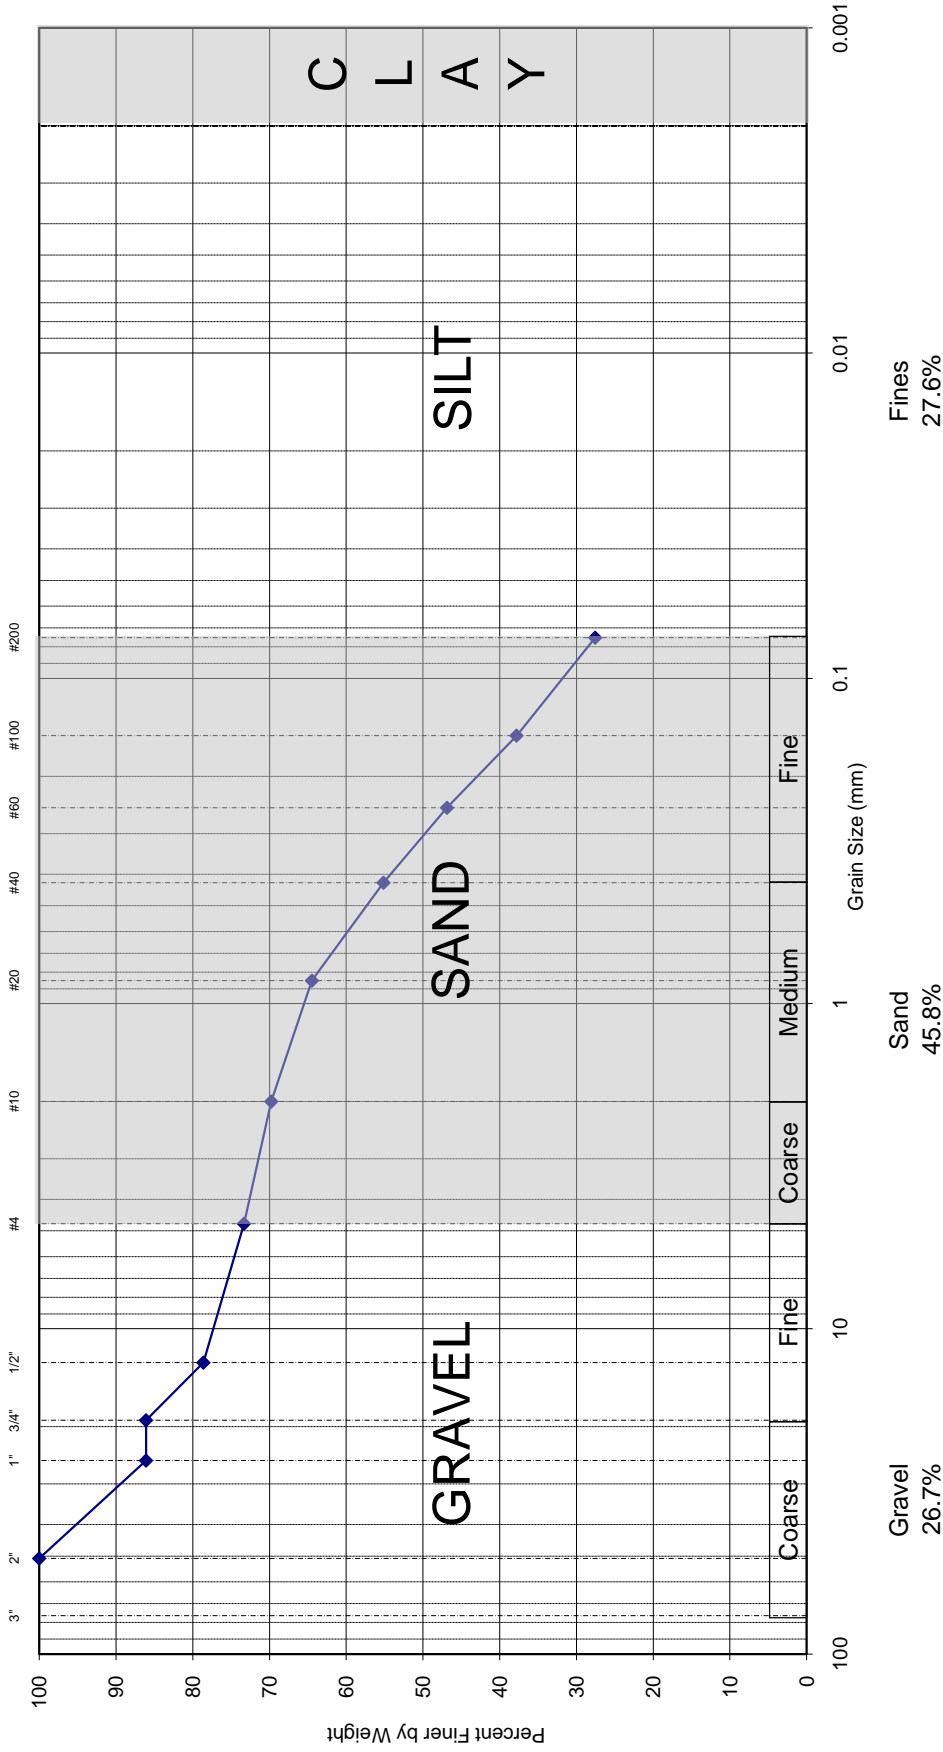
Lab #	Exploration	Sample	Depth (ft)	Description	WC	LL	PL	PI
16	BB-KMR-303	5D	8-10'	Brown Silty Sand with Gravel (SM)

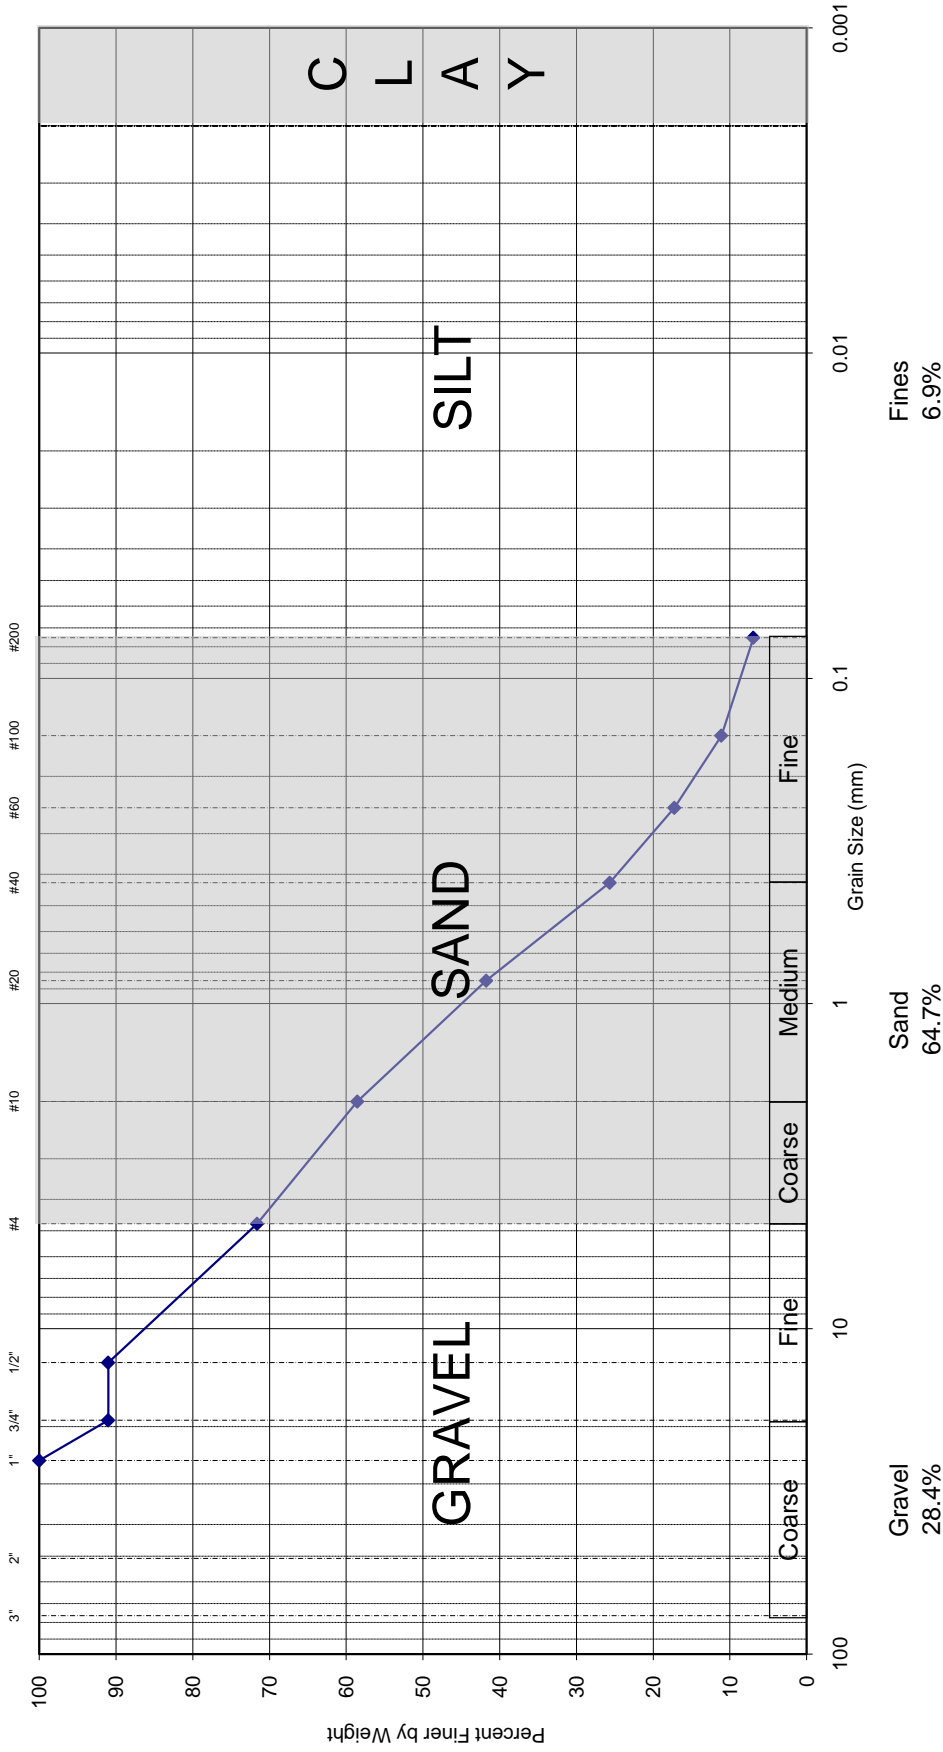
Lab #	Exploration	Sample	Depth (ft)	Description	WC	LL	PL	PI
17	PC-1	--	1-3'	Brown Poorly-graded Sand with Silt and Gravel (SP-SM)

Fines
6.9%
