# Bridge Deck Condition Survey Using Ground Penetrating Radar (GPR) on the I-295 Corridor, Portland, ME

## Final Report

**INFRASENSE, Inc.**

December 10, 2009

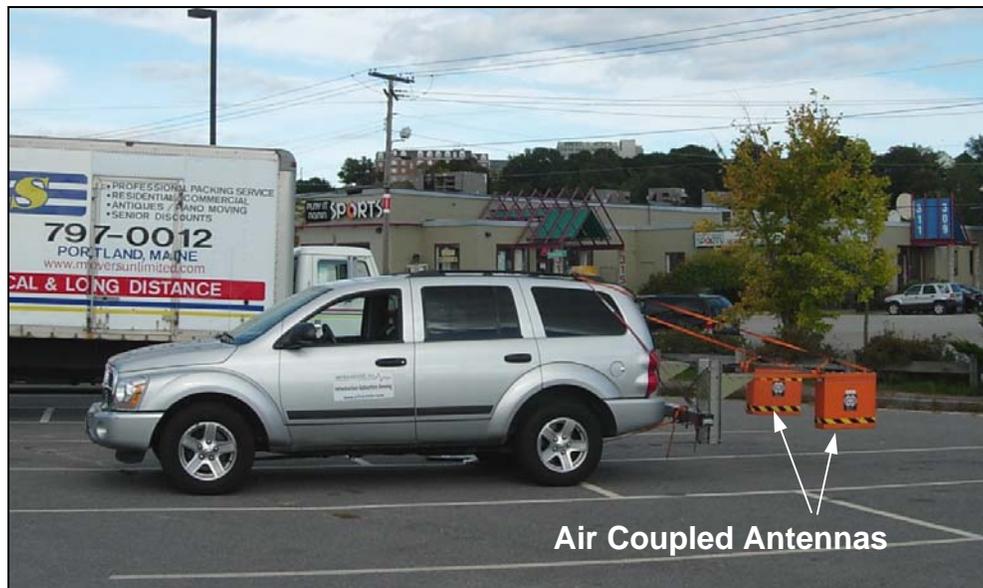
Figure 2 – GPR Survey Vehicle using Air Coupled Antenna System

The GPR survey was conducted on October 2, 2009. The GPR equipment was a dual 1 GHz air coupled horn antenna system manufactured by GSSI, Inc. of Salem, NH and is shown in Figure 2. The vehicle was equipped with an electronic distance-measuring instrument (DMI) mounted to the rear wheel of the survey vehicle, providing distance data as the GPR data was collected. The data collection and recording was controlled by the SIR-20 GPR system operated from within the survey vehicle. Data was digitized and stored to hard disk as the survey progressed. The DMI distance data was synchronously recorded into each GPR record, so that each GPR data scan had an associated distance.
