**SUBSURFACE INVESTIGATION FOR
STABILIZATION OF SOUTH LUBEC ROAD
LUBEC, MAINE**

Washington County
PIN 18317.00

Soils Report No. 2011-120

To: Shawn Davis, P. E., Project Manager
cc: David Gardner, Construction Resident
From: Kitty Breskin, P. E., Sr. Geotechnical Engineer
Date: December 16, 2011
Subject: South Lubec Road, PIN 18317.00

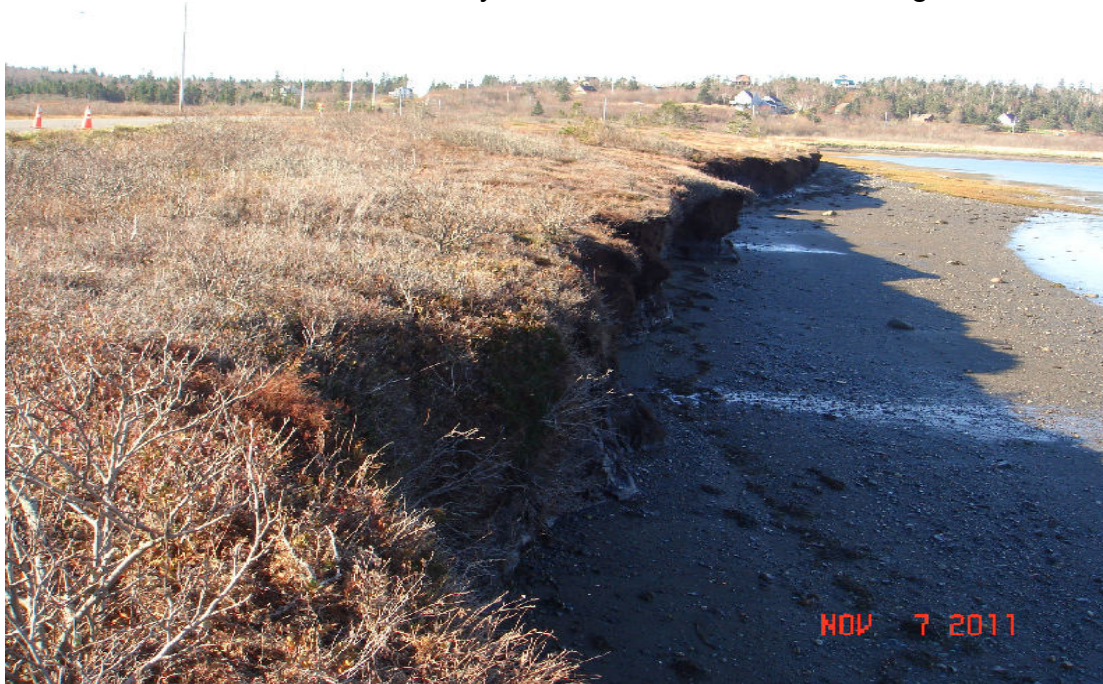
The South Lubec Road is constructed on the north side of an isthmus of organic soils. These soils extend east from the sharp bend at Carrying Place Cove Road for approximately 1500 feet across Carrying Place Heath until firmer soils and shallow bedrock are reached. Although Lubec Embayment to the north is sheltered compared to conditions on the south side of the isthmus, there is enough fetch with a northeast wind to produce damaging waves. The peat has been eroding and breaking way in blocks for many years according to local residents, and in the area of concern the peat bluff has moved from 50 feet away to 25 feet or less from the edge of the roadway.

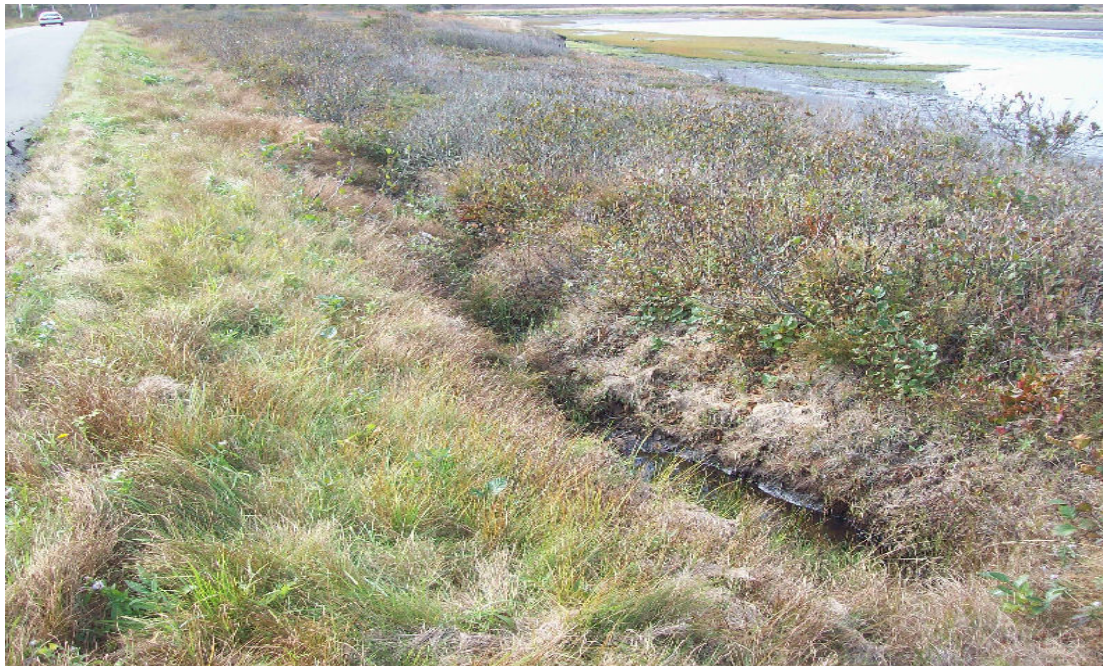
A 150 foot long portion of this roadway now has serious cracks in the pavement and a deep crack in the peat near the edge of the shoulder. The north edge of the pavement has dropped substantially below the centerline even in uncracked sections. The crack in the peat appears to extend to a depth of approximately 5 feet, and the face of the peat is undercut at the beach. In other sections, the roadway has settled and the outer edge of peat has raised up with a shallow vertical face that is likely to become a block failure in the future from breakage of the organic fibers that produce “apparent cohesion” in peat soils. This portion of the north lane of the South Lubec Road has been closed to reduce the load at the crack and to protect the public safety when this block breaks away.

I recommend that a stone revetment be constructed on the beach at the edge the peat for a length of approximately 120 feet as an emergency stabilization. No treatment of other areas is required at this time, although further erosion of the peat face would make treatment of other areas necessary in the future. According to my computer modeling, a 1.5h:1v slope can be used on the beach with a vertical slope at the peat face for the height needed. A steeper face might be feasible, but it would be difficult to build and this slope repair will be built in challenging conditions. A mixture of stone sizes will be needed to form a compact, stable mass, with large stone armor at the face. The stones at the inner, vertical face of the revetment must carefully placed to be self-supporting to ensure that large stresses are not induced on the peat face. All stones used in this construction must meet the angularity requirements of the current revised specifications for large stone materials – rounded and sub-rounded pit tailings will not be allowed. A typical section is attached to this report. I anticipate that this revetment will extend to approximately 50 feet from the edge of pavement, to fill in the area where is appears that past block failures have occurred.

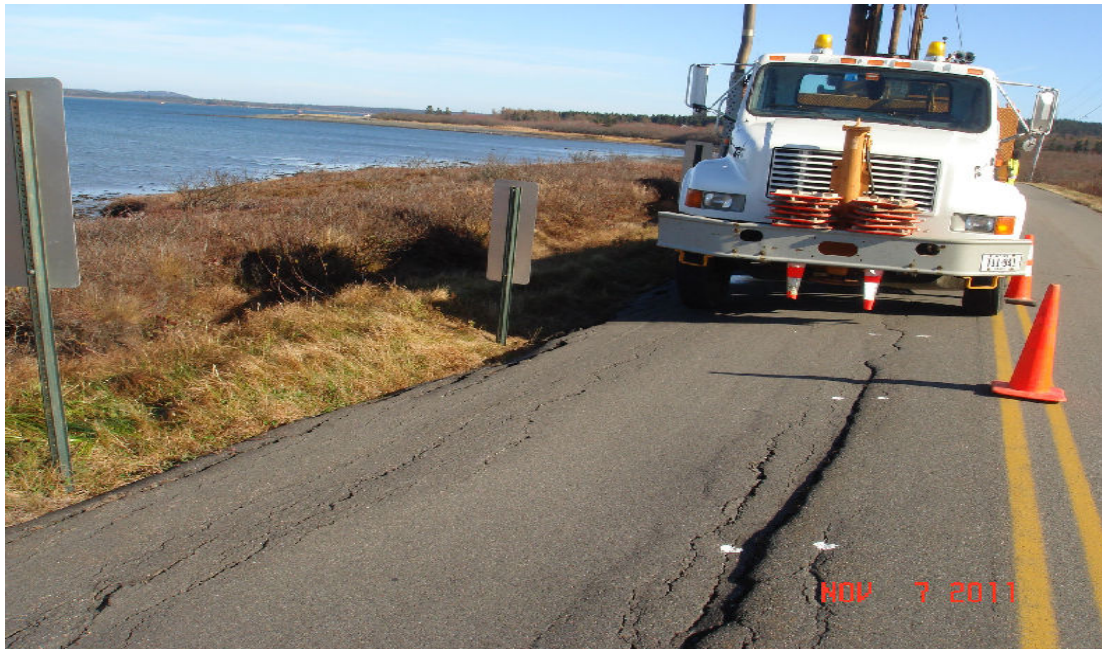
No as-built records exist for this roadway. It appears from the vegetation and topography that gravel may extend out from the roadway for several feet on each side acting as a form of shoulder, however no explorations were done beyond the pavement. Our subsurface investigation included an auger boring at the east end of the severely cracked area, a washboring extended to bedrock at the west end, and a hand-dug test pit in the beach adjacent to the area of concern. The existing HMA pavement is 4.5” to 5” thick over 5.5 to 6 feet of gravelly sand. This is underlain by a peat layer measured as 10.5 feet thick. A sample off the auger flights showed a mixture of fibrous and amorphous peat. Below the peat, at beach level, we encountered a layer of sand underlain by soft plastic clay-silt with trace sand. The borings were stopped at or near bedrock, 28.5 to 35.5 feet down. The test pit in the beach showed 3” of brown stony gravel over 6” of gray fine sand. Below that we encountered 6” of gray, gravelly sand. The pit was not extended beyond this layer. Boring logs are attached to this report.

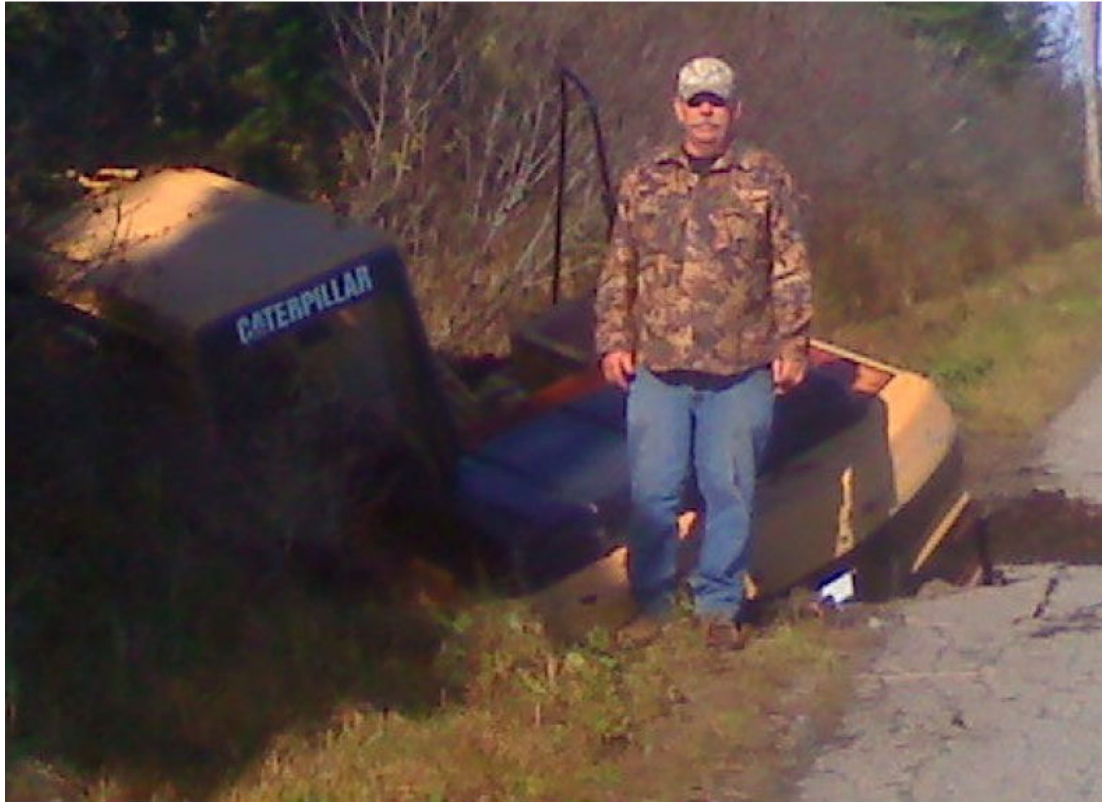
During the first week of November, 2011, a CAT 312B excavator went off the pavement on the Carrying Place Cove Road just south of the intersection with South Lubec Road, and sank.

This is a small excavator, and the calculated stress under the shoes, unloaded, is on the order of 920 psf or 6.3 psi. The strength of the peat was not adequate to support this weight. No testing was done on our peat samples due to both technical difficulties in obtaining an undisturbed sample and questions about the meaning of tests on peat, but the difference in strength between the peat in this location and the material around the corner in the area of concern are likely to be small.
