Milo, Maine

Pleasant River Bridge

Bridge #3244

Deck Core Sampling Results

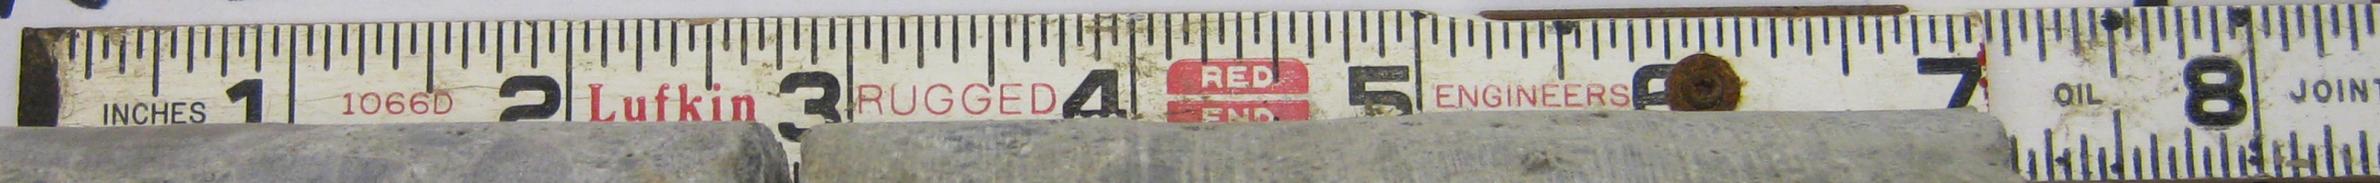
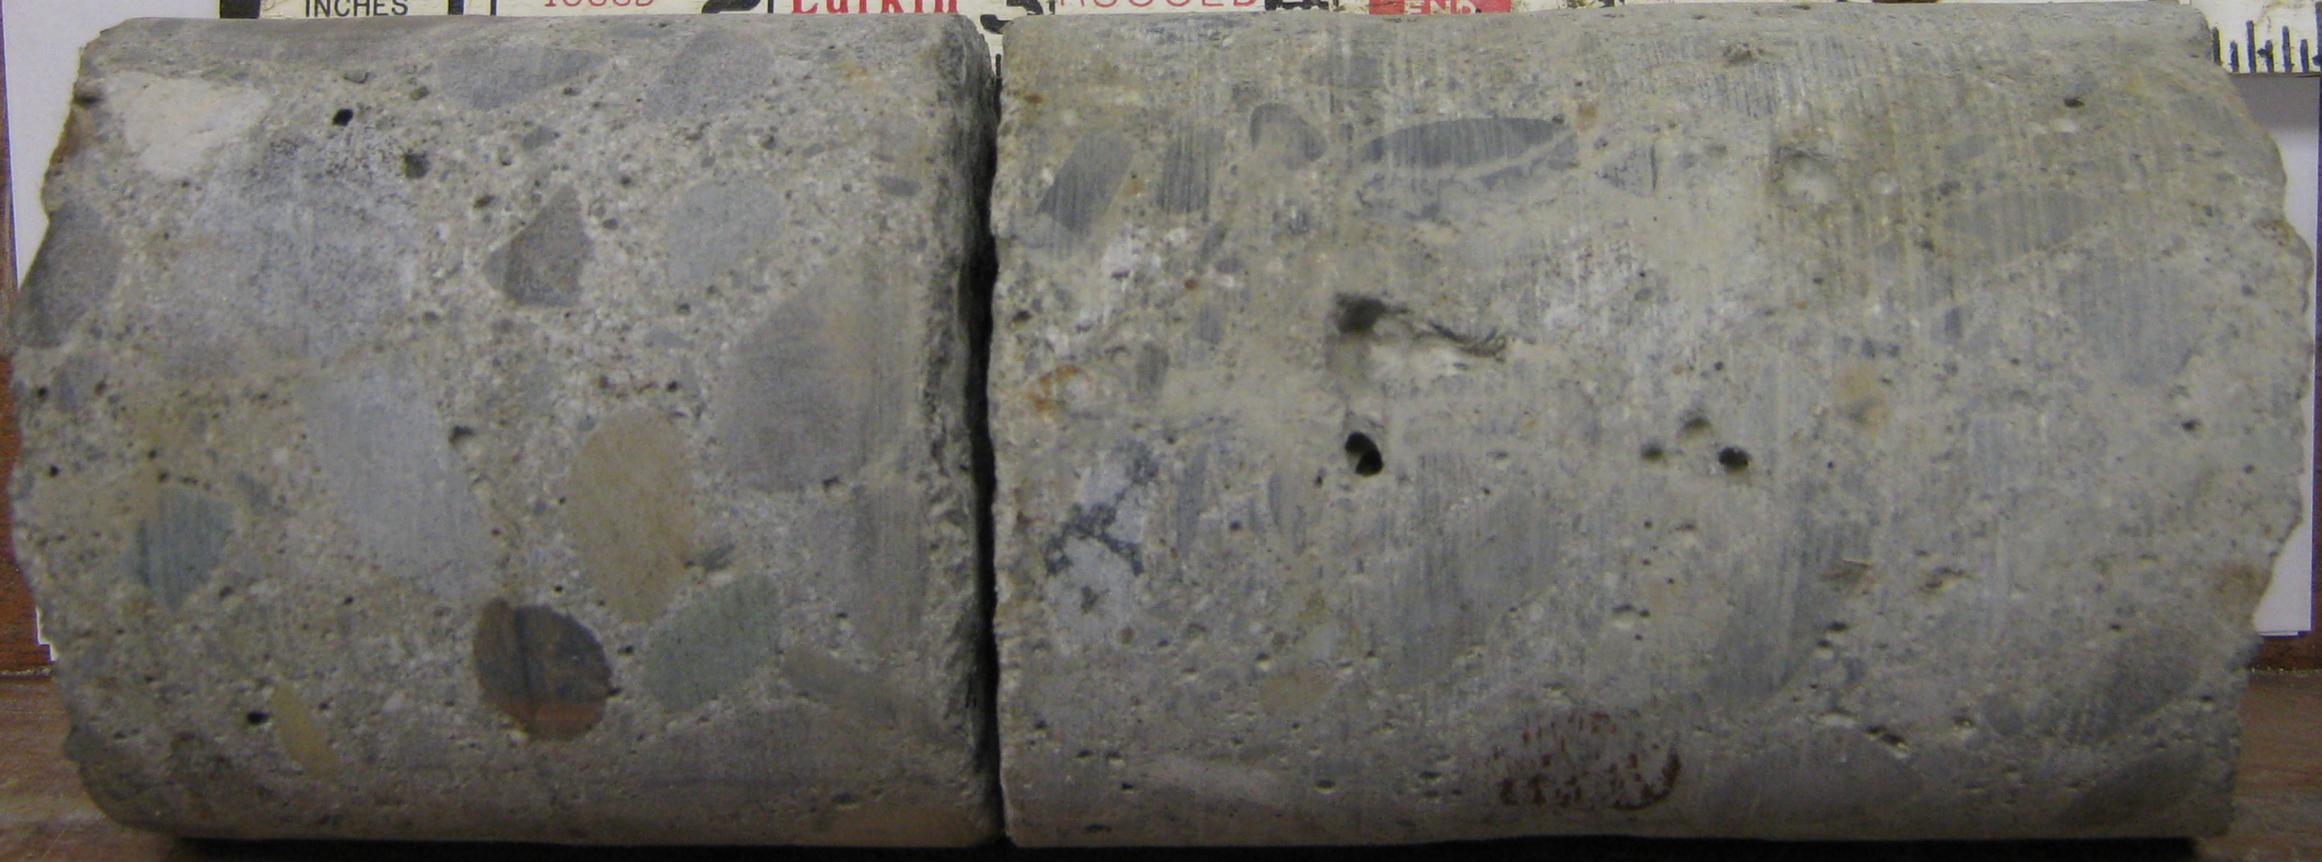
Pleasant River Bridge Core #

Location, inch	Chloride Level, lb/yd ³
0.0-0.5	3.09
1.0-1.5	2.05
2.0-2.5	1.26

Location, inch	Strength, psi
Specimen 1	3.0-7.0	5621.00
Specimen 2

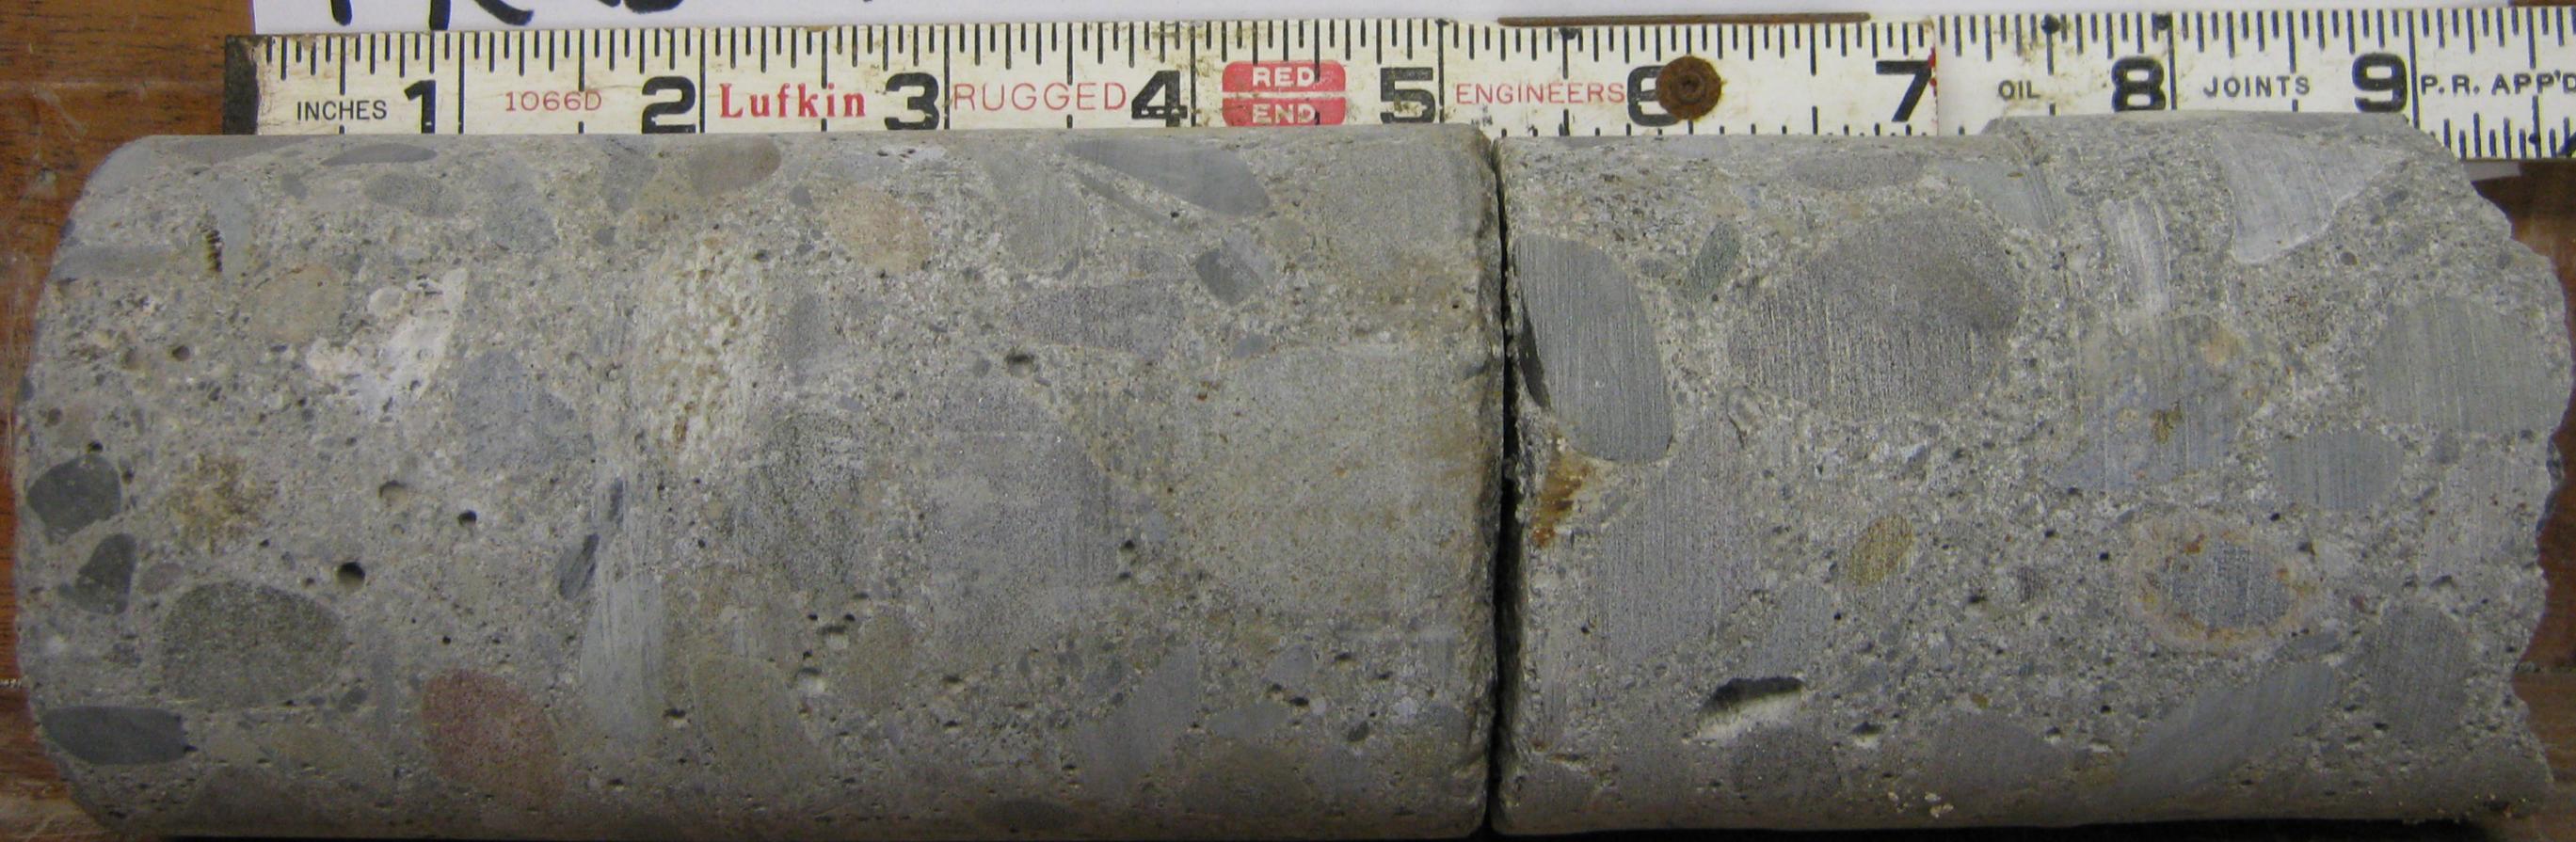
Pleasant River Bridge Core # 2

Location, inch	Chloride Level, lb/yd ³
0.0-0.5	9.72
2.5-3.0	4.51
5.25-5.75	1.77

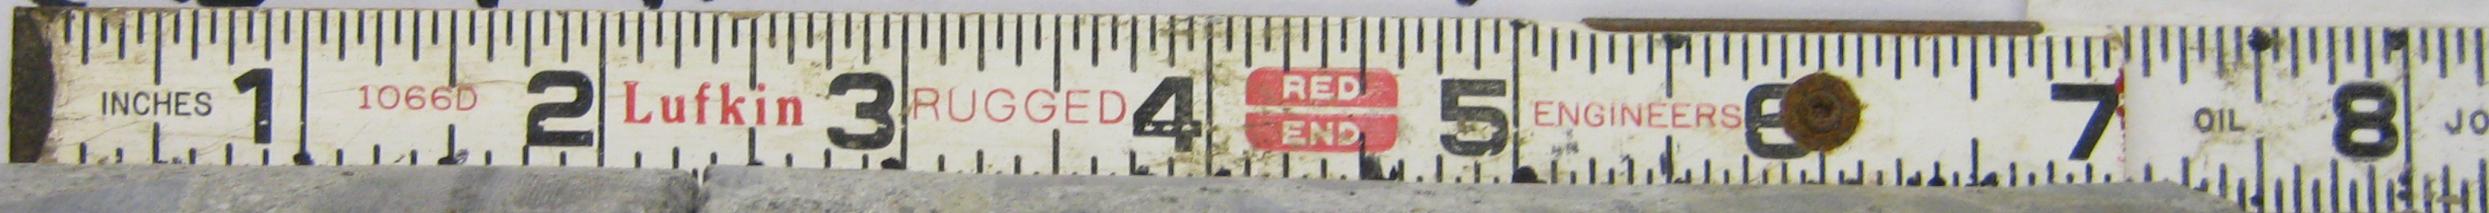
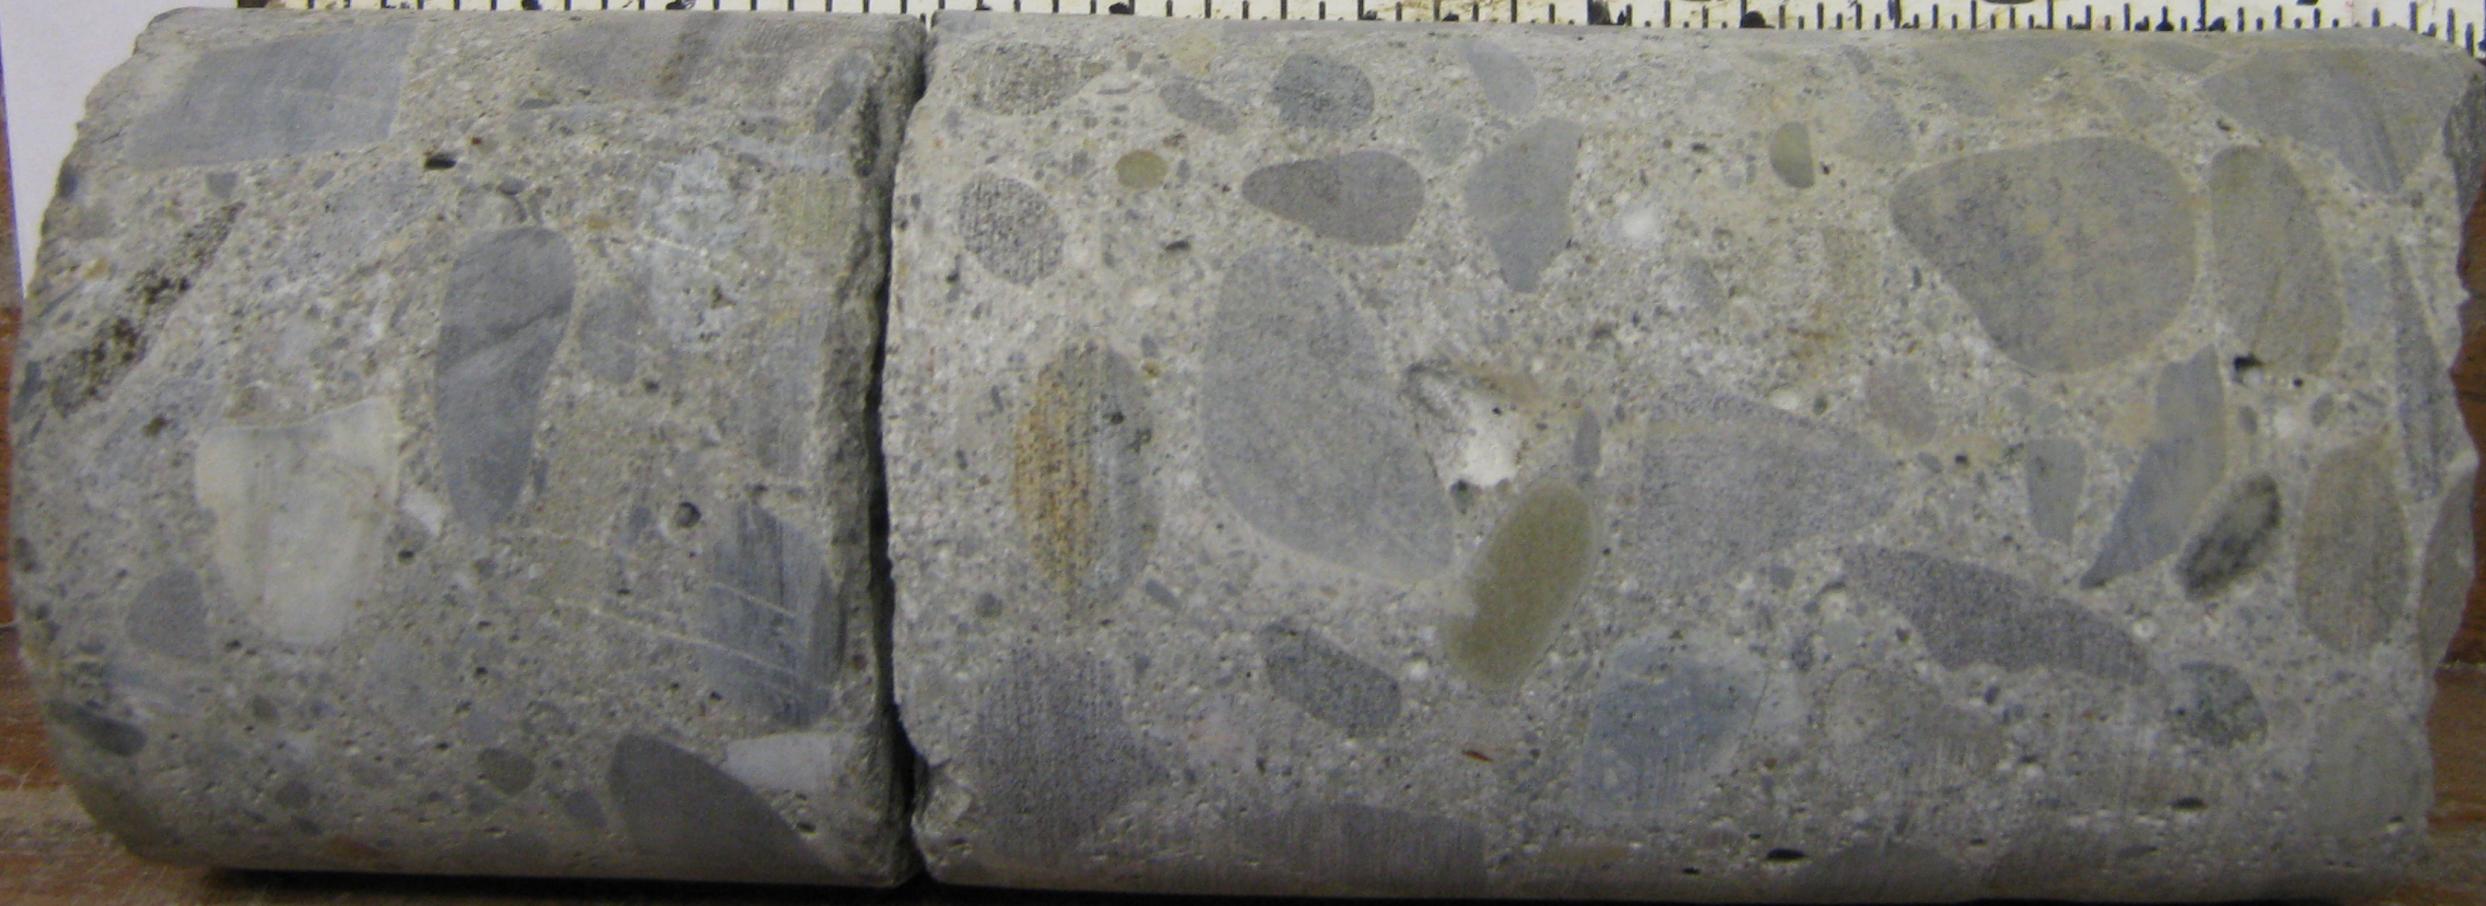
Pleasant River Bridge Core #

Location, inch	Chloride Level, lb/yd ³
0.0-0.5	4.47
2.0-2.5	2.34
2.5-3.0	1.23

Location, inch	Strength, psi
Specimen 1	3.0-7.5	6469.00
Specimen 2

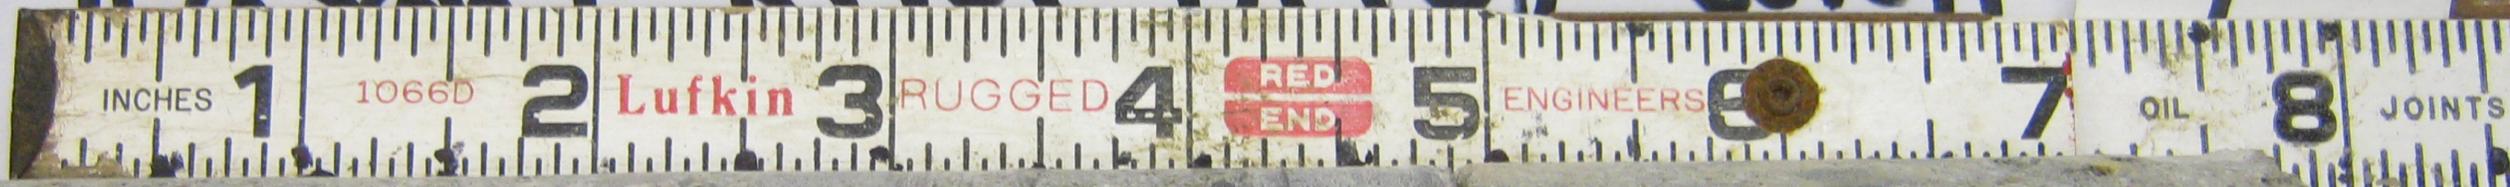
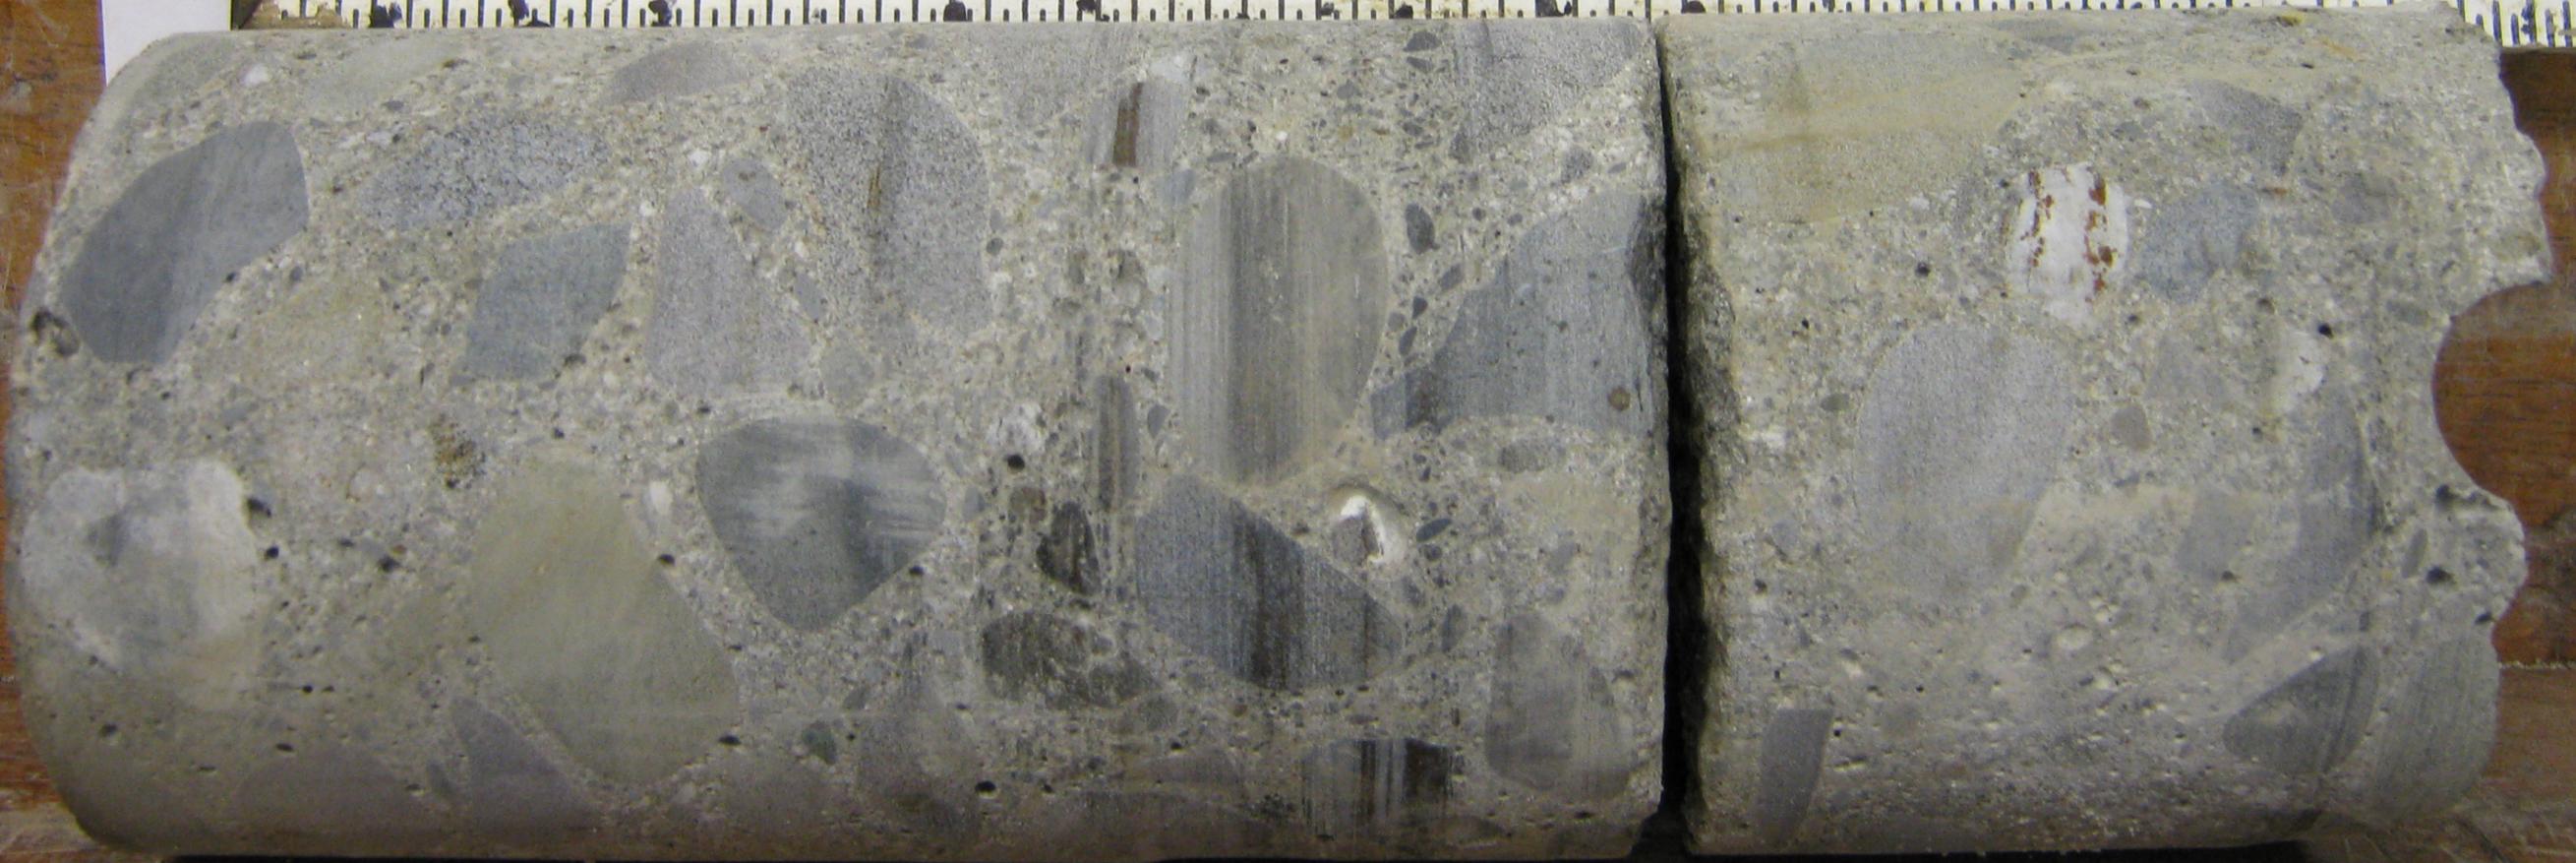
Pleasant River Bridge Core #

Location, inch	Chloride Level, lb/yd ³
0.0-0.5	9.25
2.5-3.0	4.26
5.0-5.5	2.69

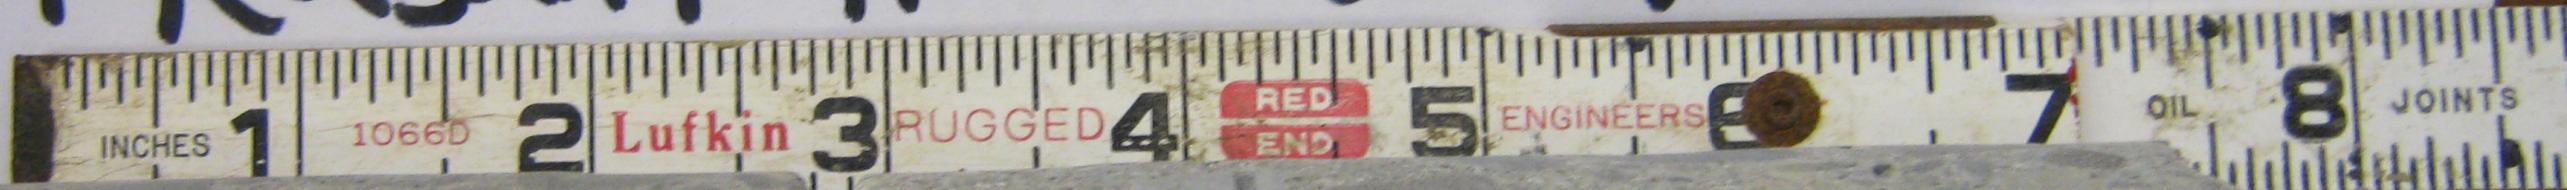
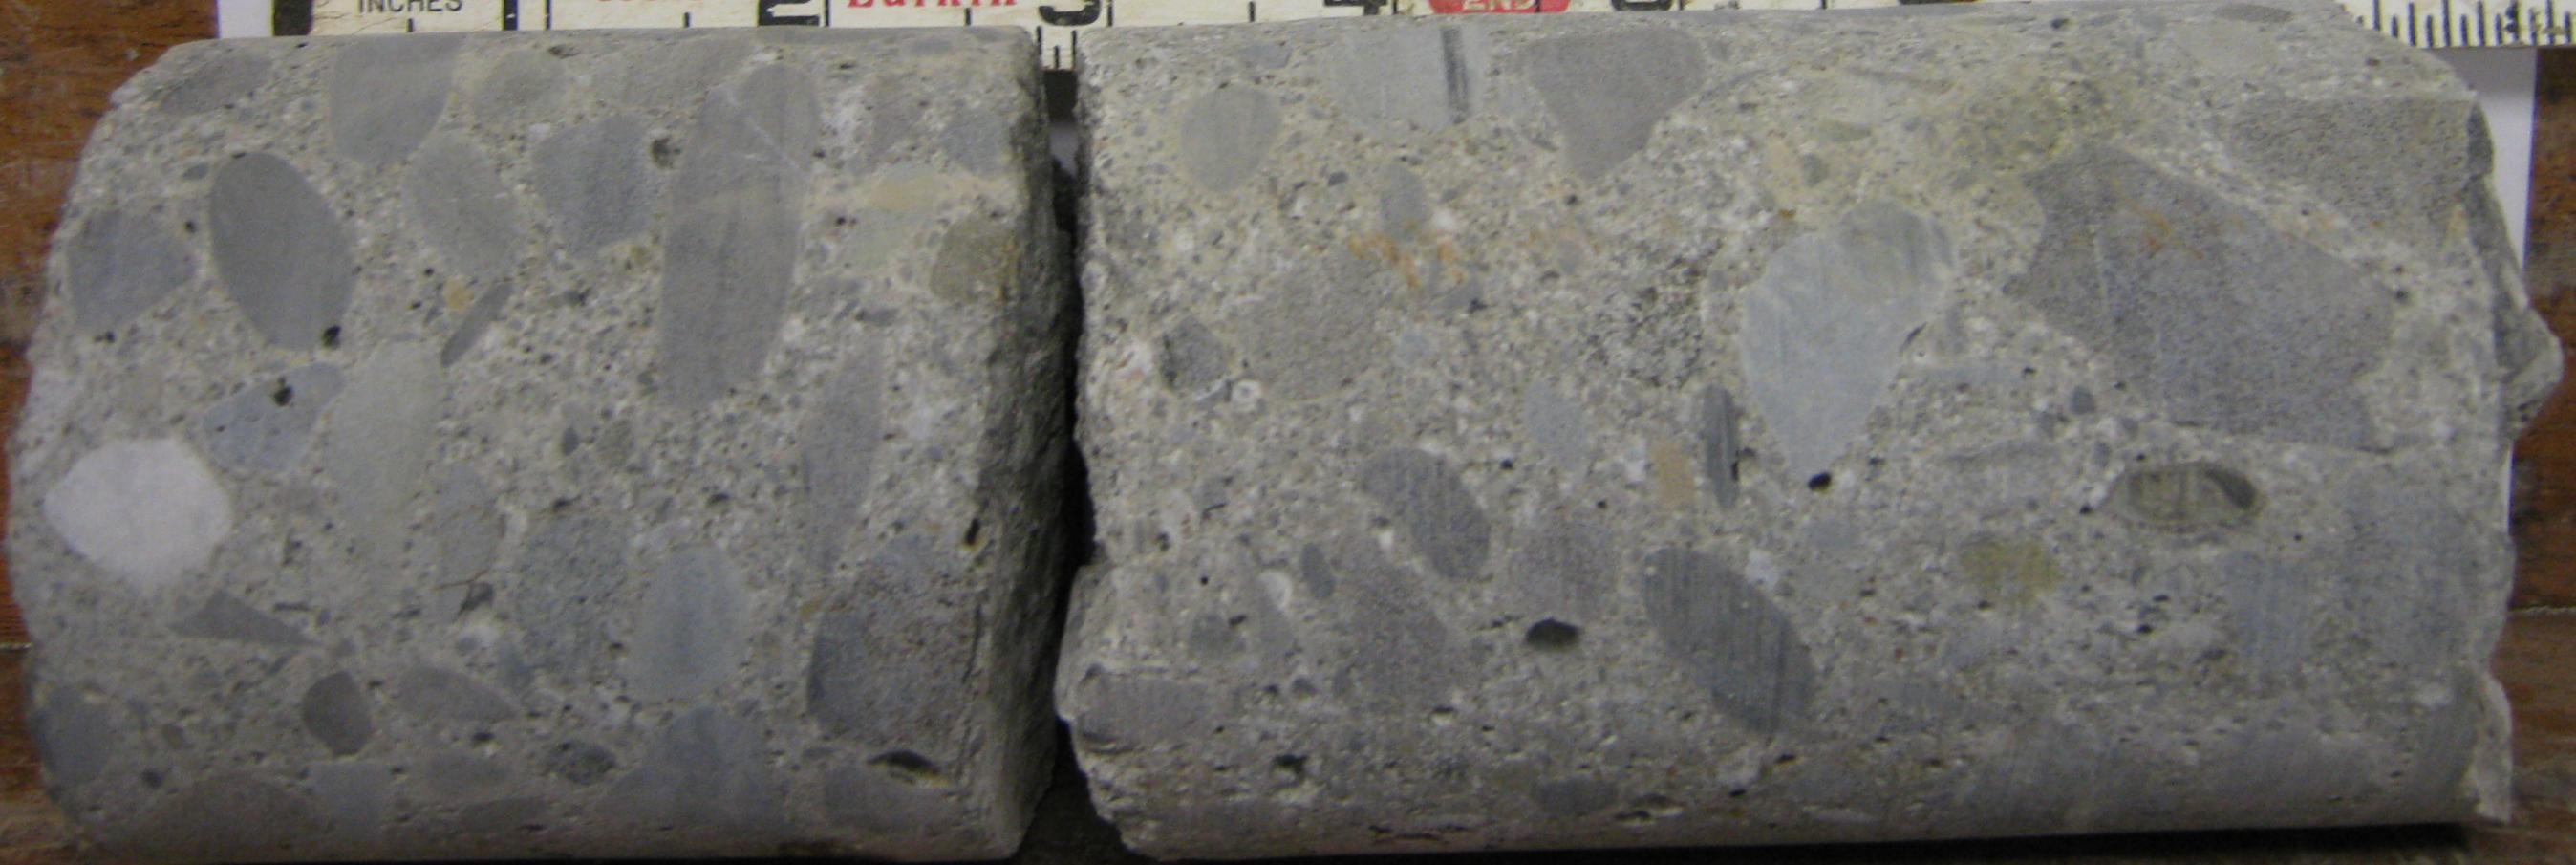
Pleasant River Bridge Core # 5

Location, inch	Chloride Level, lb/yd ³
0.0-0.5	5.15
2.0-2.5	2.23

Location, inch	Strength, psi
Specimen 1	3.0-7.75	5331.00
Specimen 2

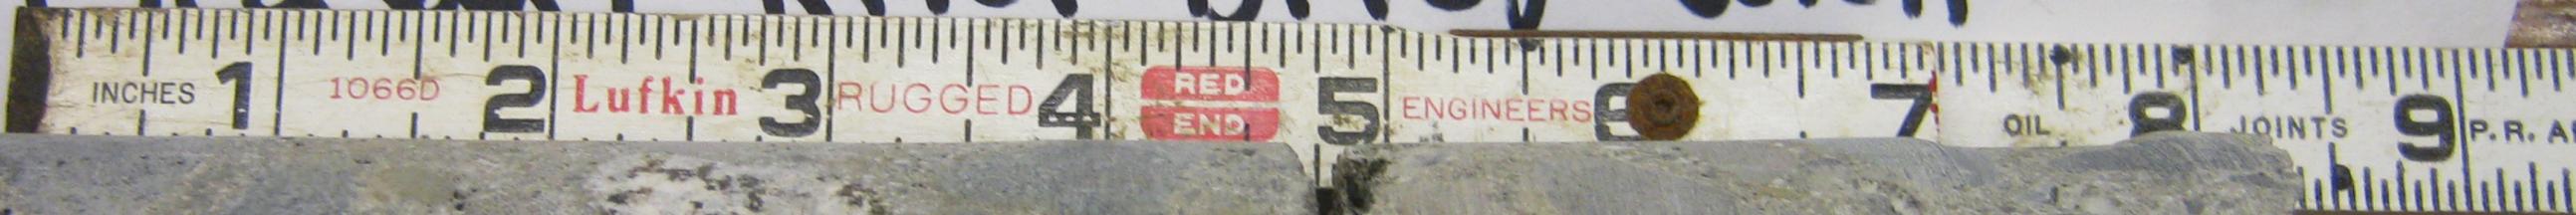
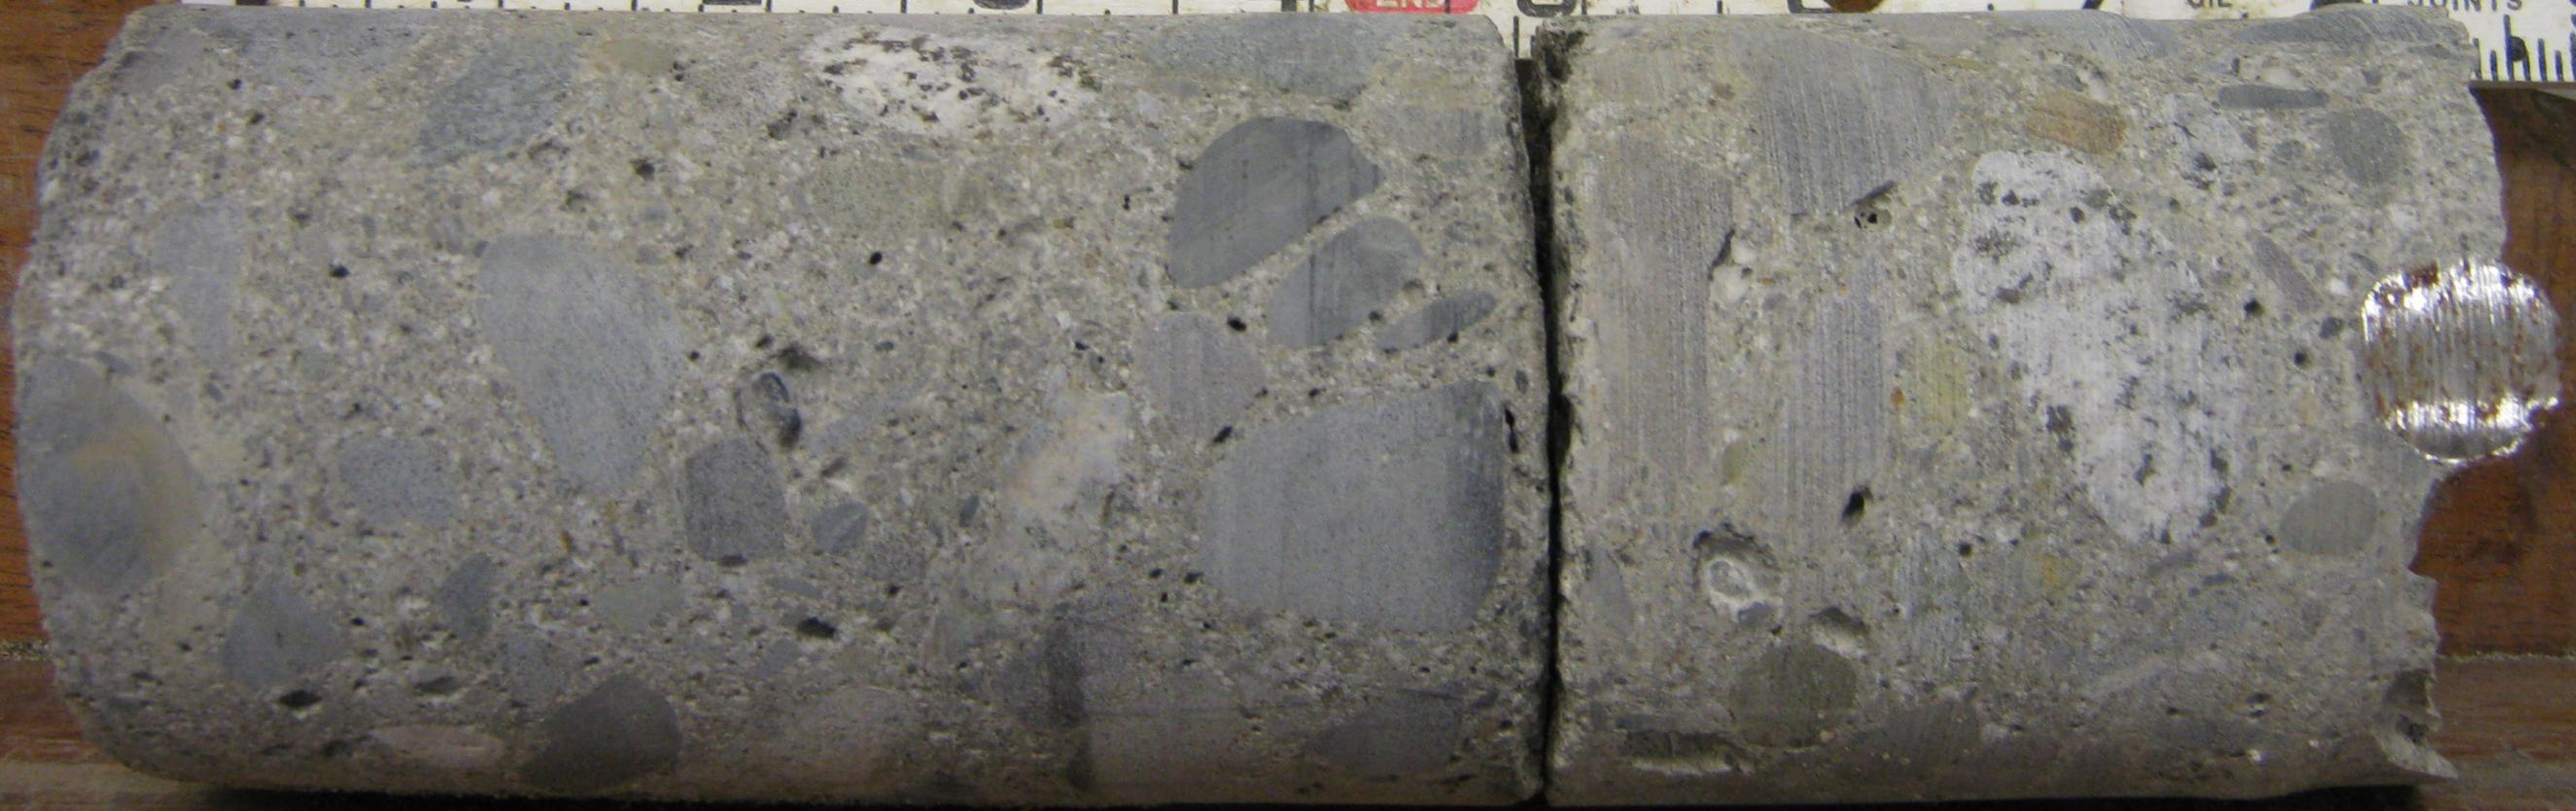
Pleasant River Bridge Core# 6

Location, inch	Chloride Level, lb/yd ³
0.0-0.5	11.66
3.0-3.5	4.13
5.0-5.5	2.74

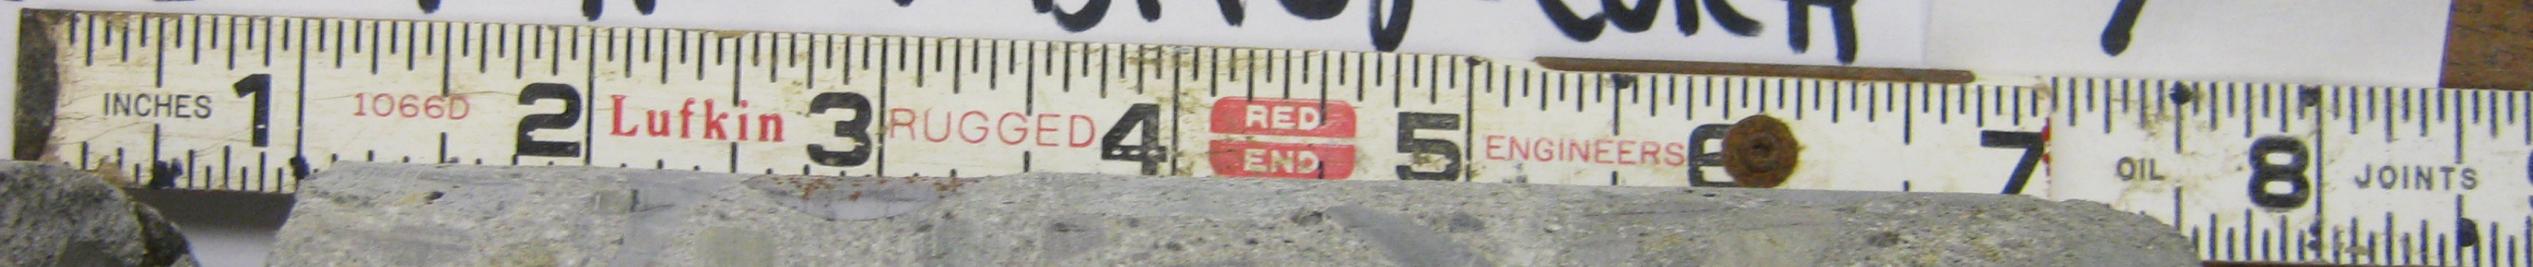
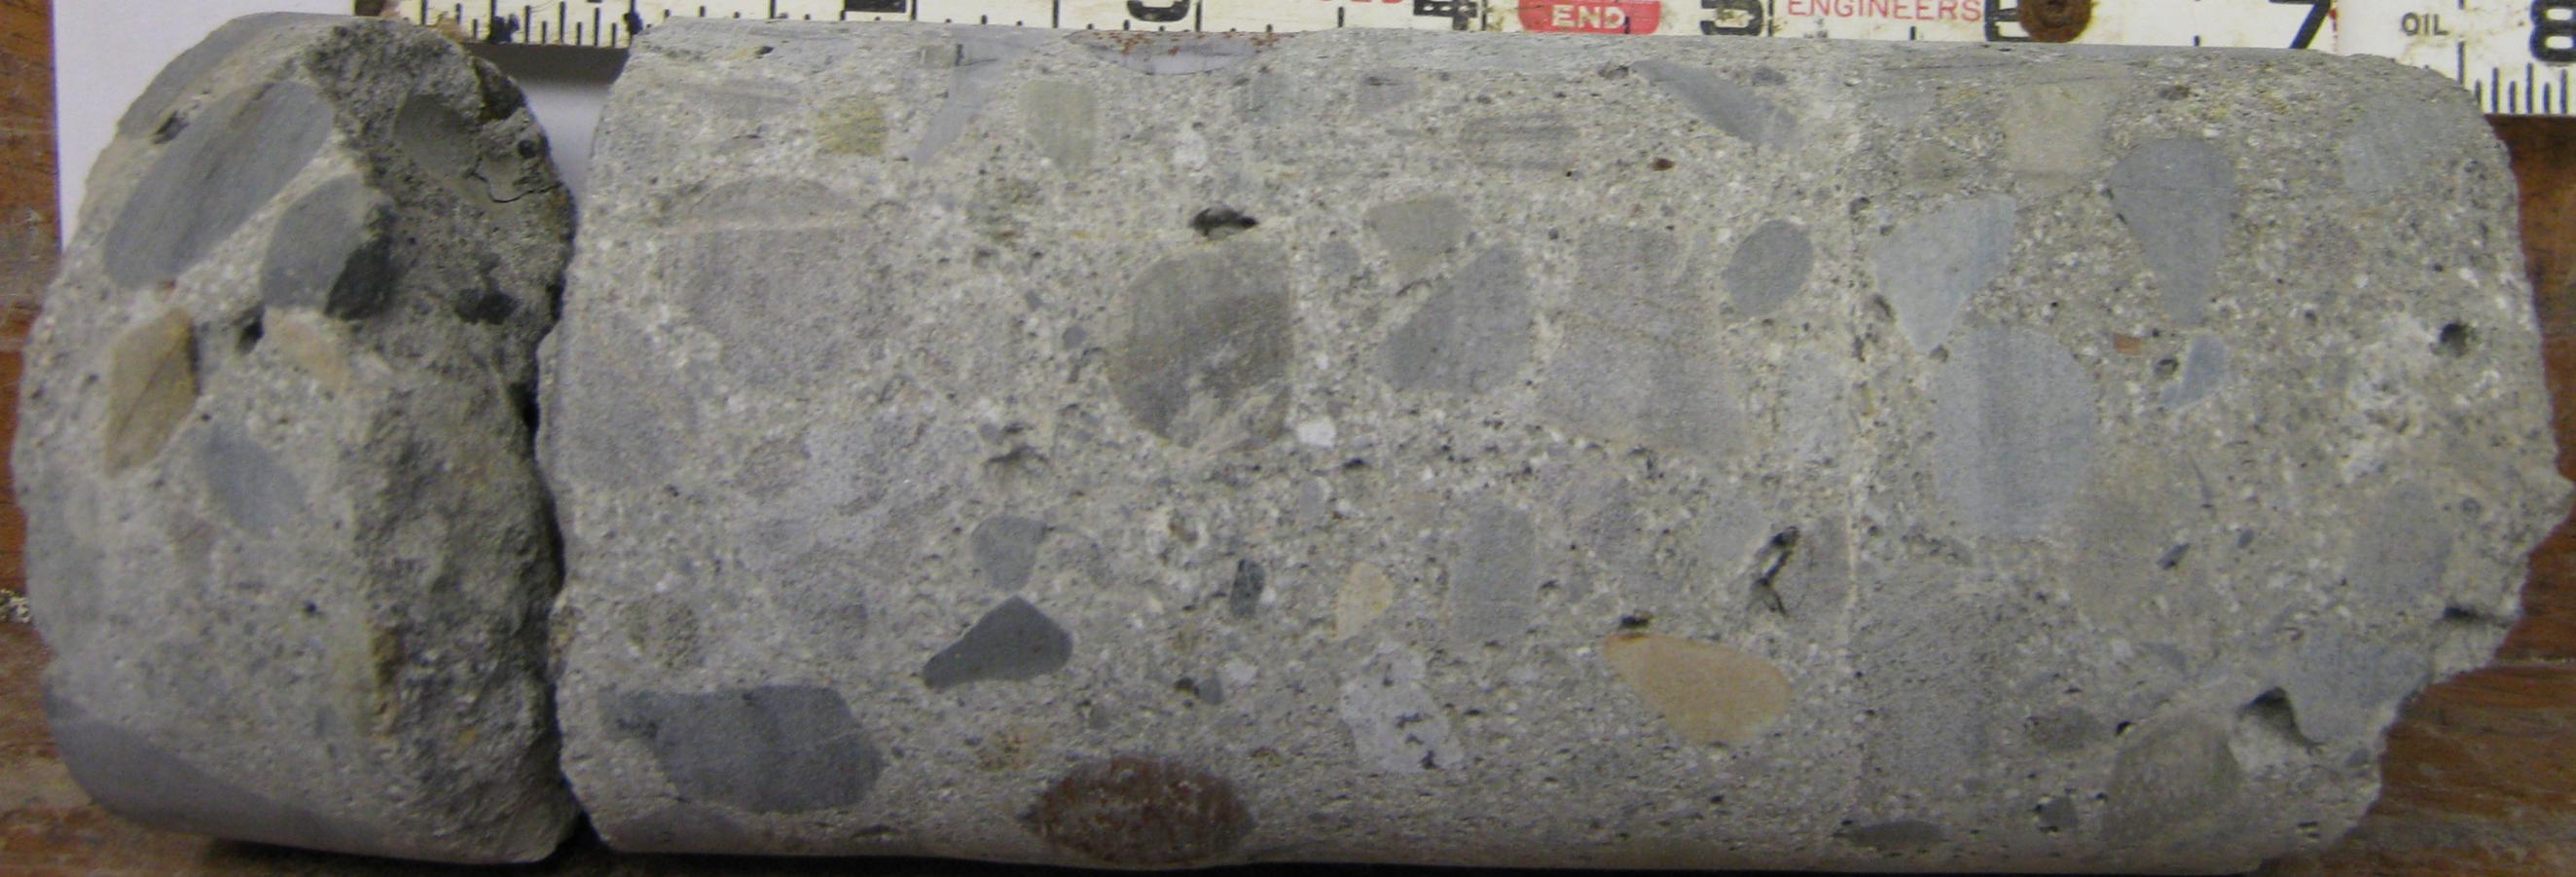
Pleasant River Bridge Core #

Location, inch	Chloride Level, lb/yd ³
0.0-0.5	5.68
1.0-1.5	5.16
4.5-5.0	2.05

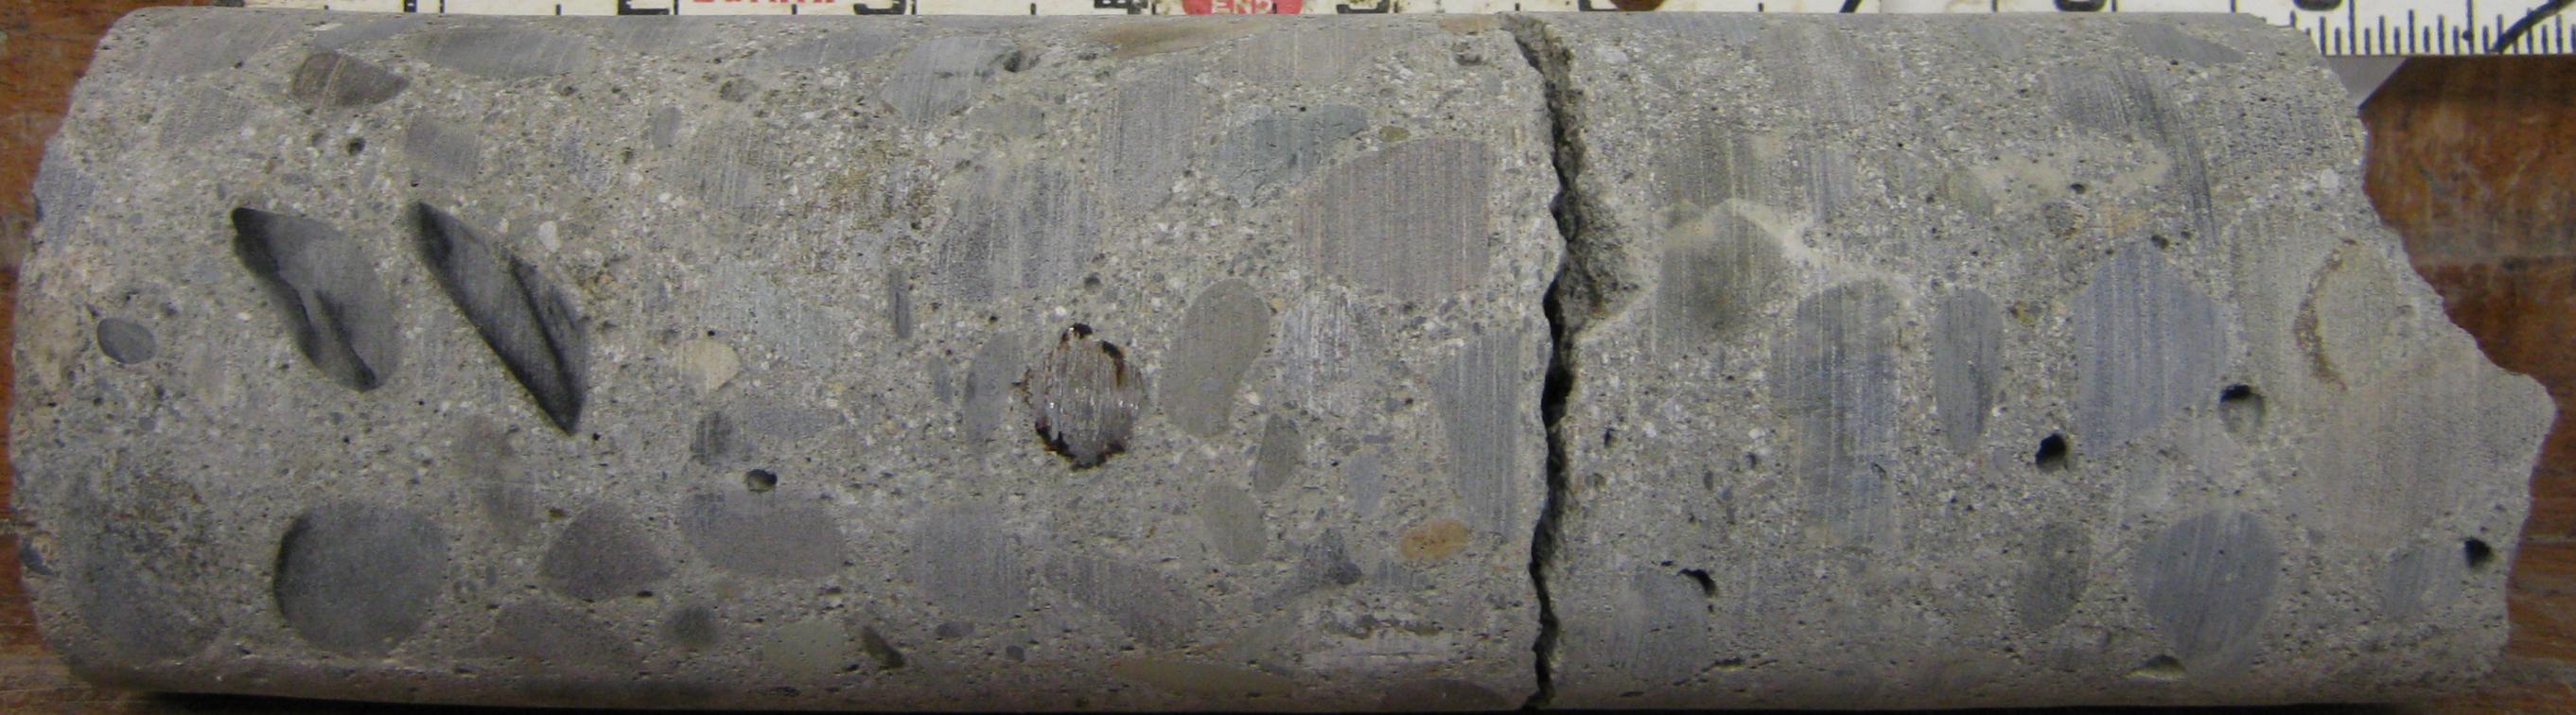
Pleasant River Bridge Core#

Location, inch	Chloride Level, lb/yd ³
0.0-0.5	14.17
2.5-3.0	9.97
5.5-6.0	6.05

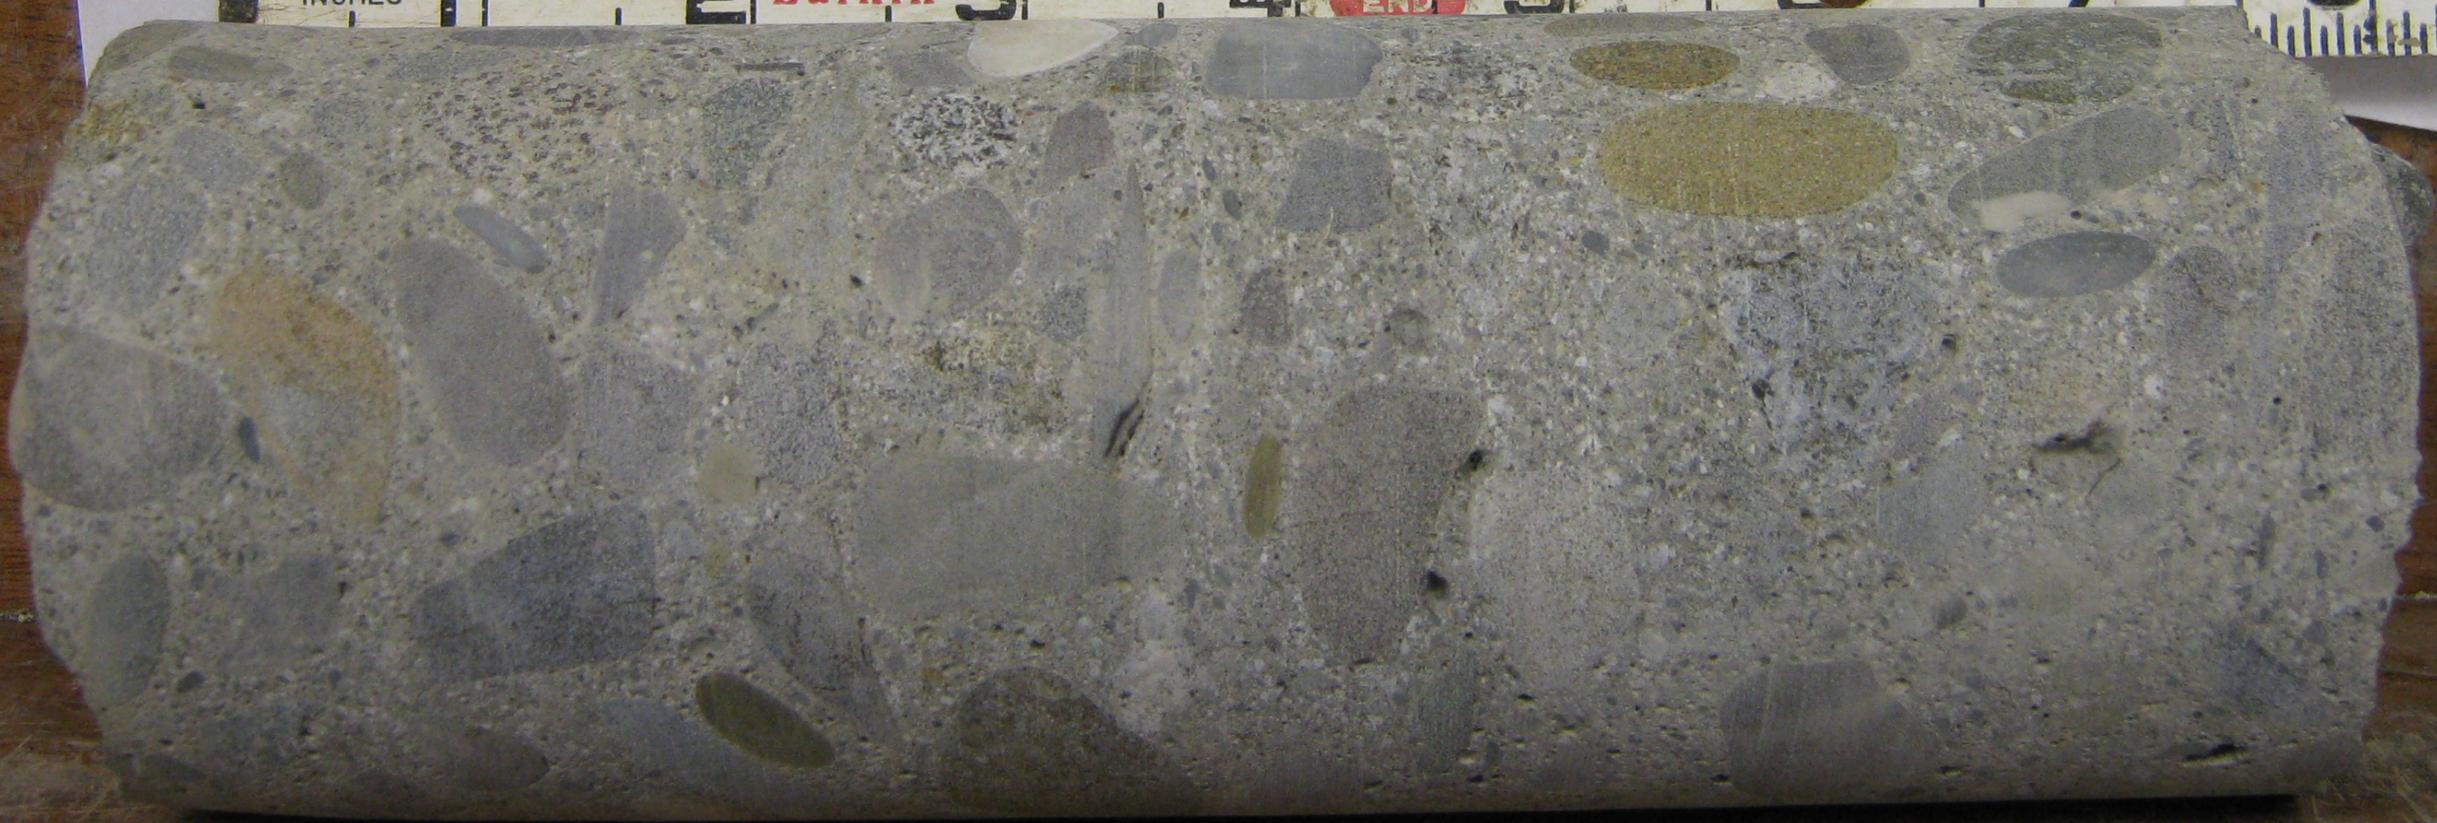
Pleasant River Bridge Core#

- 6) Most of the chloride level measurements from the wearing surface level immediately above the deck range from 1.23 to 6.05 lbs./CY.
- 7) The lowest levels of Cores #9 and #10 measured have extremely high chloride levels, 8.81 lbs./CY and 10.36 lbs./CY. This may indicate slab problem areas, despite the likelihood that these lowest measurements for Cores #9 and 10 were taken in a level of the wearing surface above the slab. It seems the bottom of the measured level was 1 inch above the slab for Core #9, and 2.5 inches above for Core #10).

Location, inch	Chloride Level, lb/yd ³
0.0-0.5	6.45
1.0-1.5	8.81

Location, inch	Strength, psi
Specimen 1	3.5-7.5	4593.00
Specimen 2
