Milo, Maine

Pleasant River Bridge

Bridge #3244

Deck Core Sampling Results

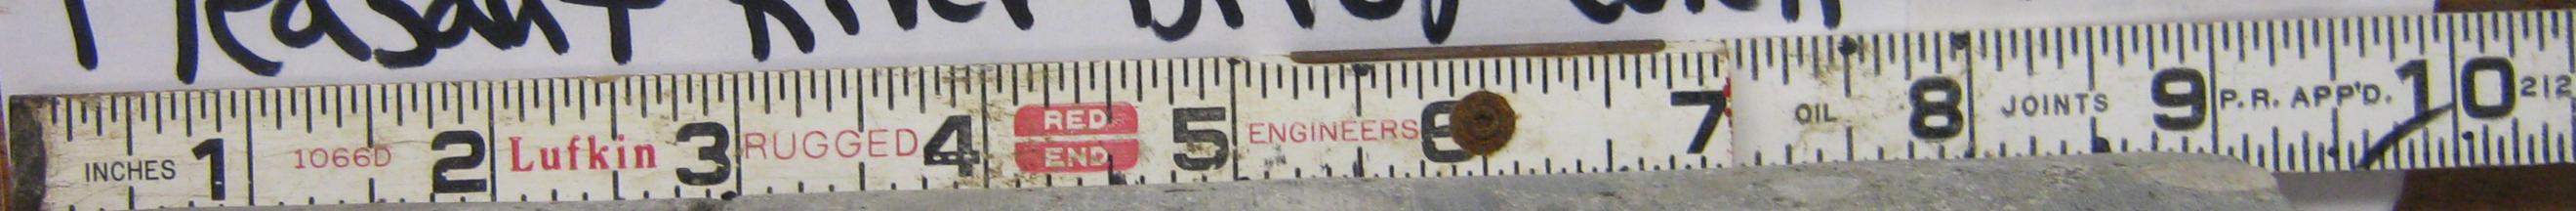
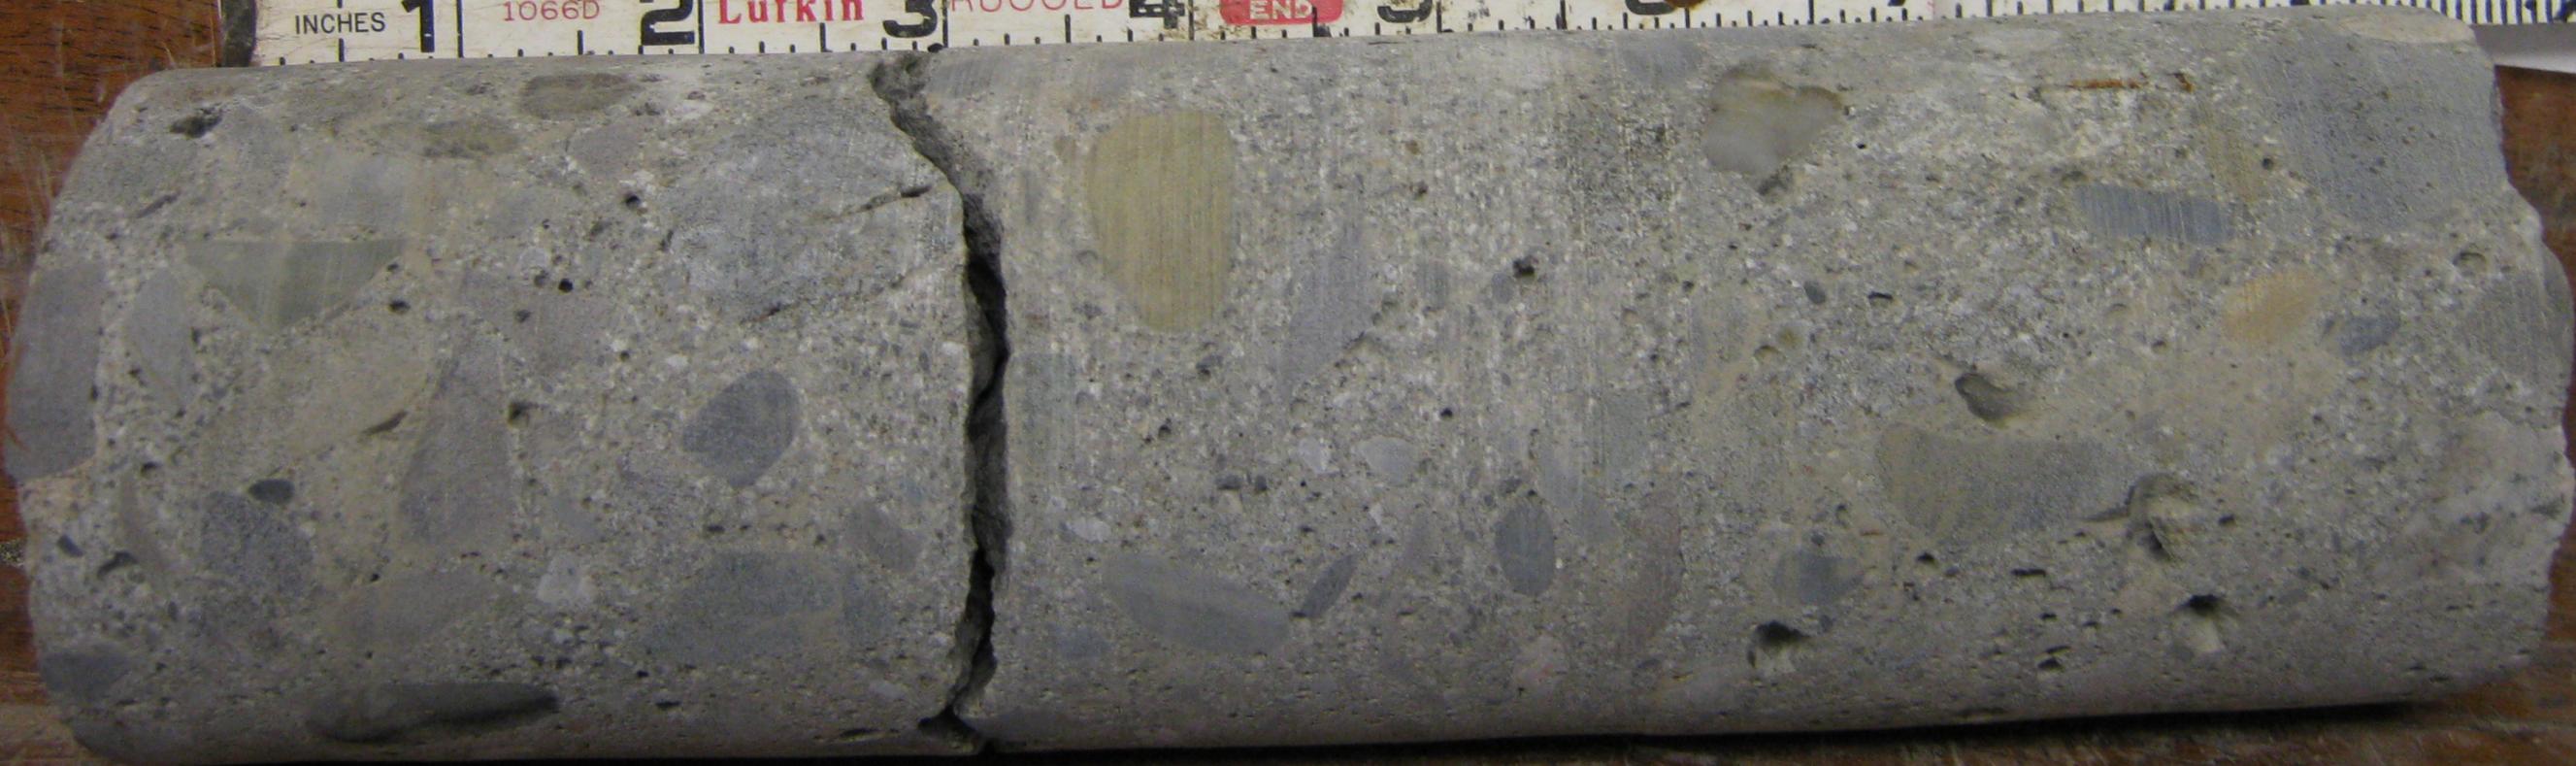
Pleasant River Bridge Core# 10

- 6) Most of the chloride level measurements from the wearing surface level immediately above the deck range from 1.23 to 6.05 lbs./CY.
- 7) The lowest levels of Cores #9 and #10 measured have extremely high chloride levels, 8.81 lbs./CY and 10.36 lbs./CY. This may indicate slab problem areas, despite the likelihood that these lowest measurements for Cores #9 and 10 were taken in a level of the wearing surface above the slab. It seems the bottom of the measured level was 1 inch above the slab for Core #9, and 2.5 inches above for Core #10).

Location, inch	Chloride Level, lb/yd ³
0.0-0.5	11.31
2.5-3.0	10.36

Location, inch	Strength, psi
Specimen 1	5.0-9.5	5001.00
Specimen 2

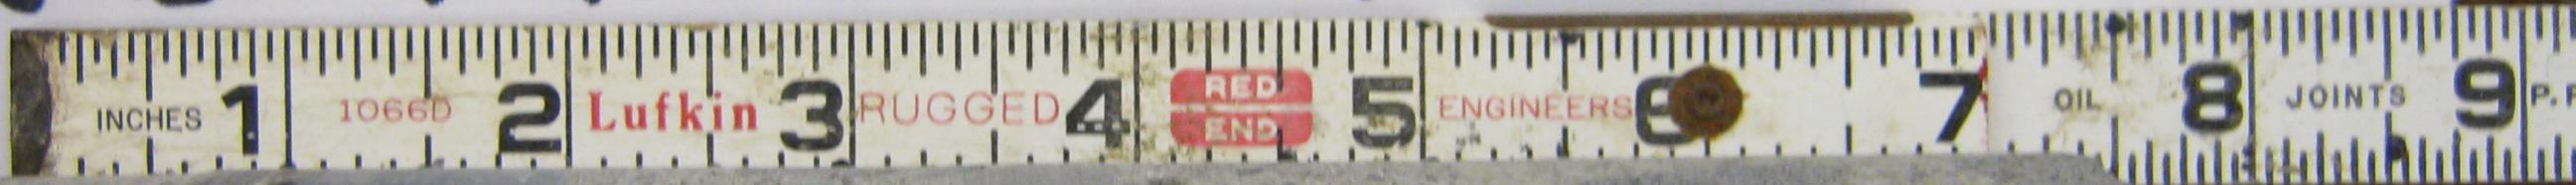
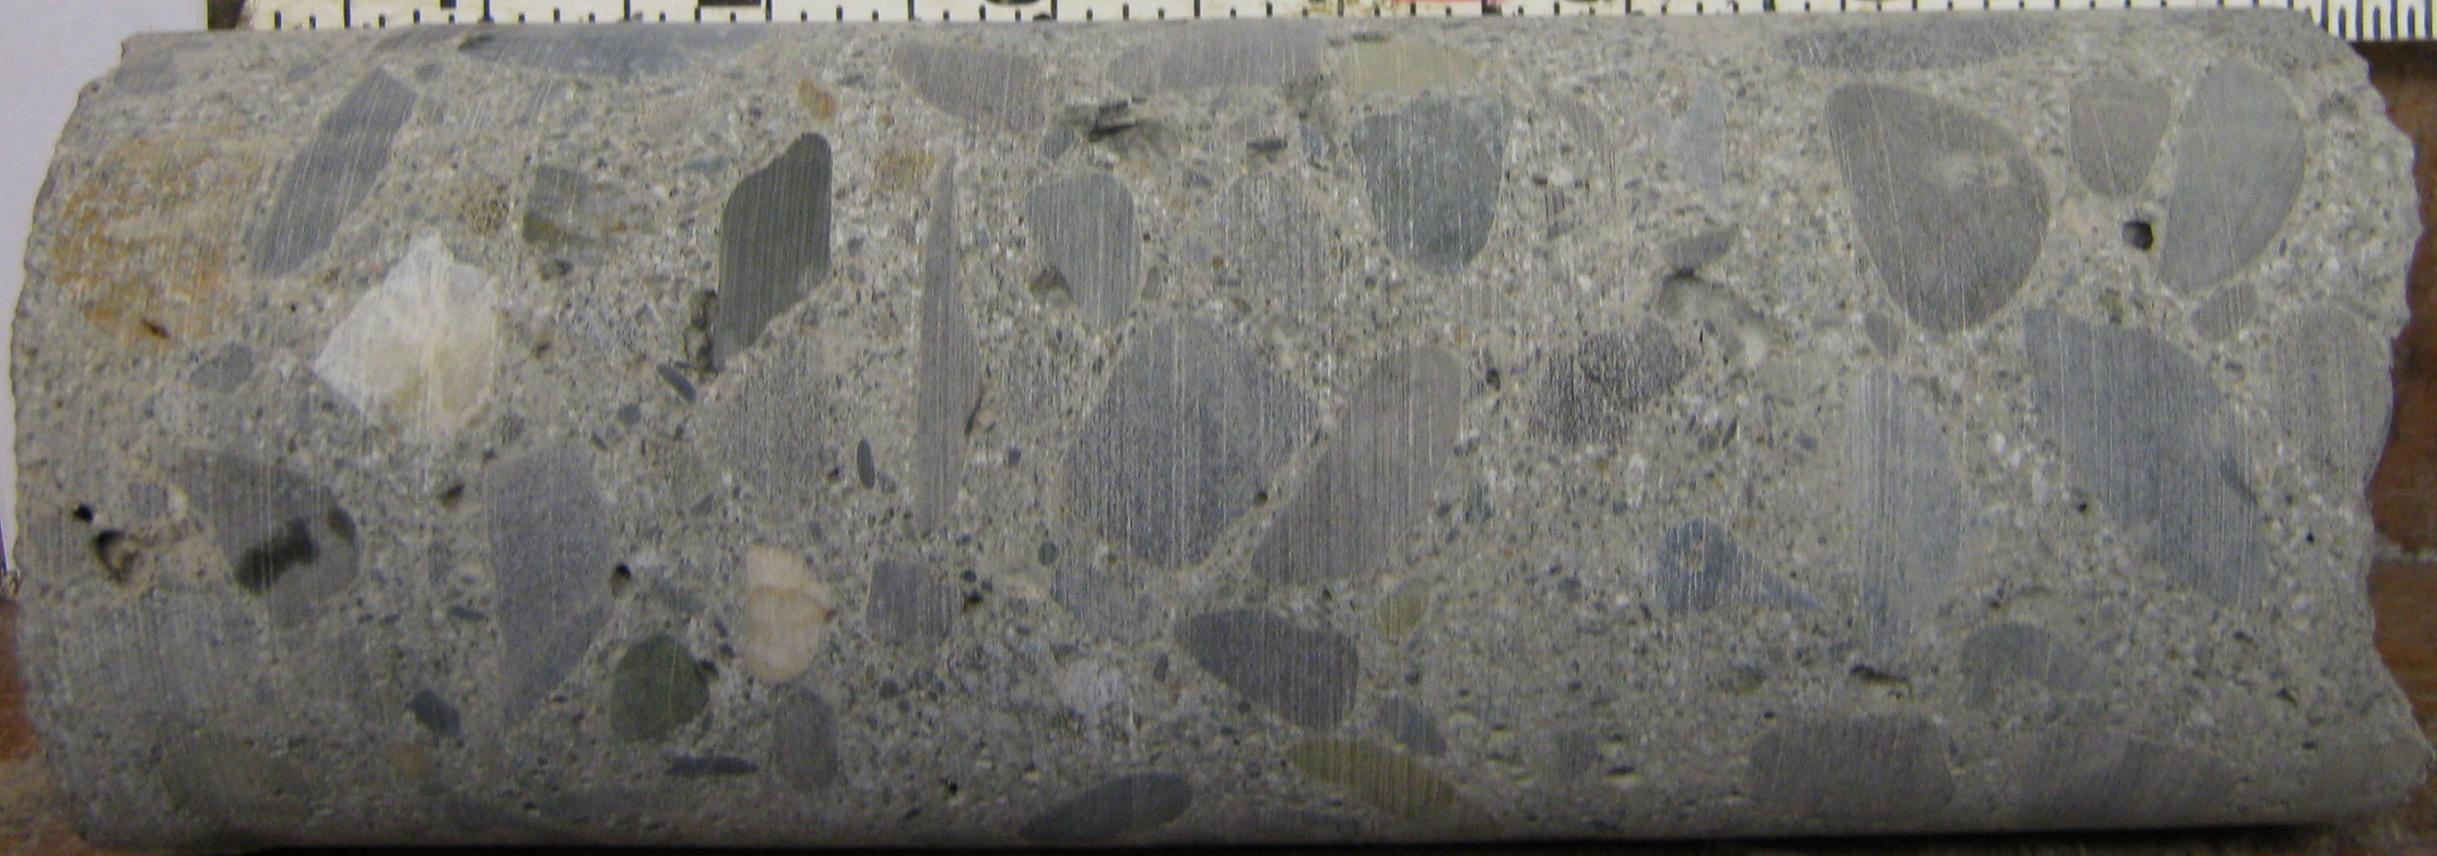
Pleasant River Bridge Core #

Chloride Content (T 260)	
Location, inch	Chloride Level, lb/yd ³
0.0-0.5	10.77
1.0-1.5	5.37

Compressive Strength (T 22)		
	Location, inch	Strength, psi
Specimen 1	1.75-6.0	4263.00
Specimen 2

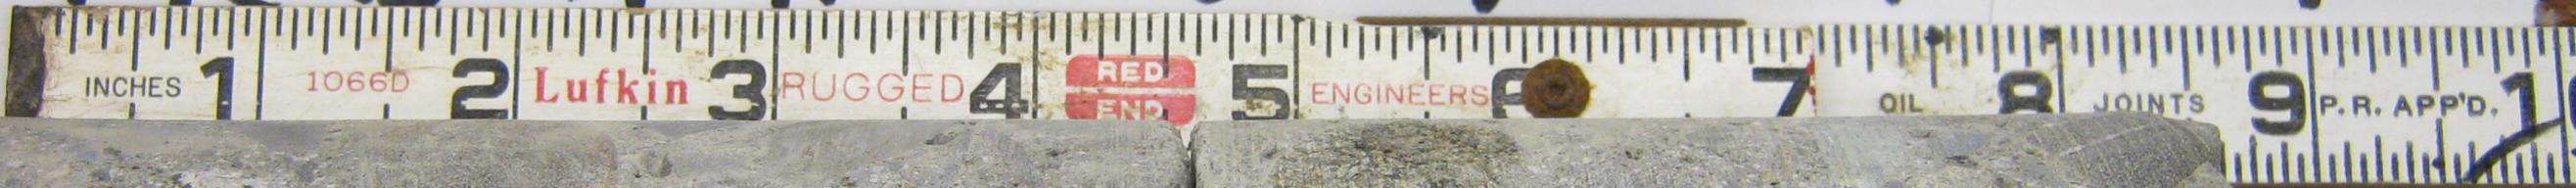
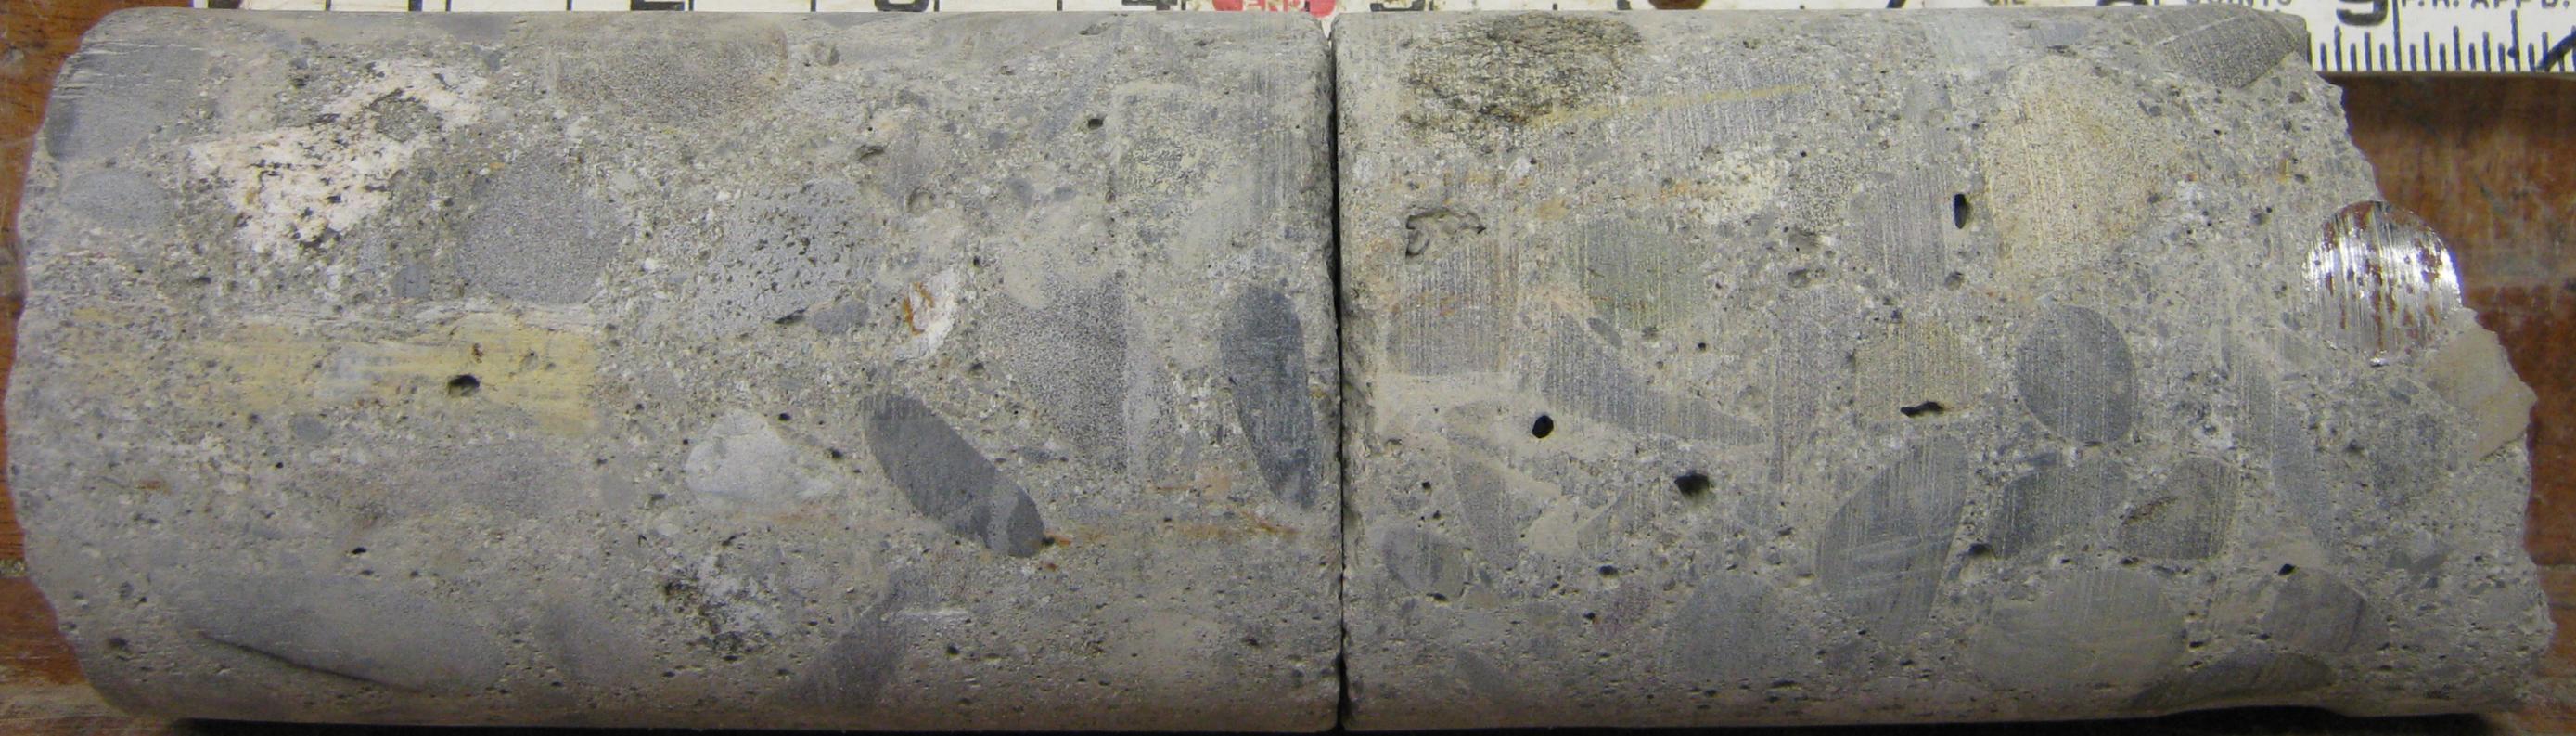
Pleasant River Bridge Core #

Location, inch	Chloride Level, lb/yd ³
0.0-0.5	12.24
1.0-1.5	9.88
2.5-3.0	5.09

Location, inch	Strength, psi
Specimen 1	4.5-8.5	6272.00
Specimen 2
