MGS Memos and DEP Permits

Brunswick, Miller Point

Brunswick, Bunganuc Bluff

Lubec, Shoreline Restoration

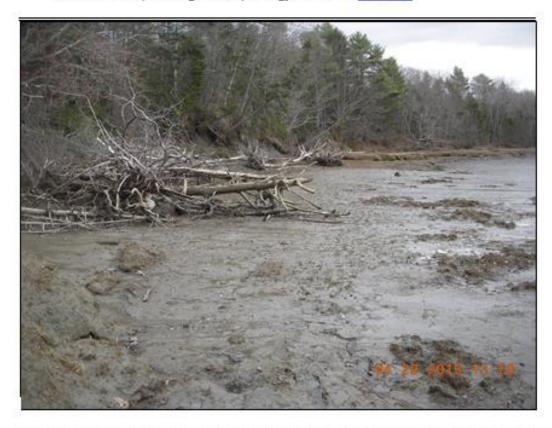
Figure 1. This photograph shows the Miller Point shoreline in the xicinity of the project area. Unstable slopes (Bryant et al., 2002) of Presumpscot Formation mud experience slope failures that lead to drift logs on the upper intertidal profile and sediment platforms that become colonized with salt marsh vegetation. Fringing marshes exist in the foreground (lower left) and distance. These marsh segments are experiencing erosion as part of a natural cycle. Eroded sediment is contributed to the adjacent mud flats. MGS file photo by S. M. Dickson, April 29, 2015.

On May 12, 2015 MGS met on the site with staff from DEP, IF&W, Joe LeBlanc of LeBlanc Associates, Inc. (project engineer), and Lance Linkel of Linkel Construction. The outcome of these discussions was a revised hybrid engineering design that incorporates on-site sediment and trees that are destined to fall into the intertidal zone due to landslides and slumps (Figures 1 and 2; Bryant et al., 2002; Dickson, 2001).

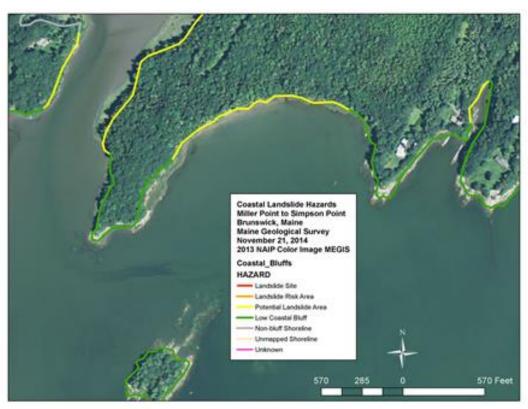
Figure 2. A portion of the MGS Coastal Landslide Hazards Map for Miller Point, Brunswick, Maine. For a full explanation of the map units and processes see Dickson (2001). The proposed hybrid shoreline stabilization project is in the Potential Landslide Area above the legend. Also visible are fringing salt marshes along the Low Coastal Bluff near both bedrock peninsulas framing the cove. Within the project area there are intermittent patches of fringing salt marsh. The tide in this image is close to high. Most of the cove (above the legend box) becomes subaerial at low tide. The engineering footprint is approximately twice the yellow line width. Map by S.M. Dickson, November 21, 2014.

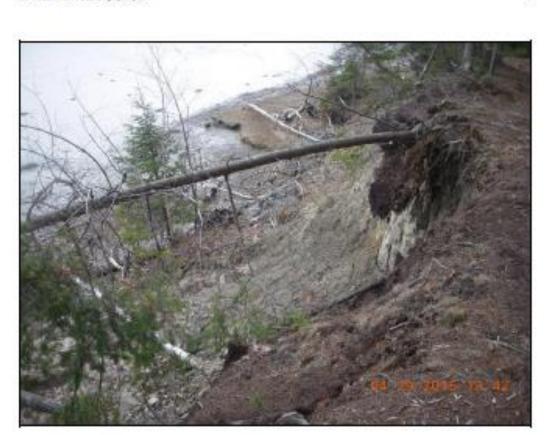
Figure 3. This image shows the top of an eroding coastal bluff at Miller Point in Brunswick, Maine. This bluff is also prone to episodic landslides that deposit sediment in the high intertidal zone and become colonized with salt marsh (upper part of photo with drift log). Based on historical air photos, the large drift log has been on the marsh for at least a decade. Note how the edge of the fringing marsh is eroding with a relief of 2-3 feet. MGS file photo by S. M. Dickson, April 29, 2015.

This design, to the maximum extent practicable, mimics the transfer of soil from land to the sea over what we estimate to be the next one to two decades. Without any shoreline stabilization, natural slope failures at this site will result in the injection of large volumes of muddy sediment (the Presumpscot Formation; Weddle, 2000) into the upper intertidal zone. This sediment is often colonized by salt marsh vegetation resulting in a fringing marsh at the toe of the coastal bluff that helps protect the bluff from further erosion (Figure 3; Kelley et al., 1988).

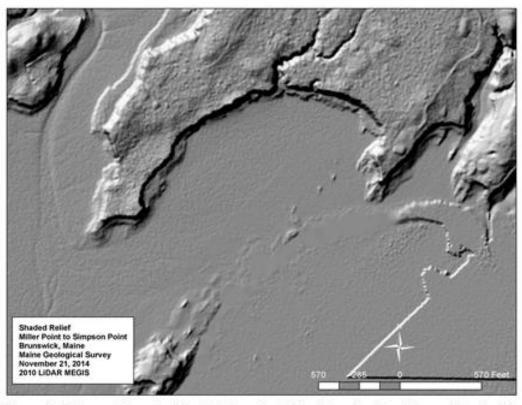
Figure 4. This map shows shaded relief along the Miller Point shoreline. The eroding bluff is cast in shadow. Along the north shore of the cove (and partially masked in shadow) are patches of fringing salt marsh seen as terraces. The marsh is more continuous along the east and west shore of the cove. The proposed project would create a more continuous fringing marsh along the shoreline. The linear discontinuity near the north arrow is an artifact of different tide levels. Topography collected by Light Detection and Ranging (LiDAR) from an aircraft. Metadata is available at the Maine Office of GIS web site. Map by S.M. Dickson, November 21, 2014.

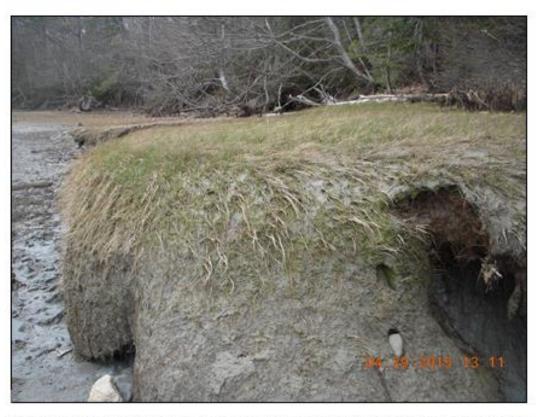
Figure 5. This photo shows an eroding fringing marsh with a seaward embankment of 2-4 feet of relief. The proposed project would create an embankment of drift logs of similar relief to help a marsh get established. Over time the engineered marsh and drift logs are expected to decay and time-release sediment to the intertidal zone in a manner somewhat analogous to the existing process. MGS file photo by S. M. Dickson, April 29, 2015.

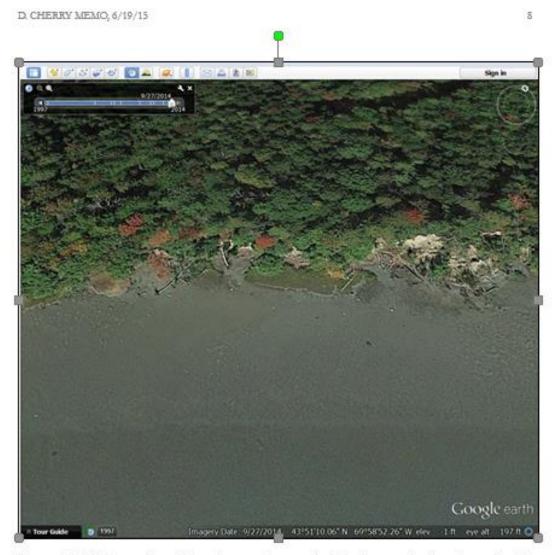
Figure 6. This image shows the project area in a vertical air photograph taken September 27, 2014. Fringing salt marshes occur in patches and have indentations that will be infilled with sediment and planted with native vegetation in the proposed project. Along the right (east) edge of the image is a landslide area with exposed Presumpscot Formation above the slump block. Image courtesy of Google Earth.

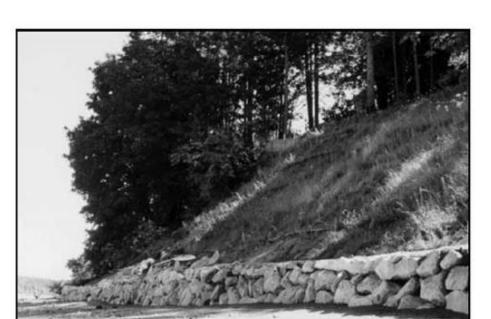
Figure 2. View from the beach. The lift layers can be seen. The slope is approximately 1H:1V, compared to its original near-vertical pre-construction state. The bluff is 30+ feet tall (the rock bulkhead is 5-6 feet high).

Figure 2. A reproduction of Figure 2 from page 19 of Zelo et al. (2000) showing a stabilized and vegetated bank with a 1:1 slope in Washington State.

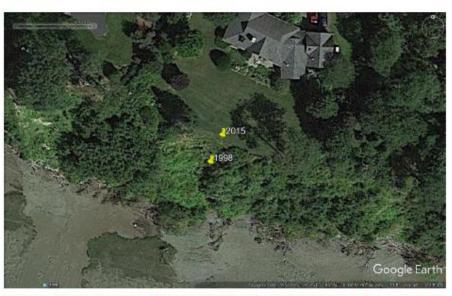
Figure 1. Shoreline change at Bunganuc Bluff seaward of the Carey residence. Each pin shows the location of the top of the bluff in different years. The bluff retreated 25 feet from 1998 to 2015 for an erosion rate of about 1.5 feet per year.

Because land movements are episodic, a time span of many years is needed to calculate an average annual erosion rate. We estimate that the top of the bluff retreated about 25 feet from 1998 to 2015 using historical images in Google Earth along a transect seaward of the house (Figure 1). This included a period of stability from 1998 to 2003 at the transect while there were slope failures to the west and east (Figure 2). Around the year 2012 there was a landslide on the transect (Figure 3). By 2014 there was a salt marsh established in the high intertidal zone on the slumped sediment (Figure 4). The average retreat rate from 1998 to 2015 was about 1.5 feet per year at the top of the bluff. Smith (1990) also calculated a rate of Bunganuc Bluff erosion from the base of the slope to be 1.5 feet per year between 1940 and 1986.

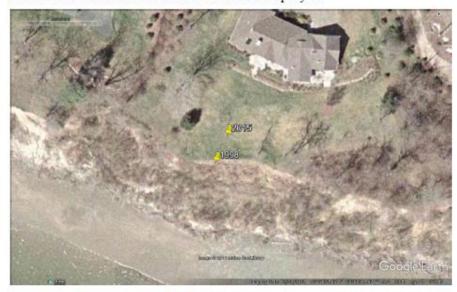
Figure 2. This December 31, 2002 photo shows the same pins as in Figure 1. From 1998 to the date of the photo there is very little retreat of the top of the bluff where the pins are located. Exposed sediment on the bluff face on the left and right sides of the photo are from slope failures that have removed vegetation. Note there are fallen trees at the base of the bluff but no patches of fringing salt marsh.

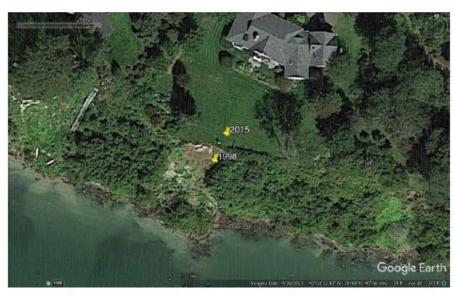
Figure 3. This September 18, 2013 image also shows the same two pins as in Figures 1 and 2 for reference. A landslide next to the 1998 pin shows vegetation and sediment slumped seaward of the base of the former bluff toe. The slump resulted in the headwall retreating 10 feet or more toward the house. The tide is relatively high and covers a fringing salt marsh seaward of the slump.

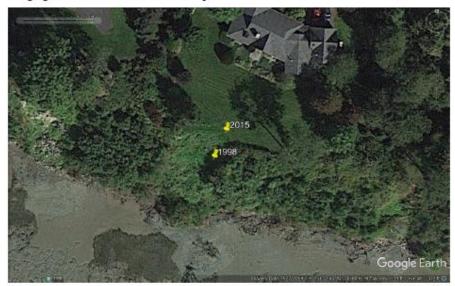
Figure 4. By September 27, 2014 the landslide area was grown in with vegetation and the toe area with trees still forming a protrusion along the shoreline. A fringing salt marsh is visible in the high intertidal zone and the tide is out. The March 2016 landslide has not yet occurred.

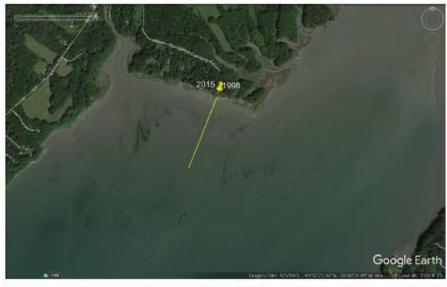
Figure 5. A shore-perpendicular transect 500 yards long is illustrated with the yellow line used to estimate an intertidal sediment budget. For reference, Bunganuc Rock is visible about 200 yards south of the end of the yellow line.

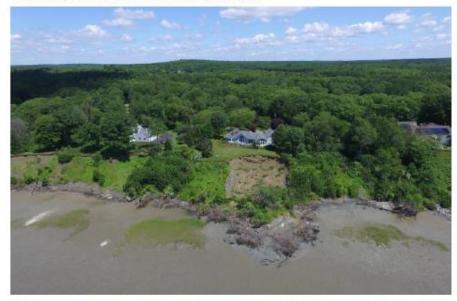
Figure 6. An oblique aerial photograph of the March 2016 landslide at Bunganuc Bluff. The slope failed east of the 2013 landslide shown in Figure 3. June 30, 2016 photo courtesy of Rick Harbison, GPCOG.

The March 2016 slope failure described in the permit application happened along this transect. This slump resulted in an additional 20 to 25 feet of bluff retreat at the top of the slope (Attachment 1; Sheet C1.0). Using this additional land loss of 20 feet, the average bluff retreat rate from 1998 to 2016 was about 2.5 feet per year at this one more localized section.

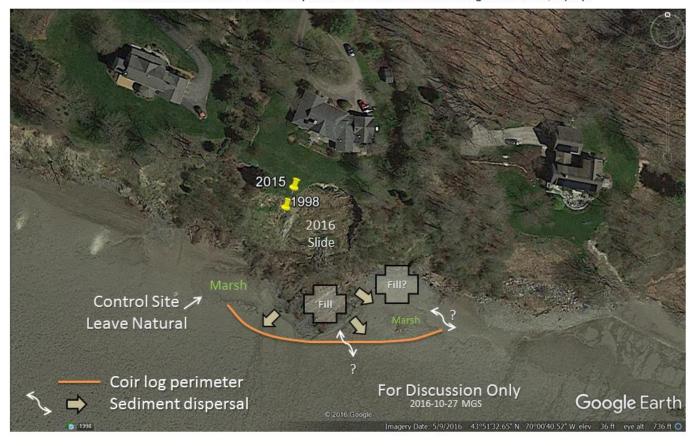
Bunganuc Bluff Living Shoreline Concept Sketch

Surplus bank mud from grading placed over slide as fill above HAT or at base of slope below HAT Natural dispersal of landslide toe and fill is impounded (?) behind coir log sill Sediment accumulation and sill may favor salt marsh formation along toe of bank / riprap
