**PROJECT SPECIFICATIONS
FOR
ABATEMENT OF THE INTERIOR
OF THE STONE BUILDING
AUGUSTA, MAINE**

2.1.1. Project Identification: **Abatement of the Interior of the Stone Building.**

2.1.1.1. Project Location: **67 Independence Drive, Augusta, Maine.**

Hazardous Building Materials Inventory
Former Maine State Hospital: Stone Building
67 Independence Drive
Augusta, Maine

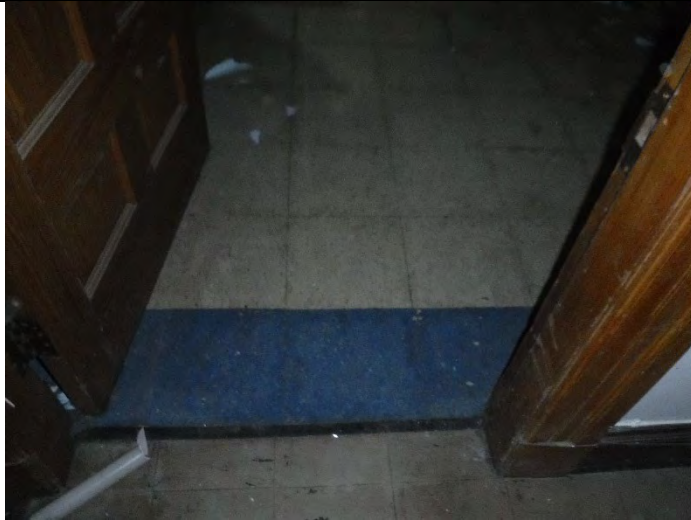
Photo 1 (12-15-2021): Administrative building/area. 9-inch VFT blue, mottled. Floor tile positive, ACM sample AD-1-01; associated mastic negative (AD-1-02).

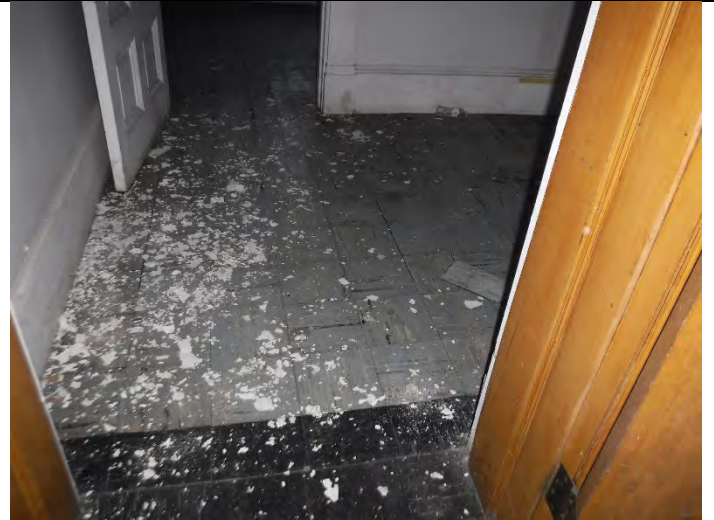
Photo 2 (12-15-2021): Administrative building/area. 9-inch VFT brown with black mottles. Floor tiles positive, ACM sample AD-1-03; associated mastic negative (AD-1-04).

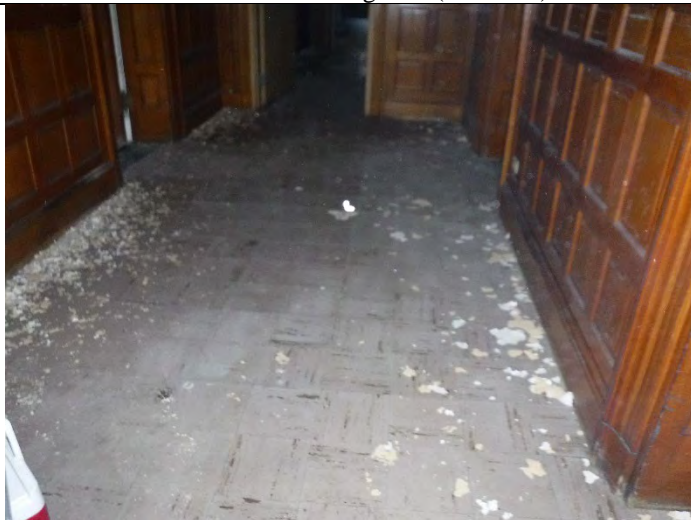
Photo 3 (12-15-2021): Administrative building/area. 9-inch VFT mottled tan. Floor tiles positive, ACM sample AD-2-01; associated mastic negative (AD-2-02).

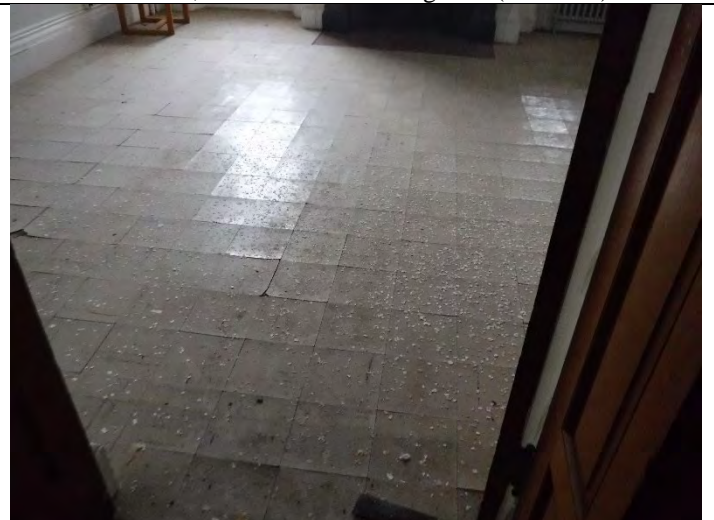
Photo 4 (12-15-2021): Administrative building/area. 9-inch VFT mottled gray. Associated mastic positive, ACM sample AD-2-04; floor tiles PACM (AD-2-03).

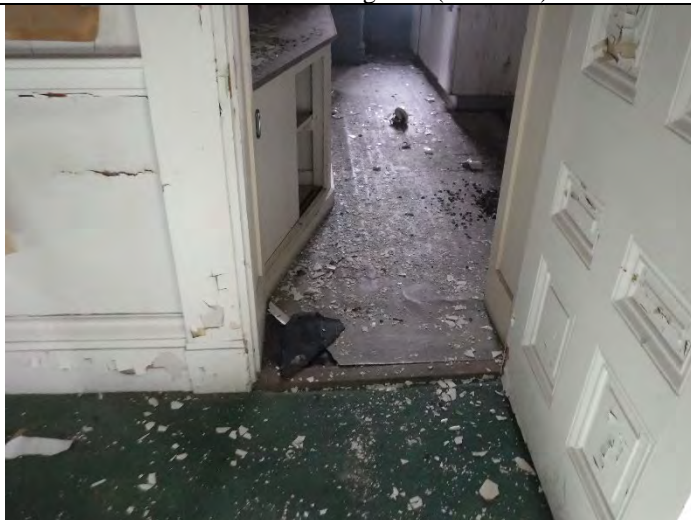
Photo 5 (12-15-2021): Administrative building/area. Kitchen linoleum. Associated mastic positive, ACM sample AD-3-10; impacted linoleum PACM (AD-3-09).

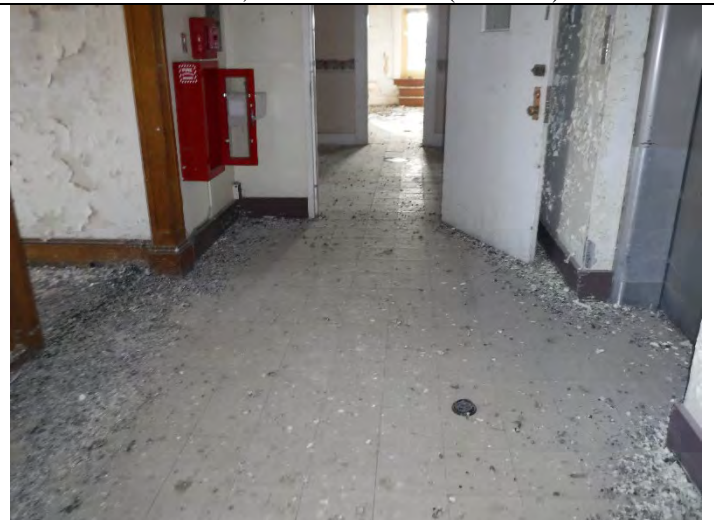
Photo 6 (12-15-2021): Administrative building/area. 9-inch VFT tan. Floor tile positive, ACM sample AD-4-01; associated mastic negative (AD-4-02).

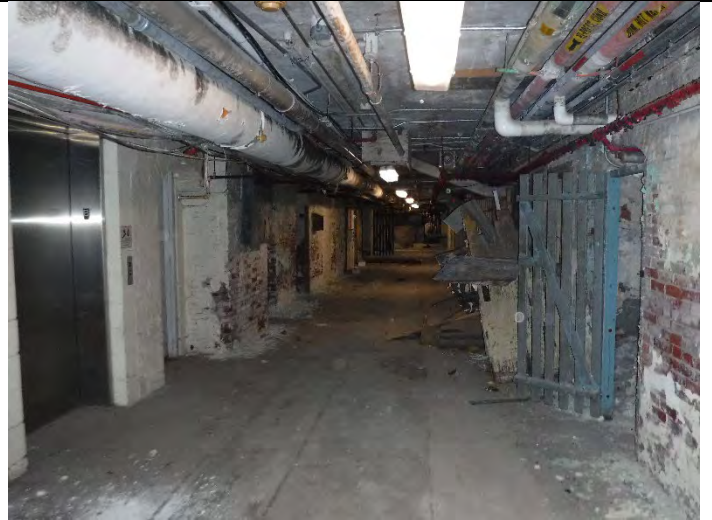
Photo 2 (12-17-2021): Basement corridors with labeled ACM TSI piping runs of various sizes.

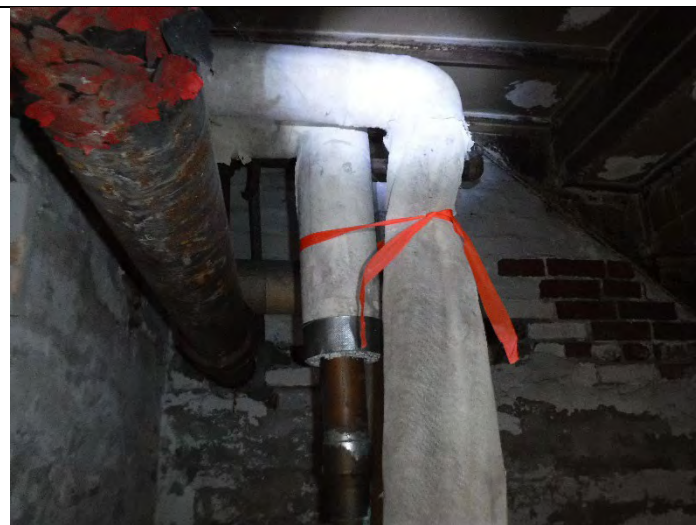
Photo 3 (12-17-2021): Location of positive ACM samples B-02A and B-03A

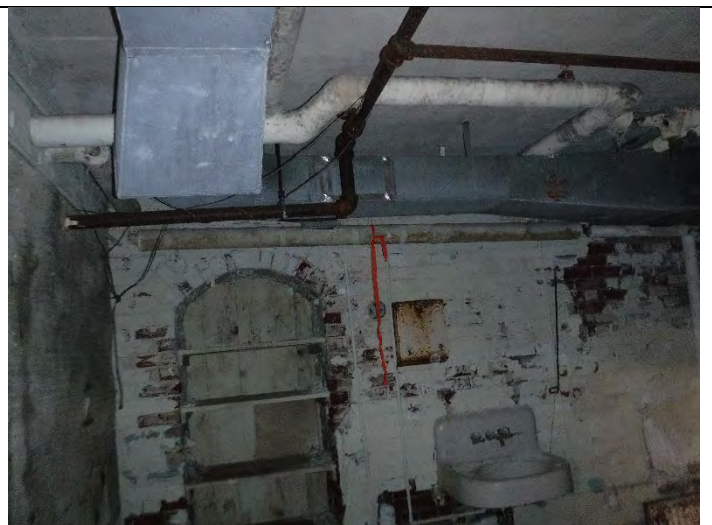
Photo 4 (12-17-2021): One of several areas of flagged ACM TSI within rooms off main corridors in basement area.

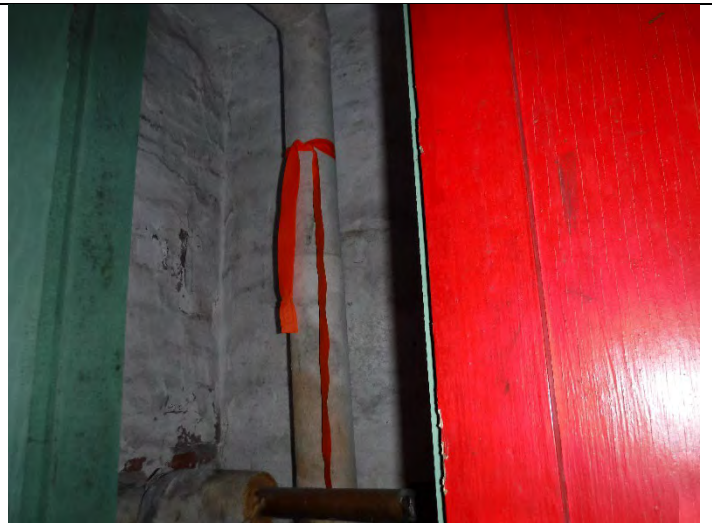
Photo 6 (12-17-2021): One of several areas of flagged ACM TSI within rooms off main corridors in basement area.

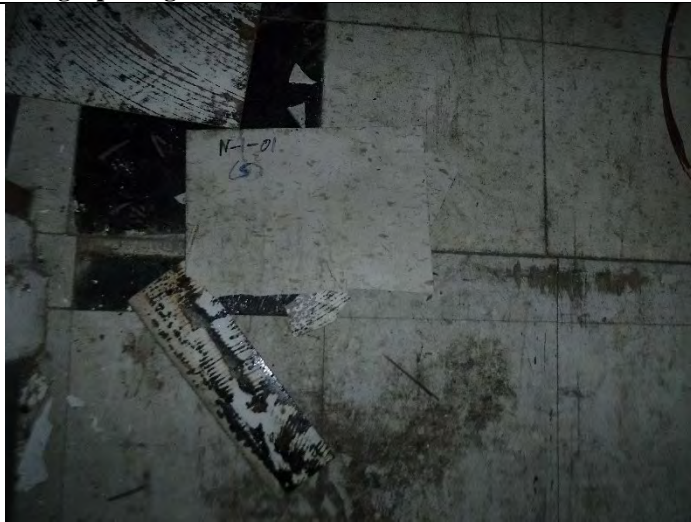
Photo 1 (12-16-2021): ACM 9-inch floor tile (NO-1-01) and associated ACM mastic (NO-1-02) located in select room of North Wing – Section I

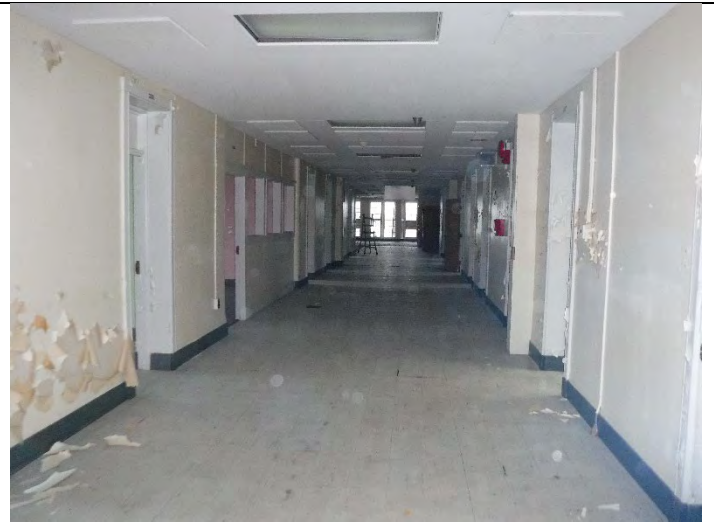
Photo 2 (12-16-2021): ACM 9-inch floor tile (NO-3-01) located throughout hall/rooms of North Wing – Section I.

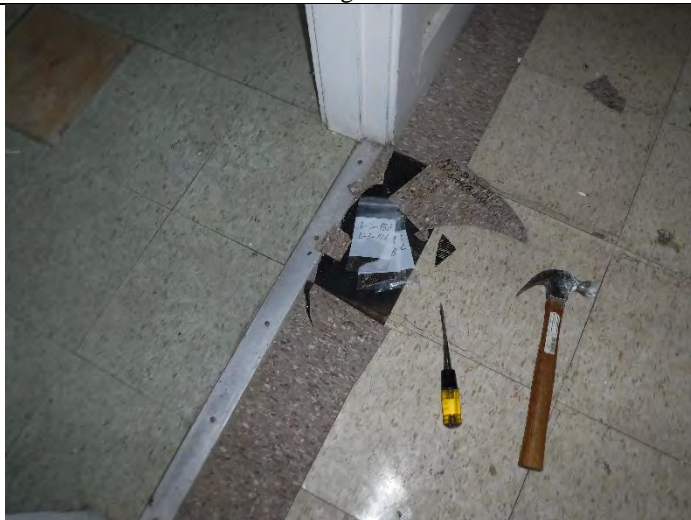
Photo 3 (12-16-2021): ACM mastic (NO-3-14) associated with multiple 12-inch floor tiles located throughout North Wing – Section II and III.

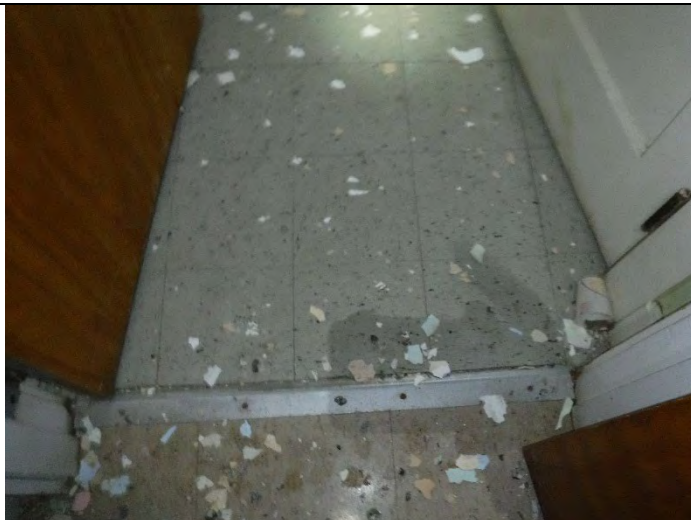
Photo 5 (12-16-2021): ACM 9-inch floor tile (NO-3-19) located in North Wing – Section II.

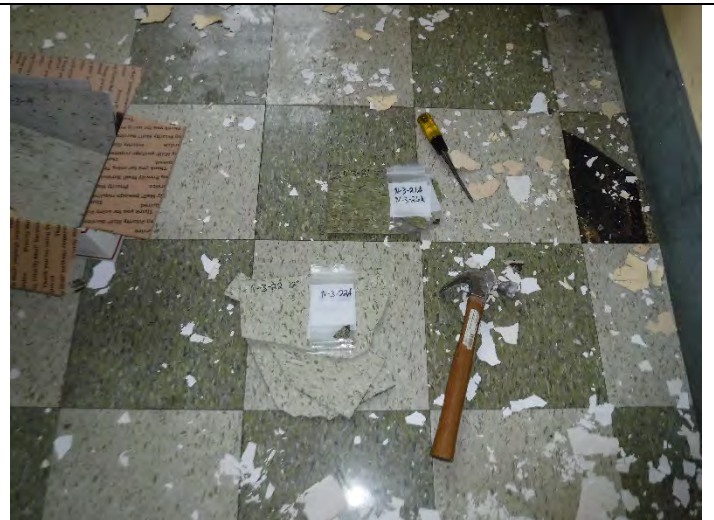
Photo 6 (12-16-2021): ACM 12-inch floor tile (NO-3-21) and ACM mastic (NO-3-26) located in various rooms throughout North Wing – Sections II and III.

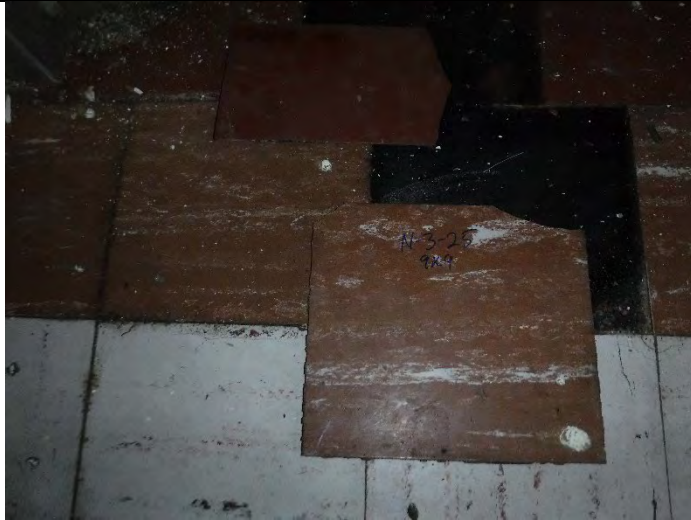
Photo 7 (12-16-2021): Three types of ACM or PACM 9-inch floor tile (NO-3-24, NO-3-25), all associated with ACM mastics located in North Wing – Section III.

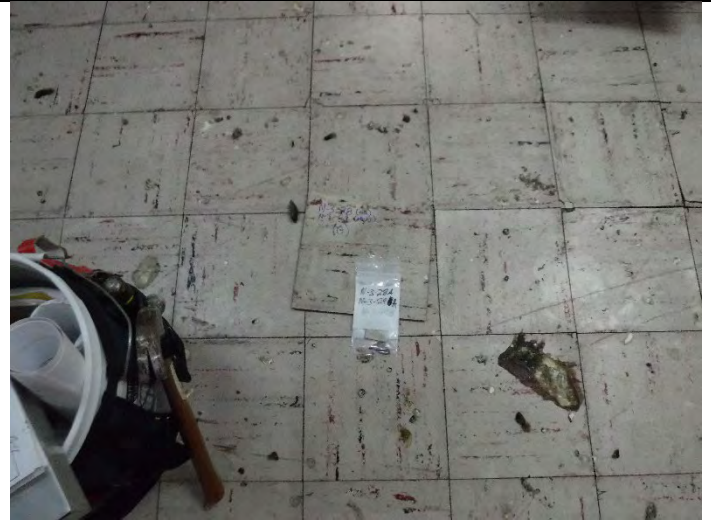
Photo 8 (12-16-2021): PACM 9-inch floor tile (NO-3-28) and associated ACM mastic (NO-3-29) located in North Wing – Section III.

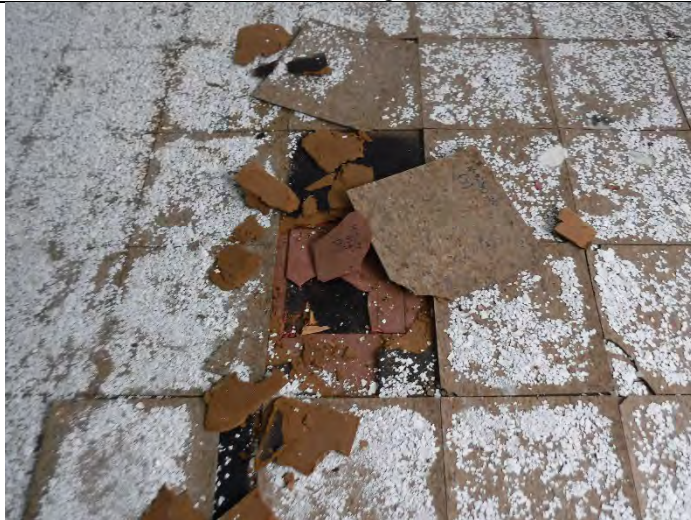
Photo 9 (12-16-2021): ACM 12-inch floor tile (NO-3-30) overlying ACM 9-inch floor tile (NO-3-31) and associated ACM mastic (NO-3-29) in North Wing – Section III.

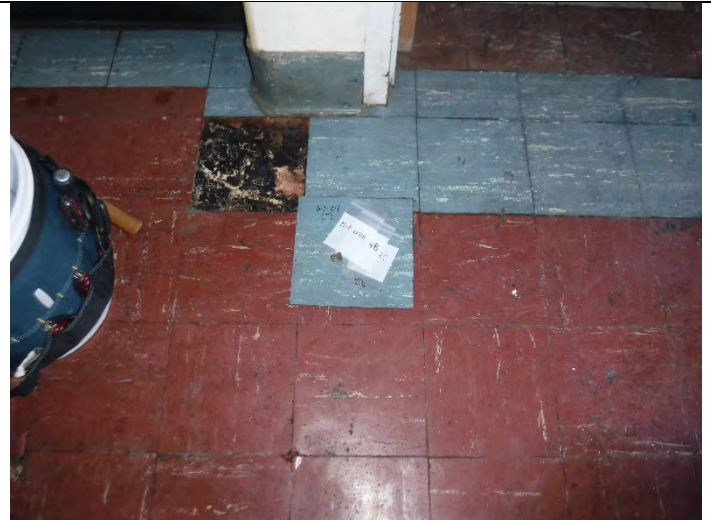
Photo 10 (12-16-2021): ACM 9-inch floor tile (NO-1-04) and PACM mastic and 9-inch floor tile located in North Wing – Section III.

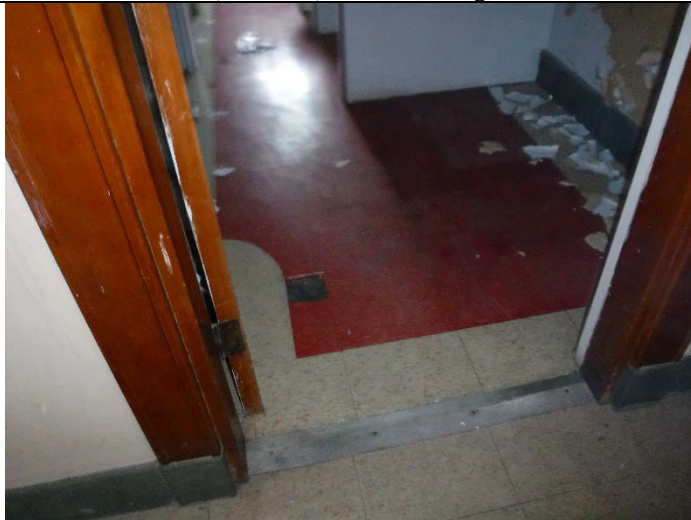
Photo 11 (12-16-2021): ACM black mastic (NO-2-03-Layer 2) associated with PACM 12-inch floor tile in North Wing – Section II.

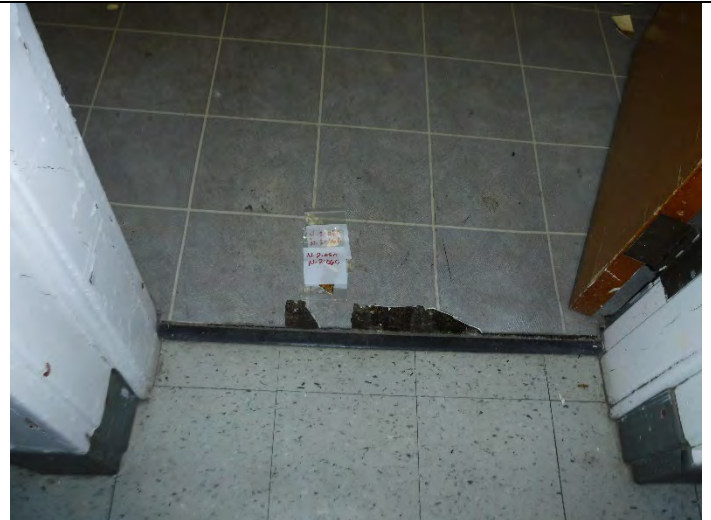
Photo 12 (12-16-2021): ACM mastic (NO-2-06) associated with PACM linoleum (NO-2-05) in North Wing – Section II.

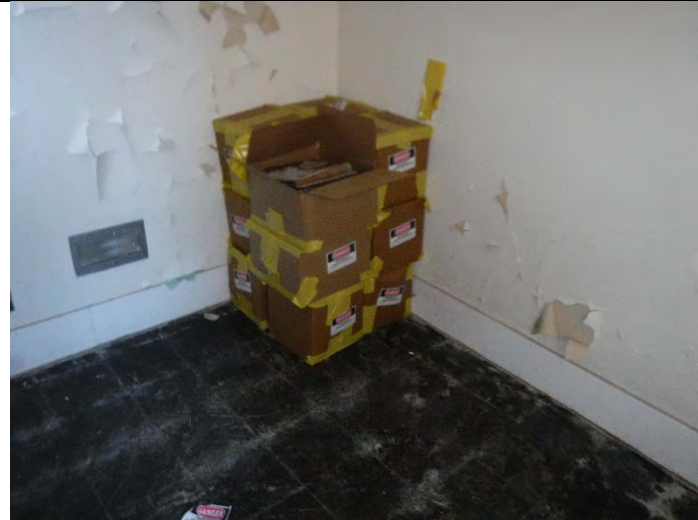
Photo 1 (12-17-2021): Boxed and labeled ACM flooring, located on first floor of South Wing – Section I

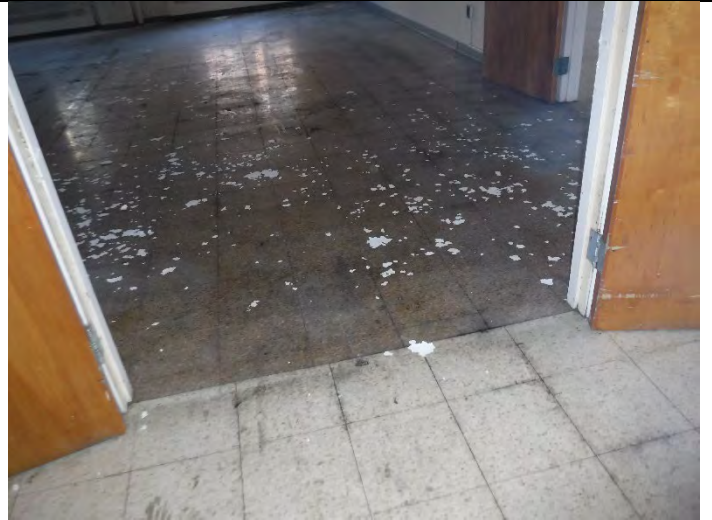
Photo 2 (12-17-2021): ACM 12-inch floor tiles (NO-3-30) located in select areas/room of South Wing – Sections II and III

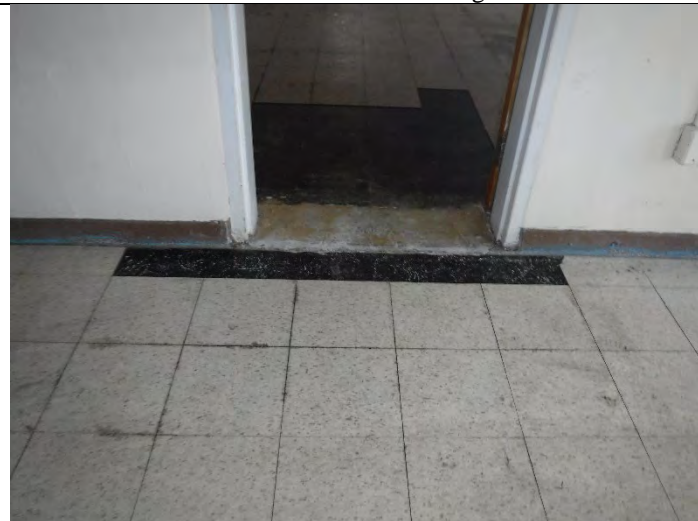
Photo 3 (12-17-2021): ACM 9-inch floor tiles (SO-2-01) and associated ACM mastic (SO-2-02) discovered beneath an area of 12-inch floor tiles (NAD). South Wing – Section III.

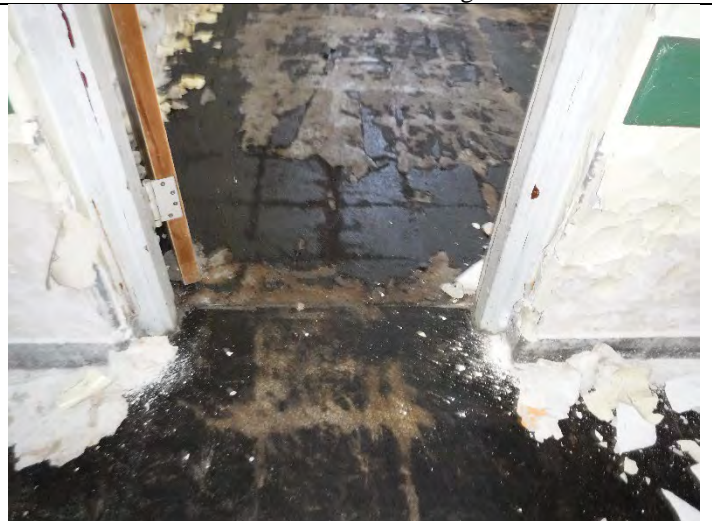
Photo 4 (12-17-2021): ACM thick black mastic (SO-3-02) located in select rooms/areas of South Wing – Section III.
