DRAWING NUMBER  
B-518  
Squadron Operations/MN  
20 of 21

MAINE AIR NATIONAL GUARD  
101ST CIVIL ENGINEERING SQUADRON  
106 ASHLEY ST SUITE 486  
BANGOR, ME  
04401-3051  
BGS PROJECT # 3388  
1 MARCH 2024

PROJECT TITLE  
SQUADRON OPERATIONS/MN  
BANGOR INTERNATIONAL AIRPORT  
AIR NATIONAL GUARD  
BANGOR, MAINE

DRAWING TITLE  
EXTERIOR ELEVATIONS  
PROJECT NO. 15104-15  
DESIGNED BY CTS  
DRAWN BY CTS  
CHECKED BY GON  
SCALE 1/8" = 1'-0"  
DATE 7 AUGUST 1996  
DRAWING NO.  
A402

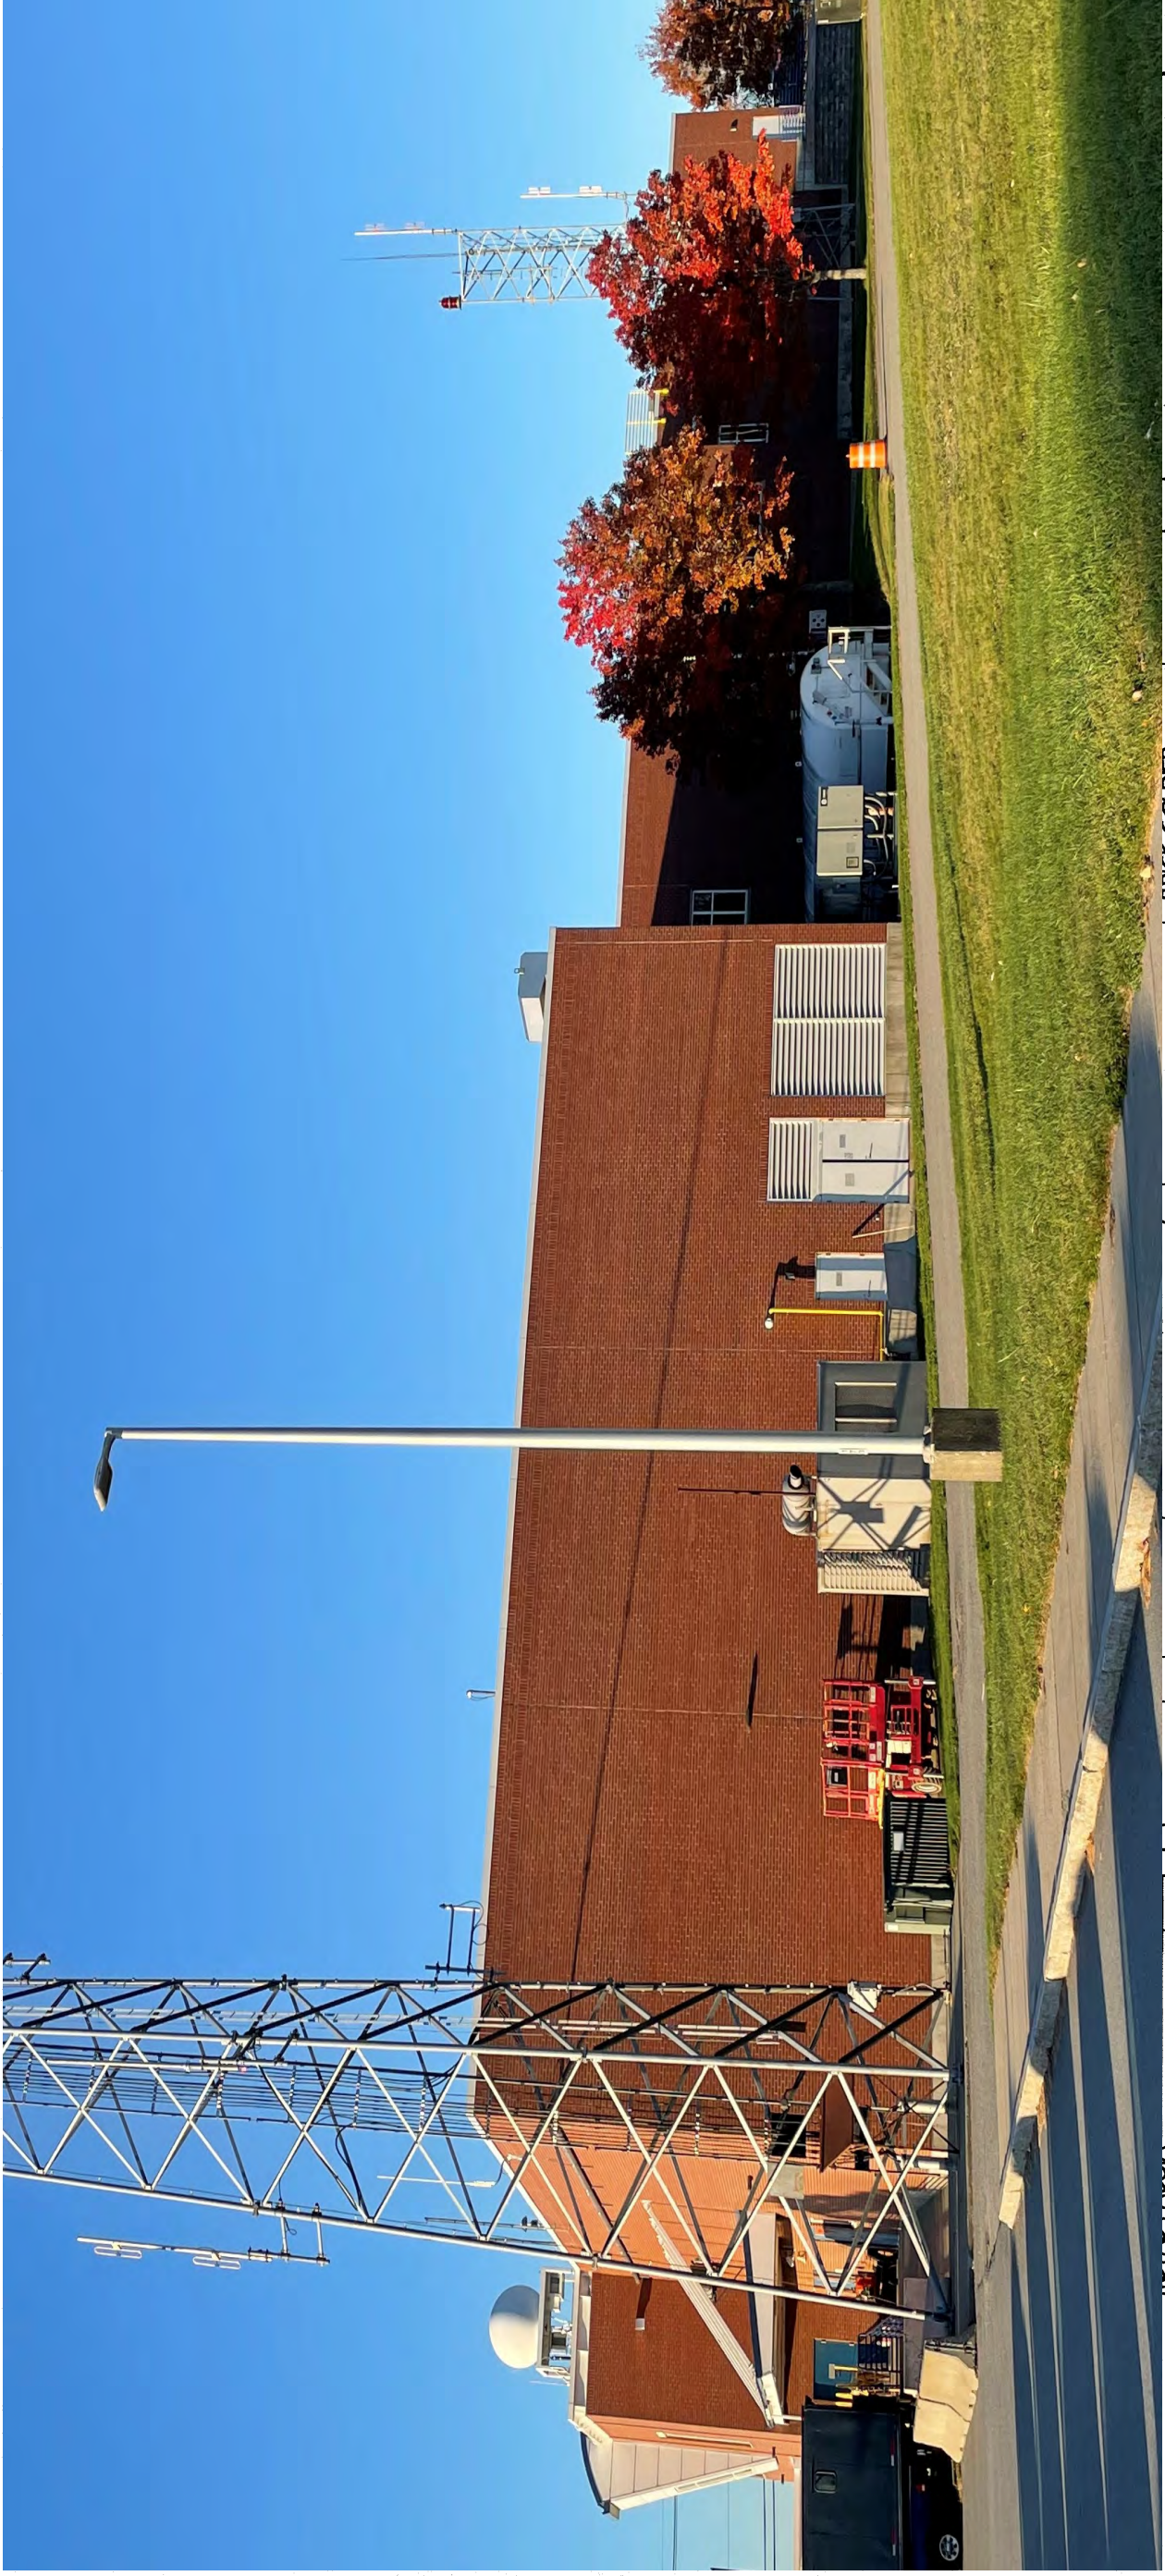
A2

NORTHEAST ELEVATION  
1/8" = 1'-0"  
REF: A402

1. Repair (3) loose pre-cast concrete window sill and one course of bricks directly under concrete sill on windows noted. Maintain weep holes above the gavl. metal flashing.

2. Remove old sealant and install new backer rod and sealant around the perimeter of all windows. Repair deteriorated mortar joints on the windows brick soldier course header, steel lintel and pre-cast concrete sills.

3. Remove and reinstall sealant and deteriorated mortar around the steel window lintel on all windows Type F, F1, B, D. Remove old sealant and install new backer rod and install new sealant around the perimeter of the window.

4. Remove old sealant and reinstall new backer rod, and sealant on all vertical and Horiz. control joints (CJ).
5. Remove and reinstall sealant in control joints and around steel box brackets (typical 18 brackets locations).

6. Remove and reinstall sealant in joint between the metal cornice and bricks.
7. Remove and reinstall sealant in the constr. joint between the metal panels and brick on the two tip out windows.

8. Apply (2) coats of masonry sealant to all brick surfaces.

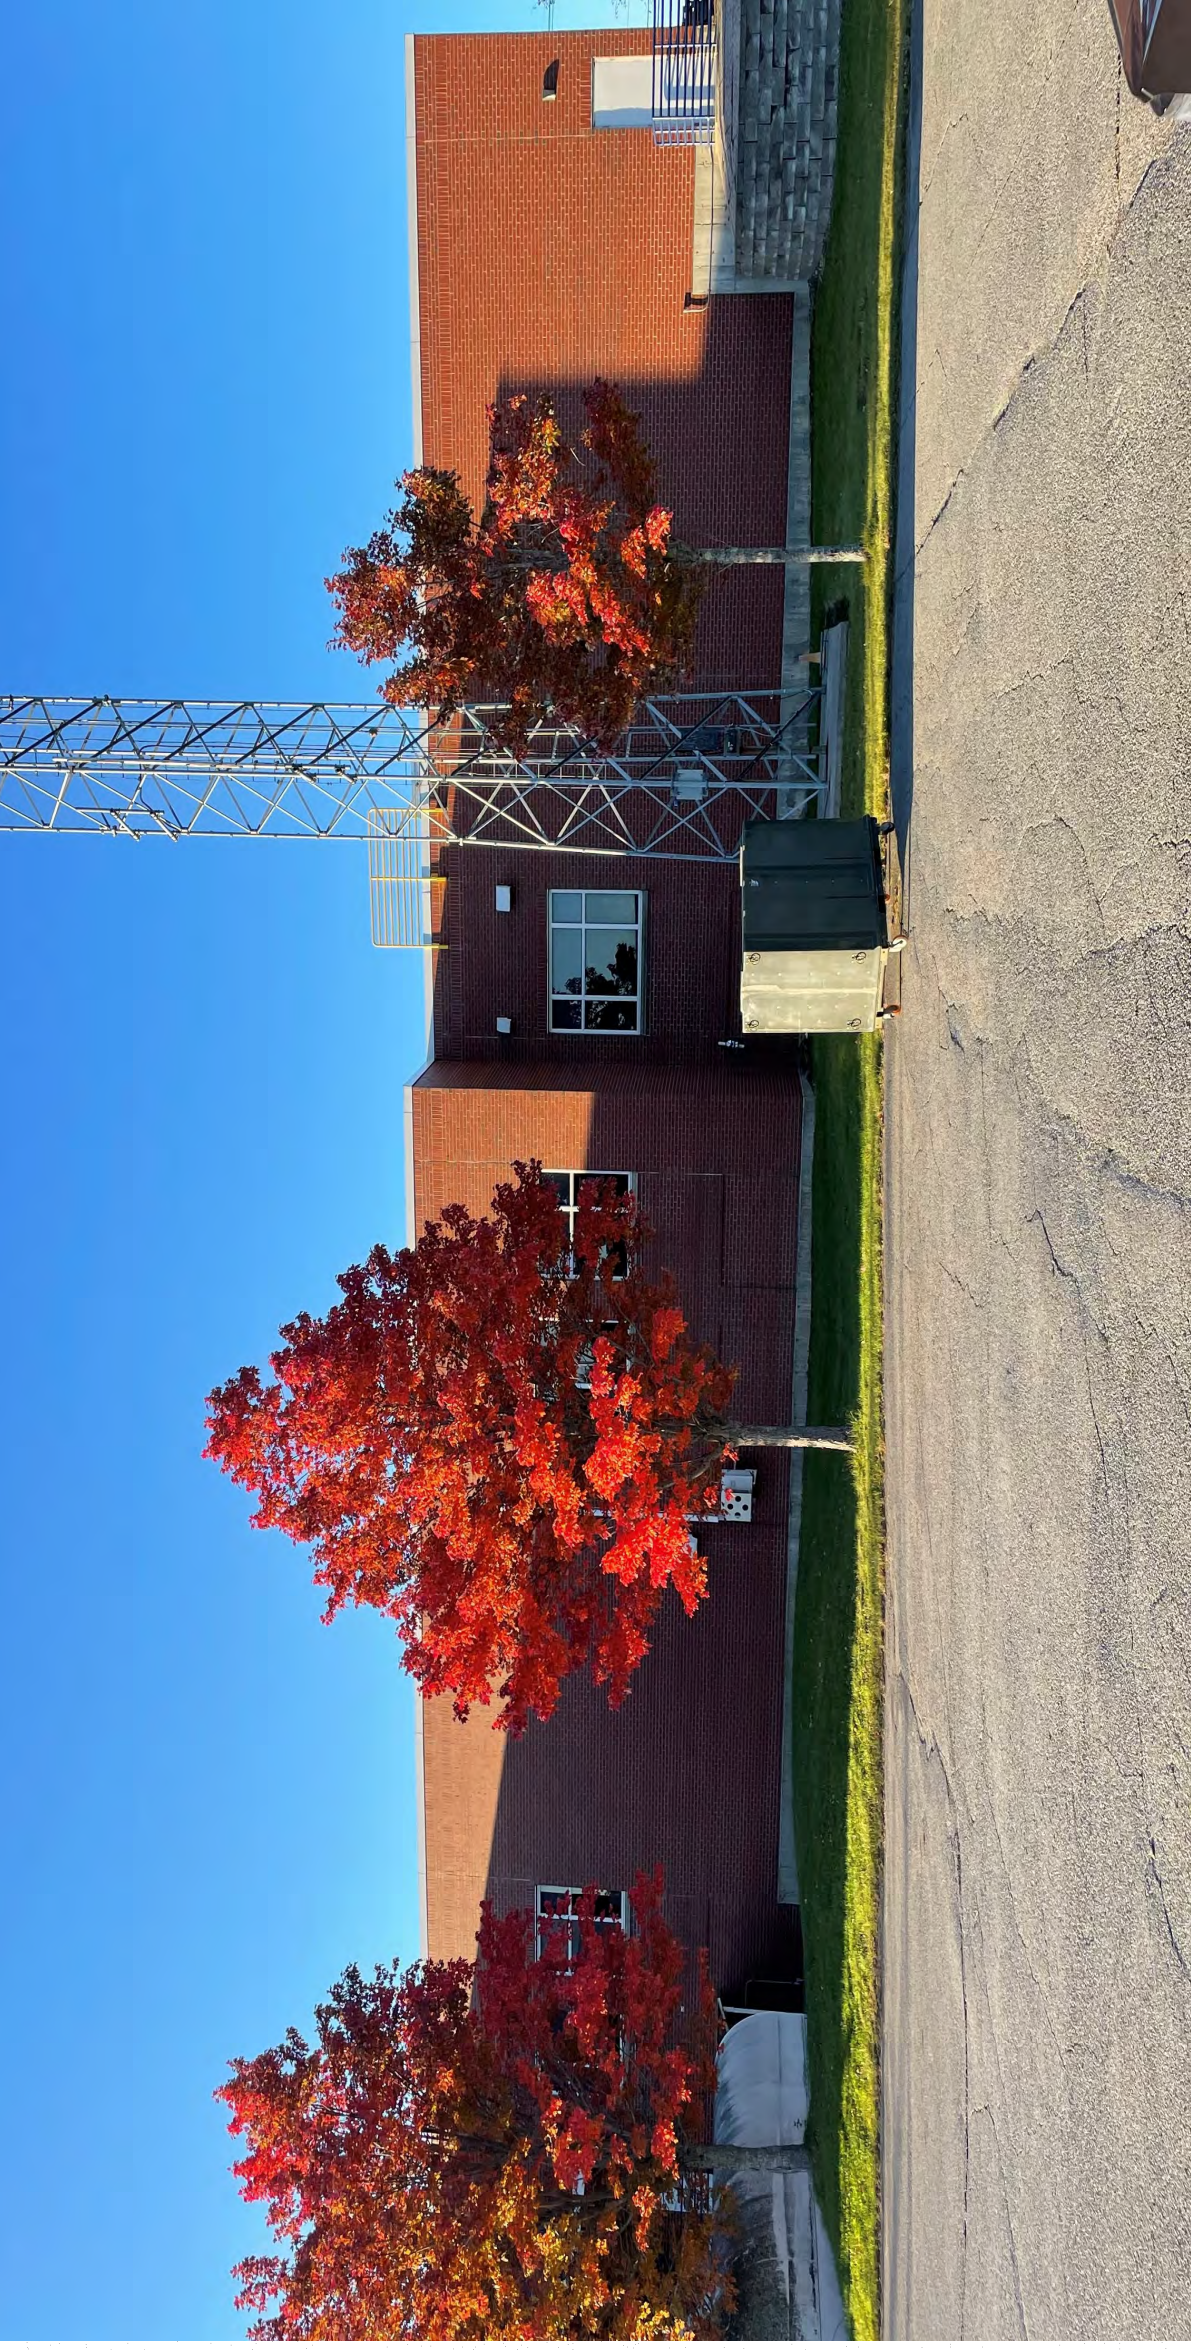
A1

NORTHWEST ELEVATION  
1/8" = 1'-0"  
REF:
