# **Juniper Ridge Landfill Phase II Expansion Project Overview Meetings**

## **Meeting #3**

Geology, Hydrogeology, Water Quality,  
Leachate Management, PFAS Treatment

December 4, 2024

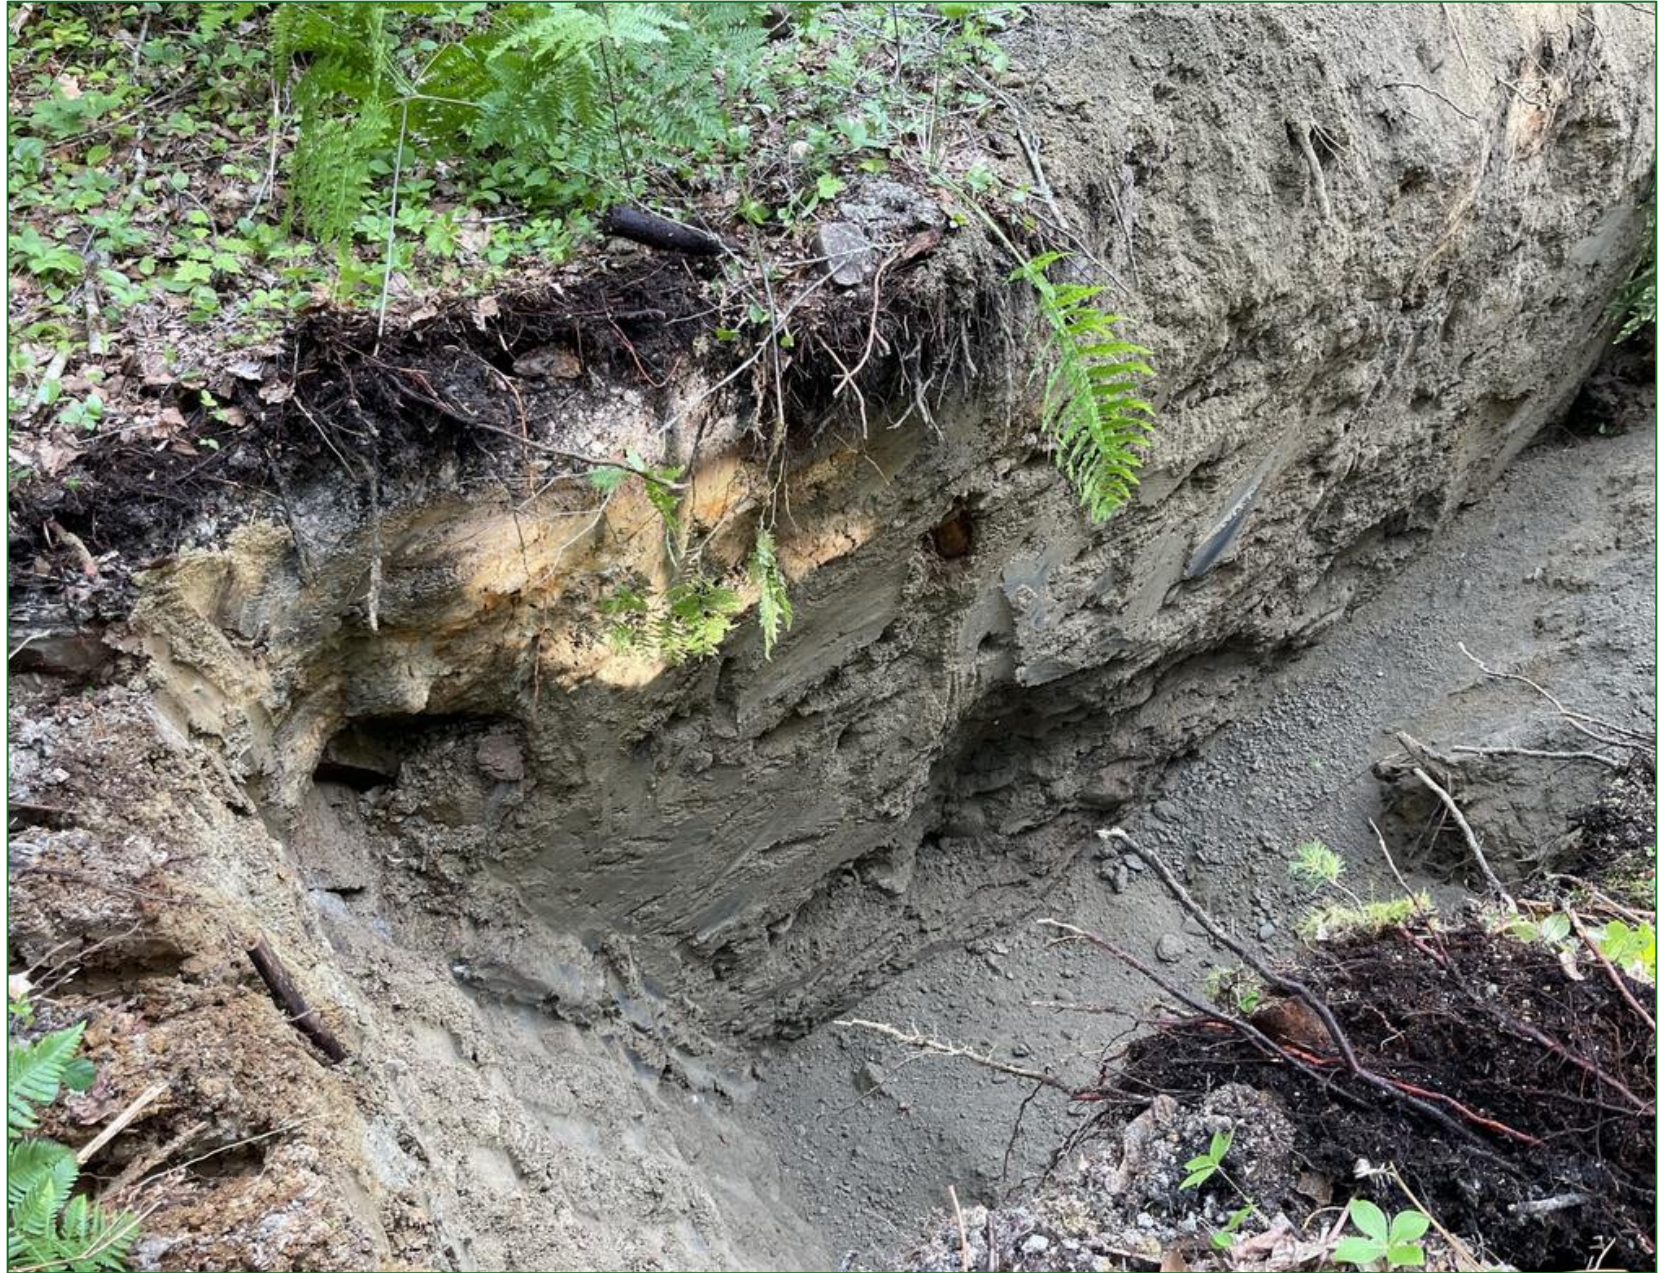
# Dense Basal Till

- Dense because it was compacted by the glacier
- Basal means scraped across the rocks by a glacier
- Till is a mix of clay, boulders, and everything in between

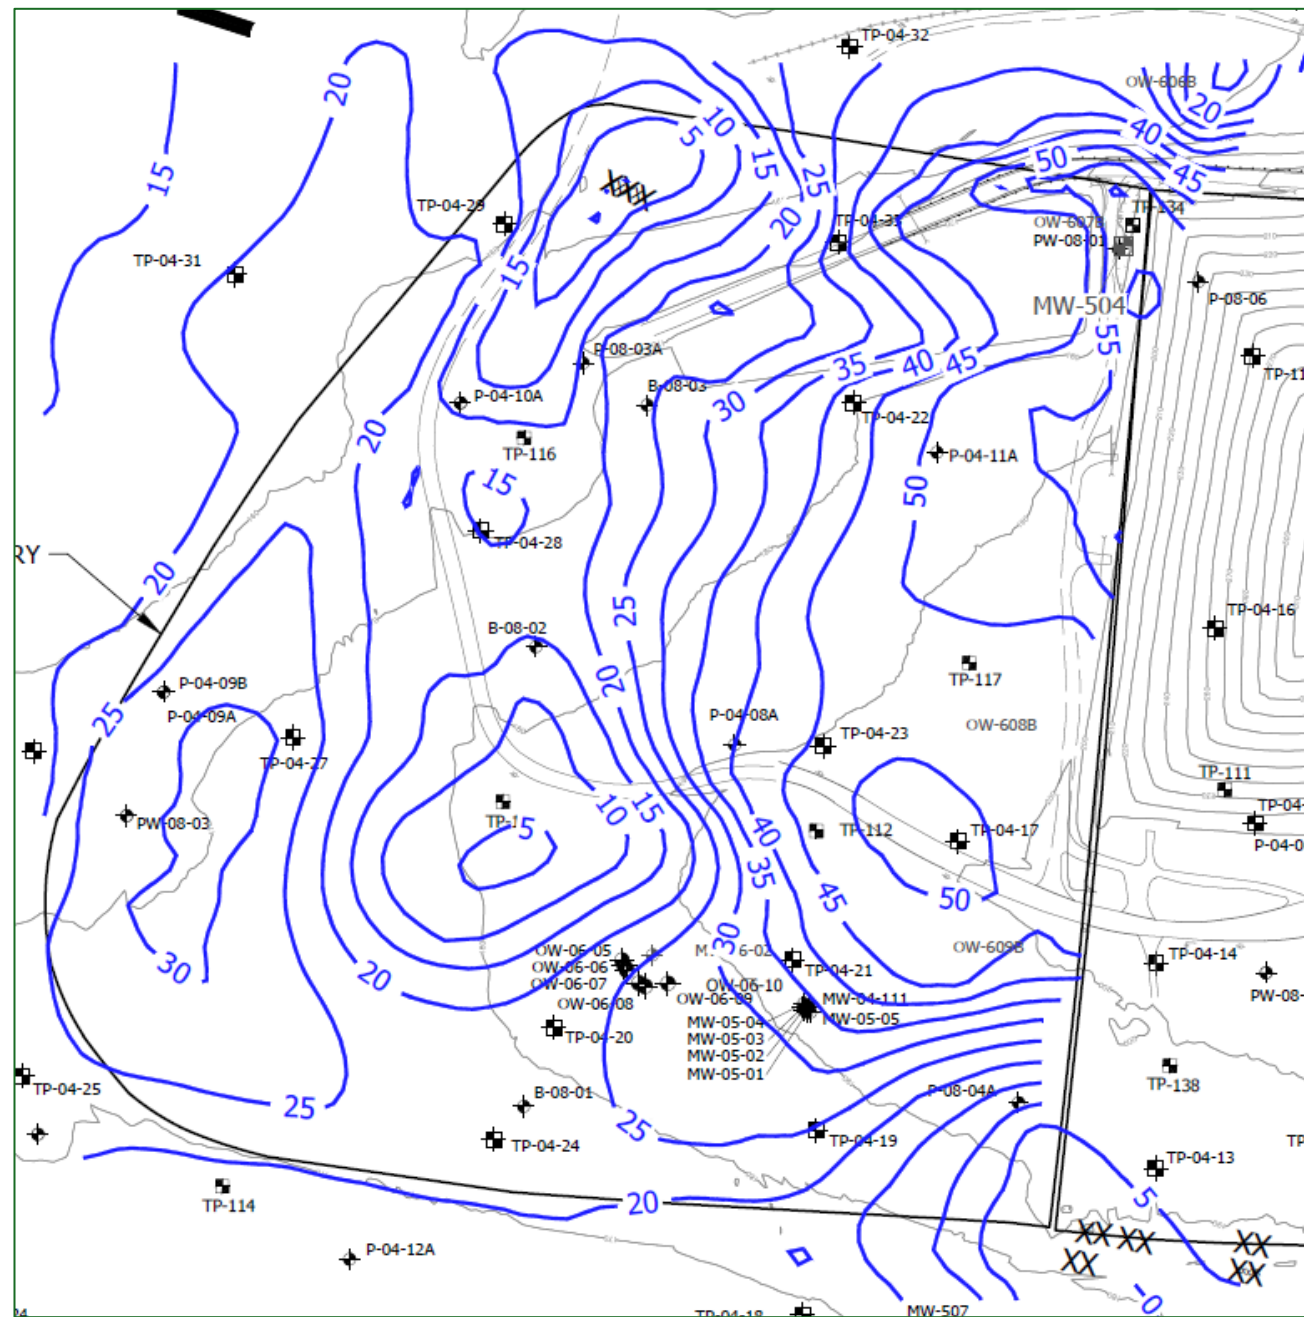
# Soil thickness map

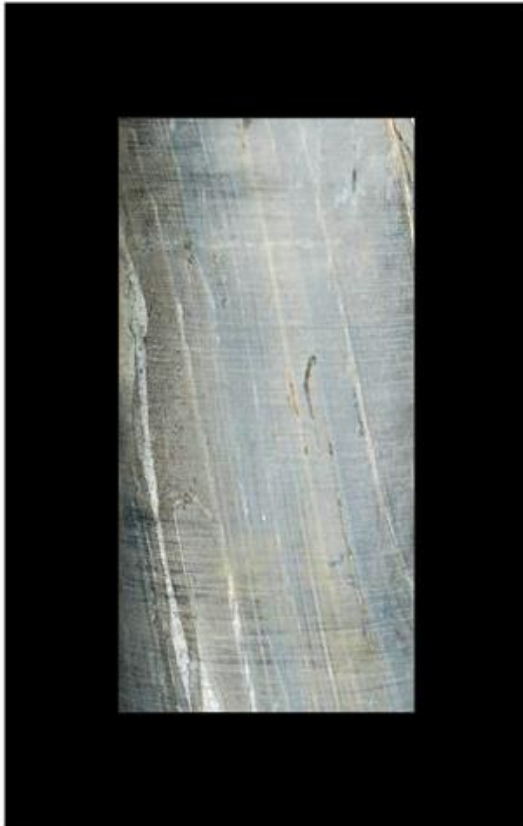
METASILTSTONE

# Competent, somewhat metamorphosed rock

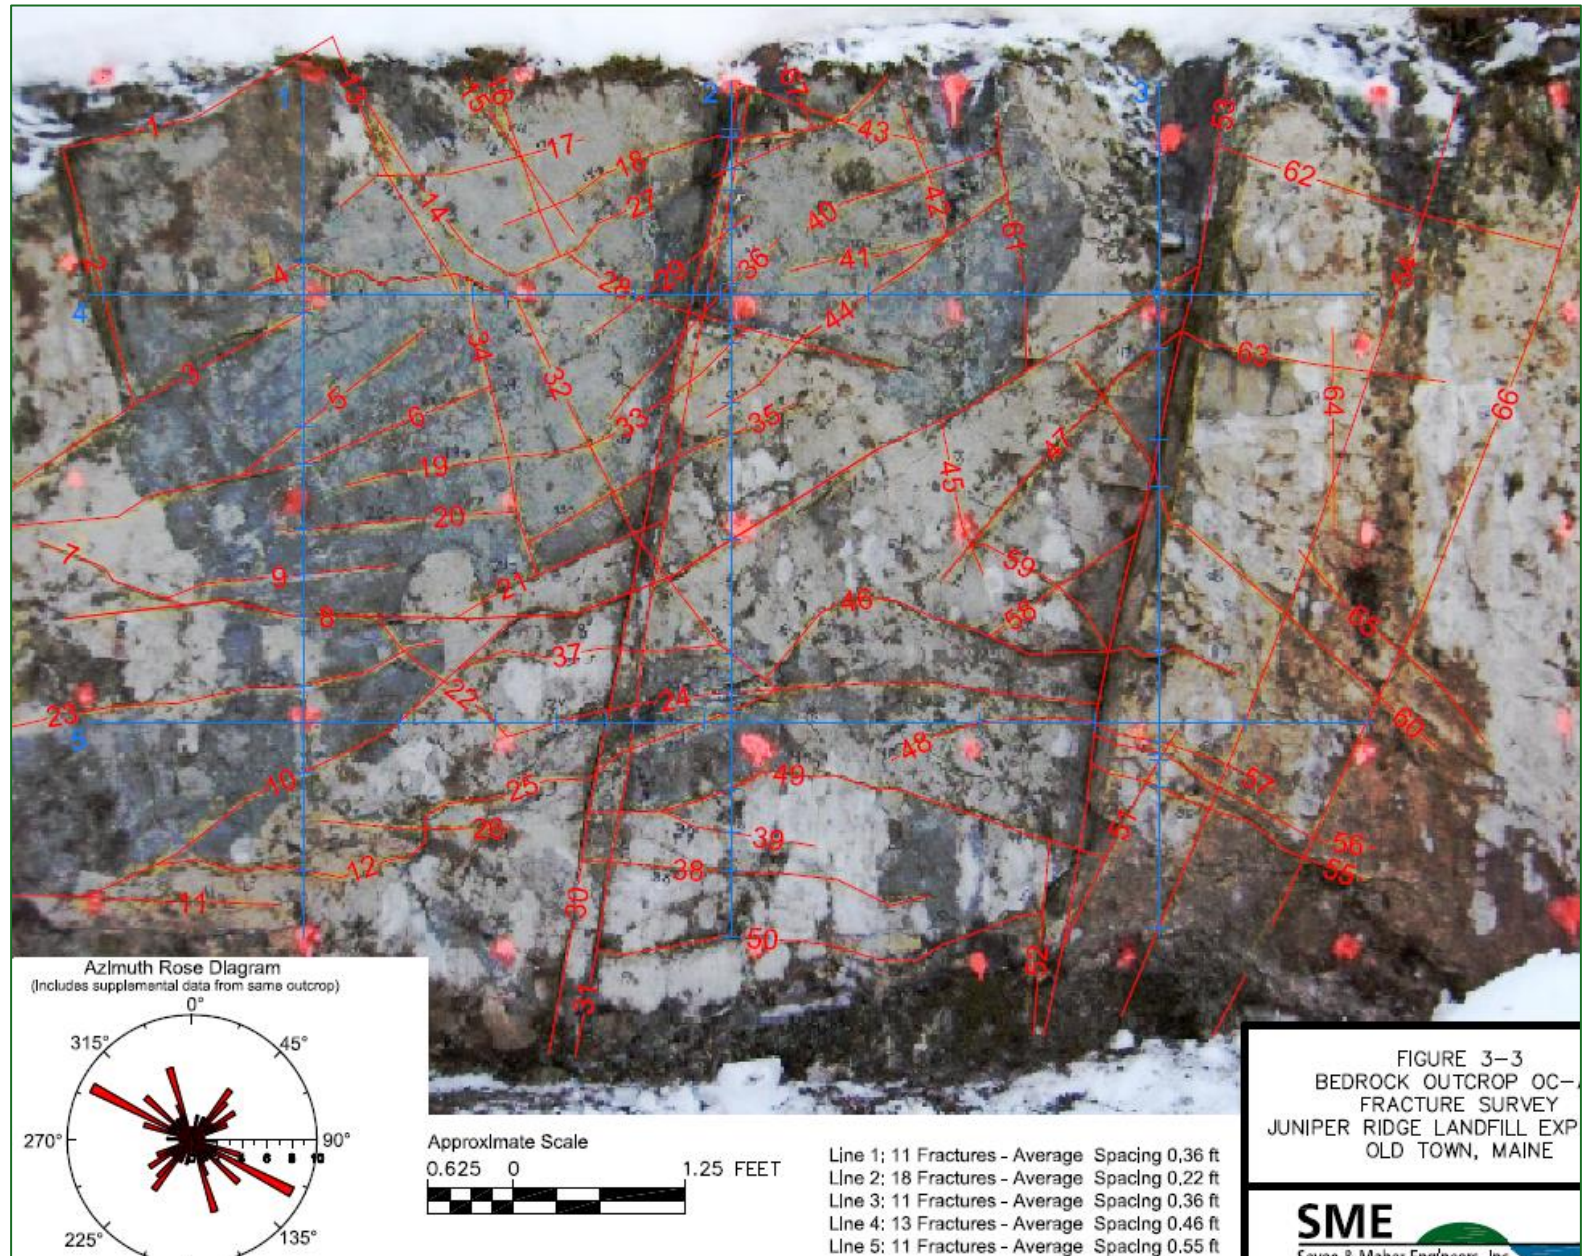
# Bedrock Fractures

- Large bedrock outcrop (about 7'x11' shown)
- Lines are the fractures we found:
  - Interconnected network
  - Uniformly fractured
- Bedrock could be pumped JUST IN CASE – (verified by pumping tests)

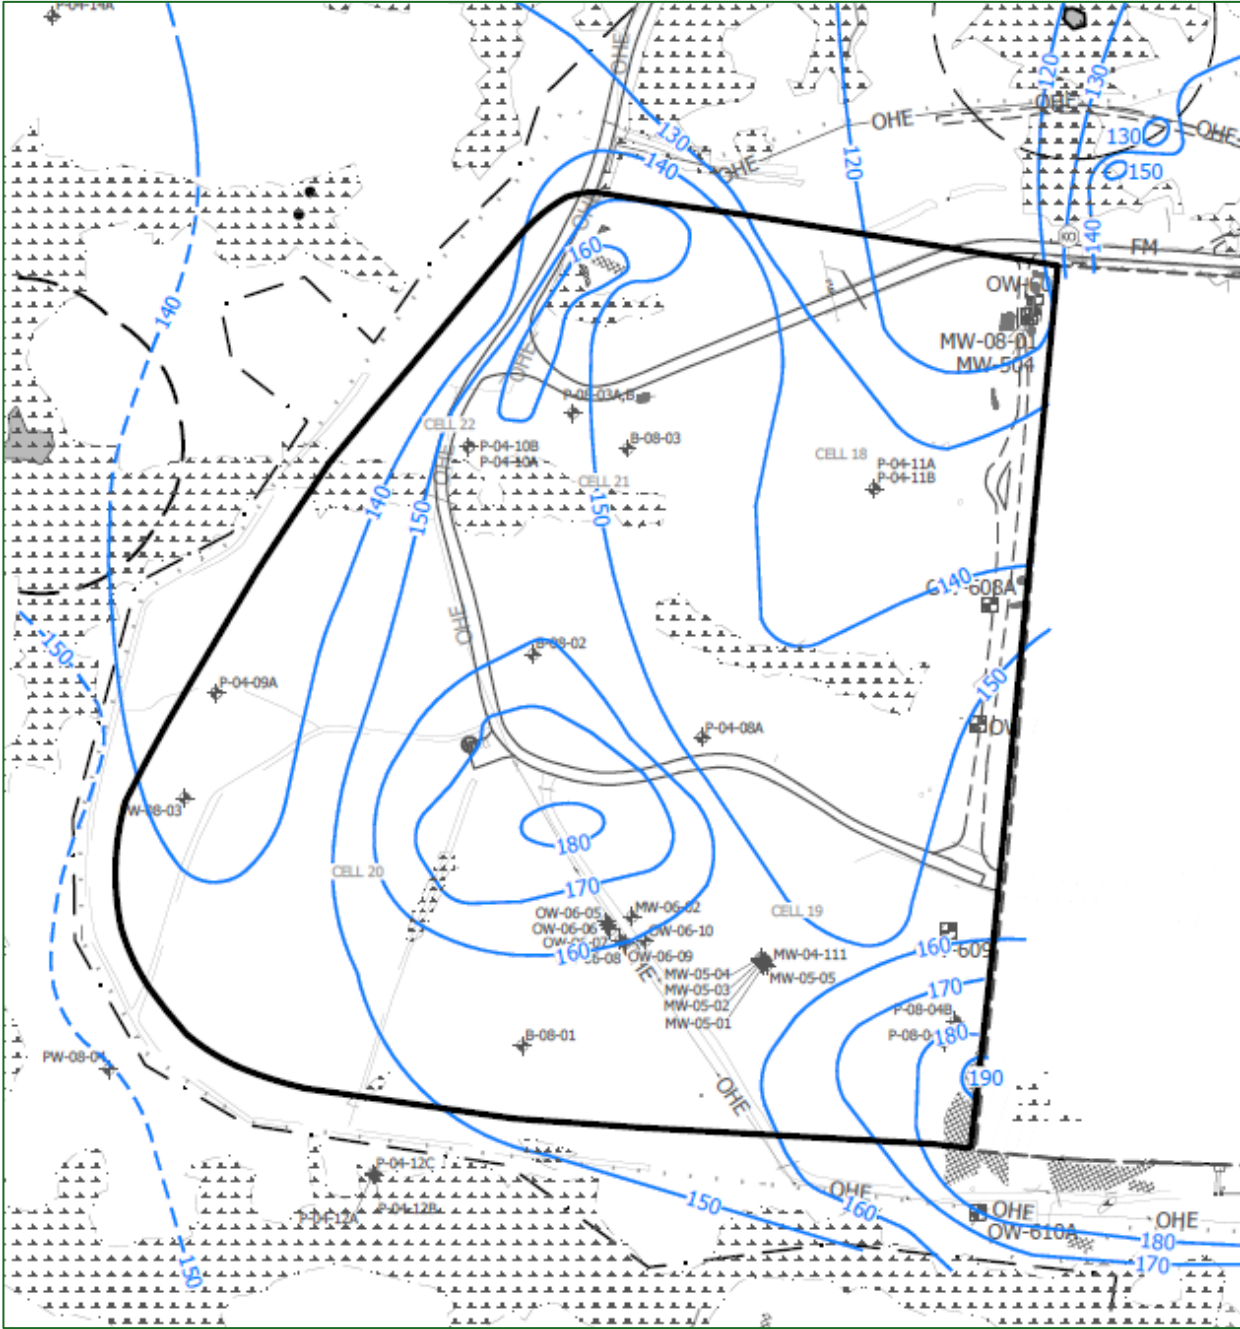
# Bedrock surface map

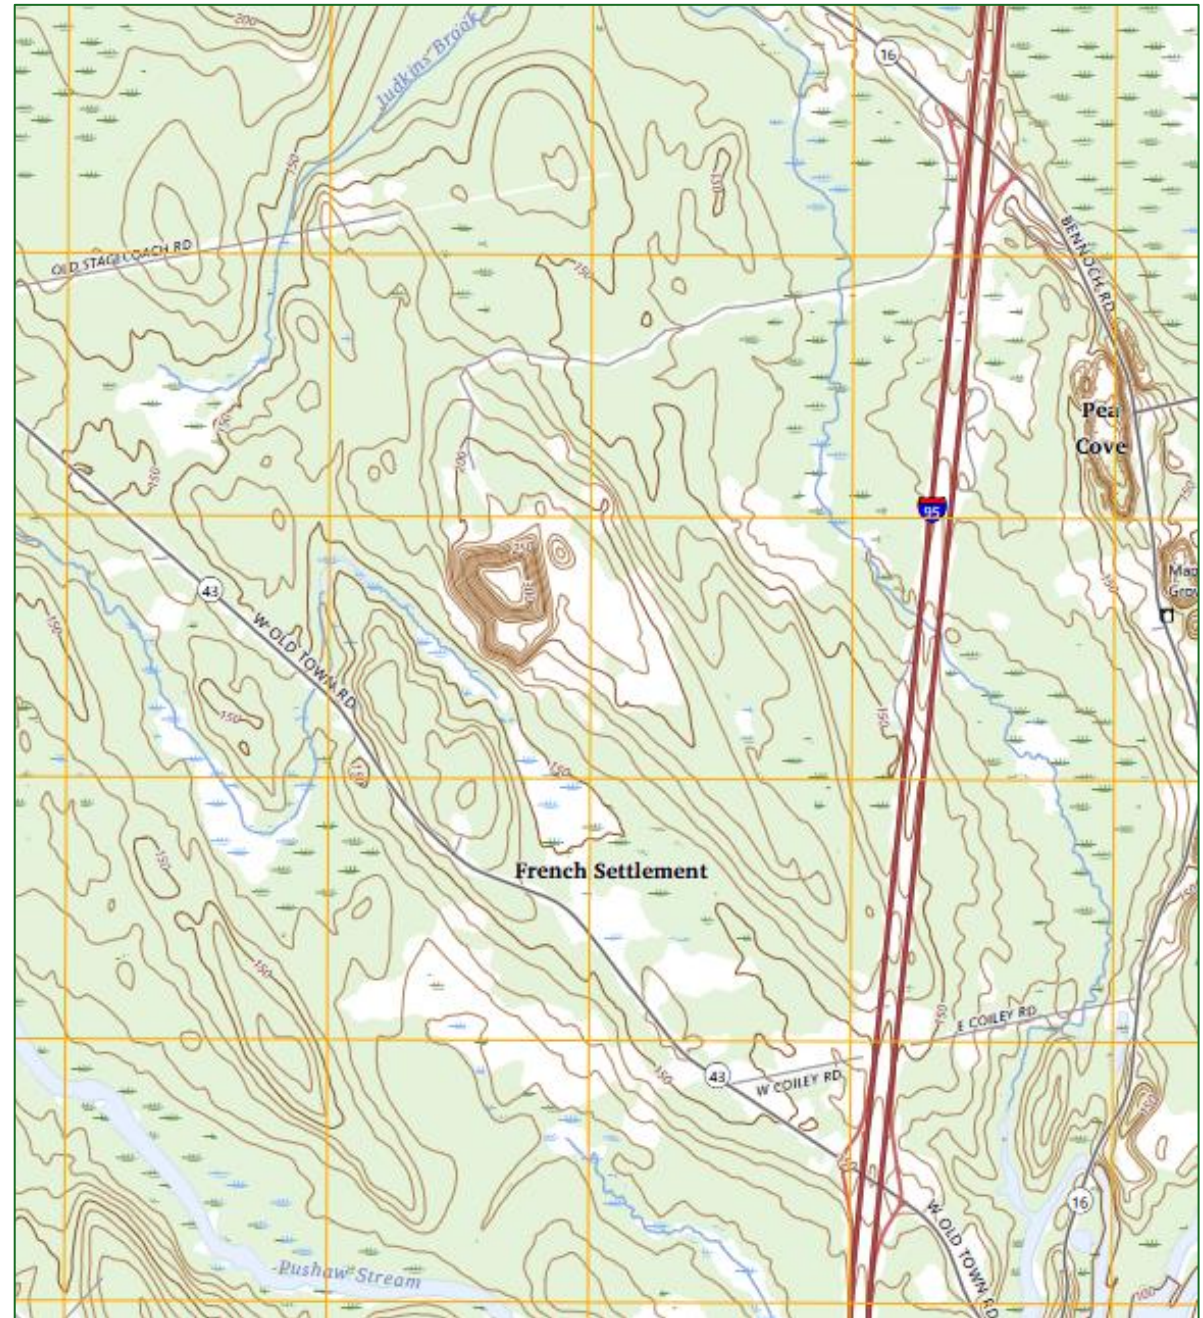
# Groundwater Movement

- Water flows downhill, even underground
- From the drumlin to surrounding surface waters

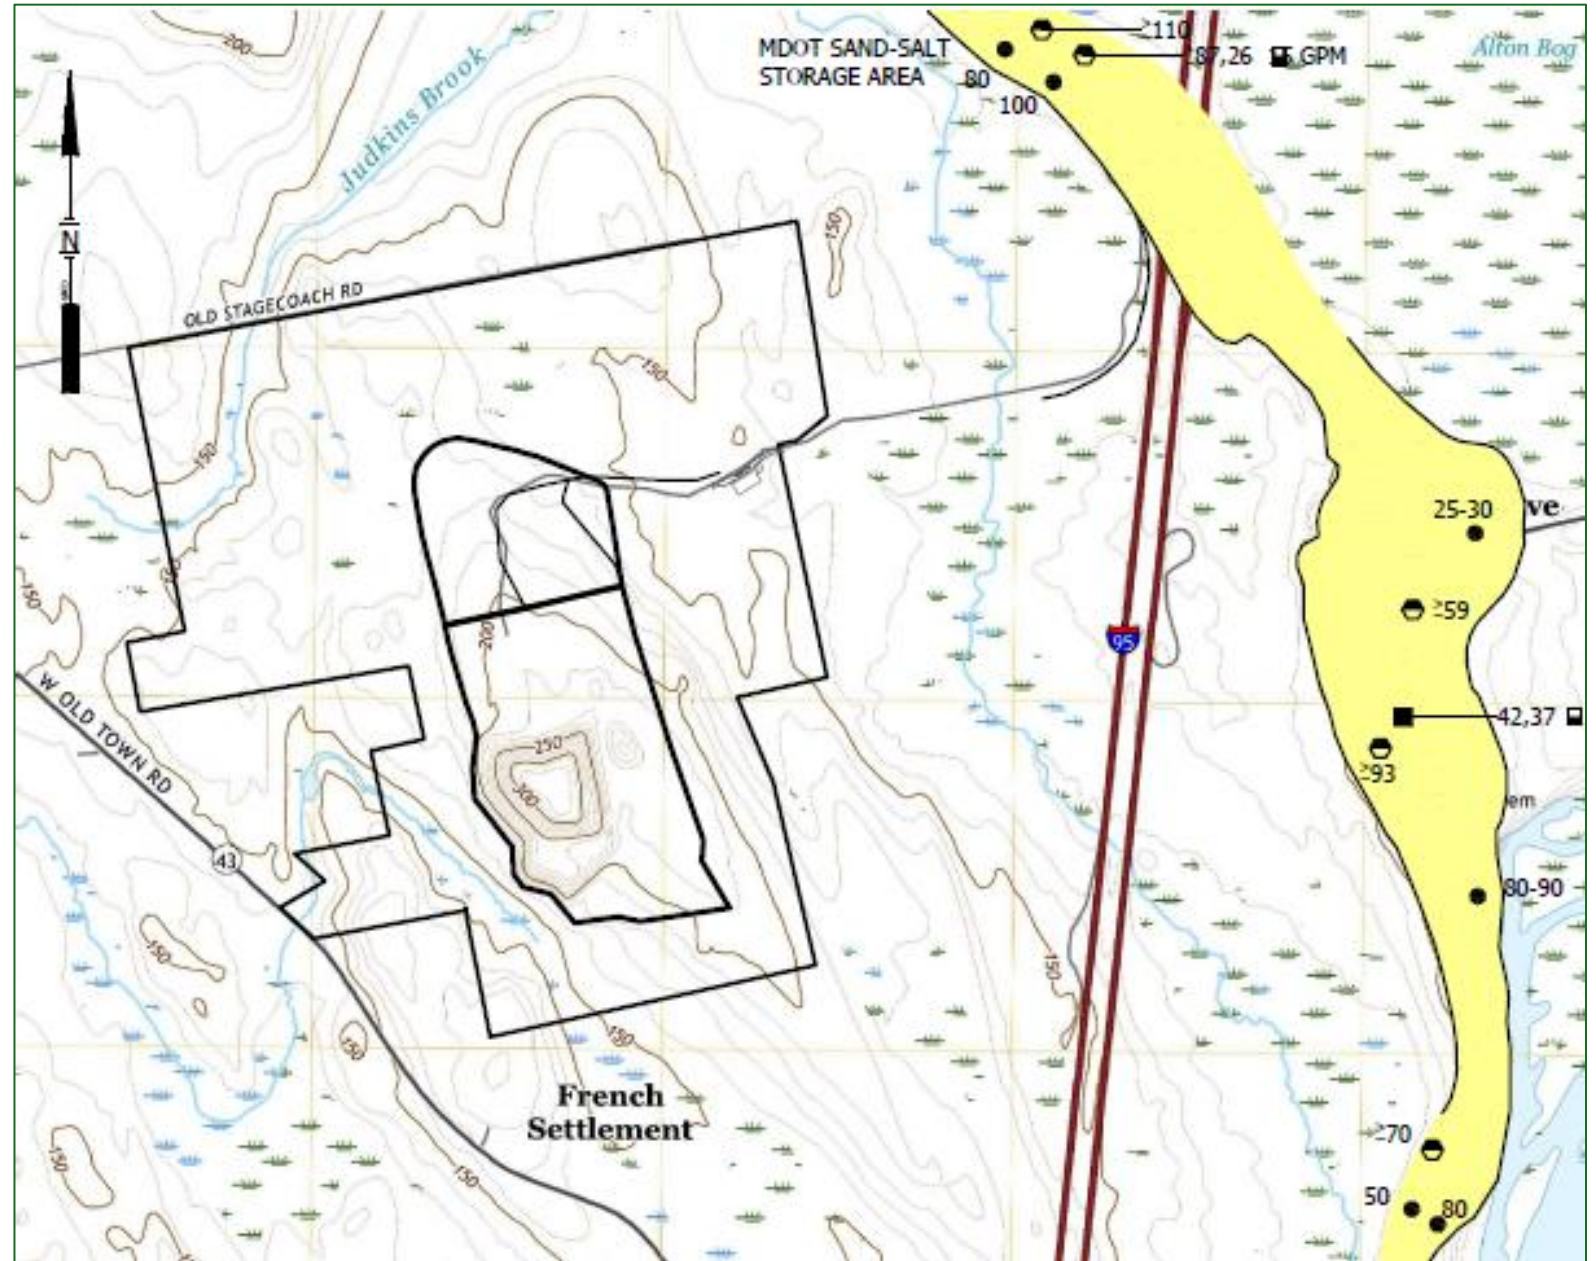
# Sand and Gravel Aquifer

- 300' required for Solid Waste Rules
- Sand and gravel aquifer is >1 mile away

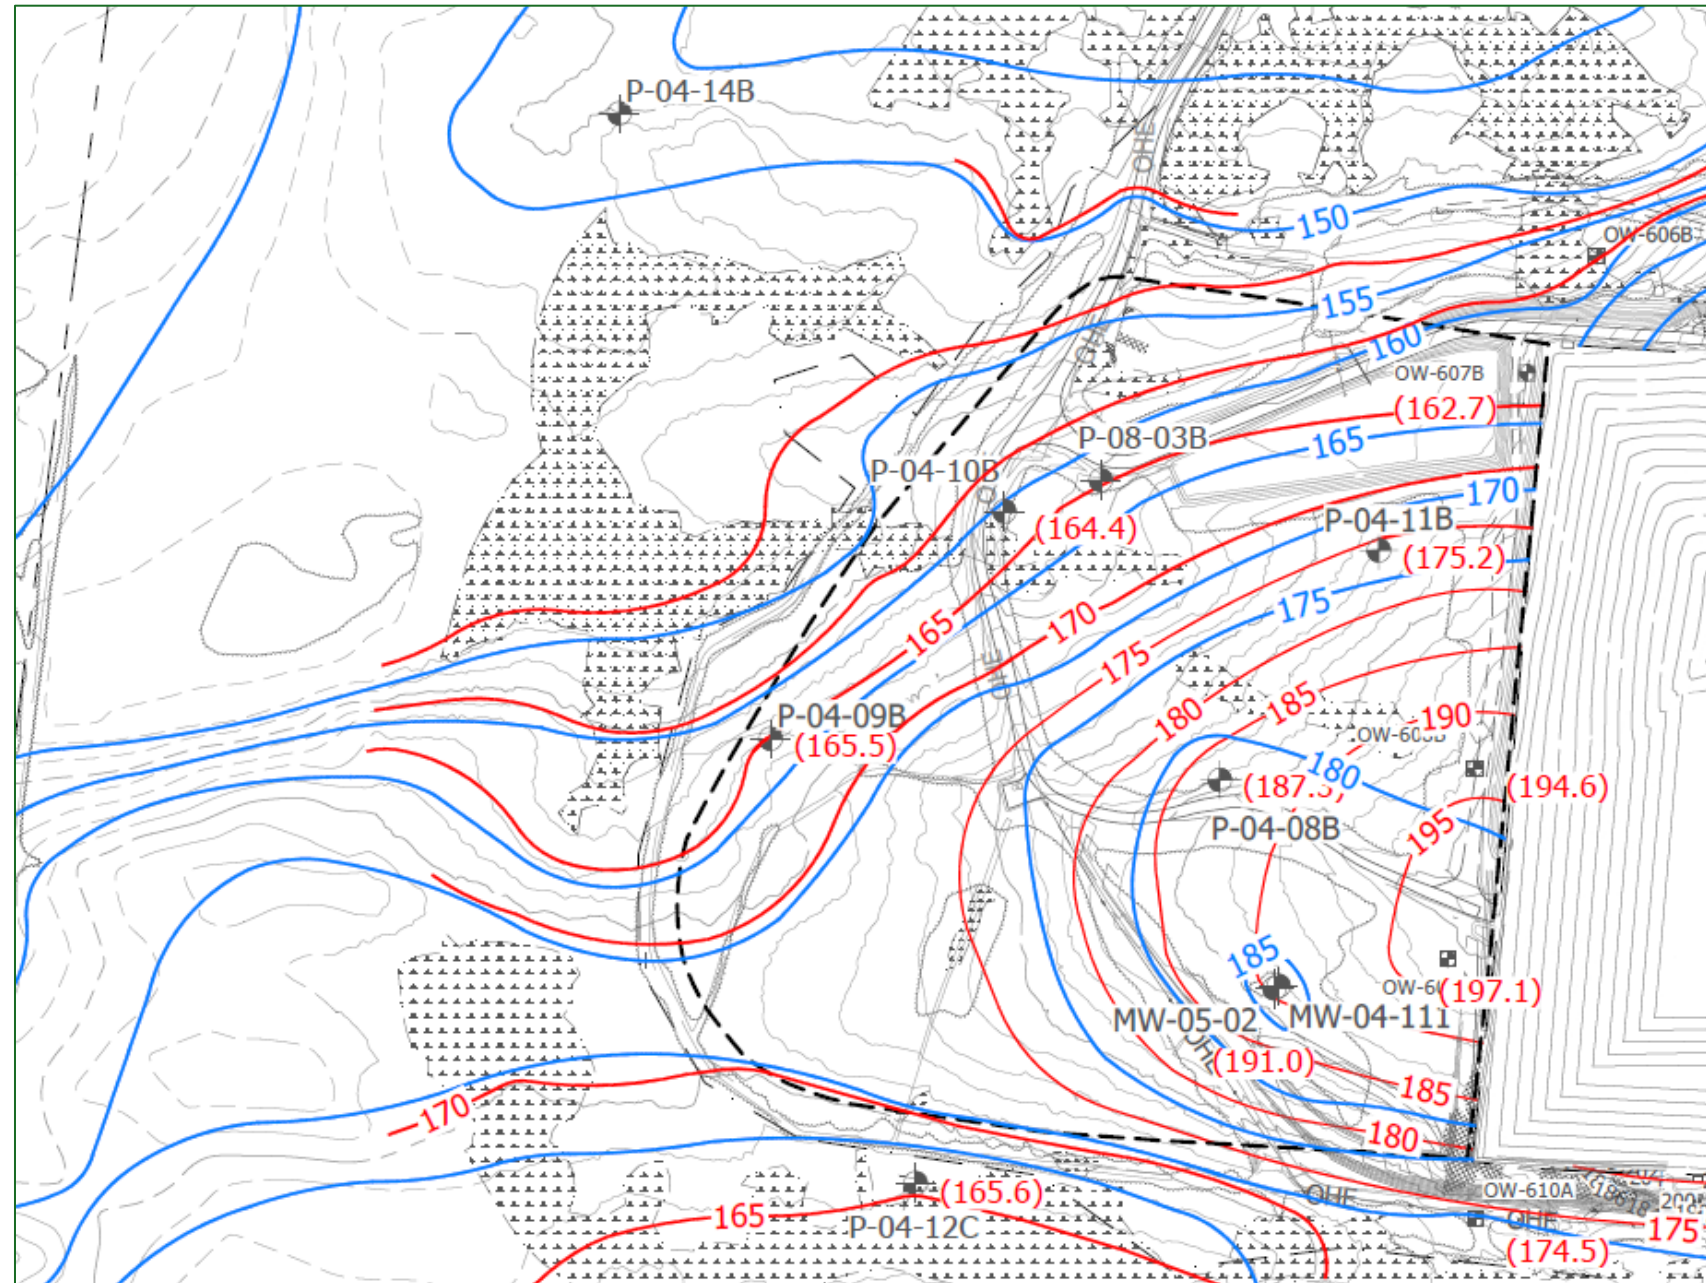
# Water levels in till

- Groundwater velocity:
  - 1'-2' per year horizontally
  - 0.04'- 0.37' per year vertically (1/2" to 4.5" per year)

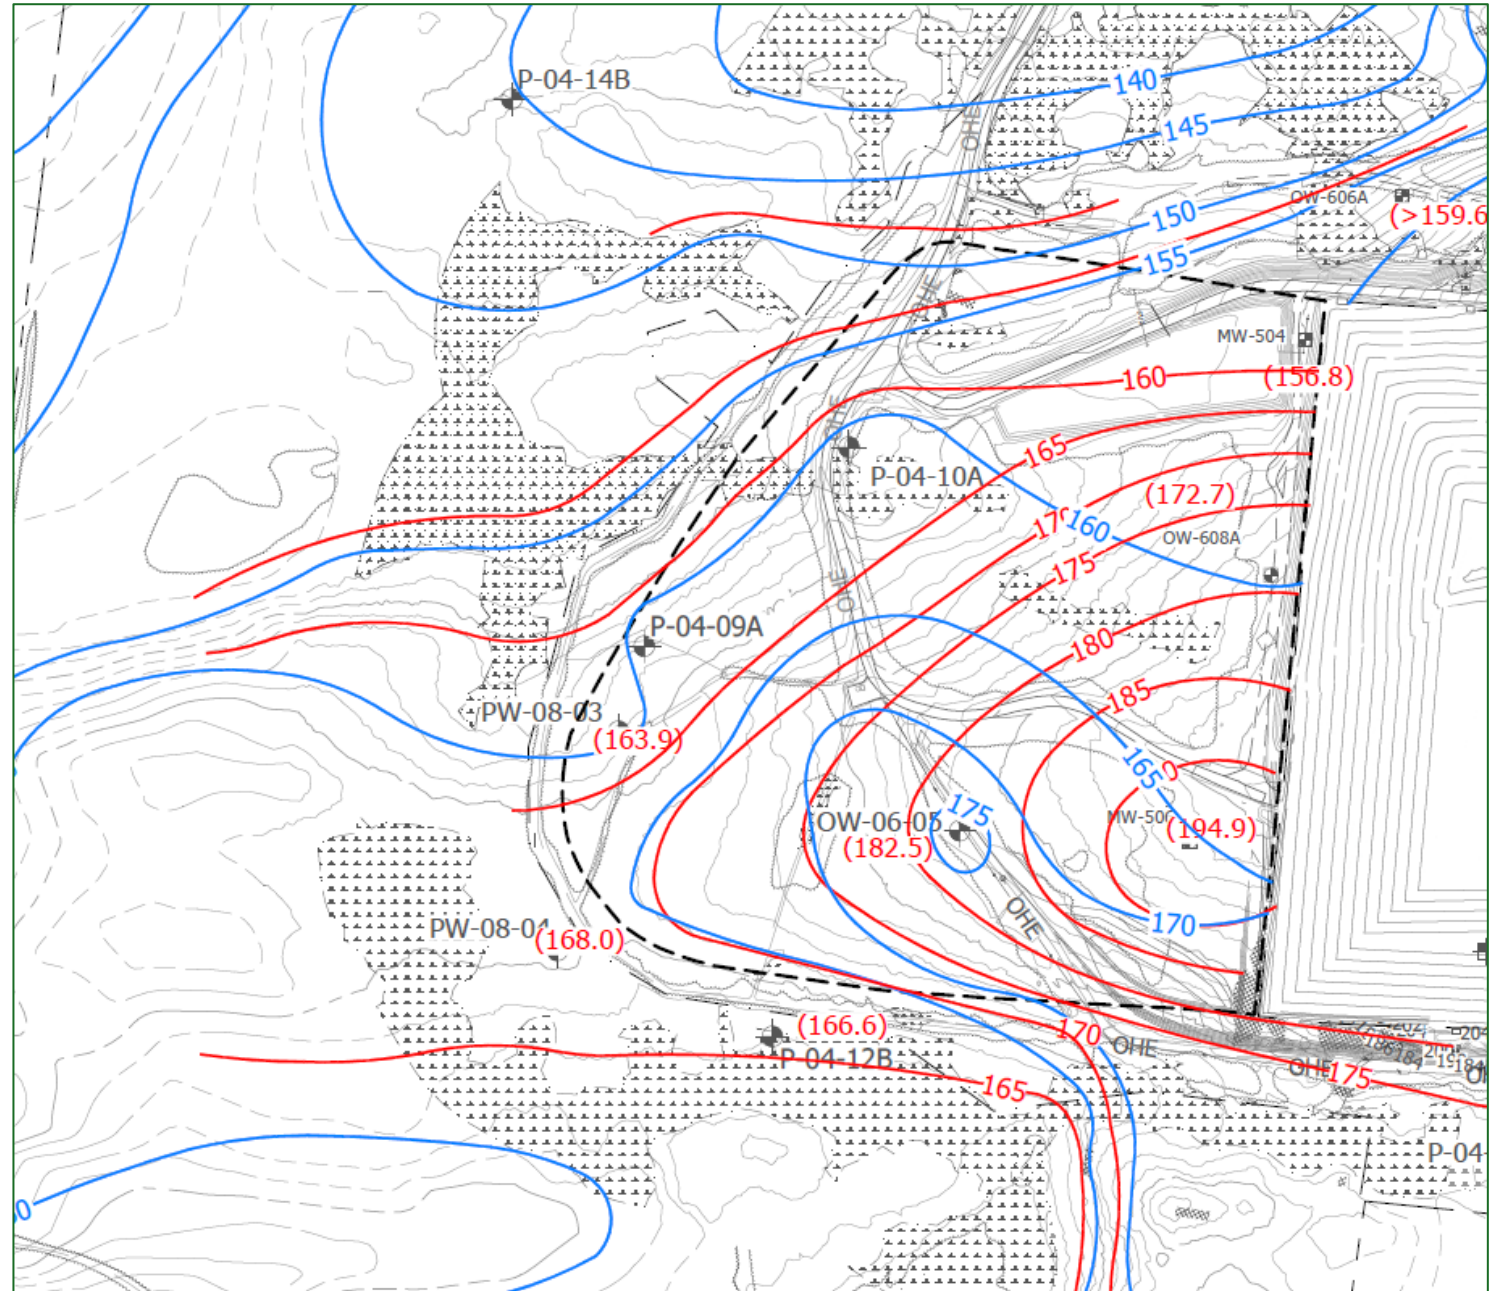
# Water levels in bedrock

- Groundwater  
velocity:
  - 2'-6' per day  
horizontally
  - (or 700'-2200'  
per year)

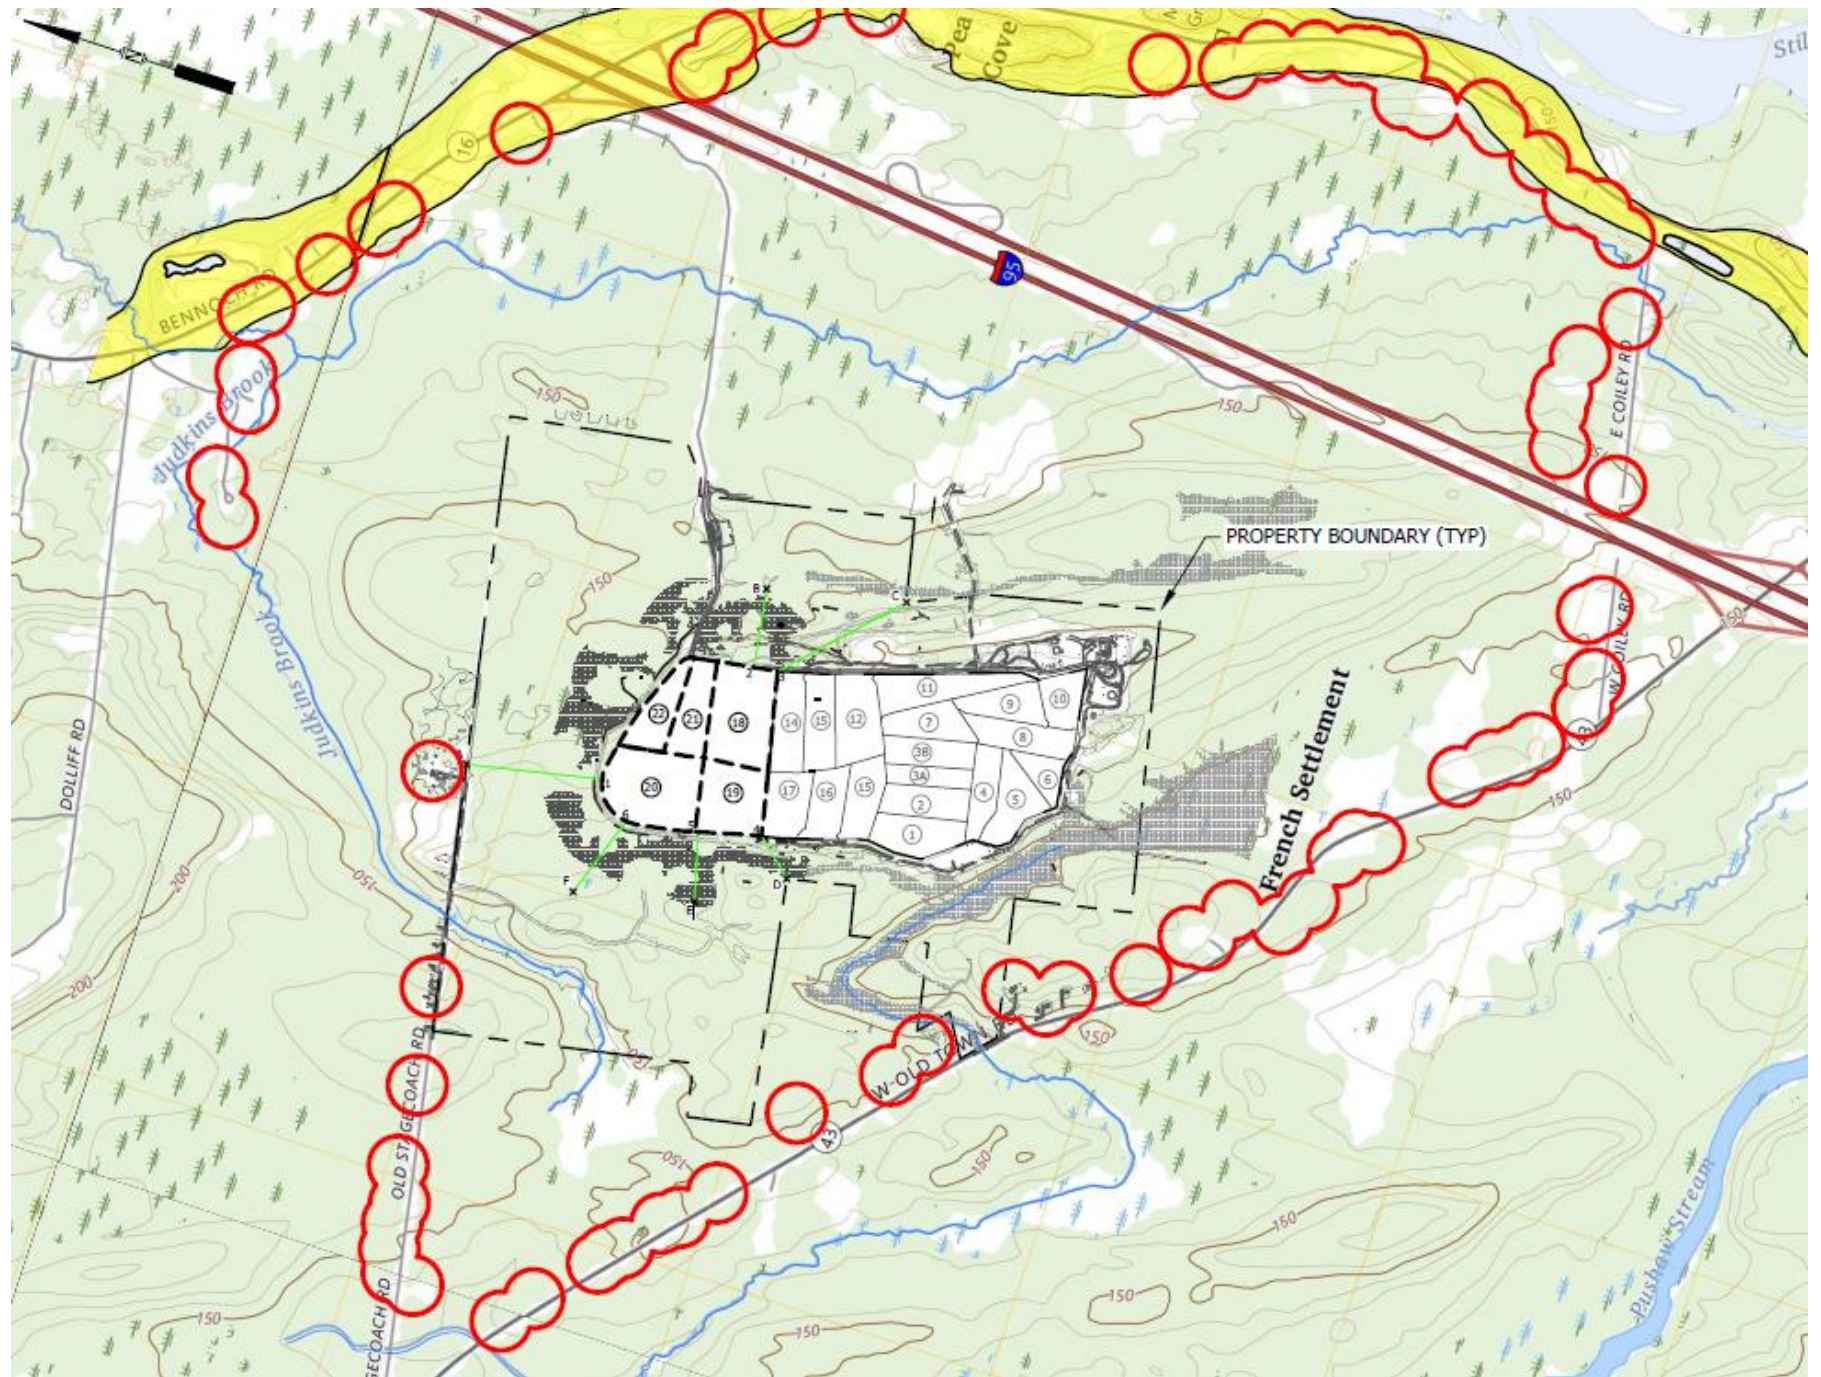
Area needed  
to recharge a  
domestic well  
is equivalent  
to about a  
300' radius  
around each  
well

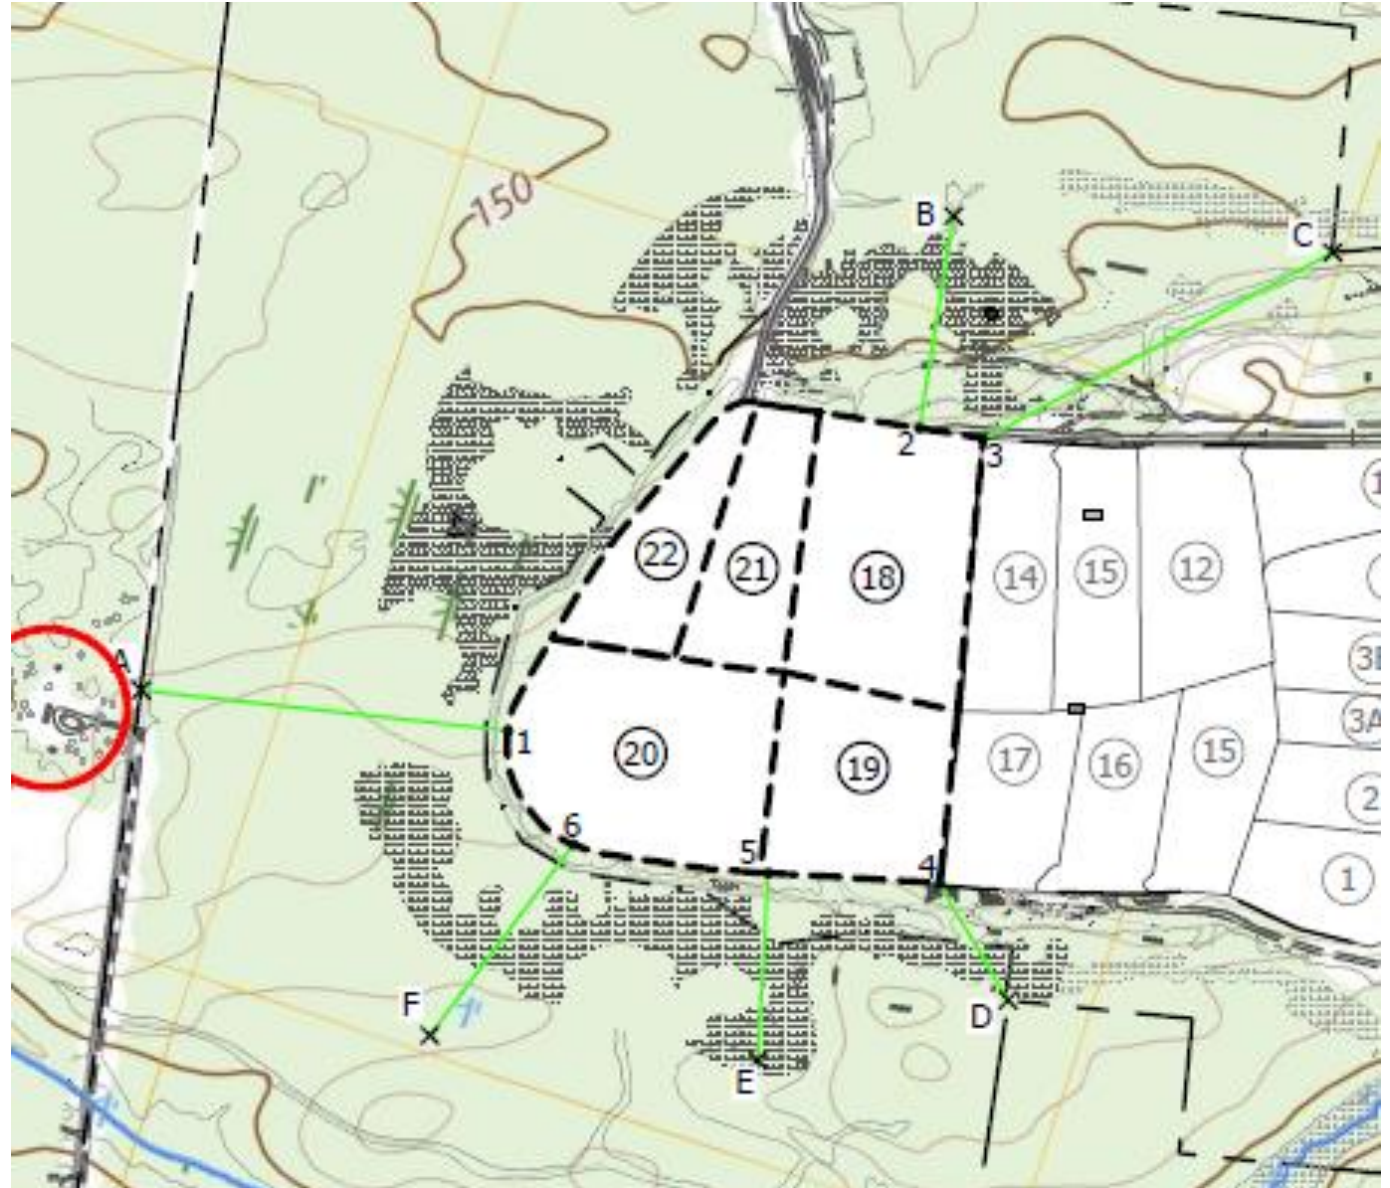
# Sensitive Receptors

A	Closest Property Line - N	1403'
B	Tributary to Judkins Brook	817'
C	Closest Property Line - E	1507'
D	Closest Property Line - W	513'
E	Tributary to Pushaw	712'
F	Tributary to Judkins Brook	907'

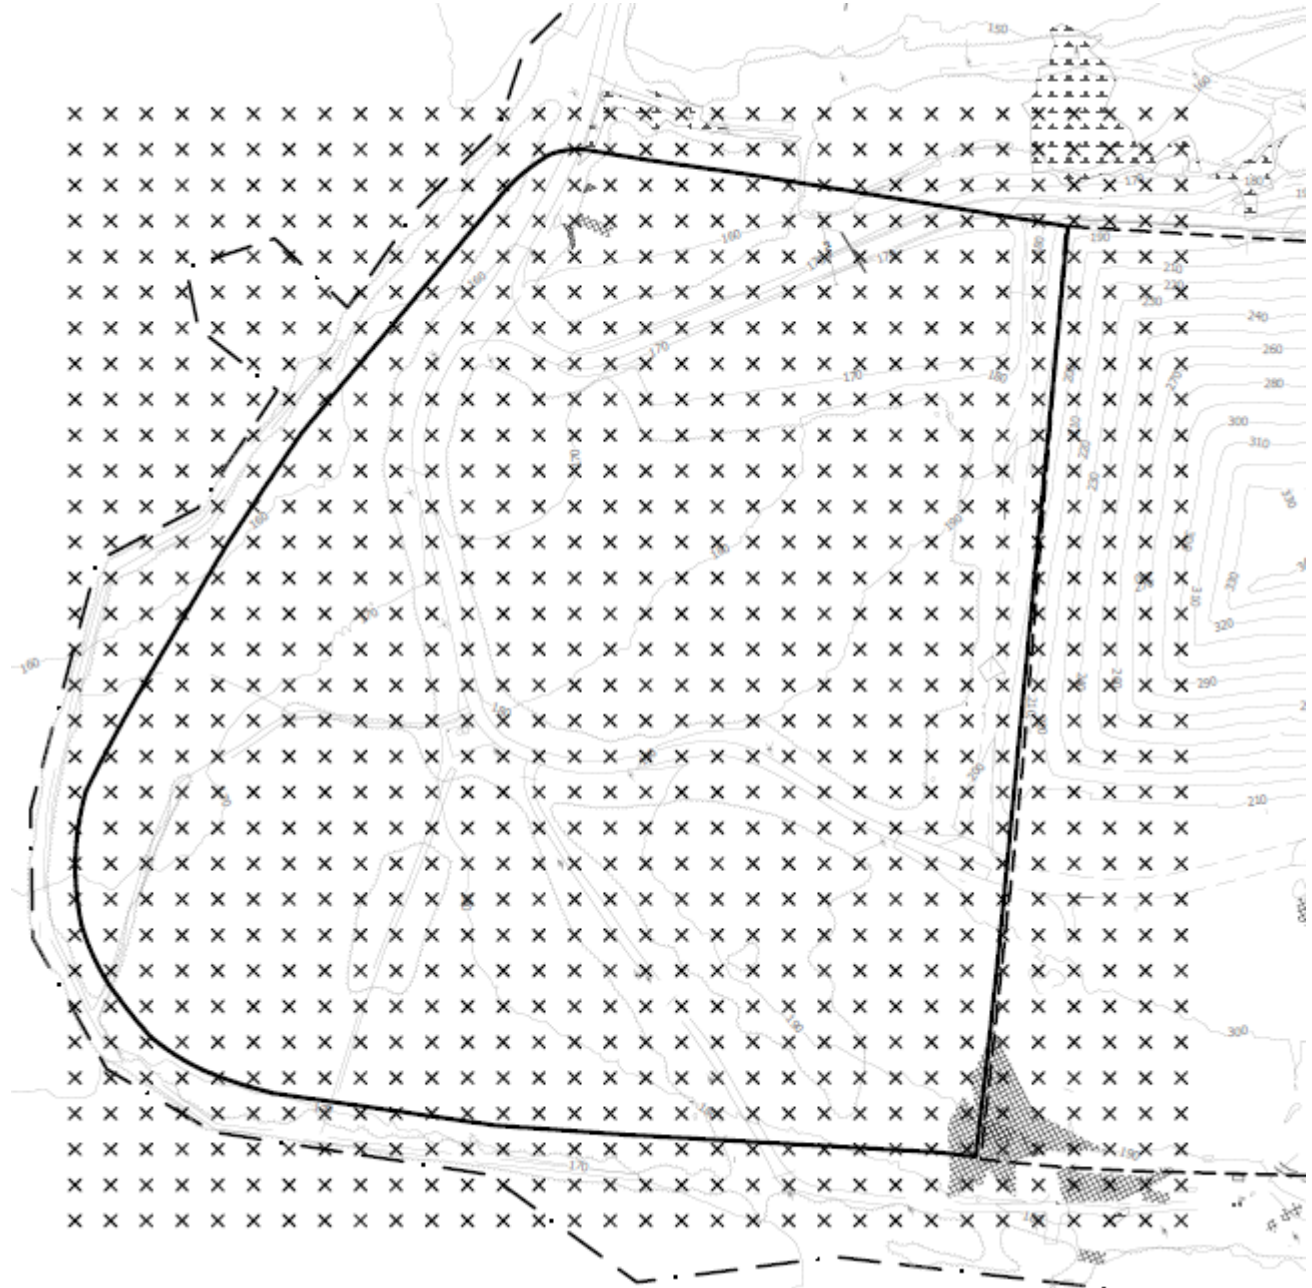
## 6-year Travel Time

- Rules require looking at a 6-year travel time JUST IN CASE
- Used a grid to evaluate travel time
- Found one spot – SW corner

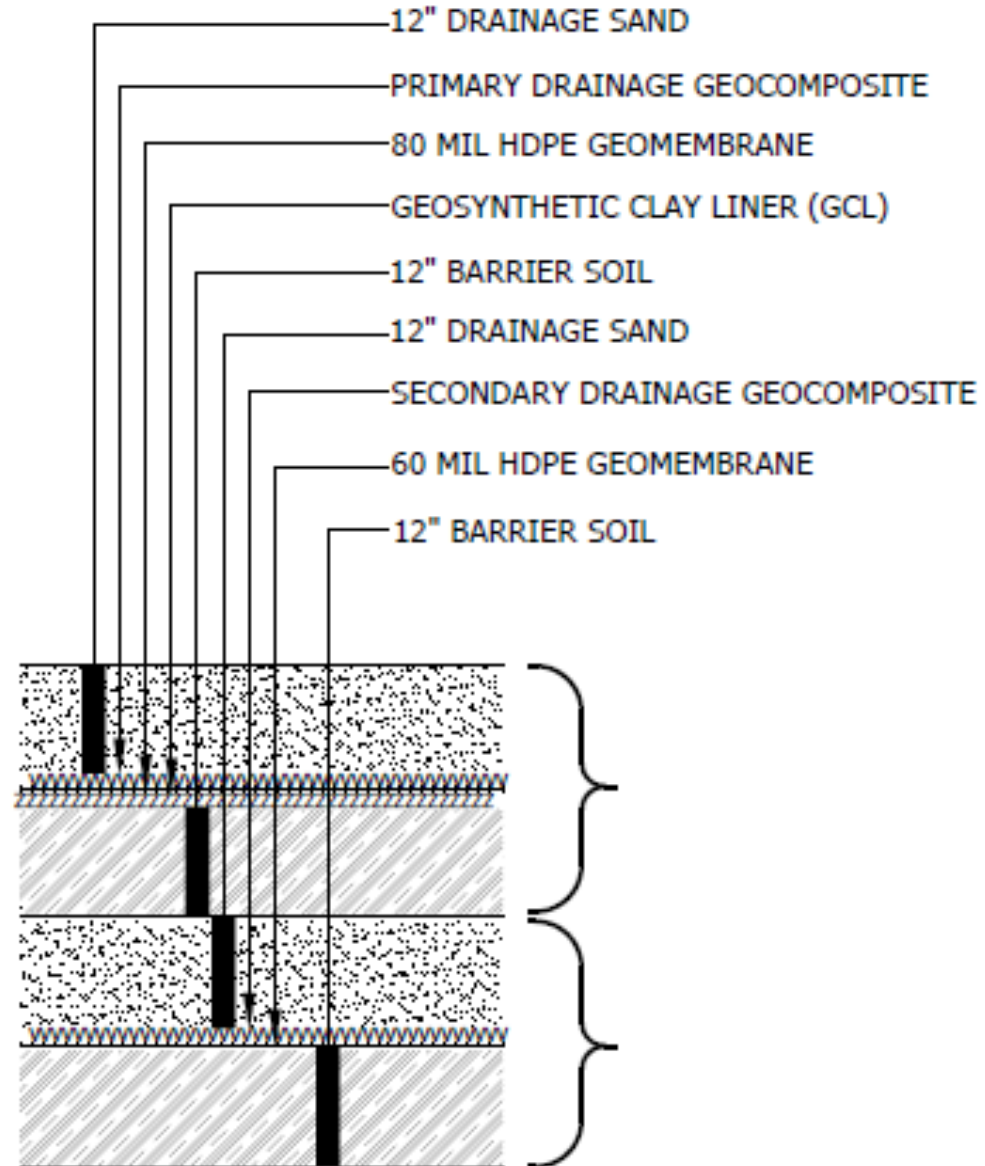
# Expansion's 4-foot thick Dual- Liner System
