# **Juniper Ridge Landfill Phase II Expansion Project Overview Meetings**

## **Meeting #3**

Geology, Hydrogeology, Water Quality,  
Leachate Management, PFAS Treatment

December 4, 2024

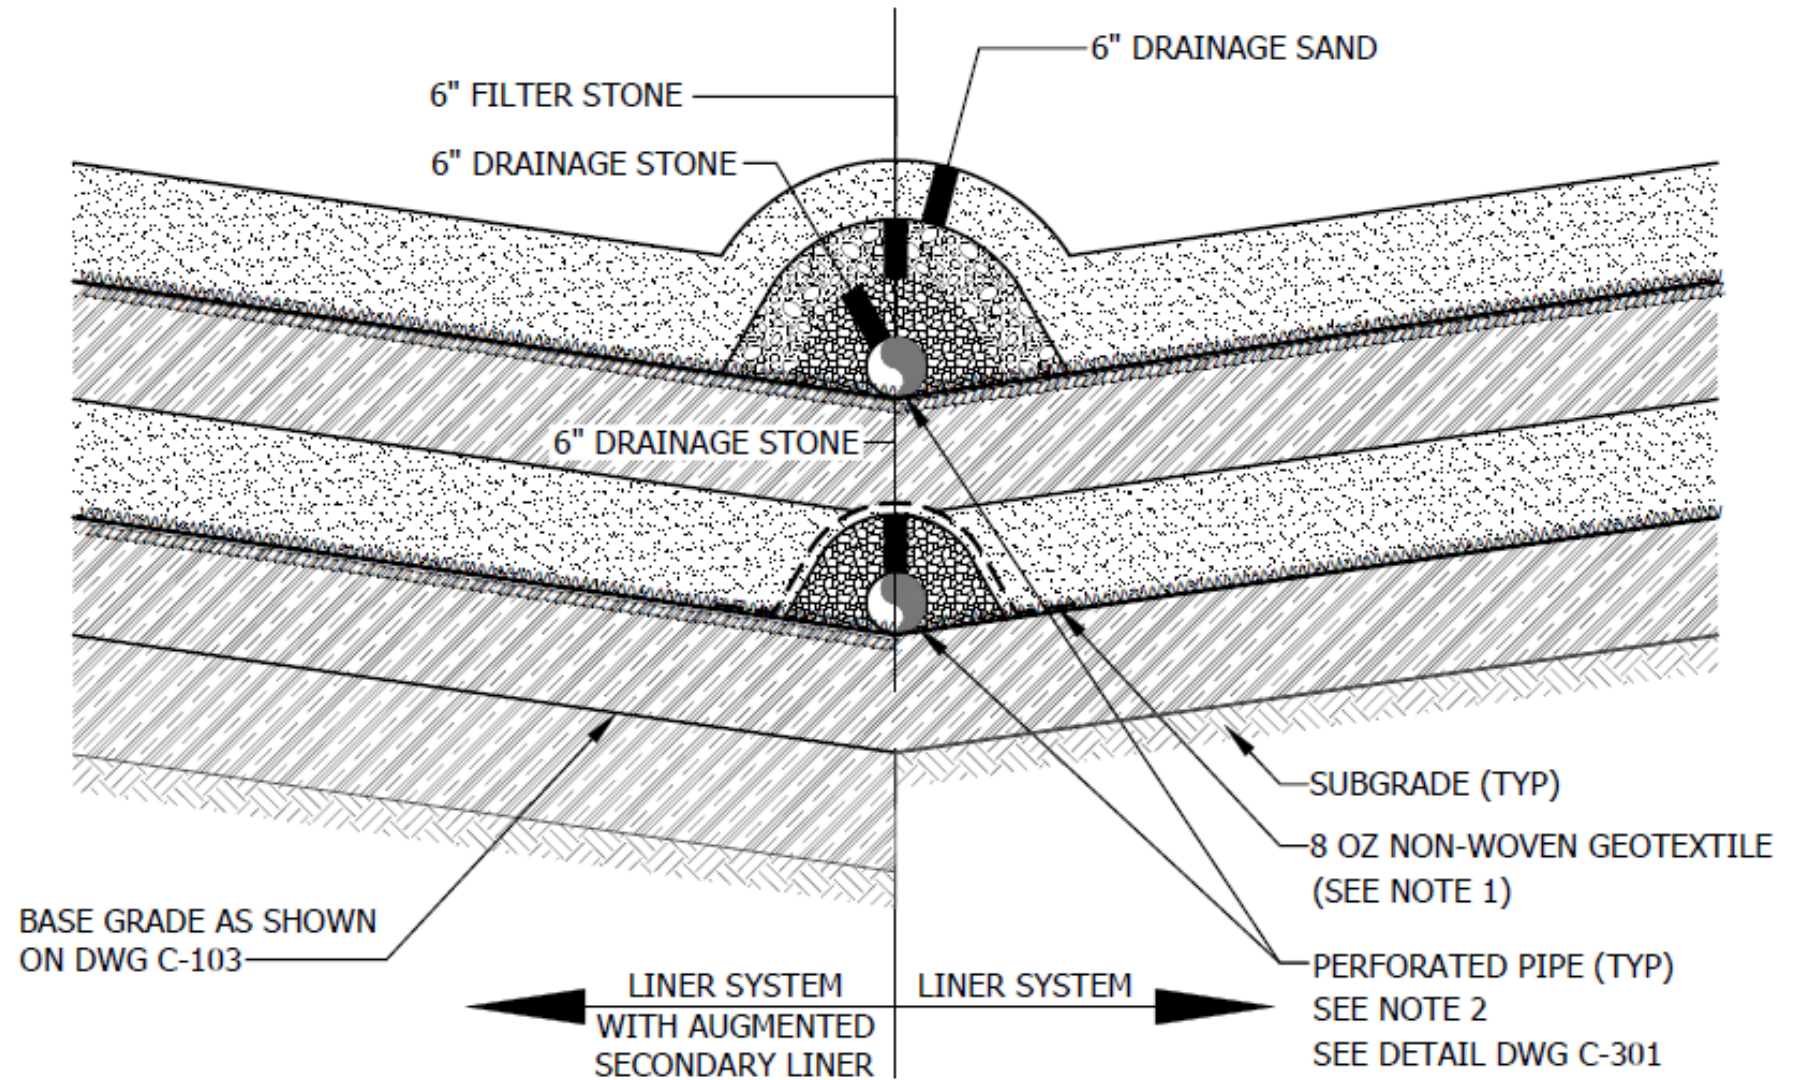
# Augmented Liner

- Site is hydraulically isolated ✓
- Water moves ***very slowly*** downward in the soils ✓
- Can meet the six-year travel time to sensitive receptors ✓
- Add augmented liner over bedrock outcrops ✓
- Uniformly fractured rock could be pumped if there were a problem - JUST IN CASE ✓

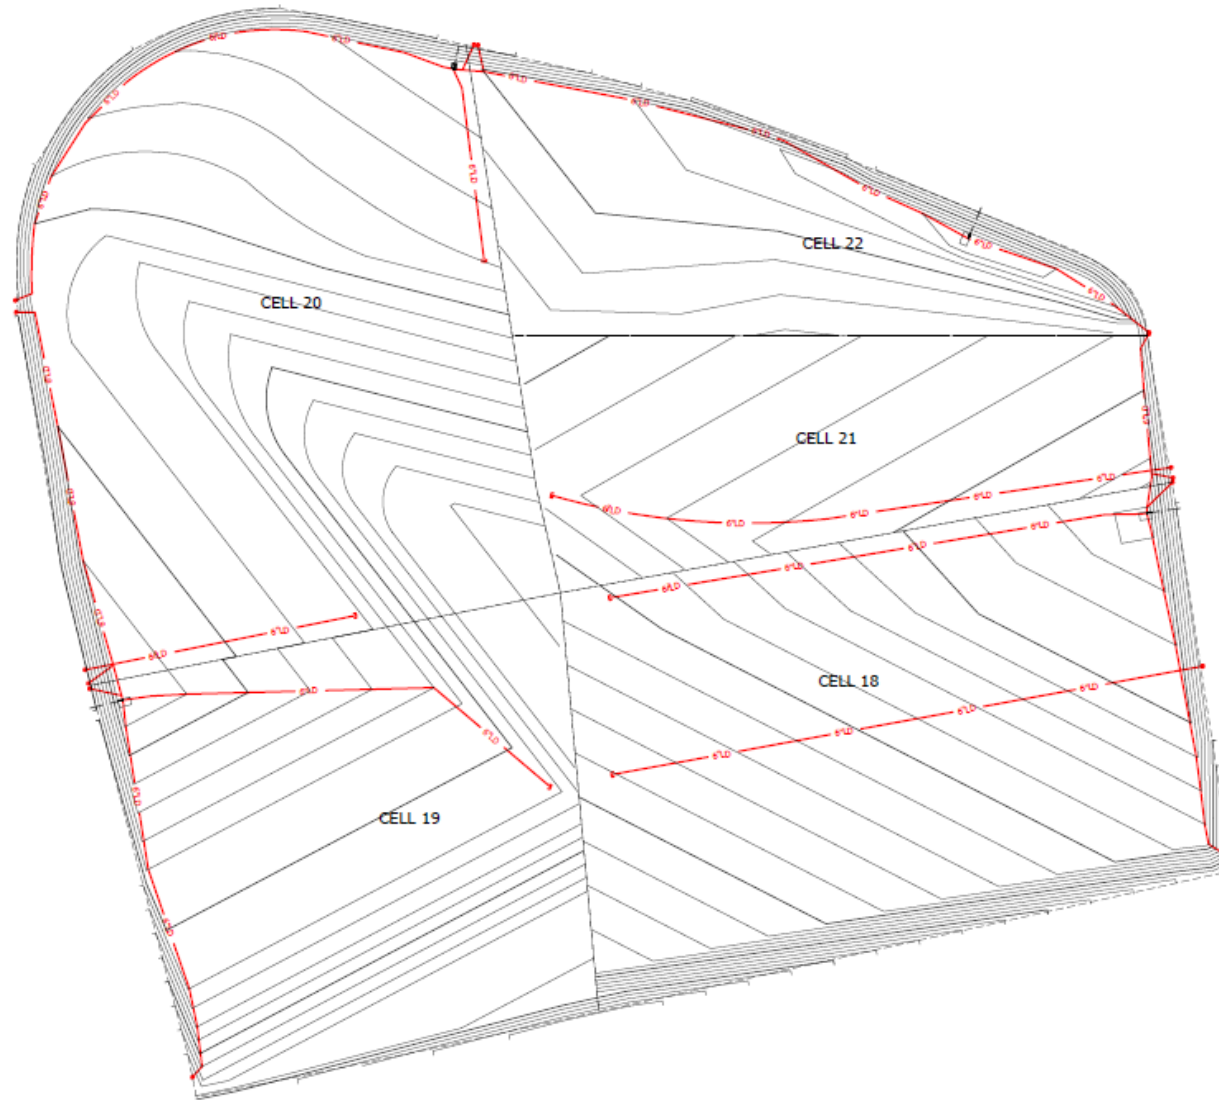
# Leak Detection piping in the cells

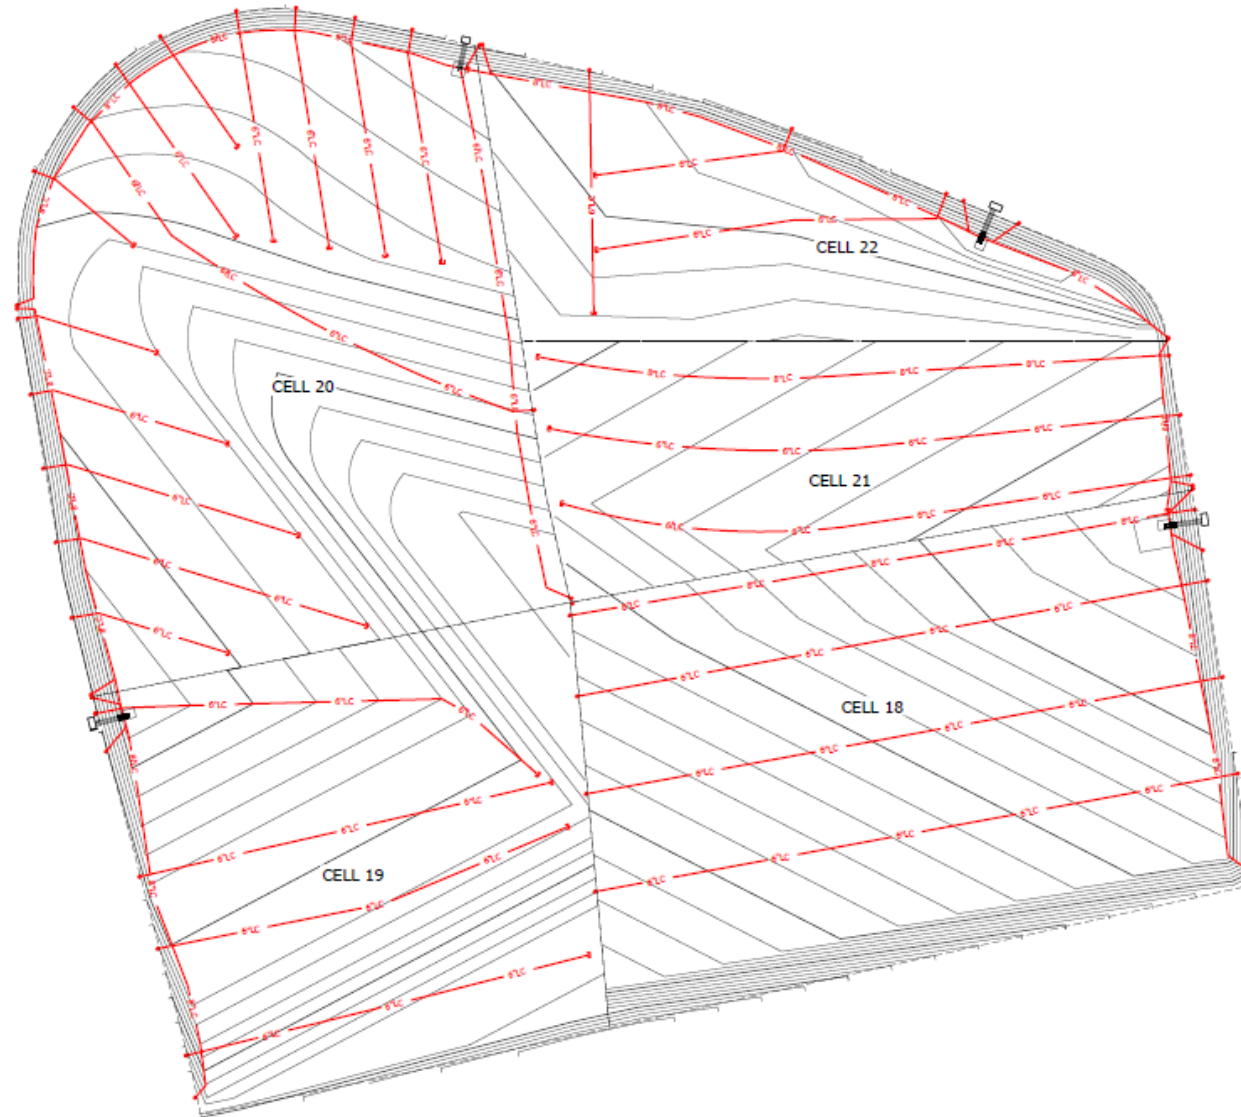
# Leachate Collection piping in the cells

- Drainage geocomposite net
- Sand
- Pipes with stone

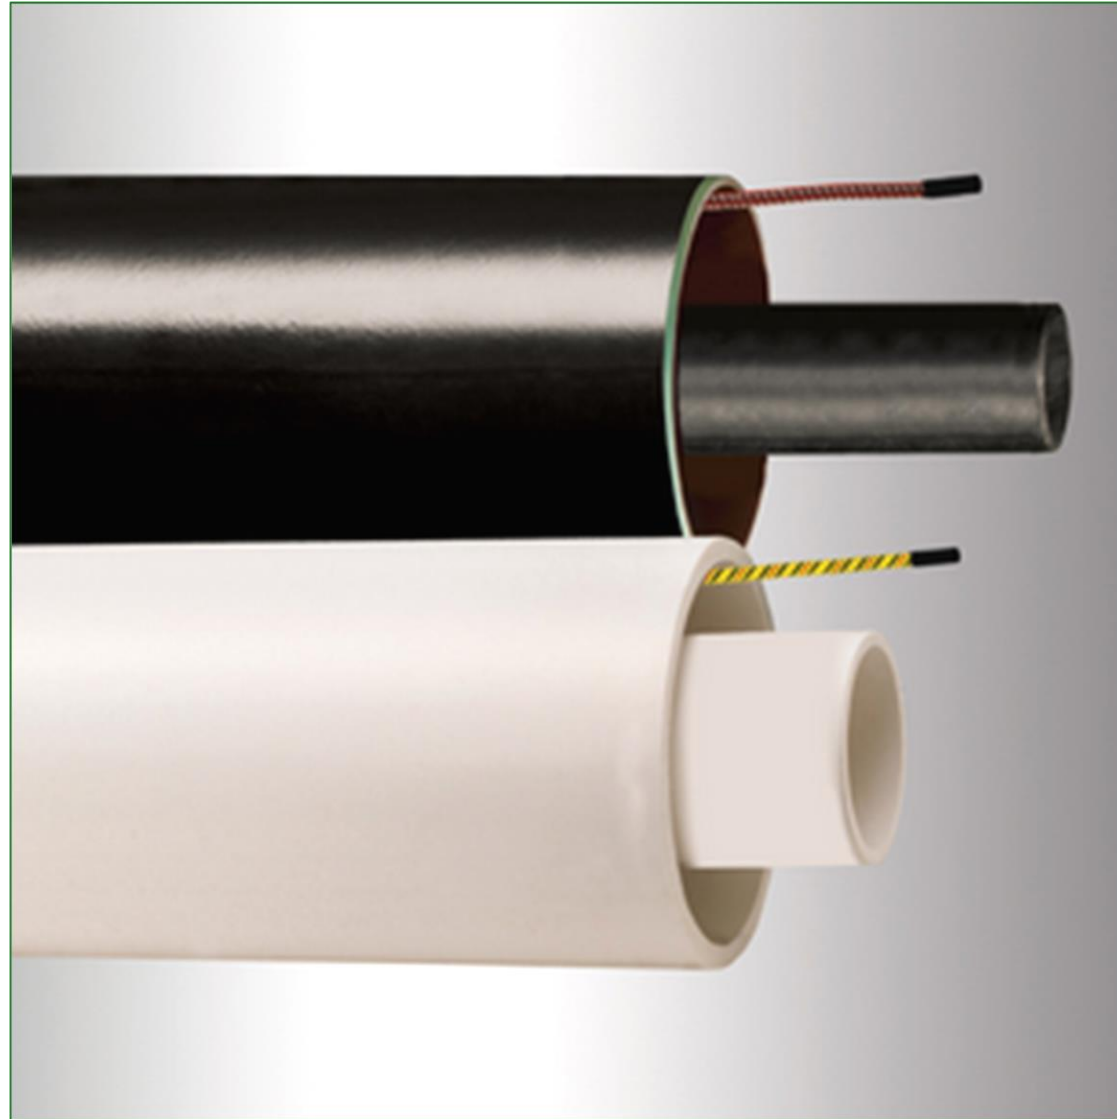
- Dual-Wall Force Main from Pump Stations to Leachate Tank

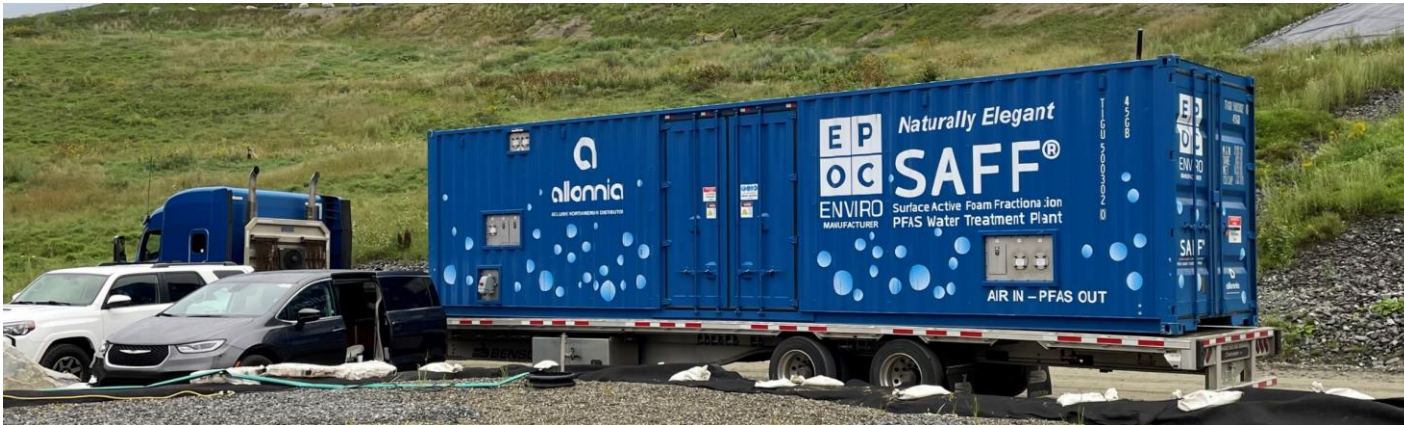
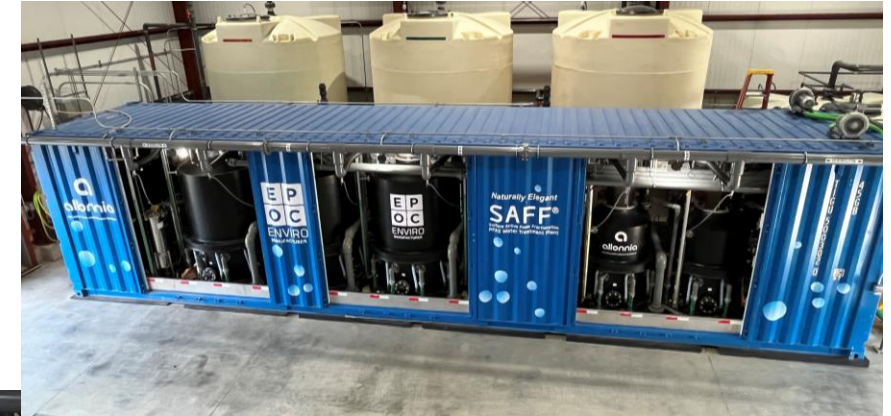
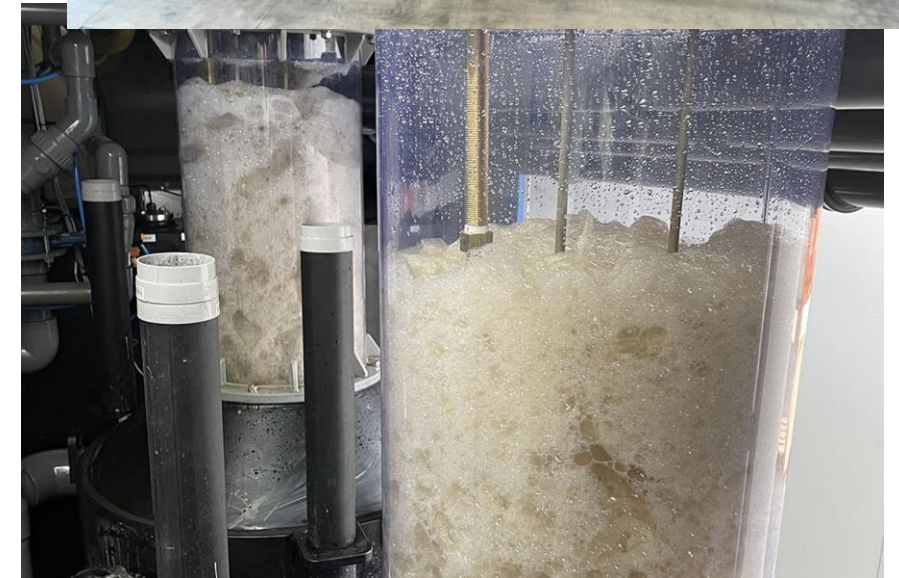
## Foam Fractionation (FF)

- FF is an absorptive bubble separation technique
- This technology historically has been utilised for proteins, enzymes and surfactant type compounds
- Evaluation will occur in close coordination with vendor selected to assure best possible results

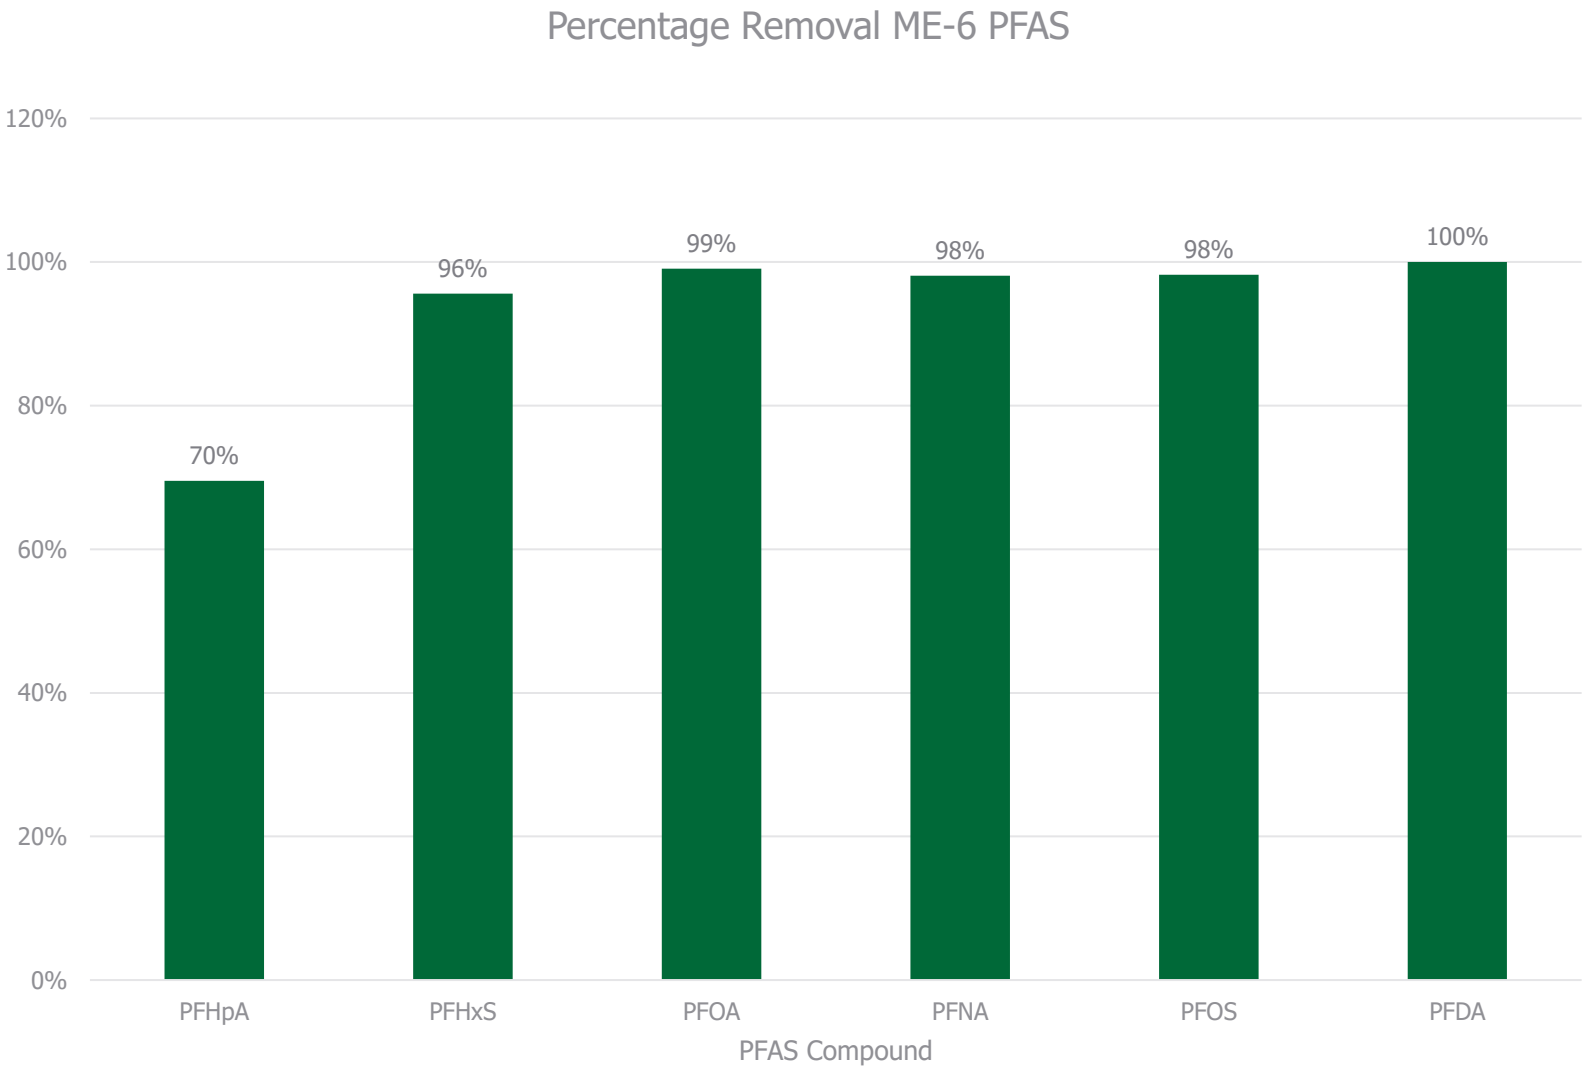
## Test Results (Average) with FF\*

- 1. PFOA 99% removal
- 2. PFOS 98% removal
- 3. PFNA 98% removal
- 4. PFHxS 96% removal
- 5. PFHpA 66% removal
- 6. PFDA 99+% removal

\*Removal based on laboratory reporting limits

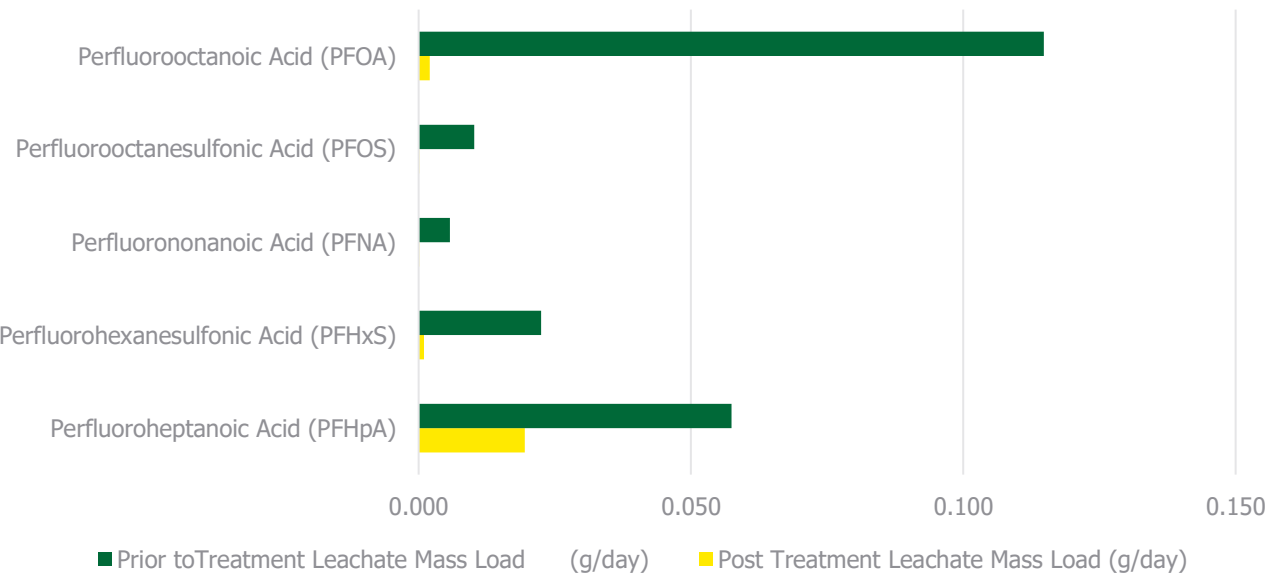
## Our contribution to Montpelier VT 5 PFAS inputs

Post Treatment Mass Load VT 5 Compounds

Mass Contribution of PFAS from Leachate

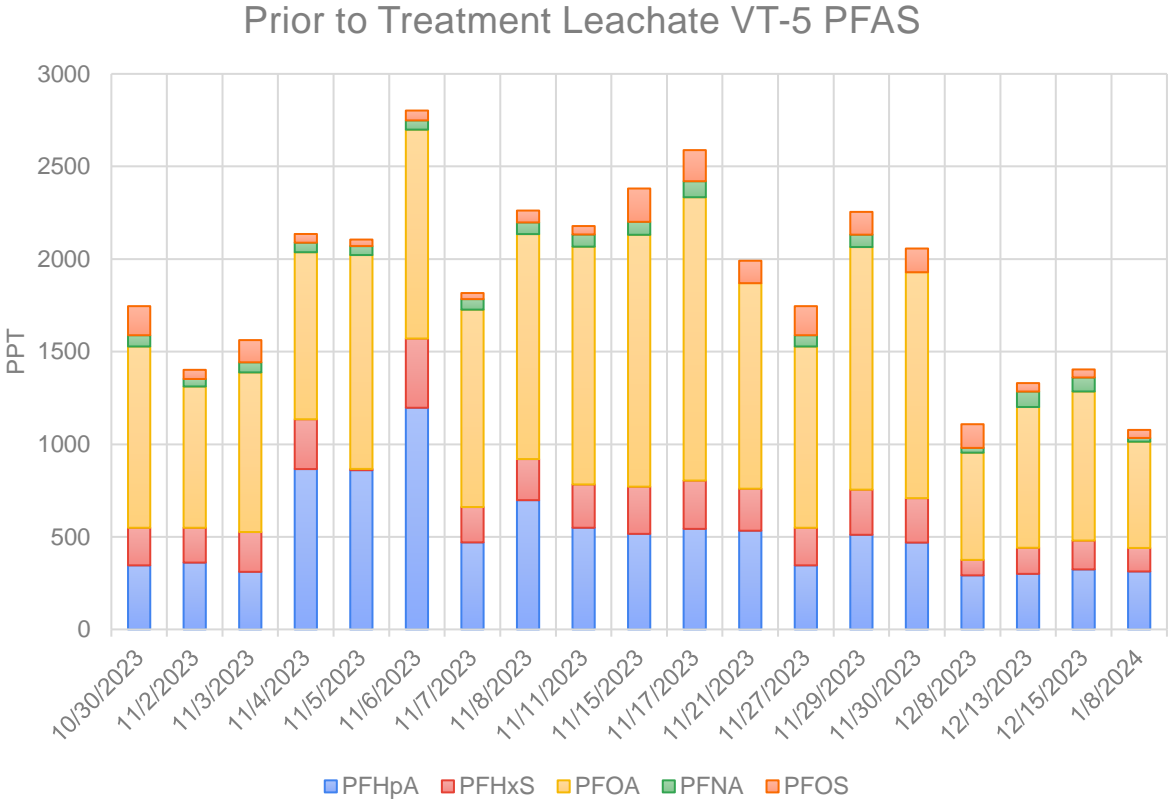
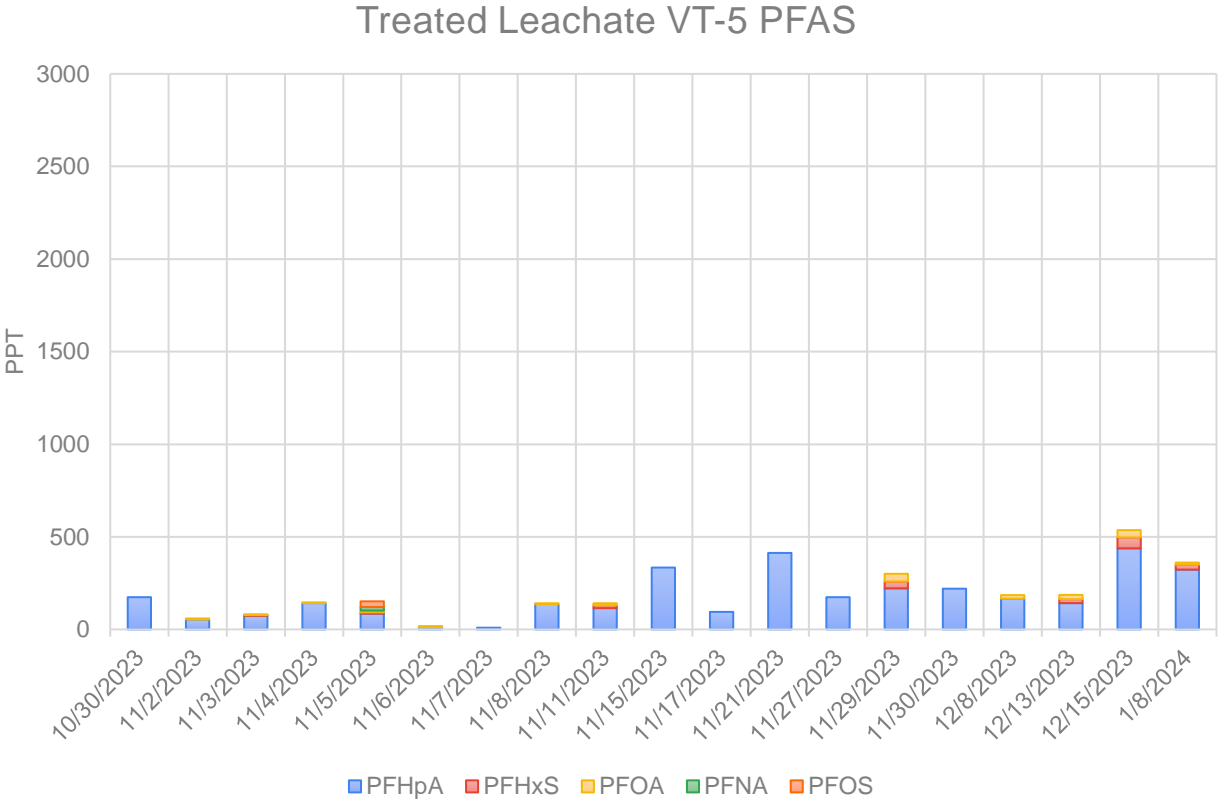
## Results of Treatment Shakedown

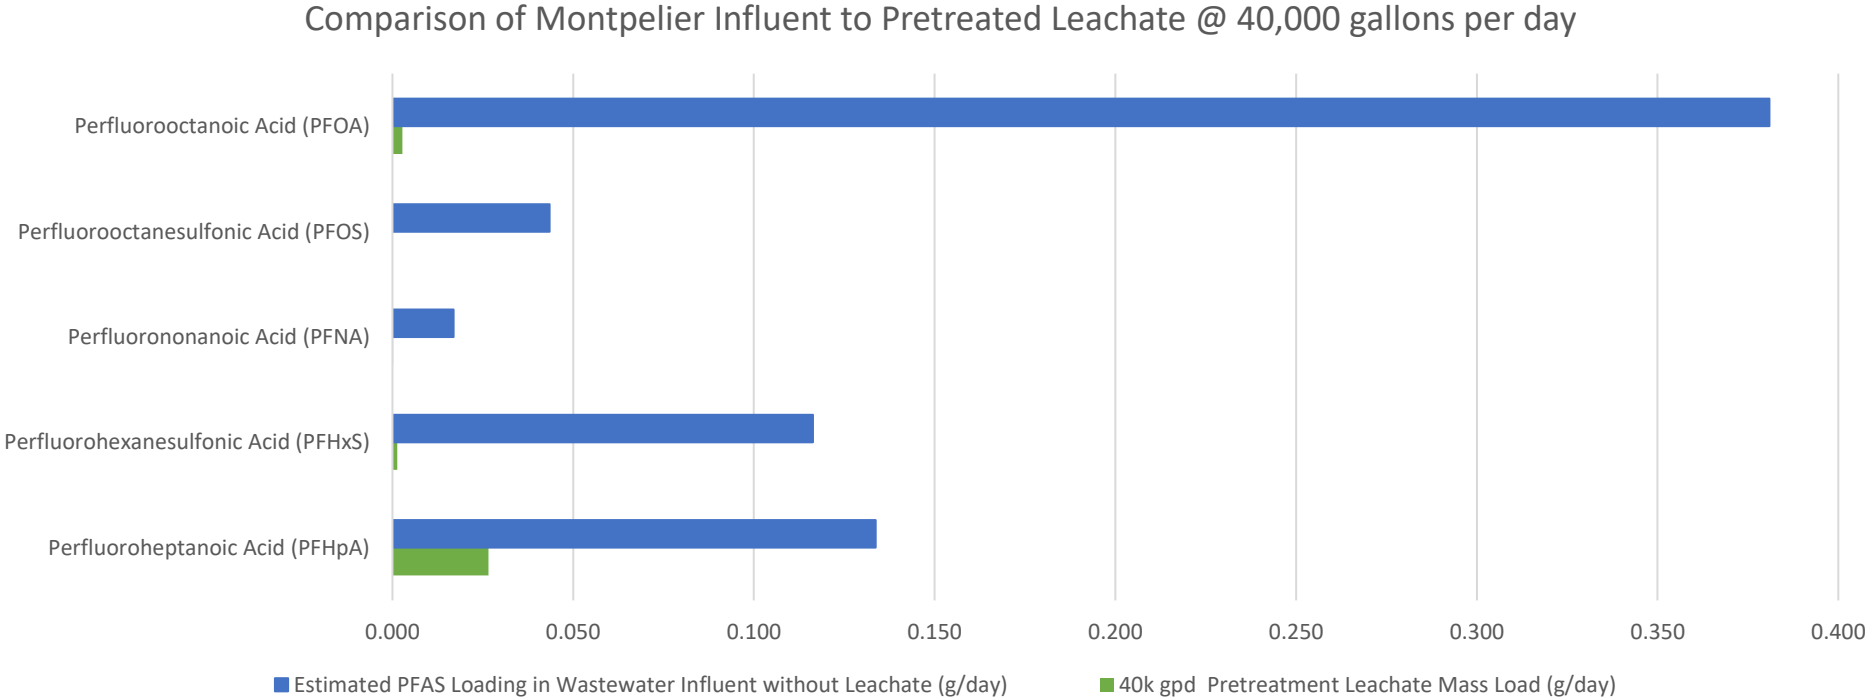
## Results of Treatment Shakedown
