## LIMITED HAZARDOUS BUILDING MATERIALS INVENTORY

**CHARLOTTE SMITH PROPERTY  
881 MAIN STREET  
MEDDYBEMPS, MAINE**

**Prepared for: State of Maine  
Department of Environmental Protection  
Division of Remediation & Waste Management  
Bangor, Maine**

**January 19, 2021  
JN: 10193.060**

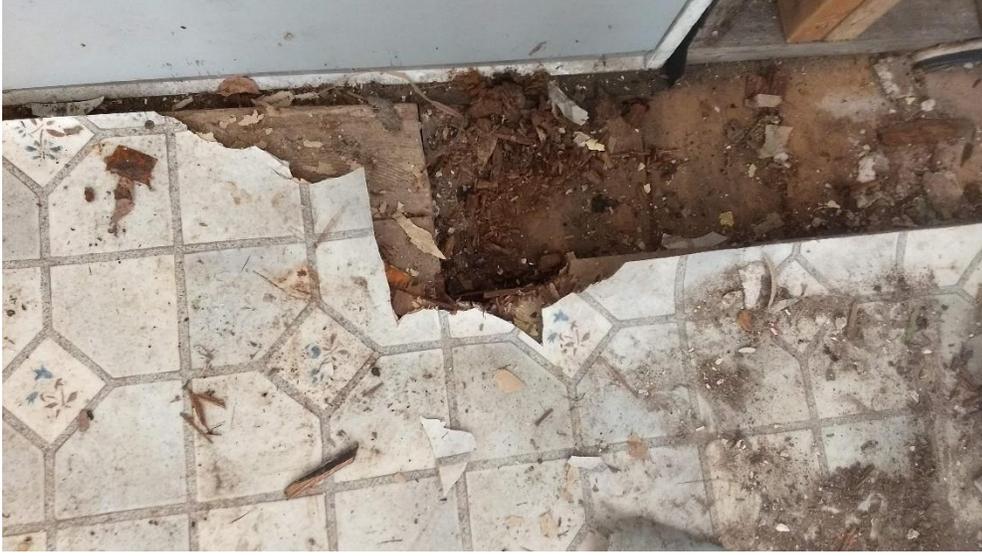
<p><b>Photo No.</b> 1</p>
	<p><b>Photo Date:</b> November 18, 2020</p>
	<p><b>Site Location:</b> 881 Main Street Meddybemps, Maine</p>
	<p><b>Description:</b> First Floor; Kitchen (Rm. #1) – two layers of ACM sheet flooring (MS-001A).</p>
<p><b>Photo By:</b> DAK</p>

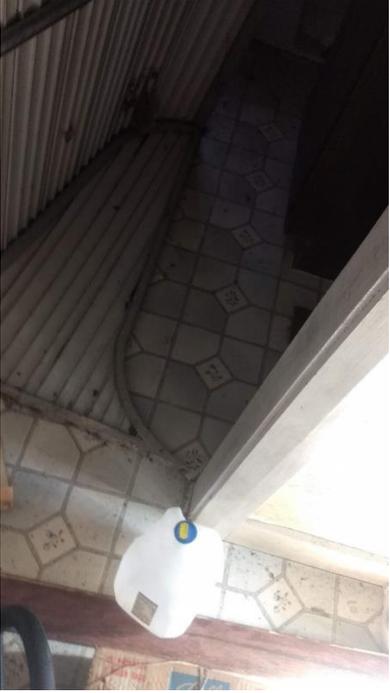
<p><b>Photo No.</b> 2</p>
	<p><b>Photo Date:</b> November 18, 2020</p>
	<p><b>Site Location:</b> 881 Main Street Meddybemps, Maine</p>
	<p><b>Description:</b> First Floor; Bathroom (Rm. #2) – two layers of ACM sheet flooring (MS-009A).</p>
<p><b>Photo By:</b> DAK</p>

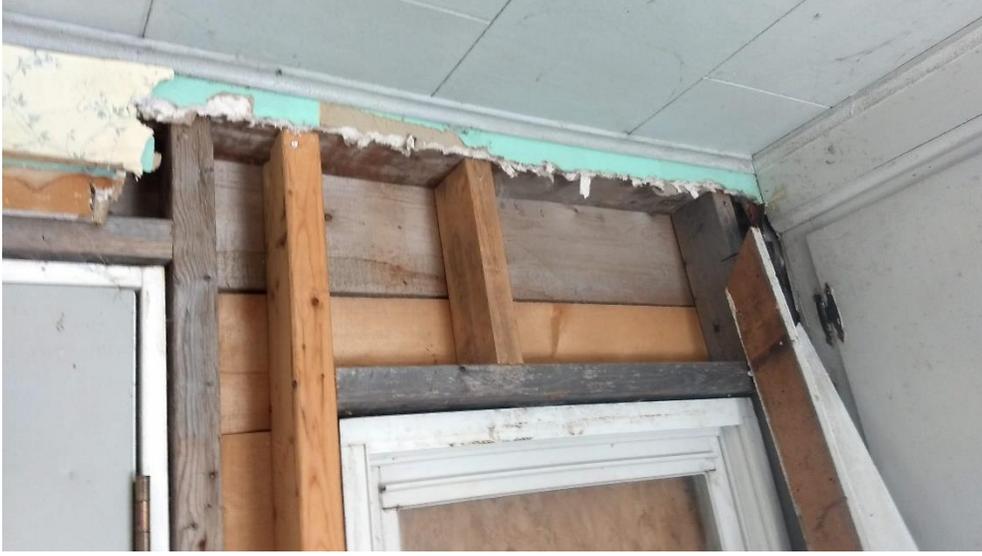
<p><b>Photo No.</b> 3</p>
	<p><b>Photo Date:</b> November 18, 2020</p>
	<p><b>Site Location:</b> 881 Main Street Meddybemps, Maine</p>
	<p><b>Description:</b> First Floor; Kitchen (Rm. #1) – Sheetrock wall system near entry door. Non-ACM ceiling tiles present (MS-010A).</p>
<p><b>Photo By:</b> DAK</p>

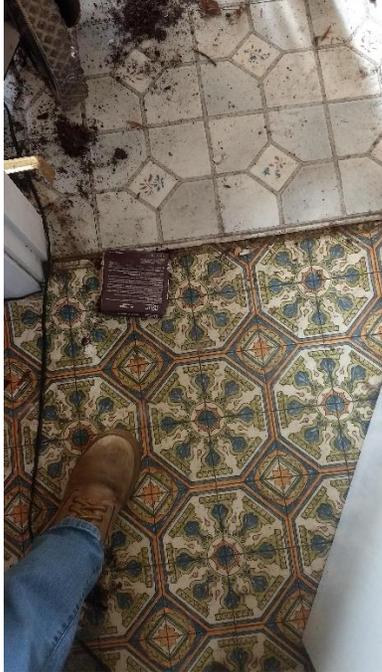
<p><b>Photo No.</b> 4</p>
	<p><b>Photo Date:</b> November 18, 2020</p>
	<p><b>Site Location:</b> 881 Main Street Meddybemps, Maine</p>
	<p><b>Description:</b> First Floor; Hallway (Rm. #6 partial) near Bedroom #1 Entry Door. ACM sheet flooring in Bedroom #1 (Sample MS-004A).</p>
<p><b>Photo By:</b> DAK</p>

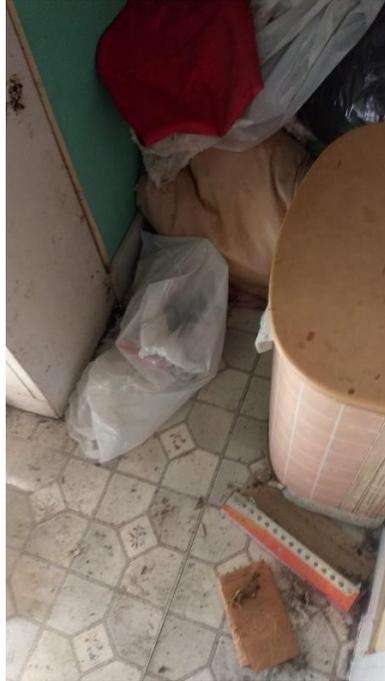
**Photo No. 5**

**Description:**  
First Floor; Kitchen  
(Rm. #1) Closet – same  
double layer of sheet  
flooring as Kitchen  
(MS-001A).

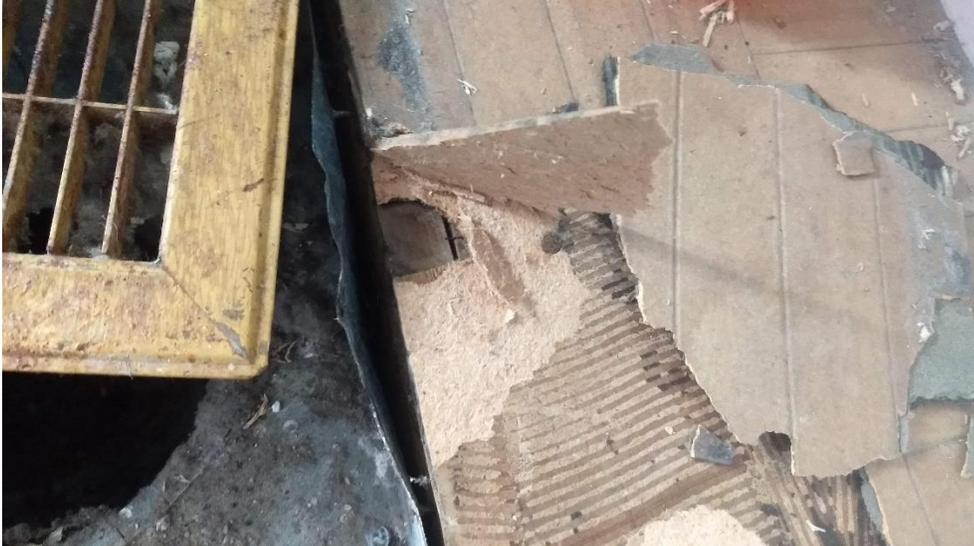
<p><b>Photo No.</b> 7</p>
	<p><b>Photo Date:</b> November 18, 2020</p>
	<p><b>Site Location:</b> 881 Main Street Meddybemps, Maine</p>
	<p><b>Description:</b> First Floor; Living Room (Rm. #7) – two layers of Non-ACM flooring material (MS-002A and MS-003A).</p>
<p><b>Photo By:</b> DAK</p>

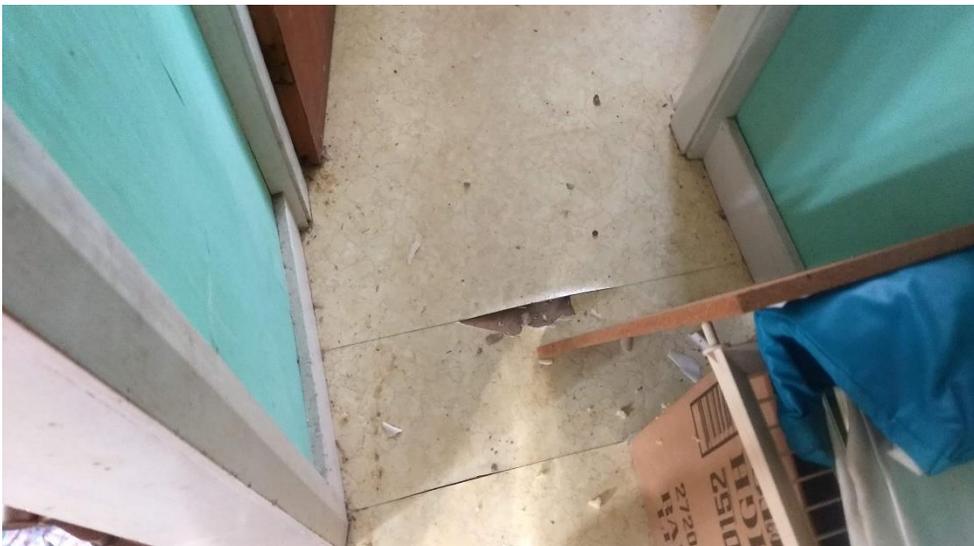
<p><b>Photo No.</b> 8</p>
	<p><b>Photo Date:</b> November 18, 2020</p>
	<p><b>Site Location:</b> 881 Main Street Meddybemps, Maine</p>
	<p><b>Description:</b> First Floor; Hallway (partial; Rm. #6) – ACM Cream pattern sheet flooring (MS-007A).</p>
<p><b>Photo By:</b> DAK</p>

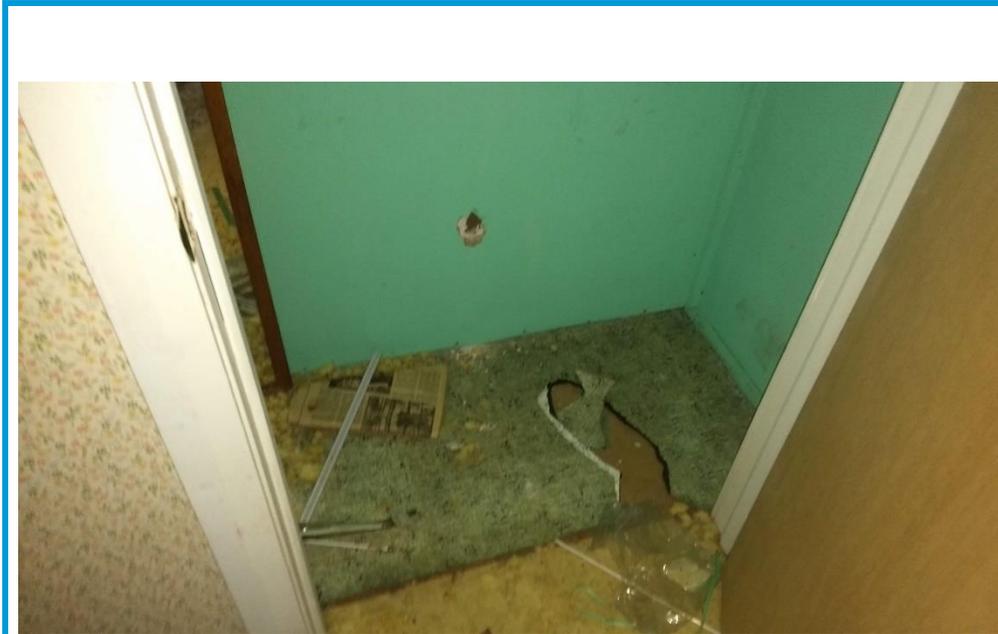
**Photo No.** 9

**Description:**  
First Floor; Bedroom #3  
Closet (Rm. #5) - Non  
ACM sheet Flooring  
(MS-005C)

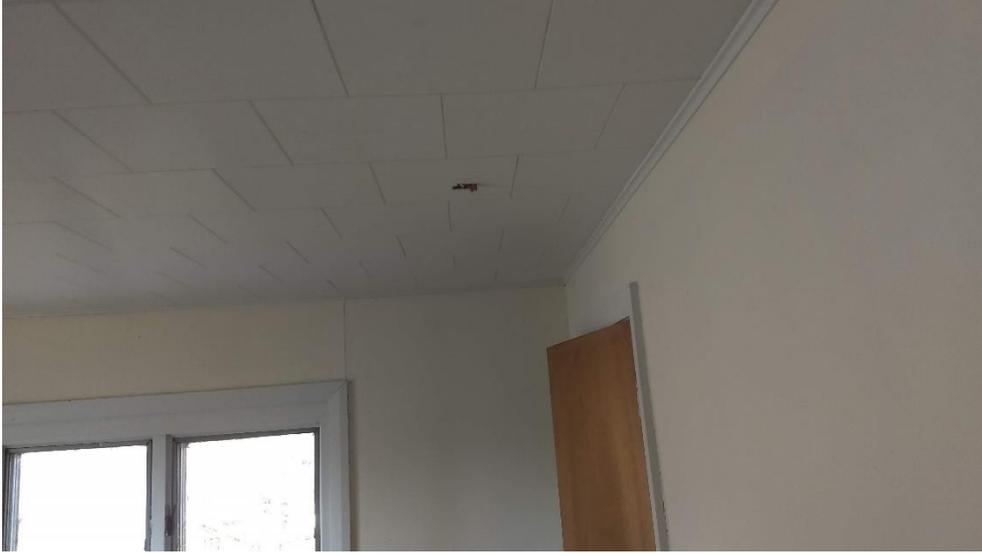
<p><b>Photo No.</b> 11</p>
	<p><b>Photo Date:</b> November 18, 2020</p>
	<p><b>Site Location:</b> 881 Main Street Meddybemps, Maine</p>
	<p><b>Description:</b> First Floor; Bedroom #3 (Rm. #5) – Non ACM ceiling tiles and sheetrock (MS-010A and MS-008A, respectively).</p>
<p><b>Photo By:</b> DAK</p>

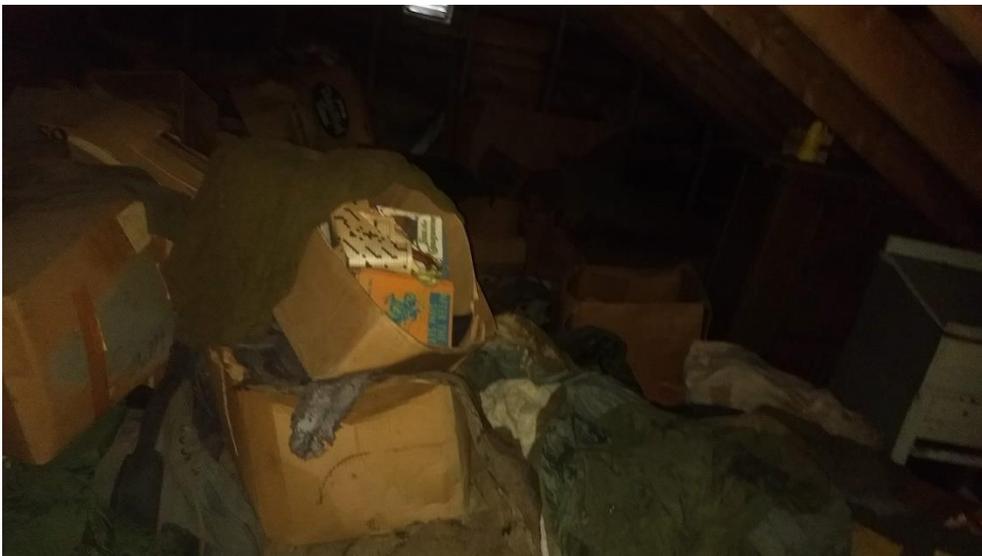
<p><b>Photo No.</b> 12</p>
	<p><b>Photo Date:</b> November 18, 2020</p>
	<p><b>Site Location:</b> 881 Main Street Meddybemps, Maine</p>
	<p><b>Description:</b> Attic space – view of attic floor restricted. Performed visual assessment from top of pull-down ladder.</p>
<p><b>Photo By:</b> DAK</p>

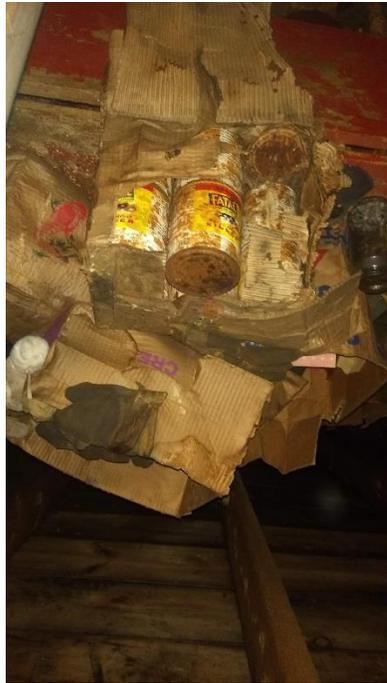
**Photo No.** 13

- ◆ Mercury-containing thermostat
- ◆ Eight one-gallon containers of warfarin-containing<sup>1</sup> rat and mouse killer (observed to be in poor condition)
- ◆ Sodium vapor lamps
- ◆ Above-ground Storage Tank

**Description:**  
Attic Space – Eight one-gallon deteriorated containers of warfarin-containing rat and mouse killer.

Should the identified materials above be impacted by planned renovation, demolition, site work, or any other disturbance, removal or remediation of the identified materials is required prior to disturbance, in accordance with applicable state and federal regulations.

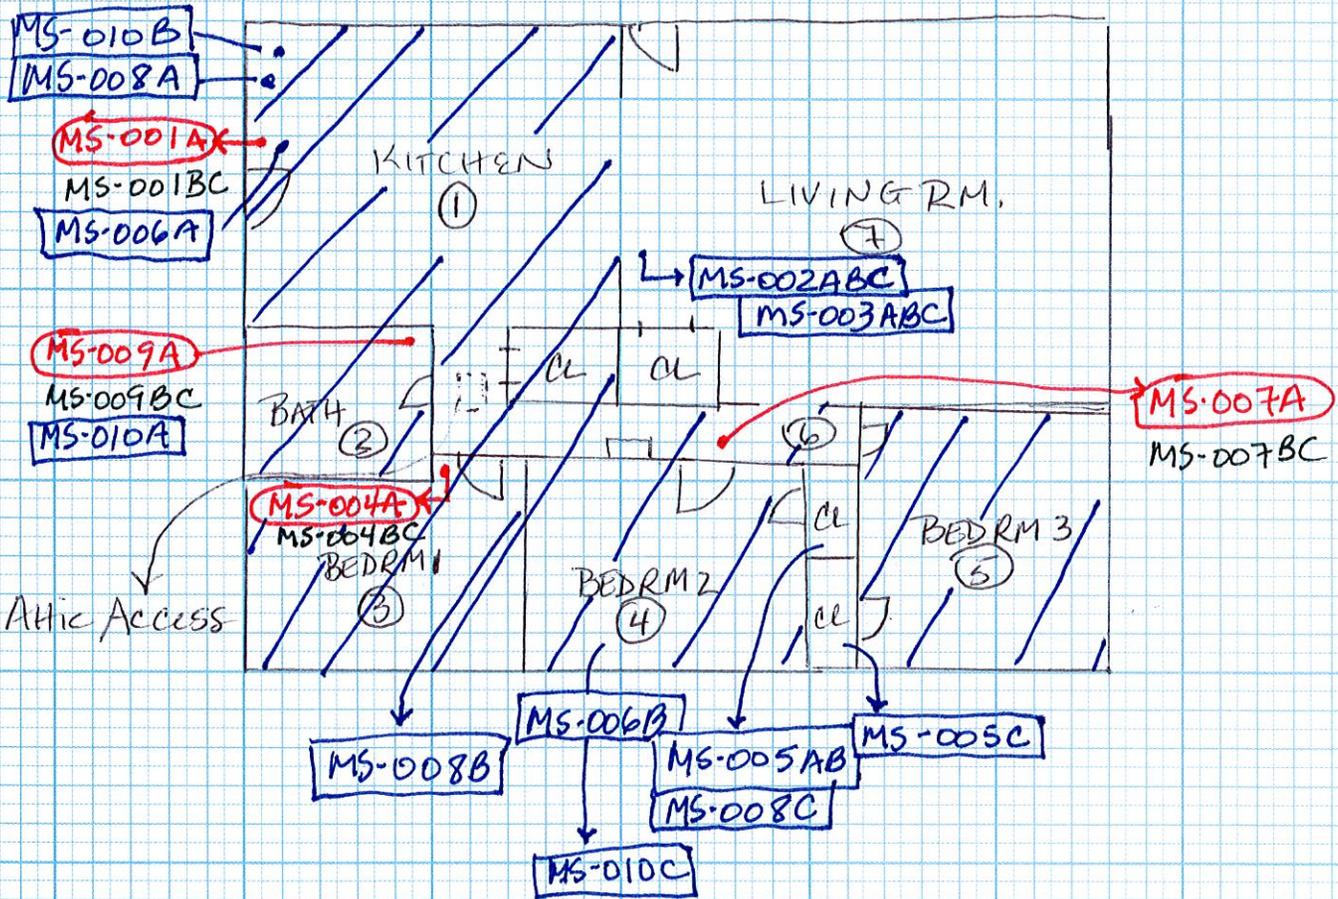
FIRST FLOOR:

MS-001A Sample # + Location testing positive for asbestos

// ACM Sheet Flooring
