Investigation and Sampling Report
Winthrop Commerce Center LUST Site
Haefele Damage Claim
October 2006

John E. Beane, Senior Geologist
Bureau of Remediation and Waste Management
Maine Department of Environmental Protection
January 4, 2007

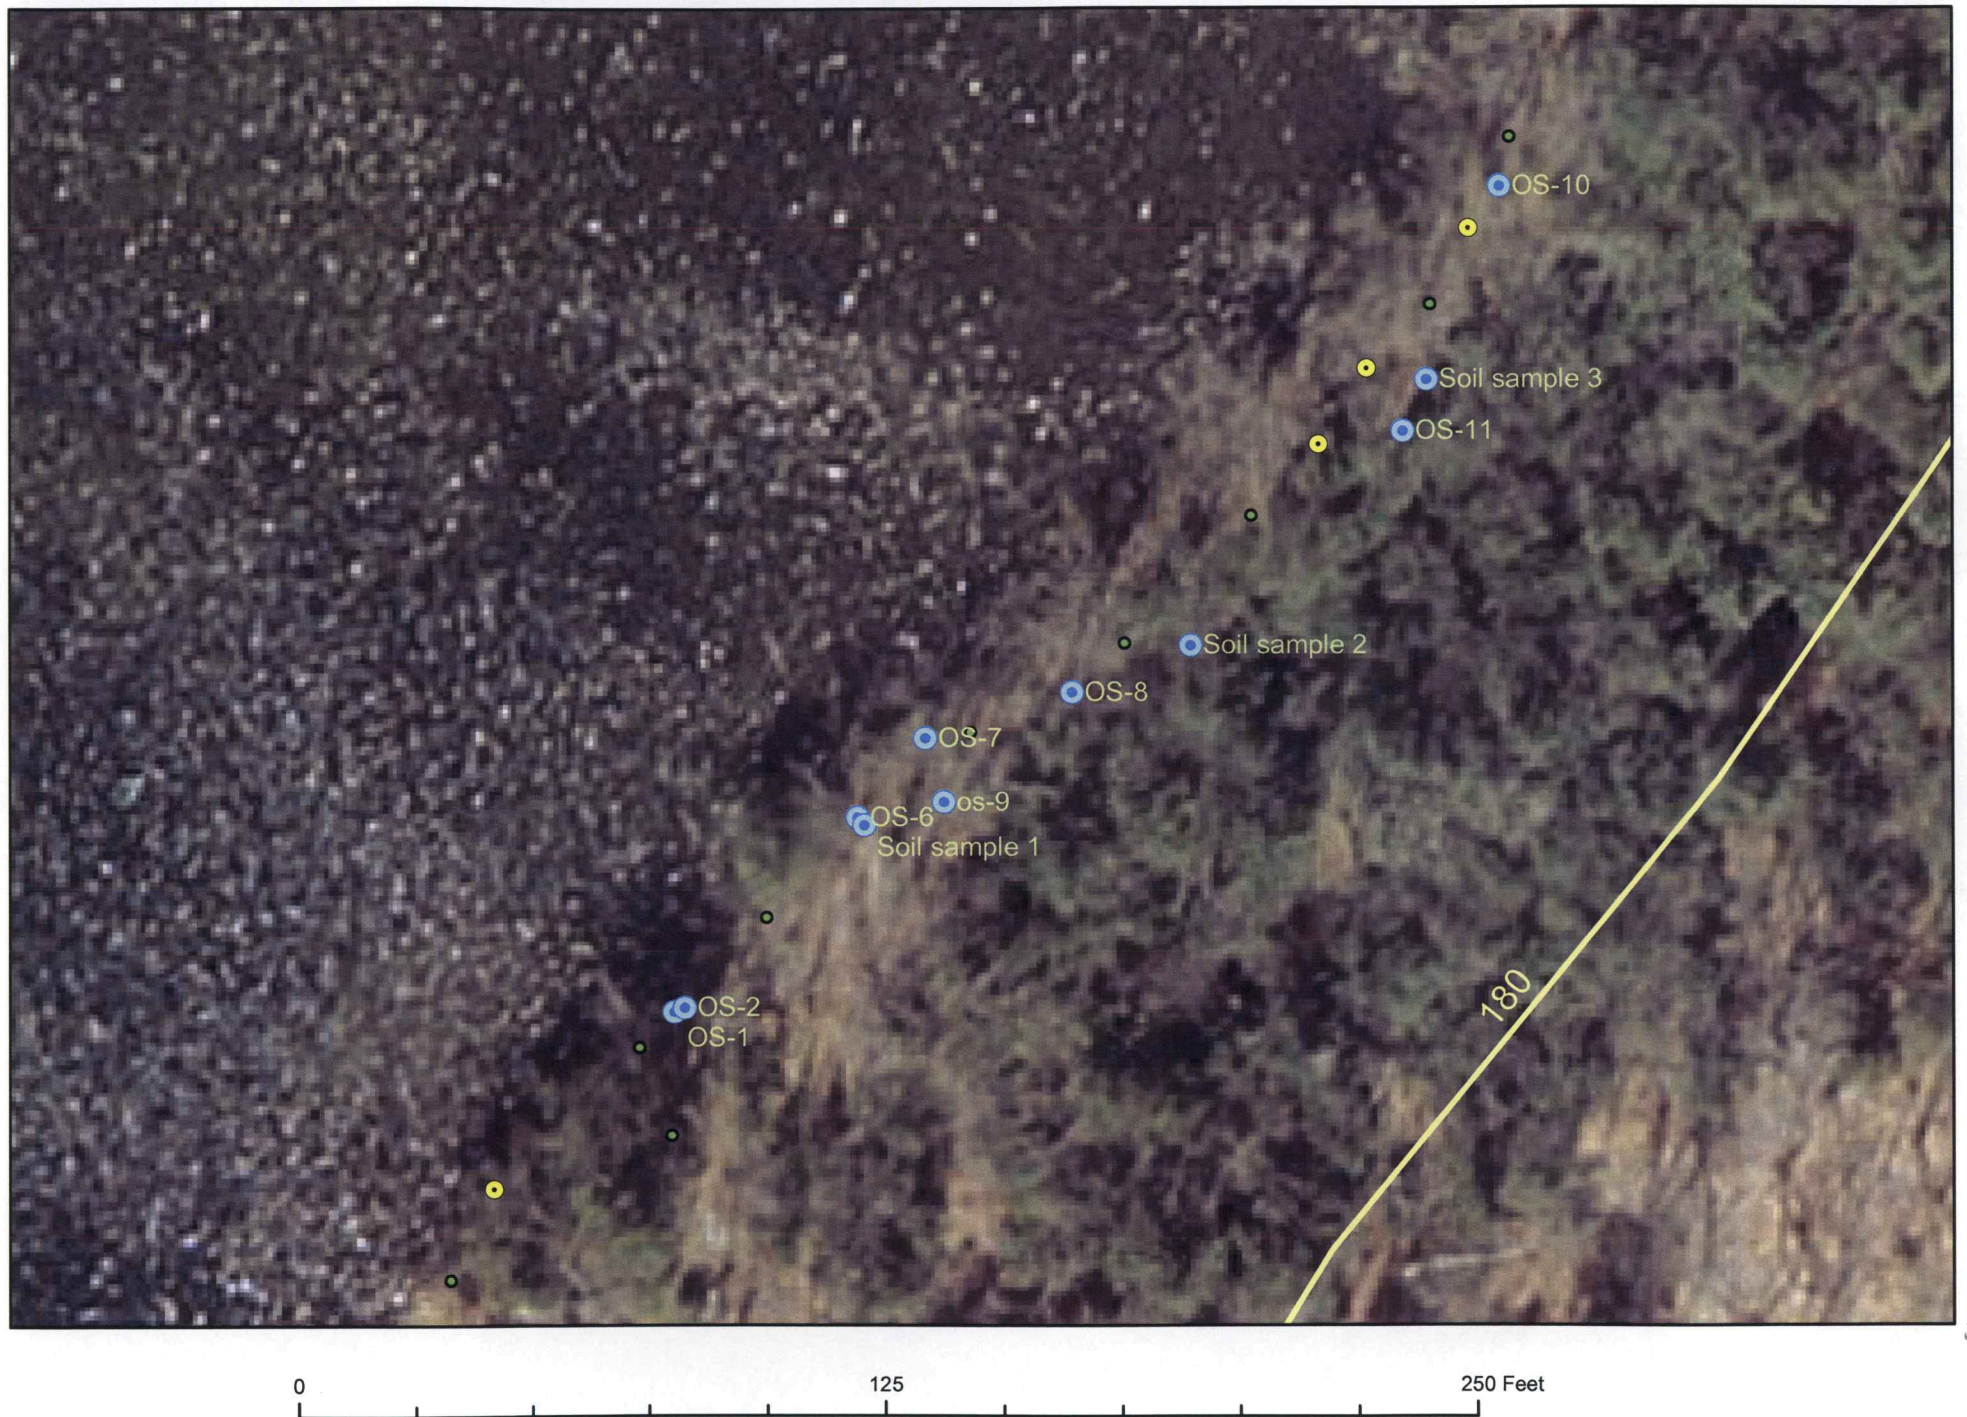
Figure 3. Locations of oil stains (OS) and soil samples

OS-9 (oil stain number nine) was not so much a soil sample as a sample of leaf litter that had been heavily contaminated with black oil (location shown in Figure 3). Its elevation was about 1.3 feet above summer lake level, or about a foot below the high-water oil stains on the trees. It appeared to be a raft of floating leafy debris that had been stuck together by the floating oil. Shiny and tacky oil surfaces could be found by turning the material over and pulling it apart. I broke up some of the debris and packed it into the sample jar, being sure to include many oily surfaces. This sample was intended to represent *known contamination* with which to compare samples in which the oil was less evident or not apparent at all.

SS-1 (soil sample number one) was collected about 15 feet west of OS-9. The location was just below the 2.25' contour that marked the high water during the spill. It was a wind-swept northwest-facing location where the leaf litter comprised trigs and hemlock needles (Appendix B). Oil stains were evident on twigs in the litter and there appeared to be clumps of black oil on the surface. The upper 1 inch of the soil, mostly litter and duff, was mixed in a stainless steel bowl and sub-sampled into the sample jar. Due to the visual evidence of oil, contamination was expected in SS-1.

SS-2 was collected from a "random" location below the 2.25 foot contour where the mineral soil (topsoil) was exposed at the surface. No visual evidence of oil was noted at SS-2. Again, the upper 1" of soil was mixed in a stainless steel bowl and sub-sampled into the sample jar.

SS-3 was collected from a northwest facing hummock about 20 feet inland from the shore, about 6 inches below the 2.25 foot contour, where no visual evidence of oil was noted. The upper 1" was all duff and tree roots.

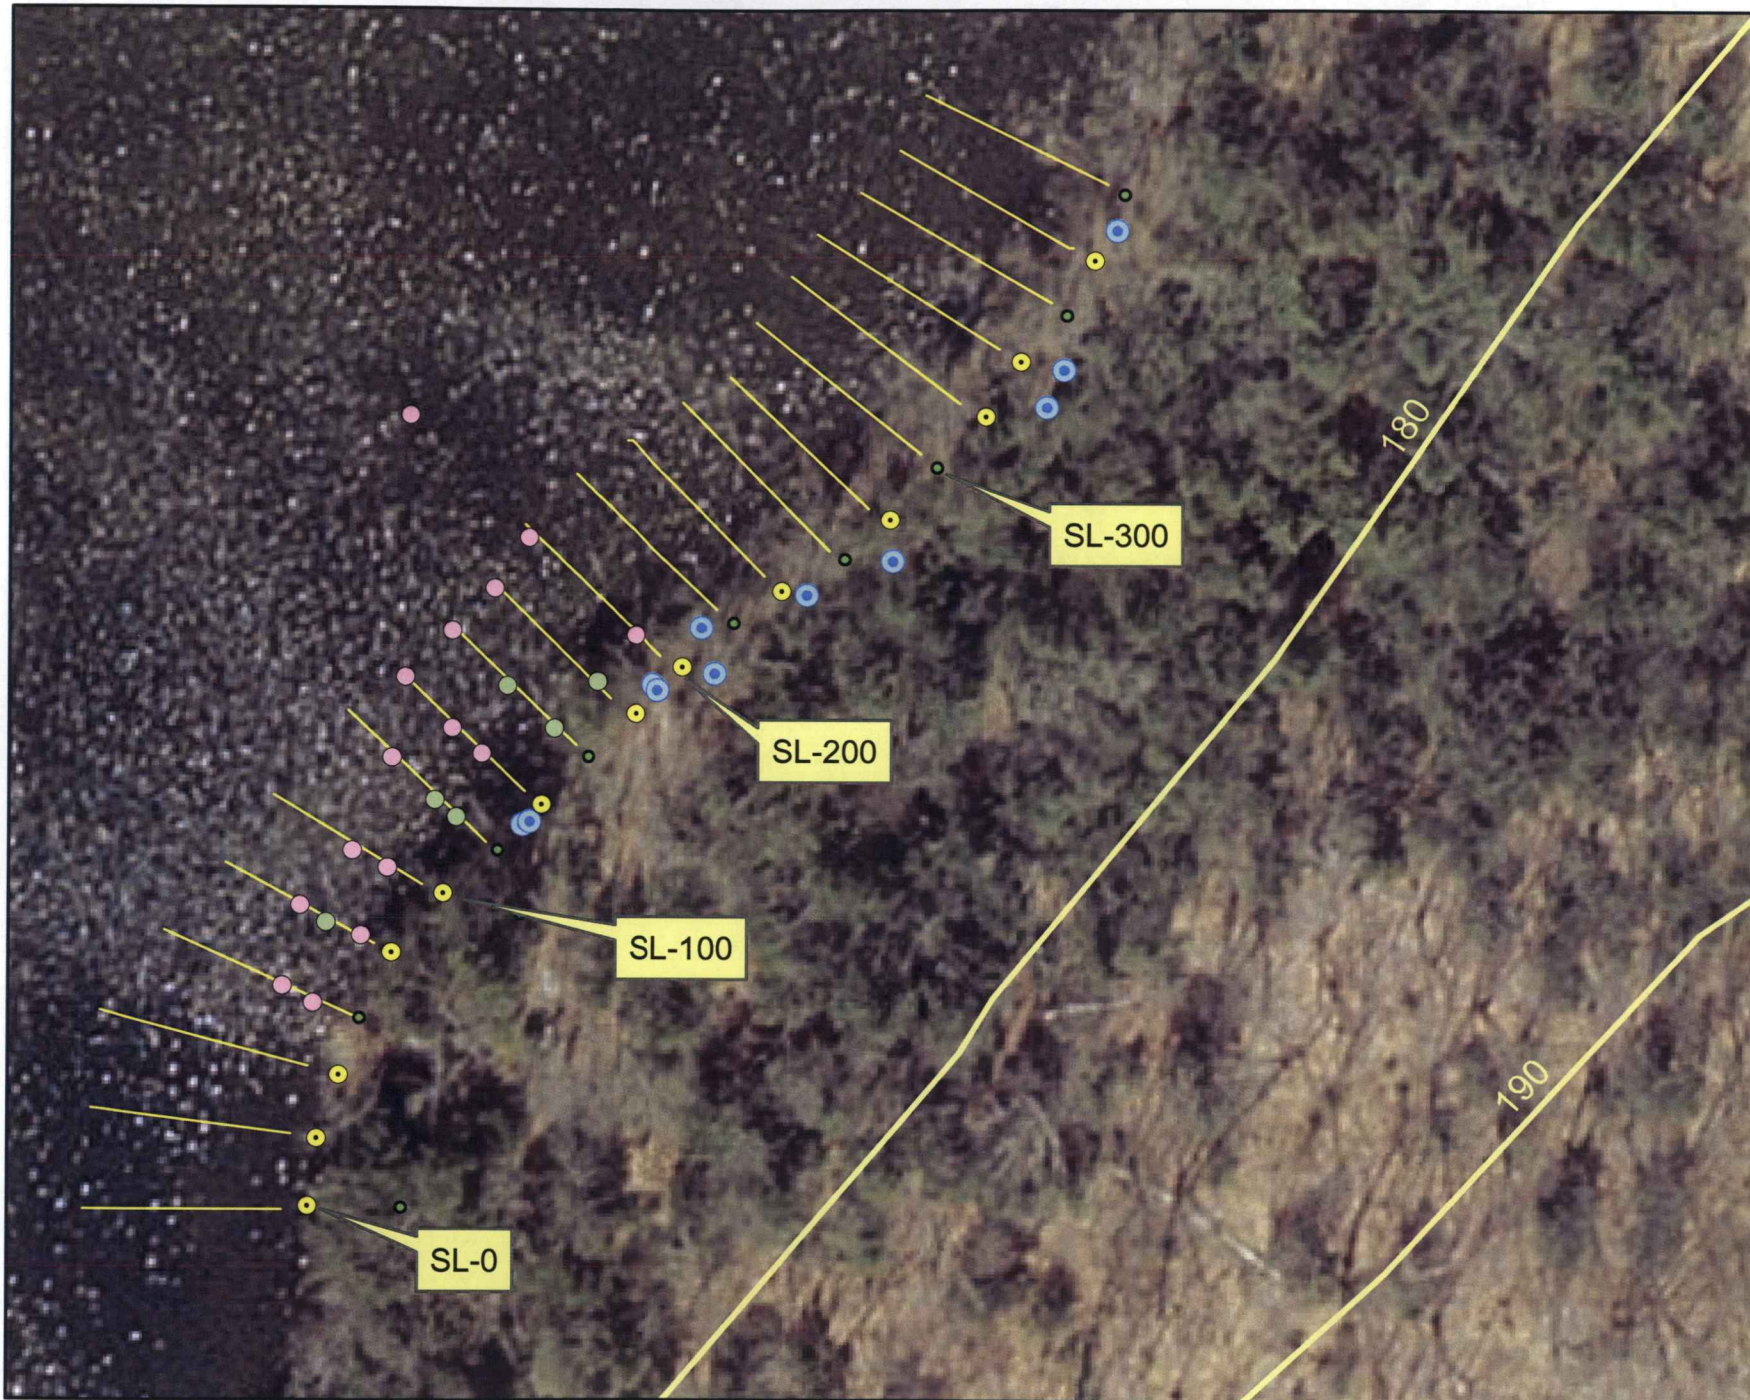
Figure 4. Locations of Sheen Mobilization Tests.

We launched the canoe between SL-60 and SL-80, and worked north along the shoreline. The plan was to disturb the bottom at 2-, 4- and 6-foot depths every twenty feet along the shoreline to see if sunken oil could be mobilized to produce a sheen on the surface. It should be noted at the outset that we observed several oily sheens that spontaneously surfaced during the time we were sampling. Although we did not see the oil arrive at the surface, the sheens deformed and dispersed quickly enough (several minutes) that they could not have floated in from any significant distance. They had to have surfaced locally near the Haeefe property. Data on the attempts to mobilize oil and produce a sheen are tabulated in Table 3. Locations of the attempts are shown on Figure 4, with the locations of observed sheens shown in light green. The sheen mobilization tests were stopped before the completion of all the locations specified in the work plan because it became clear that sunken oil was rather common along the Haeefe shoreline, and that it was in fact possible to mobilize a sheen by disturbing the bottom sediments.

- Sheen
- No Sheen

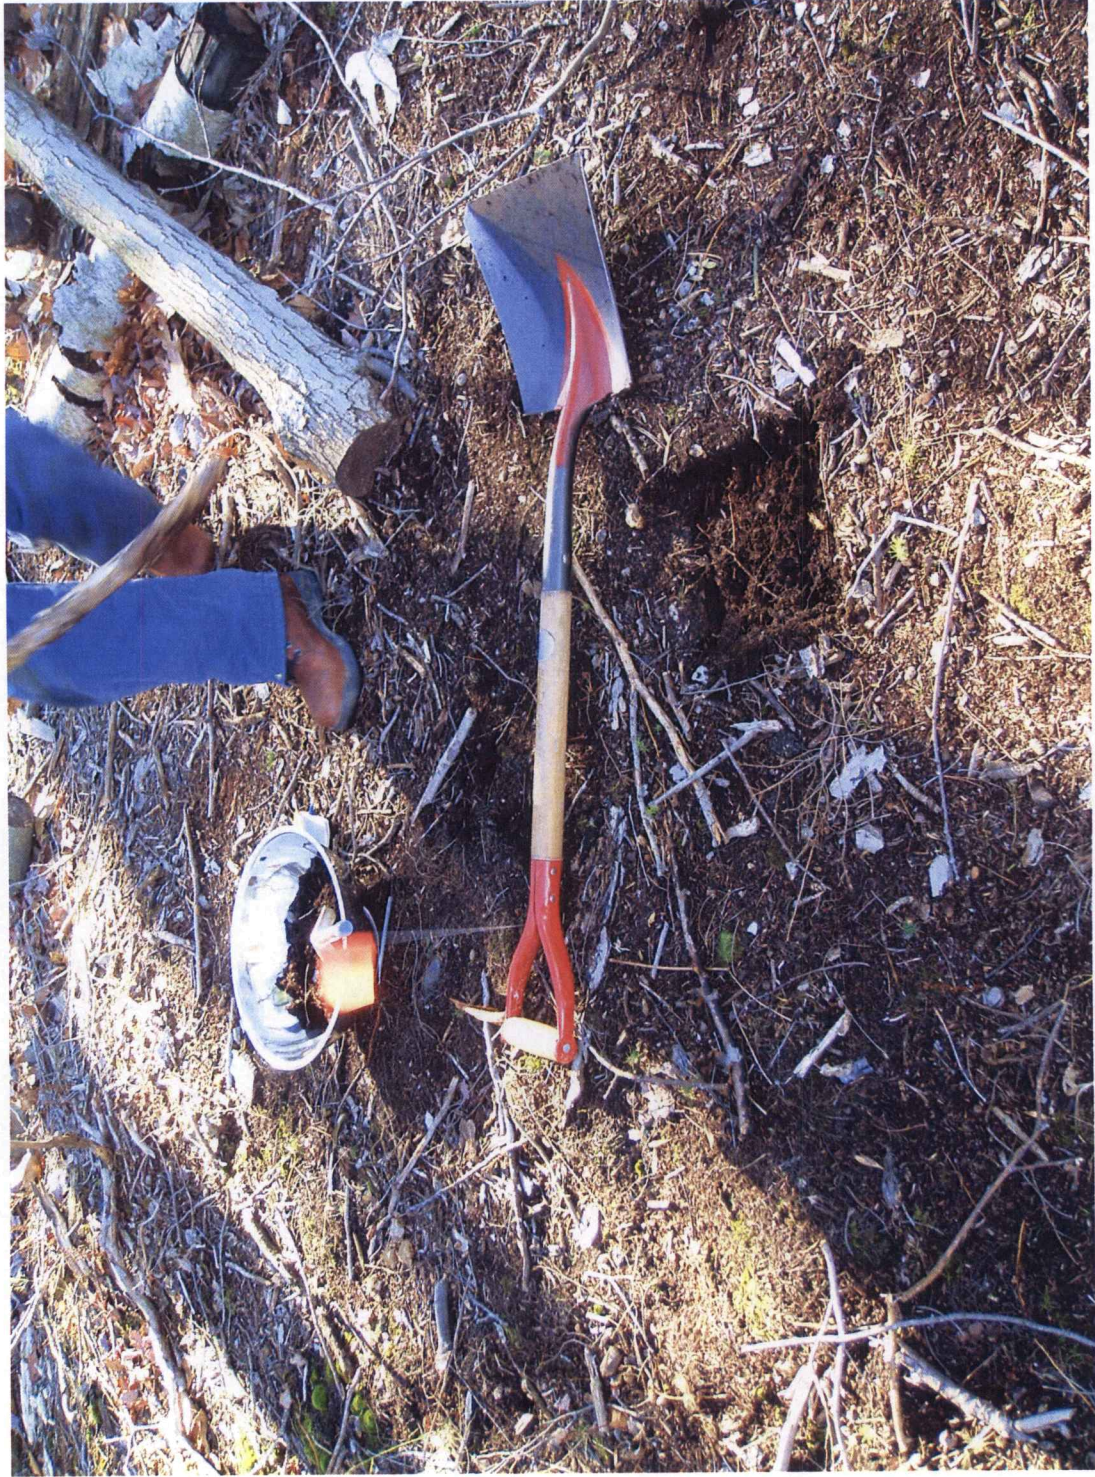
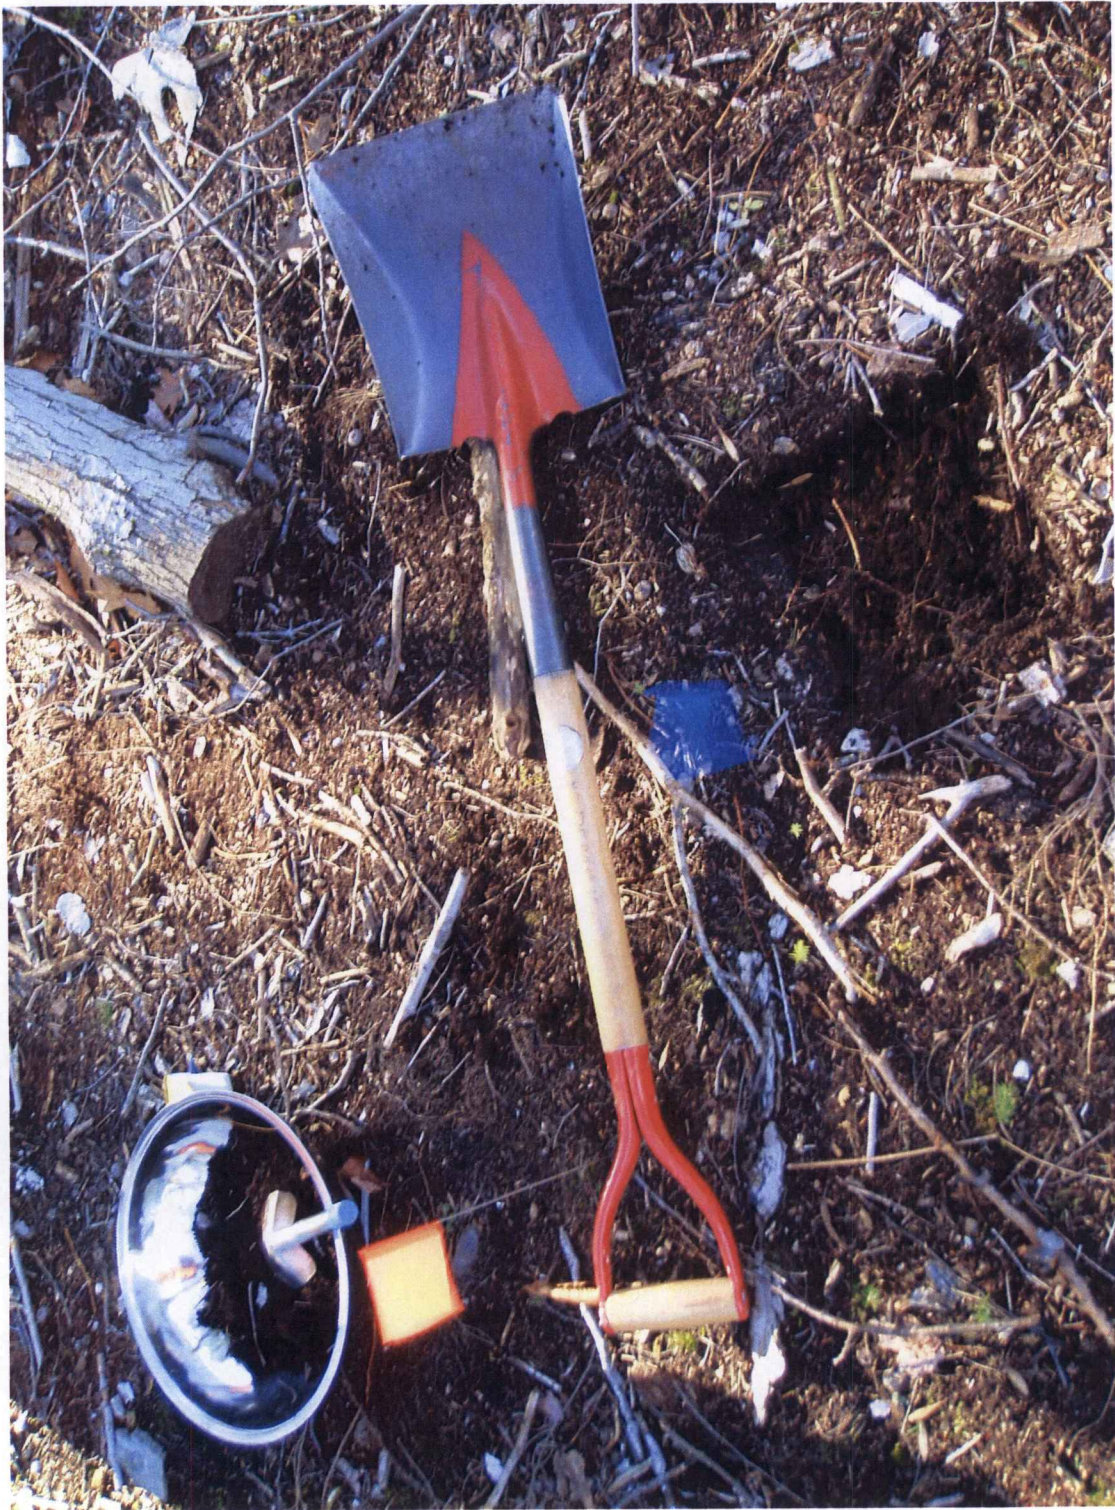
Soil sample SS-1 was from the duff layer in a windy location swept clean of deciduous leaves (see photo in Appendix B). There were black oil stains on some of the twigs and conifer needles on the ground surface. The PAH concentrations are in similar proportions to those in OS-9, but at about two thirds of the concentration values. SS-1 has a benzo (a) pyrene concentration of 0.98 mg/kg (980 ug/kg or micrograms per kilogram), and a benzo (a) pyrene toxicity equivalent concentration of 1.6 mg/kg. Both are below the remedial action guideline for soil of 2 mg/kg.

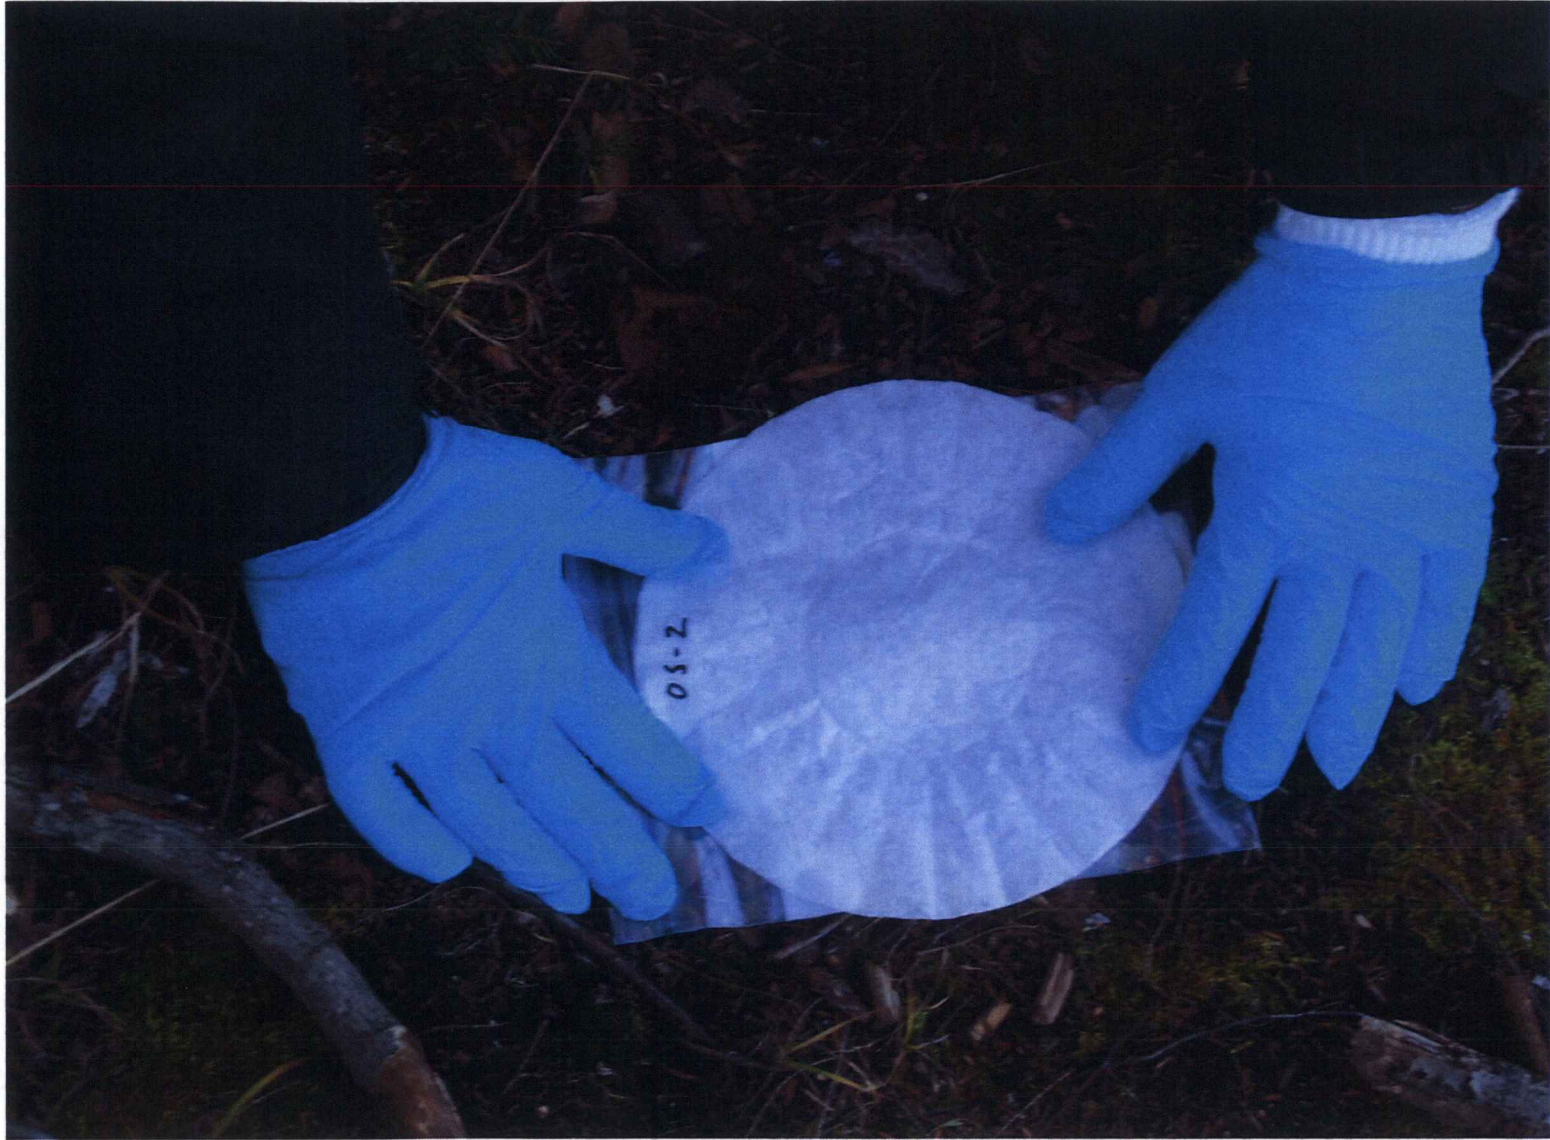
Transfer Test – OS-2

sized black stains were transferred by pressure at OS-6 (Appendix C). Rubbing any of the dried oil stains with a plastic sampling glove would transfer some of the dried oil to the glove (OS-2 photo, Appendix C). Finally, sheens that were observed are clear evidence that there was oil on the bottom of the lake in shallow water near the Haefele shoreline. All of the sheens that were seen as evidence of this oil on the bottom were small, discrete and discontinuous. The sheens were in the order of five inches in diameter or less, down to fractions of an inch in diameter. The scale of the oil sheens observed was more consistent with sunken waterlogged oily debris than with “tar balls” or such larger aggregations of sunken oil. Thus, casual recreation on land is not very likely to result in appreciable transfer of oil to persons or pets although small stains are certainly possible. Swimmers would be likely to mobilize small oily sheens and to swim through them.

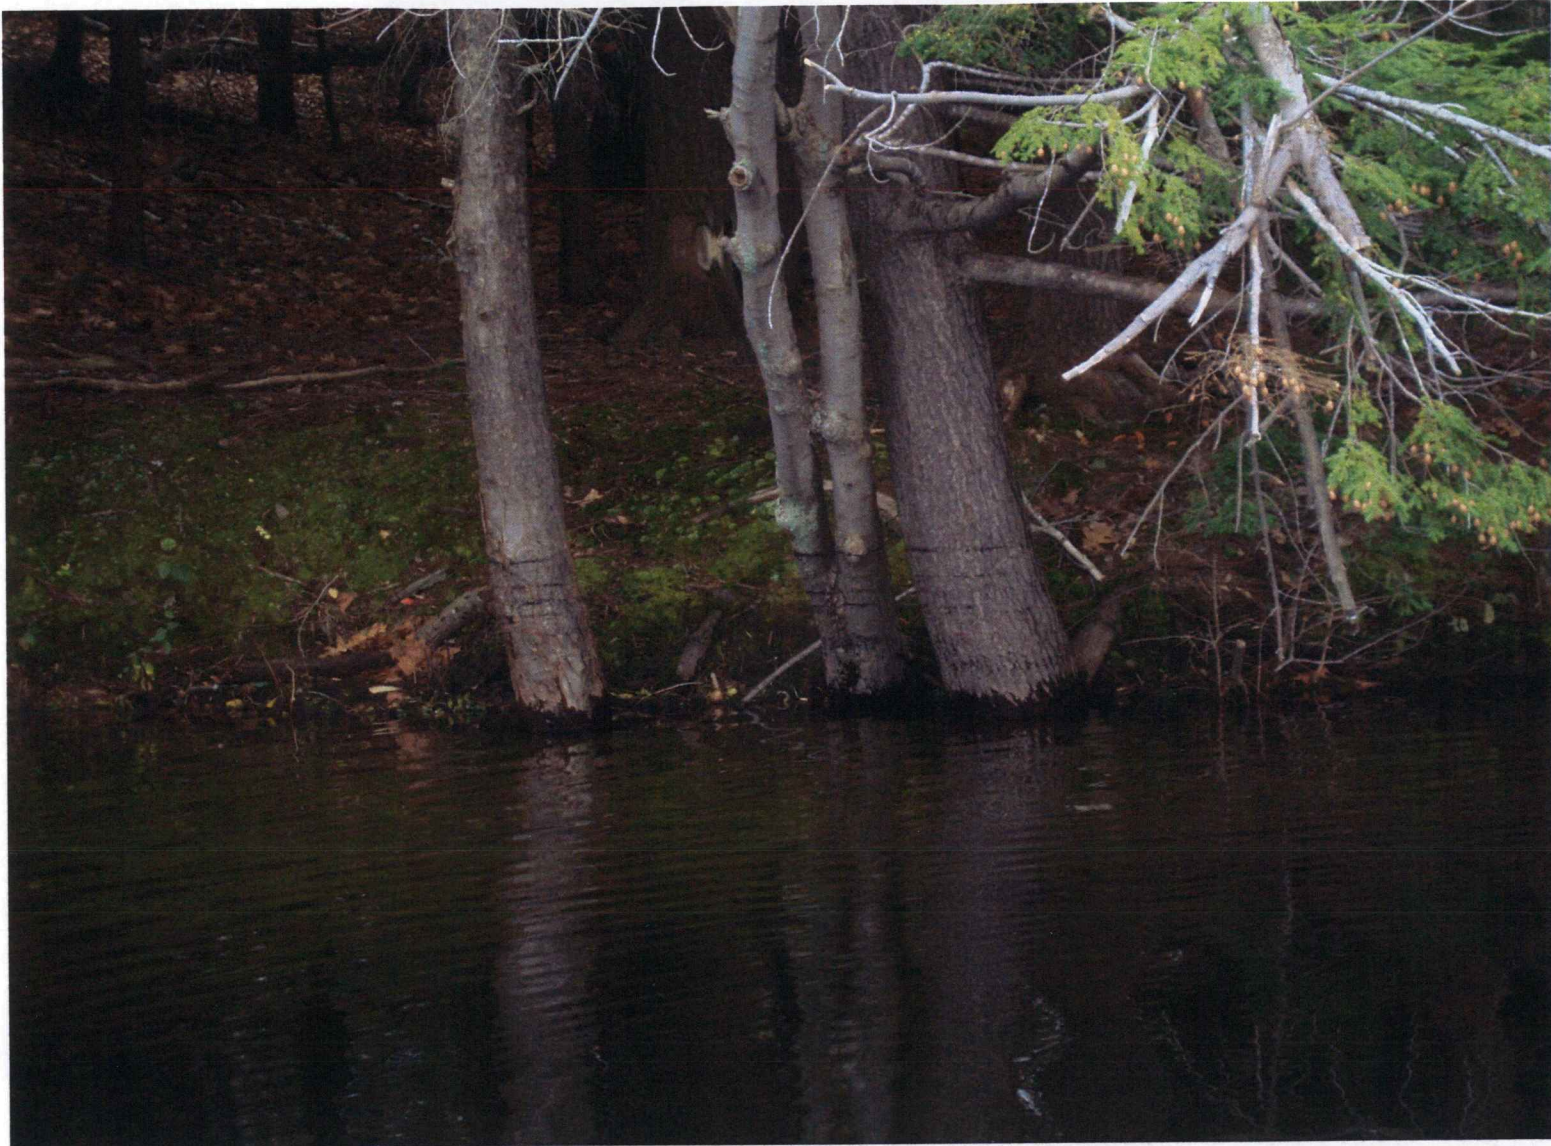
Oil stains at multiple levels on shoreline trees south of Haefele property

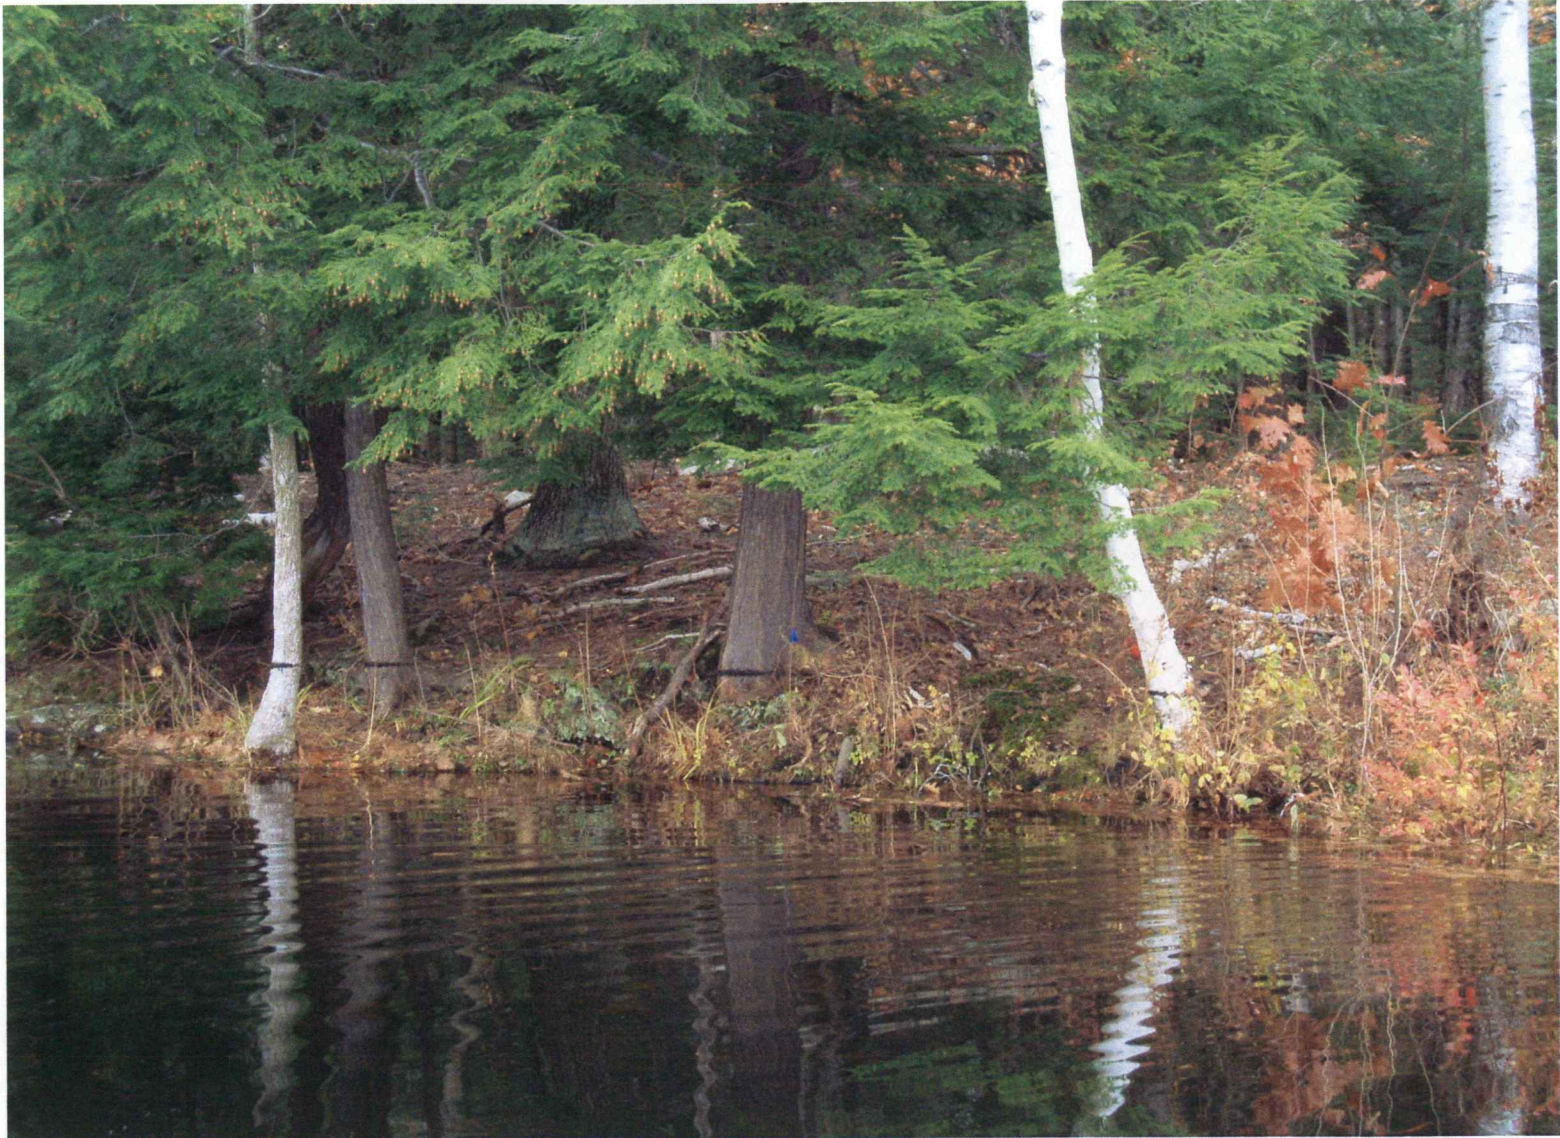
Oil stain on trees around SL-80. Note prominent single stain level at high water level.

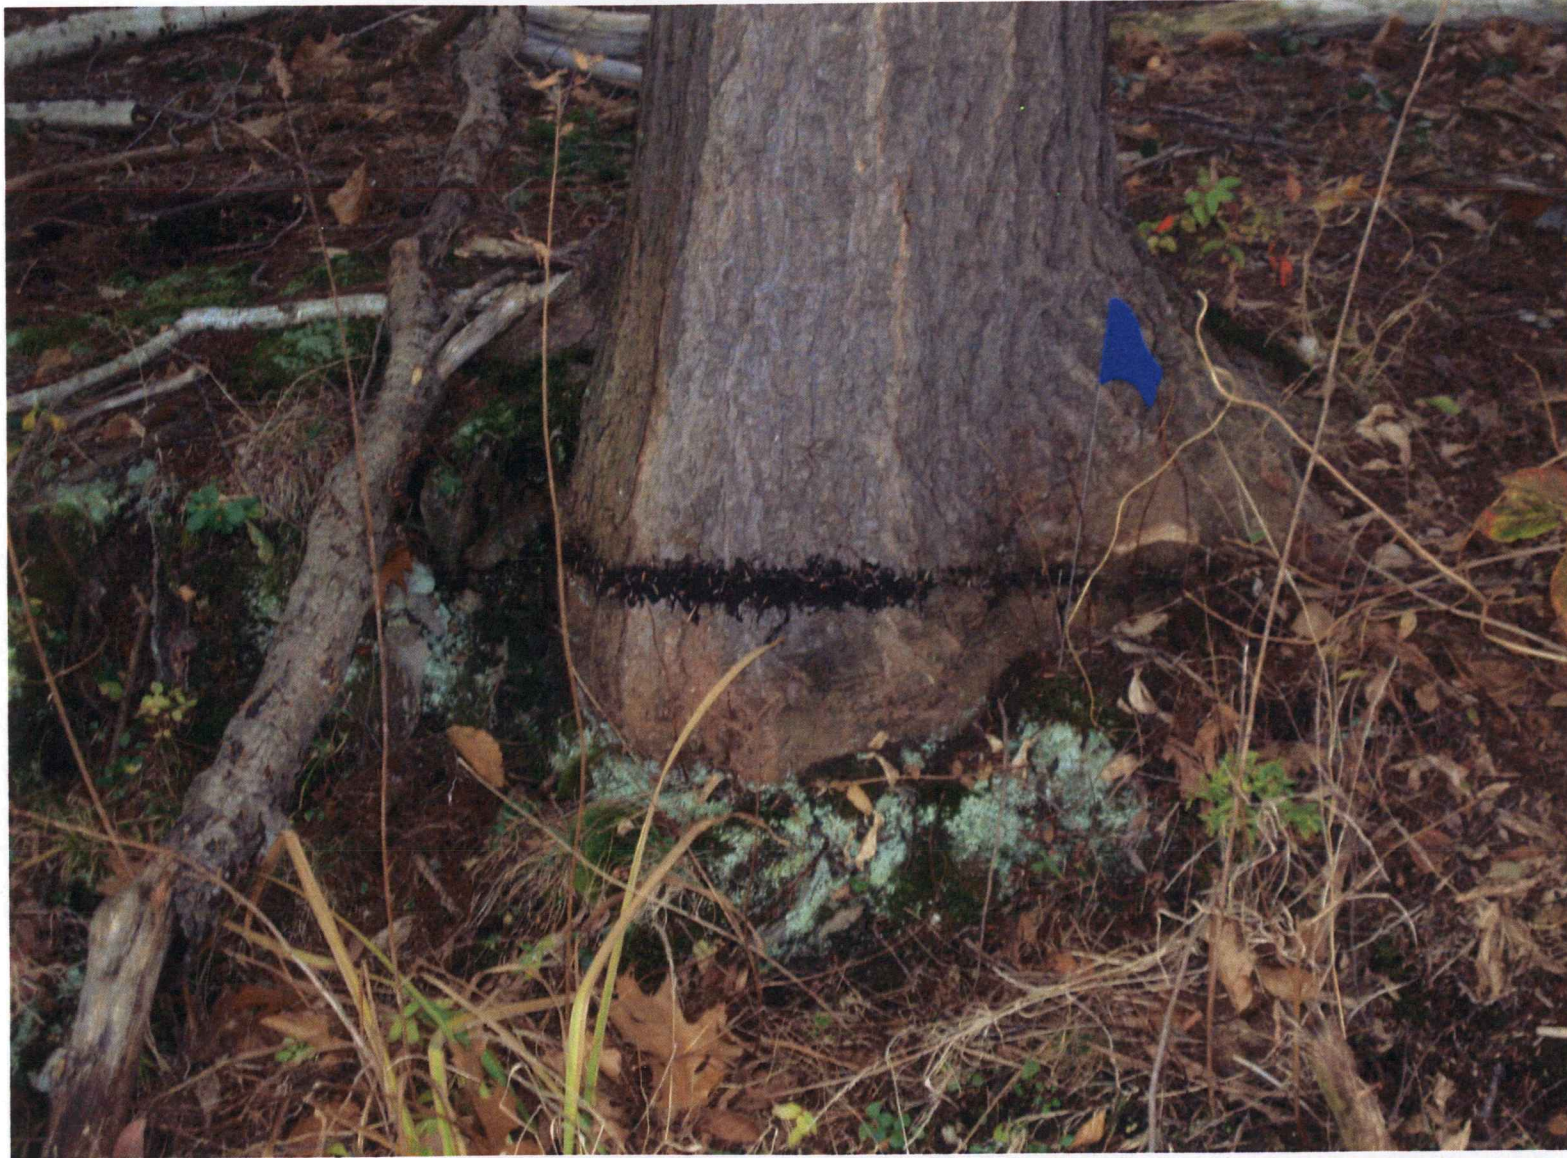
Oil stain on trees at SL-80. Note evergreen needles adhering to oil. Oil is no longer tacky.

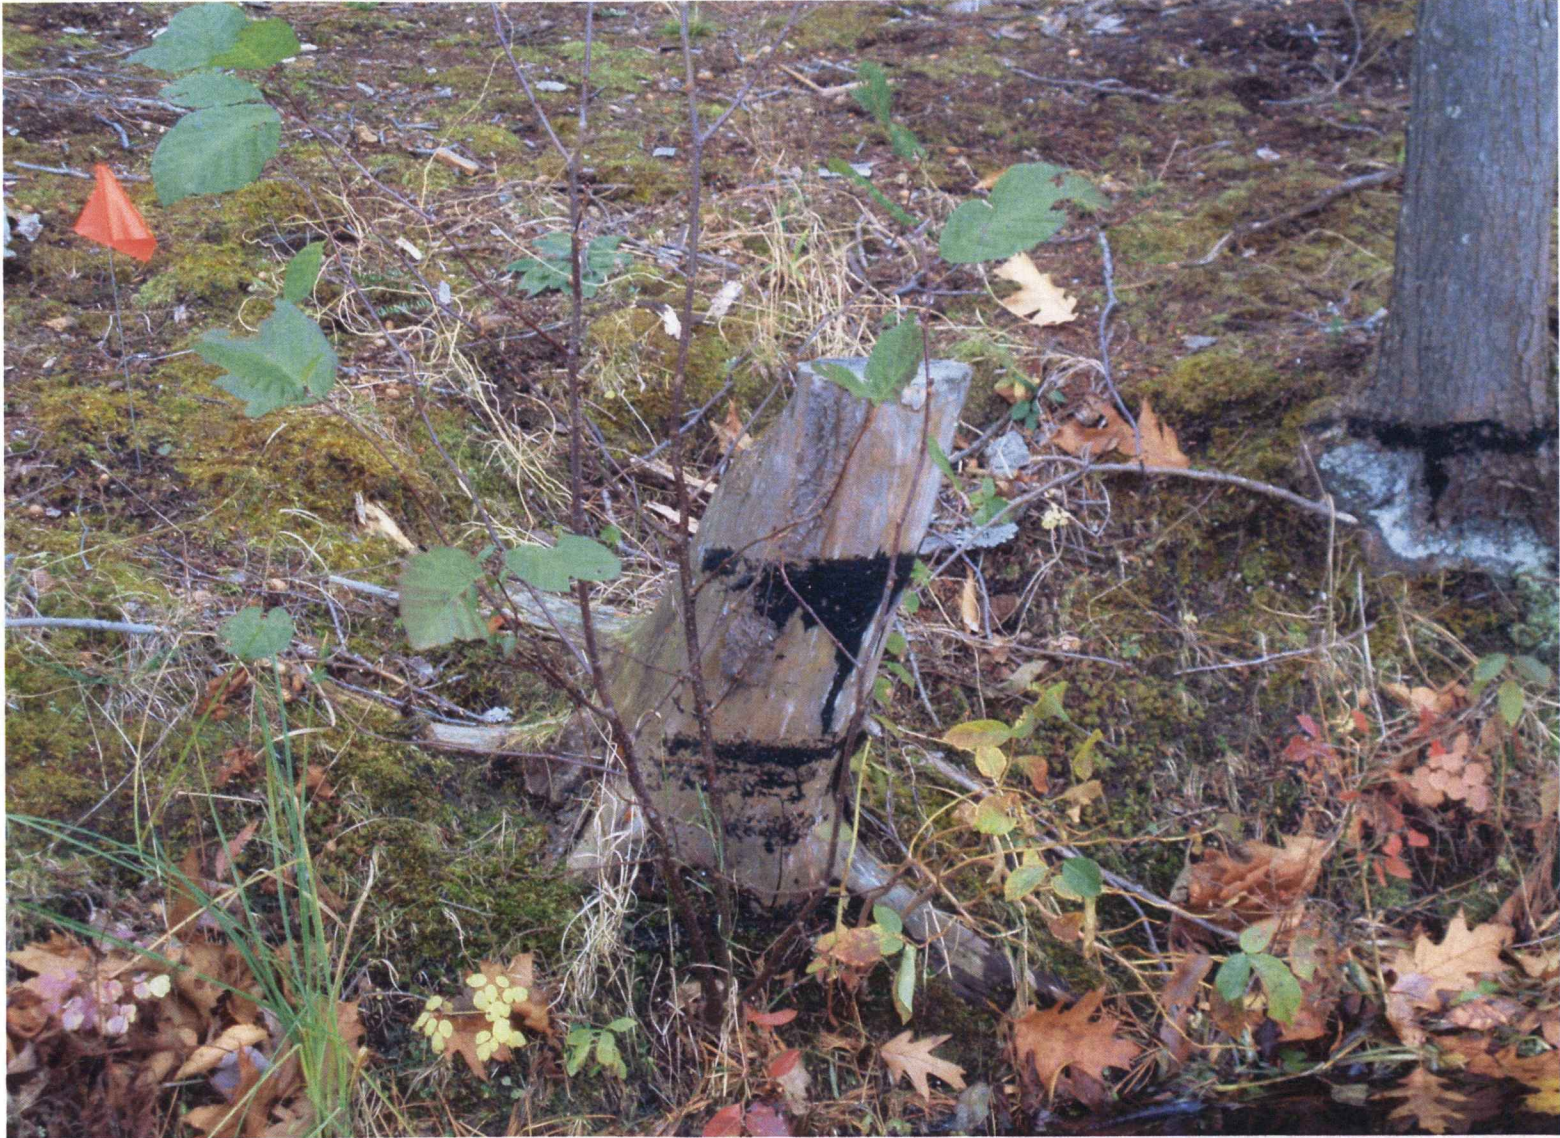
Large oil stains that dribbled after water level fell. Near SL-160.

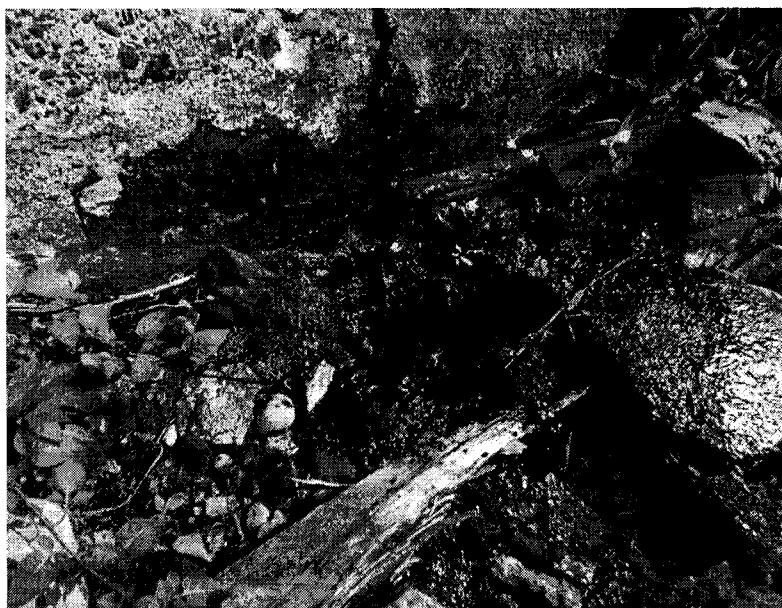
Photograph No. 1, Oil Seep Below Boiler Room

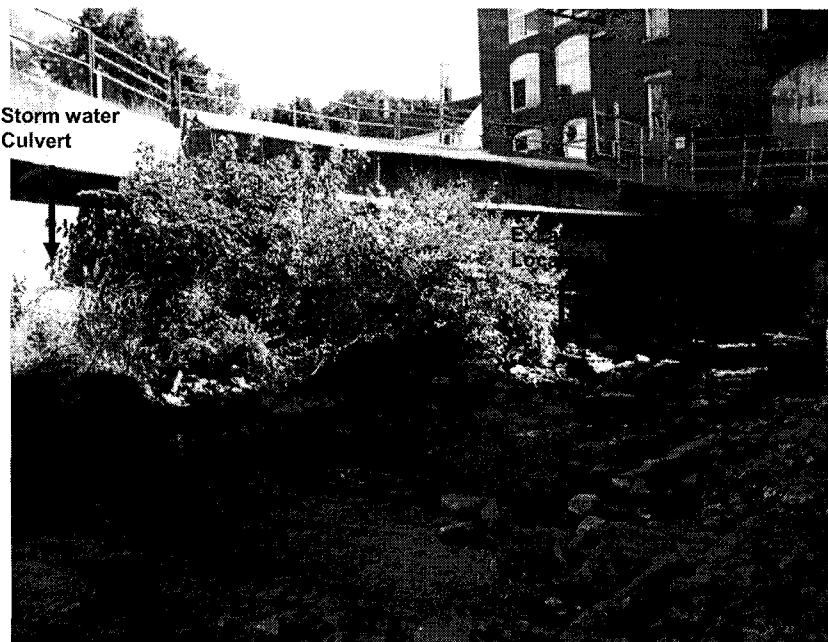
Photograph No. 3, Oil Seep at Retaining Wall Crack
