**Figure 4-24D**  
**Surface Water, Sediment, Hydric Soil, Shallow**  
**Groundwater, and Porewater Analytical Results**  
**Greenlaw Brook Drainage Basin**  
 Remedial Investigation Site Characterization Summary Report  
 Former Loring Air Force Base, Limestone, ME

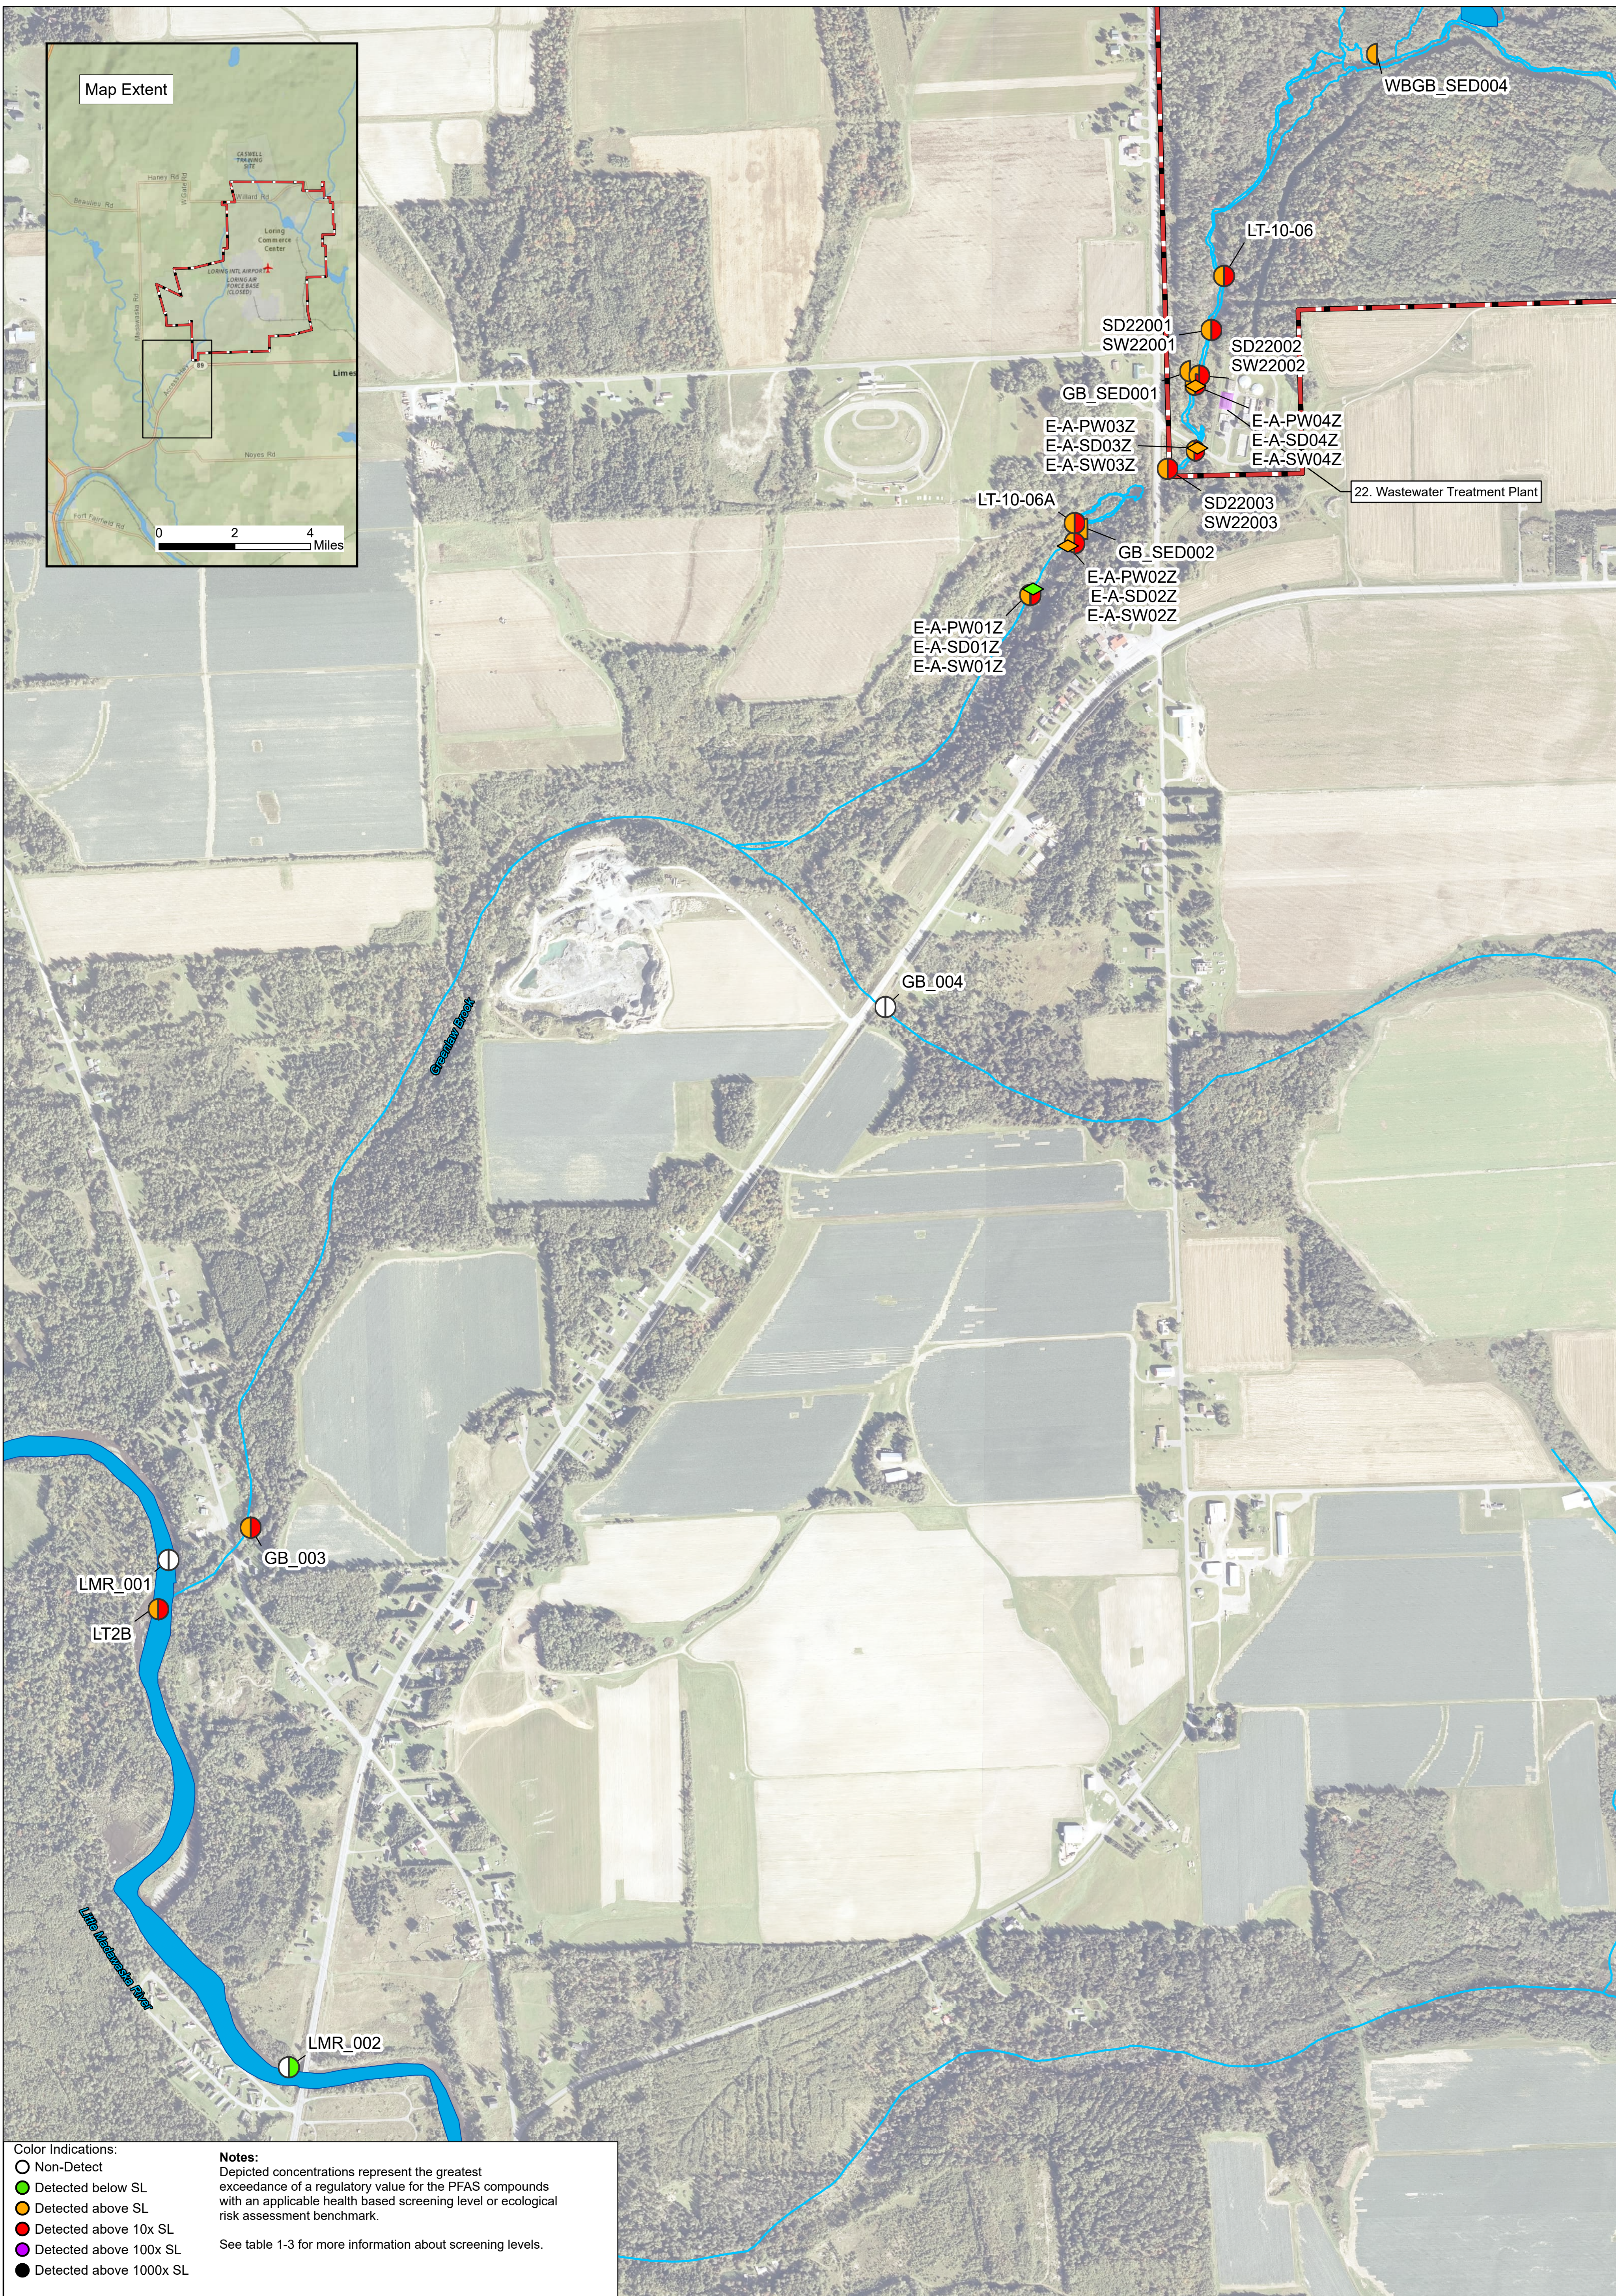
**Notes:**  
 Depicted concentrations represent the greatest exceedance of a regulatory value for the PFAS compounds with an applicable health based screening level or ecological risk assessment benchmark.  
 See table 1-3 for more information about screening levels.
