**Figure 5-2**  
**PFAS MCL Exceedance Plume**  
Remedial Investigation Site Characterization Summary Report  
Former Loring Air Force Base, Limestone, ME

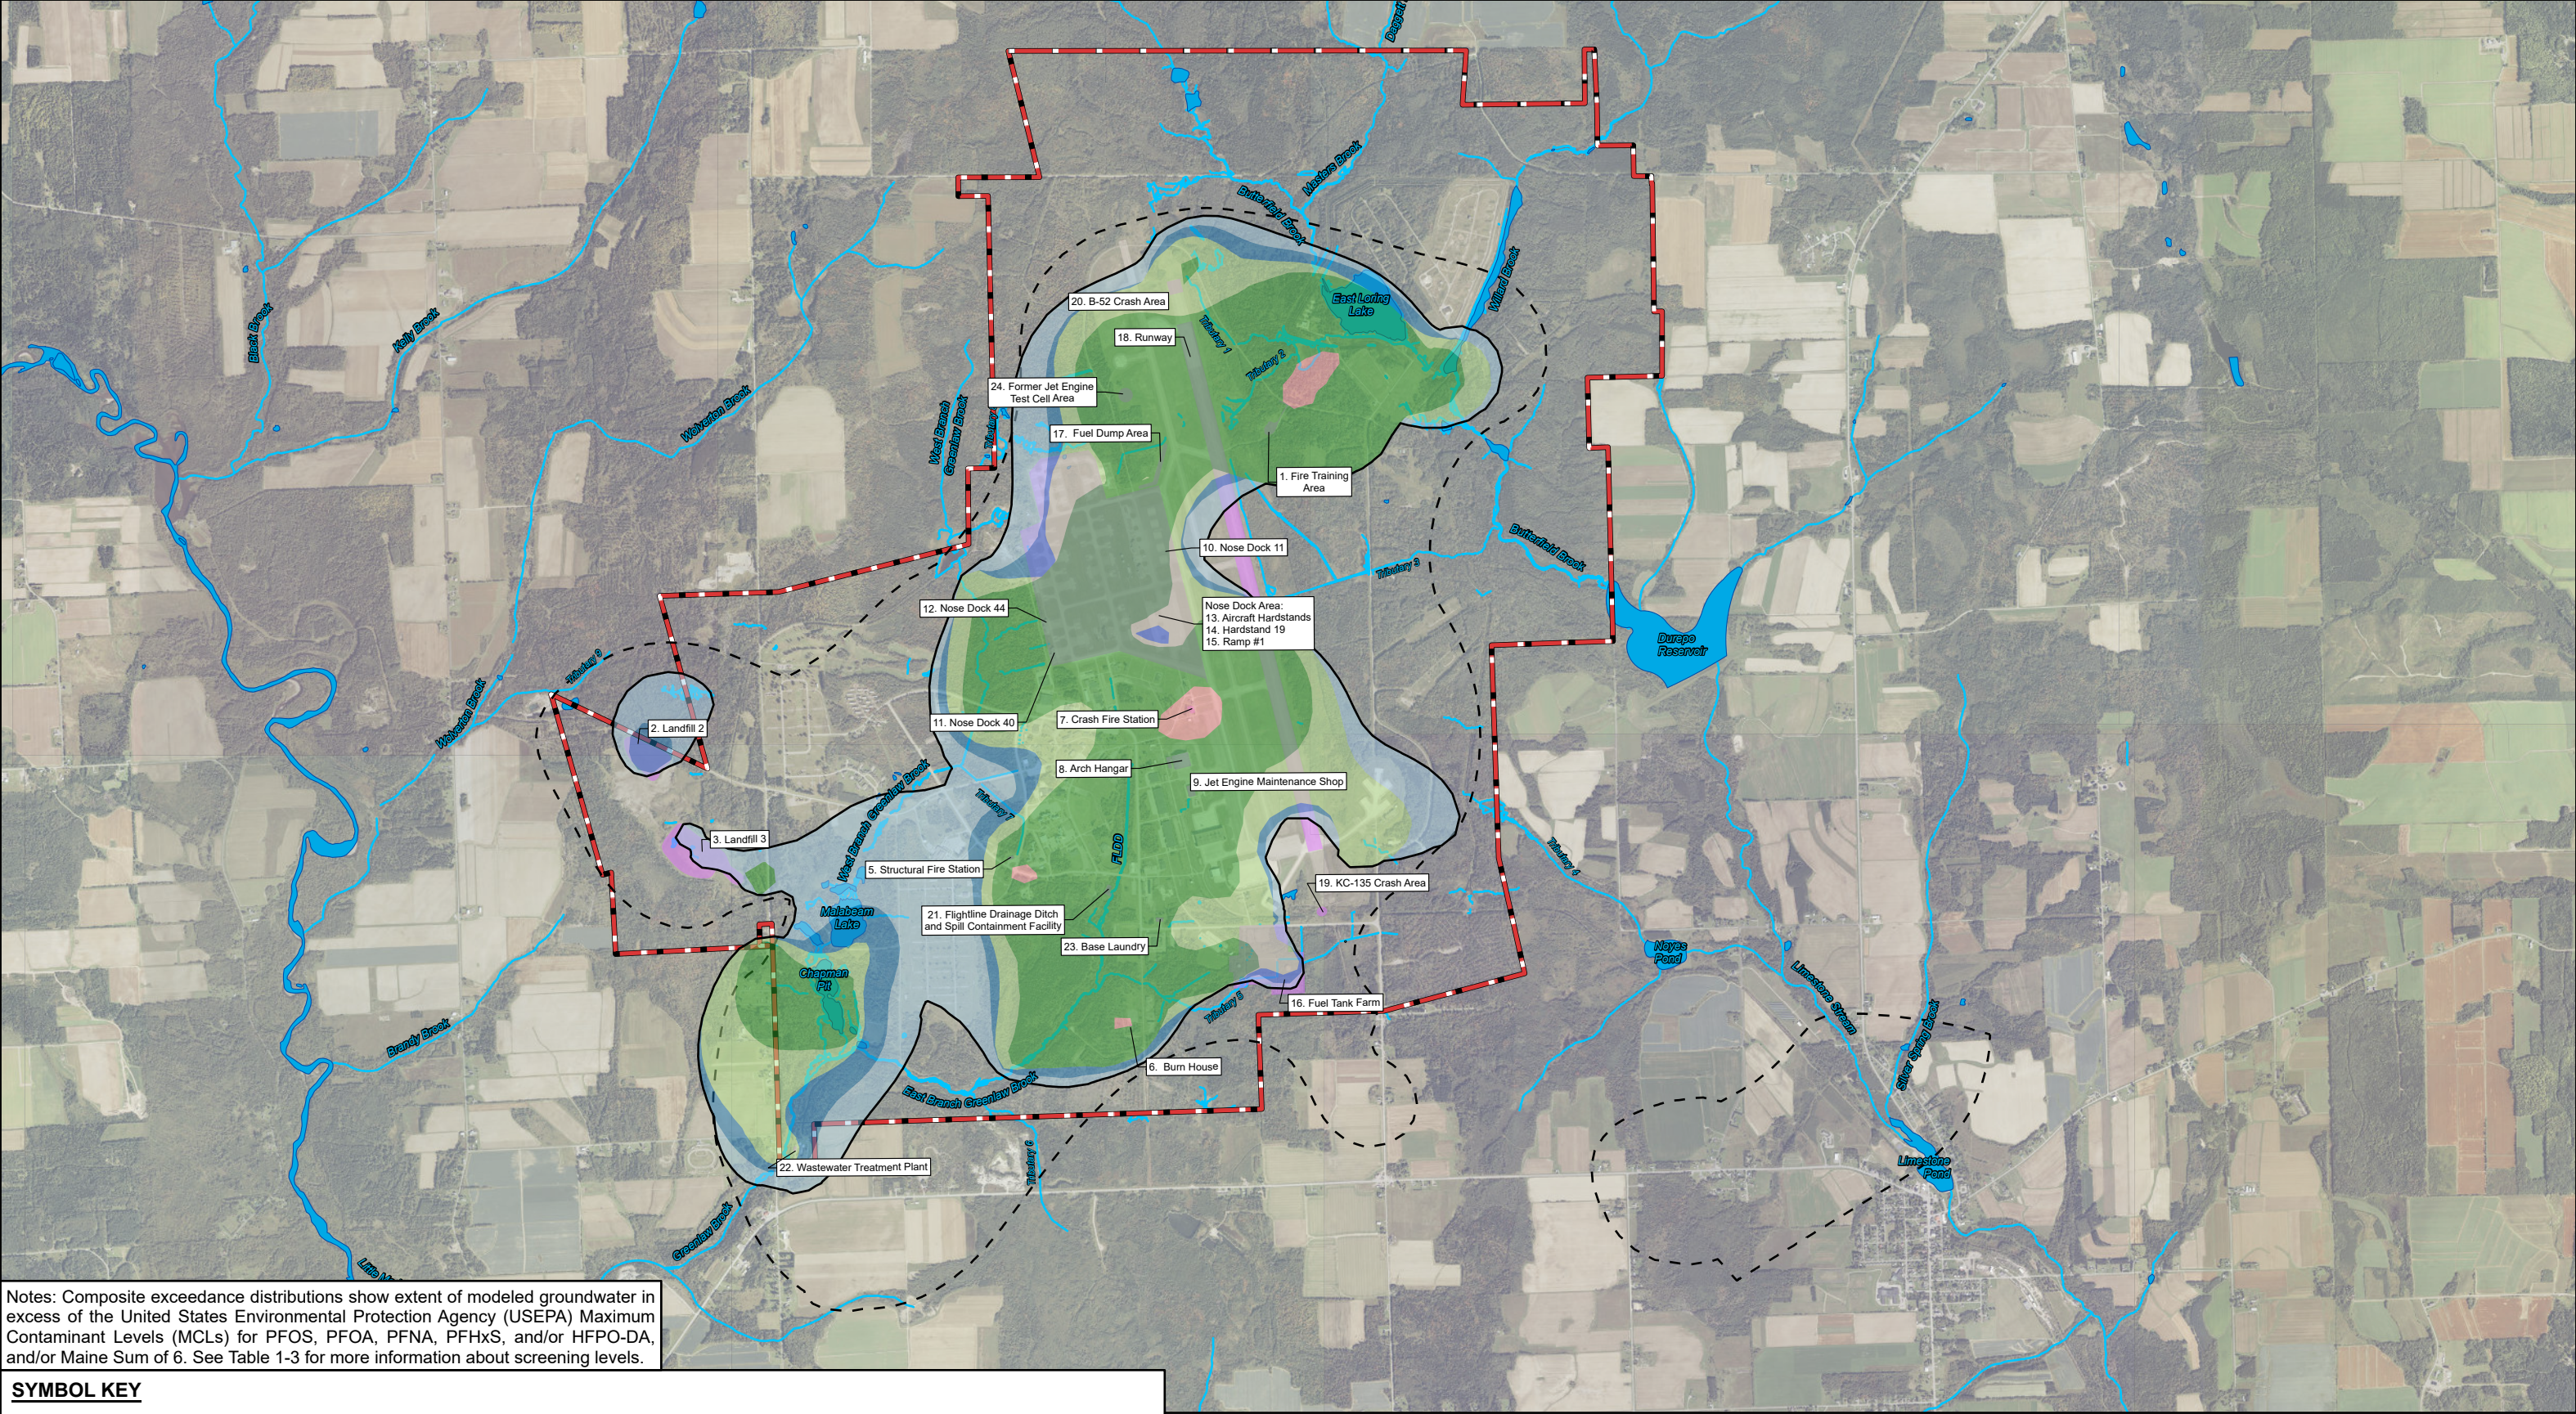
Notes: Composite exceedance distributions show extent of modeled groundwater in excess of the United States Environmental Protection Agency (USEPA) Maximum Contaminant Levels (MCLs) for PFOS, PFOA, PFNA, PFHxS, and/or HFPO-DA, and/or Maine Sum of 6. See Table 1-3 for more information about screening levels.
