QAPP Worksheet #10: Conceptual Site Model
(UFP-QAPP Manual Section 2.5.2)
(EPA 2106-G-05 Section 2.2.5)

Former Dow Air Force Base
 Bangor, Maine
 Formerly Used Defense Site (FUDS)
 Property and Project Number D01ME0004 02
HILLSHADE RELIEF MAP
 Phase III Remedial Investigation
 U.S. Army Corps of Engineers, New England District

Conceptual Geological Cross Section
Former Dow Air Force Base
Bangor, Maine
Formerly Used Defense Site (FUDS)
Property and Project Number D01ME0004 02

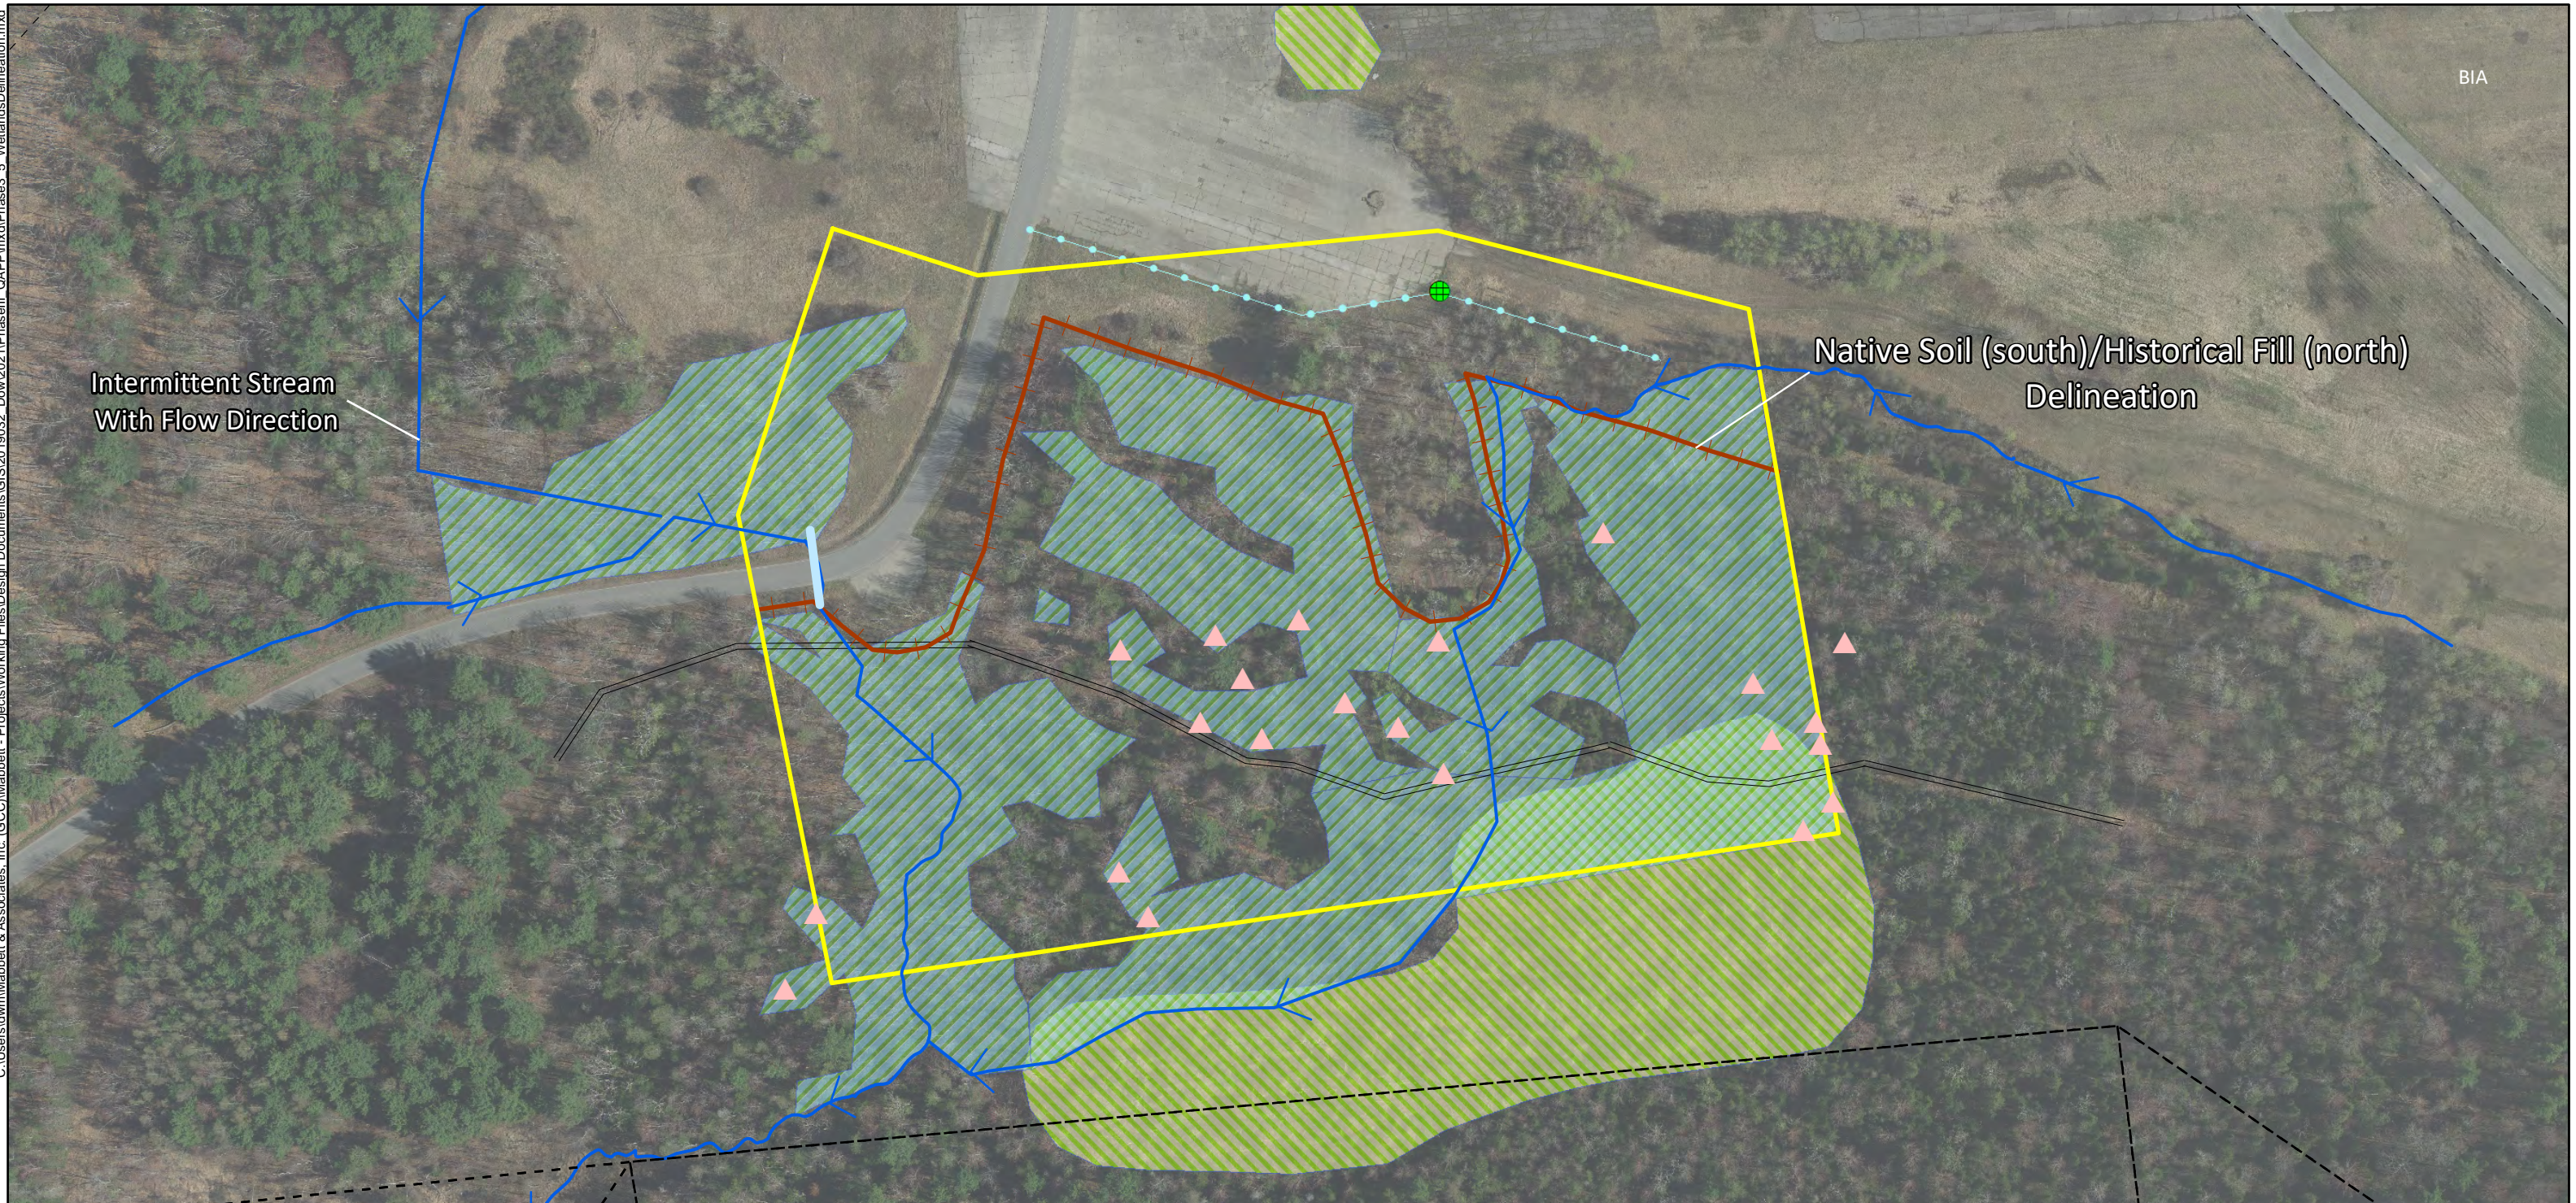
WETLAND DELINEATION AND VERNAL POOL LOCATIONS
Phase III Remedial Investigation

The un-named intermittent stream is a seasonal water feature that is dry during some summers or periods of prolonged drought. The surface water volume in the un-named intermittent stream is largely dictated by precipitation amounts, with the prolonged drought conditions in the region up through the end of 2016 and near normal precipitation amounts through the first six-months of 2017 and 2018 affecting surface water availability within and proximate to the FUDS Project Area. The western stream segment was noted as being dry during the USACE PDT site walk in October 2016 with no water evident in the culvert, the intermittent stream, or the previously (in 2008) wet area north of Hildreth Street North. USACE PDT site visits in mid- and late-May 2017 identified the existence of multiple wetland types and enhanced stream bed positioning due to wetter than average conditions for the first six months of 2017. A series of vernal pool ecosystems and a scrub wetland bound on three sides by running water south of the FUDS Project Area were also identified and mapped by the PDT as depicted in Figure 8.
