**PHASE I ENVIRONMENTAL SITE ASSESSMENT  
AND SUBSURFACE INVESTIGATION**

**KNOX SEMICONDUCTOR, INC.  
12 INDUSTRIAL PARK ROAD  
ROCKPORT, MAINE**

Date: June 28, 2005

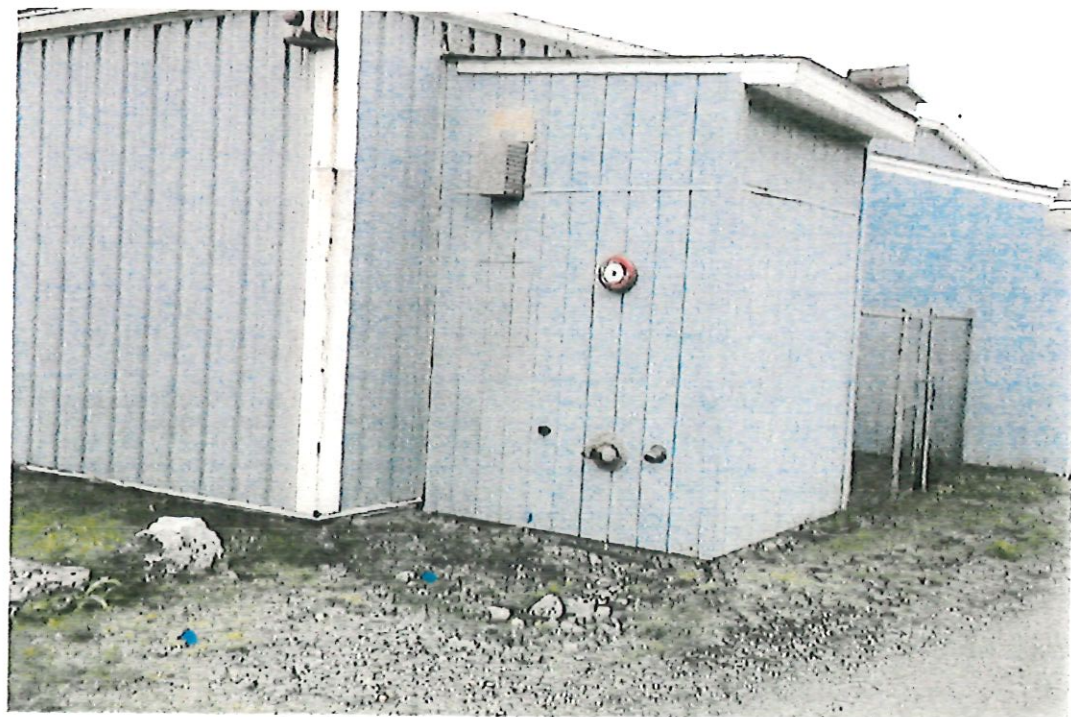
2. View of water connection, northwest corner.

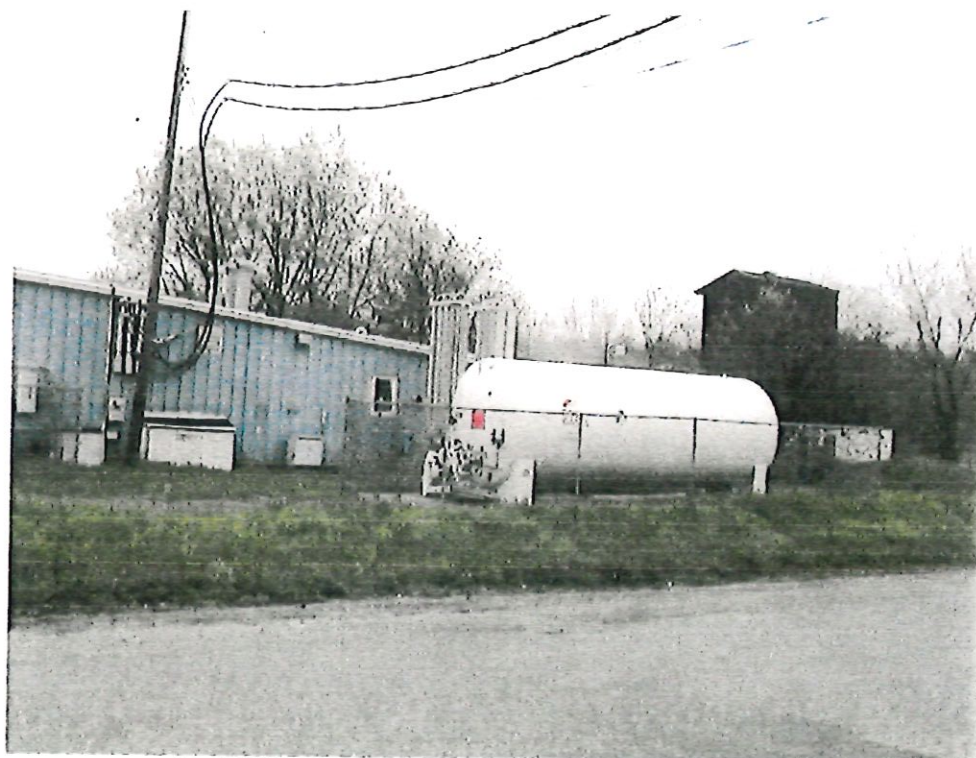
A 6,000-gallon AST containing liquid nitrogen and two liquid oxygen tanks are located on the west side of the Property and are surrounded by a chain-link fence. Electrical and telephone lines connect to the facility overhead on the west side of the building. A disconnected dry transformer was observed along the western exterior wall. Stains and stressed vegetation were not observed in the vicinity of the former transformer. Other potential polychlorinated biphenyls containing equipment was not observed.

4. 6,000-gallon liquid nitrogen AST. West side of facility.

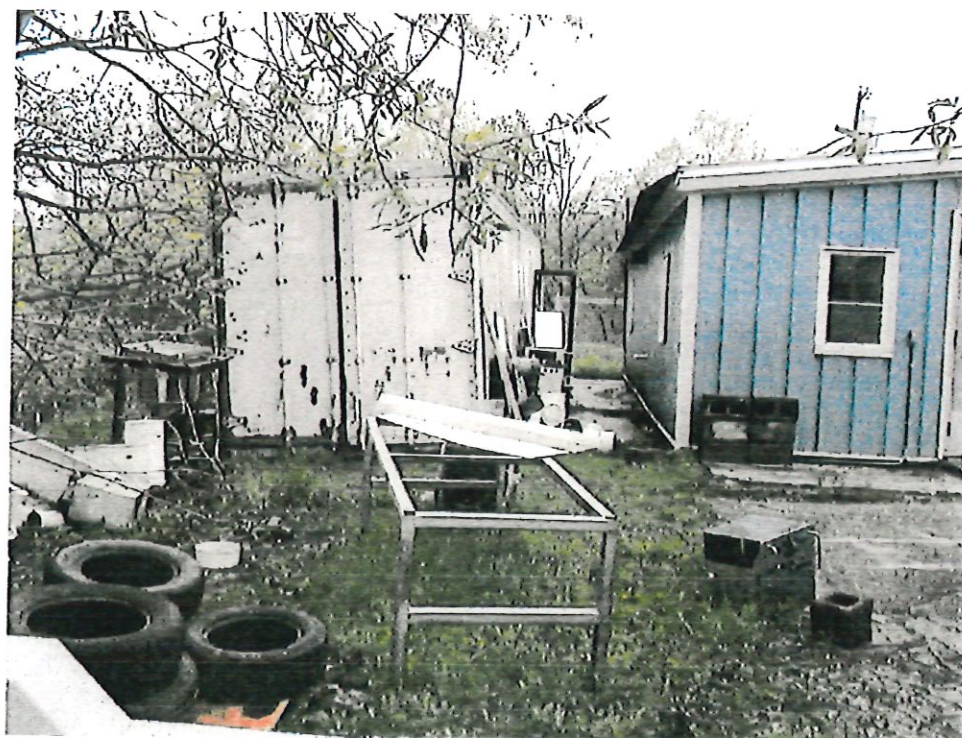
A storage trailer is located between the building and the southern Property line is used for storage of mechanical parts and tools. Metal debris, spare parts, rubber tires, and tools are stored outside around the south corner of the building. An empty 55-gallon container of epoxy vinyl ester resin and two small gasoline cans were observed under a canopy on the south side of the building. Storage of hazardous waste and substances outside of the building were not observed. Staining, stressed vegetation, or other evidence of a past release to the ground surface was not observed on the Property.

6. View of storage trailer along southern Property line.

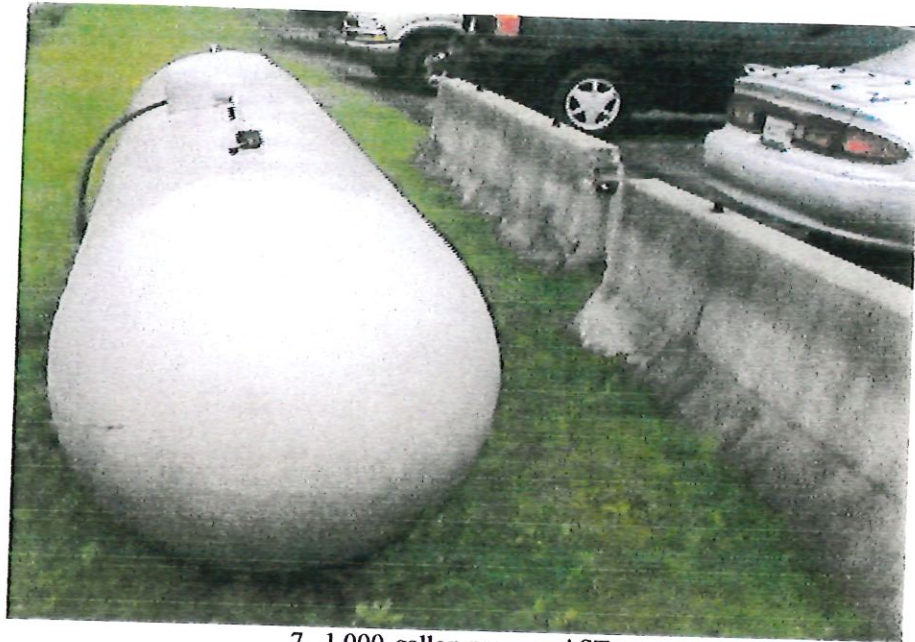
A 1,000-gallon propane AST is located on the east side of the Property and appeared to be in good condition without rust or deterioration. Evidence of current or former underground storage tanks (USTs) was not observed on the Property.

- The Property is served by municipal water and sewer systems. The building is heated by a forced hot air system, which is connected to a 1,000-gallon propane AST located on the east side of the property. The 1,000-gallon propane AST appeared in good condition.

7. 1,000-gallon propane AST.

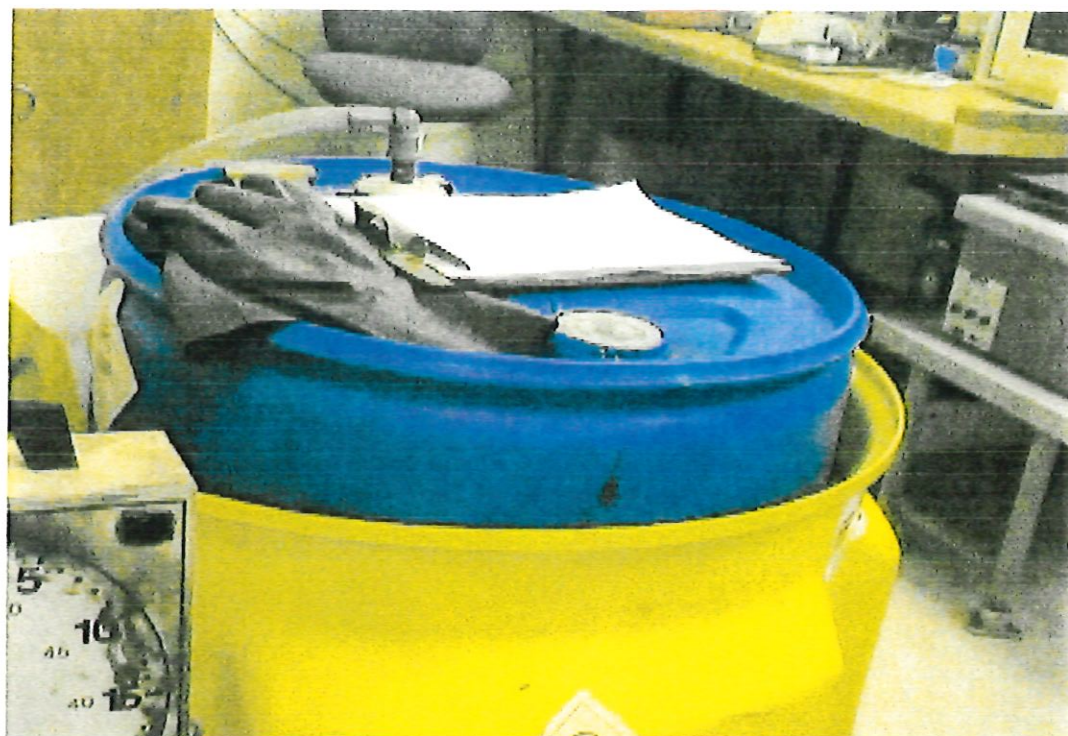
The second satellite accumulation area is located in the Finish Room, where a 55-gallon plastic container of spent cyanide plating solution is contained inside a secondary containment vessel. Reportedly this spent cyanide plating solution is shipped off-site once the container is full (approximately once per year). One-gallon containers of xylenes and acetone used in the Finish Room production process are contained in plastic trays and stored along the south wall. Signs of staining or leaks were not observed on the floor tiles or other surfaces of the room.

11. Spent waste cyanide and secondary containment vessel, Finish Room.

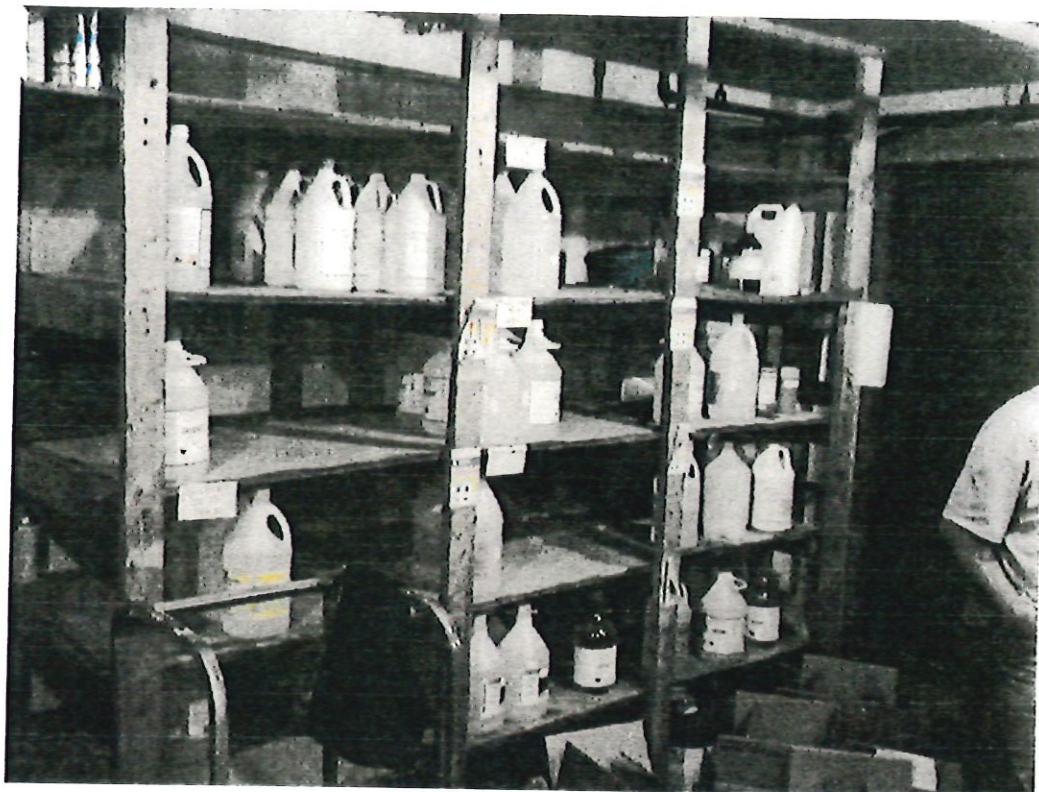
The following are list of virgin chemicals stored in 1-gallon containers on labeled shelving in the Chemical Storage Room: hydrofluoric acid, hydrochloric acid, sulfuric acid, ammonium hydroxide, nitric acid, hydrogen peroxide 30 percent, buffered oxide etches, acetic acid, phosphoric acid, xylene, isopropyl alcohol, and acetone. The Chemical Storage Room has a concrete floor and concrete berm. The floor was in good condition without evidence of cracks or significant deterioration. Stains, leaks, and container spills were not observed in the Chemical Storage Room.

13. Chemical Storage Room.

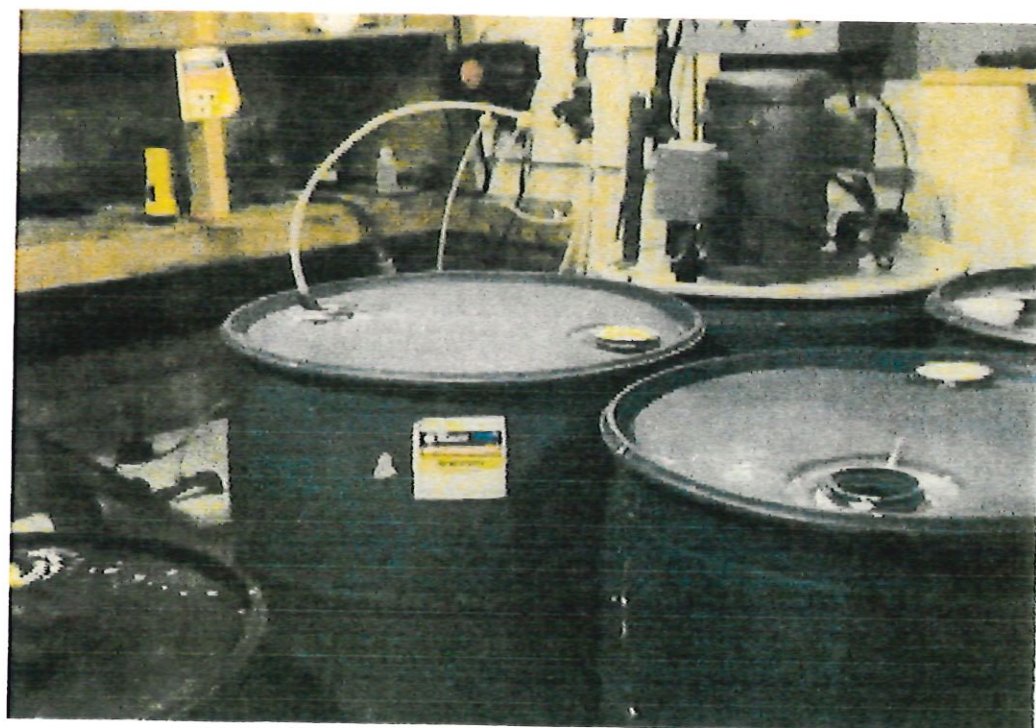
- Floor drain lines are interconnected and discharge to the municipal sewer system. An acid neutralization tank is used in the Chemical Storage room to neutralize wastewater from the Etch room before being discharged into the municipal sewer system. Evidence of staining or leaks from chemicals or hazardous substances used and stored were not observed on the floor tiles, walls or other surfaces in the building or on the Property.

14. Acid neutralization tank area.
