Subject: Bingham Wind Project, Response to Preliminary Review Comments from MDIFW Fisheries Division

*RE: Blue Sky West LLC, Blue Sky West II LLC (First Wind) - Bingham Wind Project:
further concerns and preliminary review comments from MDIFW Fisheries Division*

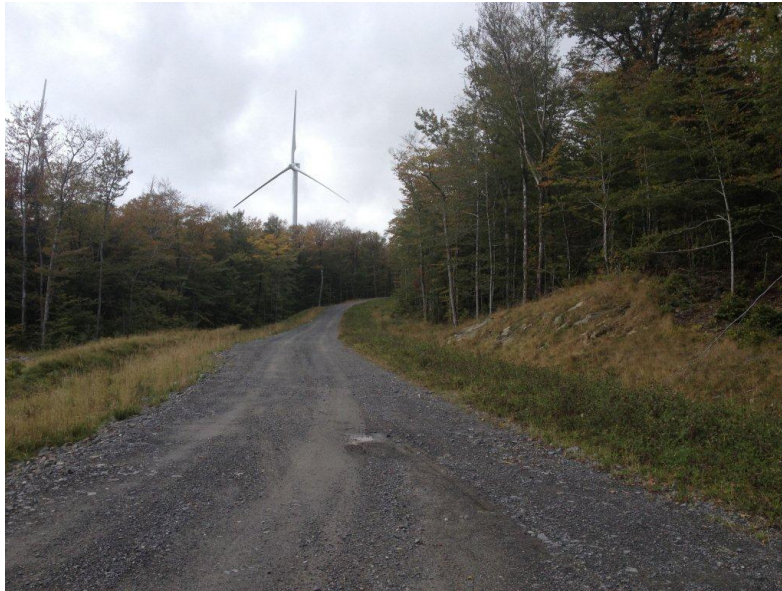
Photo of a post-construction crane road with re-vegetated shoulders at the Sheffield Wind Project after two growing seasons.

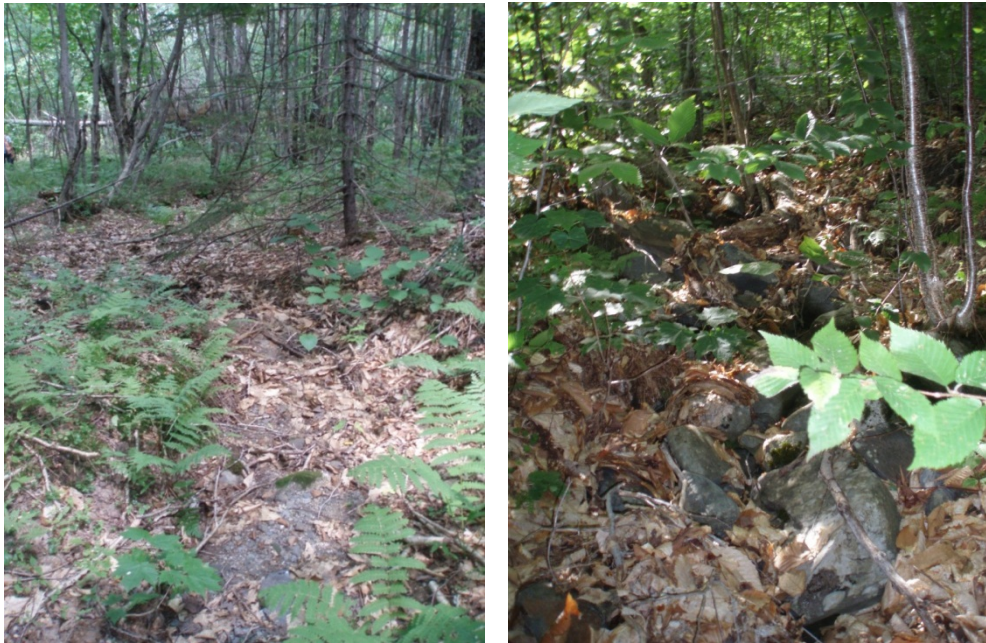
Representative photos of ephemeral streams within the project area.

First Wind Response: Streams were defined as “ephemeral” when they did not meet MDEP’s definition of a stream but did meet LUPC’s definition¹. In most cases, these are drainage ways created by the action of surface water but lacking aquatic animals and vegetation. Although they would not be considered jurisdictional streams per the MDEP criteria, they were identified and mapped to ensure they would be recognized as hydrologic features and accounted for in the design of the project. They are often small (a foot or two across and a few inches deep), and occur where anthropogenic activity (e.g., skidder ruts) has caused erosion, or in locations where exposed bedrock or dense soil conditions prevent water from infiltrating. Such drainage ways typically connect with wetland resources, albeit intermittently, during spring runoff or high flow events at other times during the year. Where these ephemeral drainage ways need to be crossed by the project, they typically have a “rock sandwich” proposed, as recommended during design consultation on other projects with MDEP and LUPC, which allows for hydrological connectivity to be maintained while minimizing the potential for further channelization. As discussed during the field visit, First Wind is open to suggestions if culverts or other alternative structures would be preferred by MDEP or MDIFW for habitat connectivity purposes.

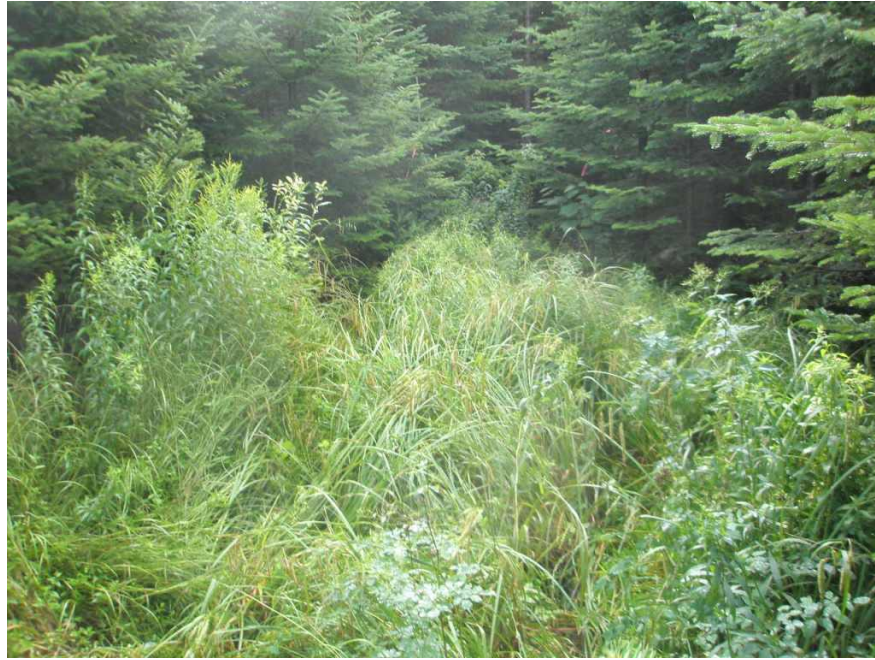
Representative photo of site conditions above S003 at proposed crossing.

Based on the discussion during the September 10, 2013 site visit, the design is currently being modified at STA 208+00. The proposed rock sandwich will be eliminated and replaced with a culvert to promote habitat connectivity as recommended by MDIFW in concurrence with MDEP and USFWS. The revised design will be provided to MDIFW once it is available. A representative photo showing existing site conditions at ST 208+00 is shown below as observed during the initial field surveys.

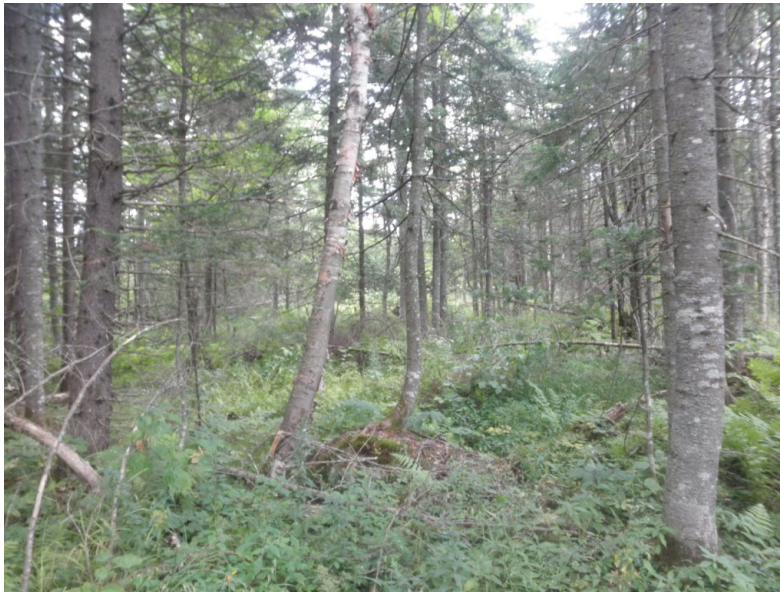
Representative photograph of wetland MAY076

At the request of John Perry, below is a representative photograph of wetland MAY076.

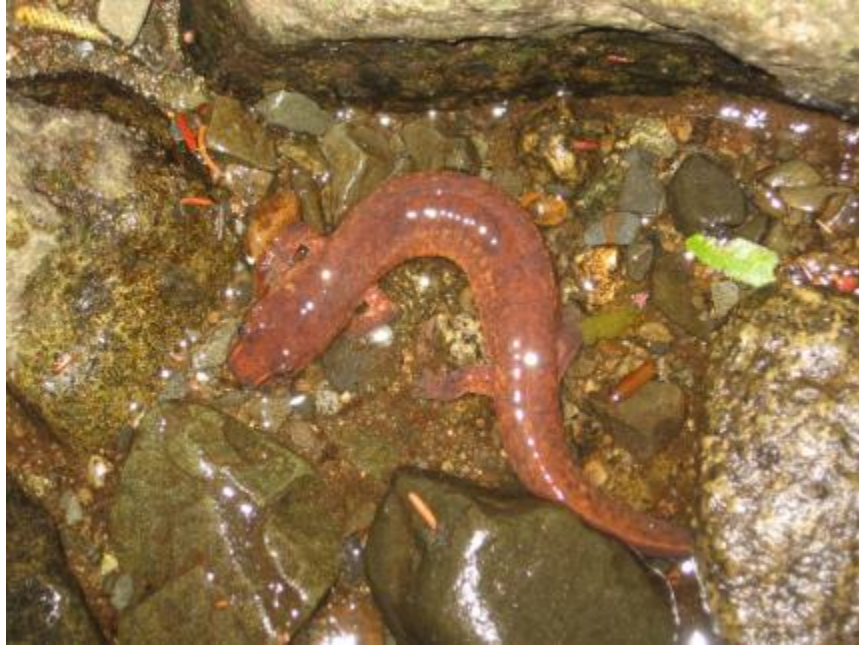
Photo 1: Northern spring salamander documented in Stream SO45 on September 10, 2013.

A northern spring salamander was observed in stream SO45 on September 10, 2013 (Figure1). The stream (Bottle Brook) is a large, undisturbed, perennial stream with a low-to-moderate gradient, and a rock-cobble-gravel-sand substrate, with little organic material in the stream channel. At the time of the survey, wetted width was approximately 15 feet with a bank full width of approximately 20 feet. Water depth averaged about 6 inches. A two-lined salamander was also observed.

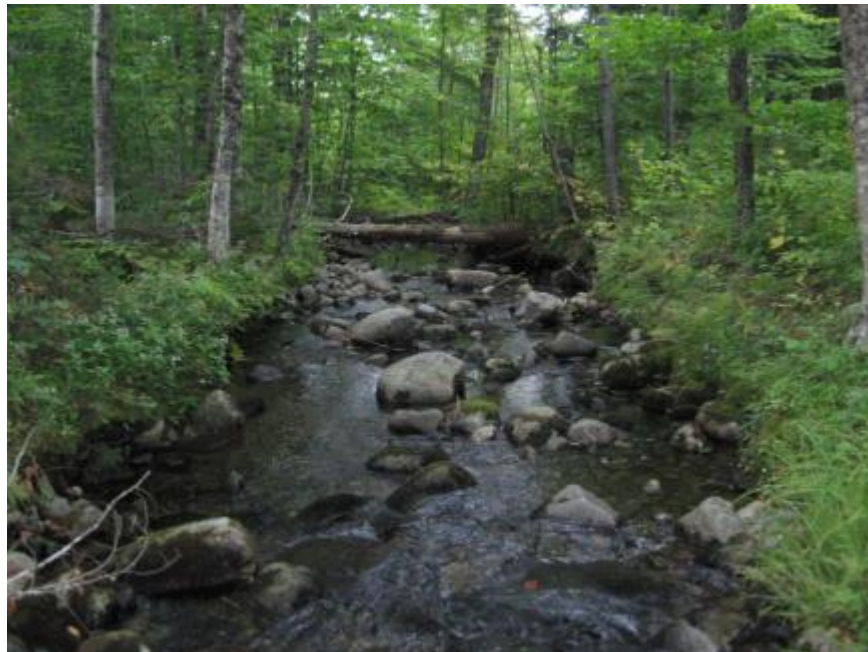
Photo 2: Stream SO45 looking south downstream on September 10, 2013.

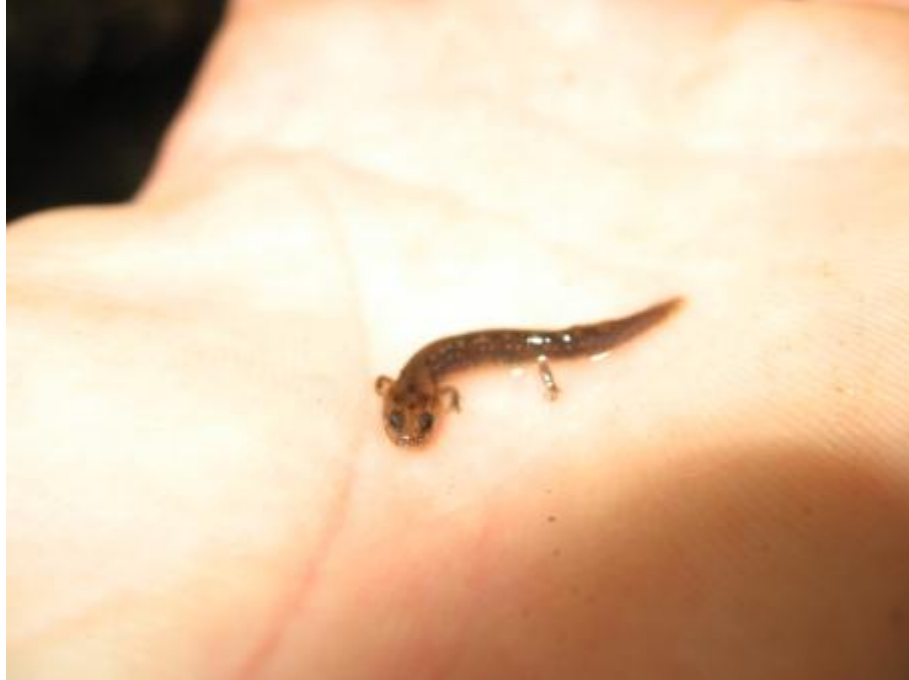
Photo 3: Larvae northern spring salamander documented in Stream SO46 on September 10, 2013.

A northern spring salamander was observed in stream SO46 on September 10, 2013 (Figure 1). The stream (unnamed tributary to Kingsbury Stream) is a small, undisturbed, perennial stream with low-to-moderate gradient and rock-cobble-gravel-sand substrate with little organic material in stream channel. At time of survey, wetted width ranged from 3 to 6 feet with a bank full width ranging from 6 to 8 feet. Water depth averaged about 6 inches.

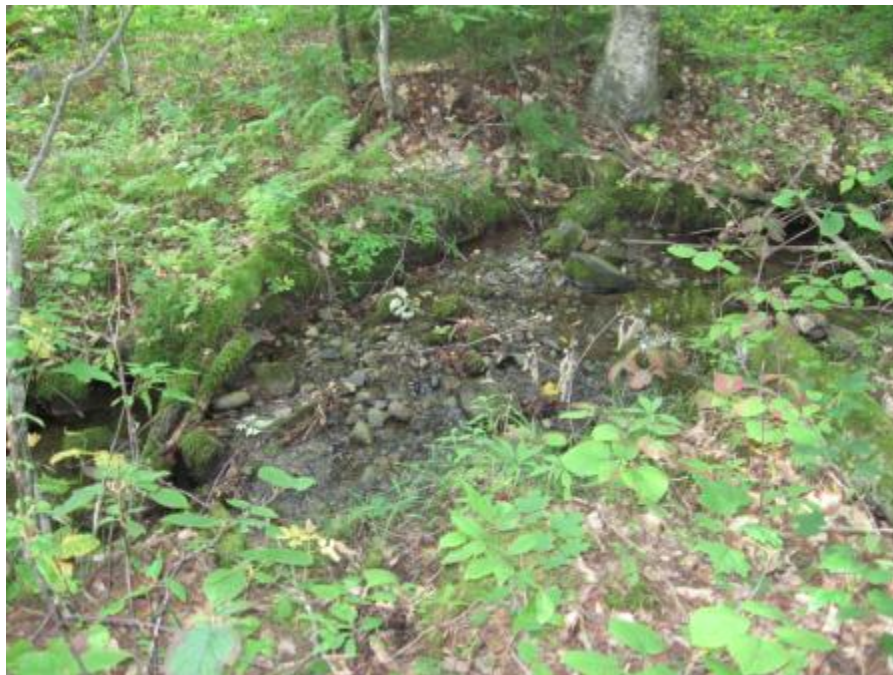
Photo 4: Stream SO46 surveyed habitat.

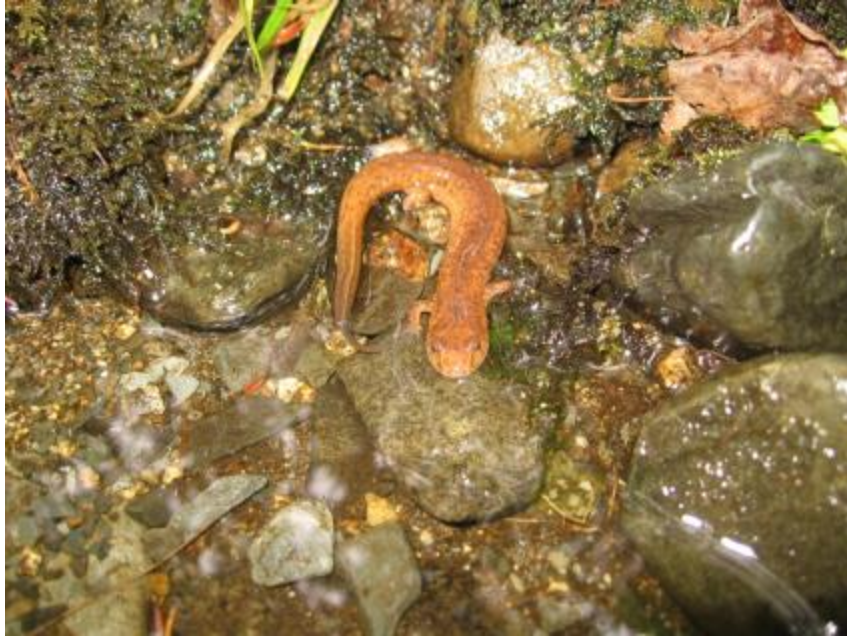
Photo 5: Adult northern spring salamander in Stream SO49 on September 10, 2013.

A northern spring salamander was observed in stream SO49 on September 10, 2013 (Figure 1). The stream (Bear Brook) is an undisturbed perennial stream with low-to-moderate gradient and a rock-cobble-gravel-sand substrate. At the time of the survey, wetted width was approximately 10 feet and bank full width ranged from 10 to 12 feet. Very little organic material observed in channel. Water depth averaged about 6 to 8 inches.

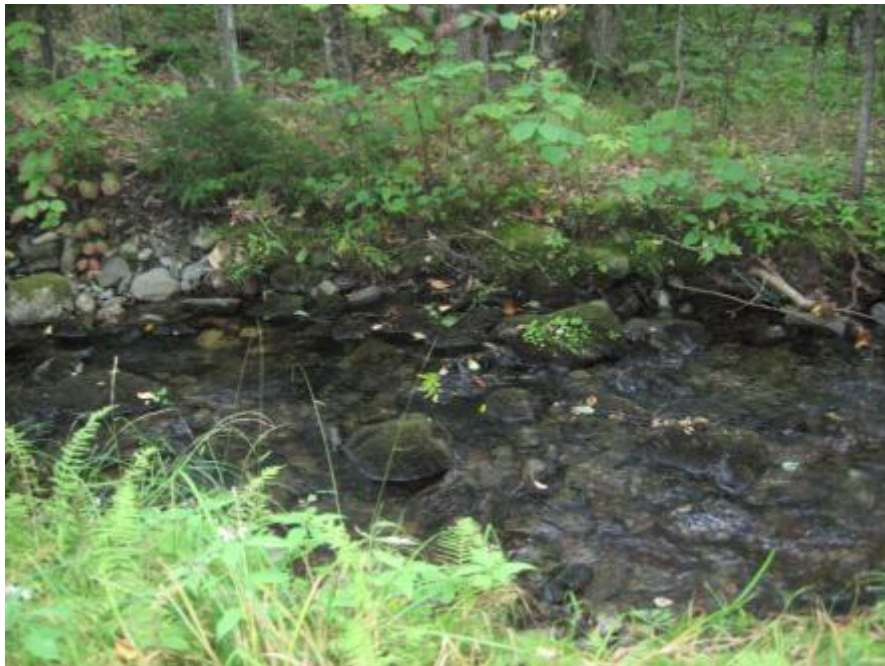
Photo 6: Stream SO49 surveyed habitat.

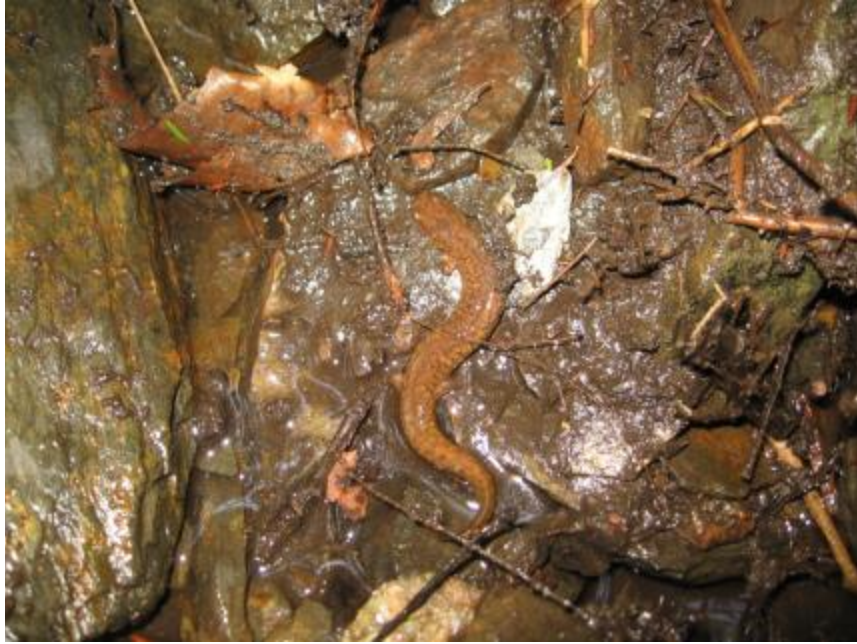
Photo 7: Adult northern spring salamander documented in Stream SO70 on September 11, 2013.

A northern spring salamander was observed in stream SO70 on September 11, 2013 (Figure 1). The stream (unnamed tributary to Gales Brook) is a small, undisturbed, perennial stream with low-to-moderate gradient and rock-cobble-gravel-sand-silt substrate with organic material in portion of stream channel running through a wetland complex. At the time of the survey, wetted width was approximately 3 feet. The stream lacks well defined banks in most places within wetland. Water depth averaged 6 to 8 inches with pools up to 12 inches.

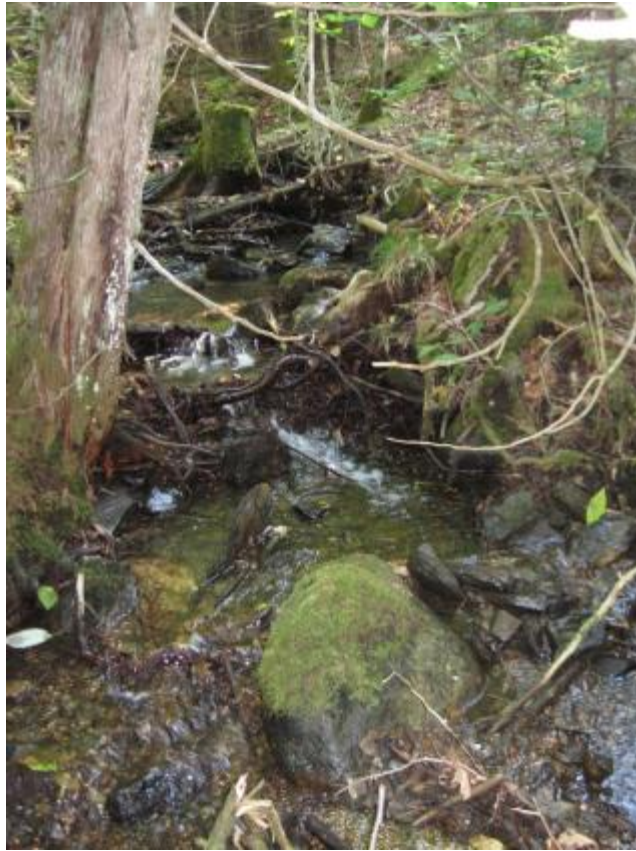
Photo 8: Stream SO70 surveyed habitat.

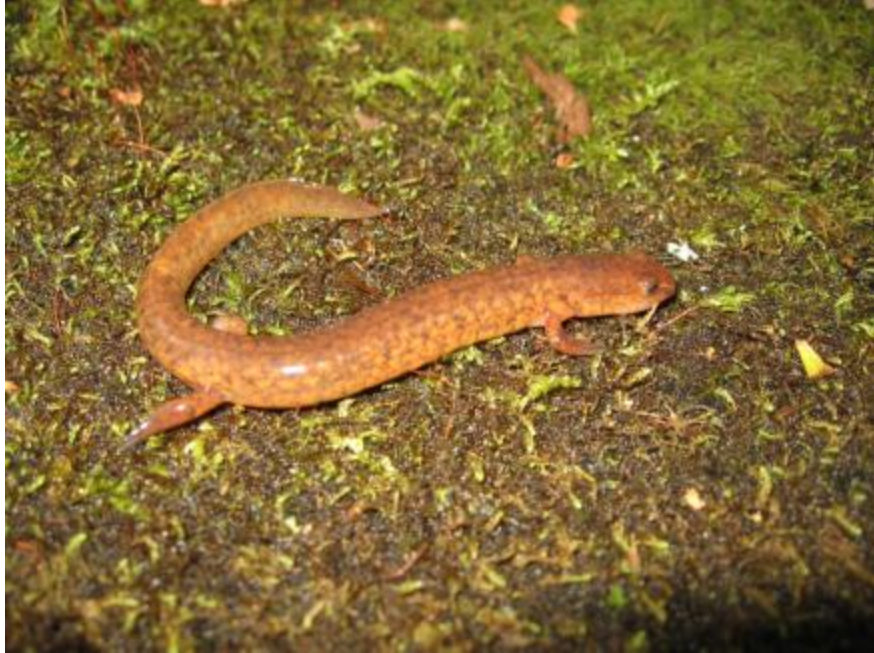
Photo 9: Adult northern spring salamander documented in Stream SO71 on September 11, 2013.

A northern spring salamander was observed in stream SO71 on September 11, 2013 (Figure 1). The stream (unnamed tributary to Gales Brook) is a small, undisturbed, perennial stream with low-to-moderate gradient and rock-cobble-gravel-sand substrate. The stream has many flat stones and several areas of exposed ledge. At the time of the survey, wetted width ranged from 3 to 15 feet with bank full width ranging from 10 to 15 feet. Water depth averaged about 3 to 6 inches. Three northern dusky salamanders were also observed.

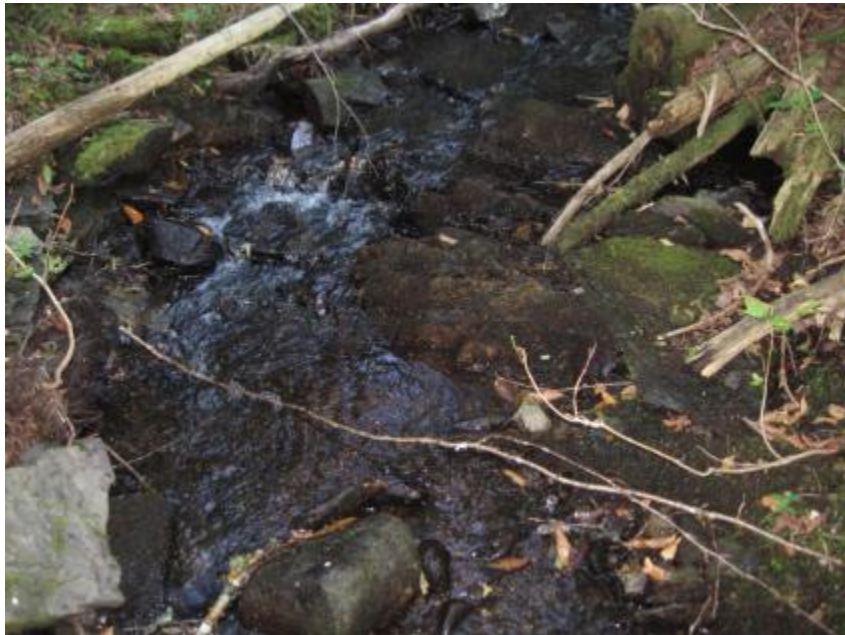
Photo 10: Stream SO71 surveyed habitat.
