January 9, 2014

**Subject: Bingham Wind Project, Summary of Spring Salamander Surveys and Proposed Habitat Management
Project # L-25973-24-A-N / L-25973-TG-B-N**

Project Survey Summary

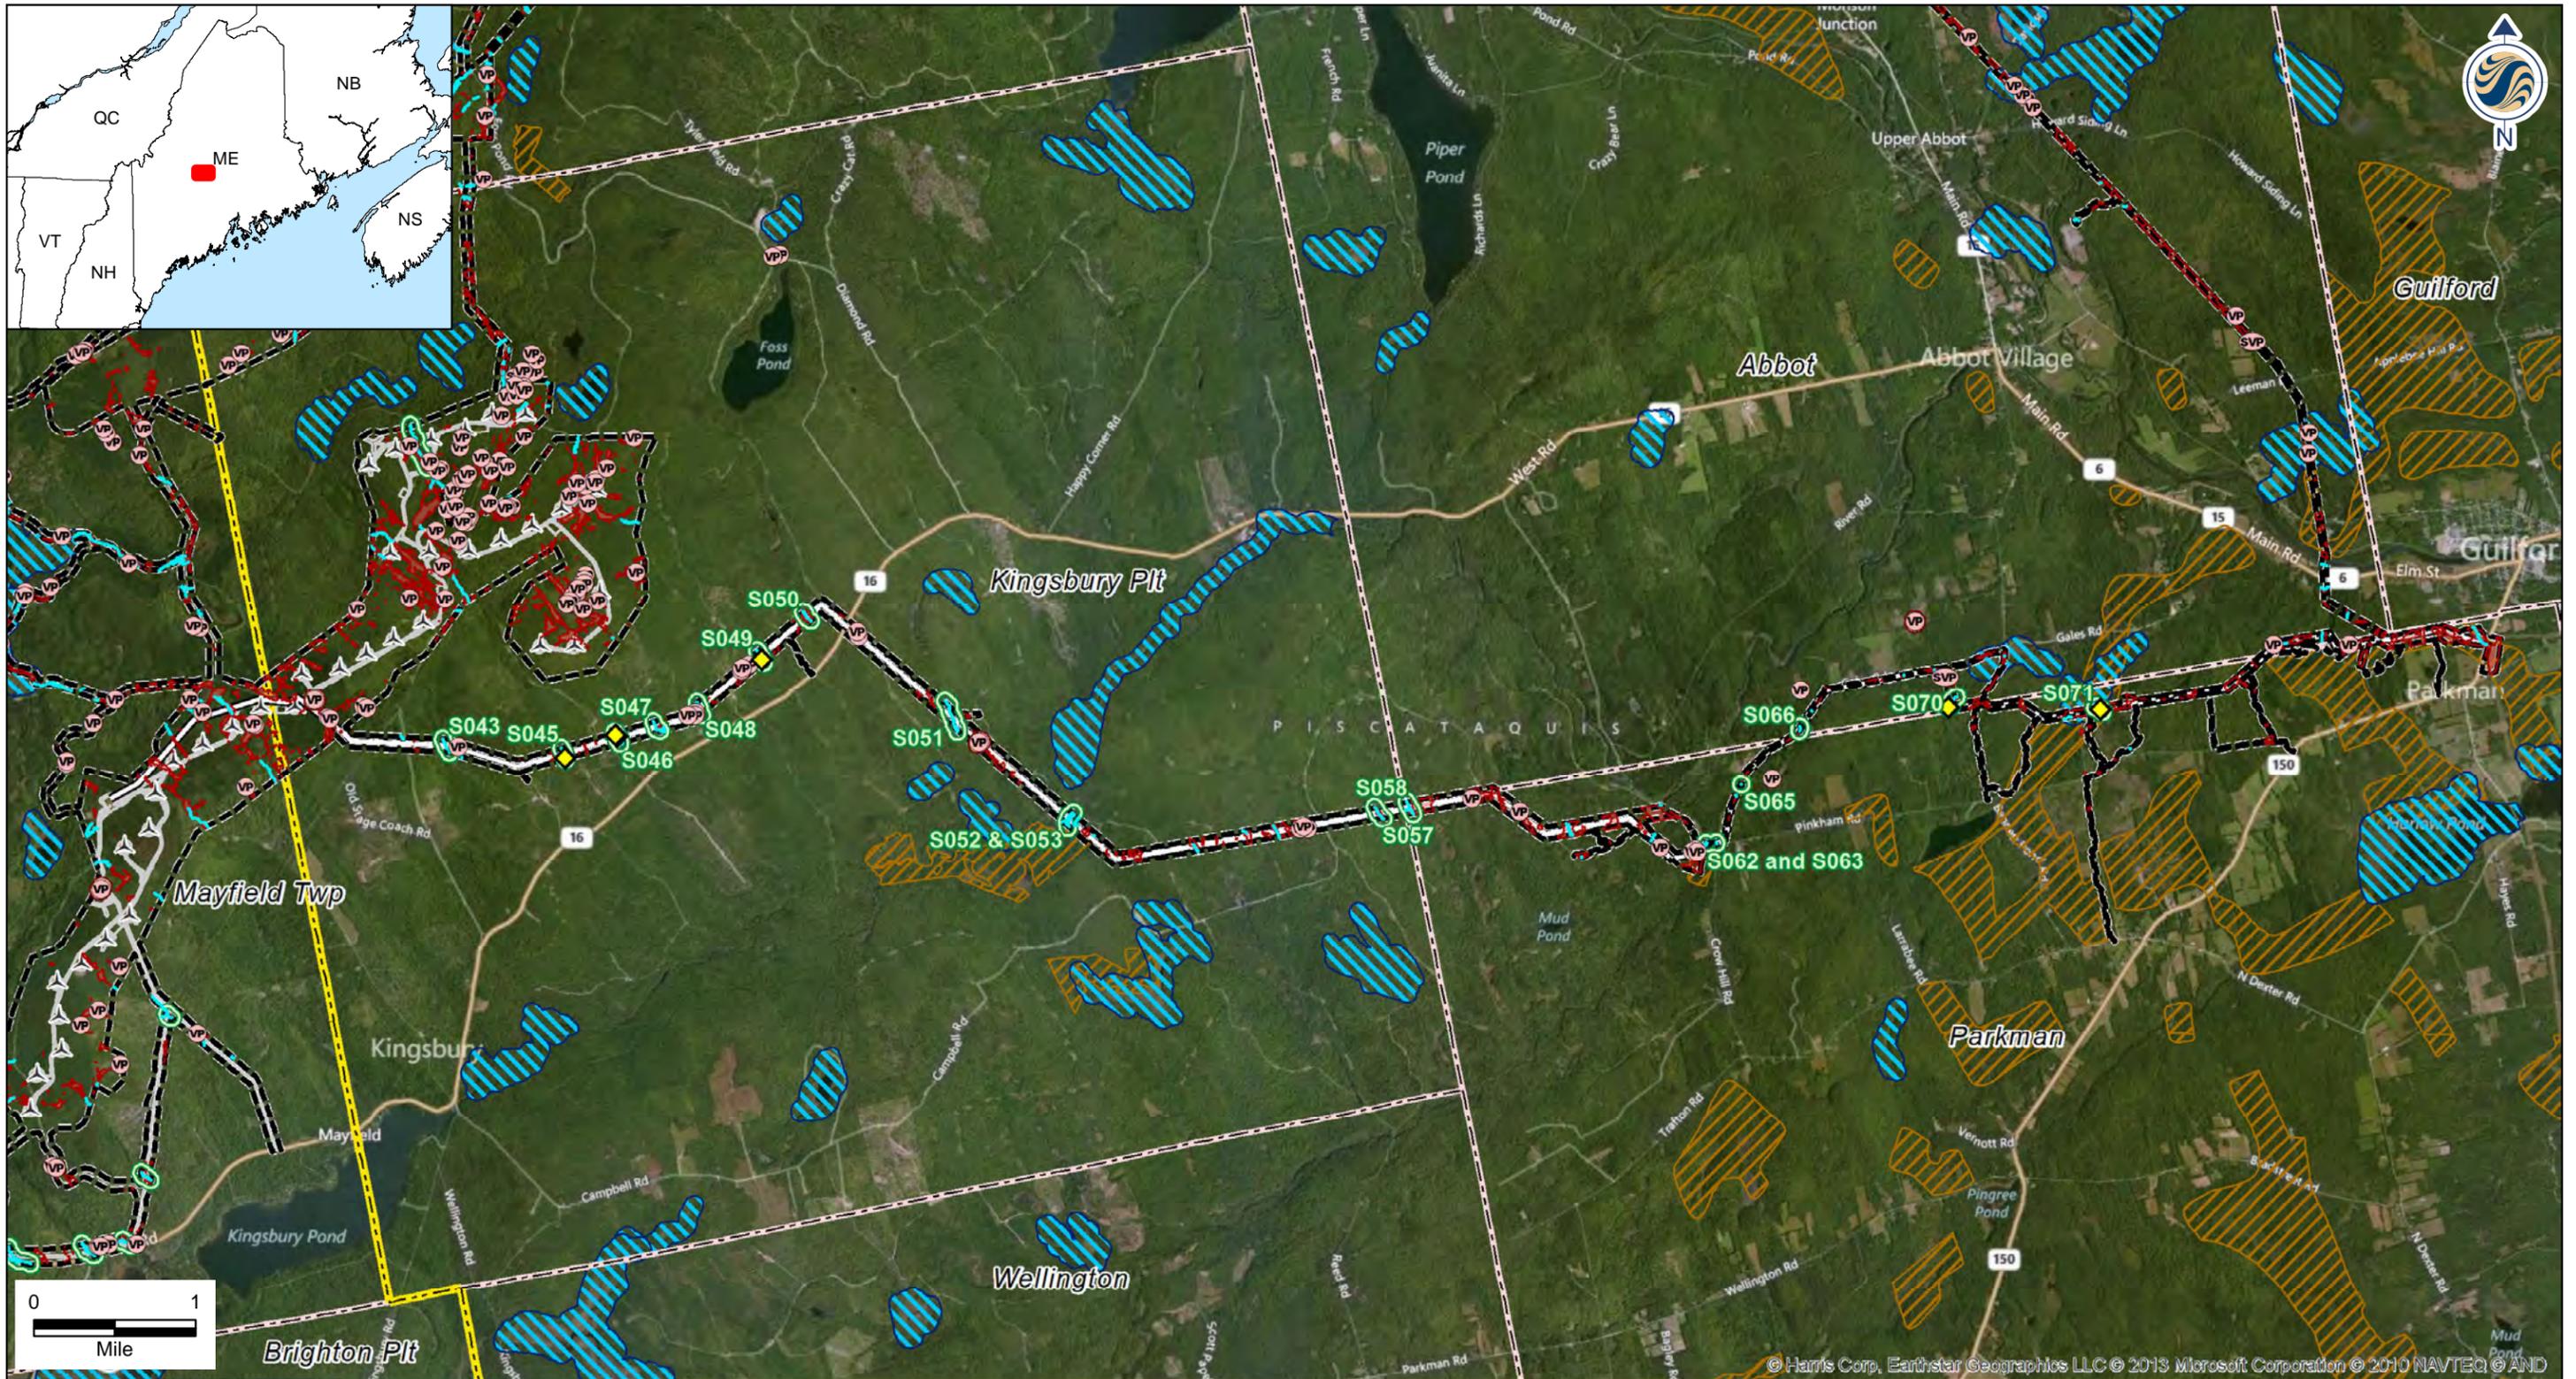
Figure 1

A northern spring salamander was observed in stream SO45 on September 10, 2013 (Figure1). The stream (Bottle Brook) is a large, undisturbed, perennial stream with a low-to-moderate gradient, and a rock-cobble-gravel-sand substrate, with little organic material in the stream channel. At the time of the survey, wetted width was approximately 15 feet with a bank full width of approximately 20 feet. Water depth averaged about 6 inches. A two-lined salamander was also observed.

A northern spring salamander was observed in stream SO46 on September 10, 2013 (Figure 1). The stream (unnamed tributary to Kingsbury Stream) is a small, undisturbed, perennial stream with low-to-moderate gradient and rock-cobble-gravel-sand substrate with little organic material in stream channel. At time of survey, wetted width ranged from 3 to 6 feet with a bank full width ranging from 6 to 8 feet. Water depth averaged about 6 inches.

A northern spring salamander was observed in stream SO49 on September 10, 2013 (Figure 1). The stream (Bear Brook) is an undisturbed perennial stream with low-to-moderate gradient and a rock-cobble-gravel-sand substrate. At the time of the survey, wetted width was approximately 10 feet and bank full width ranged from 10 to 12 feet. Very little organic material observed in channel. Water depth averaged about 6 to 8 inches.

A northern spring salamander was observed in stream SO70 on September 11, 2013 (Figure 1). The stream (unnamed tributary to Gales Brook) is a small, undisturbed, perennial stream with low-to-moderate gradient and rock-cobble-gravel-sand-silt substrate with organic material in portion of stream channel running through a wetland complex. At the time of the survey, wetted width was approximately 3 feet. The stream lacks well defined banks in most places within wetland. Water depth averaged 6 to 8 inches with pools up to 12 inches.

A northern spring salamander was observed in stream SO71 on September 11, 2013 (Figure 1). The stream (unnamed tributary to Gales Brook) is a small, undisturbed, perennial stream with low-to-moderate gradient and rock-cobble-gravel-sand substrate. The stream has many flat stones and several areas of exposed ledge. At the time of the survey, wetted width ranged from 3 to 15 feet with bank full width ranging from 10 to 15 feet. Water depth averaged about 3 to 6 inches. Three northern dusky salamanders were also observed.

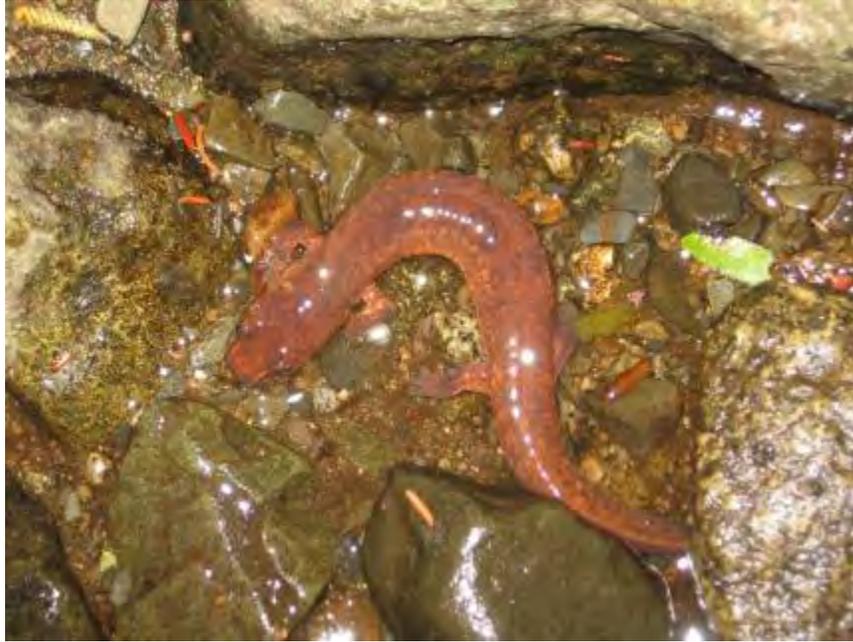
Photo 1: Northern spring salamander documented in Stream SO45 on September 10, 2013.

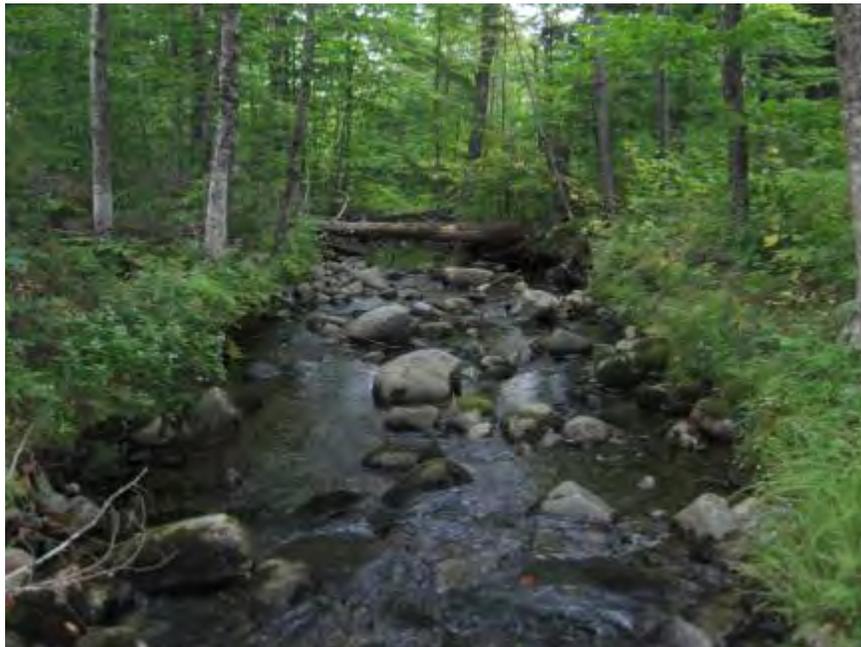
Photo 2: Stream SO45 looking south downstream on September 10, 2013.

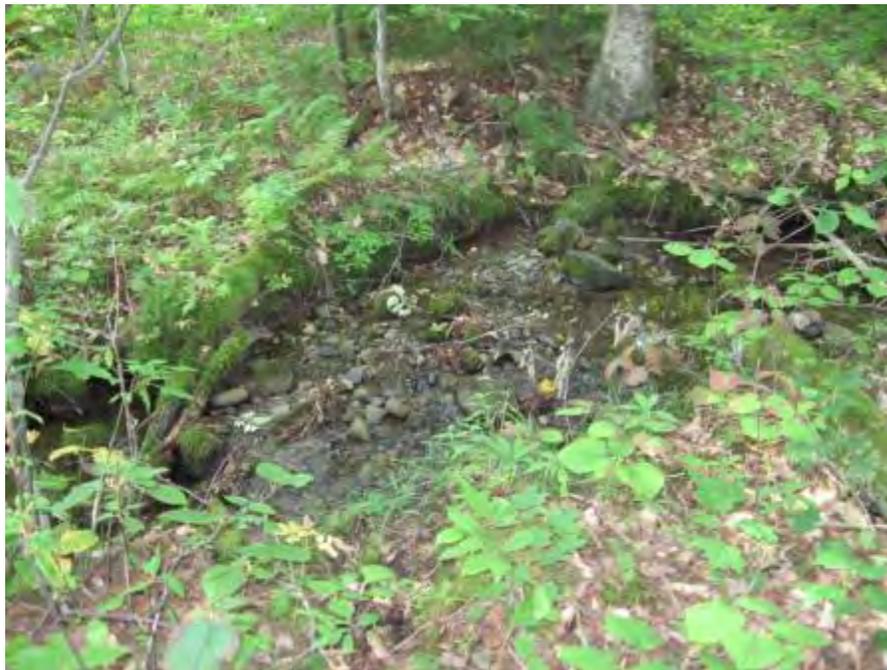
Photo 4: Stream SO46 surveyed habitat.

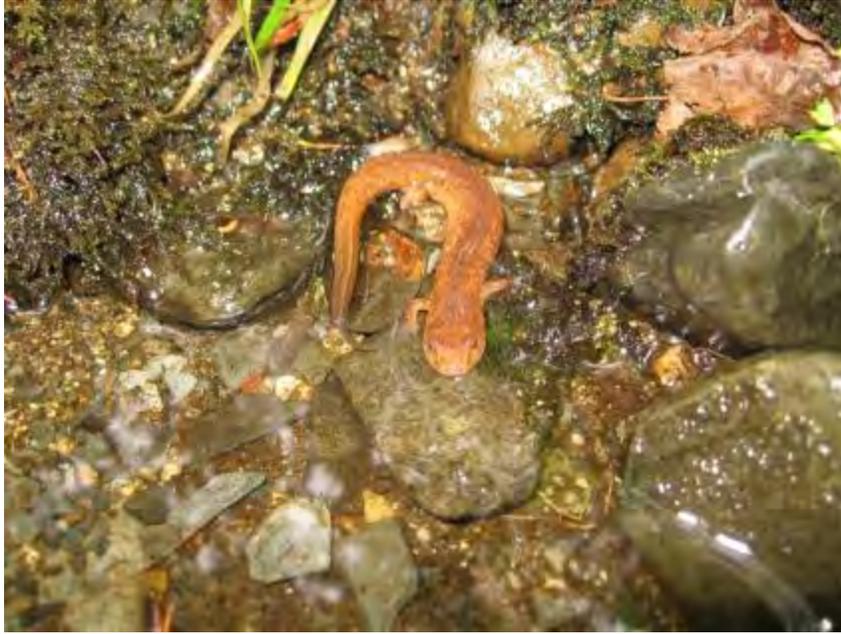
Photo 5: Adult northern spring salamander in Stream SO49 on September 10, 2013.

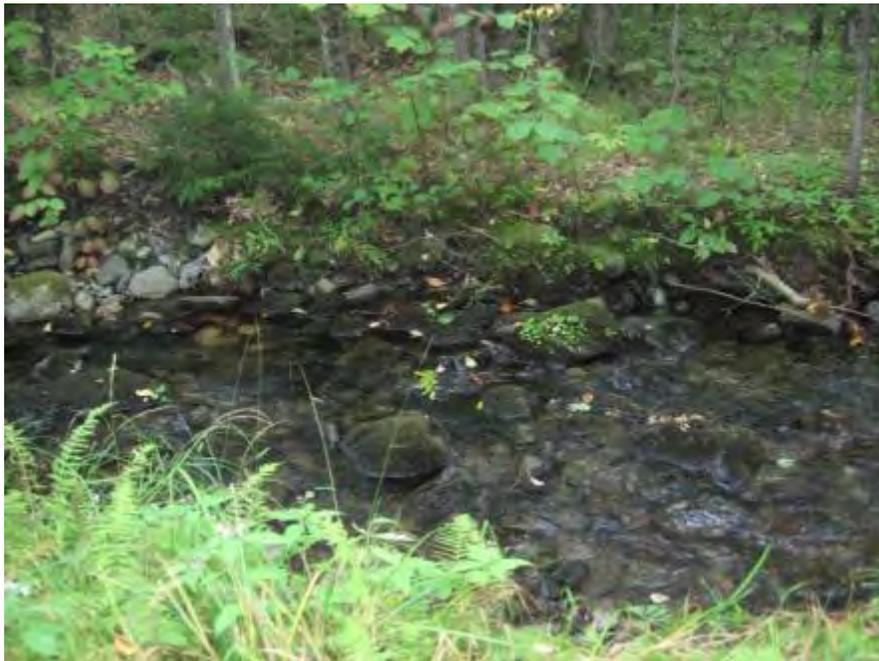
Photo 6: Stream SO49 surveyed habitat.

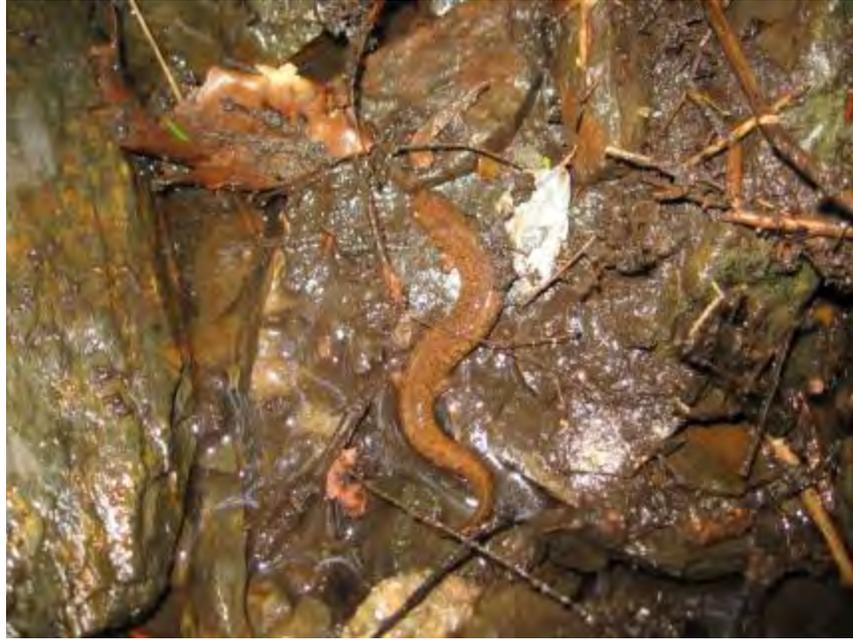
Photo 7: Adult northern spring salamander documented in Stream SO70 on September 11, 2013.

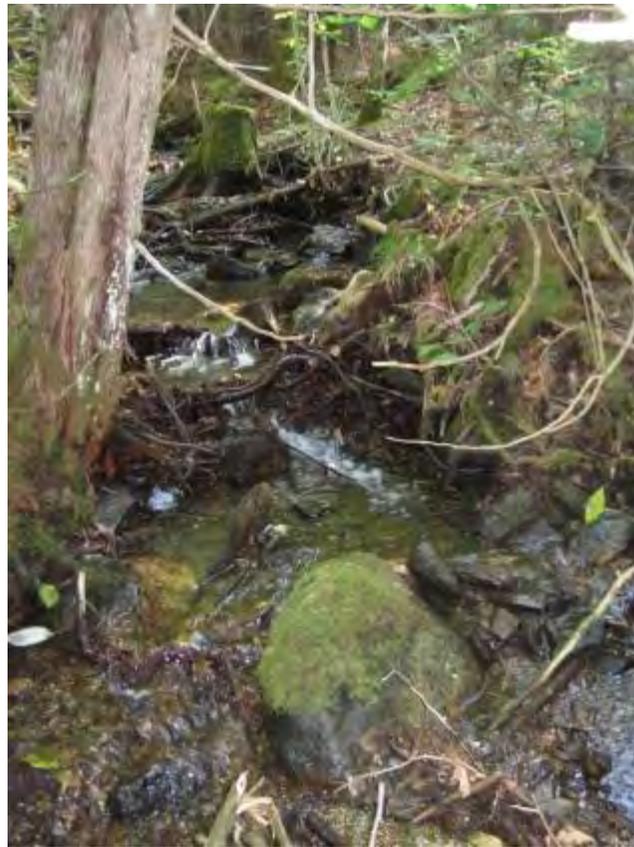
Photo 8: Stream SO70 surveyed habitat.

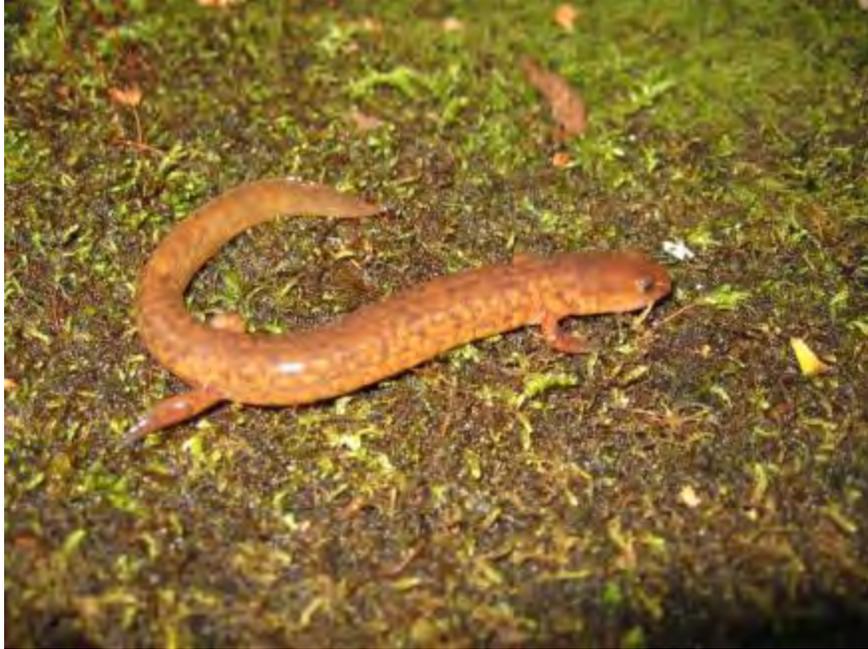
Photo 9: Adult northern spring salamander documented in Stream SO71 on September 11, 2013.

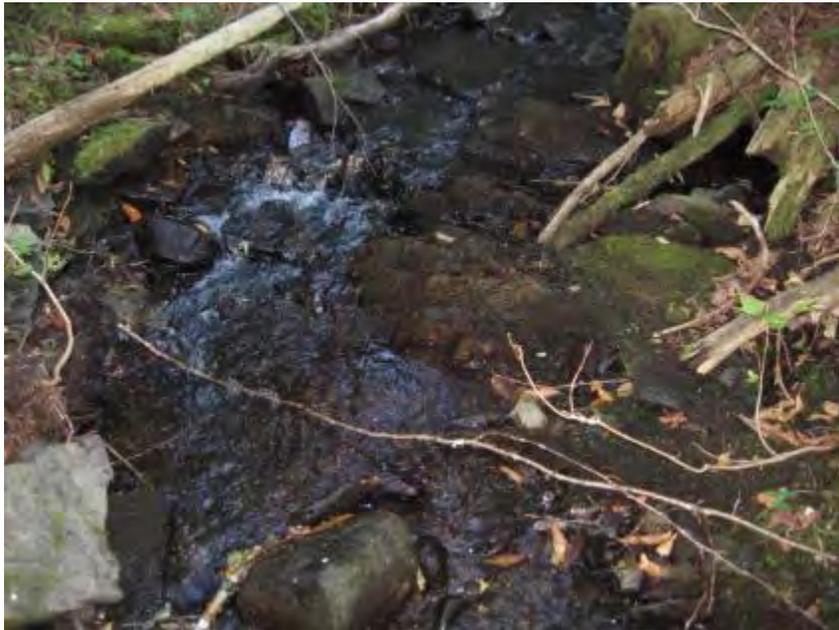
Photo 10: Stream SO71 surveyed habitat.

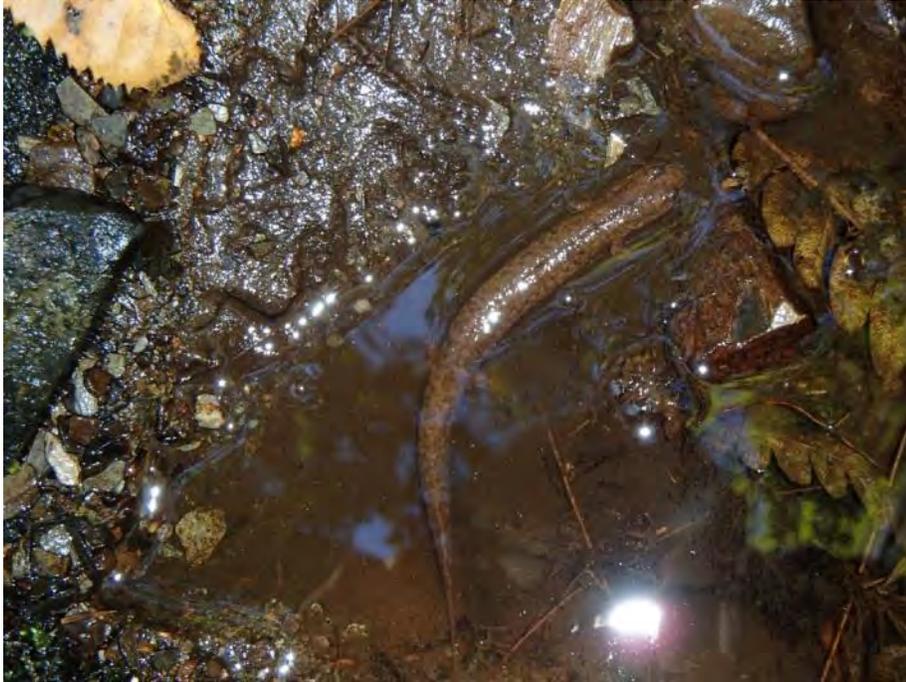
Photo 1: Northern spring salamander documented in Stream SO23 on September 18, 2013.

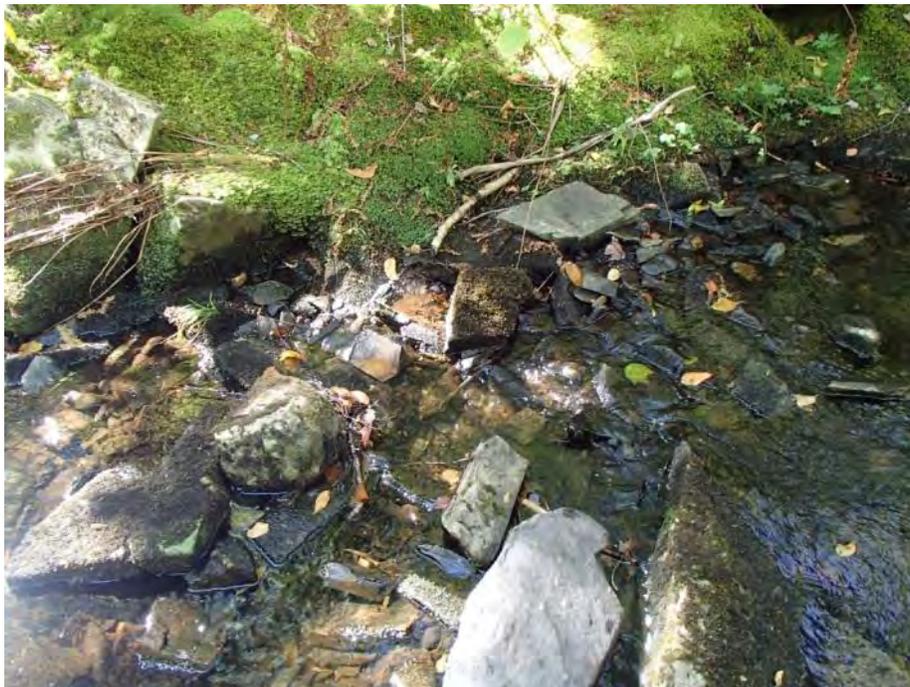
Photo 2: Stream SO23 capture site on September 18, 2013.

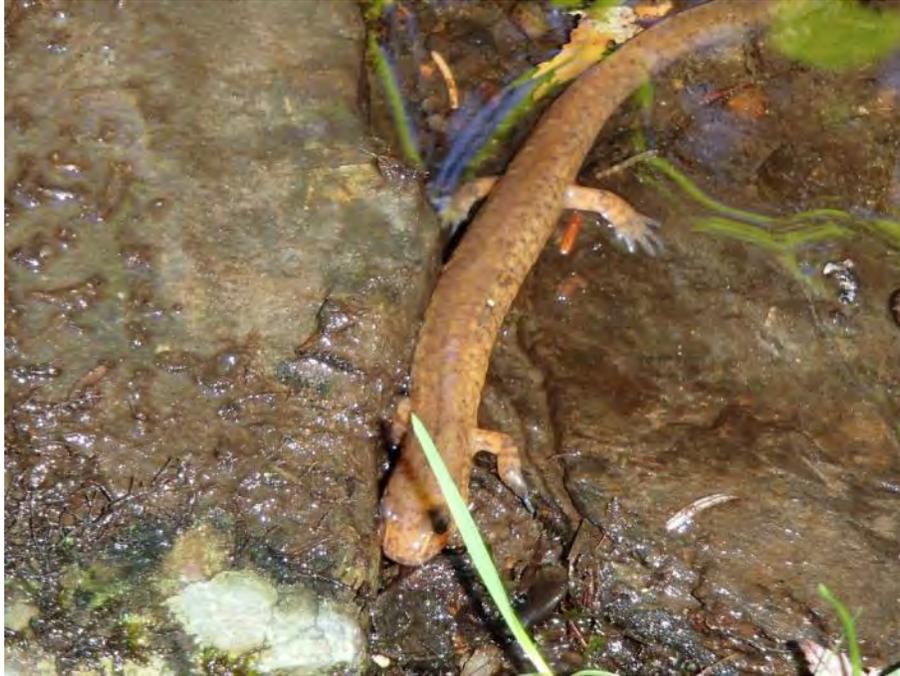
Photo 3: Northern spring salamander documented in Stream SO23 on September 18, 2013.

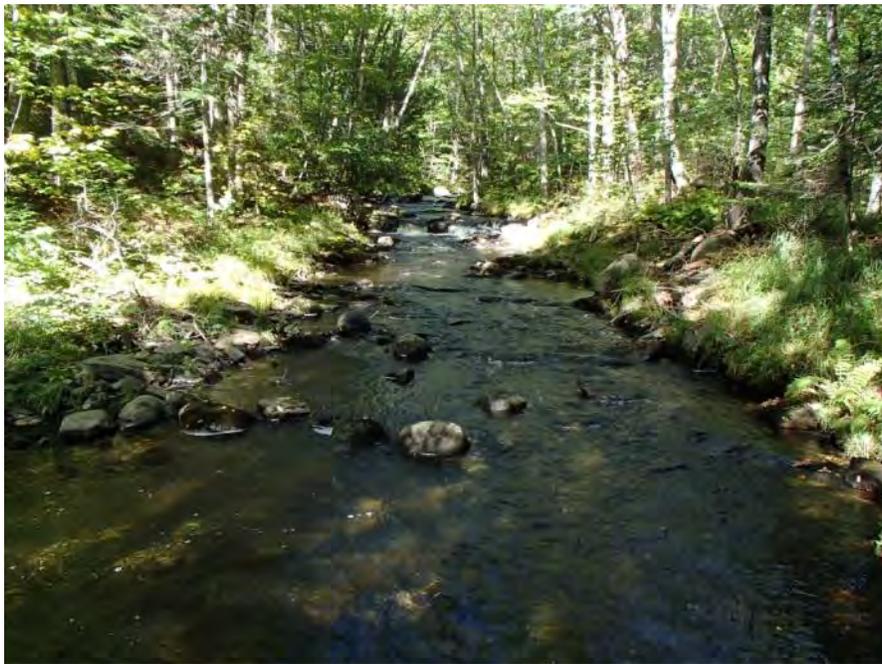
Photo 4: Stream SO23 surveyed habitat.

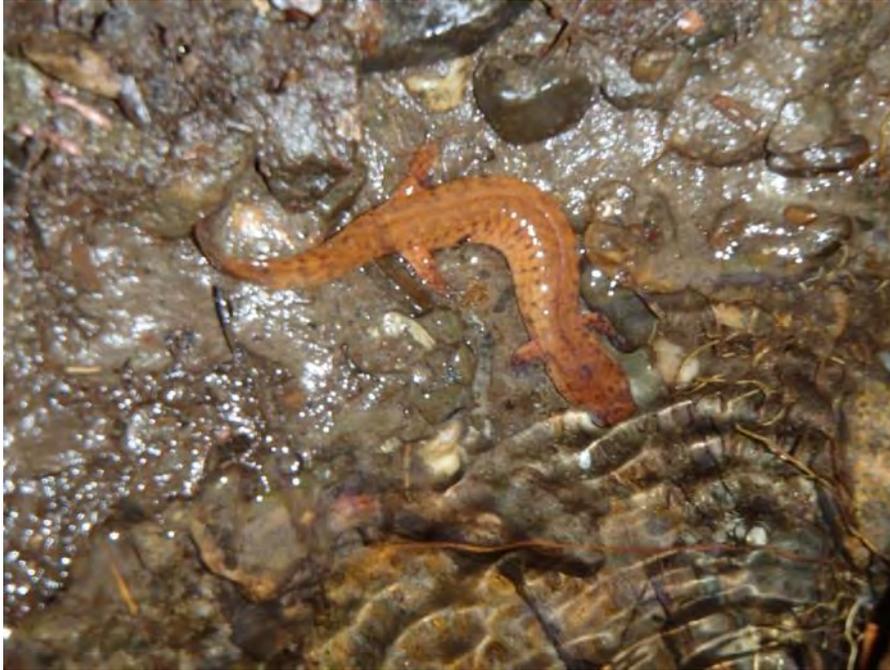
Photo 5: Adult northern spring salamander in Stream SO25 on September 18, 2013.

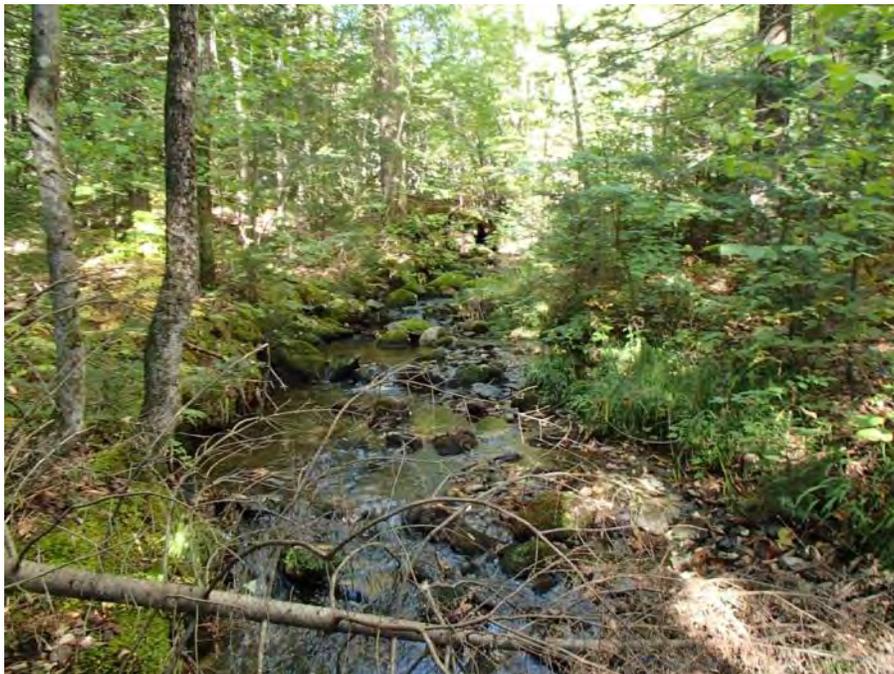
Photo 6: Stream SO25 surveyed habitat.

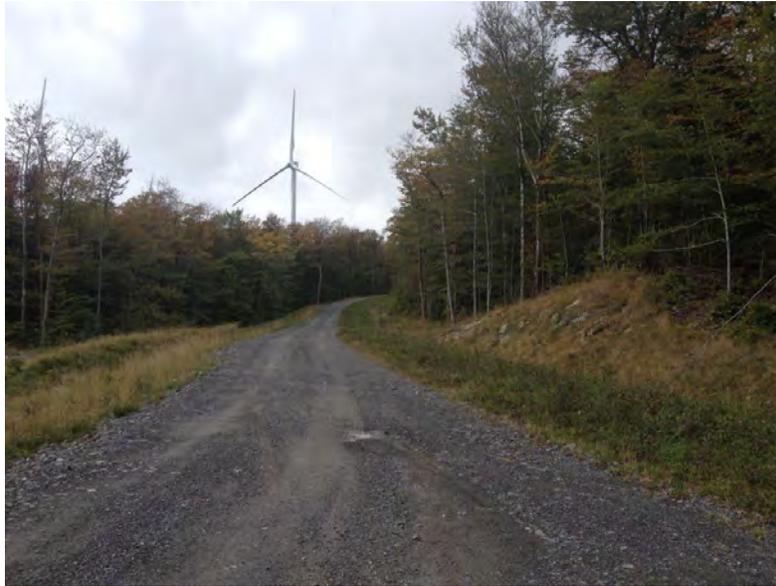
Photo of a post-construction crane road with re-vegetated shoulders at the Sheffield Wind Project after two growing seasons.

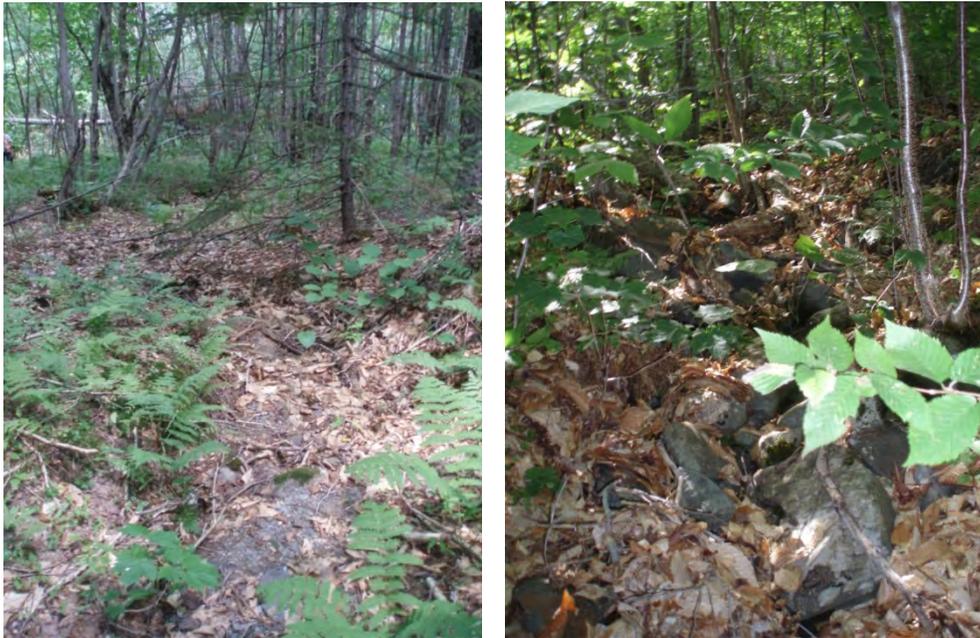
First Wind Response: Streams were defined as “ephemeral” when they did not meet MDEP’s definition of a stream but did meet LUPC’s definition¹. In most cases, these are drainage ways created by the action of surface water but lacking aquatic animals and vegetation. Although they would not be considered jurisdictional streams per the MDEP criteria, they were identified and mapped to ensure they would be recognized as hydrologic features and accounted for in the design of the project. They are often small (a foot or two across and a few inches deep), and occur where anthropogenic activity (e.g., skidder ruts) has caused erosion, or in locations where exposed bedrock or dense soil conditions prevent water from infiltrating. Such drainage ways typically connect with wetland resources, albeit intermittently, during spring runoff or high flow events at other times during the year. Where these ephemeral drainage ways need to be crossed by the project, they typically have a “rock sandwich” proposed, as recommended during design consultation on other projects with MDEP and LUPC, which allows for hydrological connectivity to be maintained while minimizing the potential for further channelization. As discussed during the field visit, First Wind is open to suggestions if culverts or other alternative structures would be preferred by MDEP or MDIFW for habitat connectivity purposes.

Representative photos of ephemeral streams within the project area.

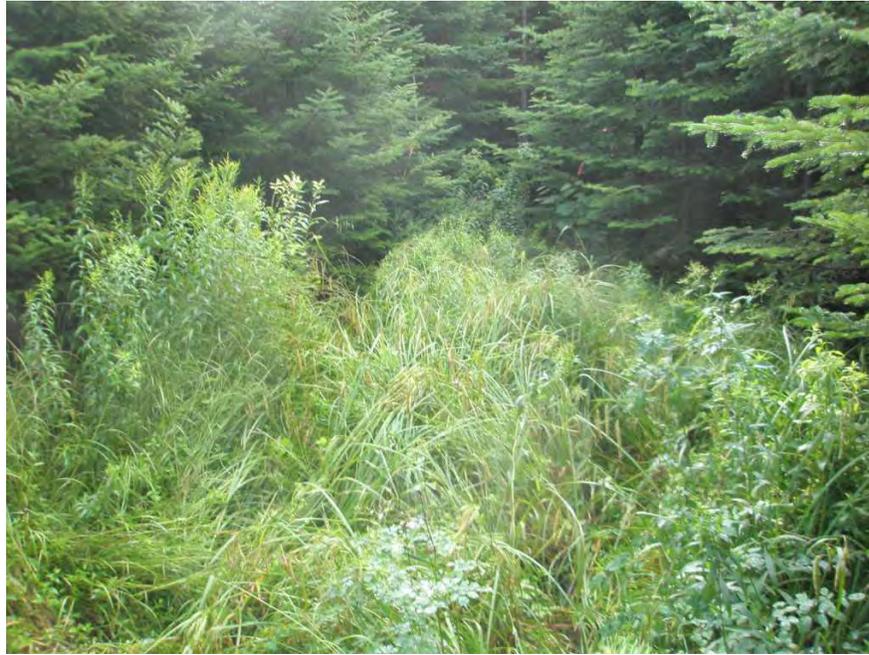
Representative photo of site conditions above S003 at proposed crossing.

Based on the discussion during the September 10, 2013 site visit, the design is currently being modified at STA 208+00. The proposed rock sandwich will be eliminated and replaced with a culvert to promote habitat connectivity as recommended by MDIFW in concurrence with MDEP and USFWS. The revised design will be provided to MDIFW once it is available. A representative photo showing existing site conditions at ST 208+00 is shown below as observed during the initial field surveys.

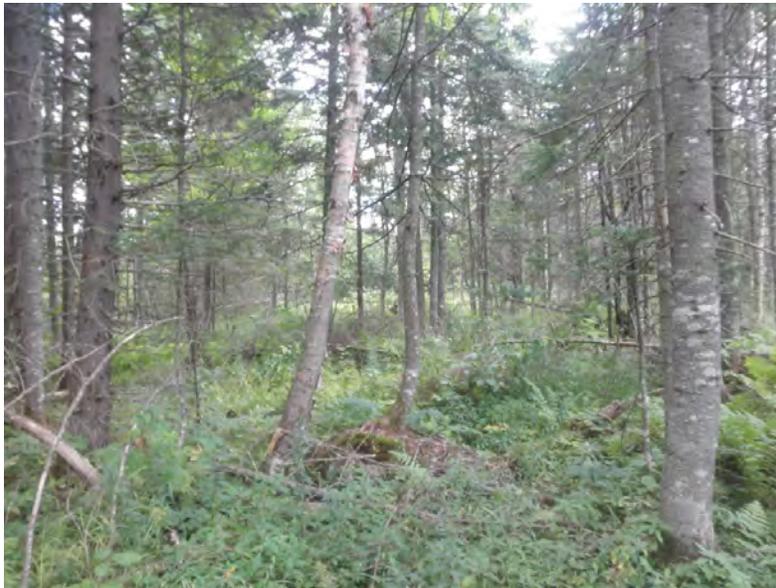
Representative photograph of wetland MAY076

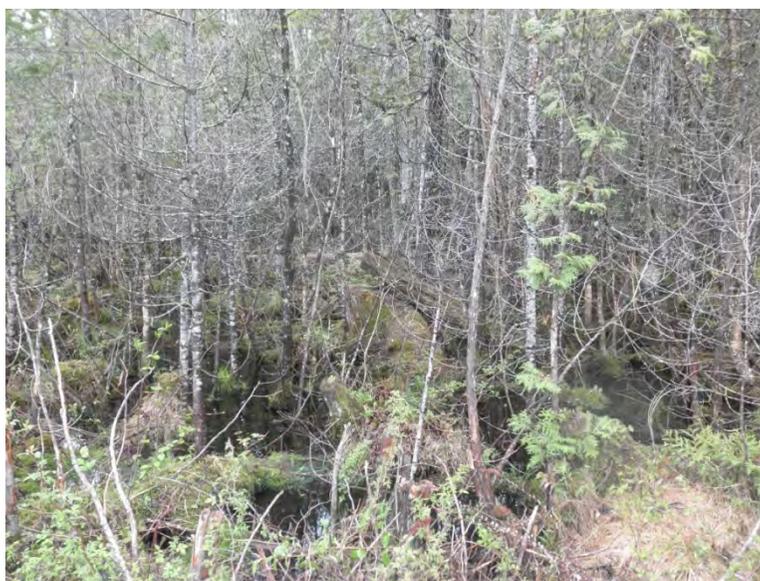
Applicant Response: Pool #53KN_N is located adjacent to the west side of a private ATV trail. The trail leads south from a cabin on Gales Road. The trail bisects a forested wetland (ABB_W385 and ABB_W386) dominated by Northern white-cedar (*Thuja occidentalis*). Stream S069 crosses under the ATV trail through an 18-inch diameter corrugated metal pipe approximately 145 feet north of Pool #53KN_N. The surface of the ATV trail is approximately 6-12 inches higher than the ground level within the forested wetland. Elevation drops roughly 3-5 feet from the northern edge of the wetland near Gales Road to Pool #53KN_N. On May 18, 2011 and May 23, 2011, egg masses were concentrated in areas of pooled water within the wetland. Saplings, trees, rotting stumps and logs, and mossy hummocks are scattered throughout the pool. The eastern edge of the pool abuts the ATV trail and extends west into the forested wetland. During site visits with MDIFW, the Applicant recommended visiting Pool #53KN_N. MDIFW noted at that time that there were no issues with Pool #53KN_N, and there was no interest in visiting the pool.

May 2011. Looking west into Pool #53KN_N from edge of ATV trail.

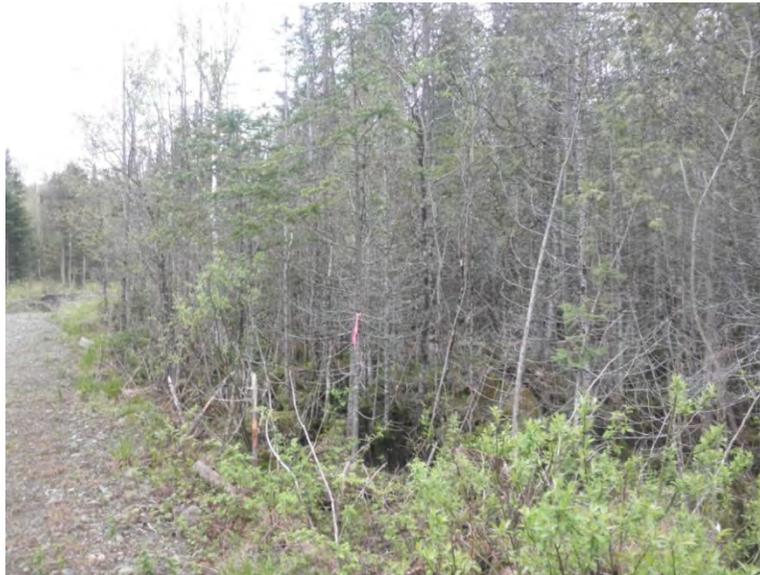
May 2011. Looking south down ATV trail adjacent to Pool #53KN_N.

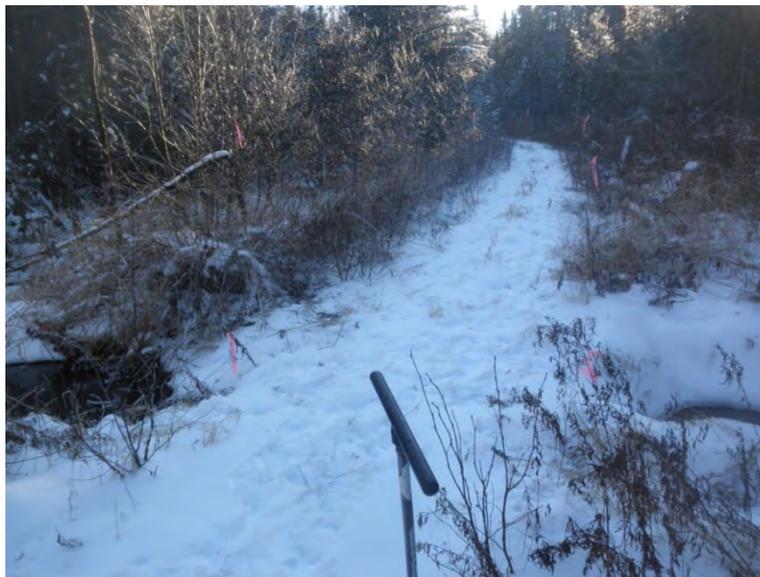
December 2012. Looking south from Stream S069 down ATV trail. Pool #53KN_N is located in the background near the bend in the ATV trail.

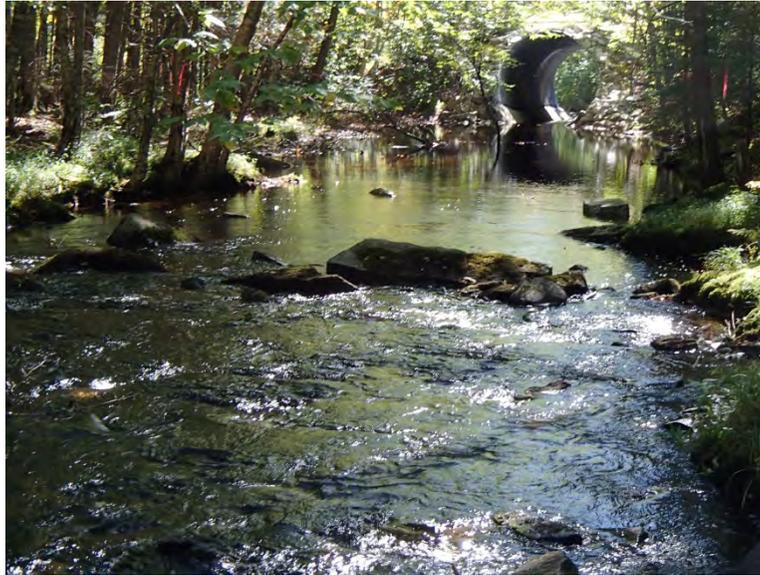
Bigelow Brook — The collector line will cross Bigelow Brook approximately 185 feet northwest of the Route 16 crossing. A steep bank on the west side of the stream should help increase conductor height over the stream and reduce the number of trees that will need to be topped.

September 2013. Bigelow Brook. From approximate collector line crossing looking south towards Route 16.

An approximately 42-foot-tall canopy will be retained within 25-feet on either side of the stream.

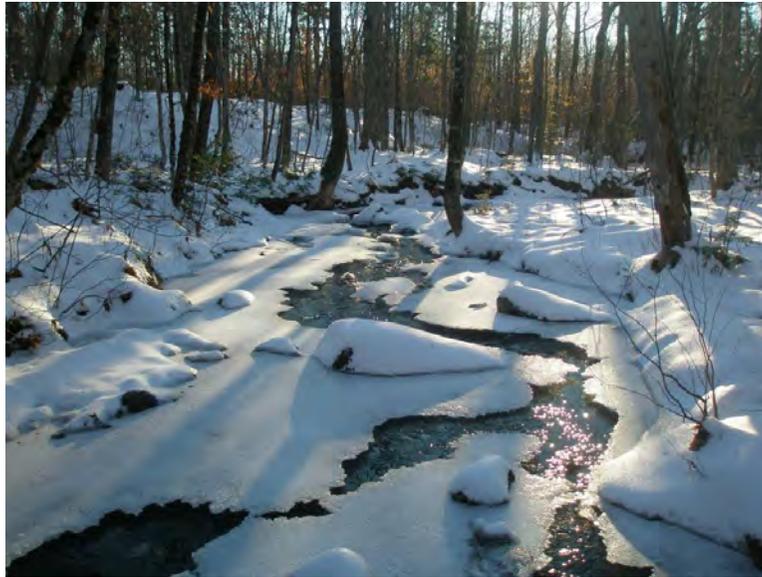
Bear Brook — Bear Brook is situated in a small valley and bordered by upland forest. The surrounding forest is several feet higher than the stream and should help increase conductor height over the stream and reduce the number of trees that will need to be topped. Further, the narrow width of Bear Brook in this area will allow for the development of a dense streamside shrub community. These shrubs will provide the stream channel itself with canopy cover, limiting or mitigating any potential warming concerns.

December 2012. Bear Brook. Looking south, downstream. Note steep bank leading to upland forest on the east side of the stream.

An approximately 34-foot-tall canopy will be retained within 25-feet on either side of the stream.

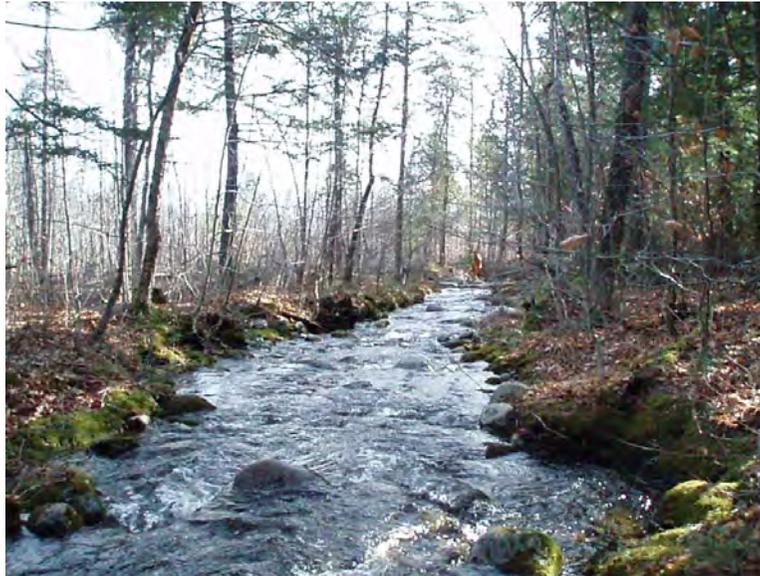
Bottle Brook — Bottle Brook is situated in a small valley. A steep slope leads down to the stream from the west. This slope should help increase conductor height over the stream and reduce the number of trees that will need to be topped. Timber harvesting operations occurred within the last 3-4 years on the east side of the stream. Disturbance and tree removal extends to within approximately 25-35 feet of the stream bank. A limited number of trees remain on the east bank that will need to be topped. Vegetation maintenance at this crossing will allow for the reestablishment of dense shrubs and saplings along the banks of this narrow brook, particularly along the previously impacted eastern bank. This shrub and sapling development will provide shading to the already exposed stream channel.

November 2010. Bottle Brook. Looking south, downstream. Note thinned canopy from timber harvesting on the east side of the stream.

An approximately 34-foot-tall canopy will be retained within 25-feet on either side of the stream.

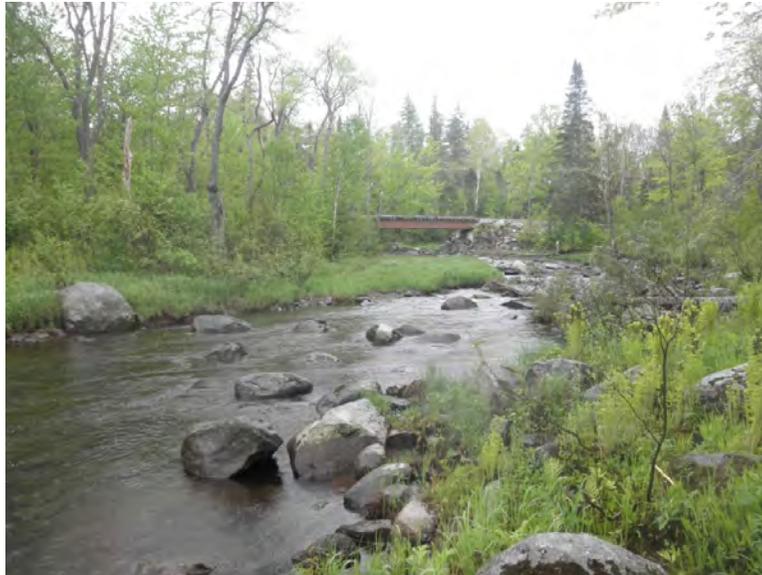
Kingsbury Stream — The generator lead will cross Kingsbury Stream adjacent to an existing bridge. Current conditions in this area provide little shading of the stream. It is likely that topping trees within 100 feet of the Kingsbury Stream will not result in adverse impacts to the stream. While some trees currently providing some shade to the channel will be removed, the width of the stream already creates a high degree of sun exposure.

May 2010. Kingsbury Stream. Looking southwest back towards bridge where generator lead will be co-located.

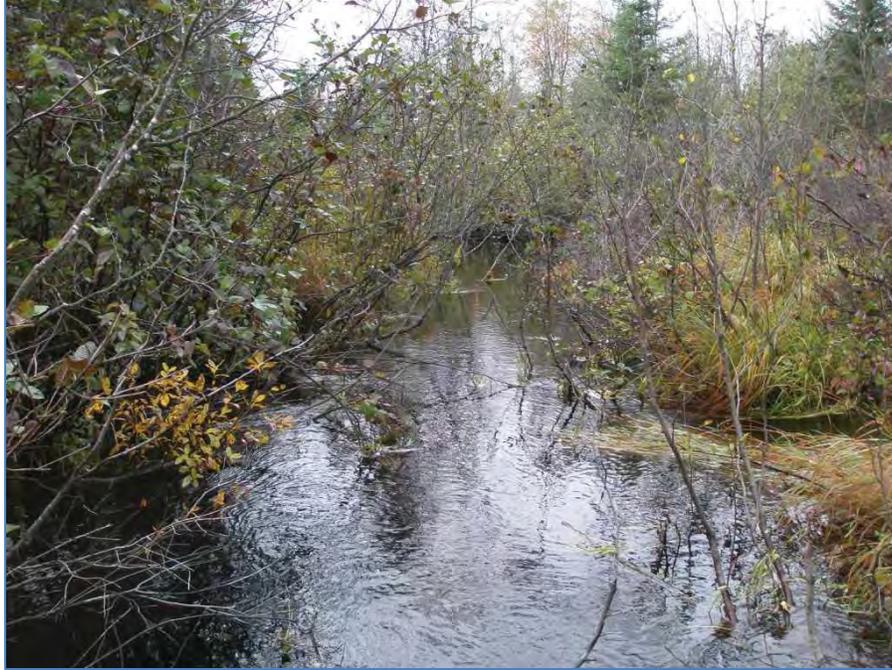
Photo 1: Perennial stream S007.
Stantec Consulting, October 1, 2012.

The stream and associated wetland will be crossed by the aboveground portion of the electrical collector. One pole (structure) will be located within 100-feet of this stream. A 25-foot buffer will be maintained on each side of the stream. During construction and maintenance, capable trees (i.e., those that could grow to within 15 feet of a conductor within 3-4 years) will be topped, but no other vegetation will be cut. If topping individual trees will not leave sufficient foliage to sustain the tree, the tree will be cut at ground level. Herbicide use will not be allowed within this buffer. Construction and maintenance access will occur via existing access from adjacent Route 16; therefore, there will be no temporary or permanent access road crossing of the stream or its associated wetland.

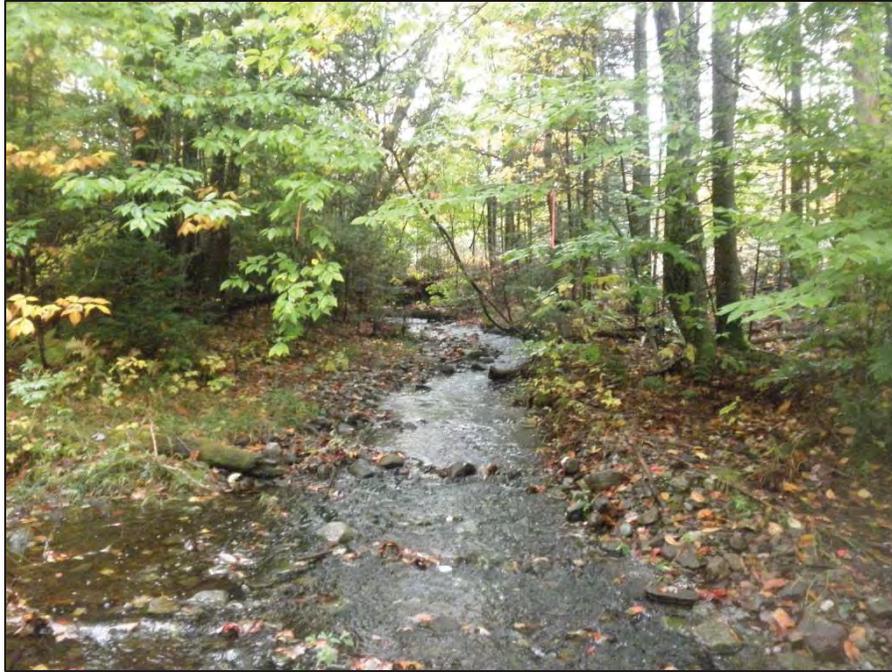
- ≠ Perennial stream occurring in a forested wetland.
- ≠ Channel substrate is a combination of cobble, gravel, sand and muck.
- ≠ Silt is embedded at 25 percent.
- ≠ Aquatic mosses and macro-invertebrates occur throughout the stream channel.
- ≠ Physical characteristics (**Photo 2**):
 - Bankfull width is 3-8 feet (Average 5.5 feet);
 - Water depth in October of 2012 was 3-18 inches;
 - Low gradient with only riffles;
 - Overhanging vegetation creates 100 percent cover.

Photo 2: Perennial stream S009.
Stantec Consulting, October 1, 2012.

The stream and associated wetland will be crossed by the aboveground portion of the electrical collector. One pole (structure) will be located within 100 feet of this stream. This stream has the potential to contain northern spring salamanders (*Gyrinophilus porphyriticus*), and a 250-foot buffer will be maintained on each side of the stream. During construction and maintenance, capable trees (i.e., those that could grow to within 15 feet of a conductor within 3-4 years) will be topped, but no other vegetation will be cut. If topping individual trees will not leave sufficient foliage to sustain the tree, the tree will be cut at ground level. Herbicide use will not be allowed within this buffer. Construction and maintenance access will occur via existing access from adjacent Route 16; therefore, there will be no temporary or permanent access road crossing of the stream or its associated wetland.

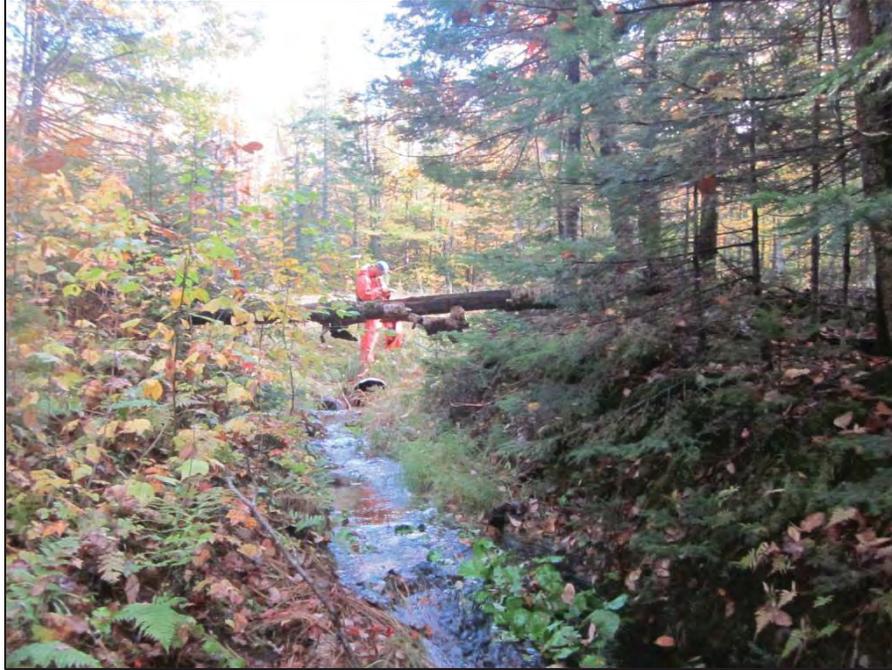
- ≠ Perennial stream occurring in forested upland and a forested wetland.
- ≠ Channel substrate is primarily gravel with silt embedded at 50 percent.
- ≠ Aquatic mosses and macro invertebrates occur throughout the stream channel.
- ≠ Physical characteristics (**Photo 3**):
 - Bankfull width is 4-6 feet (Average 5 feet) and depth is 30 inches;
 - Water depth in October of 2012 was 2-4 inches;
 - Low gradient with riffles dominating the flow structure;
 - Canopy cover is 90 percent.

Photo 3: Perennial Stream S010
Stantec Consulting, October 1, 2012

The stream and associated wetland will be crossed by the aboveground portion of the electrical collector. One pole (structure) will be located within 100 feet of this stream. A 25-foot buffer will be maintained on each side of the stream. During construction and maintenance, capable trees (i.e., those that could grow to within 15 feet of a conductor within 3-4 years) will be topped, but no other vegetation will be cut. If topping individual trees will not leave sufficient foliage to sustain the tree, the tree will be cut at ground level. Herbicide use will not be allowed within this buffer. Construction and maintenance access will occur via existing access from adjacent Route 16; therefore, there will be no temporary or permanent access road crossing of the stream or its associated wetland.
