January 9, 2014

**Subject: Bingham Wind Project, Summary of Spring Salamander Surveys and Proposed Habitat Management
Project # L-25973-24-A-N / L-25973-TG-B-N**

Project Survey Summary

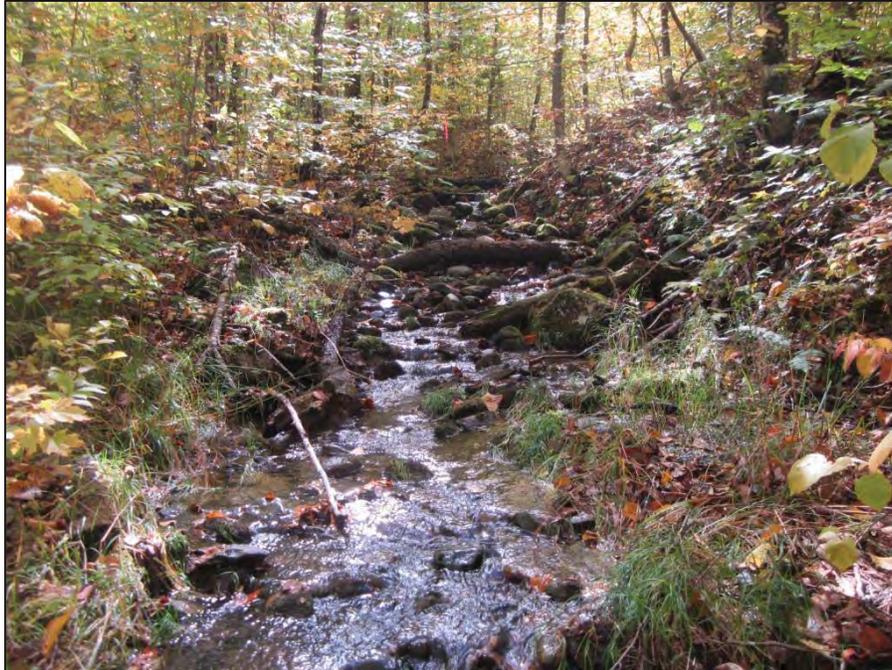
- ≠ Perennial stream occurring in a forested upland.
- ≠ Channel substrate is primarily sand, gravel and cobble.
- ≠ Macro-invertebrates are present.
- ≠ Moderate erosion characterized by vertical to undercut banks.
- ≠ Physical characteristics (**Photo 4**):
 - Bankfull width is 6-7 feet (Average 6.5 feet);
 - Water depth in October 2012 was 4-12 inches;
 - Moderate gradient with riffles and occasional pools.

Photo 4: Perennial stream S014.
Stantec Consulting, October 2, 2012.

The stream and associated wetland will be crossed by the aboveground portion of the electrical collector. One pole (structure) will be located within 100 feet of this stream. During construction and maintenance, capable trees (i.e., those that could grow to within 15 feet of a conductor within 3-4 years) will be topped, but no other vegetation will be cut. If topping individual trees will not leave sufficient foliage to sustain the tree, the tree will be cut at ground level. With regard to the pole (structure) located within the 100-foot buffer, the maximum height of vegetation within the corridor is a function of conductor height. The proximity of the pole to this stream will provide a conductor height that will allow for the establishment of taller vegetation near the stream, which will provide maximum shading of the stream. Herbicide use will not be allowed within this buffer. Construction and maintenance access will occur via existing access from adjacent Route 16; therefore, there will be no temporary or permanent access road crossing of the stream or its associated wetland.

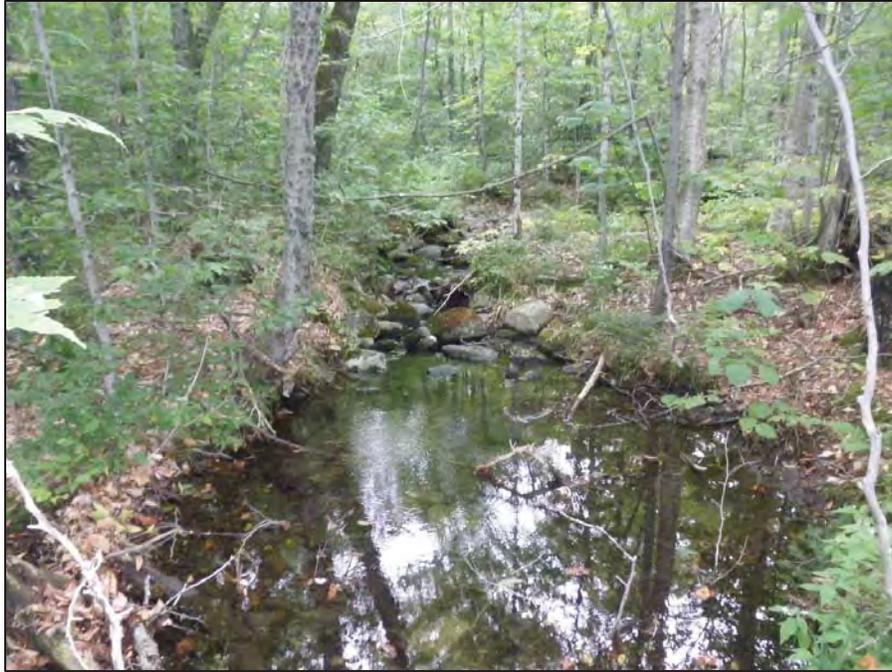
Photo 5: Perennial stream S021
Stantec Consulting, July 27, 2010.

- ≠ Perennial stream occurs within a forested upland.
- ≠ Channel substrate is primarily rock and cobble with gravel and sand and embedded silt.
- ≠ Aquatic invertebrates and aquatic fauna observed.
- ≠ Physical characteristics (**Photo 5**):
 - Bankfull width is 0.5-5 feet;
 - Water depth in September 2011 was 3-6 inches;
 - Low to moderate gradient with riffles and pools.

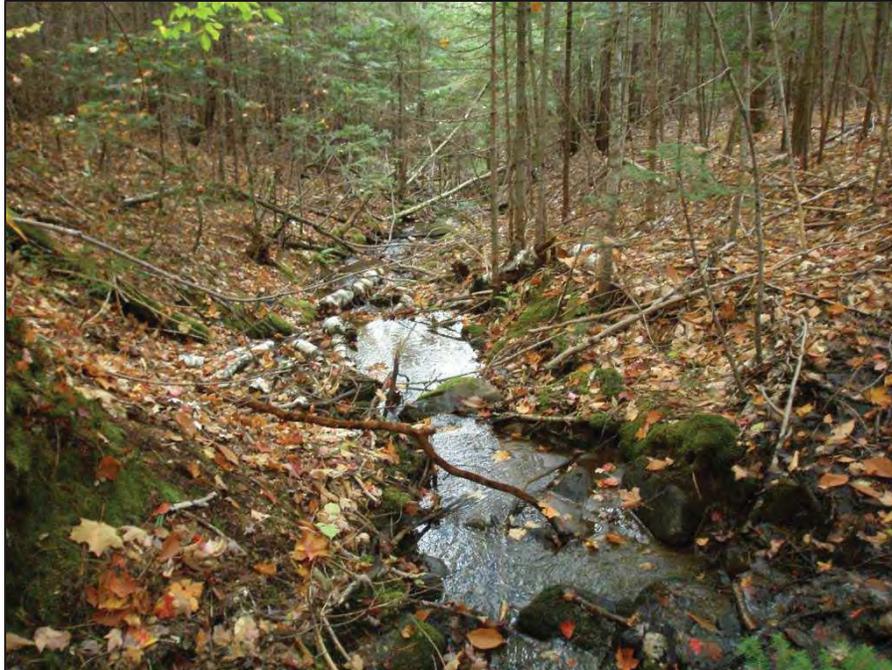
Photo 6: Perennial stream S022.
Stantec Consulting, October 3, 2012.

- ≠ Perennial stream with several associated wetlands.
- ≠ Channel substrate is primarily cobble and boulder.
- ≠ Stream is fed by groundwater and smaller tributaries.
- ≠ Physical characteristics (**Photo 6**):
 - Bankfull width is 5-10 feet (Average 7.5 feet);
 - Well-defined banks;
 - Moderate gradient.

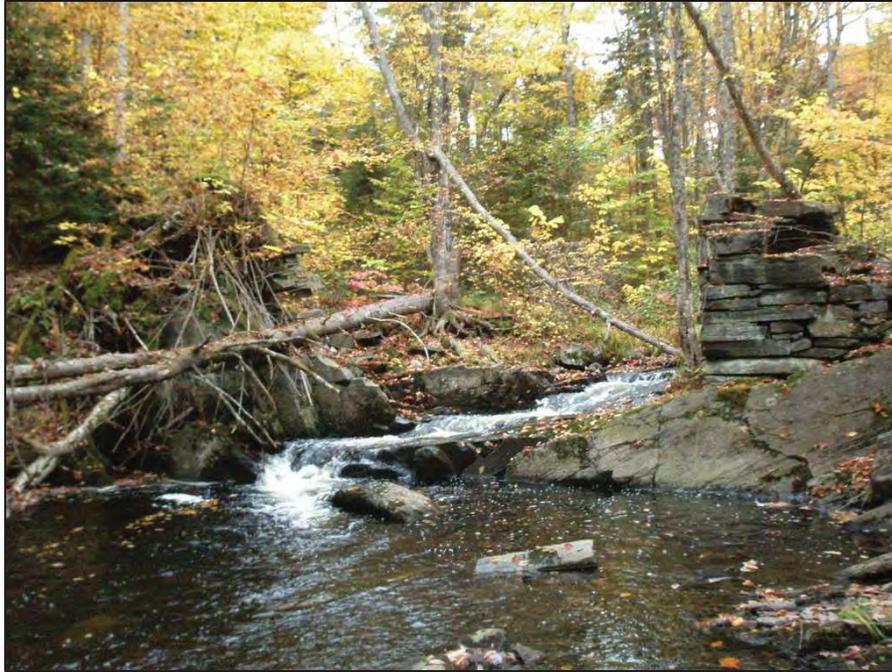
Photo 7: Perennial stream S023.
Stantec Consulting, October 4, 2012.

- ≠ Perennial stream that occurs within a forested upland.
- ≠ Substrate consists of boulders, slate, cobble, gravel, and sand.
- ≠ Aquatic invertebrates and brook trout (*Salvelinus fontinalis*) are present.
- ≠ Physical characteristics (**Photo 7**):
 - Bankfull width is 30-50 feet (Average 40 feet);
 - Water depth in October of 2012 was 5-10 feet;
 - Low to moderate gradient with riffles, runs and pools.

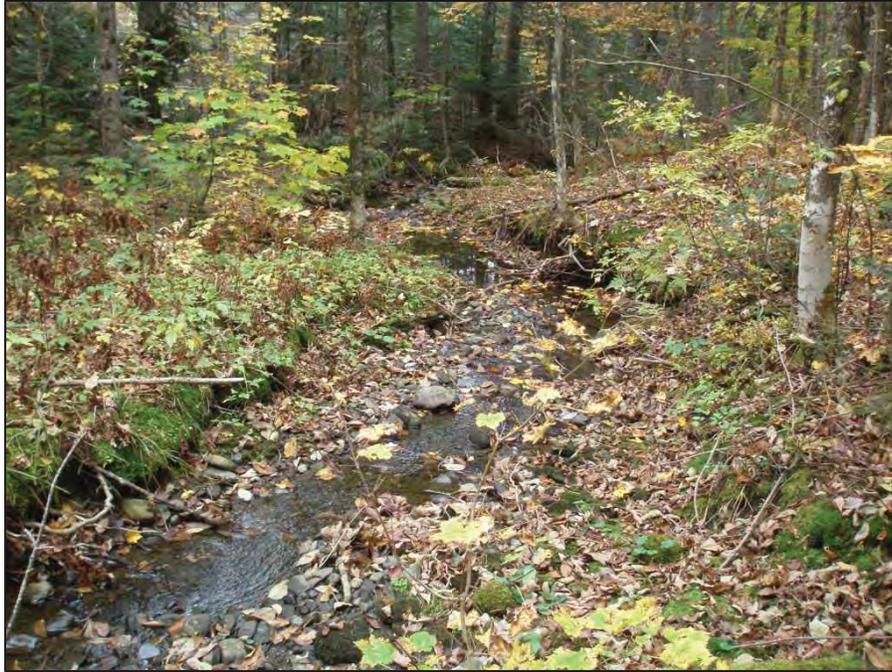
Photo 8: Perennial stream S024.
Stantec Consulting, October 4, 2012.

- ≠ Perennial stream occurs within a forested setting.
- ≠ Channel substrate consists of gravel and cobble.
- ≠ No aquatic invertebrates observed.
- ≠ Physical characteristics (**Photo 8**):
 - Bankfull width is 8 feet;
 - Water depth in October of 2012 was 2-4 feet;
 - Undercut banks and drift deposits present.

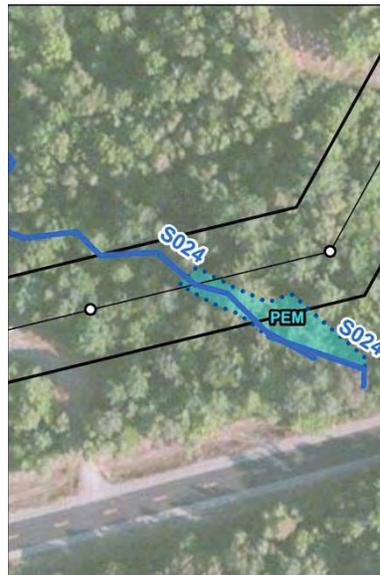
Proposed aboveground collector line crossing of stream S024.
From Figure 10, Delineated Natural Resource Map by Stantec Consulting.

The stream and associated wetland will be crossed by the aboveground portion of the electrical collector. Two poles (structures) will be located within 100 feet of this stream. During construction and maintenance, capable trees (i.e., those that could grow to within 15 feet of a conductor within 3-4 years) will be topped, but no other vegetation will be cut. If topping individual trees will not leave sufficient foliage to sustain the tree, the tree will be cut at ground level. With regard to the poles (structures) located within the 100-foot buffer, the maximum height of vegetation within the corridor is a function of conductor height. The proximity of the poles to this stream will provide a conductor height that will allow for the establishment of taller vegetation near the stream, which will provide maximum shading of the stream. Herbicide use will not be allowed within this buffer. Construction and maintenance access will occur via existing access from adjacent Route 16; therefore, there will be no temporary or permanent access road crossing of the stream or its associated wetland.

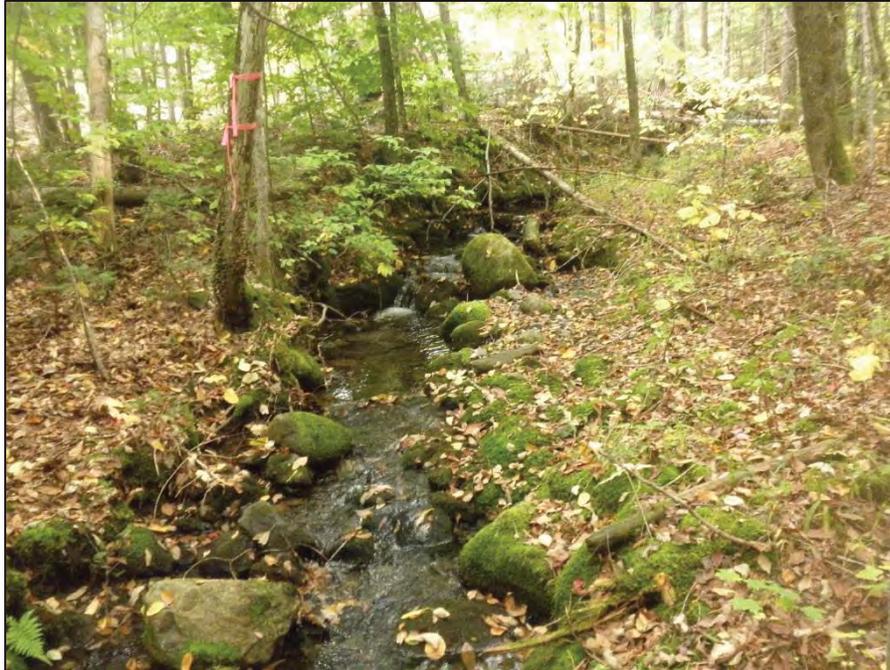
Photo 9: Perennial stream S025.
Stantec Consulting, October 3, 2012.

- ≠ Perennial stream occurring in a deciduous forest.
- ≠ Channel substrate consists of boulders, cobble, gravel, and woody debris.
- ≠ Aquatic mosses and brook trout observed.
- ≠ Physical characteristics (**Photo 9**):
 - Bankfull width is 5-8 feet (Average 6.5 feet);
 - Water depth in October of 2012 was 3-12 inches;
 - Low to moderate gradient with riffles and pools.

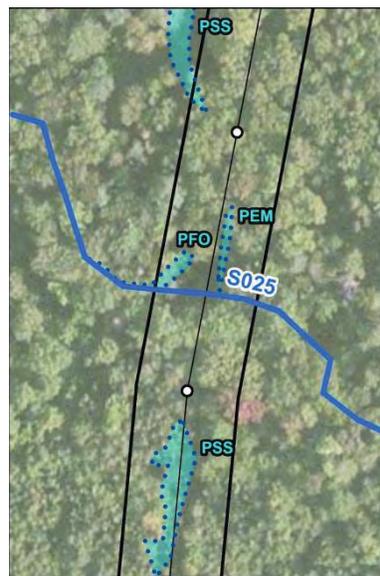
Proposed aboveground collector line crossing of stream S025.
From Figure 10, Delineated Natural Resource Map by Stantec Consulting.

The stream and associated wetland will be crossed by the aboveground portion of the electrical collector. One pole (structure) will be located within 100 feet of this stream. Northern spring salamanders were documented in this stream during surveys conducted in 2013. Because of the presence of this species, a 250-foot buffer will be maintained on each side of the stream. During construction and maintenance, capable trees (i.e., those that could grow to within 15 feet of a conductor within 3-4 years) will be topped, but no other vegetation will be cut. If topping individual trees will not leave sufficient foliage to sustain the tree, the tree will be cut at ground level. With regard to the pole (structure) located within the 250-foot buffer, the maximum height of vegetation within the corridor is a function of conductor height. The proximity of the pole to this stream will provide a conductor height that will allow for the establishment of taller vegetation near the stream, which will provide maximum shading of the stream. Herbicide use will not be allowed within this buffer. Construction and maintenance access will occur via existing access roads; therefore, there will be no temporary or permanent access road crossing of the stream or its associated wetland.

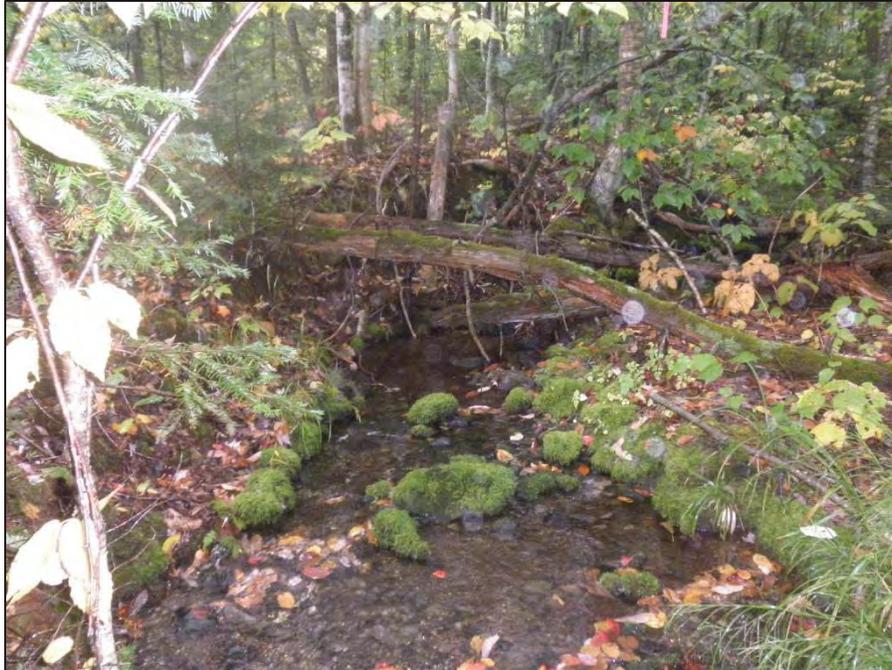
Photo 10: Perennial stream S027.
Stantec Consulting, September 28, 2010.

- ≠ Perennial stream occurring in a mixed forest.
- ≠ Channel substrate consists of cobble, boulder, bedrock and gravel.
- ≠ Aquatic invertebrates and mosses are present.
- ≠ Physical characteristics (**Photos 10 and 11**):
 - Bankfull width is 5-7 feet (Average 6 feet);
 - Water depth in October of 2012 was 2-10 inches;
 - Moderate gradient dominated by riffles with some small pools.

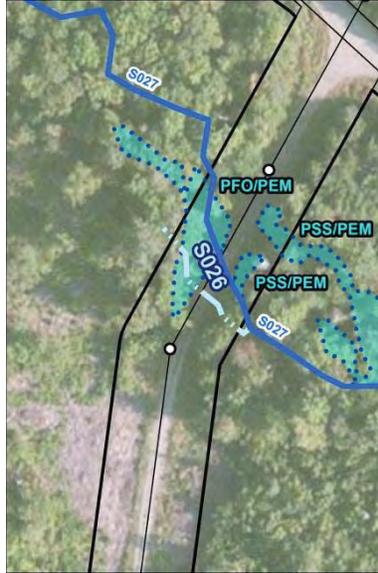
Proposed aboveground collector line crossing of stream S027. Note wetland MAY_W176 is located northwest along the existing access road and is not impacted by the proposed project.
From Figure 11, Delineated Natural Resource Map by Stantec Consulting.

The stream and associated wetland will be crossed by the aboveground portion of the electrical collector. In addition, this stream is crossed by an existing logging road and flows through a 24-inch culvert. No improvements are proposed for this road or culvert. Two poles (structures) will be located within 100 feet of this stream. This stream has the potential to contain northern spring salamanders, and (exclusive of existing roads and proposed poles) a 250-foot buffer will be maintained on each side of the stream. During construction and maintenance, capable trees (i.e., those that could grow to within 15 feet of a conductor within 3-4 years) will be topped, but no other vegetation will be cut. With regard to the poles (structures) located within the 250-foot buffer, the maximum height of vegetation within the corridor is a function of conductor height. The proximity of the poles to this stream will provide a conductor height that will allow for the establishment of taller vegetation near the stream, which will provide maximum shading of the stream. If topping individual trees will not leave sufficient foliage to sustain the tree, the tree will be cut at ground level. Herbicide use will not be allowed within this buffer.

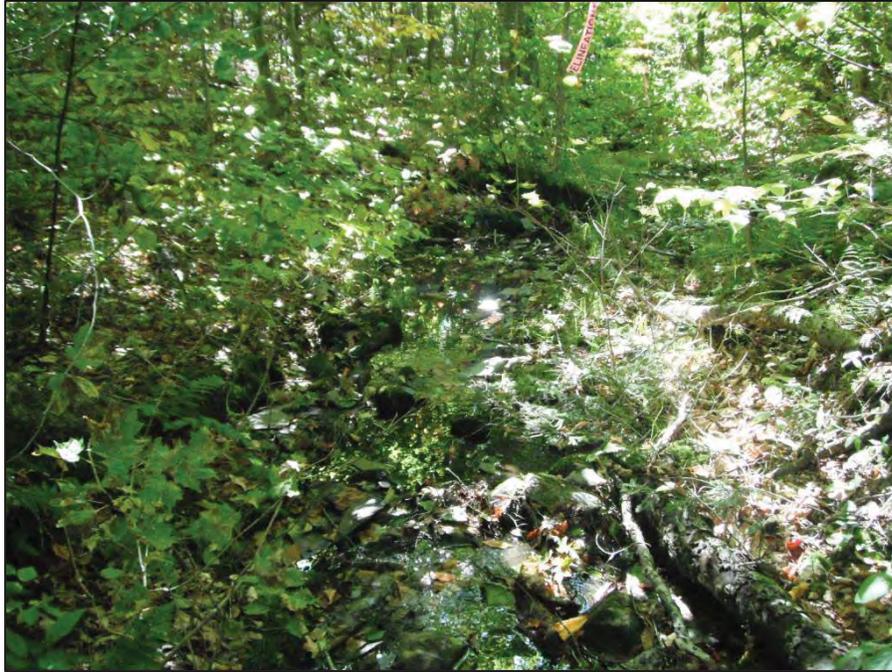
Photo 12: Perennial stream S033
Stantec Consulting, September 25, 2012

- ≠ Perennial stream occurring in a mixed forest.
- ≠ Channel substrate consists of gravel, cobble, and boulder.
- ≠ Aquatic fauna observed.
- ≠ Physical characteristics (**Photo 12**):
 - Bankfull width is 5 feet;
 - Very low flow in September of 2012;
 - Moderate slope.

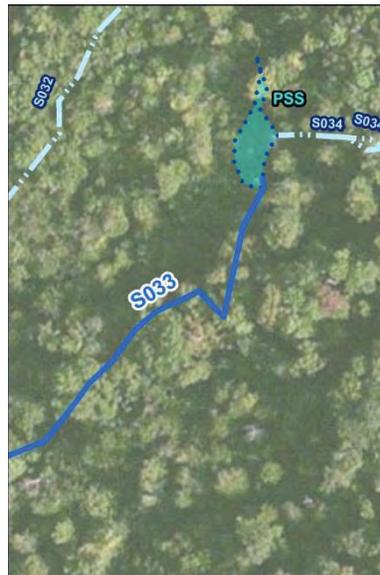
Proposed aboveground collector line in proximity to stream S033.
From Figure 14, Delineated Natural Resource Map by Stantec Consulting.

There are no proposed impacts to this stream or associated wetland. An existing gravel access road and the proposed aboveground collector line are approximately 125 feet east of the stream.

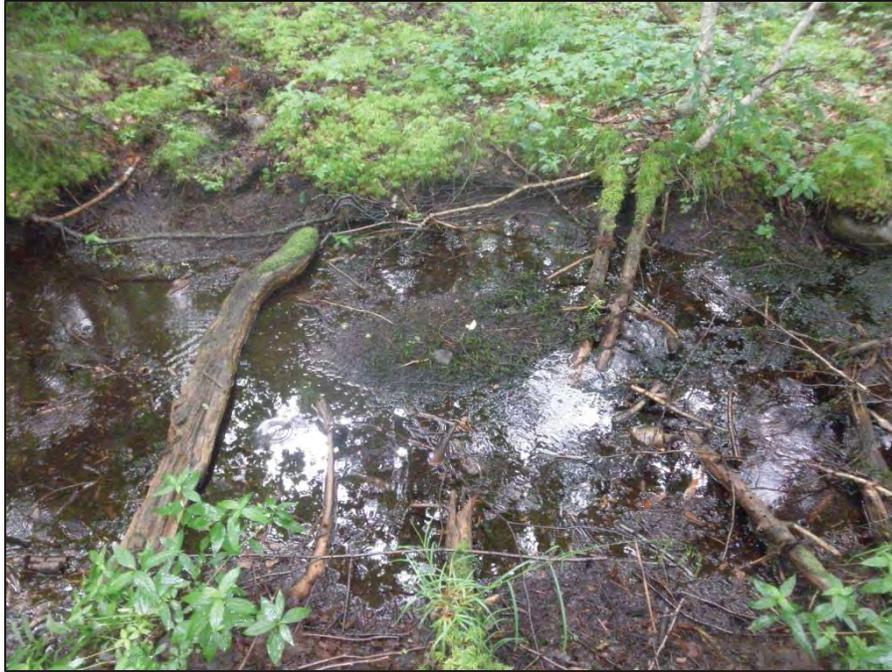
Photo 13: Perennial stream S036
Stantec Consulting, July 14, 2010

- ≠ Perennial stream occurring in a large wetland complex.
- ≠ Channel substrate consists of bedrock, cobble gravel, and mostly muck.
- ≠ Aquatic vegetation and invertebrates are present.
- ≠ Canopy cover is 100 percent.
- ≠ Physical characteristics (**Photo 13**):
 - Bankfull width is 4-5 feet (Average 4.5 feet);
 - The flow is predominated riffles and runs with a few pools and glides.

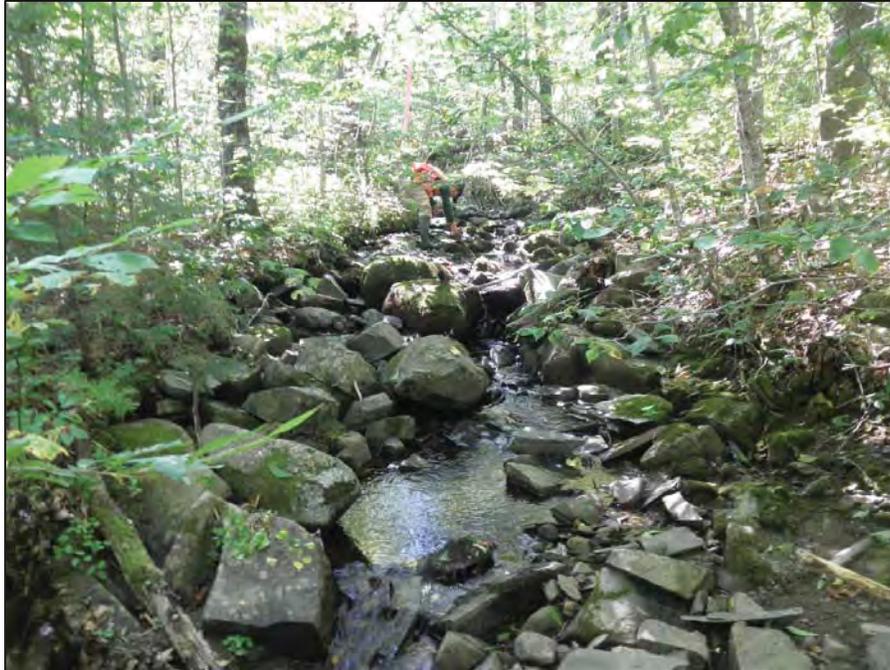
Photo 14: Perennial stream S041.
Stantec Consulting, September 13, 2011.

- ≠ Perennial stream that flows out of beaver impoundment.
- ≠ Channel substrate consists of rock, cobble, gravel, and sand.
- ≠ Aquatic mosses, invertebrates, dusky salamanders (*Desmoganthus fuscus*), and two-lined salamanders (*Eurycea bislineata*) are present.
- ≠ Canopy cover is 75 percent.
- ≠ Physical characteristics (**Photo 14**):
 - Bankfull width is 8-12 feet (Average 10 feet)
 - Water depth in October of 2012 was 3-5 inches;
 - Flow structure is dominated by riffles with a few pools;
 - Low to high gradient.

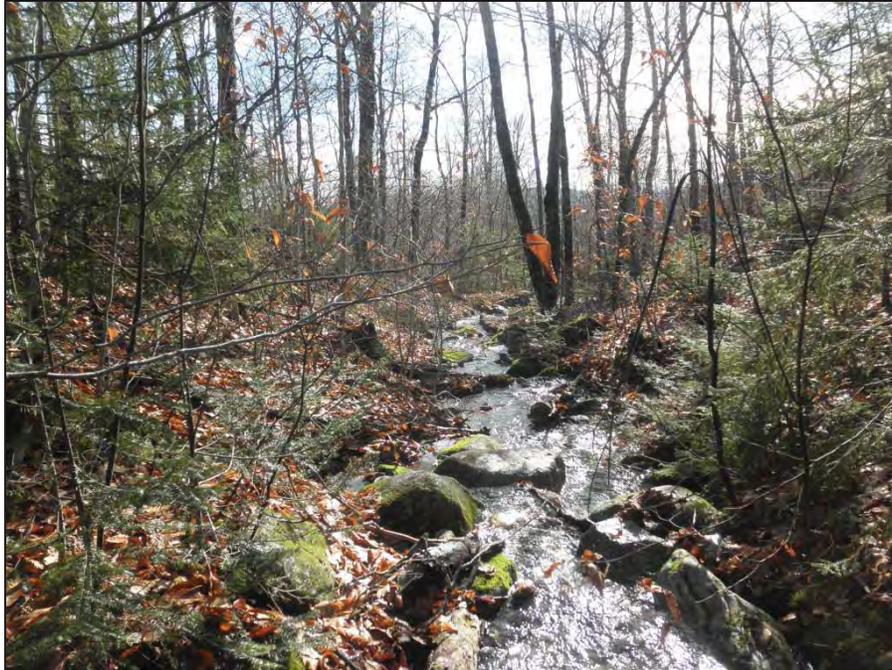
Photo 15: Perennial stream S043.
Stantec Consulting, November 10, 2010.

- ≠ Perennial stream in steep valley.
- ≠ Channel substrate is primarily boulder, cobble, and gravel.
- ≠ Aquatic mosses occur throughout the stream channel.
- ≠ Physical characteristics (**Photo 15**):
 - Bankfull width 3-6 feet (Average 4.5 feet);
 - Water depth in November of 2010 was 1-6 inches;
 - Moderate gradient riffle complexes;
 - Overhanging hardwood trees present.

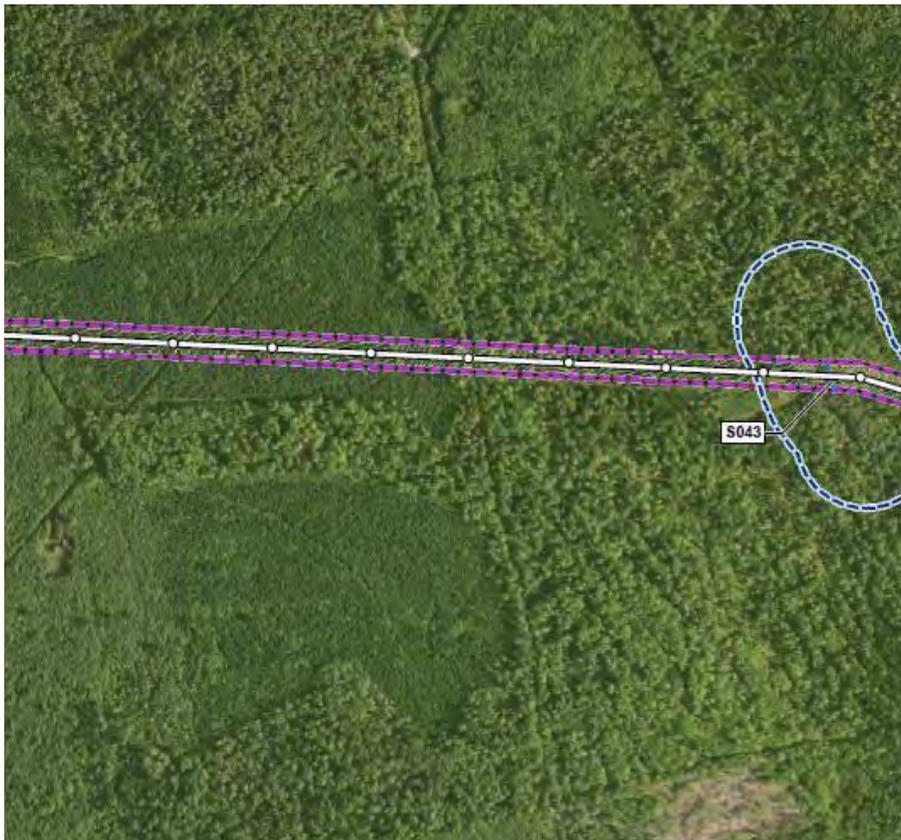
Proposed generator lead crossing of stream S043.
From Figure 19, Delineated Natural Resource Map by Stantec Consulting.

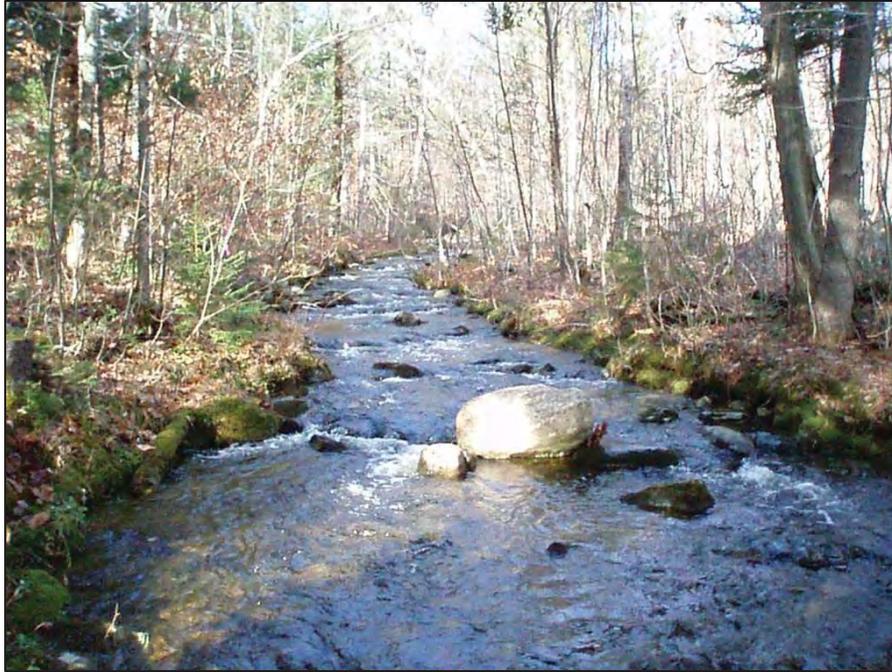
Photo 16: Perennial stream S045.
Stantec Consulting, November 10, 2010.

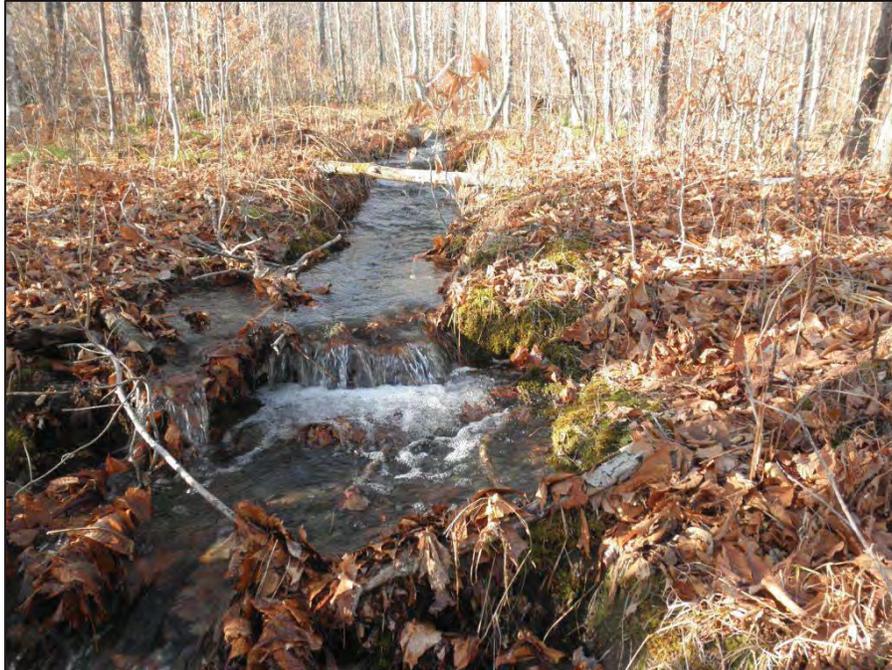
Photo 17: Perennial stream S046.
Stantec Consulting, November 10, 2010.

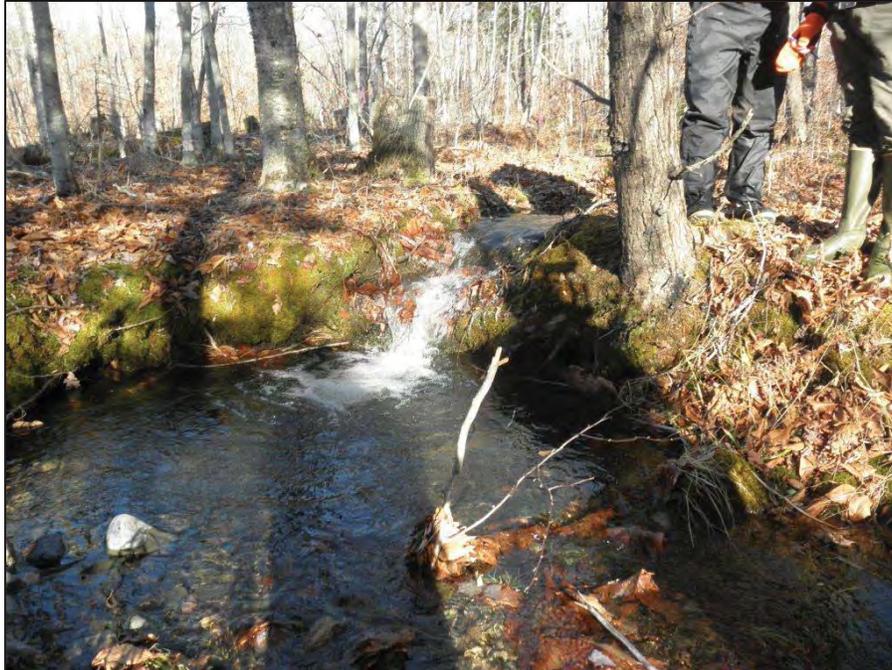
Photo 18: Perennial stream S047.
Stantec Consulting, November 10, 2010.

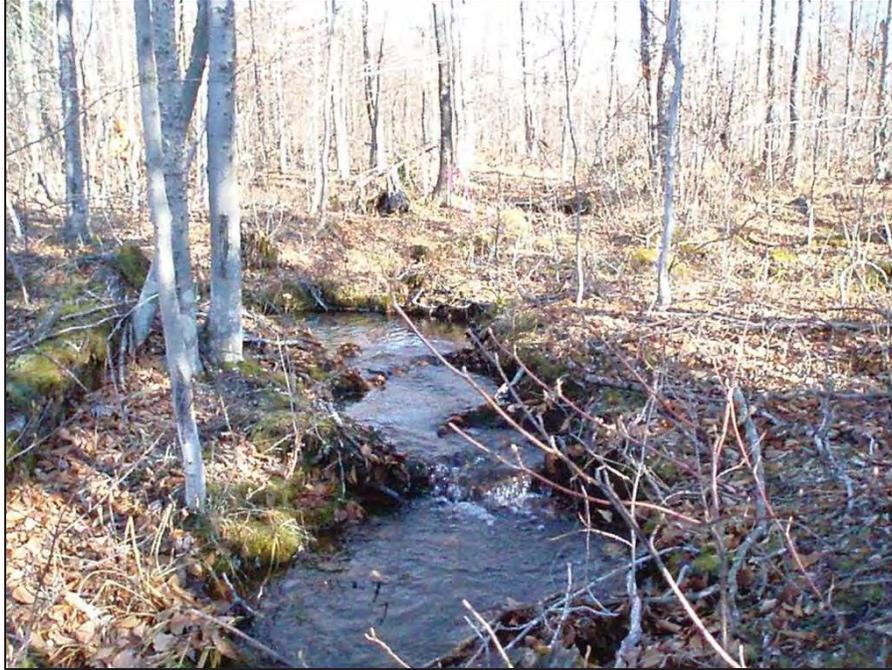
Photo 19: Perennial stream S048.
Stantec Consulting, November 11, 2010.

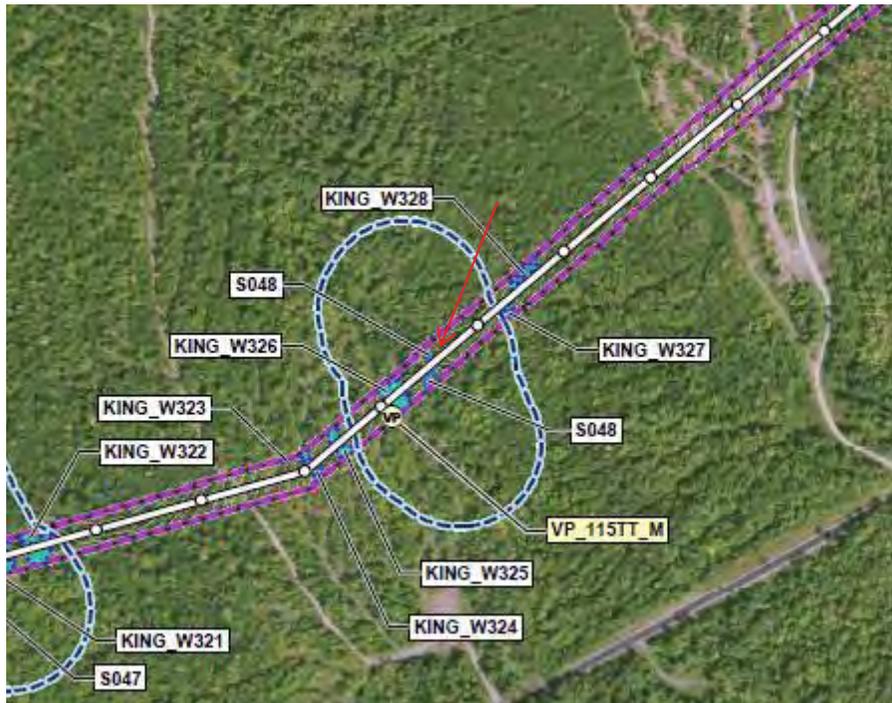
Proposed generator lead crossing of stream S048.
From Figure 21 Delineated Natural Resource Map by Stantec Consulting.

The stream will be crossed by the electrical generator lead corridor. During construction, a temporary timber mat bridge will be used to allow movement of construction equipment across the stream. There will be no direct impact to the stream channel. During construction and maintenance, capable trees (i.e., those that could grow to within 15 feet of a conductor within 3-4 years) will be topped, but no other vegetation will be cut. If topping individual trees will not leave sufficient foliage to sustain the tree, the tree will be cut at ground level. Herbicide use will not be allowed within this buffer.

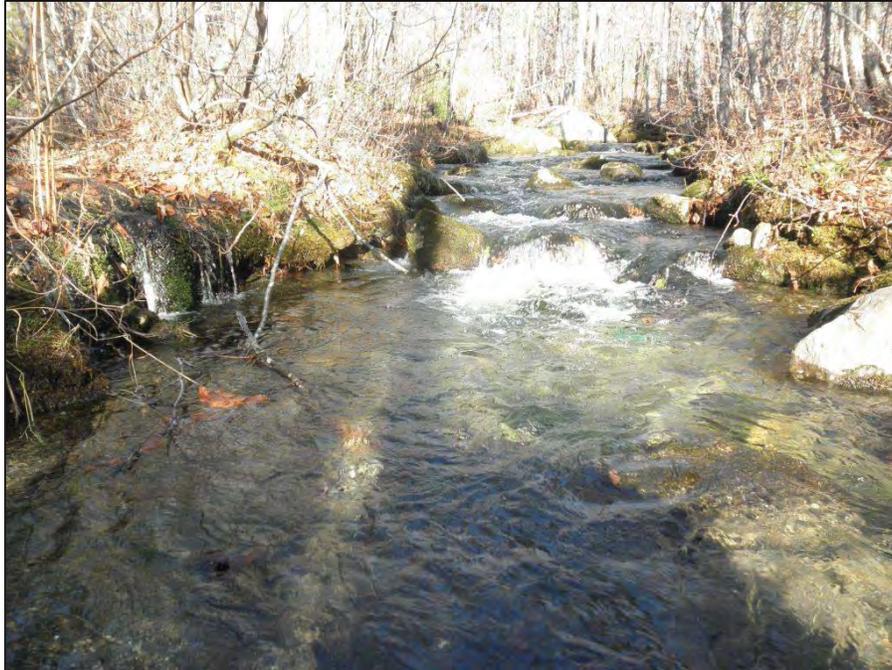
Photo 20: Perennial stream S049.
Stantec Consulting, November 11, 2010.

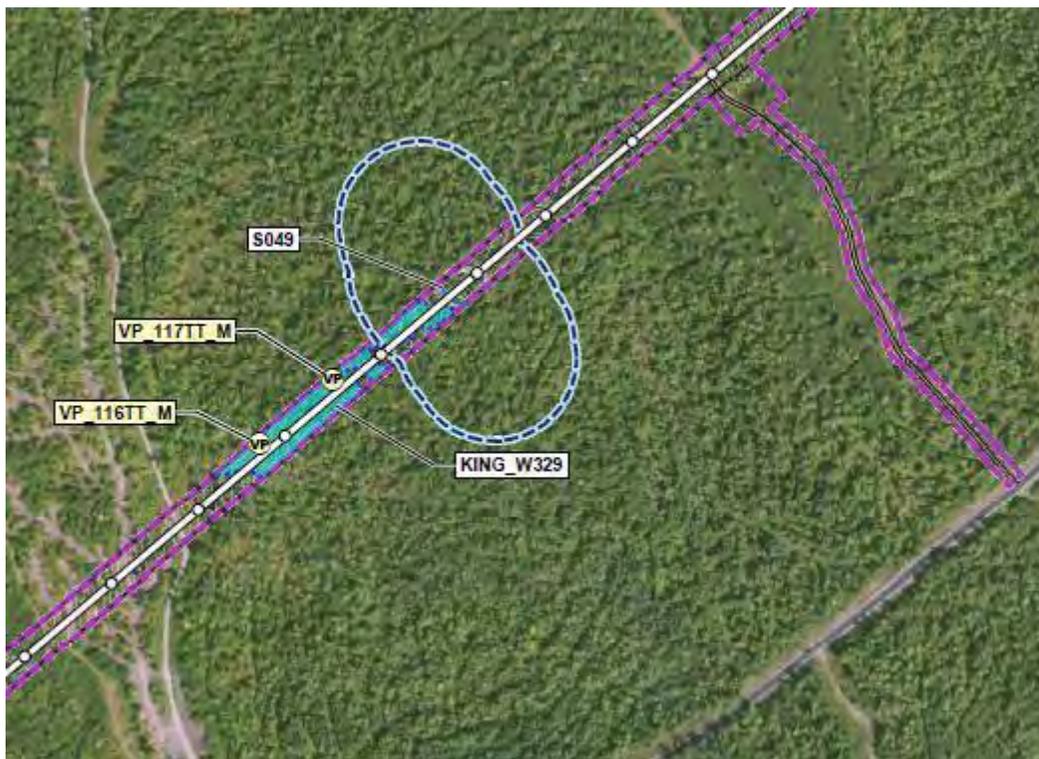
Proposed generator lead crossing of stream S049.
From Figure 21 Delineated Natural Resource Map by Stantec Consulting.

The stream will be crossed by the electrical generator lead corridor. During construction, a temporary timber mat bridge will be used to allow movement of construction equipment across the stream. There will be no direct impact to the stream channel. One pole (structure) will be located within 100 feet of this stream. Northern spring salamanders were documented in this stream during surveys conducted in 2013. Because of the presence of this species, a 250-foot buffer will be maintained on each side of the stream. During construction and maintenance, capable trees (i.e., those that could grow to within 15 feet of a conductor within 3-4 years) will be topped, but no other vegetation will be cut. If topping individual trees will not leave sufficient foliage to sustain the tree, the tree will be cut at ground level. With regard to the pole (structure) located within the 250-foot buffer, the maximum height of vegetation within the corridor is a function of conductor height. The proximity of the pole to this stream will provide a conductor height that will allow for the establishment of taller vegetation near the stream, which will provide maximum shading of the stream. Herbicide use will not be allowed within this buffer.

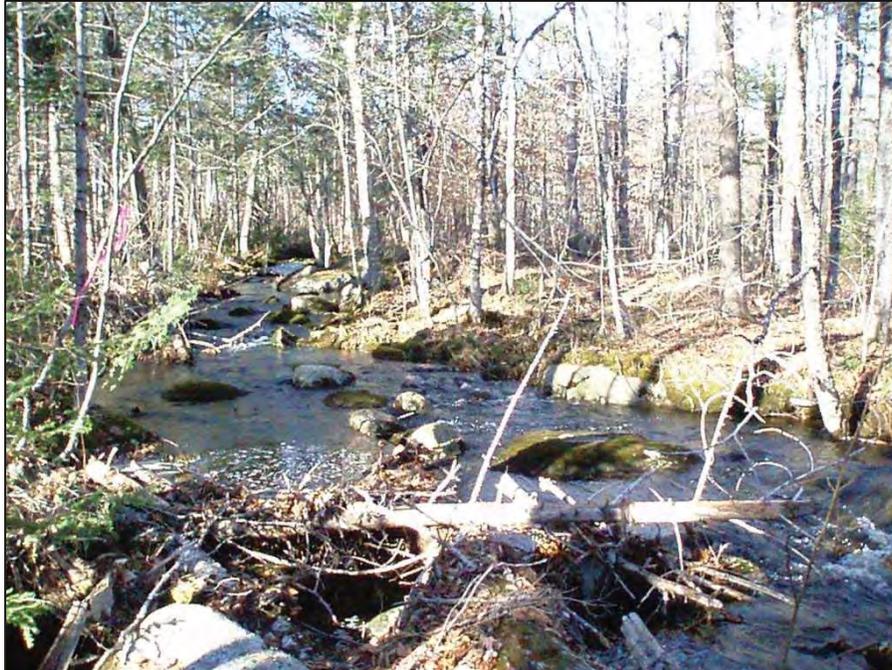
Photo 21: Perennial stream S050.
Stantec Consulting, November 11, 2010.

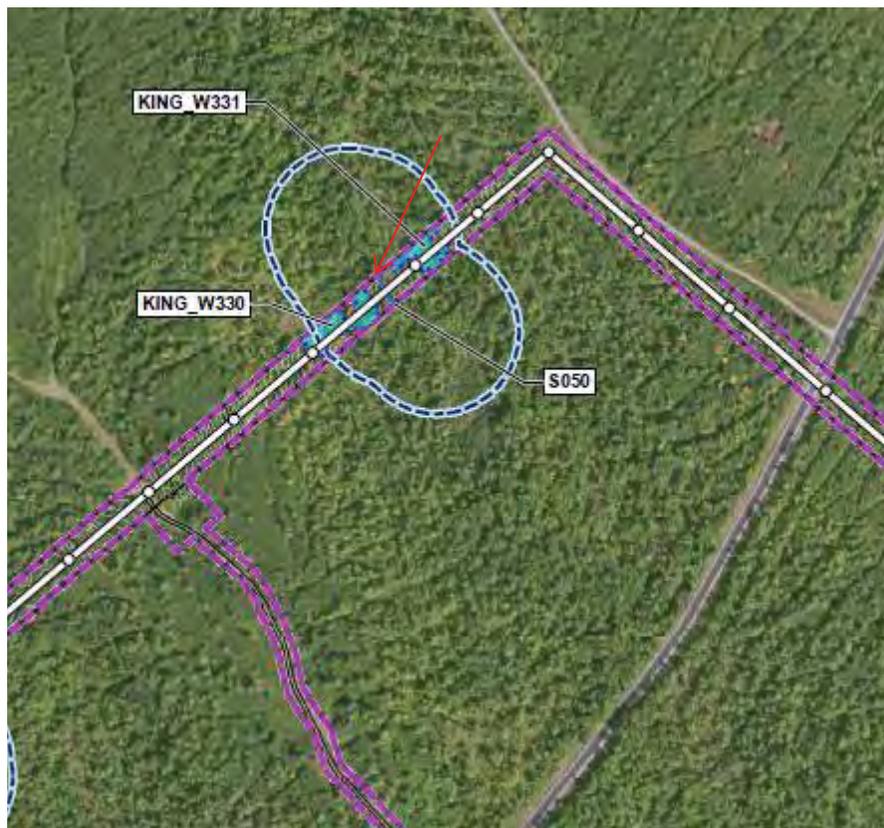
Proposed generator lead crossing of stream S050.
From Figure 21 Delineated Natural Resource Map by Stantec Consulting.

The stream will be crossed by the electrical generator lead corridor. Based upon discussions with Maine Department of Inland Fisheries and Wildlife biologist, this stream will not be crossed during construction. Construction access will occur from the east and west and there will be no need to cross the stream. During construction and maintenance, capable trees (i.e., those that could grow to within 15 feet of a conductor within 3-4 years) will be topped, but no other vegetation will be cut. If topping individual trees will not leave sufficient foliage to sustain the tree, the tree will be cut at ground level. Herbicide use will not be allowed within this buffer.

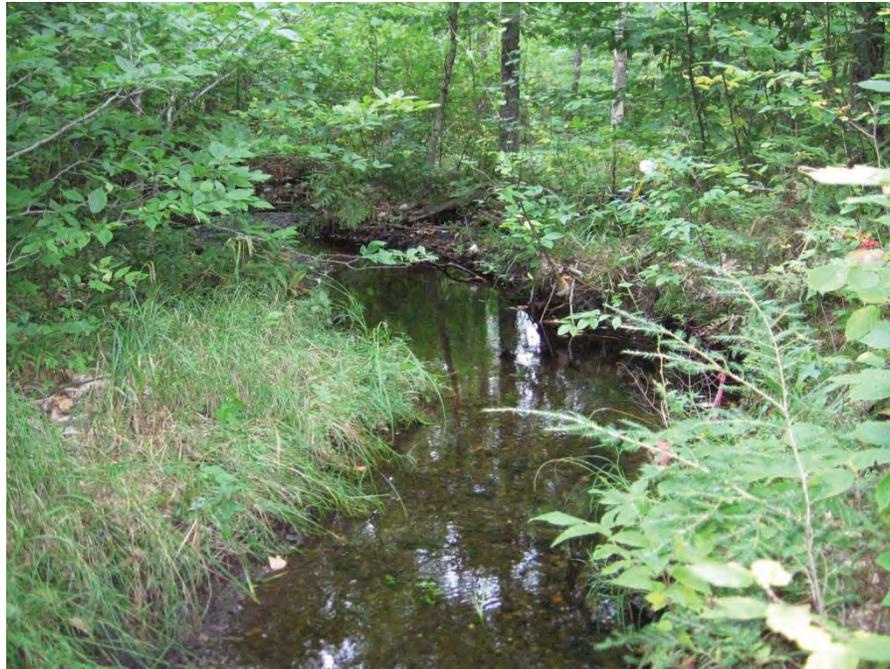
Photo 22: Perennial stream S051.
Stantec Consulting, September 10, 2013.

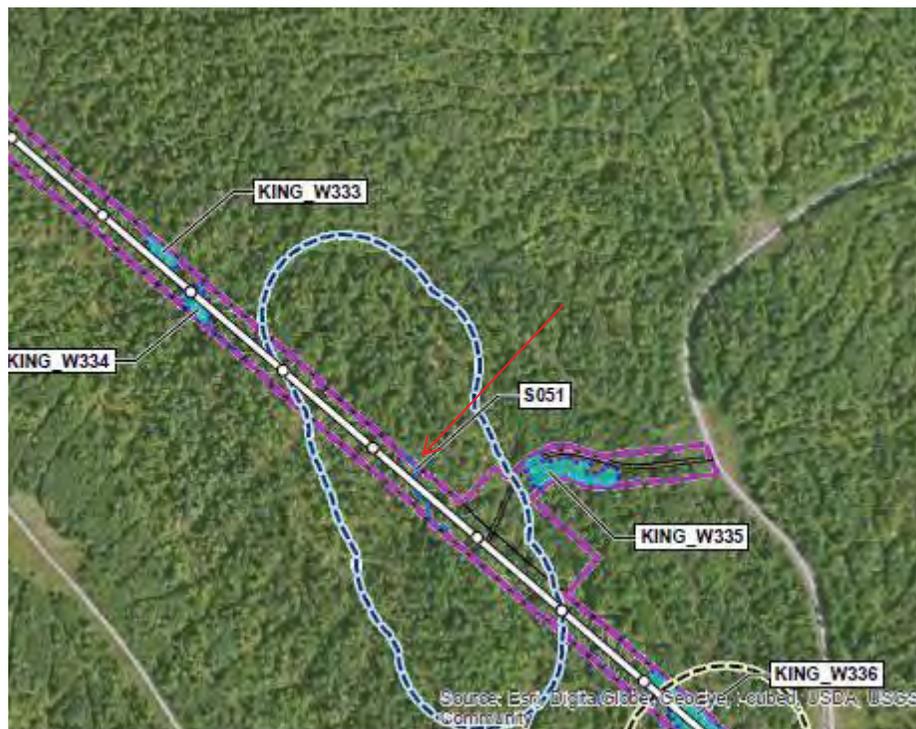
Proposed generator lead crossing of stream S051.
From Figure 22 Delineated Natural Resource Map by Stantec Consulting.

The stream will be crossed by the electrical generator lead corridor. During construction, a temporary timber mat bridge will be used to allow movement of construction equipment across the stream. There will be no direct impact to the stream channel. Two poles (structures) will be located within 100 feet of this stream. During construction and maintenance, capable trees (i.e., those that could grow to within 15 feet of a conductor within 3-4 years) will be topped, but no other vegetation will be cut. If topping individual trees will not leave sufficient foliage to sustain the tree, the tree will be cut at ground level. With regard to the poles (structures) located within the 100-foot buffer, the maximum height of vegetation within the corridor is a function of conductor height. The proximity of the poles to this stream will provide a conductor height that will allow for the establishment of taller vegetation near the stream, which will provide maximum shading of the stream. Herbicide use will not be allowed within this buffer.

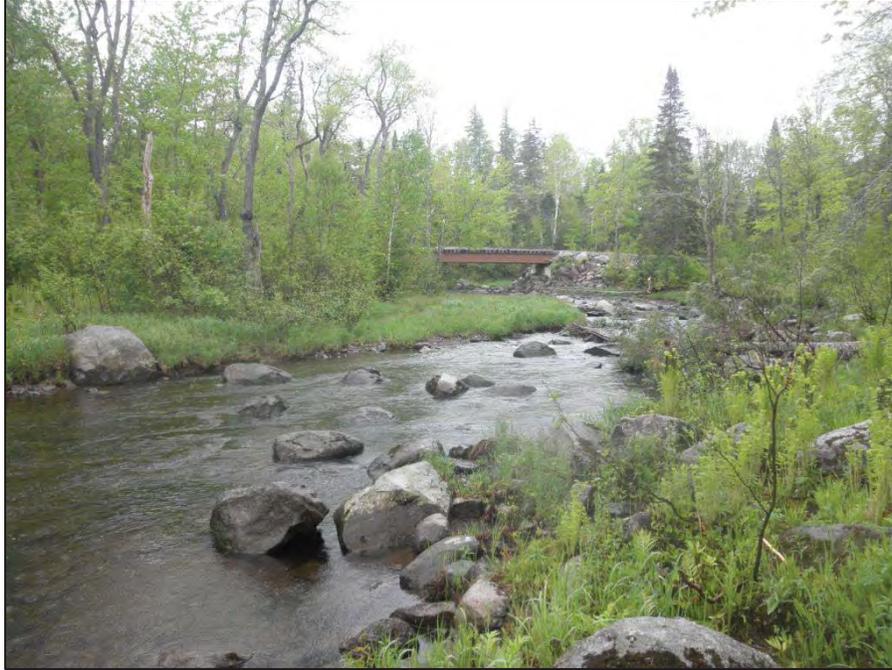
Photo 23: Perennial stream S052, Kingsbury Stream.
Stantec Consulting, May 19, 2010.

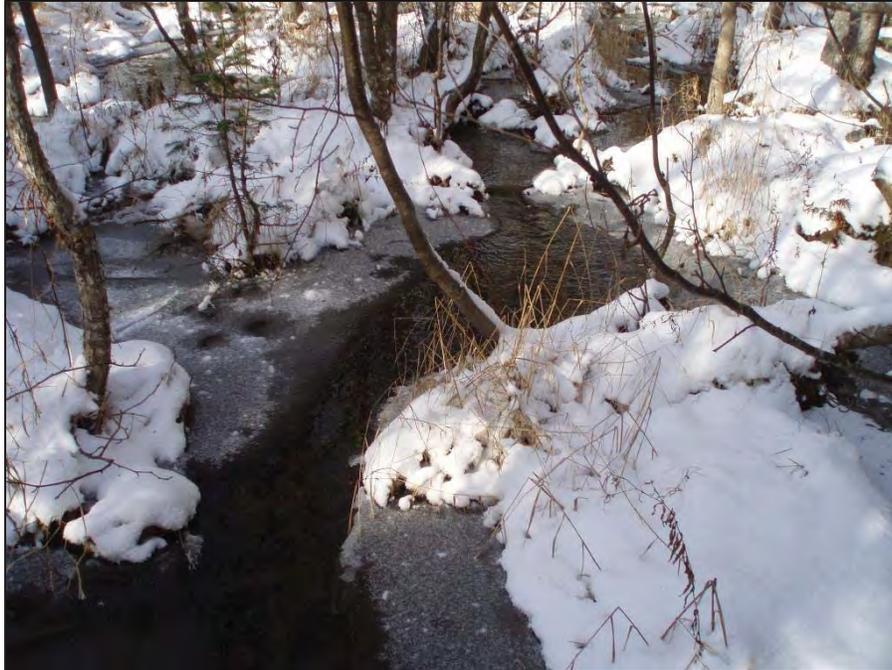
Photo 24: Perennial stream S056.
Stantec Consulting, December 8, 2010.

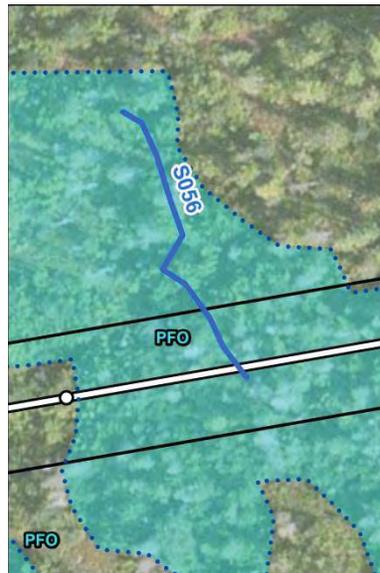
Proposed generator lead crossing of stream S056.
From Figure 24 Delineated Natural Resource Map by Stantec Consulting.

The stream and associated wetland will be crossed by the electrical generator lead corridor. Because this stream does not cross the entire width of the corridor, temporary construction crossing of this resource may not be necessary. If crossing of this stream is necessary during construction, a temporary timber mat bridge will be used to allow movement of construction equipment across the stream. There will be no direct impact to the stream channel. A 100-foot buffer will be maintained on each side of the stream. During construction and maintenance, capable trees (i.e., those that could grow to within 15 feet of a conductor within 3-4 years) will be topped, but no other vegetation will be cut. If topping individual trees will not leave sufficient foliage to sustain the tree, the tree will be cut at ground level. Herbicide use will not be allowed within this buffer.

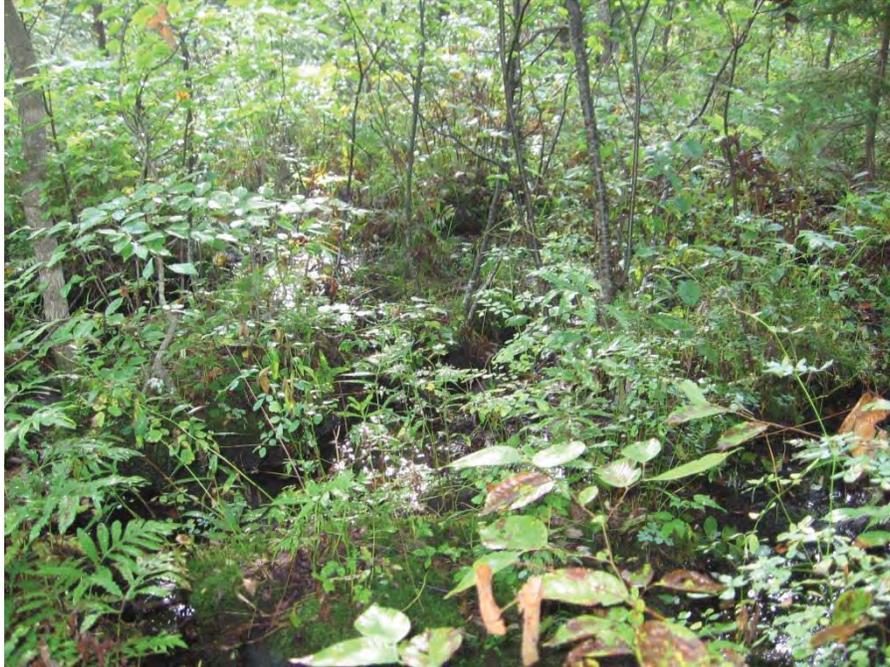
Photo 25: Perennial stream S057.
Stantec Consulting, September 11, 2013.

- ≠ Perennial stream.
- ≠ Channel substrate is primarily cobble, gravel, sand and muck.
- ≠ Aquatic mosses occur throughout the stream channel.
- ≠ Physical characteristics (**Photo 25**):
 - Bankfull width 4 feet;
 - Water depth in December of 2012 was 3 inches;
 - Low gradient riffle complexes;
 - Overhanging mixed forest trees present.

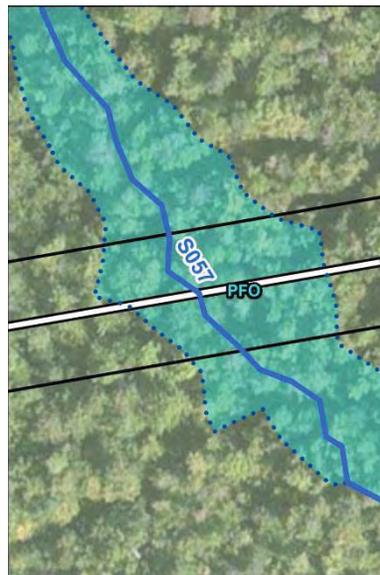
Proposed generator lead crossing of stream S057.
From Figure 25 Delineated Natural Resource Map by Stantec Consulting.

The stream and associated wetlands will be crossed by the electrical generator lead corridor. During construction, a temporary timber mat bridge will be used to allow movement of construction equipment across the stream. There will be no direct impact to the stream channel. During construction and maintenance, capable trees (i.e., those that could grow to within 15 feet of a conductor within 3-4 years) will be topped, but no other vegetation will be cut. If topping individual trees will not leave sufficient foliage to sustain the tree, the tree will be cut at ground level. Herbicide use will not be allowed within this buffer.
