January 9, 2014

**Subject: Bingham Wind Project, Summary of Spring Salamander Surveys and Proposed Habitat Management
Project # L-25973-24-A-N / L-25973-TG-B-N**

Project Survey Summary

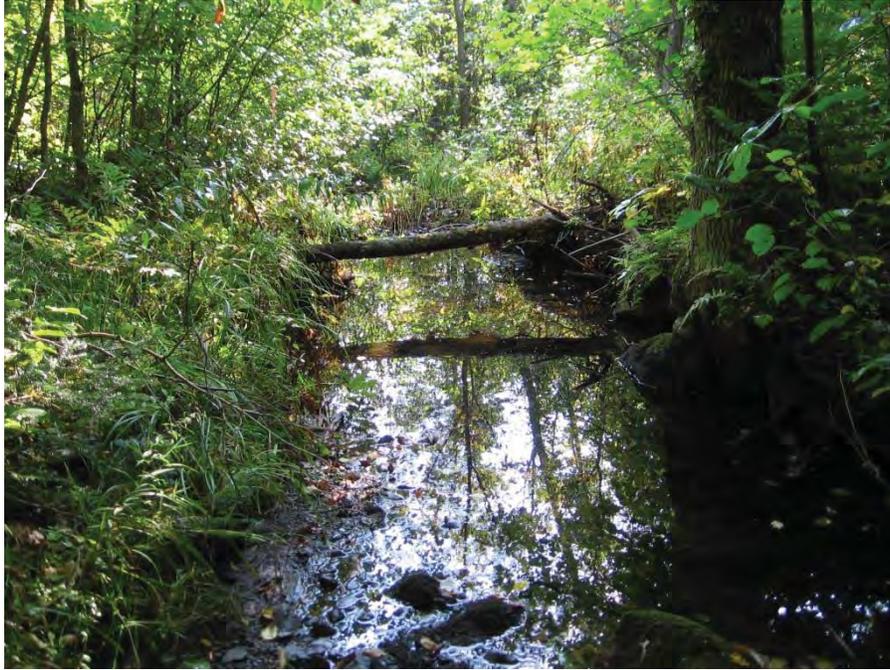
Photo 26: Perennial stream S058.
Stantec Consulting, September 11, 2013.

- ≠ Perennial stream.
- ≠ Channel substrate is primarily boulder, cobble, and gravel.
- ≠ Aquatic mosses occur throughout the stream channel.
- ≠ Physical characteristics (**Photo 26**):
 - Bankfull width 7.5 feet;
 - Water depth in December of 2012 was 2 inches;
 - Low gradient riffle complexes;
 - Overhanging hardwood trees present.

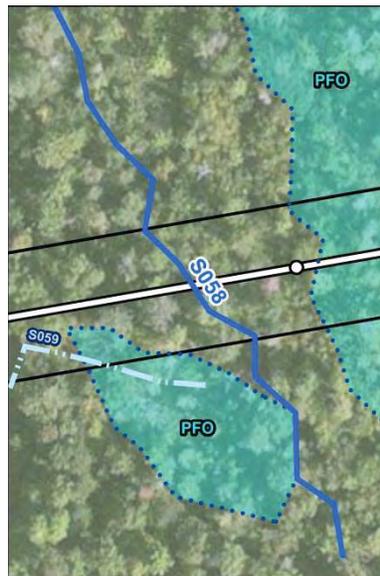
Proposed generator lead crossing of stream S058.
From Figure 25 Delineated Natural Resource Map by Stantec Consulting.

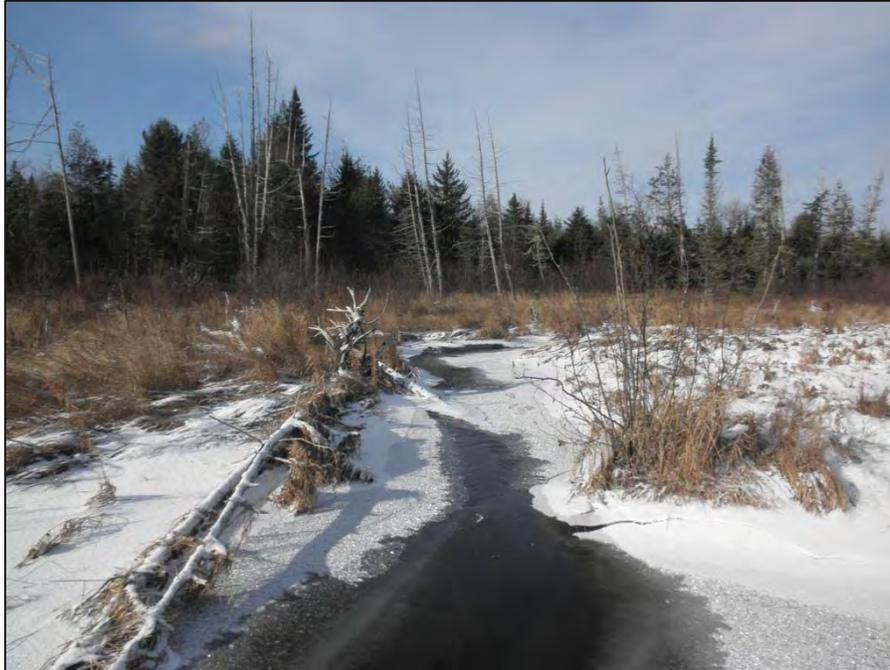
Photo 27: Perennial stream S060
Stantec Consulting, December 17, 2010.

- ≠ Perennial stream through large wetland.
- ≠ Channel substrate is primarily muck.
- ≠ Aquatic vegetation, macro-invertebrates, and fish likely occur throughout the stream channel.
- ≠ Physical characteristics (**Photo 27**):
 - Bankfull width 5-7 feet (Average 6 feet);
 - Water depth in December of 2010 was 12-20 inches;
 - Low gradient riffle and run sequences;
 - No overhanging vegetation present.

The stream will be crossed by the electrical generator lead corridor. Based upon discussions with Maine Department of Inland Fisheries and Wildlife biologist, this stream will not be crossed during construction. Construction access will occur from the east and west and there will be no need to cross the stream. A 100-foot buffer will be maintained on each side of the stream. During construction and maintenance, capable trees (i.e., those that could grow to within 15-feet of a conductor within 3-4 years) will be topped, but no other vegetation will be cut. If topping individual trees will not leave sufficient foliage to sustain the tree, the tree will be cut at ground level. Herbicide use will not be allowed within this buffer.

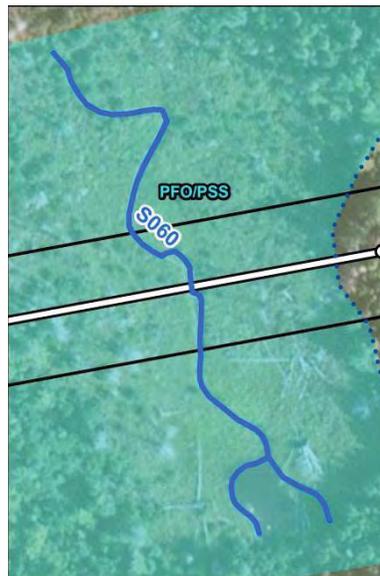
Proposed generator lead crossing of stream S060.
From Figure 26 Delineated Natural Resource Map by Stantec Consulting.

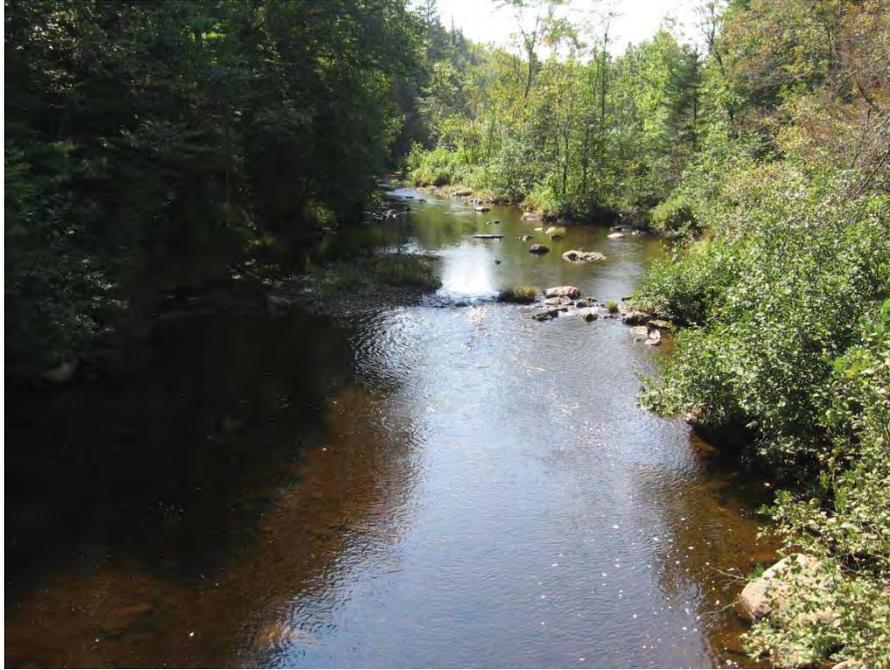
Photo 28: Perennial stream S062, Carlton Stream.
Stantec Consulting, September 11, 2013.

- ≠ Perennial stream with bridge crossing.
- ≠ Channel substrate is primarily boulder and cobble.
- ≠ Fish and macro-invertebrates likely occur throughout the stream channel.
- ≠ Physical characteristics (**Photo 28**):
 - Bankfull width 35-40 feet (Average 37.5 feet);
 - Water depth in January of 2013 was 3-5 feet;
 - Low to moderate gradient riffle, run, pool, and glide sequences;
 - Sparse overhanging hardwood trees present.

The stream will be crossed by the electrical generator lead corridor along Pease Bridge Road. Pease Bridge Road will be used for construction access so there will be no direct impact to the stream channel. One pole (structure) will be located within 100 feet of this stream. During construction and maintenance, capable trees (i.e., those that could grow to within 15 feet of a conductor within 3-4 years) will be topped, but no other vegetation will be cut. If topping individual trees will not leave sufficient foliage to sustain the tree, the tree will be cut at ground level. With regard to the pole (structure) located within the 100-foot buffer, the maximum height of vegetation within the corridor is a function of conductor height. The proximity of the pole to this stream will provide a conductor height that will allow for the establishment of taller vegetation near the stream, which will provide maximum shading of the stream. Herbicide use will not be allowed within this buffer.

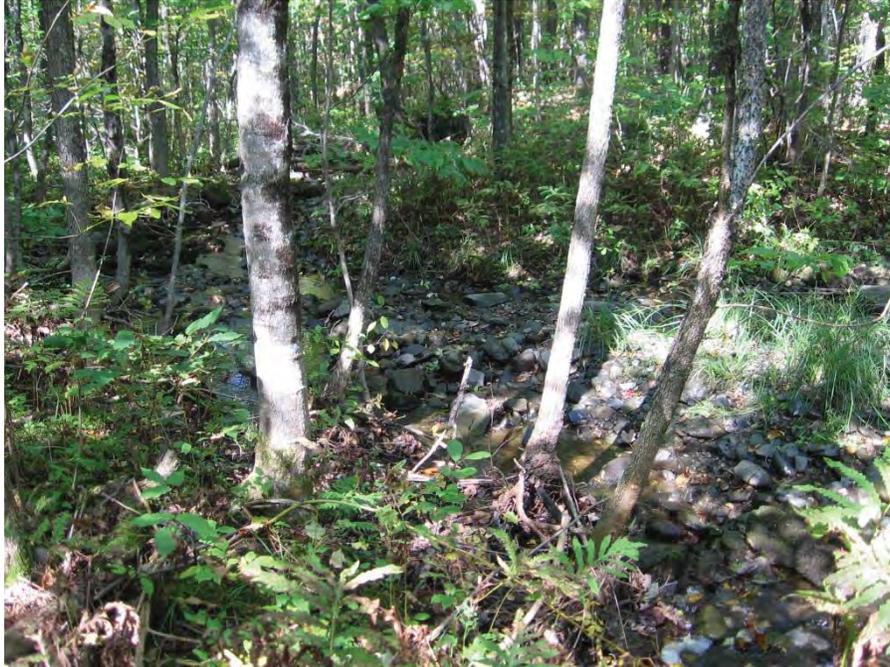
Photo 29: Perennial stream S063.
Stantec Consulting, September 11, 2013.

- ≠ Perennial stream crossing under Pease Bridge Road.
- ≠ Channel substrate is primarily boulder, cobble and gravel.
- ≠ Physical characteristics (**Photo 29**):
 - Bankfull width 10-12 feet (Average 11 feet);
 - Water depth in January of 2013 was 4-6 inches;
 - Moderate gradient with riffle, run, pool, and small plunge sequences;
 - Overhanging mixed forest trees present.

The stream will be crossed by the electrical generator lead corridor along Pease Bridge Road. Pease Bridge Road will be used for construction access; therefore, there will be no direct impact to the stream channel. One pole (structure) will be located within 100 feet of this stream. During construction and maintenance, capable trees (i.e., those that could grow to within 15 feet of a conductor within 3-4 years) will be topped, but no other vegetation will be cut. If topping individual trees will not leave sufficient foliage to sustain the tree, the tree will be cut at ground level. With regard to the pole (structure) located within the 100-foot buffer, the maximum height of vegetation within the corridor is a function of conductor height. The proximity of the pole to this stream will provide a conductor height that will allow for the establishment of taller vegetation near the stream, which will provide maximum shading of the stream. Herbicide use will not be allowed within this buffer.

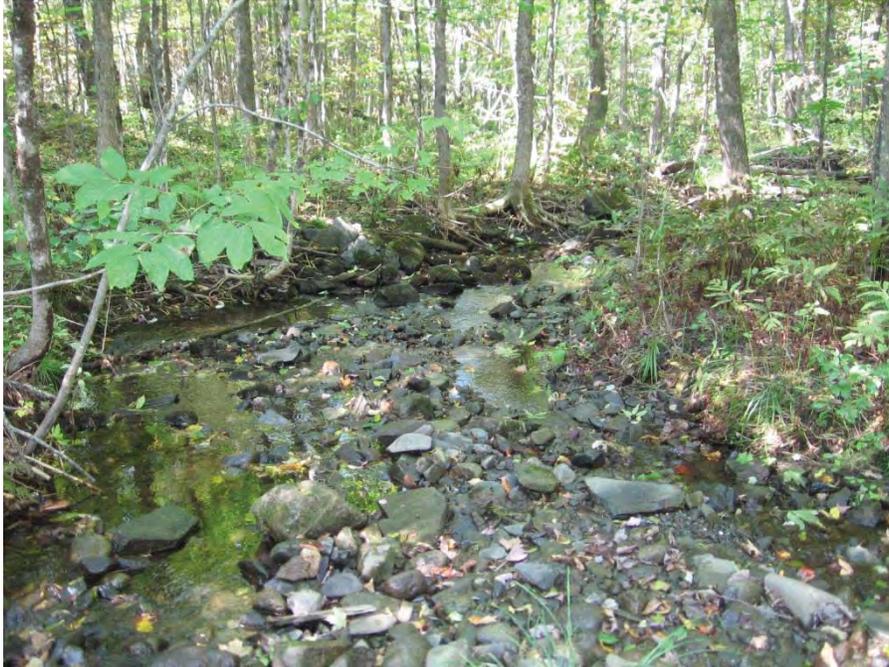
Photo 30: Perennial stream S065.
Stantec Consulting, September 11, 2013.

- ≠ Perennial stream crossing under Gales Road.
- ≠ Channel substrate is primarily boulder and cobble.
- ≠ Physical characteristics (**Photo 30**):
 - Bankfull width 6-8 feet (Average 7 feet);
 - Water depth in January of 2013 was 3-5 inches;
 - Moderate gradient riffle complexes;
 - Overhanging hardwood trees present.

The stream will be crossed by the electrical generator lead corridor along Gales Road. Construction activities will utilize the existing road corridor for the transportation of construction equipment. There are no proposed upgrades to the footprint of the road. One pole (structure) will be located within 100 feet of this stream. During construction and maintenance, capable trees (i.e., those that could grow to within 15 feet of a conductor within 3-4 years) will be topped, but no other vegetation will be cut. If topping individual trees will not leave sufficient foliage to sustain the tree, the tree will be cut at ground level. With regard to the pole (structure) located within the 100-foot buffer, the maximum height of vegetation within the corridor is a function of conductor height. The proximity of the pole to this stream will provide a conductor height that will allow for the establishment of taller vegetation near the stream, which will provide maximum shading of the stream. Herbicide use will not be allowed within this buffer.

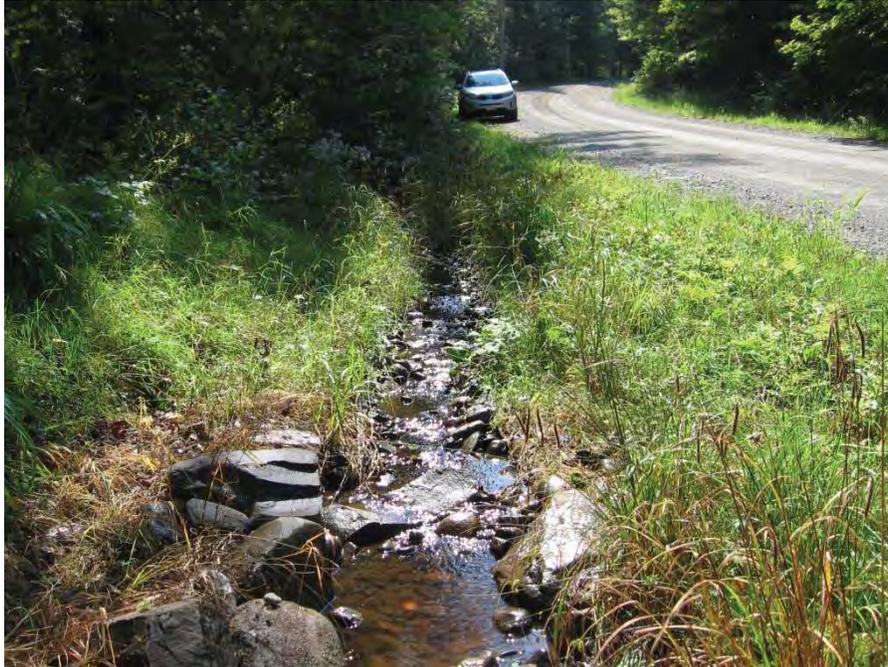
Photo 31: Perennial stream S066.
Stantec Consulting, September 11, 2013.

- ≠ Perennial stream crossing under Gales Road.
- ≠ Channel substrate is primarily boulder and cobble.
- ≠ Physical characteristics (**Photo 31**):
 - Bankfull width 6-15 feet (Average 8.5 feet);
 - Water depth in January of 2013 was 2-3 inches;
 - Moderate gradient riffle complexes;
 - Overhanging mixed forest trees present.

The forested wetland associated with this stream is dominated by northern white cedar, balsam fir, and speckled alder. Surface ice indicates the wetland periodically floods during periods of high water. Flooding is likely the result of impoundment caused by the road.

The stream will be crossed by the electrical generator lead corridor along Gales Road. Construction activities will utilize the existing road for the transportation of construction equipment. There are no proposed upgrades to the footprint of the road. One pole (structure) will be located within 100 feet of this stream. During construction and maintenance, capable trees (i.e., those that could grow to within 15 feet of a conductor within 3-4 years) will be topped, but no other vegetation will be cut. If topping individual trees will not leave sufficient foliage to sustain the tree, the tree will be cut at ground level. With regard to the pole (structure) located within the 100-foot buffer, the maximum height of vegetation within the corridor is a function of conductor height. The proximity of the pole to this stream will provide a conductor height that will allow for the establishment of taller vegetation near the stream, which will provide maximum shading of the stream. Herbicide use will not be allowed within this buffer.

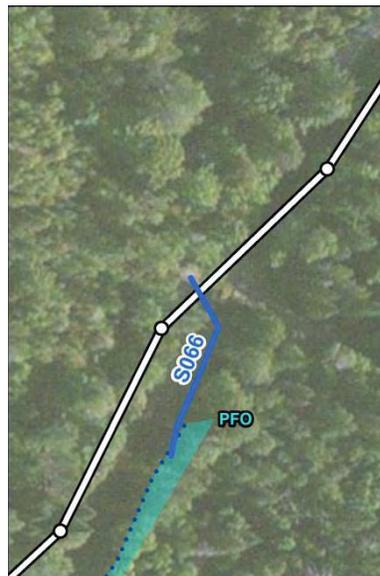
Proposed generator lead crossing of stream S066.
From Figure 27 Delineated Natural Resource Map by Stantec Consulting.

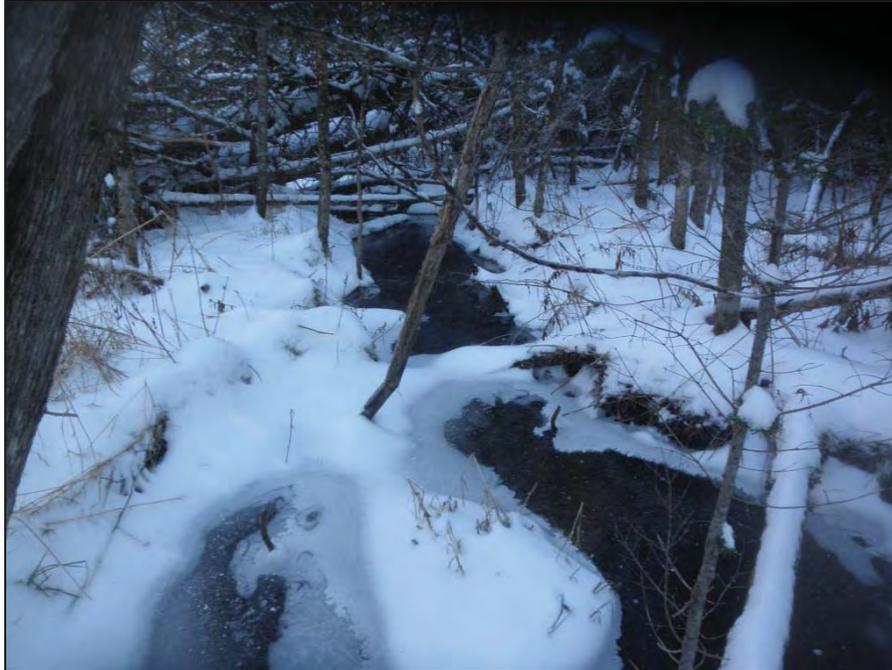
Photo 32: Perennial stream, S069.
Stantec Consulting, December 12, 2012.

- ≠ Perennial stream crossing under Gales Road and ATV trail.
- ≠ Channel substrate is primarily cobble, gravel, and muck.
- ≠ Aquatic mosses occur throughout the stream channel.
- ≠ Physical characteristics (**Photo 32**):
 - Bankfull width 5-7 feet (Average 6 feet);
 - Water depth in December of 2012 was 2-3 inches;
 - Low gradient riffle and run;
 - Overhanging softwood standing and overturned trees present.

The stream will be crossed twice by the electrical generator lead corridor, once along Gales Road and once south of Gales Road. Where possible, construction activities will utilize the existing road for transportation of construction equipment. South of Gales Road, a temporary timber mat bridge will be used to allow movement of construction equipment across the stream. A 100-foot buffer will be maintained on each side of the stream. During construction and maintenance, capable trees (i.e., those that could grow to within 15 feet of a conductor within 3-4 years) will be topped, but no other vegetation will be cut. If topping individual trees will not leave sufficient foliage to sustain the tree, the tree will be cut at ground level. Herbicide use will not be allowed within this buffer.

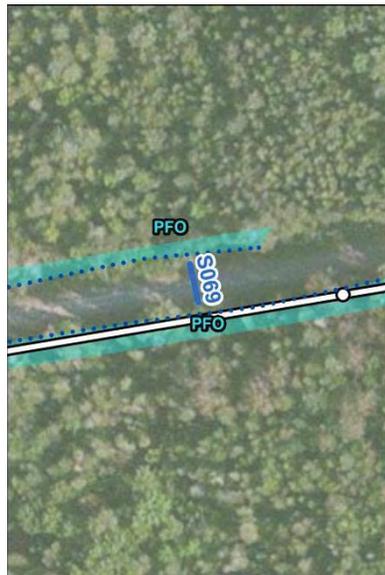
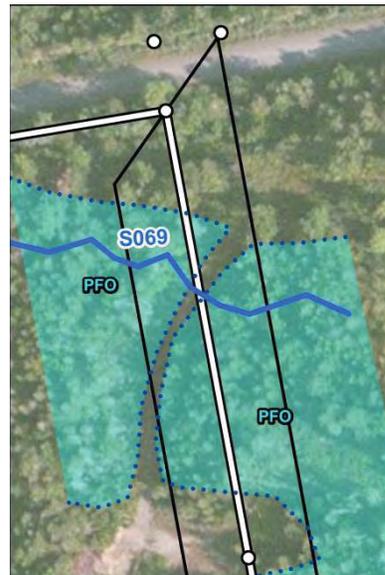
Proposed generator lead crossing of stream S069. Note no proposed impact to wetland ABB_W384.
From Figures 27 & 28 Delineated Natural Resource Map by Stantec Consulting.

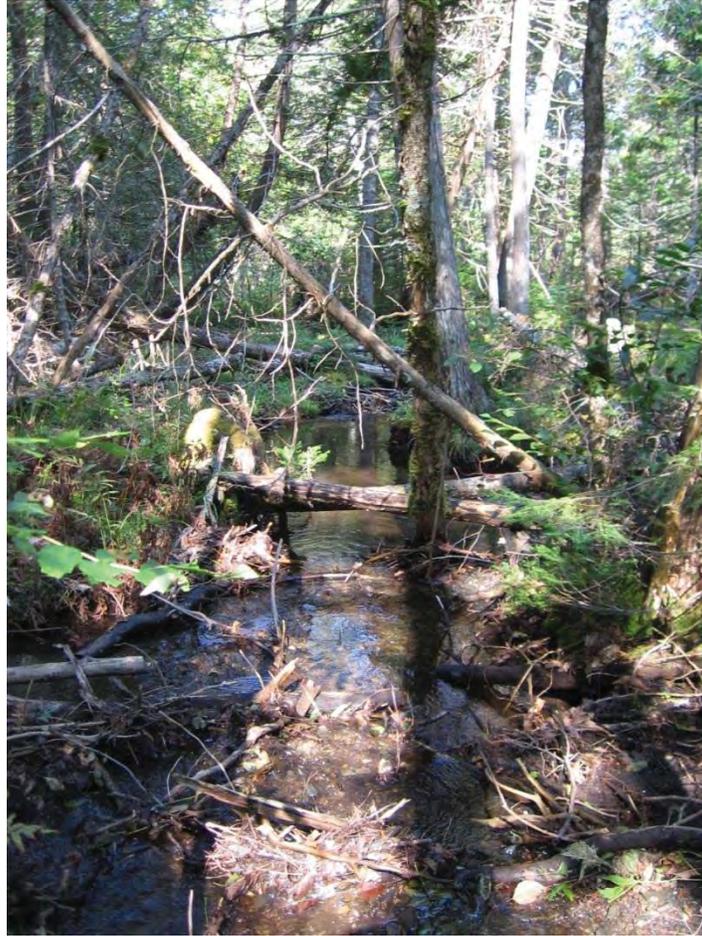
Photo 33: Perennial stream S070.
Stantec Consulting. September 11, 2013.

- ≠ Perennial stream with narrow ATV trail crossing.
- ≠ Channel substrate is primarily cobble and gravel.
- ≠ Aquatic mosses and macro-invertebrates occur throughout the stream channel.
- ≠ Physical characteristics (**Photo 33**):
 - Bankfull width 5-7 feet (Average 5 feet);
 - Water depth in December of 2012 was 1-3 inches;
 - Low to moderate gradient riffle complexes;
 - Overhanging softwood standing and wind-thrown trees present.

The stream will be crossed by the electrical generator lead corridor. During construction, a temporary timber mat bridge will be used to allow movement of construction equipment across the stream and adjacent wetland. There will be no direct impact to the stream channel. One pole (structure) will be located within 100 feet of this stream. Northern spring salamanders were documented in this stream during surveys conducted in 2013. Because of the presence of this species, a 250-foot buffer will be maintained on each side of the stream. During construction and maintenance, capable trees (i.e., those that could grow to within 15 feet of a conductor within 3-4 years) will be topped, but no other vegetation will be cut. If topping individual trees will not leave sufficient foliage to sustain the tree, the tree will be cut at ground level. With regard to the pole (structure) located within the 250-foot buffer, the maximum height of vegetation within the corridor is a function of conductor height. The proximity of the pole to this stream will provide a conductor height that will allow for the establishment of taller vegetation near the stream, which will provide maximum shading of the stream. Herbicide use will not be allowed within this buffer.

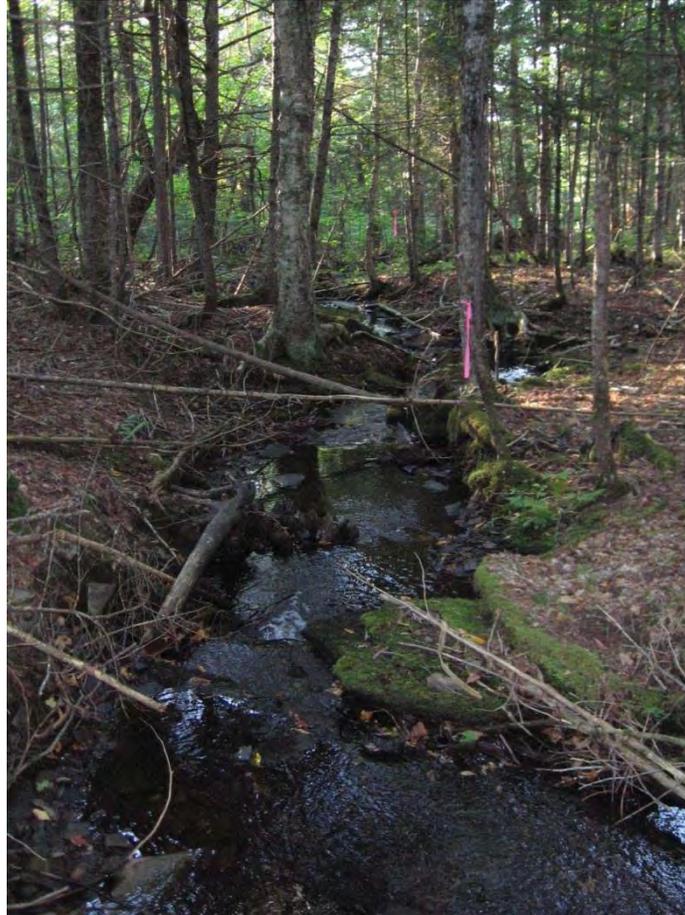
Photo 34: Perennial stream S071.
Stantec Consulting, December 12, 2012.

- ≠ Perennial stream with steep banks.
- ≠ Channel substrate is primarily bedrock, boulder, cobble, slate, and gravel.
- ≠ Aquatic mosses and macro-invertebrates occur throughout the stream channel.
- ≠ Physical characteristics (**Photo 34**):
 - Bankfull width 8-14 feet (Average 11 feet);
 - Water depth in December of 2012 was 2-6 inches;
 - Moderate gradient riffle, run, and pool sequences;
 - Overhanging mixed forest trees present.

The stream will be crossed by the electrical generator lead corridor. During construction, a temporary timber mat bridge will be used to allow movement of construction equipment across the stream and adjacent wetland. There will be no direct impact to the stream channel. One pole (structure) will be located within 100 feet of this stream. Northern spring salamanders were documented in this stream during surveys conducted in 2013. Because of the presence of this species, a 250-foot buffer will be maintained on each side of the stream. During construction and maintenance, capable trees (i.e., those that could grow to within 15 feet of a conductor within 3-4 years) will be topped, but no other vegetation will be cut. If topping individual trees will not leave sufficient foliage to sustain the tree, the tree will be cut at ground level. With regard to the pole (structure) located within the 250-foot buffer, the maximum height of vegetation within the corridor is a function of conductor height. The proximity of the pole to this stream will provide a conductor height that will allow for the establishment of taller vegetation near the stream, which will provide maximum shading of the stream. Herbicide use will not be allowed within this buffer.

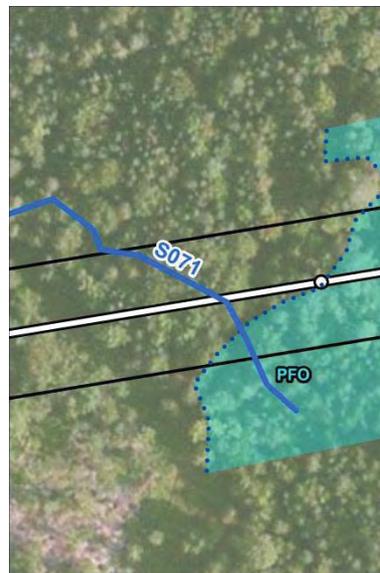
Proposed generator lead crossing of stream S071.
From Figure 28 Delineated Natural Resource Map by Stantec Consulting.

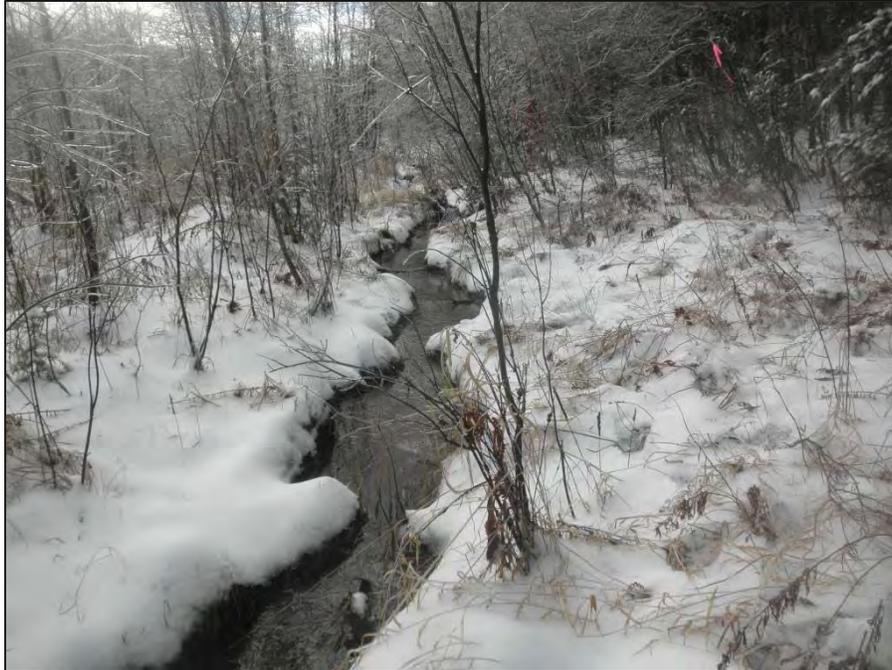
Photo 35: Perennial stream S074.
Stantec Consulting, December 11, 2012.

- ≠ Perennial stream originating at man-made impoundment.
- ≠ Channel substrate is primarily gravel and muck.
- ≠ Aquatic vegetation occurs throughout the stream channel.
- ≠ Physical characteristics (**Photo 35**):
 - Bankfull width 3-4 feet (Average 3.5 feet);
 - Water depth in December of 2012 was 3-4 inches;
 - Low gradient, slow riffle complexes;
 - Minimal overhanging shrubs present.

The stream will be crossed by the electrical generator lead corridor. It is likely that construction of the generator lead will not involve a temporary crossing of this stream, but that access will occur from either side of the stream. If crossing of this stream is necessary during construction, a temporary timber mat bridge will be used to allow movement of construction equipment across the stream and adjacent wetland. There will be no direct impact to the stream channel. A 100-foot buffer will be maintained on each side of the stream. During construction and maintenance, capable trees (i.e., those that could grow to within 15 feet of a conductor within 3-4 years) will be topped, but no other vegetation will be cut. If topping individual trees will not leave sufficient foliage to sustain the tree, the tree will be cut at ground level. Herbicide use will not be allowed within this buffer.

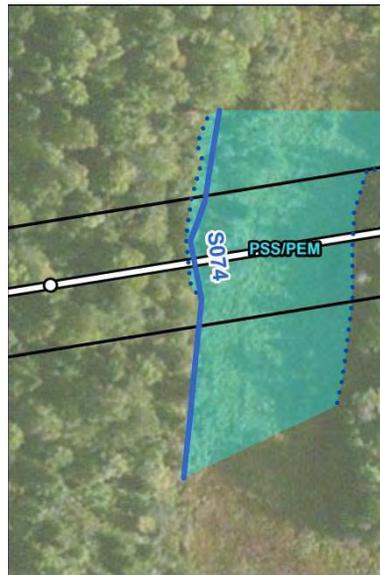
Proposed generator lead crossing of stream S074.
From Figure 29 Delineated Natural Resource Map by Stantec Consulting.

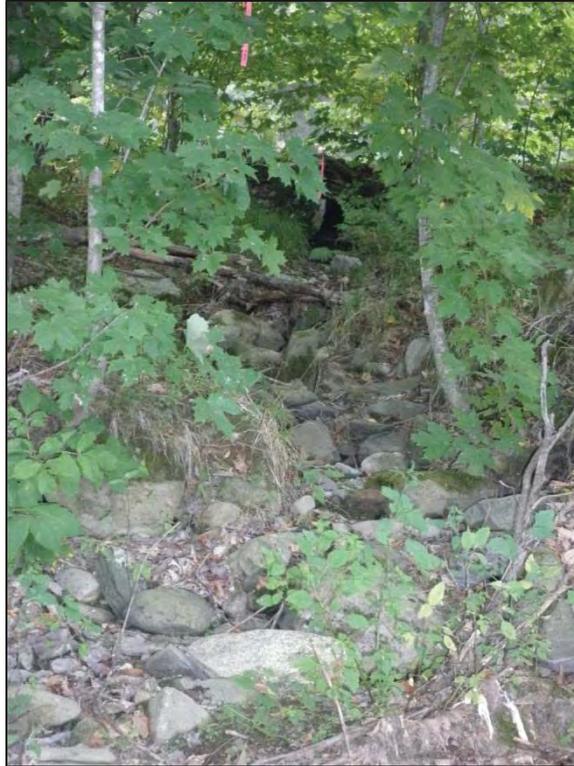
Photo 53: Intermittent stream S034.
Stantec Consulting, September 22, 2010.

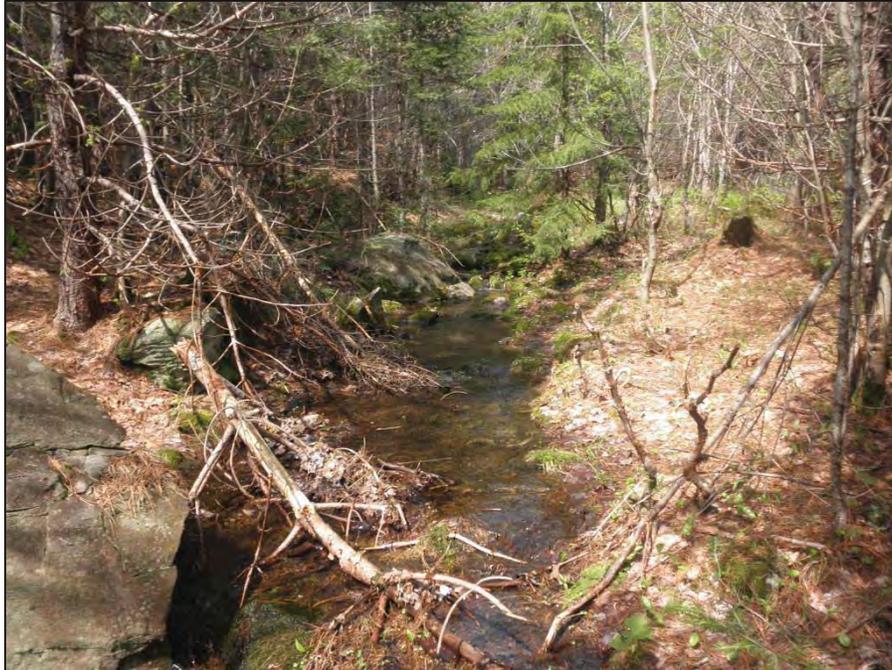
Photo 54: Intermittent stream S037.
Stantec Consulting. May 24, 2011.

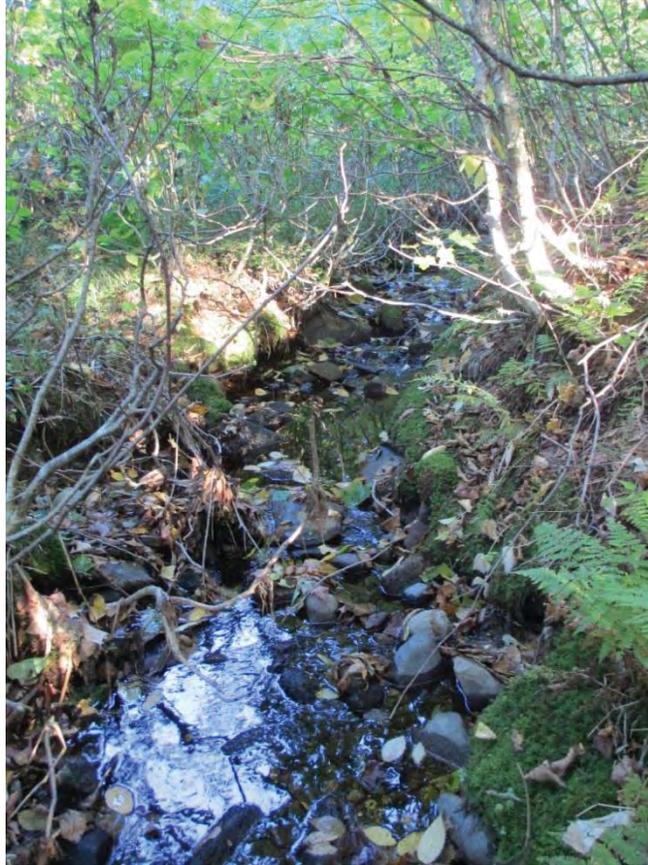
Photo 55: Intermittent stream S038.
Stantec Consulting, September 27, 2013.

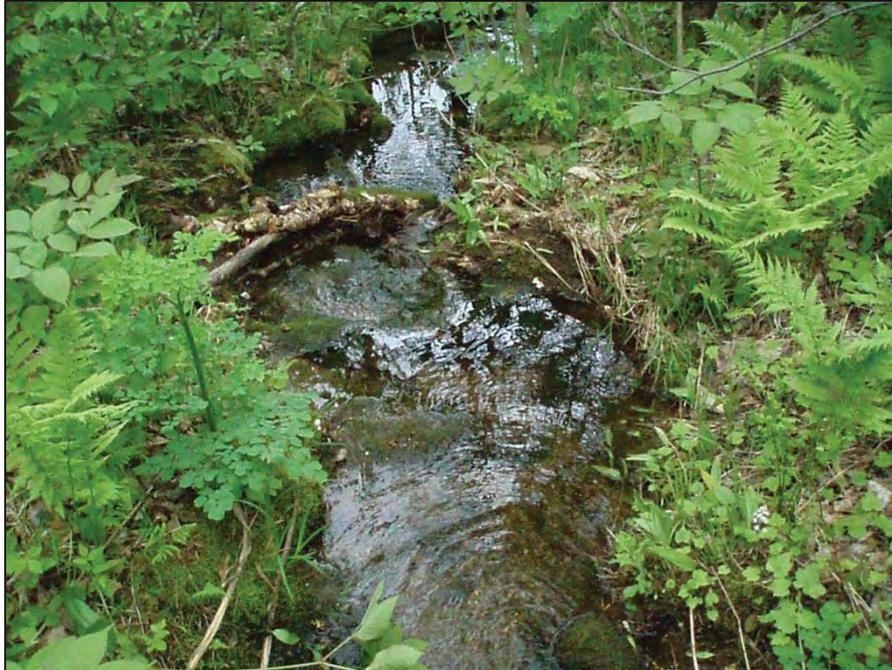
Photo 56: Intermittent stream S039.
Stantec Consulting. June 2, 2011.

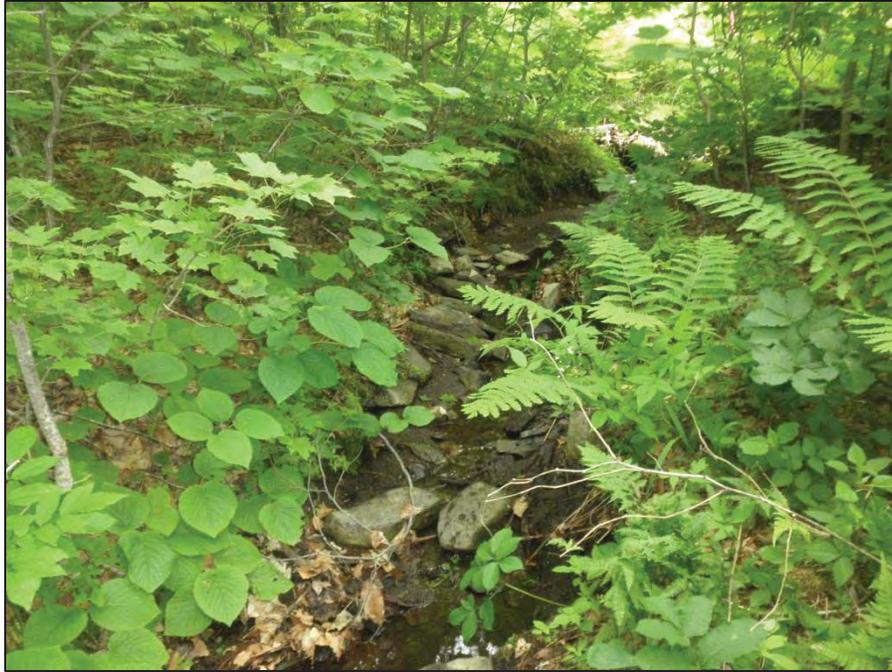
Photo 57: Intermittent stream S042.
Stantec Consulting. June 32, 2011.

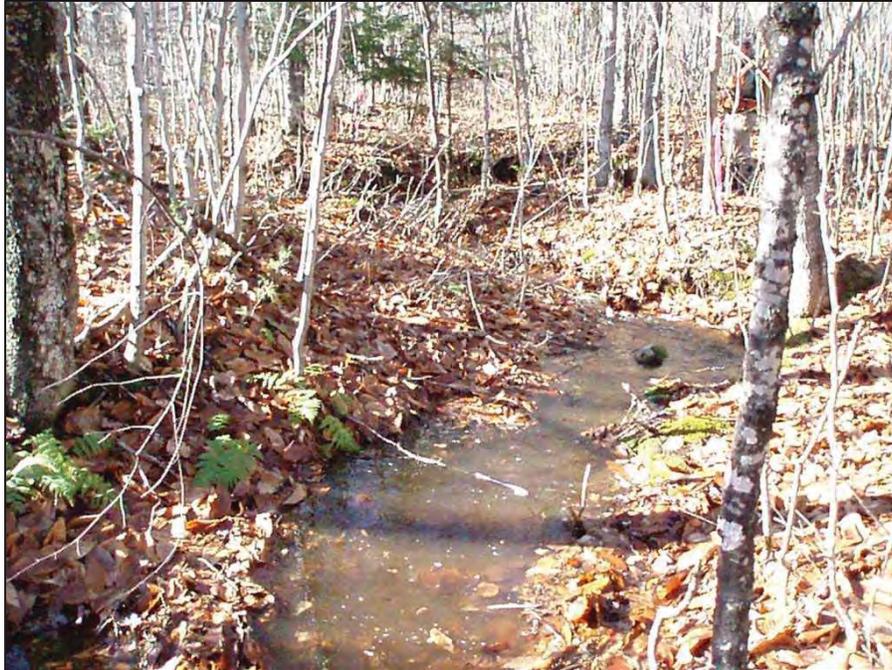
Photo 58: Intermittent stream S044.
Stantec Consulting. November 10, 2010.

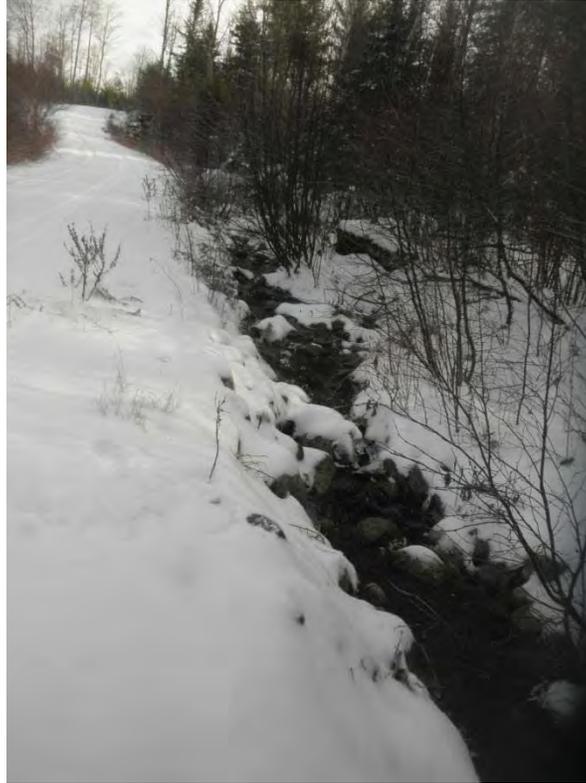
Photo 59: Intermittent stream S053.
Stantec Consulting. December 13, 2012.

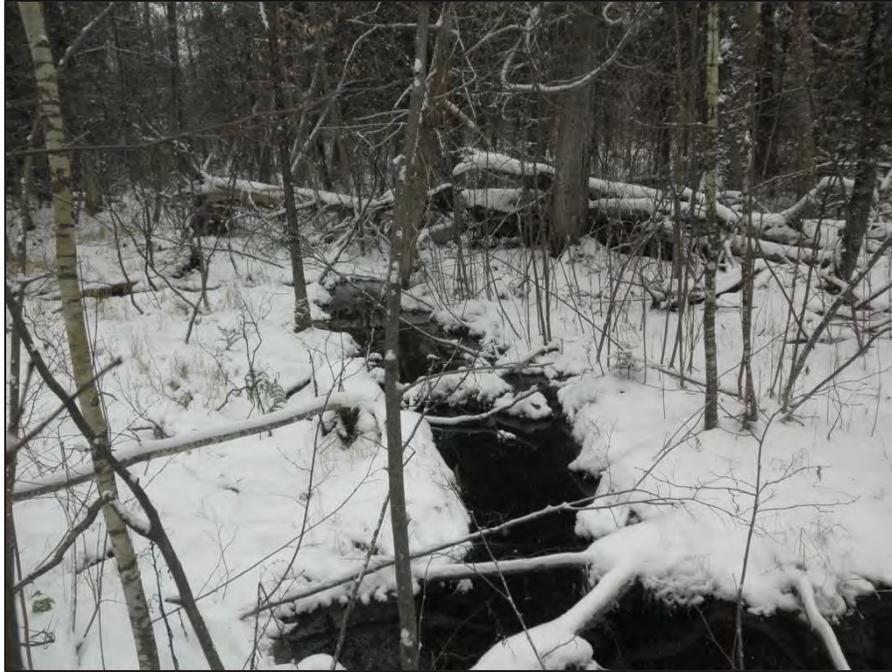
Photo 60: Intermittent stream S054.
Stantec Consulting. December 8, 2010.

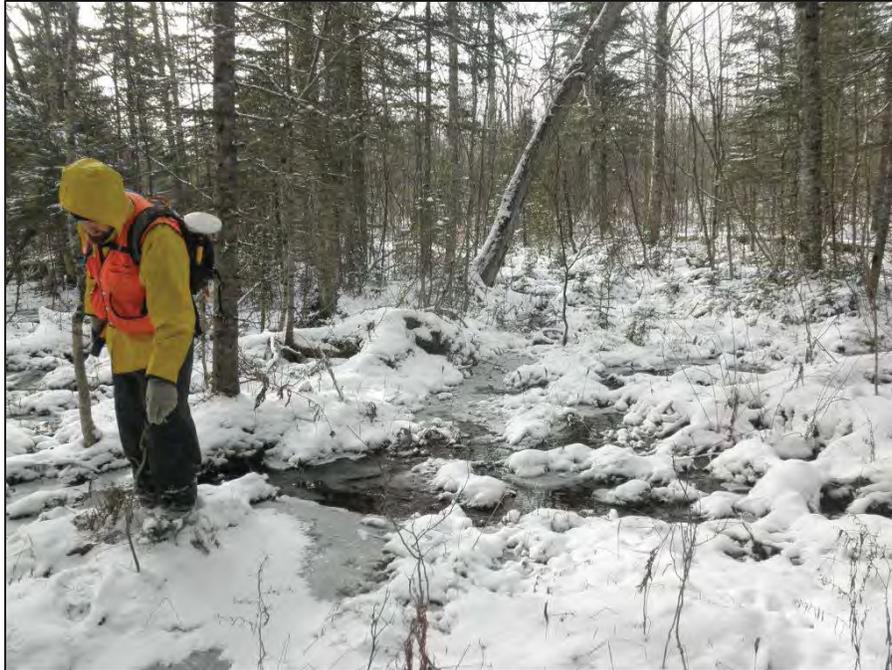
Photo 61: Intermittent stream S055.
Stantec Consulting. December 8, 2010.

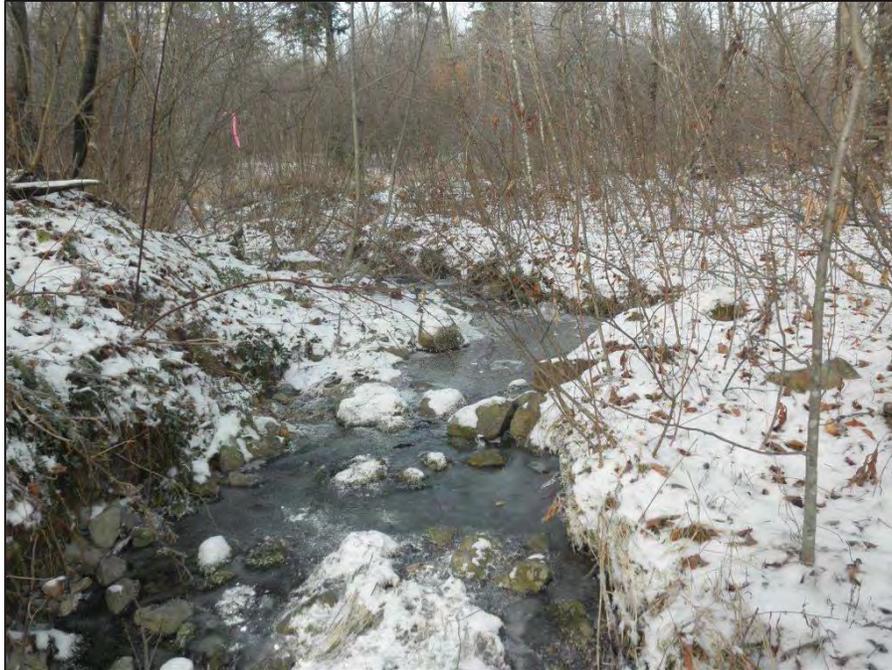
Photo 62: Intermittent stream S059.
Stantec Consulting. December 17, 2010.

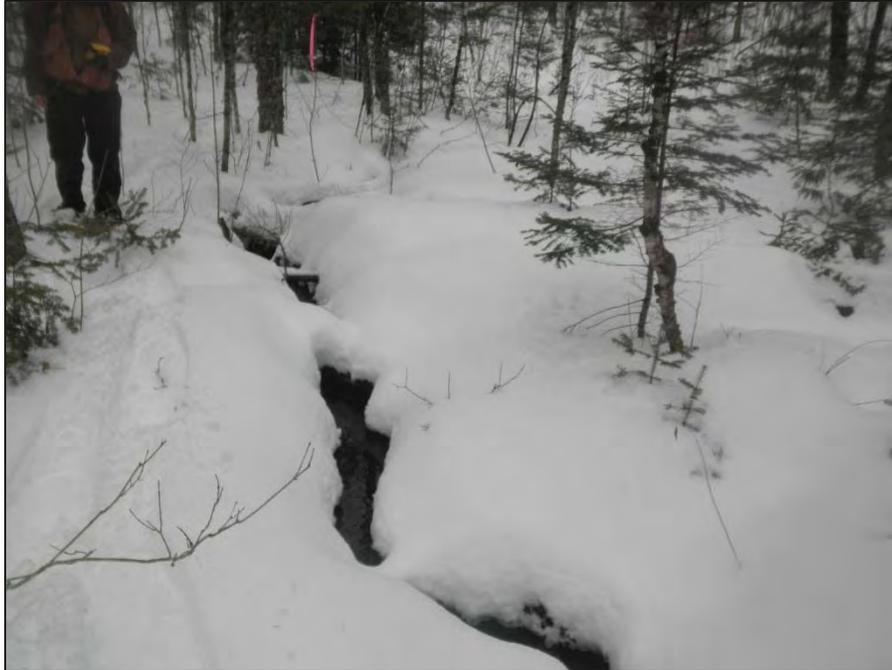
Photo 63: Intermittent stream S061.
Stantec Consulting. February 12, 1013.

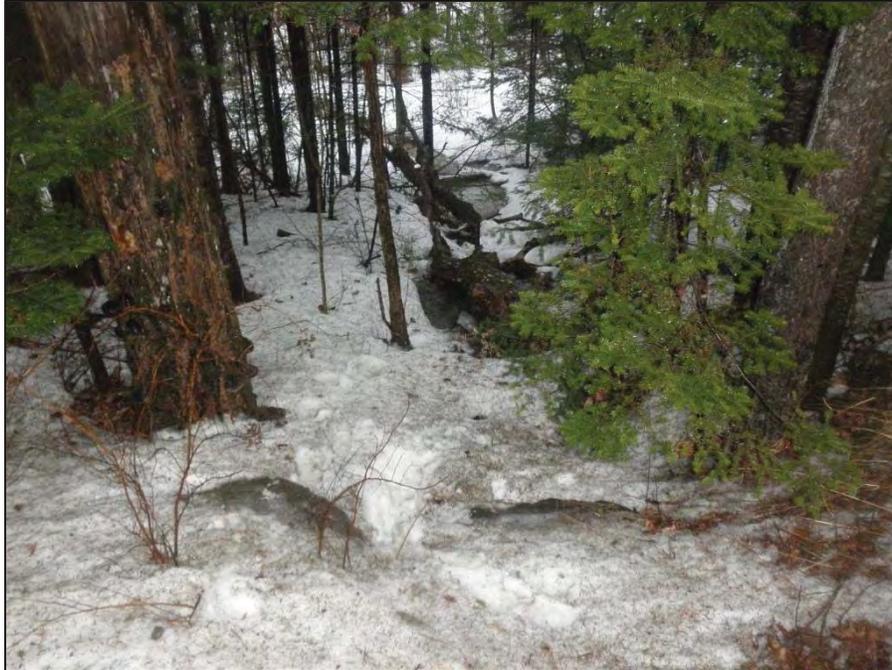
Photo 64: Intermittent stream S064.
Stantec Consulting. January 31, 2013.

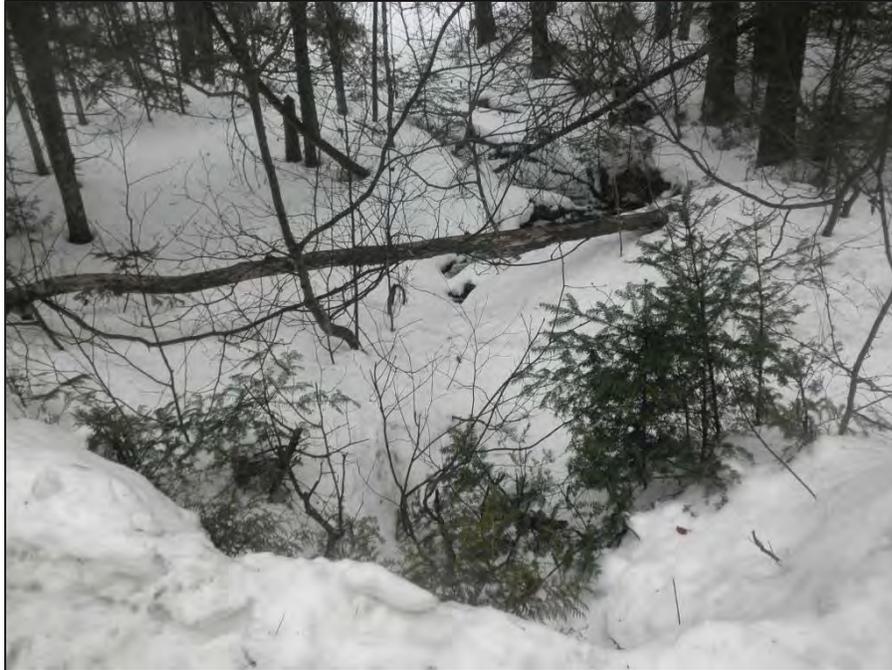
Photo 65: Intermittent stream S067.
Stantec Consulting. January 30, 2013.

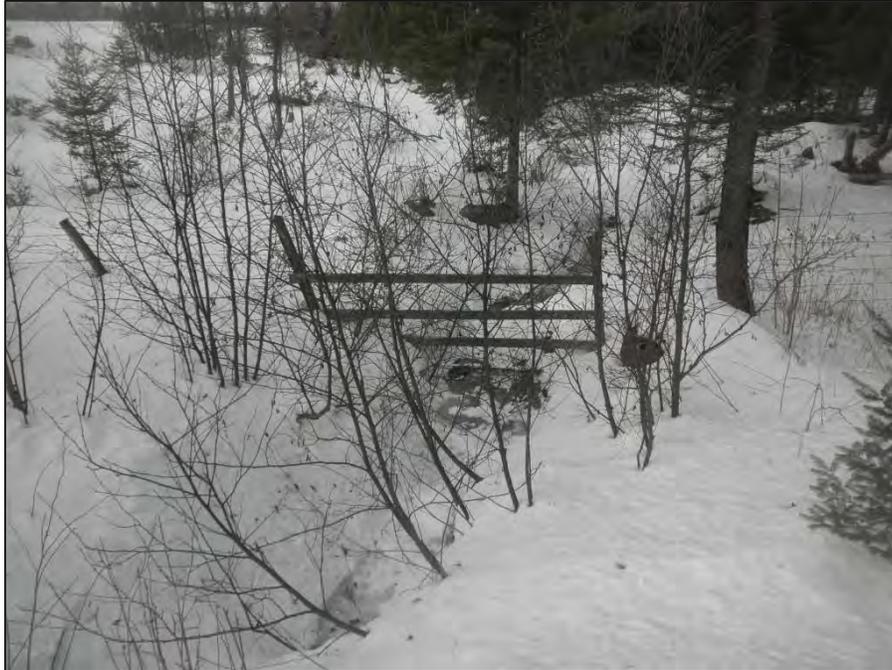
Photo 66: Intermittent stream S068.
Stantec Consulting. January 29, 2013.

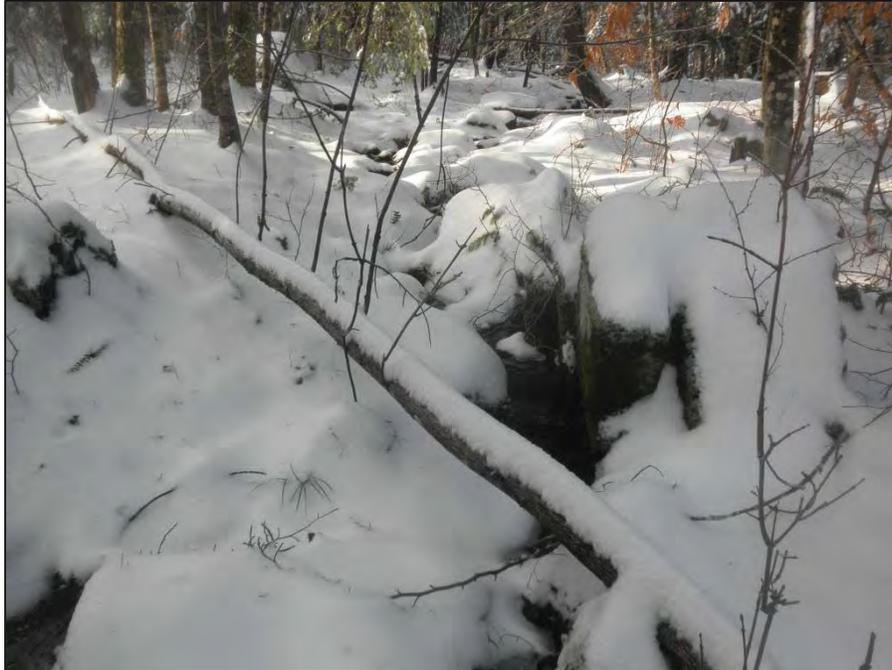
Photo 67: Intermittent stream S073.
Stantec Consulting. December 11, 2012.
