Trial by Tide:

Lessons Learned from Planning to Implementation of Nature-based Strategies

Lisa Vickers, Senior Coastal Professional

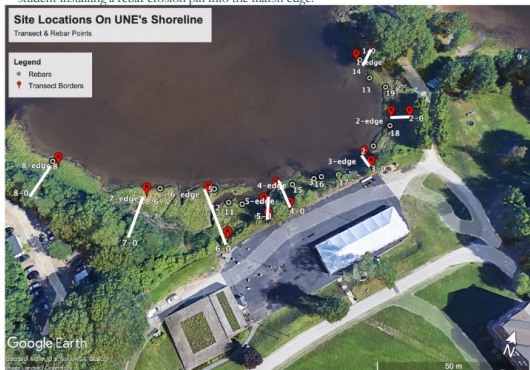
Figure 3. Map of the site featuring each transect and rebar erosion pin location.

- Erosion pin data were collected over four years and the mean change in length of the pins protruding from the marsh was calculated (Garbisch et al. 1994) (Fig 2).
- Sediment discs were deployed in the fall of 2020-2024, and we calculated how much sediment was deposited at each meter along eight transects (Fig 3, 4).
- A site map was created to show where the erosion rate at the edge of the marsh was the greatest and where the sedimentation rates on the marsh surface were the lowest.

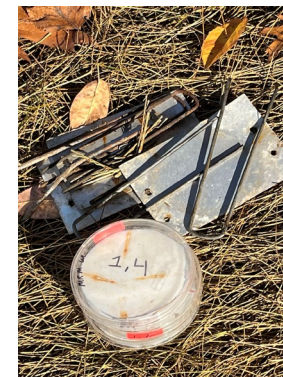
Figure 4. Sediment discs used to measure surface sedimentation rates.

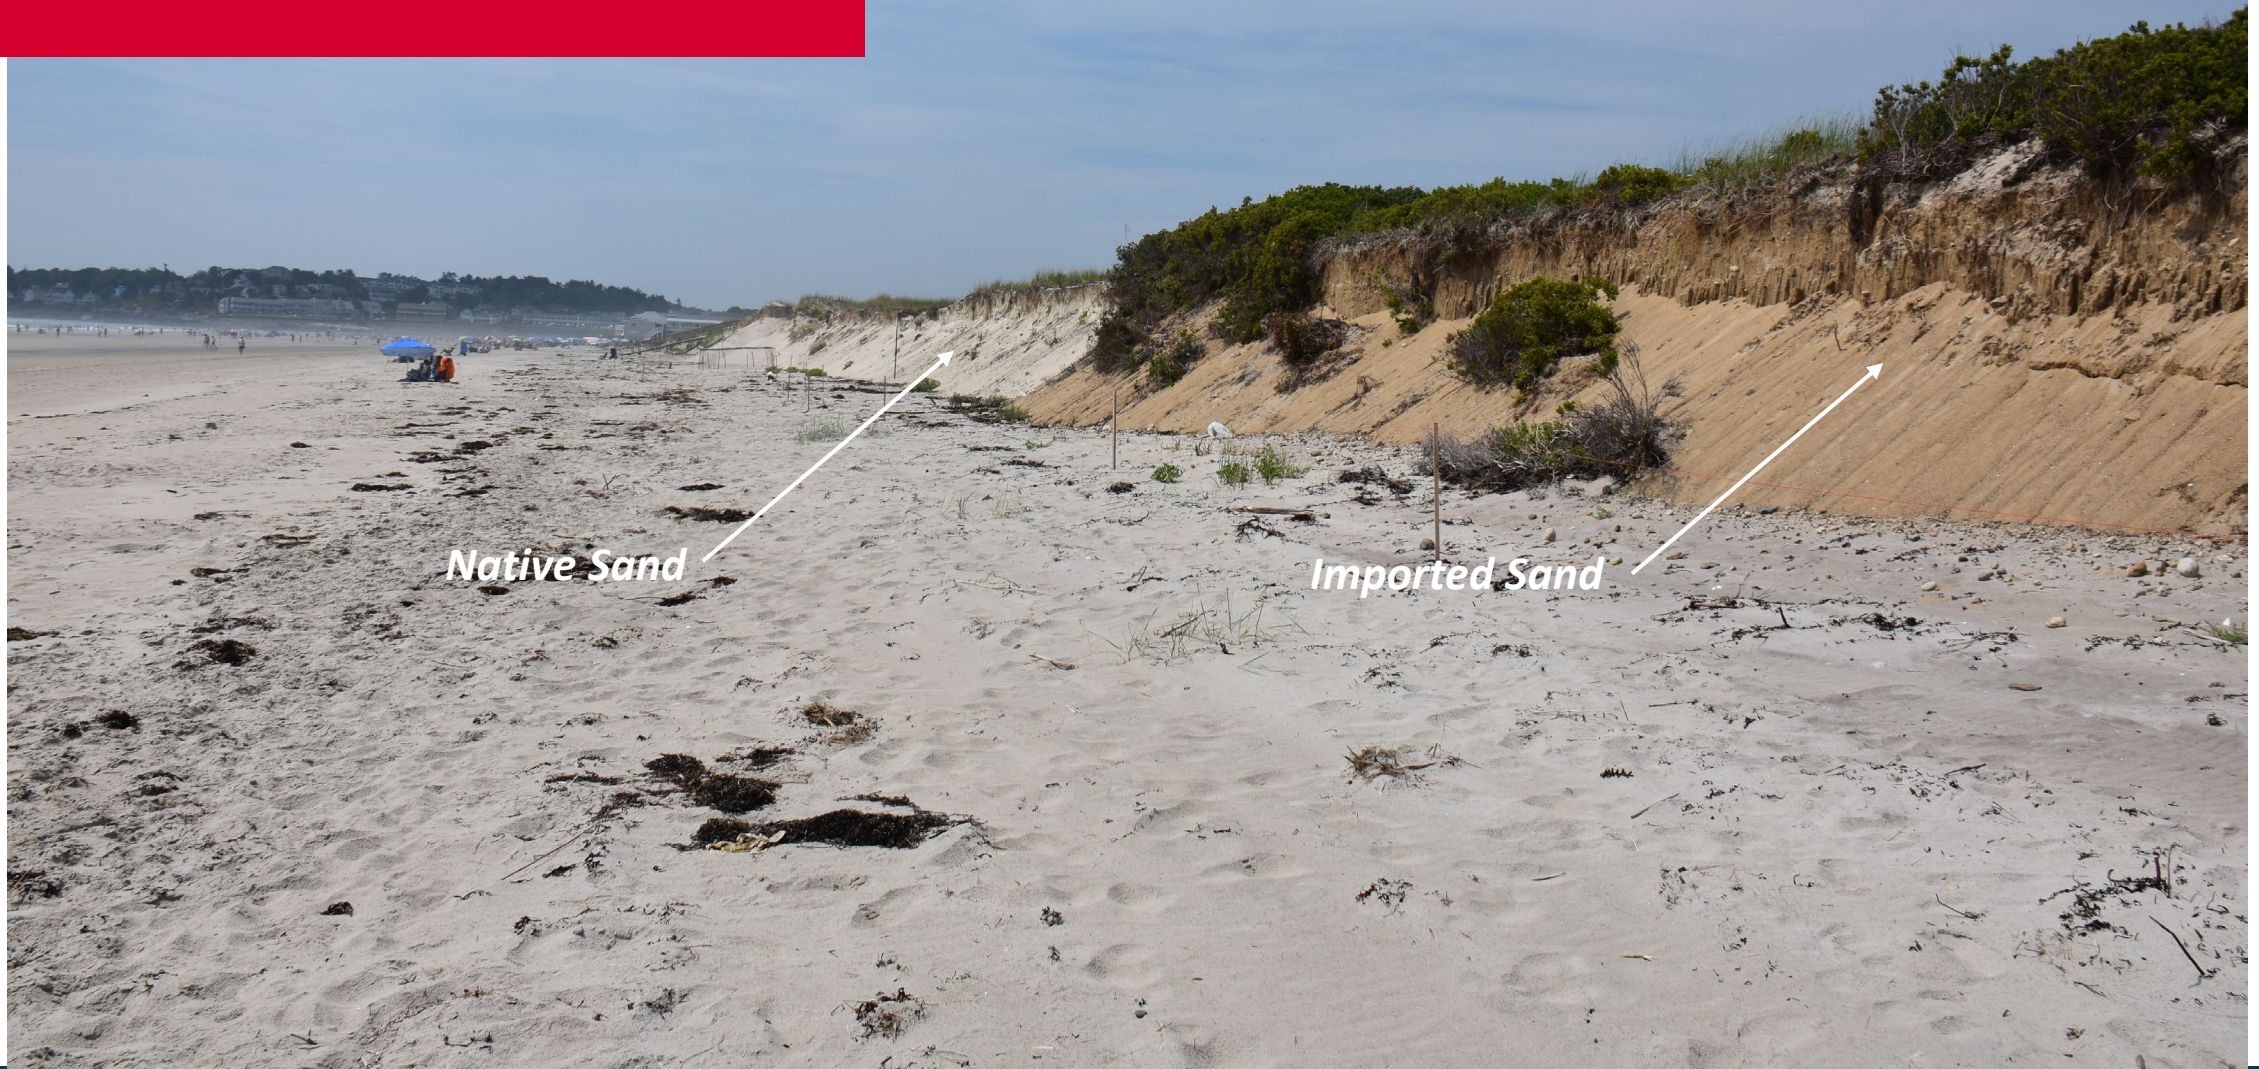
Evidence of 1974 Dune Project
