8.2 PHASE I ARCHAEOLOGICAL AND ARCHITECTURAL SURVEYS

Three Corners Solar Project

MDEP Site Location of Development Act Permit Application

SECTION 8: HISTORIC SITES

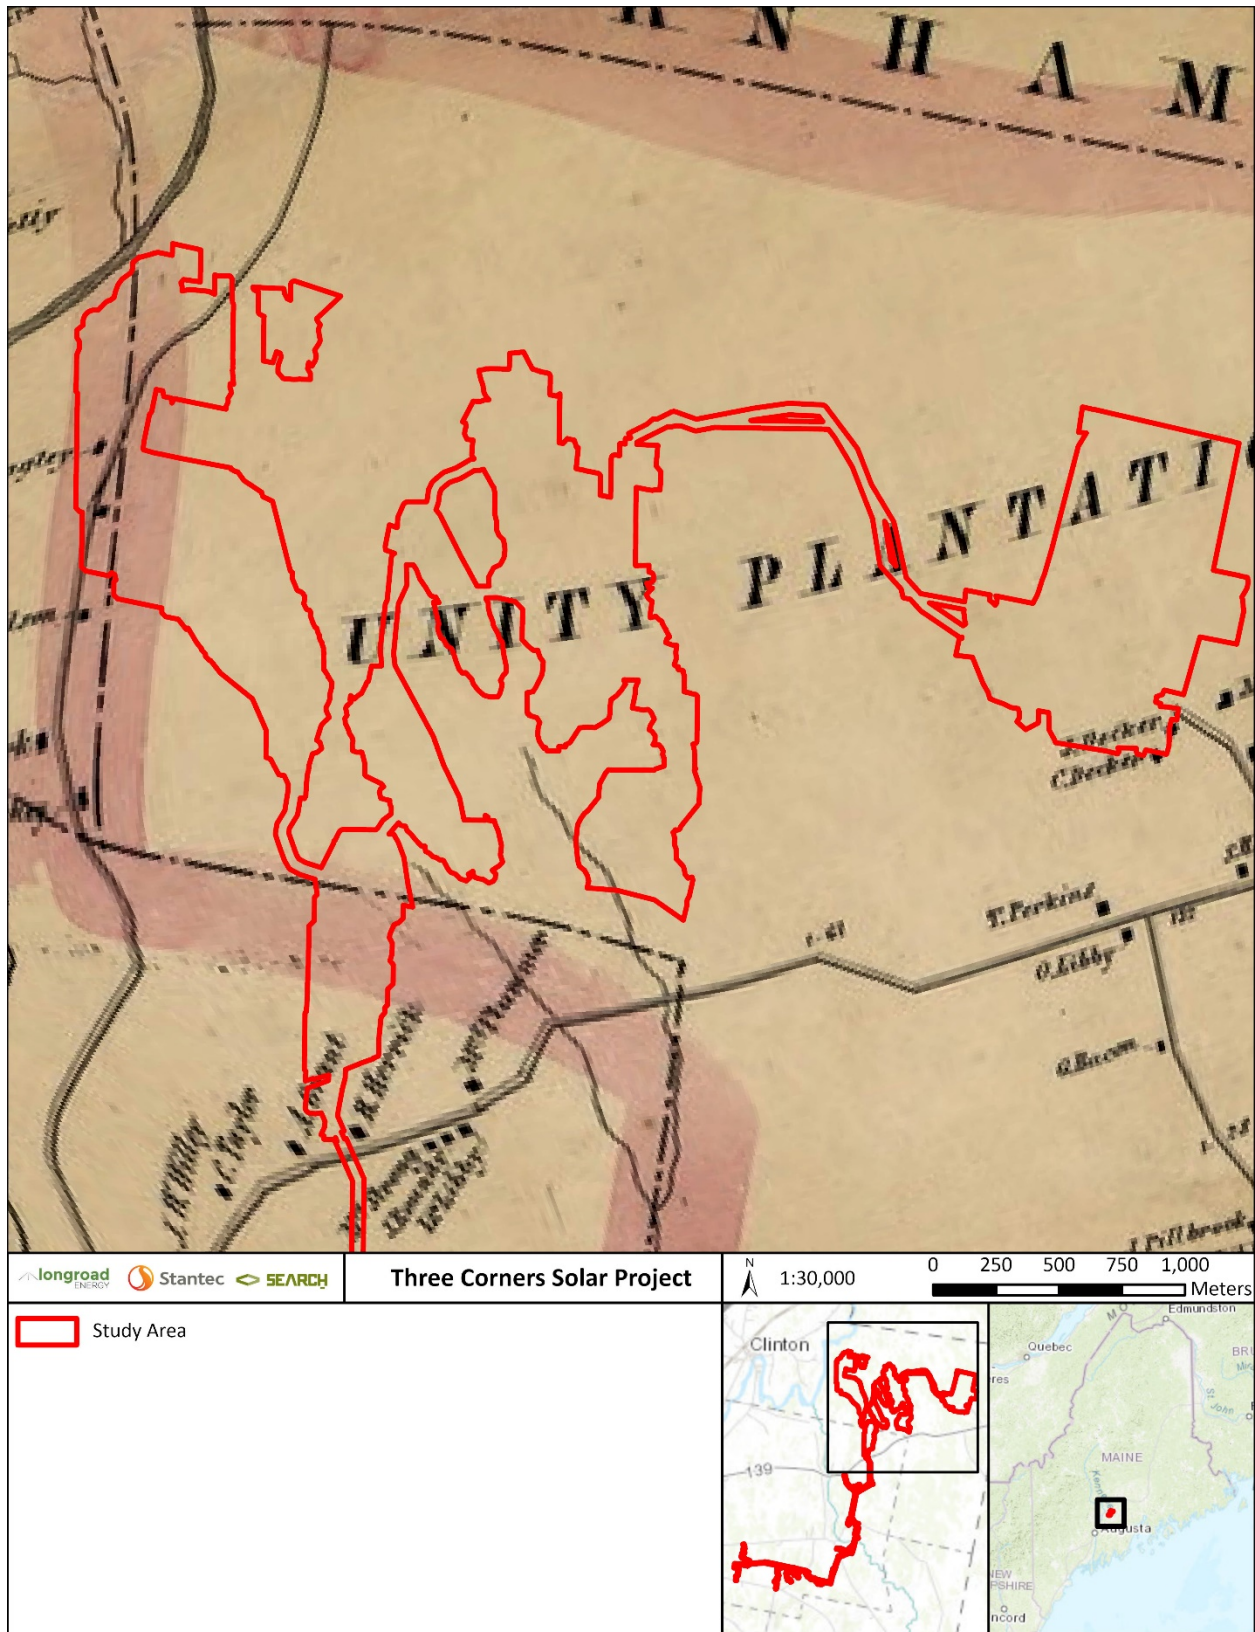
Figure 2-1. Northern part of the Three Corners Solar Project study area on the Southwick and Chace (1856) map of Kennebec County.

The Southwick and Chace (1856) map of Kennebec County was georeferenced to determine if and where nineteenth-century roads and house sites may be in the study area (**Figure 2-1** and **Figure 2-2**). Additionally, the United States Geological Survey (USGS) Historic Topo Maps basemap available through ArcGIS Online provided access to georeferenced versions of the Burnham 15-minute quadrangle (1926) and the Waterville 15-minute quadrangle (1892), both of which were also examined to identify roads and house sites. Historic roads generally follow the modern routes of Unity Road, which approximately bisects the Project; Palmer Road, which extends northward from Unity Road east of the Project before intersecting the northeastern portion of the Project; Bog Road, which crosses Fifteenmile Stream before traversing the southern portion of the Project; East Benton Road, which stretches east–west generally north of the southern portion of the Project before bending southwards to cross the Project; and Richards Road, which continues southward from East Benton Road and also traverses the southern portion of the Project. Additionally, Albion Road, though it does not cross the Project, is the terminus of two access roads that will be used during the Project, while access roads also originate from East Benton Road, Richards Road, and Unity Road. Finally, Dickey Road is currently an unmaintained road trace, but appears on the Southwick and Chace (1856) map. Named structures appear on each of these roads on the Southwick and Chace (1856) map, including four that are in or within 50 m (164 ft) of the Project.

TA-01 is in the northwestern part of the Three Corners study area, and was defined based on possible historic foundations and/or map documented structures associated with Dickey Road (see **Figure 2-1** and **Figure 5-1**). TA-01 was identified as sensitive for postcontact archaeological material. Dickey Road was laid out in 1852, and appears on the Southwick and Chace (1856) Map of Kennebec County and on the 1926 Burnham 15-minute topographic map. A total of 49 STs were excavated in TA-01 during the Phase I survey, including 10 positive for cultural material. Four sites were identified, Sites F-1, MP-14, MP-15, and SW-9, all of which are postcontact sites; one tested location within TA-01, TR-6, did not yield any cultural material (see **Figure 1-1**).

TA-02 is north of TA-01 in the northwestern part of the Three Corners study area, and was defined based on possible historic foundations and/or map-documented structures associated with Dickey Road and an elevated ridgeline overlooking the Sebasticook River valley (**Figure 2-1** and **Figure 5-1**). TA-02 was identified as sensitive for both precontact and postcontact archaeological material. Dickey Road was laid out in 1852, and appears on the Southwick and Chace (1856) Map of Kennebec County and on the 1926 Burnham 15-minute topographic map. A total of 34 STs were excavated in TA-02 during Phase I survey, including four that were positive for cultural material. Two postcontact sites were identified, Site F-2 and Site F-3; two tested locations within TA-02 (TR-1 and TR-2) did not yield any cultural material.

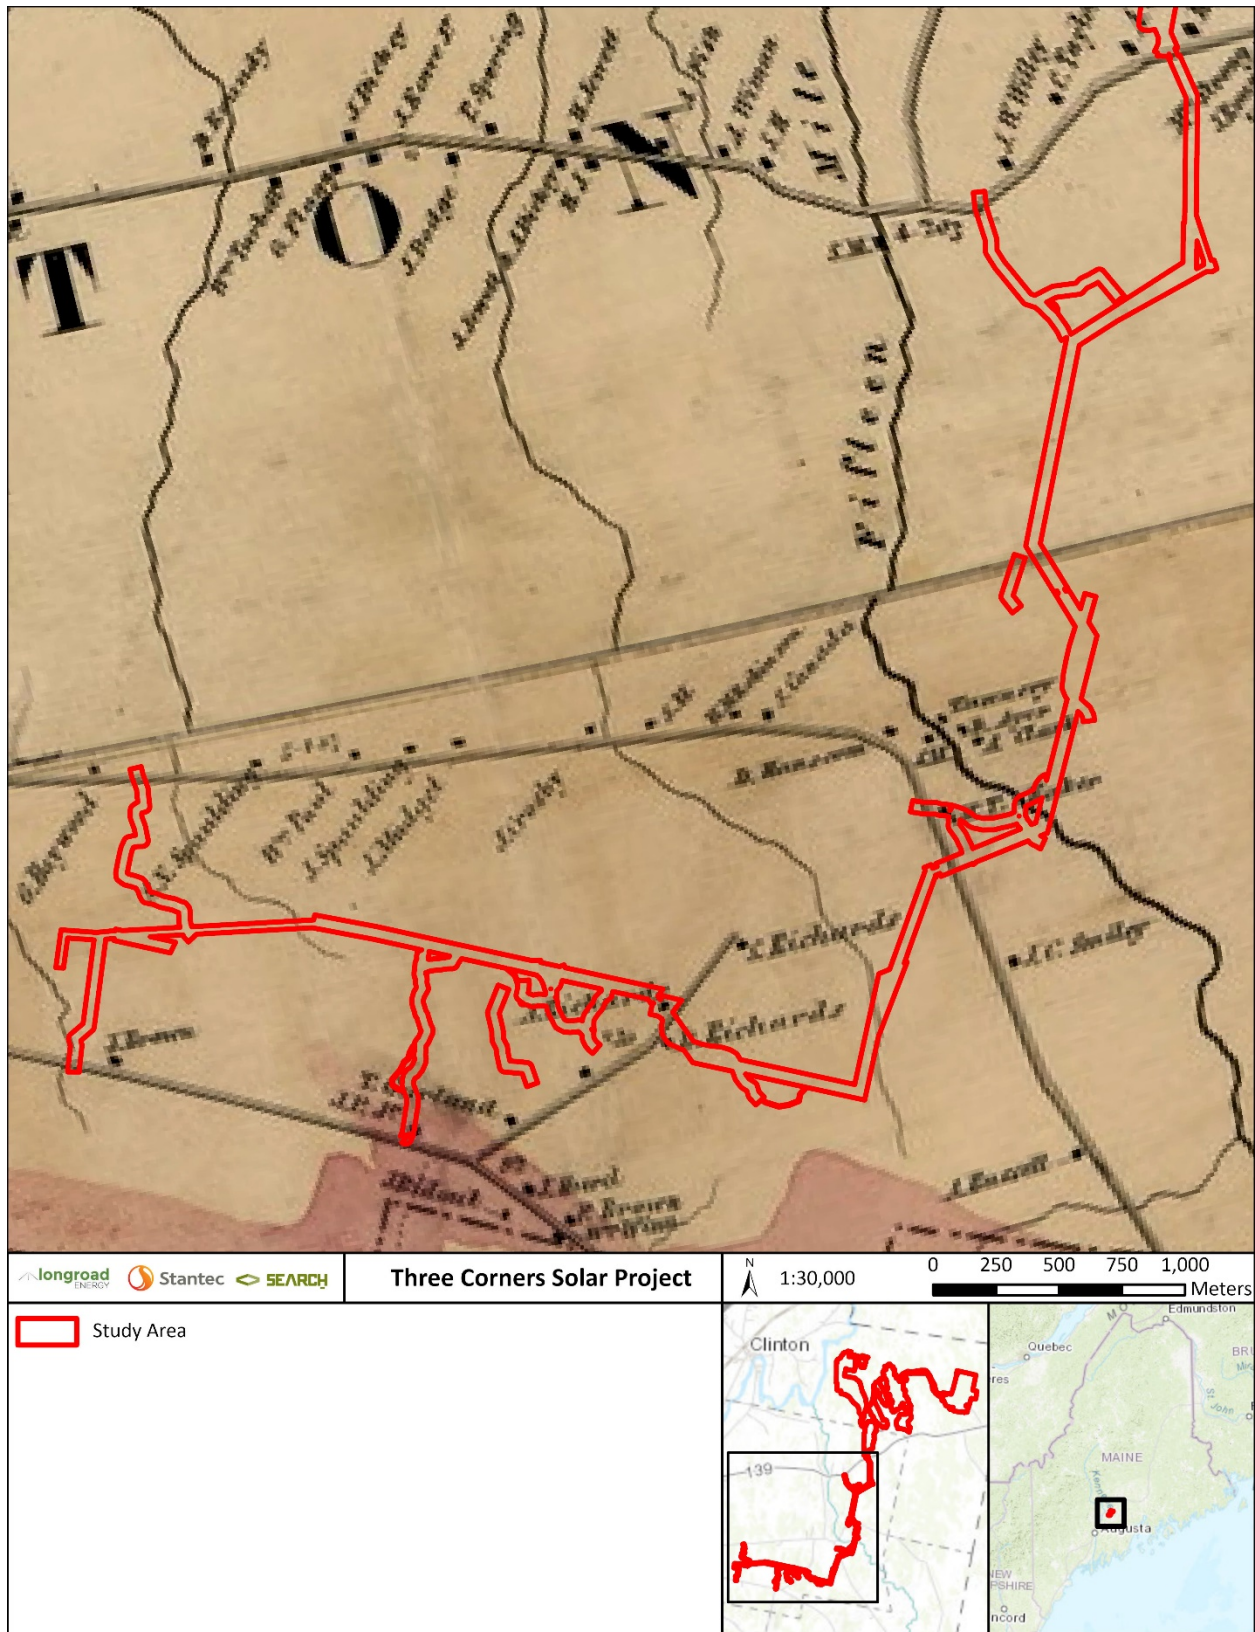
Figure 2-2. Southern part of the Three Corners Solar Project study area on the Southwick and Chace (1856) map of Kennebec County.

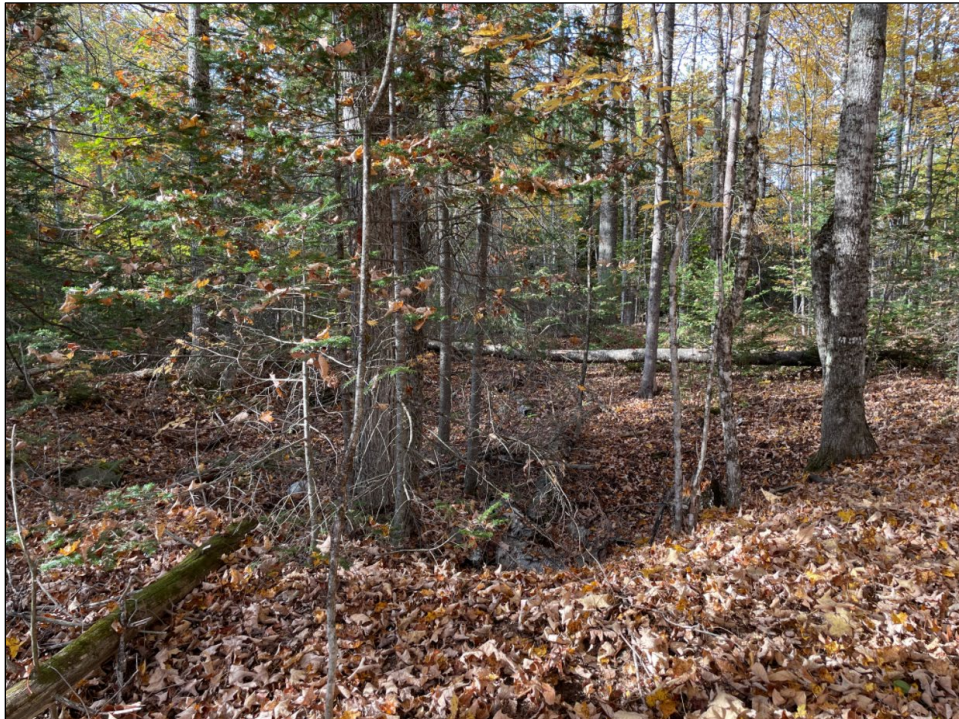
Figure 5-4. View from southeast corner of Site F-1 cellar hole, facing northwest.

Site F-1 was initially identified by a dry-laid fieldstone foundation during pedestrian reconnaissance. Further inspection during subsurface survey revealed a cellar hole measuring approximately 9.0 × 9.0 m (29.5 × 29.5 ft) (**Figure 5-4**, **Figure 5-5**, and **Appendix F-1**). The foundation has a break on the northern edge that may be the remnants of a chimney or doorway based on the presence of brick fragments in the area, but that may also be a bulkhead entrance, and a second concentration of brick along the southern wall. A length of possible foundation extends approximately 10.0 m (32.8 ft) northward from the northwestern corner of the cellar hole that may be a yard feature or may be related to an addition to the main structure (**Figure 5-6**). No other yard features or evidence of additions was identified.

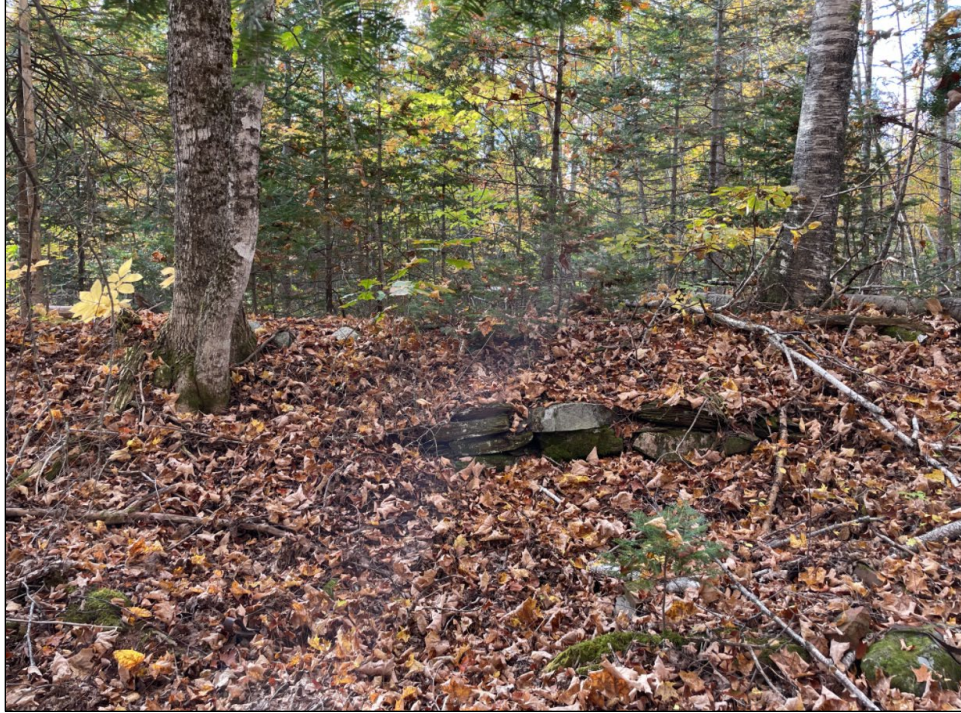
Figure 5-5. View from center of Site F-1 cellar hole, facing west.

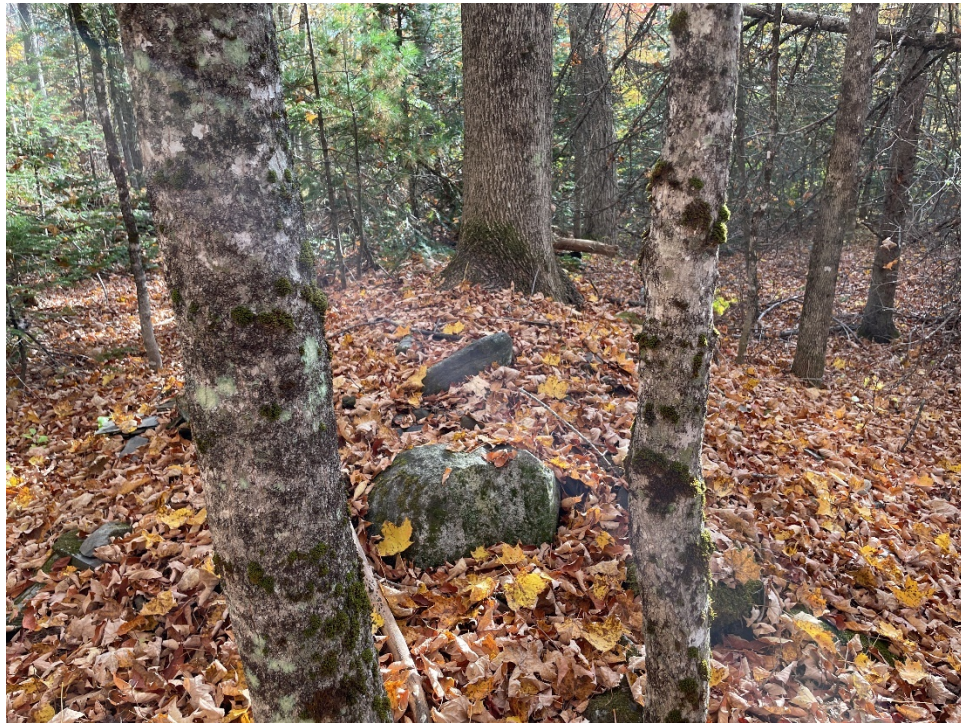
Figure 5-6. View south along possible yard feature at Site F-1.

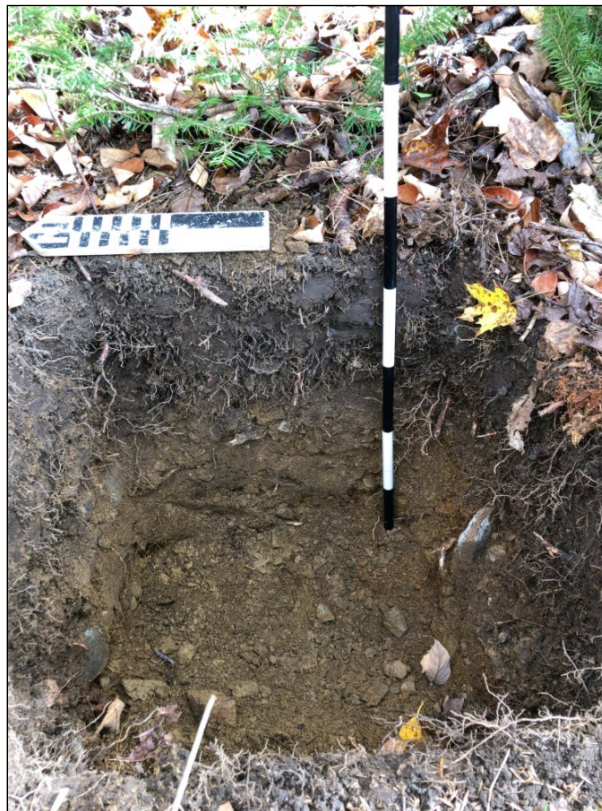
Figure 5-7. TA1-F1-2.5N east wall profile, facing east.

Artifacts were typically recovered from Ap horizon contexts (94.3%), with the remainder recovered from the BC horizon. The mean artifact density for positive STs was 90.6 (s.d. = 104.4), with a range from 2 to 206.

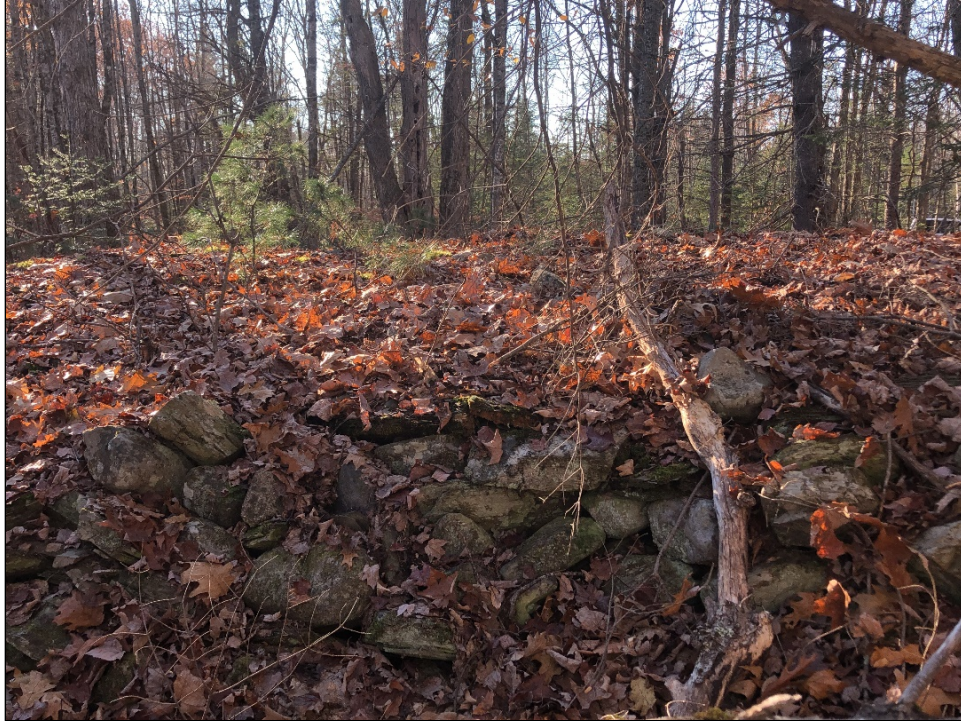
Figure 5-9. Northeast portion of Site MP-14 structure east wall, facing west.

Site MP-14 was initially identified by a dry-laid fieldstone structure observed during pedestrian reconnaissance. Further inspection during subsurface survey revealed that the structure is on the surface and does not enclose a cellar hole. It is characterized by a constructed stone containment wall on the northern, western, and eastern sides of the structure (**Figure 5-9** and **Figure 5-10**). The structure measures 9.7 m (31.8 ft) along the north wall by approximately 7.2 m (23.6 ft) along the east and west walls. The maximum wall height occurs along the north wall and is approximately 100 cm (39 in). The central area of the structure has a high concentration of small- to medium-sized rocks. The structure may be an aboveground ramp that possibly provided access to a barn or other agricultural outbuilding; however, no evidence of an associated building was identified.

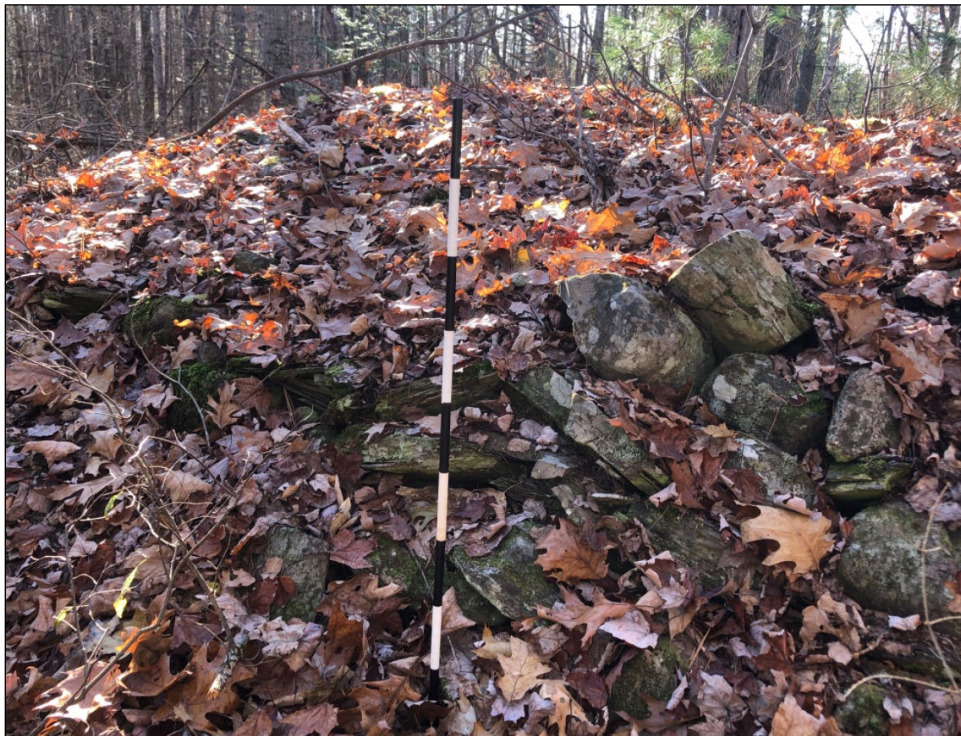
Figure 5-10. Southeast portion of Site MP-14 structure east wall, facing south.

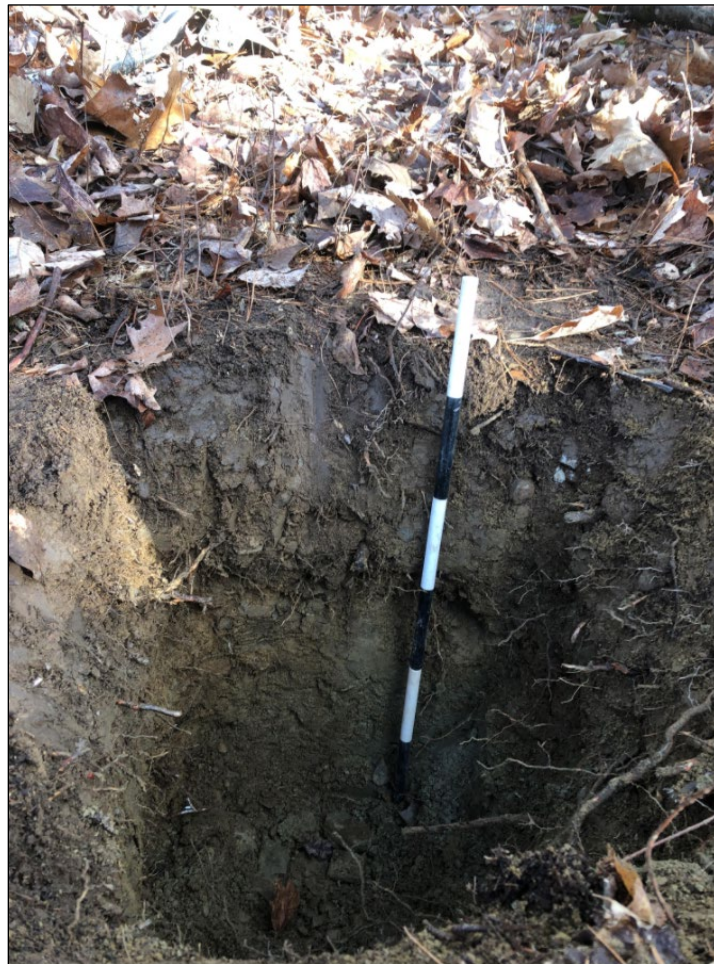
Figure 5-11. ST MP-14-20N east profile, facing east.

A typical ST soil sequence consisted of a dark brown (10YR 3/3) or brown (10YR 4/3) sandy loam Ap horizon to approximately 20.0 cm (7.9 in) bs overlying a brownish yellow (10YR 6/6) or dark yellowish brown (10YR 4/4) sandy loam BC horizon to approximately 40.0 cm (15.7 in) bs. STs were terminated due to degrading bedrock, rock impasse, or sterile soils. Observed stratigraphy was consistent with a truncated Tunbridge series pedon. The mean ST depth was 37.6 cm (14.8 in) (s.d. = 11.1). **Figure 5-11** shows the stratigraphy encountered in MP-14-20N.

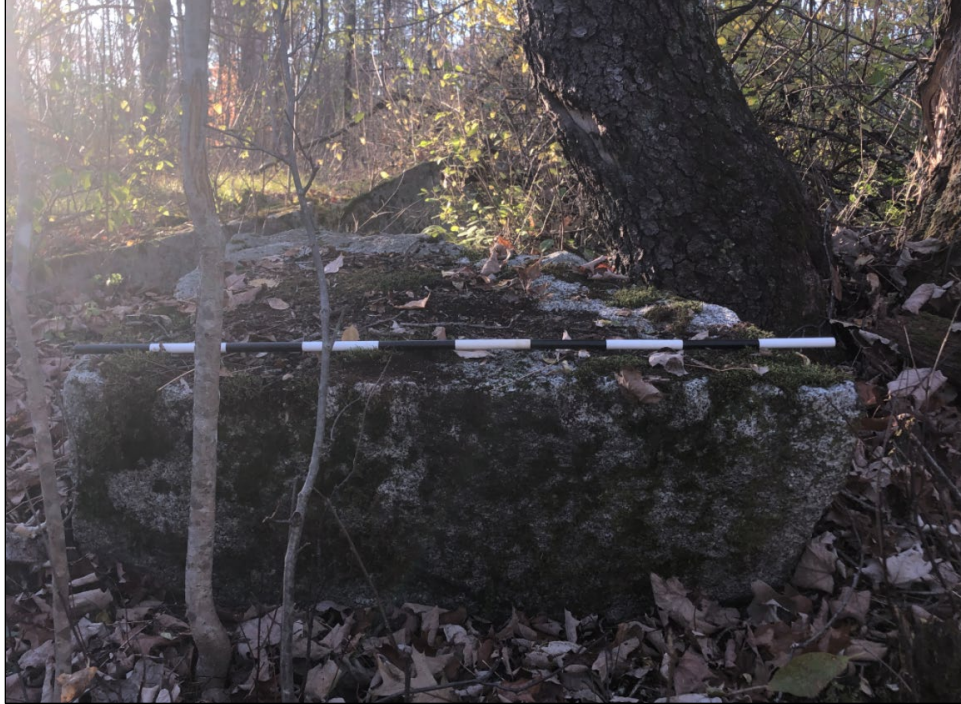
Figure 5-15. Southeast corner of footer at Site MP-15, facing west.

Site MP-15 was initially identified by a foundation observed during pedestrian reconnaissance. Further inspection during subsurface survey revealed that the foundation is characterized by a series of quarried granite blocks and other stones used as footers (**Figure 5-15** and **Figure 5-16**). The footers are arranged in four rows north to south, with interior footers displaced due to tree growth. The layout suggests a structure of 15.0 m (49.2 ft) north to south by 13.0 m (42.7 ft) east to west, likely a barn or other outbuilding. A rock and dirt berm and possible steps are on the south side of the foundation (**Figure 5-17**).

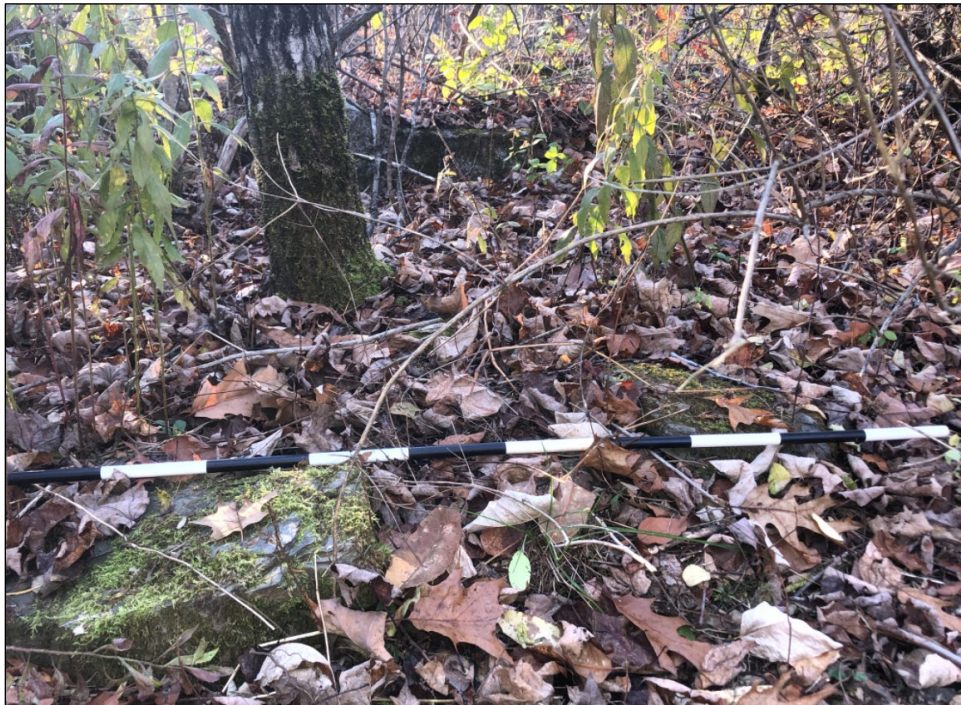
Figure 5-16. Slab footer at Site MP-15, facing west.

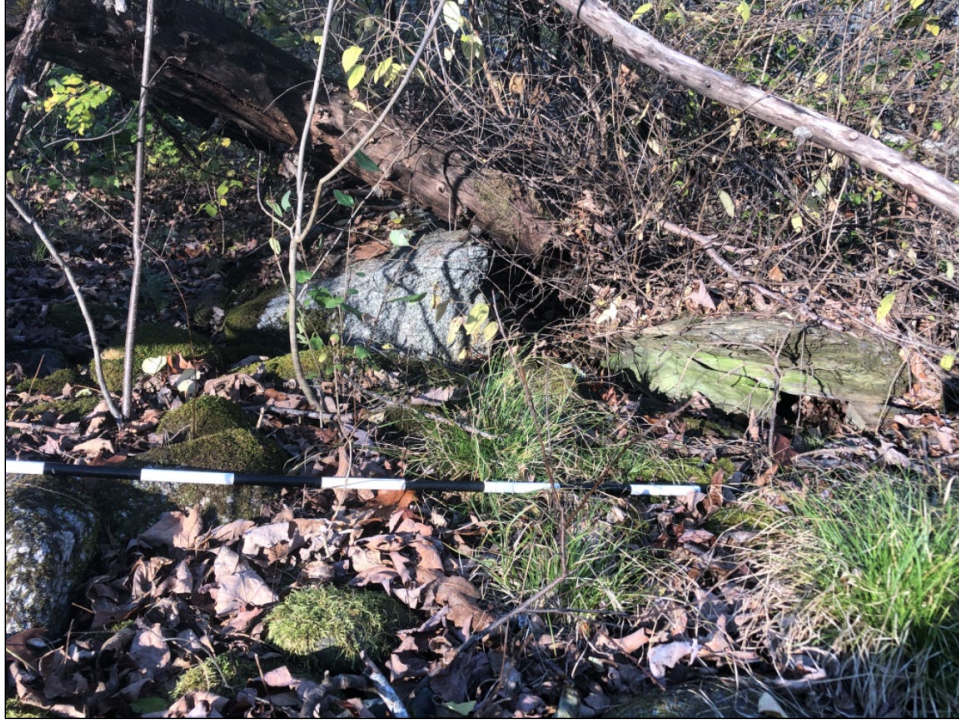
Figure 5-17. Overview of front entrance to structure at the southern extent of Site MP-15, facing north.

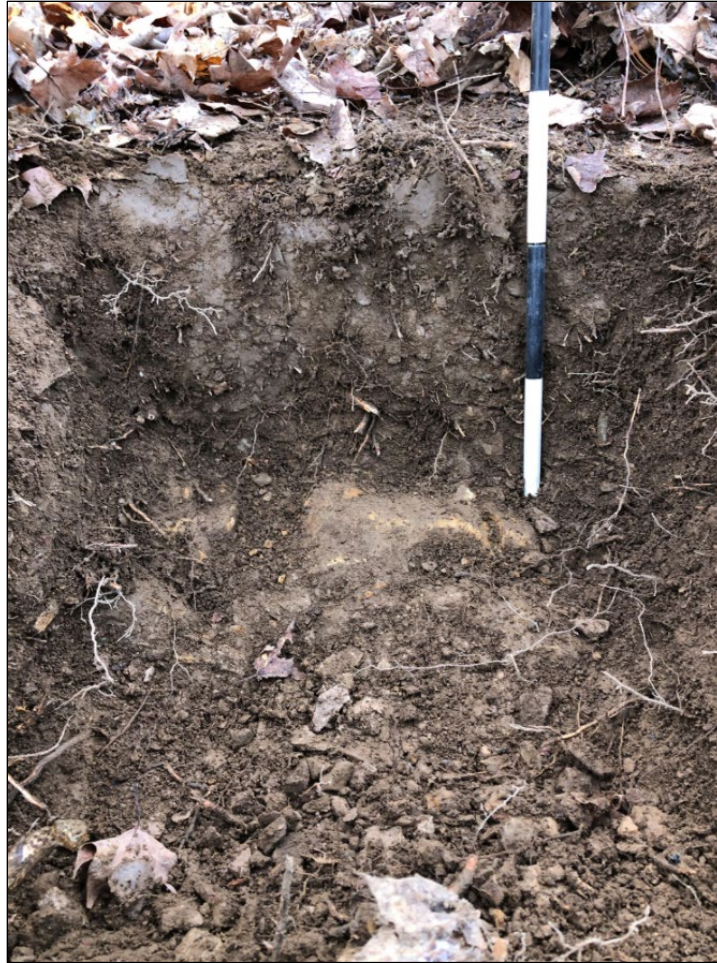
Figure 5-18. MP-15-3W west profile, facing west.

SEARCH excavated 10 STs at Site MP-15, four adjacent to the structure and the remainder at 10 m (33 ft) intervals from the approximate center of the structure. Two STs north of the structure were not excavated due to disturbance from logging staging and a laydown yard in this area. One ST was positive for cultural material, and defines the boundary of the site along with the remains of the structure. STs were typically terminated due to bedrock. The positive ST (MP-15-3W) consisted of a dark brown (10YR 3/3) sandy loam Ap matrix to approximately 26 cm (10 in) bs; the Ap rapidly transitioned with depth to a degrading shale bedrock of flat cobbles with 40% inclusions that increased until termination at bedrock. Observed stratigraphy is consistent with an eroded surface. The mean ST depth was 25.0 cm (9.8 in) (s.d. = 9.7). **Figure 5-18** shows the stratigraphy encountered in ST MP15-3W.

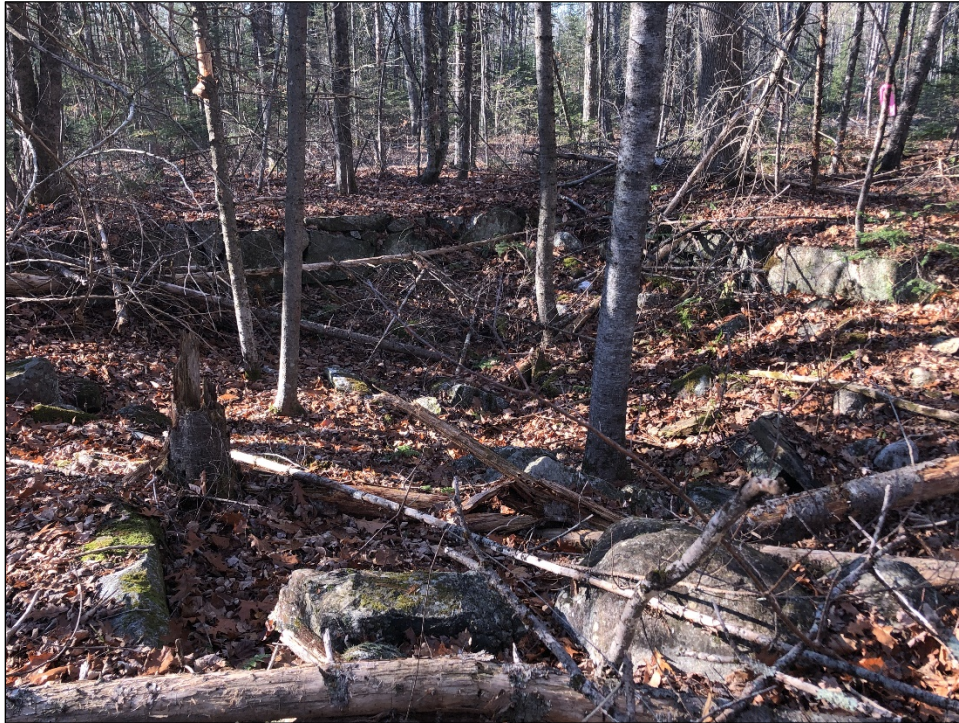
Figure 5-20. Overview of cellar hole at Site SW-9 from southeast corner, facing northwest.

Site SW-9 was initially identified from the historic foundation of a structure during pedestrian reconnaissance (**Figure 5-20**, **Figure 5-21**, and **Figure 5-22**). Further inspection during subsurface survey revealed that the foundation is a somewhat intact cellar hole measuring approximately 9.0 m (29.5 ft) east to west by 7.0 m (23.0 ft) north to south. The cellar hole is surrounded by a slight earthen berm less than 1.0 m (3.3 ft) high. Internally, the cellar hole is partially filled in with logging, tree fall debris, and some scattered stone. The foundation walls are dry-laid and consist of fieldstones and quarried material. The stones vary in size from boulders to cobbles.

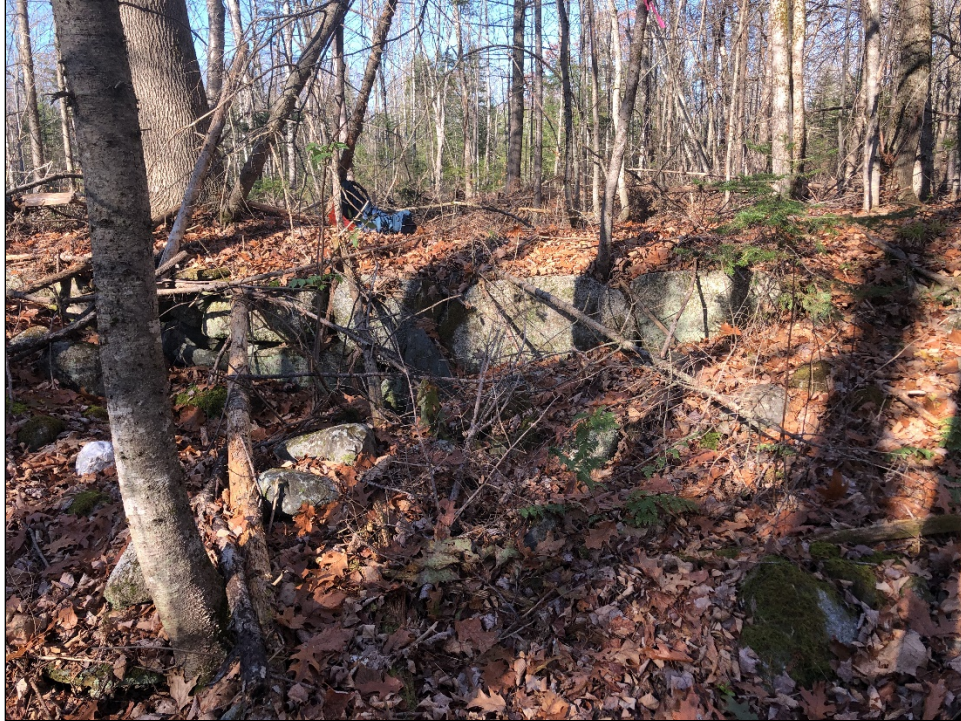
Figure 5-21. Interior of structure at Site SW-9, facing north.

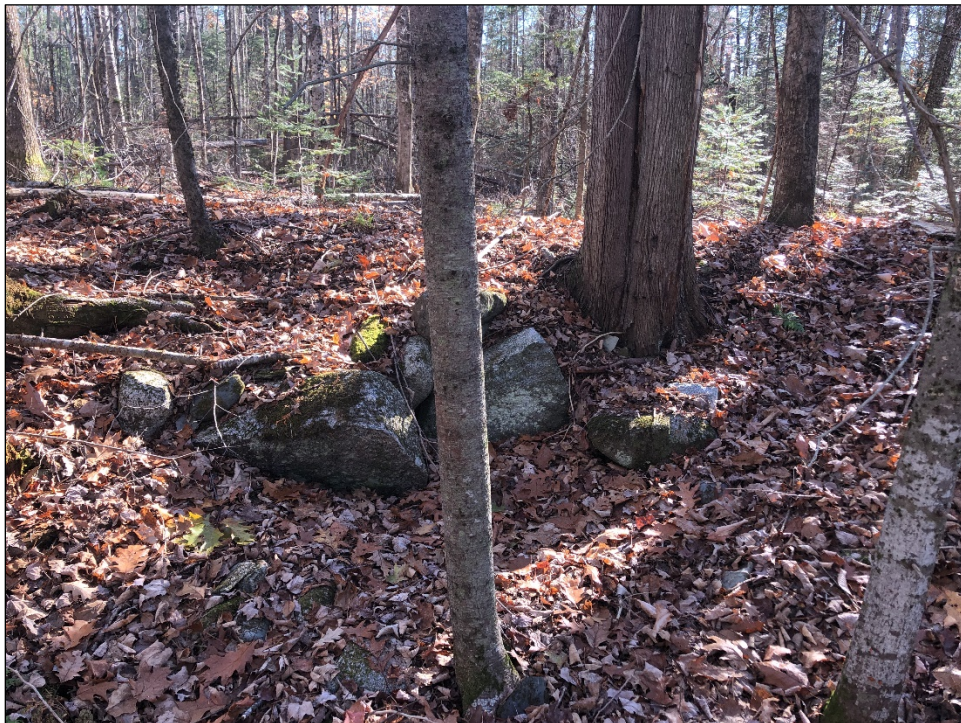
Figure 5-22. Interior of structure at Site SW-9, facing south.

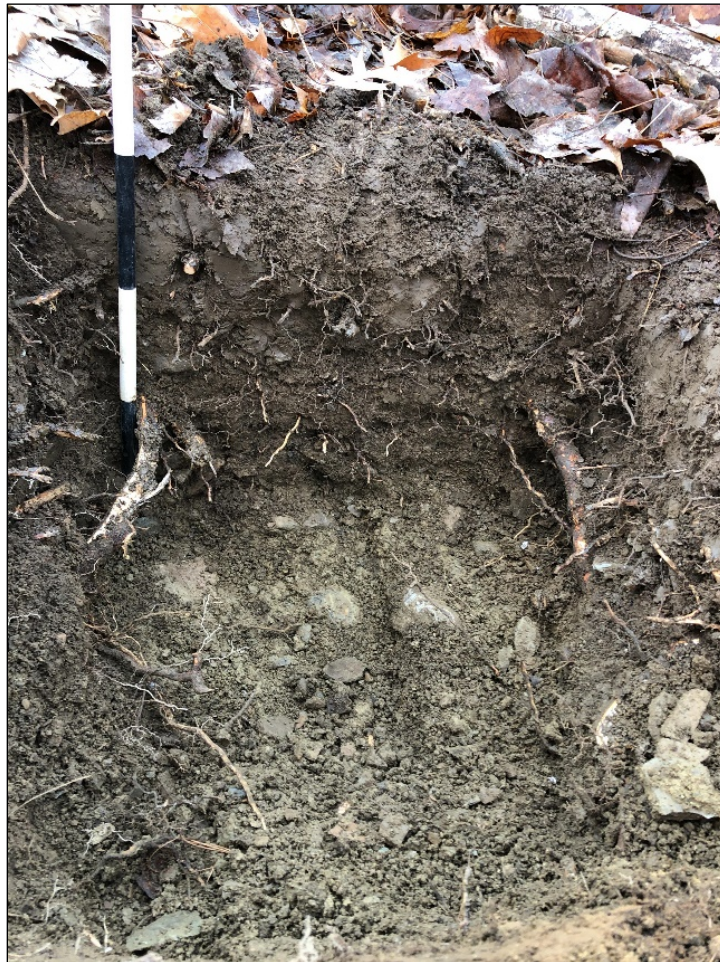
Figure 5-23. ST SW9-3E west profile, facing west.

SEARCH excavated 11 STs at Site SW-9, four adjacent to the structure and the remainder at 10 m (33 ft) intervals from the approximate center of the structure. One ST west of the structure were not excavated due to disturbance from logging. Four STs were positive for cultural material and define the extent of the site boundary along with the remnants of the historic structure. All positive STs were adjacent to the cellar hole. Soils consist of primarily two stratigraphic layers, a dark brown (10YR 3/3) sandy loam Ap horizon overlying a brownish yellow (10YR 6/6) sandy loam BC horizon. STs were typically terminated on underlying degrading bedrock or bedrock. Observed stratigraphy was consistent with a truncated Tunbridge series pedon. The mean ST depth of negative and positive STs was 33.5 cm (13.2 in) bs (s.d. = 6.7). **Figure 5-23** shows the stratigraphy encountered in ST SW9-3E.

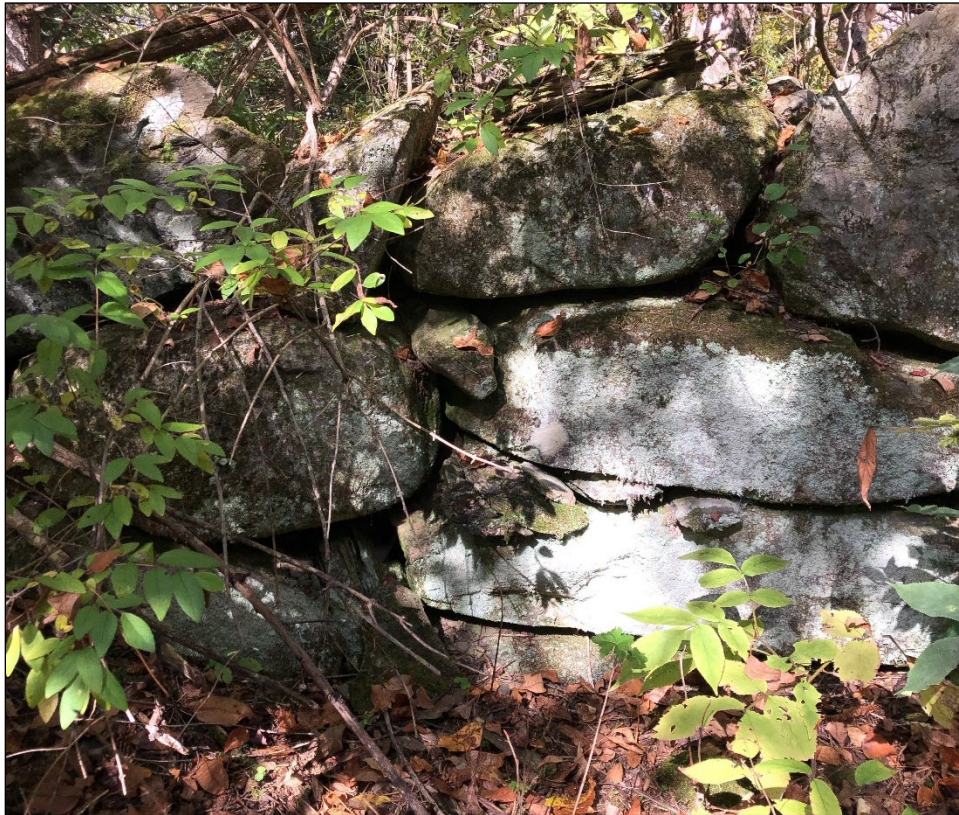
Figure 5-25. North wall of the Site F-2 foundation, facing north.

Site F-2 was initially identified by a dry-laid fieldstone foundation/cellar hole during pedestrian reconnaissance. Further inspection during subsurface survey revealed a cellar hole measuring approximately 6.0 m (19.7 ft) north–south by 5.5 m (18.0 ft) east–west (Error! Reference source not found.). The southern and western walls of the foundation were disturbed and somewhat difficult to trace, whereas the northern and eastern walls were largely intact. Displaced foundation stones were identified west and northwest of the original structure during the survey (Error! Reference source not found.).

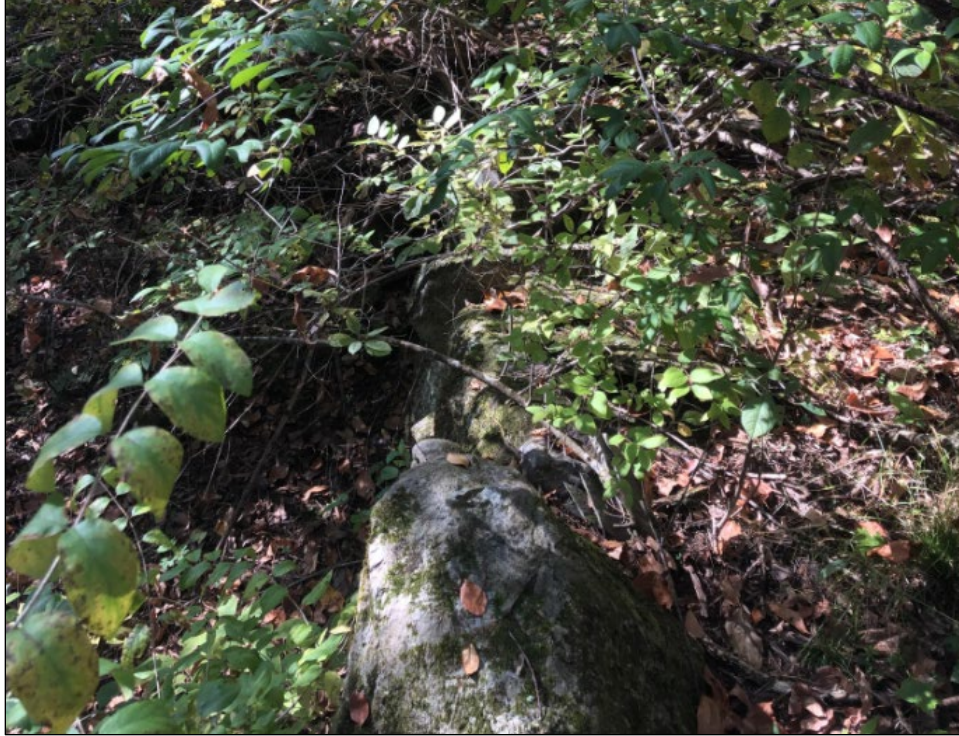
Figure 5-26. View from northeast corner of Site F-2 foundation, facing west.

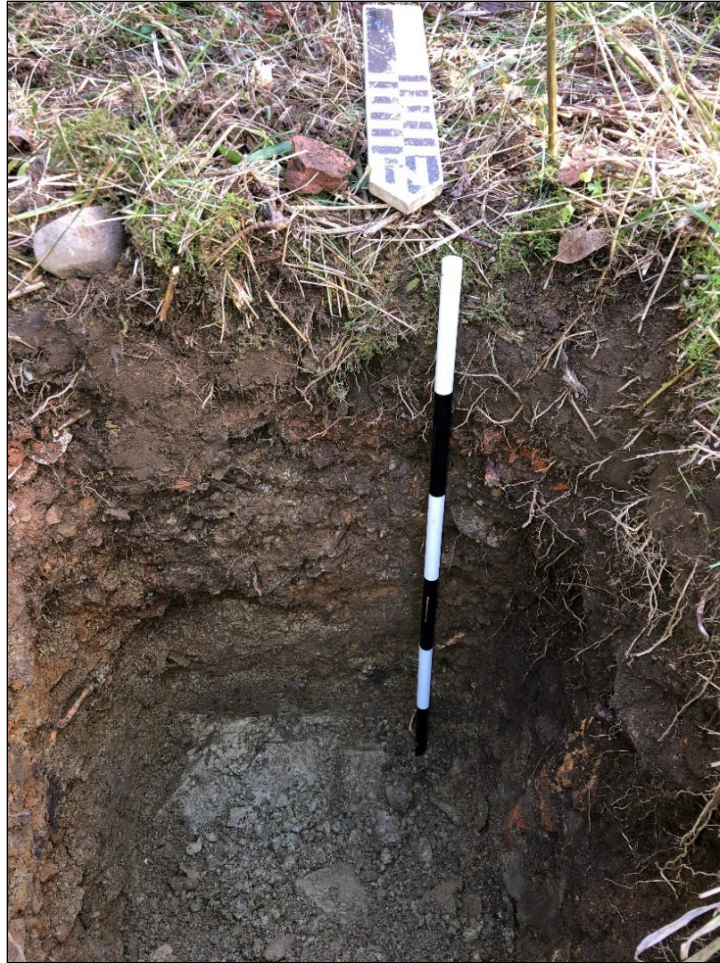
Figure 5-27. TA2-TR4-2 south profile, facing south.

Artifacts were typically recovered from Ap horizon contexts (57.0%), with the remainder recovered from the B horizon. The mean artifact density for positive STs was 25.3 (s.d. = 41.3), with a range from 3 to 87.

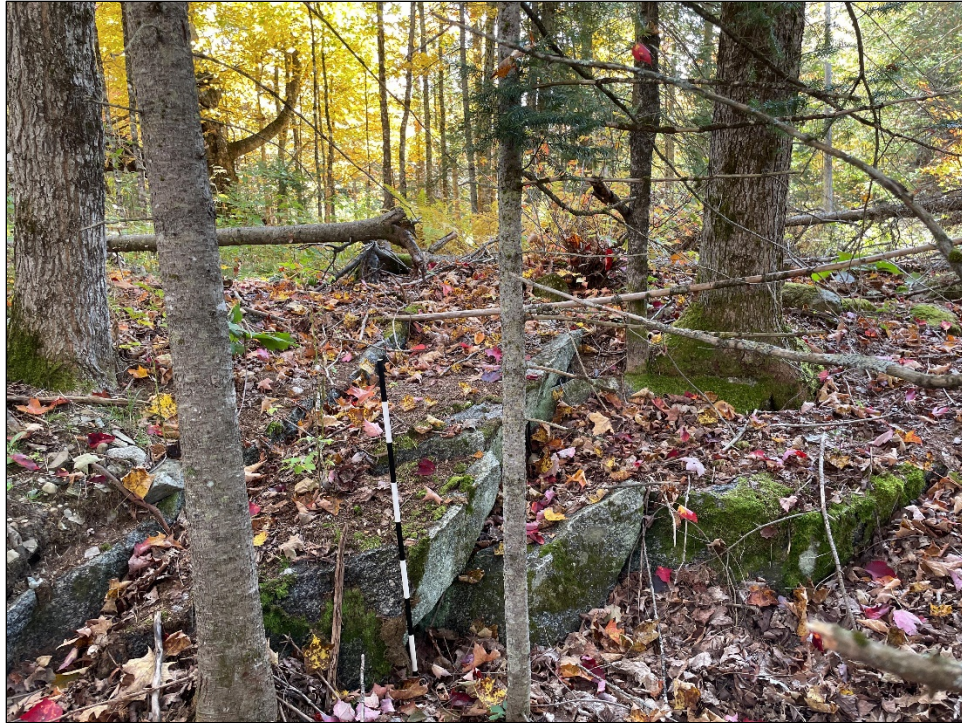
Figure 5-29. Foundation at Site F-3, facing south.

Site F-3 was initially identified by a foundation during pedestrian reconnaissance. Further inspection during subsurface survey revealed a shallow cellar hole measuring approximately 7.5 × 5.5 m (24.6 × 18.0 ft), formed by quarried granite slabs (**Figure 5-29** and **Figure 5-30**). The eastern wall is not perpendicular or parallel to the remaining walls, and is likely disturbed. A mature maple tree is 10.1 m (33.2 ft) southeast of the foundation (**Figure 5-31**), and small brick scatters occur 7.0 m (22.9 ft) south and 14.2 m (46.6 ft) east of the foundation (**Figure 5-32**).

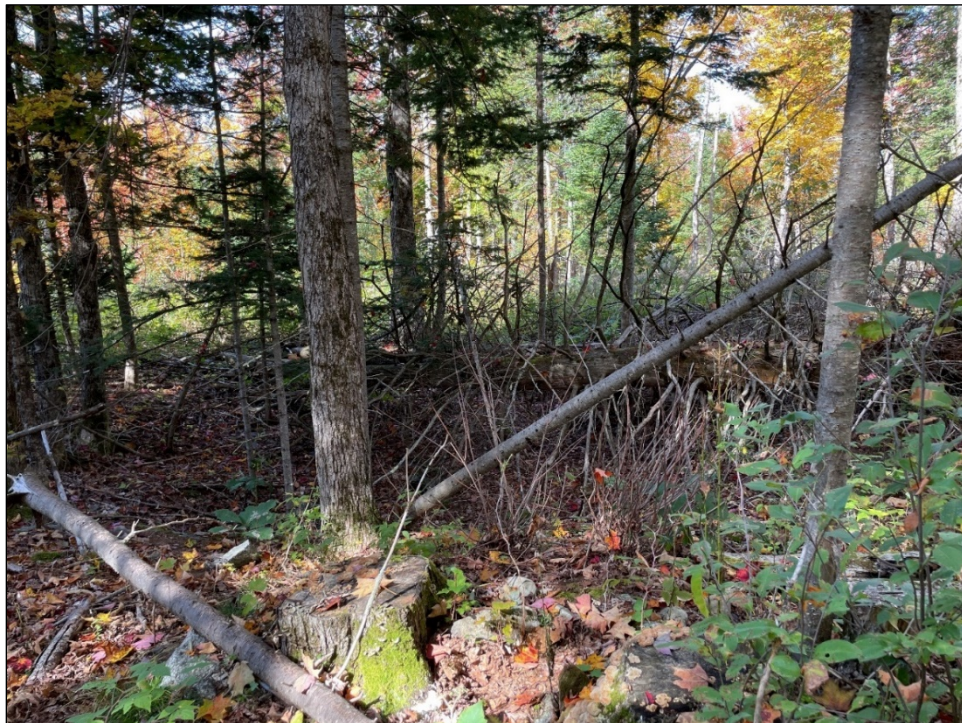
Figure 5-30. Southeast corner of foundation at Site F-3, facing northwest.

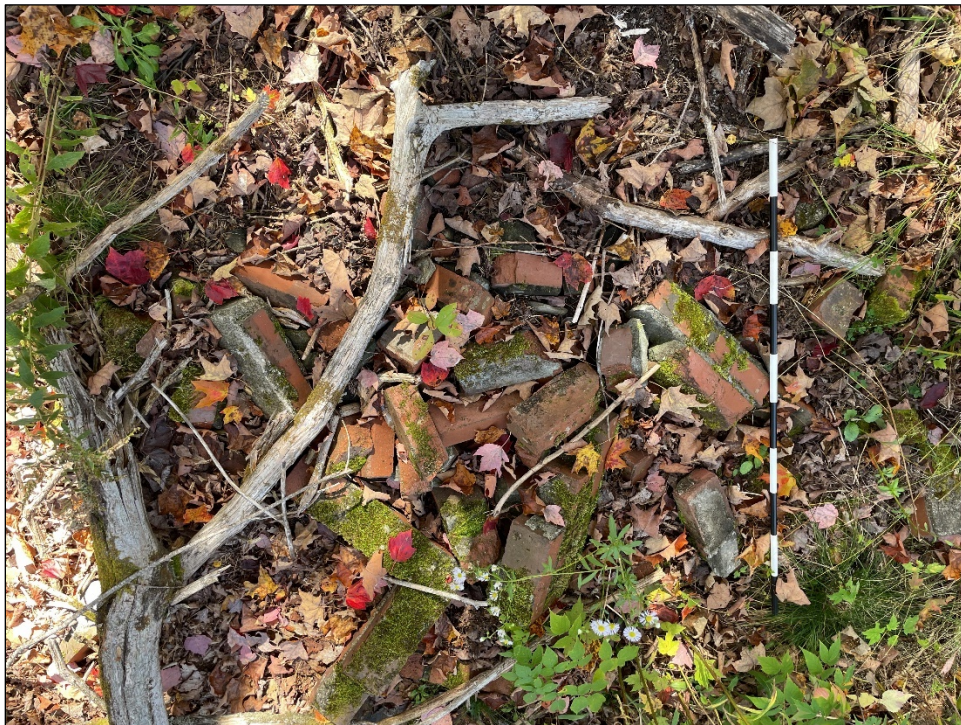
Figure 5-32. Brick scatter east of foundation at Site F-3, facing north.

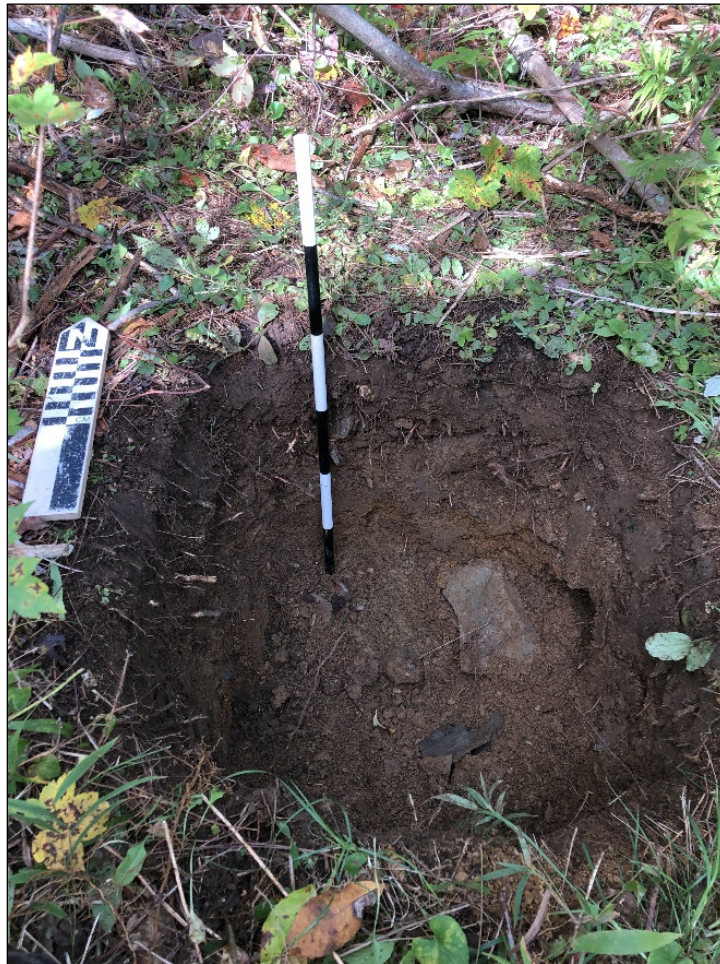
Figure 5-33. ST TR-2-6 north profile, facing north.

ST soil sequences varied in the vicinity of the site; however, the predominant sequence consisted of a dark-reddish brown (2.5YR 3/4) silty loam horizon to approximately 20.0 cm (7.9 in) bs over a red (2.5YR 4/6) silty loam horizon to 35.0 cm (13.8 in) bs. These horizons suggest a truncated Tunbridge series soil is present. SEARCH identified shale gravel over cobbles in Stratum II of two STs in the southern and eastern vicinity of the site. Termination was typically due to rock impasse or sterile soils. The mean ST depth was 25.7 cm (10.1 in) bs (s.d. = 5.5). **Figure 5-33** shows the stratigraphy encountered in ST TR-2-6.
