8.2 PHASE I ARCHAEOLOGICAL AND ARCHITECTURAL SURVEYS

Three Corners Solar Project

MDEP Site Location of Development Act Permit Application

SECTION 8: HISTORIC SITES

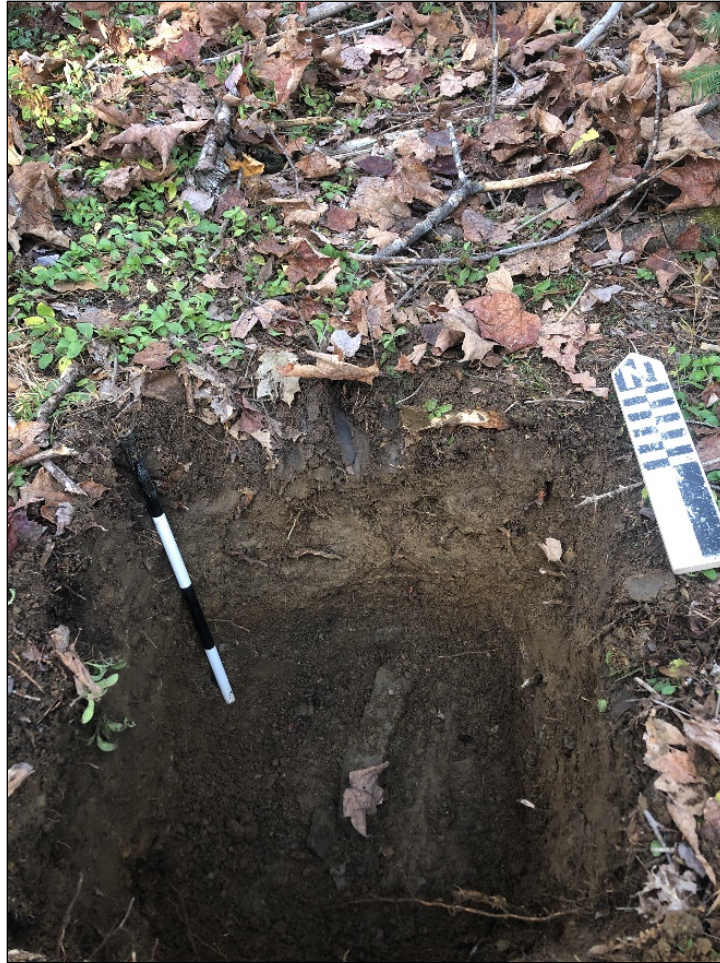
Figure 5-34. ST MPTR1-1 north profile, facing north.

TA-02 MPTR-1 consists of three STs placed to test an elevated ridge that overlooks the Sebec River valley. STs were numbered from north to south. A typical ST soil sequence encountered in TA-02 MPTR-1 consisted of a dark yellowish brown (10YR 3/4) sandy loam to approximately 15.0 cm (5.9 in) bs over a strong brown (7.5YR 4/6) sandy loam to approximately 35.0 cm (13.8 in). Underneath was a light olive brown (2.5Y 5/4) sandy clay loam to a depth of 45.0 cm (17.7 in). STs were terminated due to rock impasse or sterile soils. Approximately 10%–35% angular gravel and cobble were encountered throughout. The mean ST depth was 40.0 cm (15.7 in) with a range from 33.0 to 45.0 cm (13.0 to 17.7 in) and a standard deviation of 6.2 cm (2.4 in). **Figure 5-34** shows the stratigraphy encountered in ST MPTR1-1.

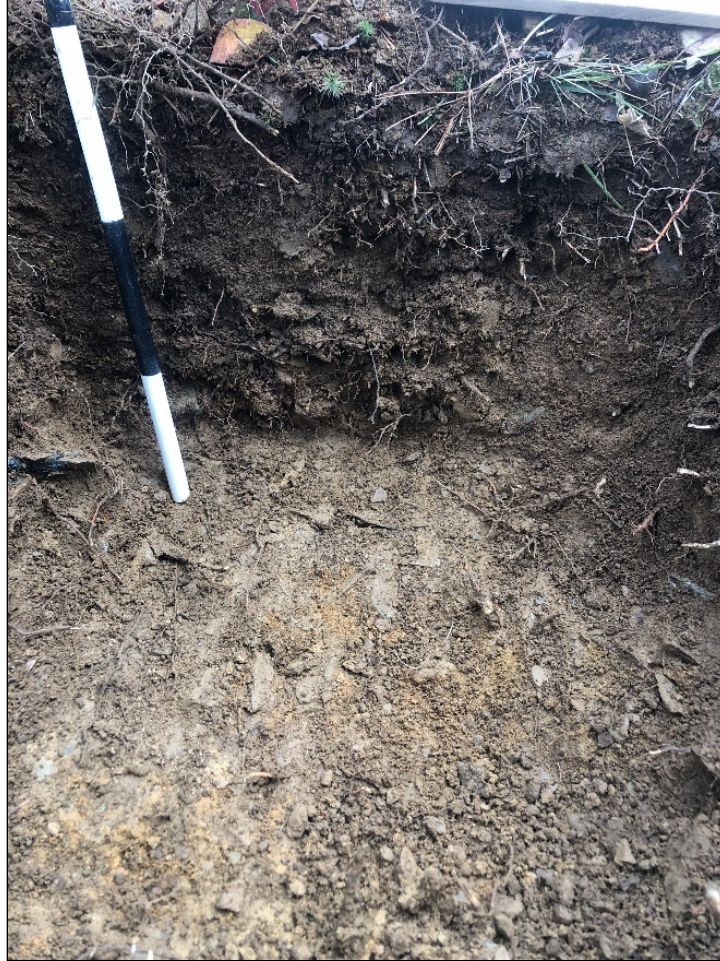
Figure 5-35. ST MPTR2-2 east profile, facing east.

TA-02 MPTR-2 consists of three STs placed to test the location of an elevated ridge that overlooks the Sebasticook River valley. STs were numbered from north to south. A typical ST soil sequence encountered in TA-02 MPTR-2 consisted of a dark yellowish brown (10YR 3/4) loamy sand to approximately 18.0 cm (7.1 in) bs over a dark yellowish brown (10YR 4/6) sandy loam to approximately 34.0 cm (13.4 in) bs. STs were terminated due to bedrock or rock impasse. The mean ST depth was 36.3 cm (14.3 in) with a range from 30.0 to 45.0 cm (11.8 to 17.7 in) and a standard deviation of 7.8 cm (3.1 in). **Figure 5-35** shows the stratigraphy encountered in ST MPTR2-2.

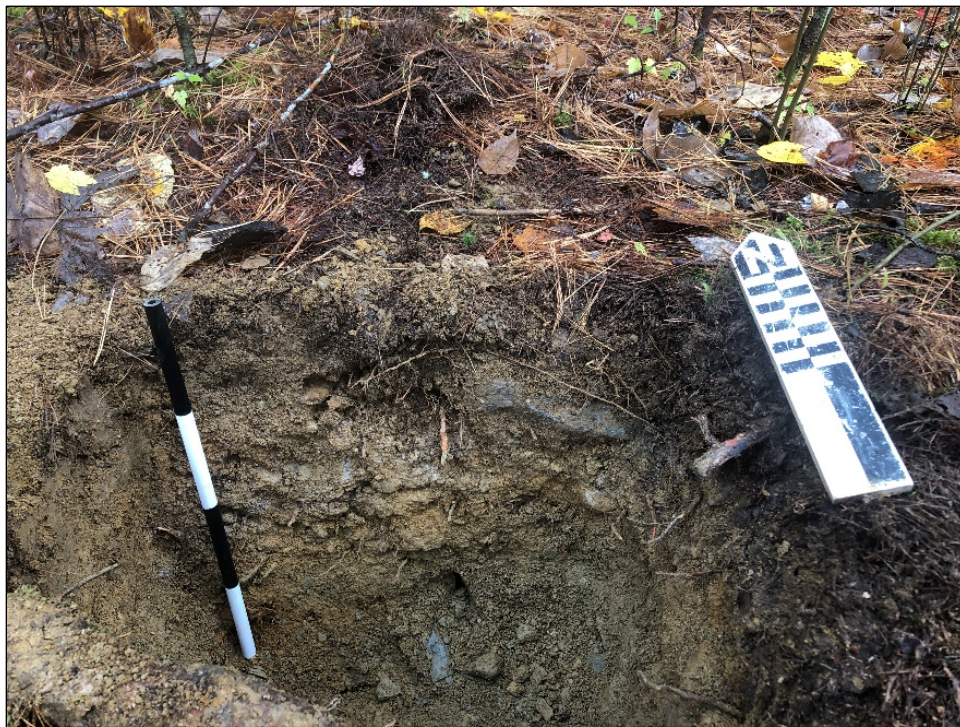
Figure 5-37. TA3-TR1-5 north profile, facing north.

A typical ST soil sequence encountered in TA3-TR1 consisted of a brown (10YR 3/2) sandy loam Ap horizon to approximately 10.0 cm (3.9 in) bs over a strong brown (7.5YR 4/6) loamy sand Bs horizon to approximately 20.0 cm (7.9 in) bs. Stratum III generally consists of grayish brown (2.5Y 5/2) sand BC horizon to approximately 35.0 cm (13.8 in) bs. Stratigraphy encountered was consistent with a truncated Lyman series profile. STs were terminated due to sterile soils or rock impasse. The mean ST depth was 36.0 cm (14.2 in) with a range from 30.0 to 46.0 cm (11.8 to 18.1 in) and a standard deviation of 6.1 cm (2.4 in). **Figure 5-37** shows the stratigraphy encountered in ST TA3-TR1-5.

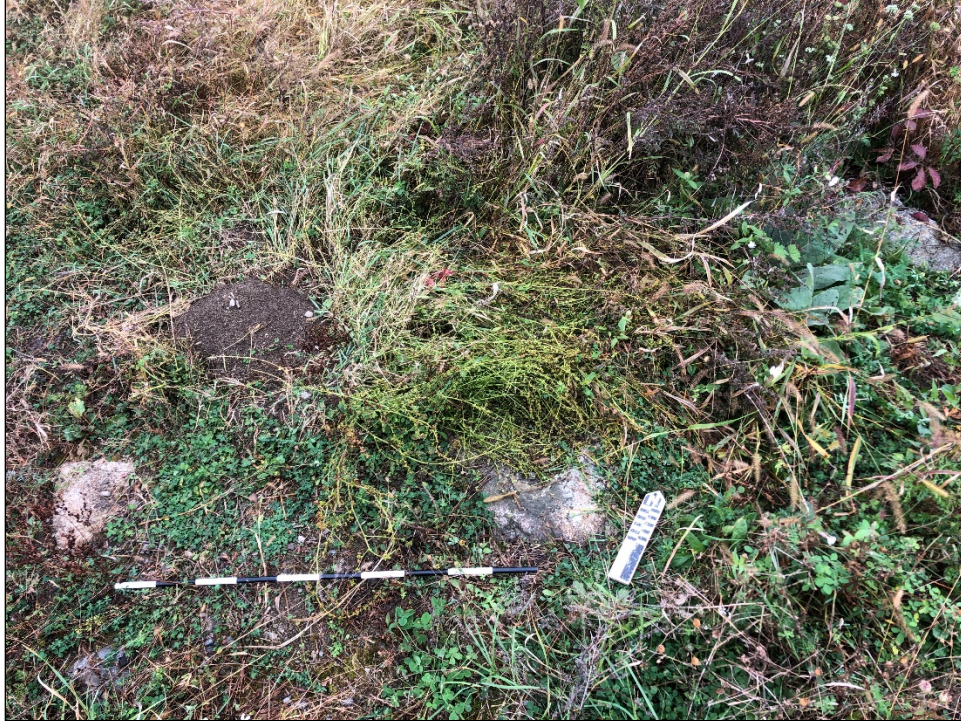
Figure 5-42. Remnant foundation at Site F-4, looking north.

Site F-4 was initially identified by a heavily disturbed fieldstone foundation during pedestrian reconnaissance (**Figure 5-42**). The foundation is on the north side of Palmer Road between several agricultural fields, and there is a small solar panel nearby as well. Palmer Road is used by timbering operations as well as farm equipment, and heavy machinery operation in the site vicinity has likely impacted the site, including the foundation. Further inspection during subsurface survey suggested that the disturbed foundation may be the remnants of a cellar hole that has been infilled with debris (**Figure 5-43**). Estimated dimensions on the possible cellar hole are 14.6 m (47.9 ft) east–west by 10.4 m (34.2 ft) north–south. A stone-lined well was identified approximately 26.6 m (87.2 ft) south-southwest of the possible cellar hole. The well was about 1.5 m in diameter with modern debris scattered around the surface. Evidence of mechanical disturbance was observed in association with the well.

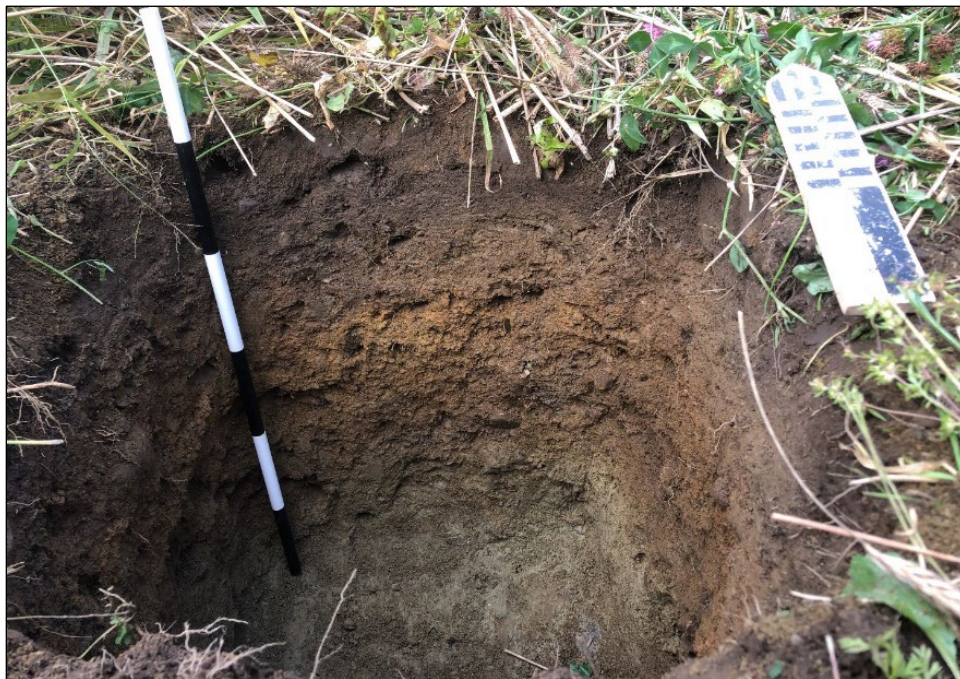
Figure 5-44. ST TA4-F4-20S north profile, facing north.

Artifacts were typically recovered from Ap horizon contexts (89.5%), with the remainder recovered from the B horizon. SEARCH recovered eight artifacts from TA4-F4-2.5N and 11 artifacts from TA4-F4-20S.

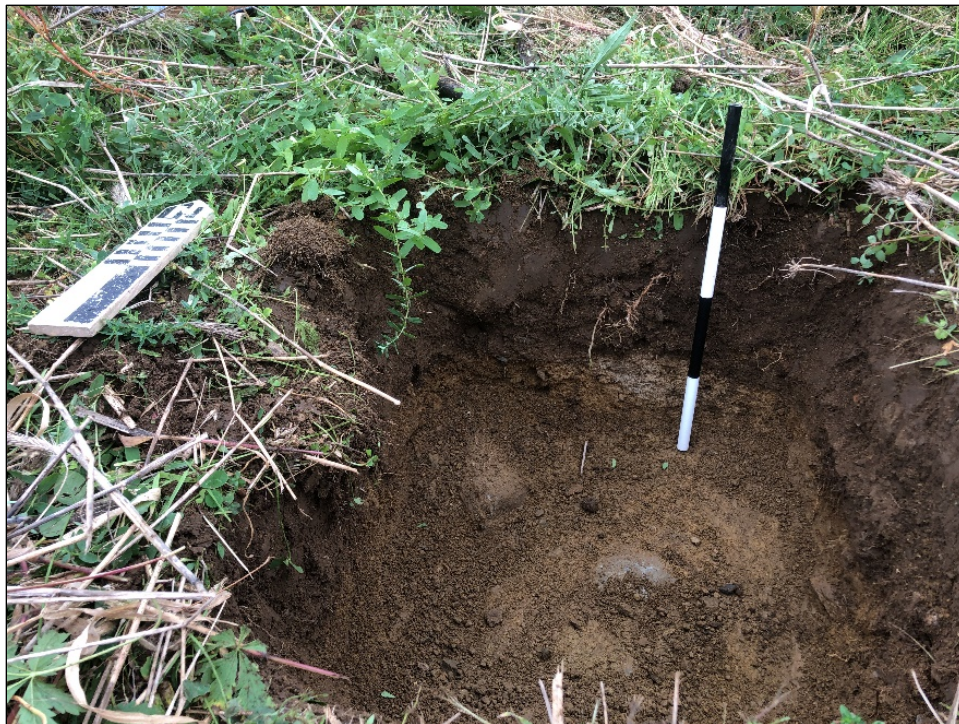
Figure 5-45. ST TA4-TR1-3 north profile, facing north.

TA-04 TR-1 consists of 11 STs placed to test north of Site F-4. STs were numbered from south to north. A typical ST soil sequence encountered in TA-04 TR-1 consisted of a dark brown (10YR 3/3) sandy loam to approximately 20.0 cm (7.9 in) bs over a strong brown (7.5YR 4/6) loamy sand to approximately 45.0 cm (17.7 in) bs. STs were terminated due to rock impasse or sterile soils. Approximately 5% to 65% round and subrounded gravel as well as 20% to 60% subrounded and subangular cobble was present in the STs. The mean ST depth was 43.7 cm (17.2 in) with a range from 34.0 to 53.0 cm (13.4 to 20.9 in) and a standard deviation of 6.2 cm (2.4 in). **Figure 5-45** shows the stratigraphy encountered in ST TA4-TR1-3.

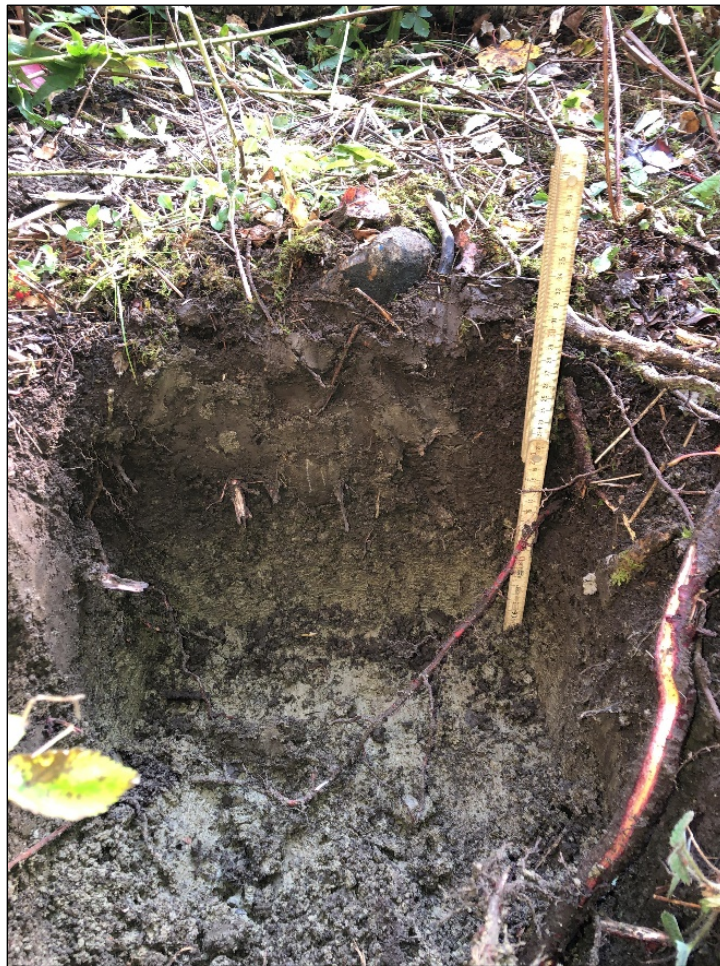
Figure 5-46. ST TA1-TR3-5 south profile, facing south.

TA-05 TR-3 consists of six STs placed to test the location of a possible structure documented on mid-nineteenth-century maps of Kennebec County (Southwick and Chace 1856). STs were numbered from south to north. A typical ST soil sequence encountered in TA-05 TR-3 consisted of a dark brown (10YR 3/3) sandy loam to approximately 17.0 cm (6.7 in) bs over a light olive brown (2.5Y 5/6) to approximately 30.0 cm (11.8 in) bs. STs were terminated due to sterile soils. The mean ST depth was 31.5 cm (12.4 in) with a range from 18.0 to 38.0 cm (7.1 to 15.0 in) and a standard deviation of 7.4 cm (2.9 in). **Figure 5-46** shows the stratigraphy encountered at ST TA1-TR3-5.

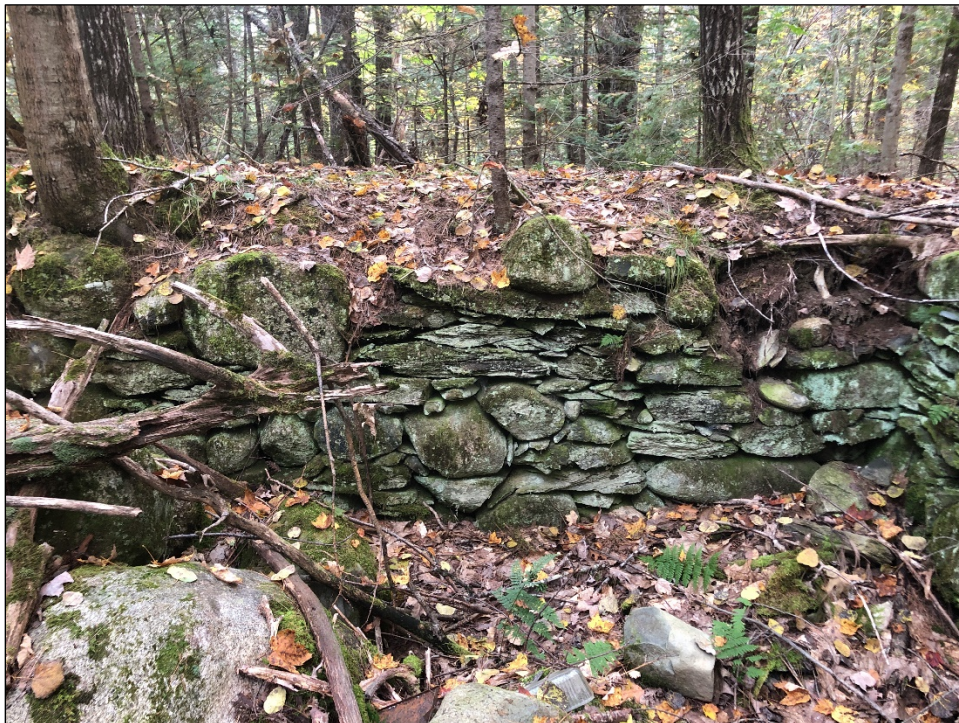
Figure 5-49. North wall of cellar hole at Site F-6, looking north.

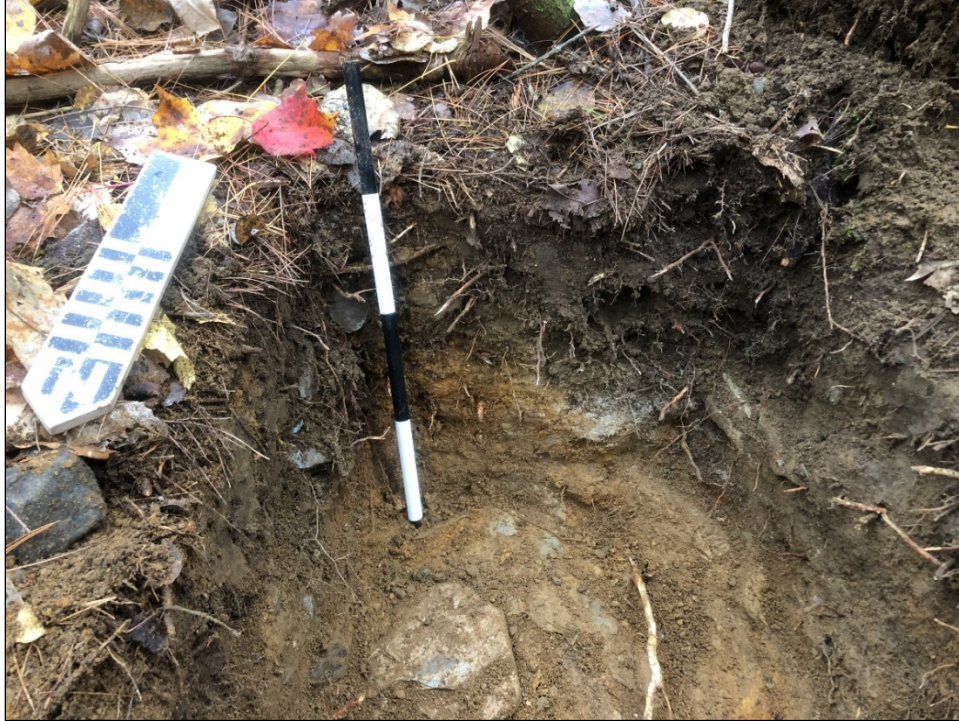
Figure 5-51. TA6-F6-2.5N south wall profile, facing south.

A typical ST encountered a brown (10YR 4/3) sandy loam Ap horizon to a depth of approximately 20.0 cm (7.9 in) bs over a grayish brown (2.5Y 5/2) sand BC horizon or dark yellowish brown (10YR 4/6) loamy sand to an approximate depth of 40.0 cm (15.7 in) bs. STs were typically terminated due to rock impasse or sterile soils. The mean ST depth of STs was 37.7 cm (14.8 in) bs (s.d. = 14.7). **Figure 5-51** shows the stratigraphy encountered in ST TA6-F6-2.5N.

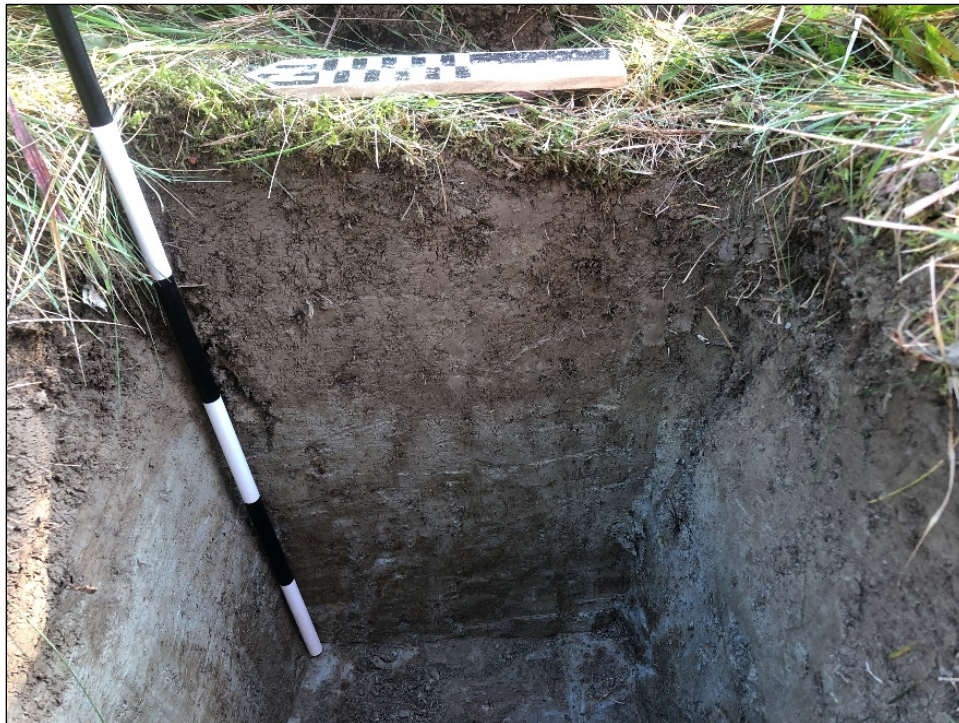
Figure 5-52. TA7-TR1-5 east wall profile, facing east.

TA-07 TR-1 consists of six STs that were placed to conduct limited testing of an area identified sensitive for precontact archaeological material. During pedestrian reconnaissance, soils in the vicinity of TR-1 appeared less disturbed with lower instances of stony or gravelly inclusions when compared to other portions of the study area. STs were numbered from east to west. A typical ST soil sequence encountered in TA-07 TR-1 consisted of a brown (10YR 4/3) silty clay loam to approximately 20.0 cm (7.9 in) bs over a grayish brown (2.5Y 5/2) silty clay to approximately 40.0 cm (15.7 in) bs. SEARCH staff noted compacted soils and evidence of glacial outwash in three STs. STs were generally terminated due to sterile soils. The mean ST depth was 41.8 cm (16.5 in) with a range from 32.0 to 51.0 cm (12.6 to 20.0 in) and a standard deviation of 7.3 cm (2.9 in). **Figure 5-52** shows the stratigraphy encountered at TA7-TR1-5.

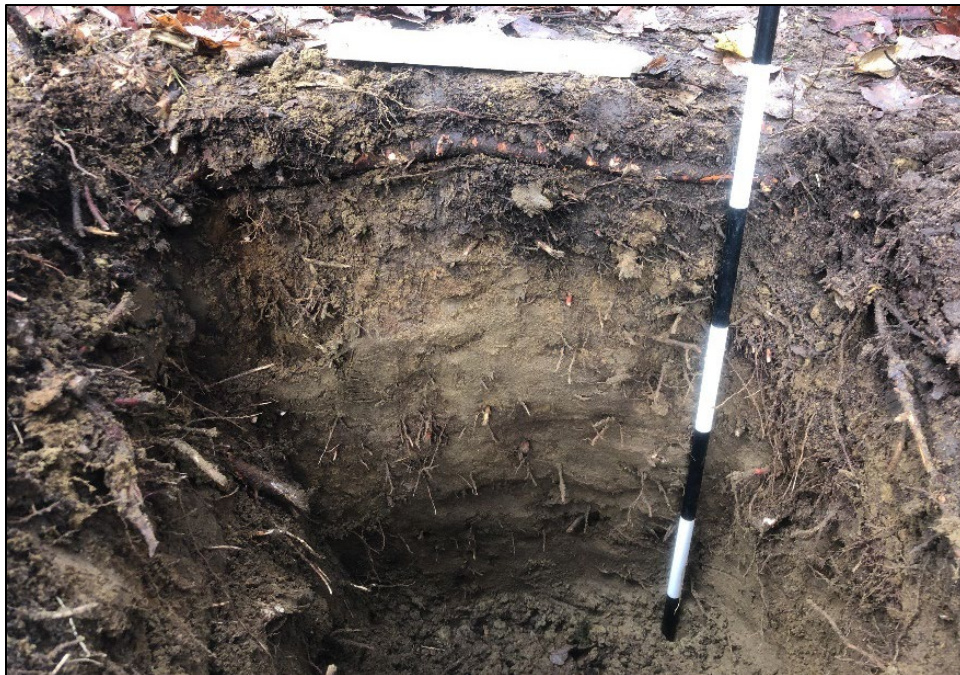
Figure 5-53. TA8-TR1-3 west wall profile, facing west.

TA-08 TR-1 consists of six STs placed to test the location of possible remnants of a historic structure and possible well associated with a mature sugar maple tree identified during pedestrian reconnaissance. STs were numbered from east to west. ST-4 was not excavated due to the presence of a wide ephemeral drainage. A typical ST soil sequence encountered in TA-08 TR-1 consisted of a dark brown (10YR 3/3) sandy loam to approximately 17.0 cm (6.7 in) bs over a dark yellowish brown (10YR 4/6) loamy sand or yellowish brown (10YR 5/6) silty clay to 38.0 cm (15.0 in) bs. STs were generally terminated due to sterile soils or large roots. The mean ST depth was 38.4 cm (15.1 in) with a range from 31.0 to 56.0 cm (12.2 to 22.0 in) and a standard deviation of 10.6 cm (4.2 in). **Figure 5-53** shows the stratigraphy encountered at TA8-TR1-3.

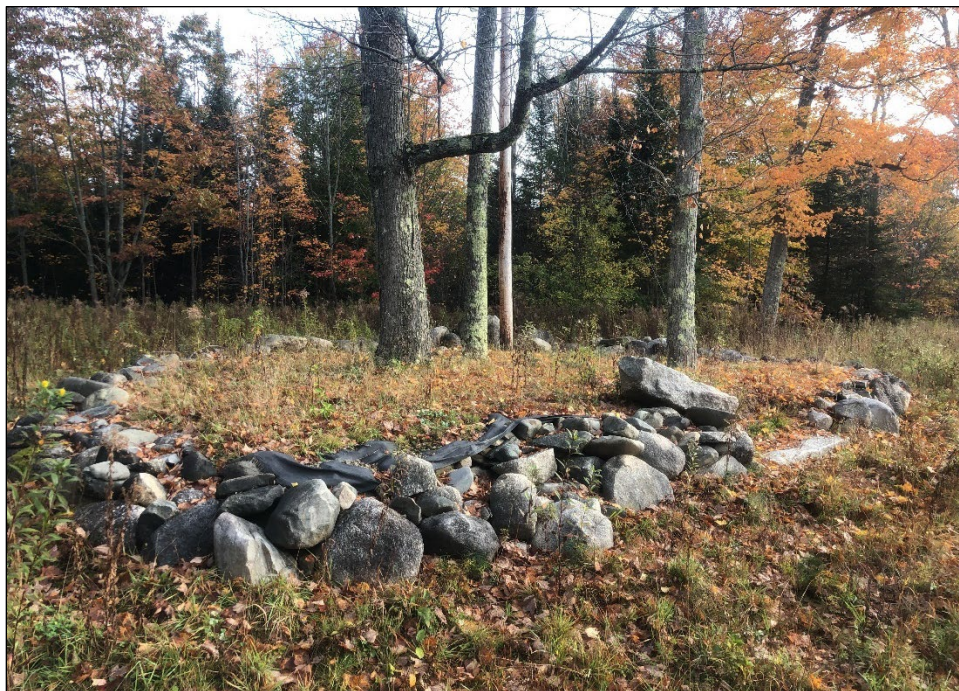
Figure 5-54. Modern circular stone and fill feature in TA-09, looking northeast.

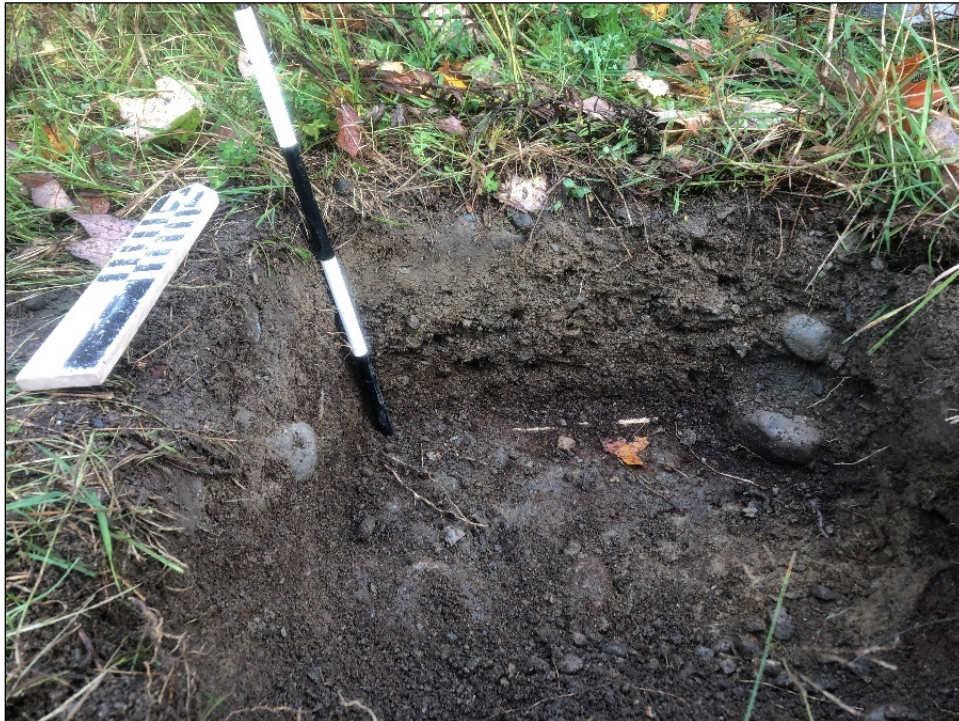
Figure 5-56. TA9-TR1-5 north wall profile, facing north.

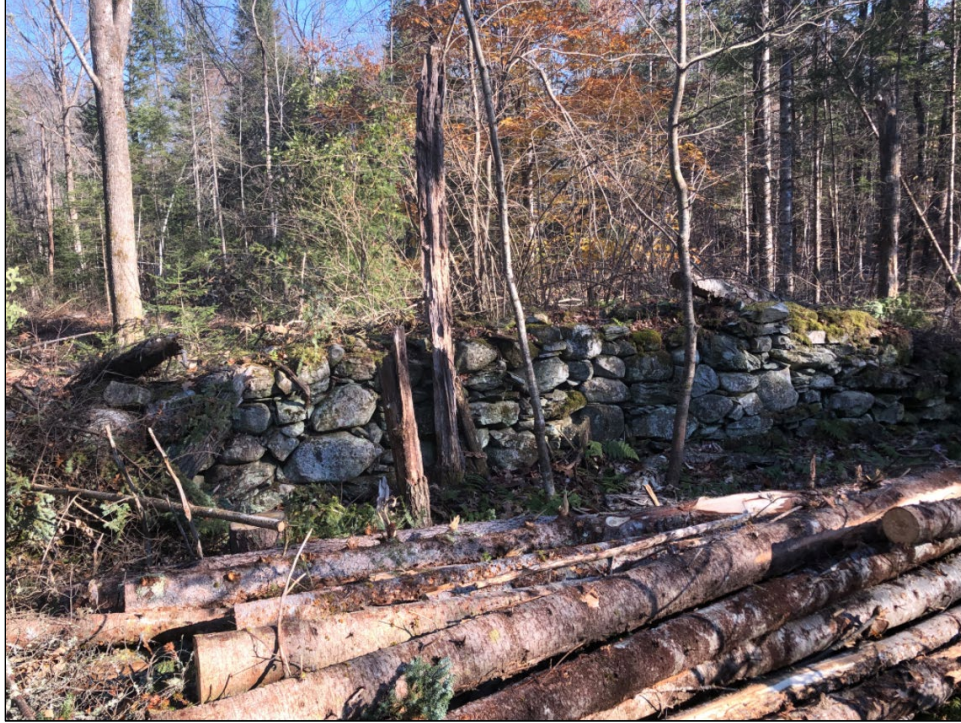
Figure 5-58. Intact southern wall of structure at Site MP-1, facing northeast.

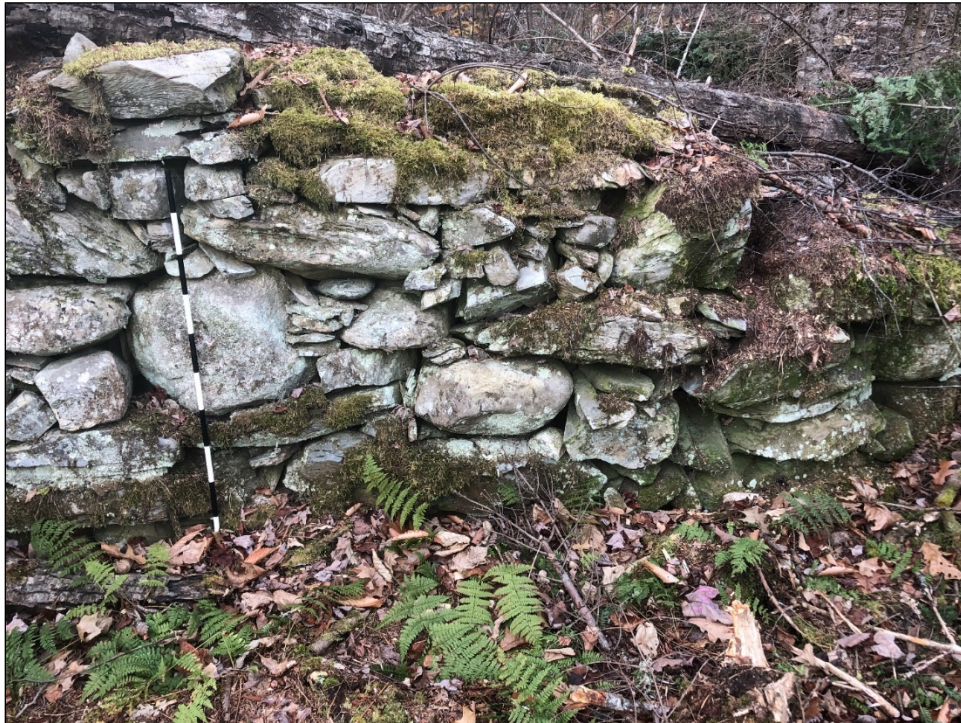
Figure 5-59. East half of intact south wall of structure at Site MP-1, facing north.

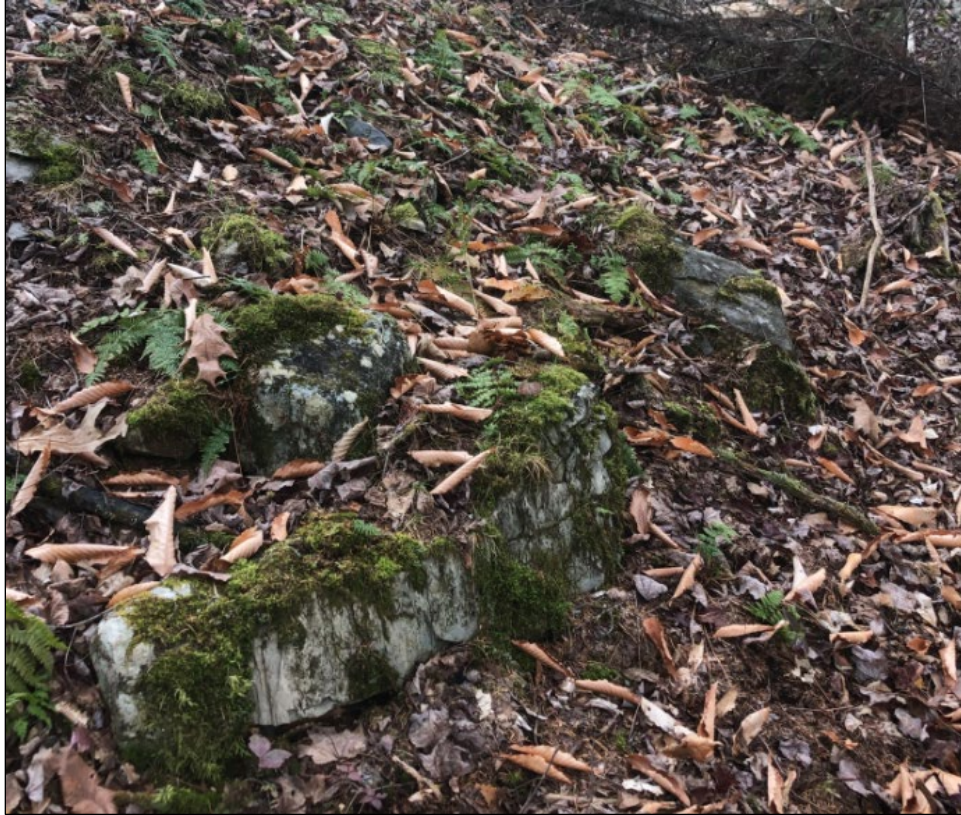
Figure 5-60. North wall of structure at Site MP-1 from northeast corner, facing west.

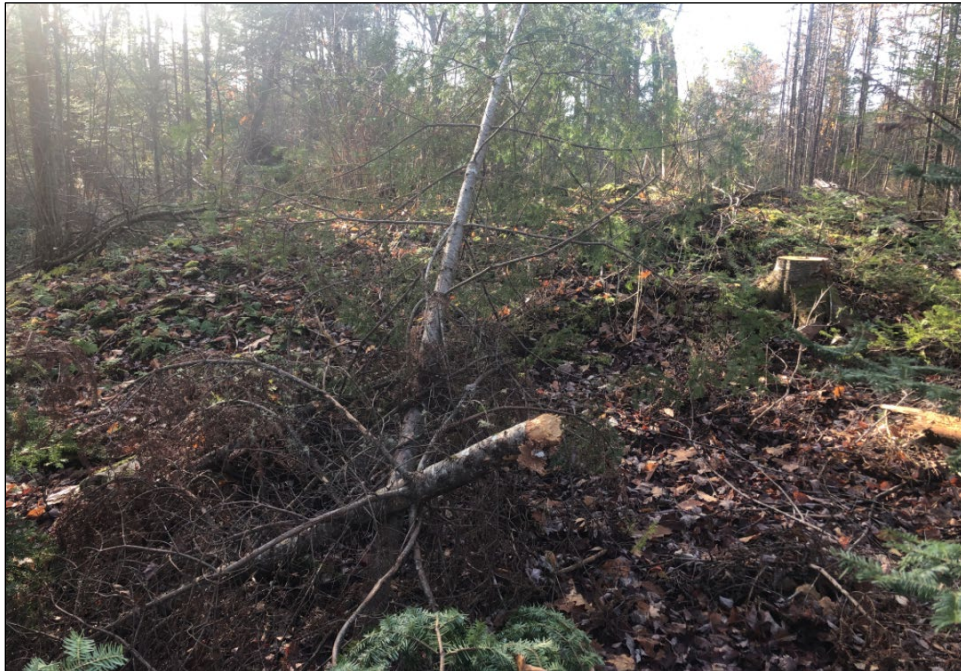
Site MP-1 was initially identified by a dry-laid fieldstone structure observed during pedestrian reconnaissance. Further inspection during subsurface survey revealed that the structure is on the surface and does not enclose a cellar hole. It features an intact southern wall that is approximately 1.2 m (4.1 ft) high and 7.0 m (23 ft) long (**Figure 5-58** and **Figure 5-59**). The remaining three walls are indistinct, either through damage or because they were not built to the height of the southern wall or with the same amount of care (**Figure 5-60**). The interior of the structure is filled to the top of the surrounding walls, possibly forming a ramp (**Figure 5-61**). The entire structure measures approximately 7.0 × 5.0 m (23.0 × 16.4 ft). Estimated 30.0 m (98.4 ft) west of MP-1 is a short section of stone wall extending north-south for a distance of approximately 6.0 m (19.7 ft), and also remnants of stone wall 13.7 m (44.9 ft) northeast of MP-1 continuing intermittently west-southwest for a distance of 84.5 m (277.2 ft). Site SW-1, a quarry, is approximately 67.0 m (219.8 ft) to the east southeast.

Figure 5-61. Interior of structure at Site MP-1 showing fill, facing south.

Site MP-1 does not meet the Secretary of the Interior's criteria of significance, and SEARCH recommends a determination of not eligible for NRHP listing. As an ineligible resource, Site MP-1 does not require avoidance.

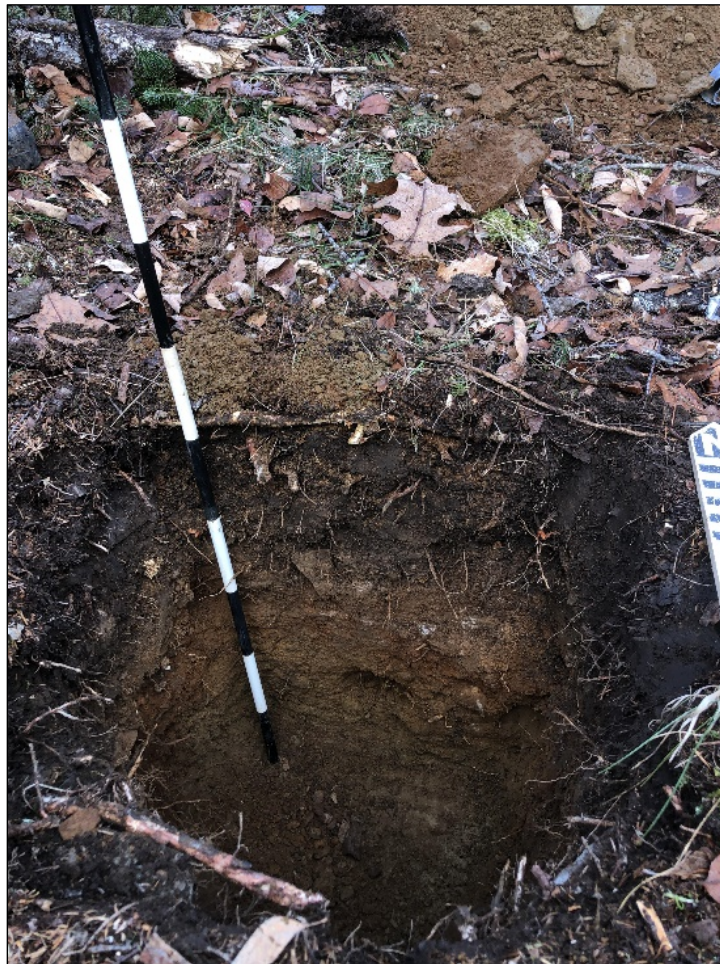
Figure 5-62. North wall profile of ST MP-1-10S.

SEARCH excavated eight STs radially from the MP-1 structure. All eight STs were negative for cultural material. A typical ST encountered a dark brown (10YR 3/3) or brown (10YR 4/3) sand/silt loam Ap horizon to approximately 20 cmbs, a dark yellowish brown (10YR 4/4) or strong brown (7.5YR 4/6) silt/sand loam Bs horizon to approximately 35 cmbs, and a light olive brown (2.5Y 5/4) sandy loam BC horizon to approximately 45 cmbs. Observed stratigraphy was consistent with a truncated Tunbridge series pedon. STs were typically terminated due to bedrock. The mean ST depth was 34.2 cm (s.d. = 15.3). **Figure 5-62** shows the stratigraphy encountered in ST MP-1-10S.

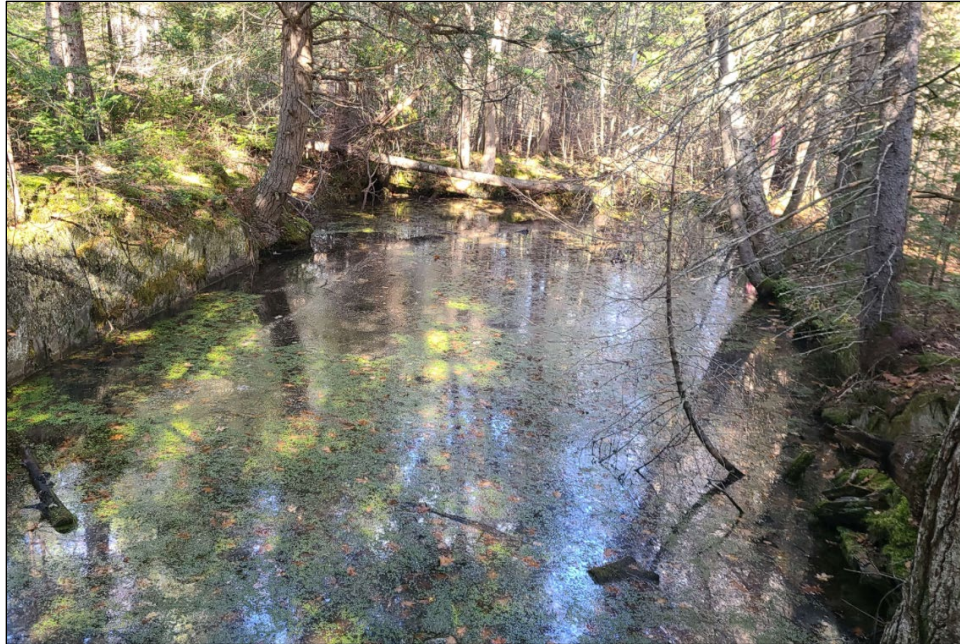
Site SW 1 was initially identified by a water-filled quarry observed during pedestrian reconnaissance. Further inspection during subsurface survey revealed that the quarry is generally rectangular with the long axis aligned north to south measuring approximately 15.0 m (49.2 ft), and a width of approximately 8.0 m (26.2 ft) at the widest at the northern end of the quarry (**Figure 5-64, Figure 5-65, Figure 5-66**). The depth of the quarry was not determined. The southern and western portions of the quarry appear deeper and more intensely quarried (**Figure 5-67**).

Figure 5-64. Site SW-1, facing north.

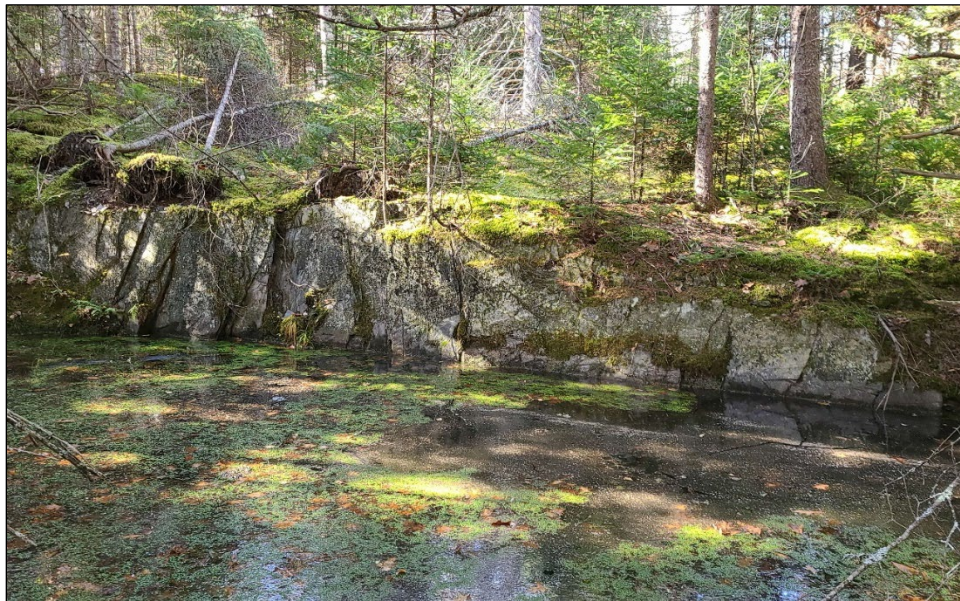
Figure 5-65. Site SW-1, facing west.

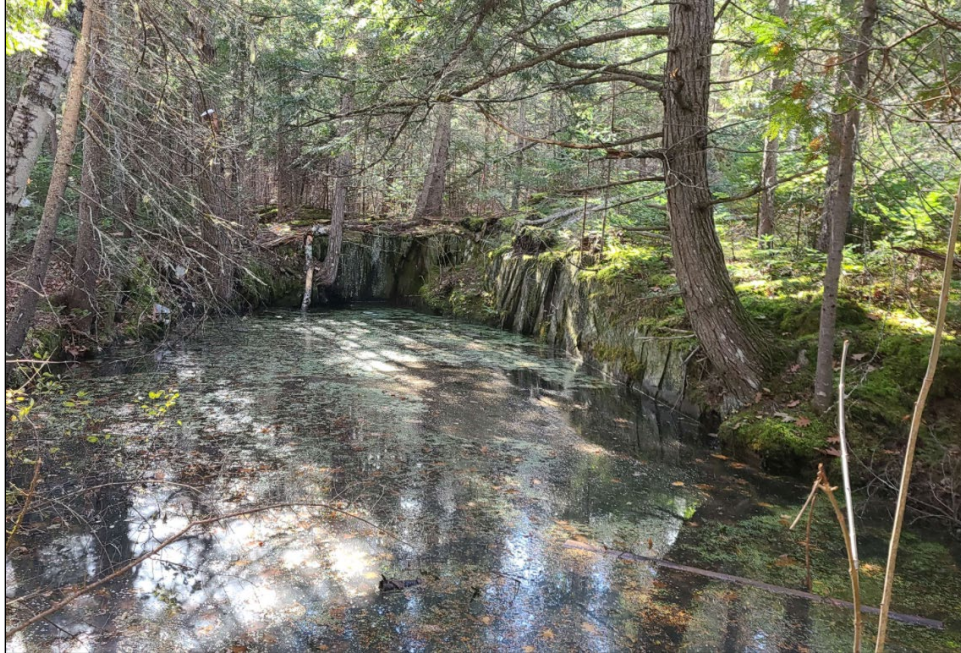
Figure 5-66. Site SW-1, facing south.

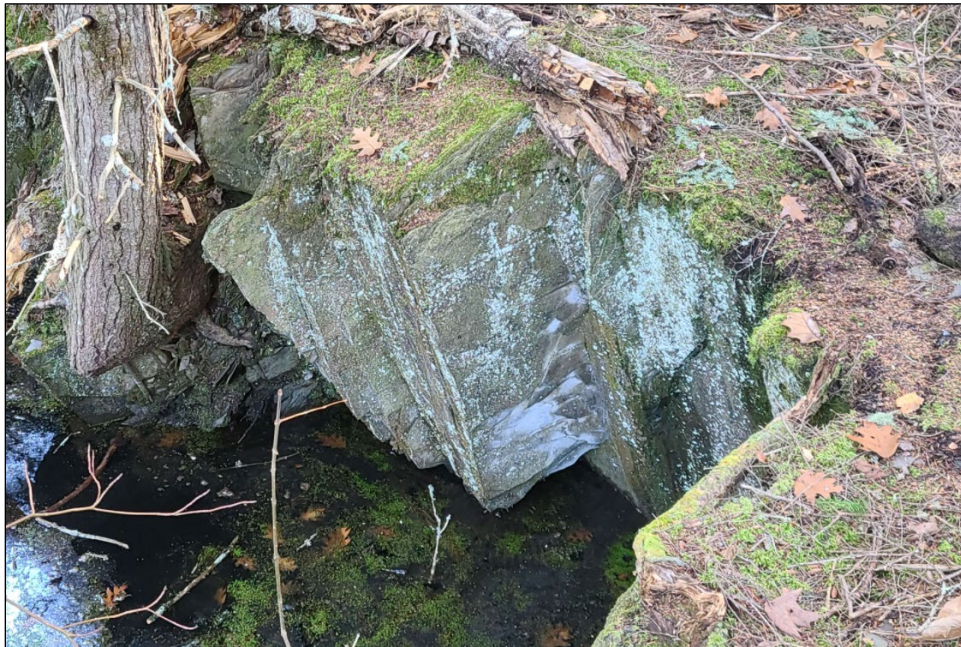
Figure 5-67. Close up of Site SW-1, facing south.

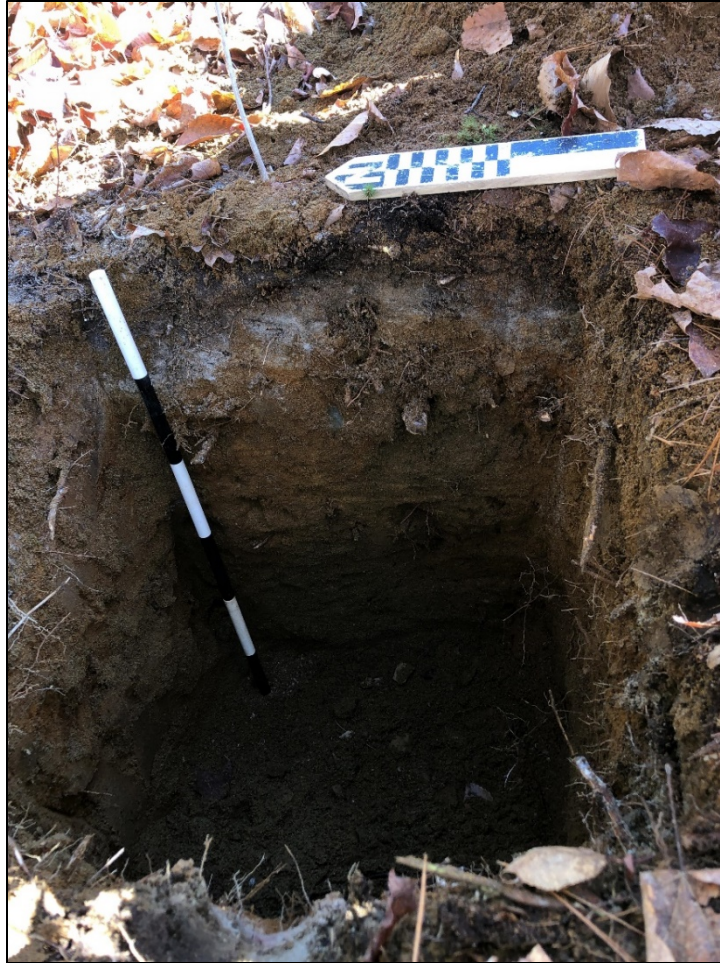
TA-12 MPTR-5 consists of three STs placed to test the location of terrace associated with a wetland area identified during pedestrian reconnaissance. STs were numbered from south to north. A typical ST soil sequence encountered in TA-12 MPTR-5 consisted of similar strata, aside from Stratum I. Stratum I coloration differed across all STs. Stratum I at ST MPTR5-01 consisted of a light grey (10YR 7/1) sandy loam to 15.0 cm (5.9 in) bs, Stratum I at ST MPTR5-02 consisted of a very dark brown (10YR 2/2) sandy loam to 14.0 cm (5.5 in) bs, and Stratum I at MPTR5-03 consisted of a dark brown (10YR 3/3) sandy loam to 18.0 cm (7.0 in) bs. Stratum II consisted of a dark yellowish brown (10YR 4/6) loamy sand to about 30.0 cm (11.8 in) bs and Stratum III consisted of a light olive brown (2.5Y 5/4) sand to approximately 50.0 cm (19.6 in) bs. STs were terminated due to sterile soils. An Estimated 15% to 25% flat and subrounded gravel was found throughout. The mean ST depth was 50.0 cm (19.6 in) with a range from 40.0 to 60.0 cm (15.7 to 23.6 in) and a standard deviation of 10.0 cm (3.9 in). **Figure 5-68** shows the stratigraphy encountered in ST MPTR5-01.

Figure 5-68. ST MPTR-5-01 east wall profile, facing east.

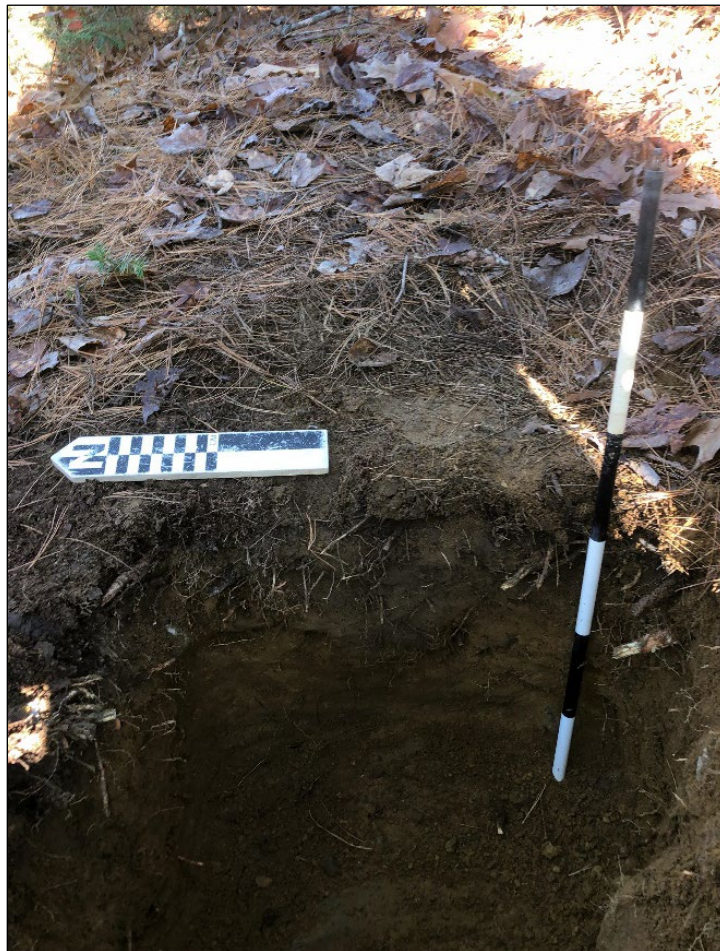
TA-14 MPTR-7 consists of three STs placed to test the location of a terrace associated with a wetland area identified during pedestrian reconnaissance. STs were numbered from west to east. A typical ST soil sequence encountered in TA-14 MPTR-7 consisted of a dark brown (10YR 3/3) sandy loam to approximately 15.0 cm (5.9 in) bs over a dark yellowish brown (10YR 4/6) sandy loam to about 35.0 cm (13.8 in) bs. STs were terminated due to rock impasse or bedrock. The mean ST depth was 35.6 cm (14.0 in) with a range from 35.0 to 37.0 cm (13.8 to 14.6 in) and a standard deviation of 1.2 cm (0.5 in). **Figure 5-69** shows the stratigraphy encountered in ST MPTR7-02.

Figure 5-69. ST MPTR7-02 east wall profile, facing east.

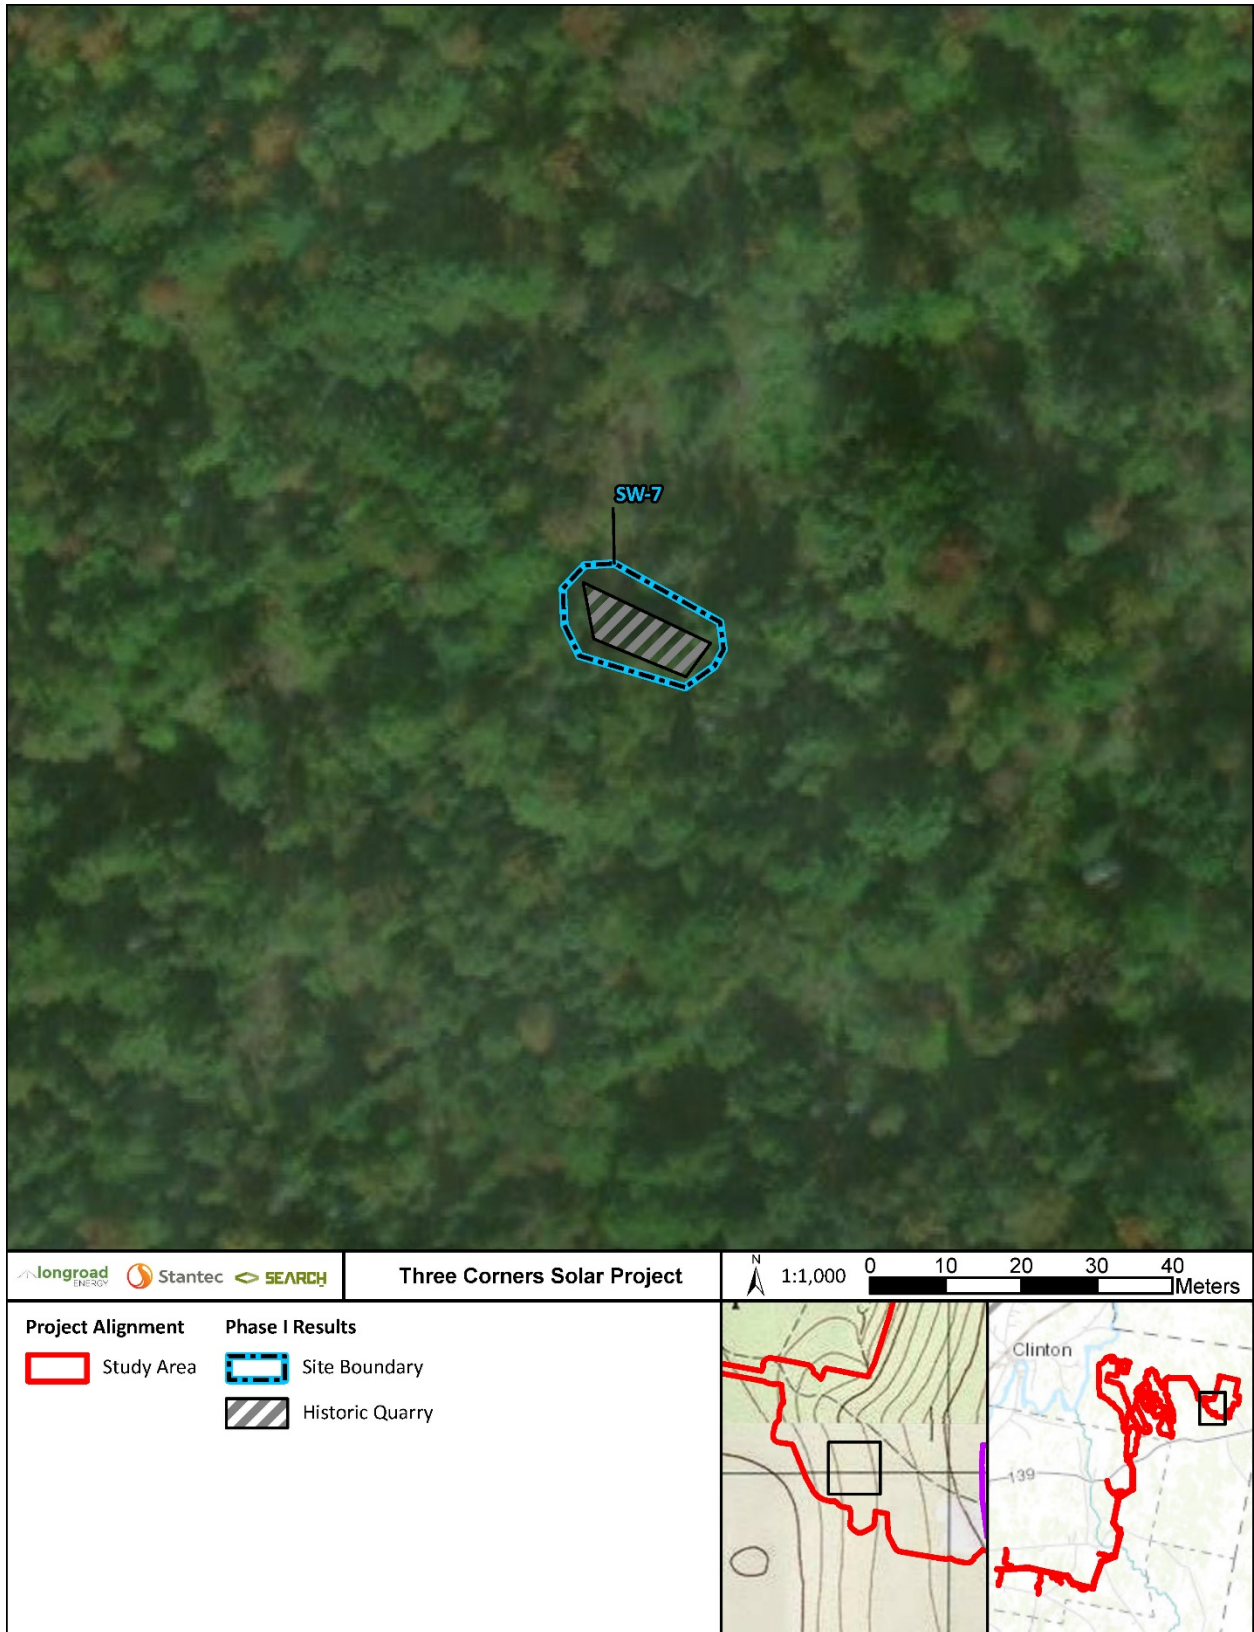
Figure 5-70. Plan of SW-7.

SW-7 is a historic site Unity Township in the eastern portion of Kennebec County, Maine, in the east-central portion of Kennebec County at UTM Zone 19 N4941236 E466749 (**Figure 5-70**). The site covers an area of approximately 230.4 m² (2,480.0 ft²) and has a mean elevation of 72.2 m (236.9 ft) amsl. The nearest water source is Spring Brook, which is 1.2 km (0.7 mi) to the north. Additionally, 2.7 km (1.7 mi) to the east is Twentyfive mile stream. The site is approximately 120.0 m (393.7 ft) southeast of historic Palmer Road, which is currently a private road used as an active logging road due to ongoing timber harvesting. The landform occupied by the site has a gentle slope that stretches north to south, with Palmer Road being the most elevated terrain to the north, and terminates at wetlands to the south, southeast, and southwest from Site SW-7. The ground is heavily disturbed due to recent logging activity. The ground surface is undulating with intermittent wetland conditions, and strewn boulders. The area was previously forested with mixed hardwoods, cedar, pine and spruce intermixed. Presently, the area around the site is covered with felled trees, timber slash, and other debris from the recent logging activity.
