8.2 PHASE I ARCHAEOLOGICAL AND ARCHITECTURAL SURVEYS

Three Corners Solar Project

MDEP Site Location of Development Act Permit Application

SECTION 8: HISTORIC SITES

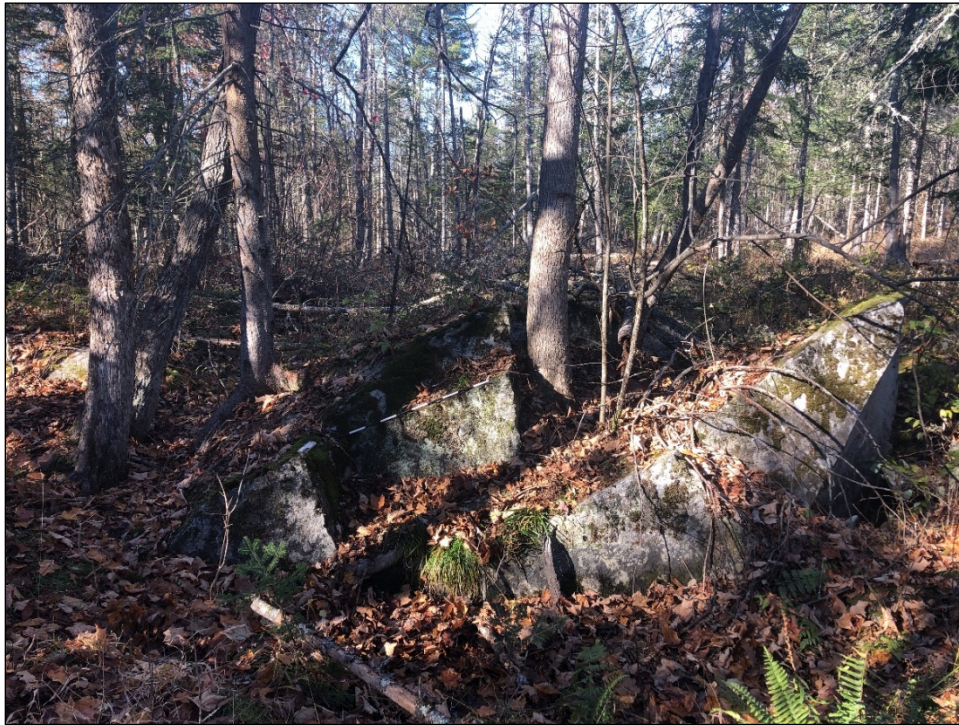
Figure 5-71. View of quarry at Site SW-7, facing north.

Site SW-7 was initially identified by a quarry that measures approximately 15.9 × 5.8 m (52.1 × 19.2 ft). Pin and feather markings were noted on the granite outcrop supporting site SW-7, along with wedge and drill holes. These markings primarily occur along the western, southern, and northern portions of the quarry (**Figure 5-71** through **Figure 5-75**). Visual inspection of the quarry suggests that the granite was harvested in a bench-like manner, especially along the northern portion. Pin and feather marks/drill holes are generally between 15.0 to 18.0 cm (5.9 to 7.1 in) apart. Wedge and pry bars would then be used to dislodge a large slab. This is evident along the northern part of the quarry (see **Figure 5-74**), where a large granite slab was removed from the quarry. The slab is approximately 250.0 × 80.0 × 40.0 cm (98.4 × 31.5 × 15.7 in) in size. These granite slabs could be used for a variety of construction applications including foundation supports, lintels or in bridge construction. The size of this granite slab would indicate a heavier industrial use; while the small size of the quarry would indicate local utilization of the material removed.

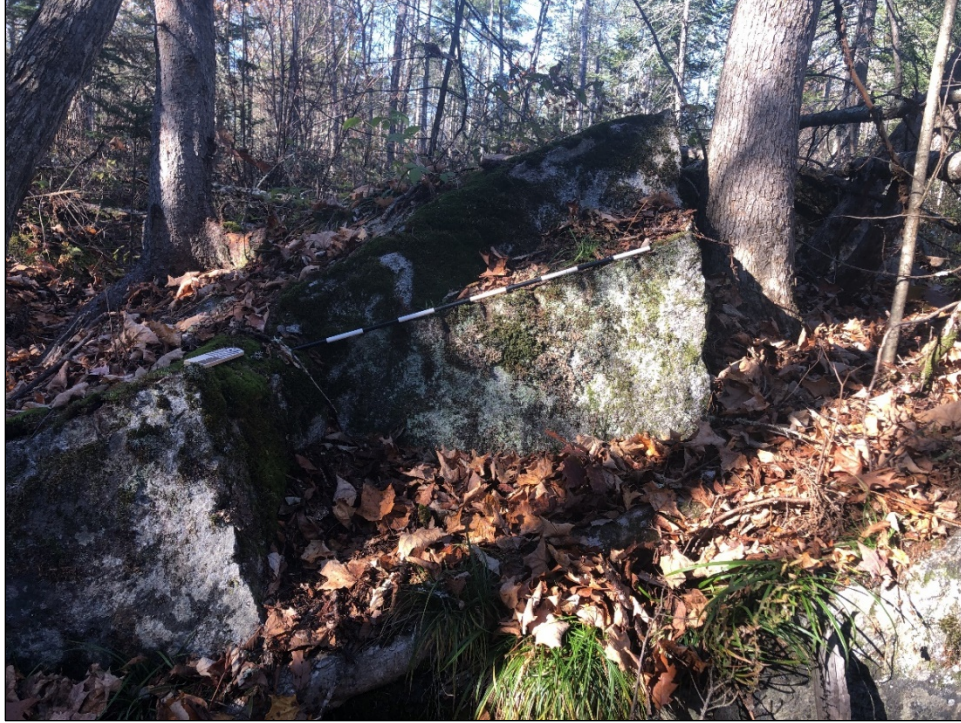
Figure 5-72. View of quarry at Site SW-7, facing north.

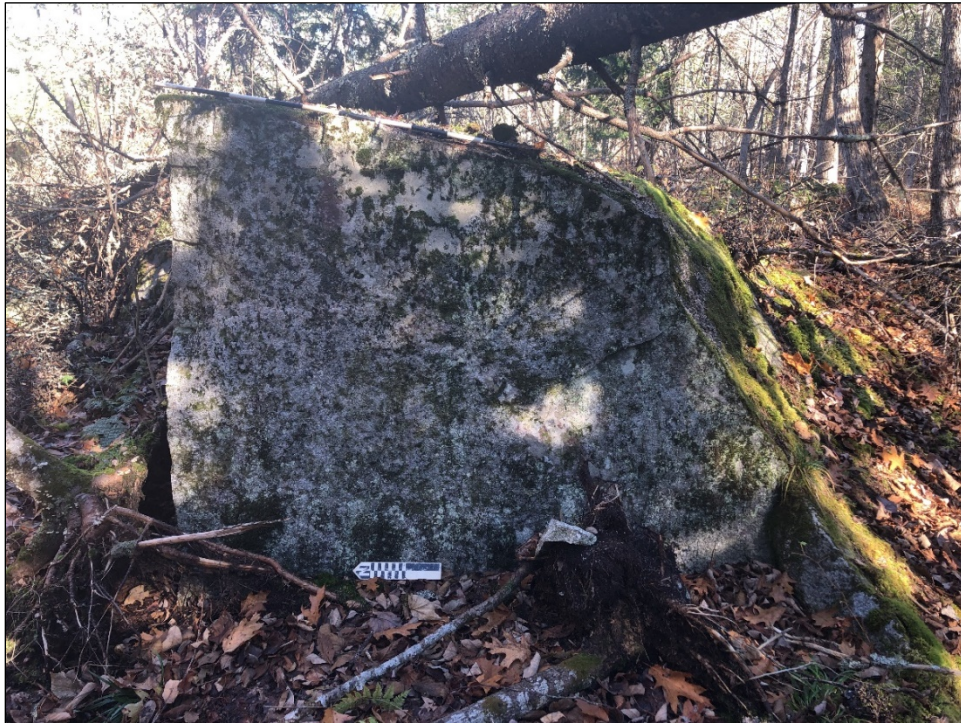
Figure 5-73. View of quarry at Site SW-7 with markings, facing east.

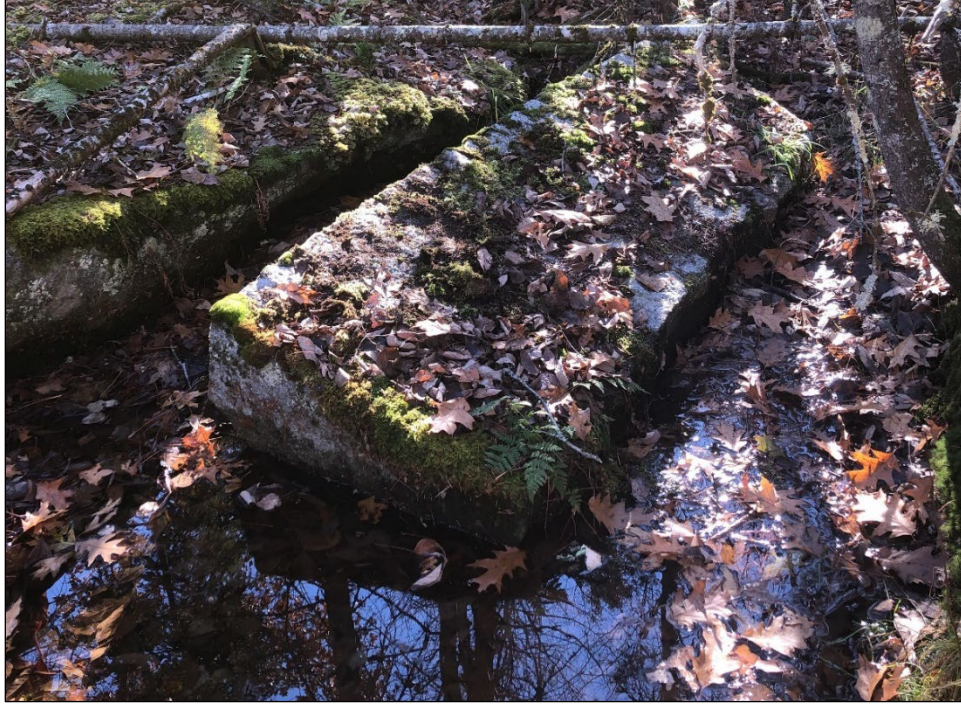
Figure 5-74. Cut stone from quarry at Site SW-7, facing southwest.

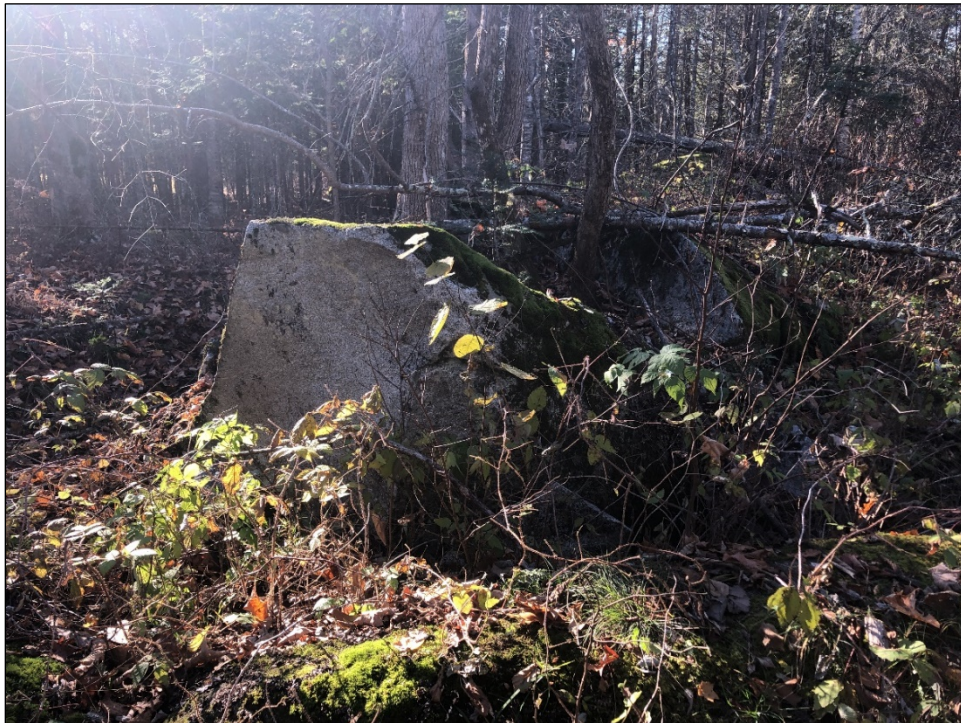
Figure 5-75. View of quarry at Site SW-7, facing west.

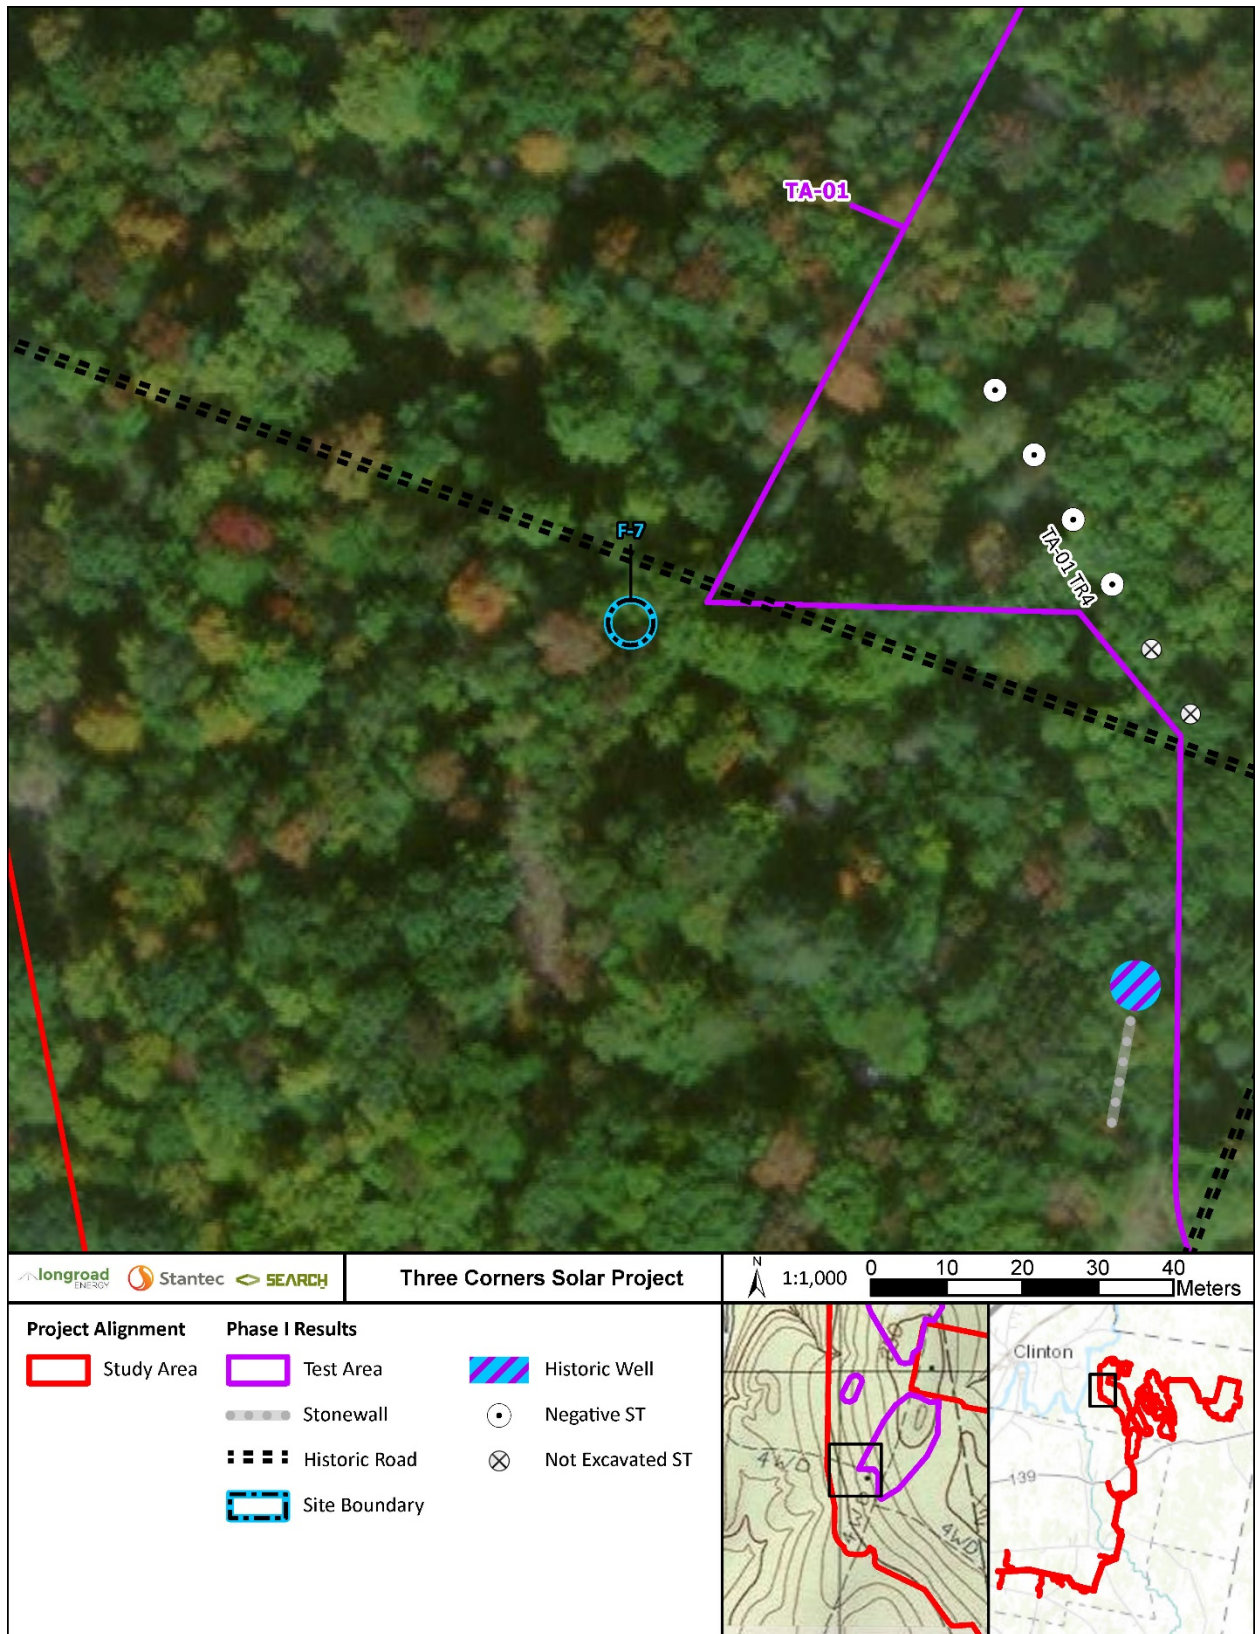
Figure 5-76. Plan of Site F-7.

Site F-7 was initially identified by a small surface scatter of historic artifacts during pedestrian reconnaissance. Further inspection during subsurface survey revealed that the scatter is of limited extent, measuring approximately 6.0 m (19.7 ft) in diameter (**Figure 5-77**). No additional site components were identified.

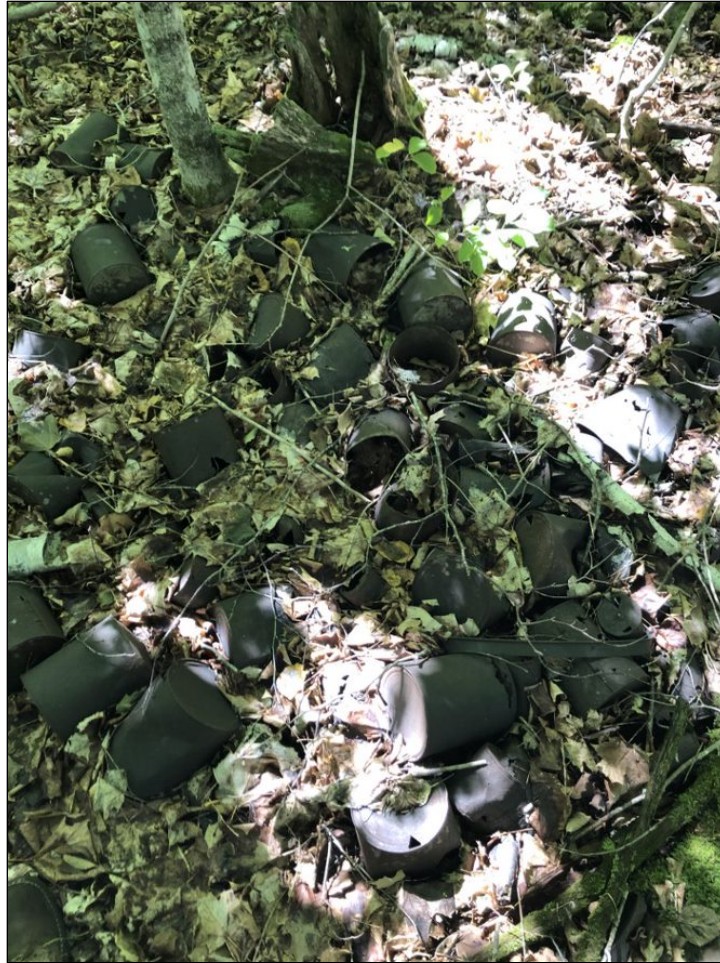
Figure 5-77. Overview of surface scatter at Site F-7.

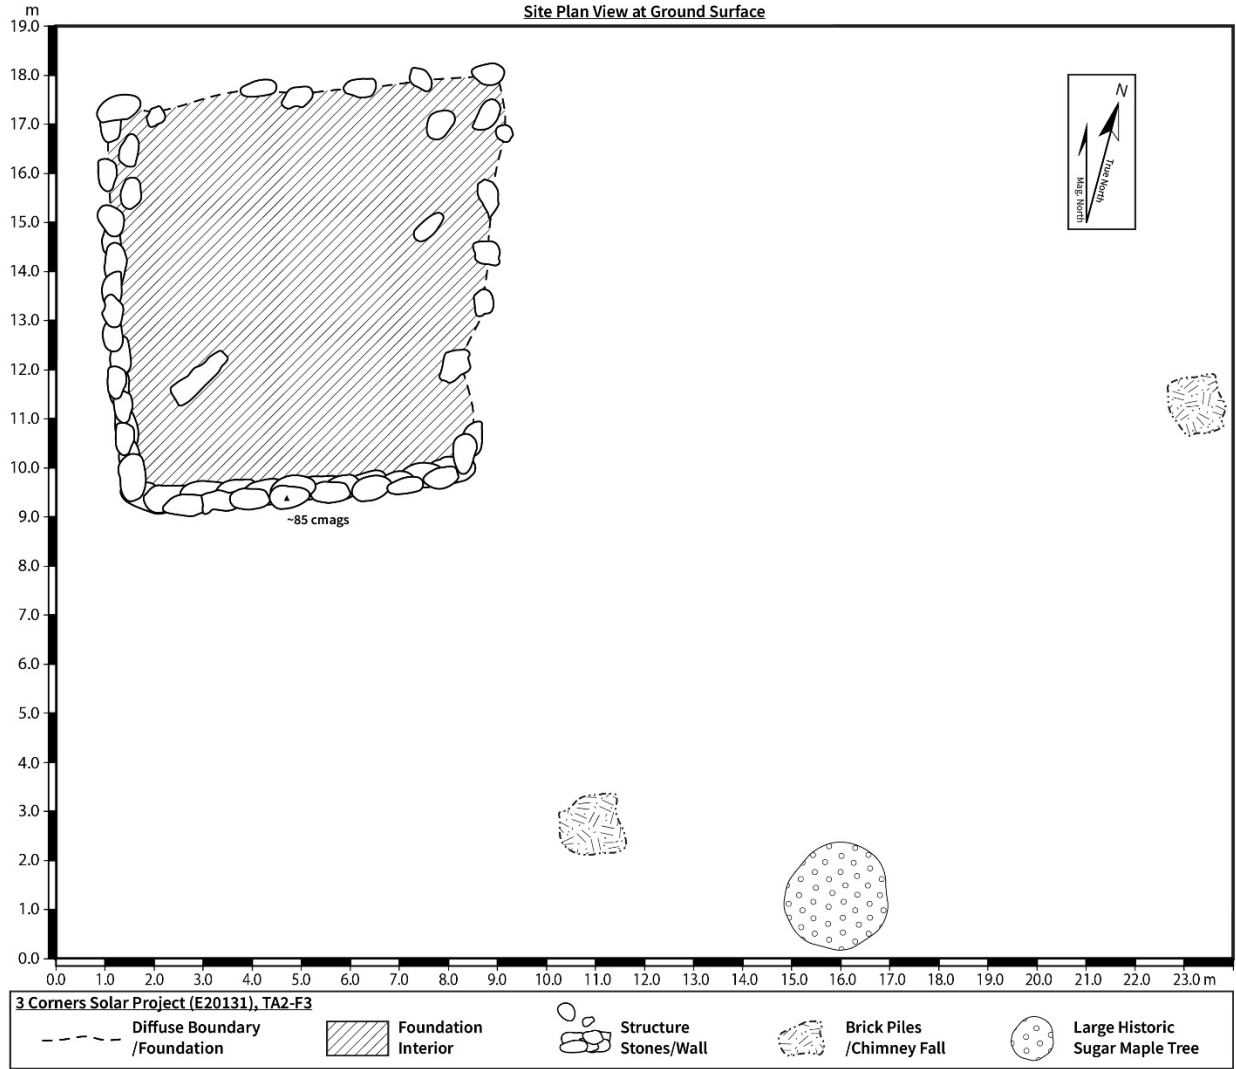
Plan of foundation at Site F-3.
