7.0 WETLANDS, WILDLIFE, AND FISHERIES

MDEP Site Location of Development Act Permit Application

SECTION 7: WETLANDS, WILDLIFE, AND FISHERIES

Three Corners Solar Project

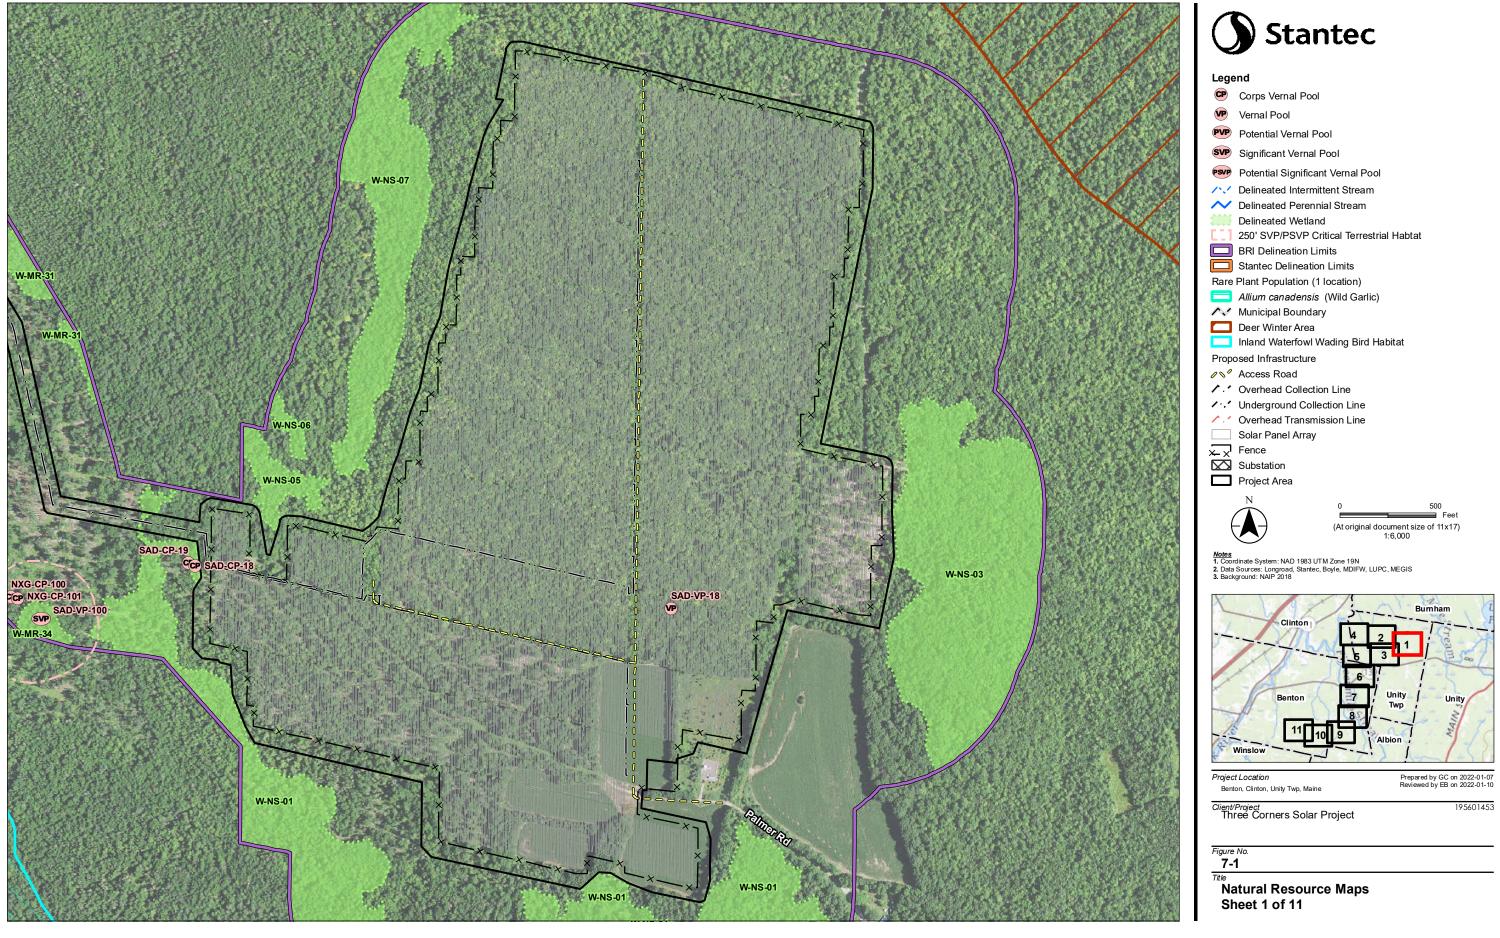
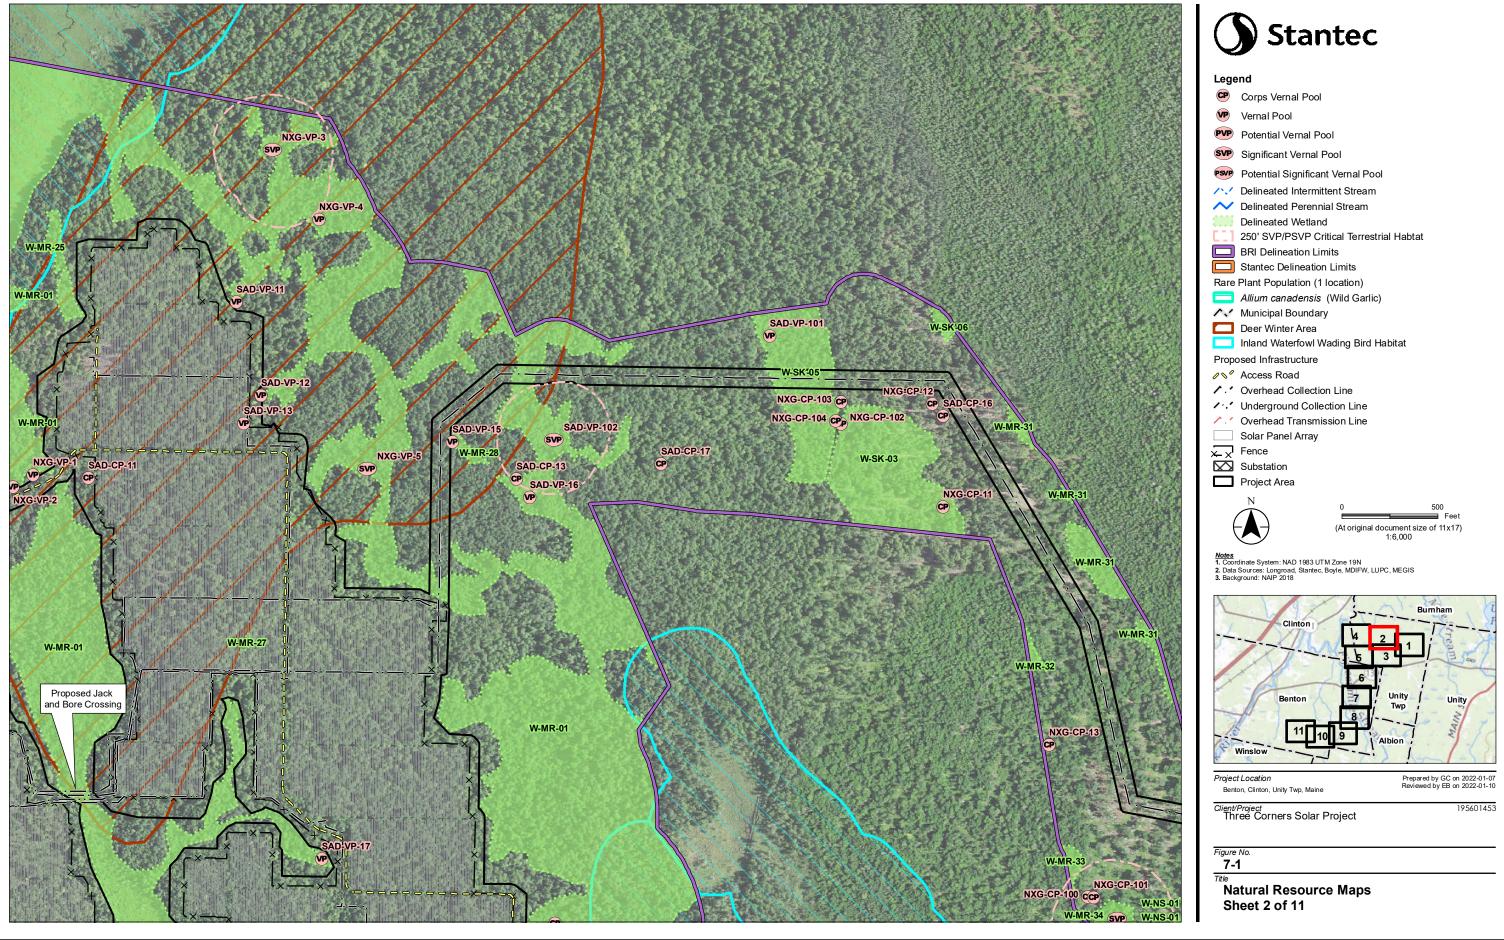
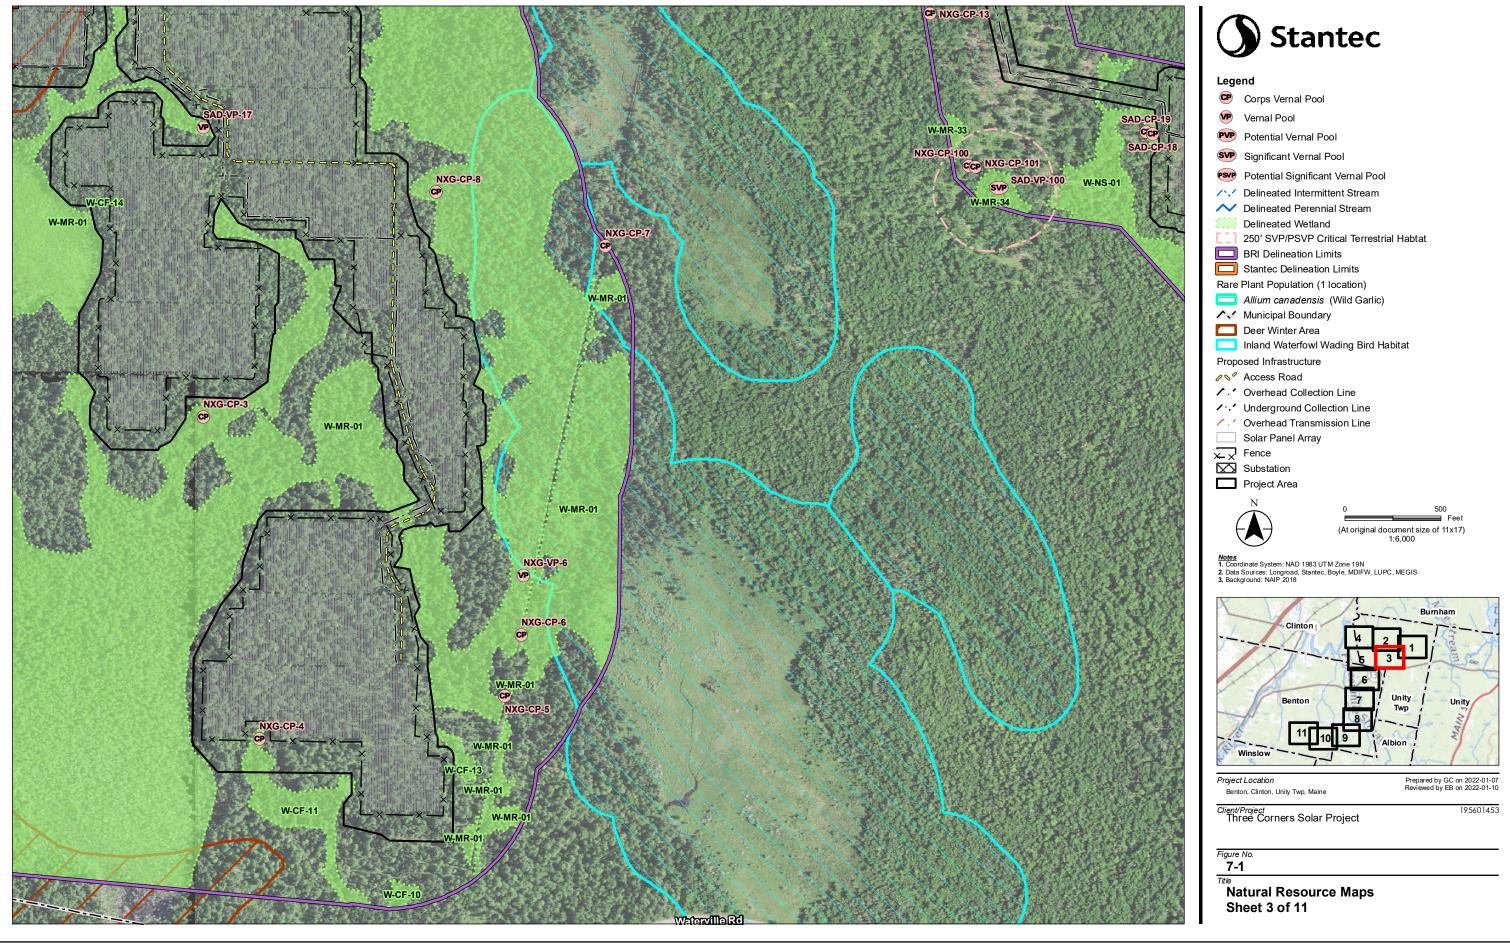
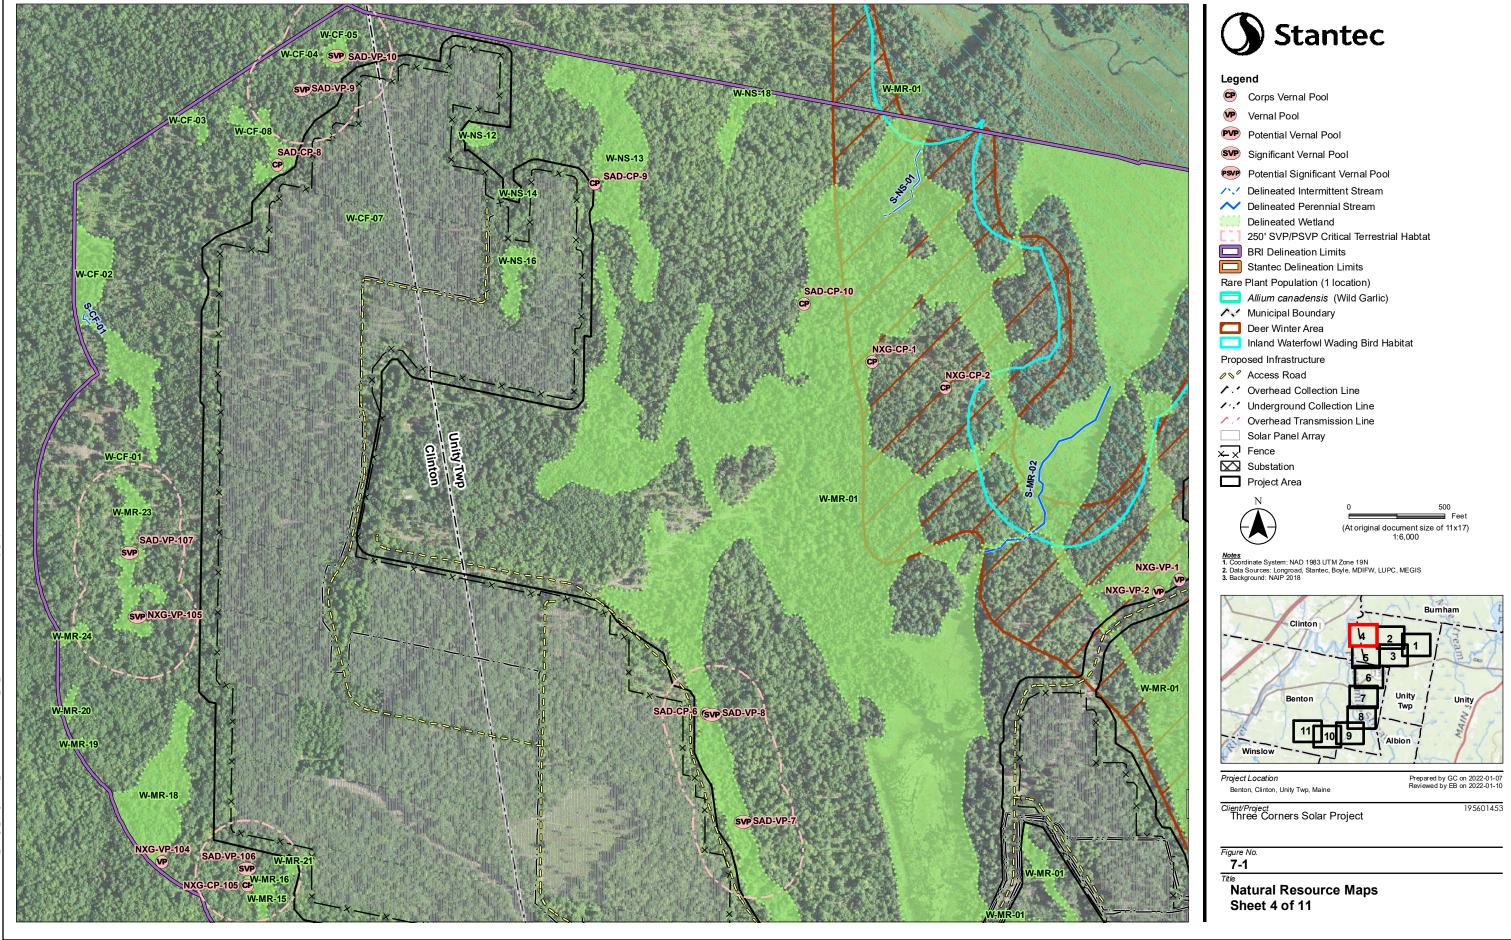
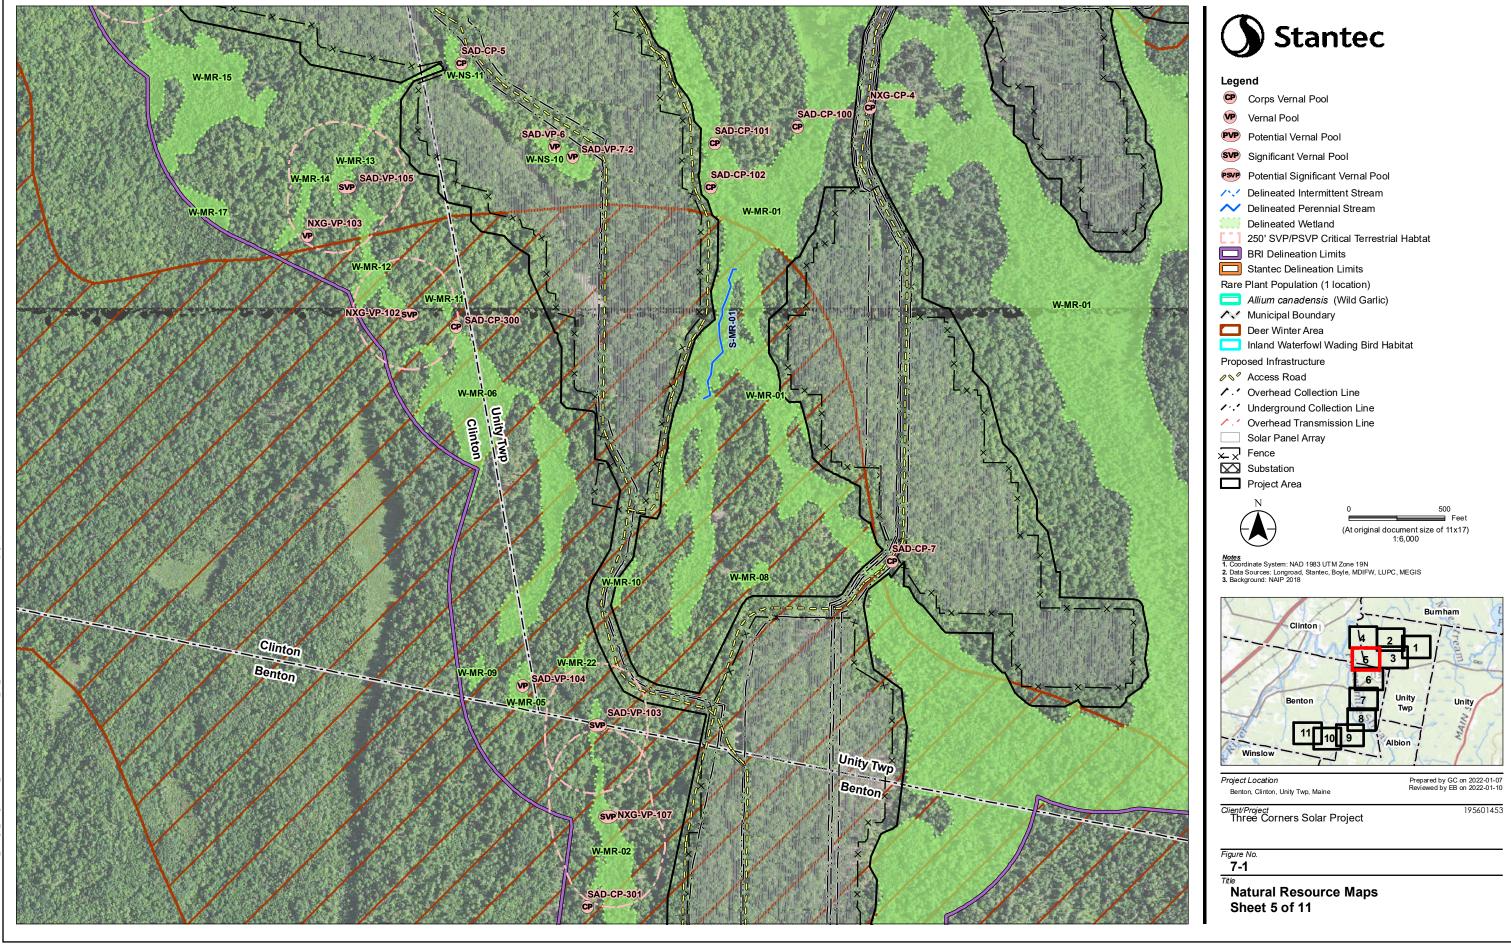
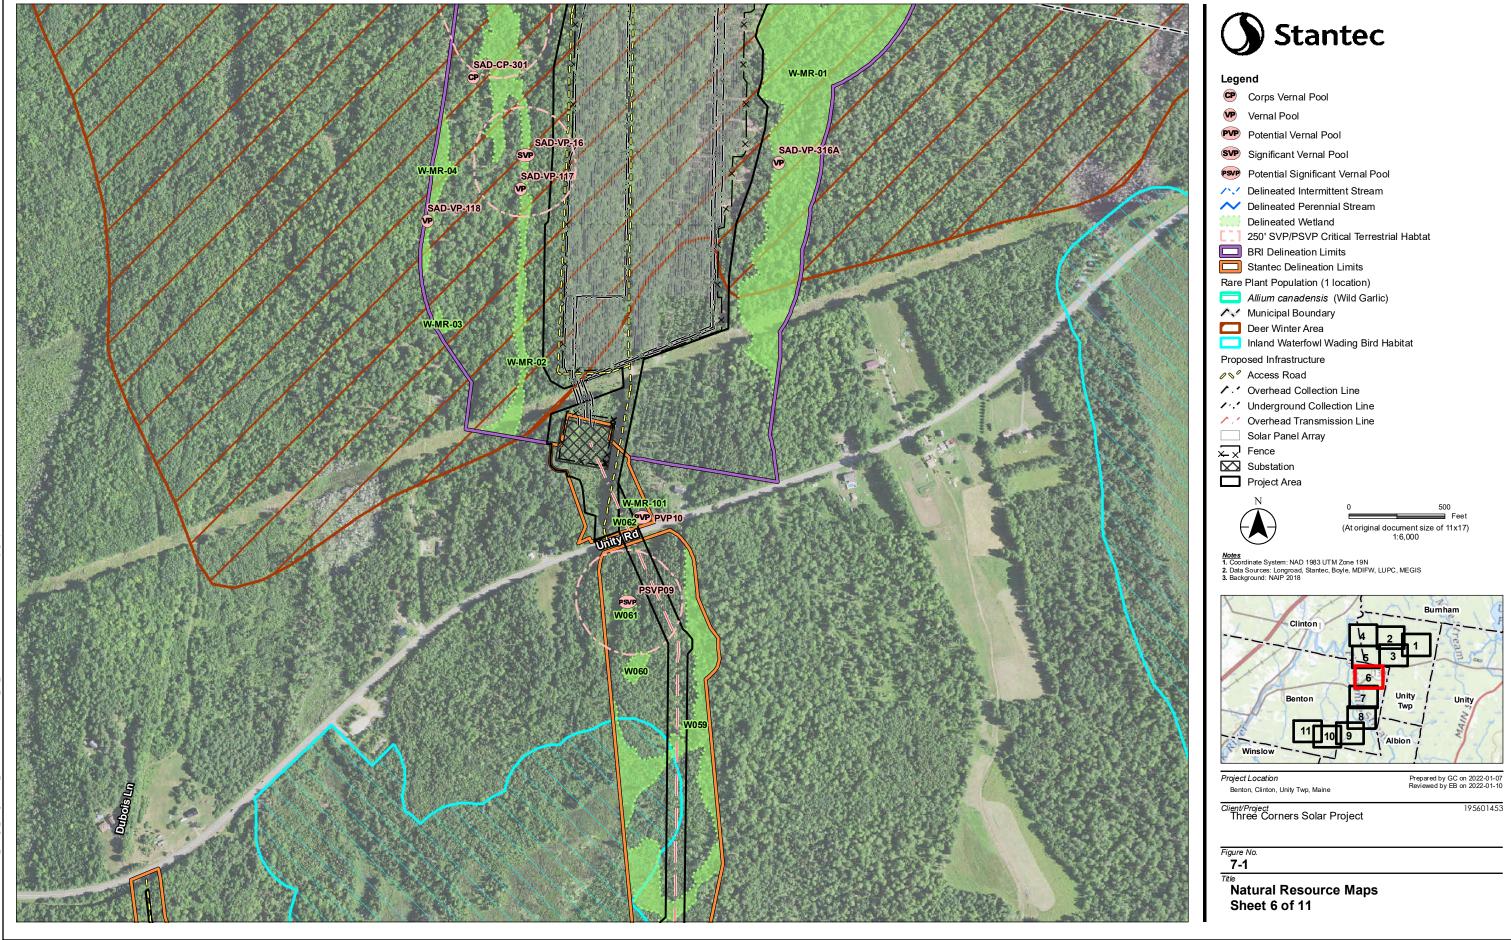
Figure 7-1

Natural Resources Overview Maps

The Maine Natural Areas Program (MNAP), Maine Department of Inland Fisheries and Wildlife (MDIFW), and U.S. Fish and Wildlife Service (USFWS) were contacted to request information regarding sensitive natural resources, including Essential Habitat, Significant Wildlife Habitat (SWH) and records of rare, threatened, and endangered wildlife and rare and exemplary botanical features that have been documented in the vicinity of the Project. Consultation responses from the MDIFW and USFWS are included as Exhibit 7-1. The MNAP agency response letter is included in Section 9, Exhibit 9-1.

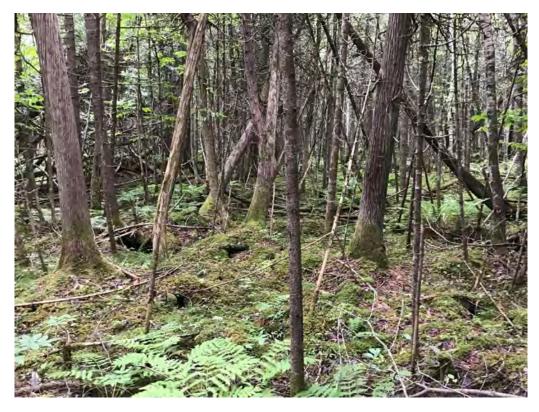
Photo 2. Representative Photo of a Forested Wetland (W-MR-17, July 14,2020).
