**Maine Department of Environmental Protection  
Natural Resources Protection Act  
Individual Permit Application**

***Three Rivers Solar Power Project  
T16MD, Hancock County, Maine***

November 01, 2019

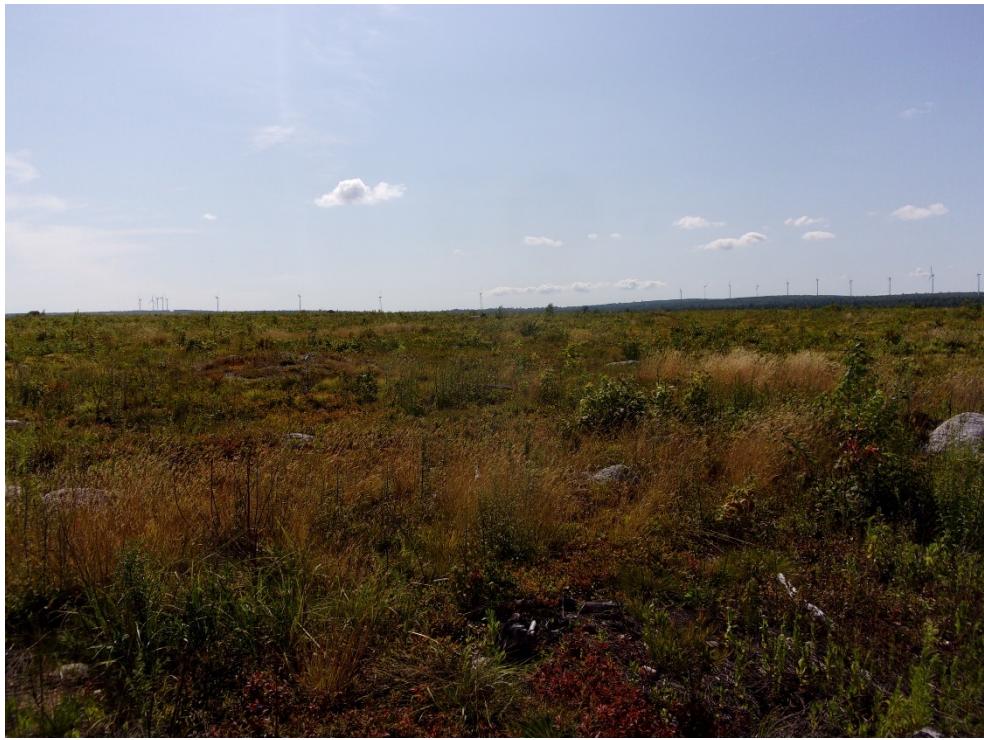
**Photo 1:** Looking west at northwest corner of Area #1. Photograph taken 08/06/19.

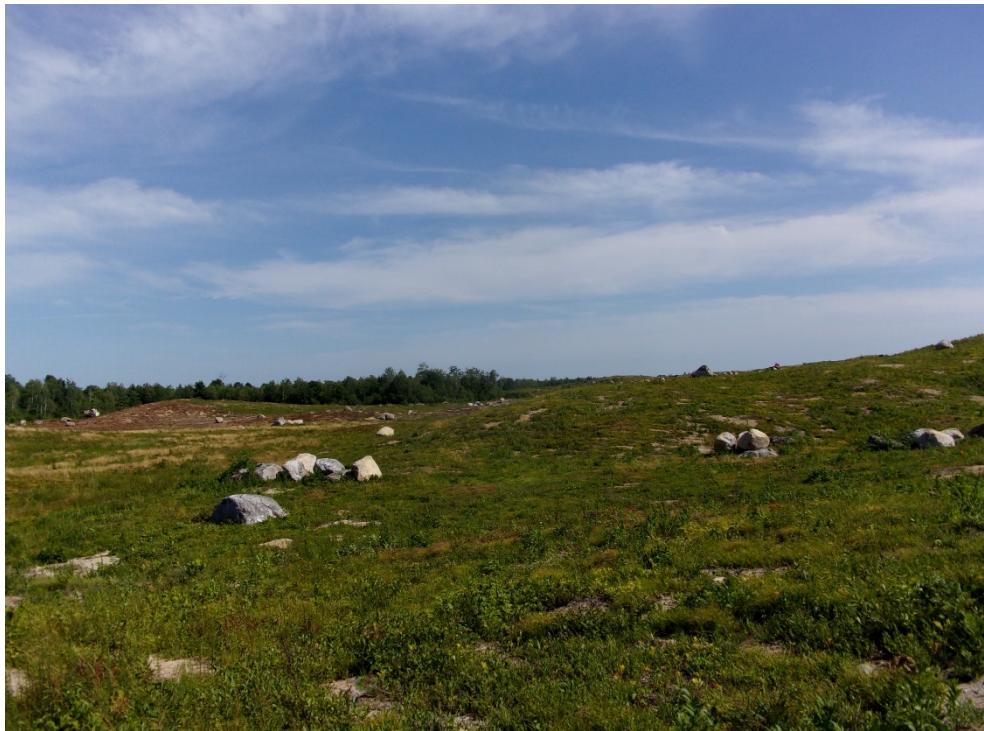
**Photo 2:** Looking east at northeast corner of Area #1. Photograph taken 08/06/19.

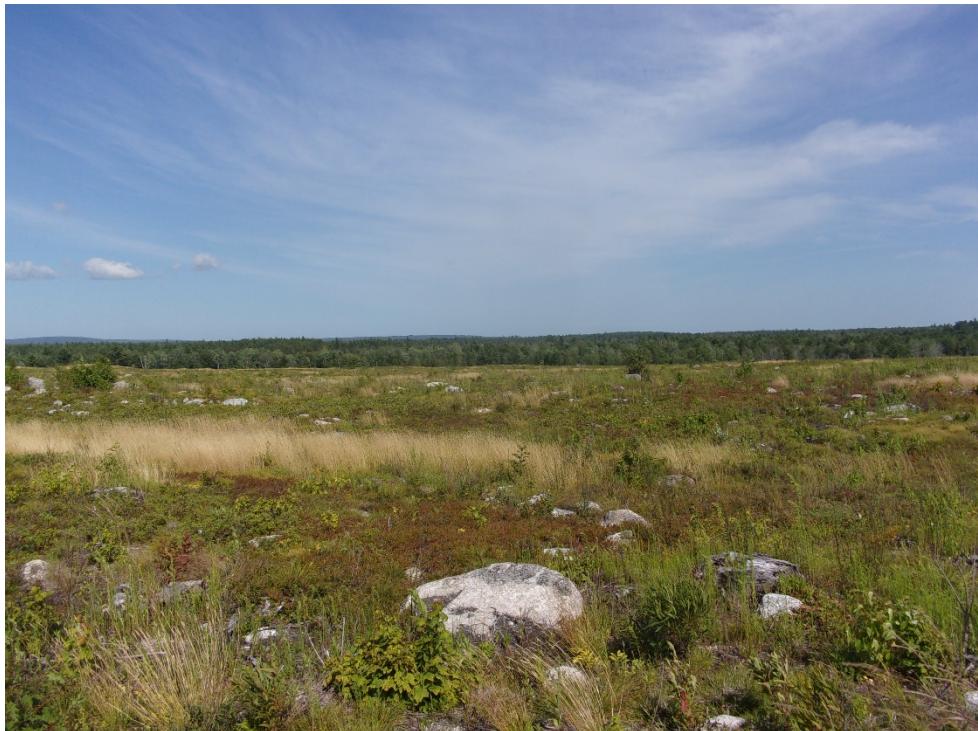
**Photo 3:** Looking west at central portion of Area #1. Photograph taken 08/06/19.

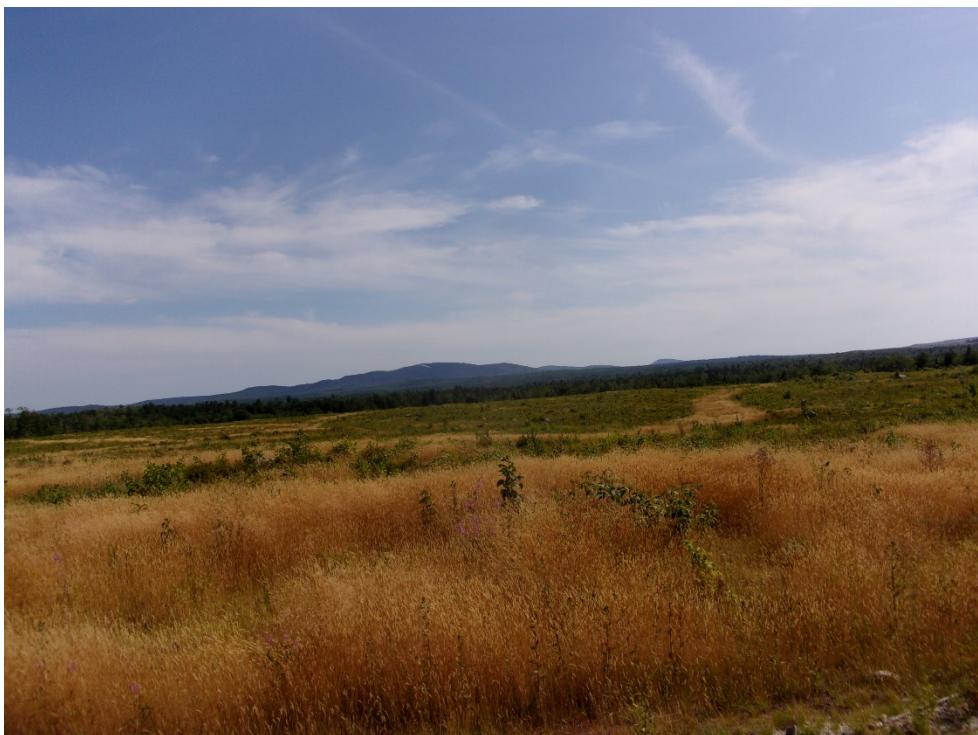
**Photo 4:** Looking south at southern portion of Area #1. Photograph taken 08/06/19.

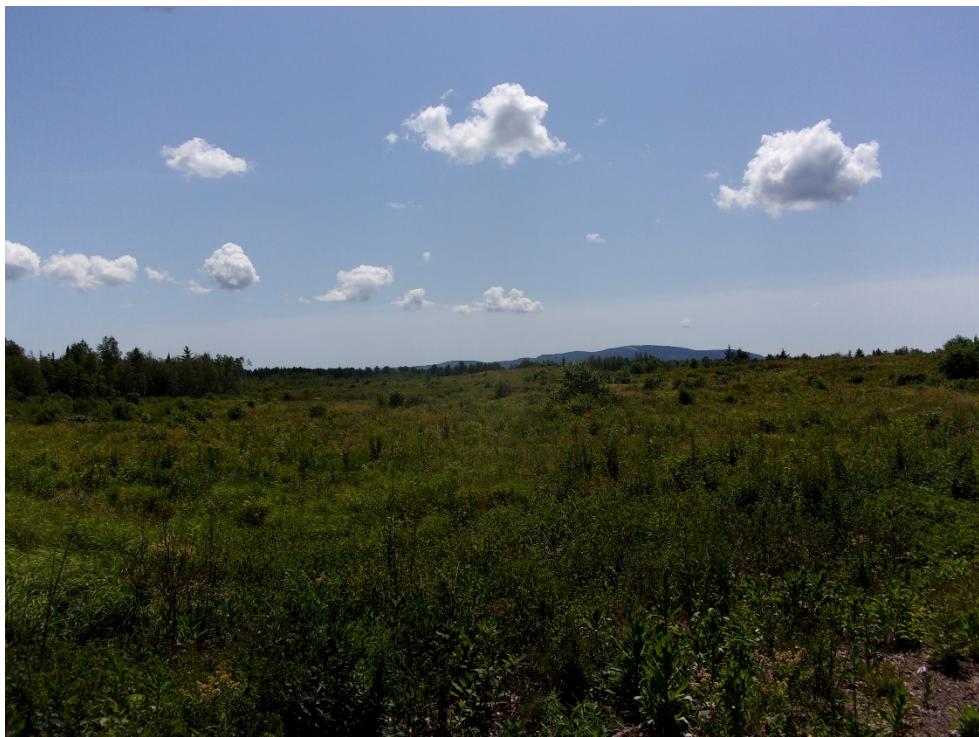
**Photo 9:** Looking west at Area #6. Substation location in forefront. Photograph taken 08/06/19.

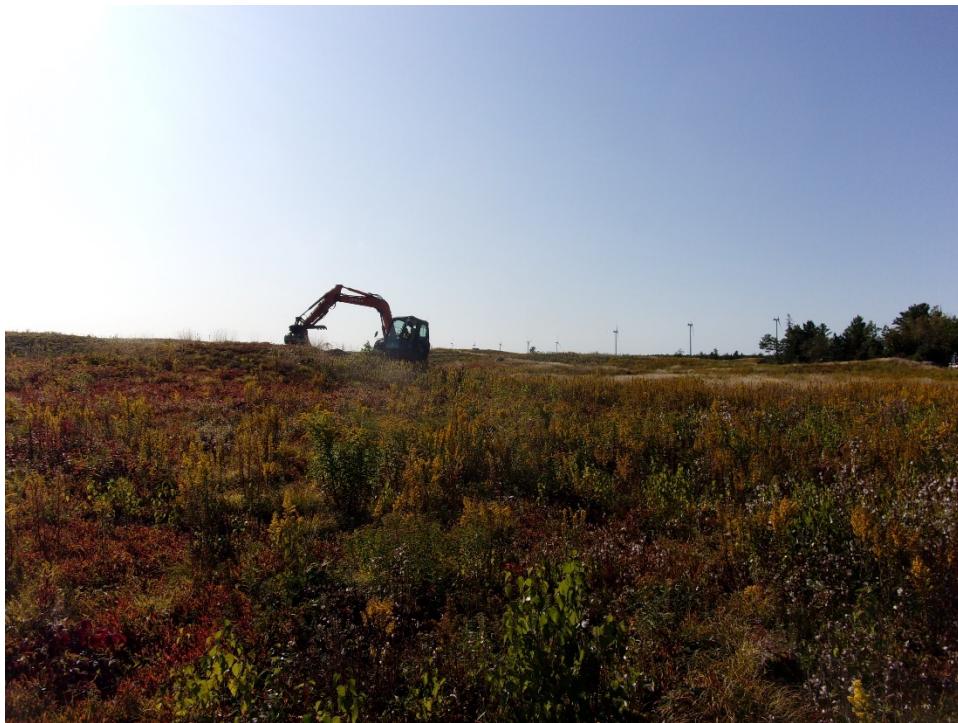
**Photo 10:** Looking west at potential laydown yard area. Photograph taken 09/18/19.

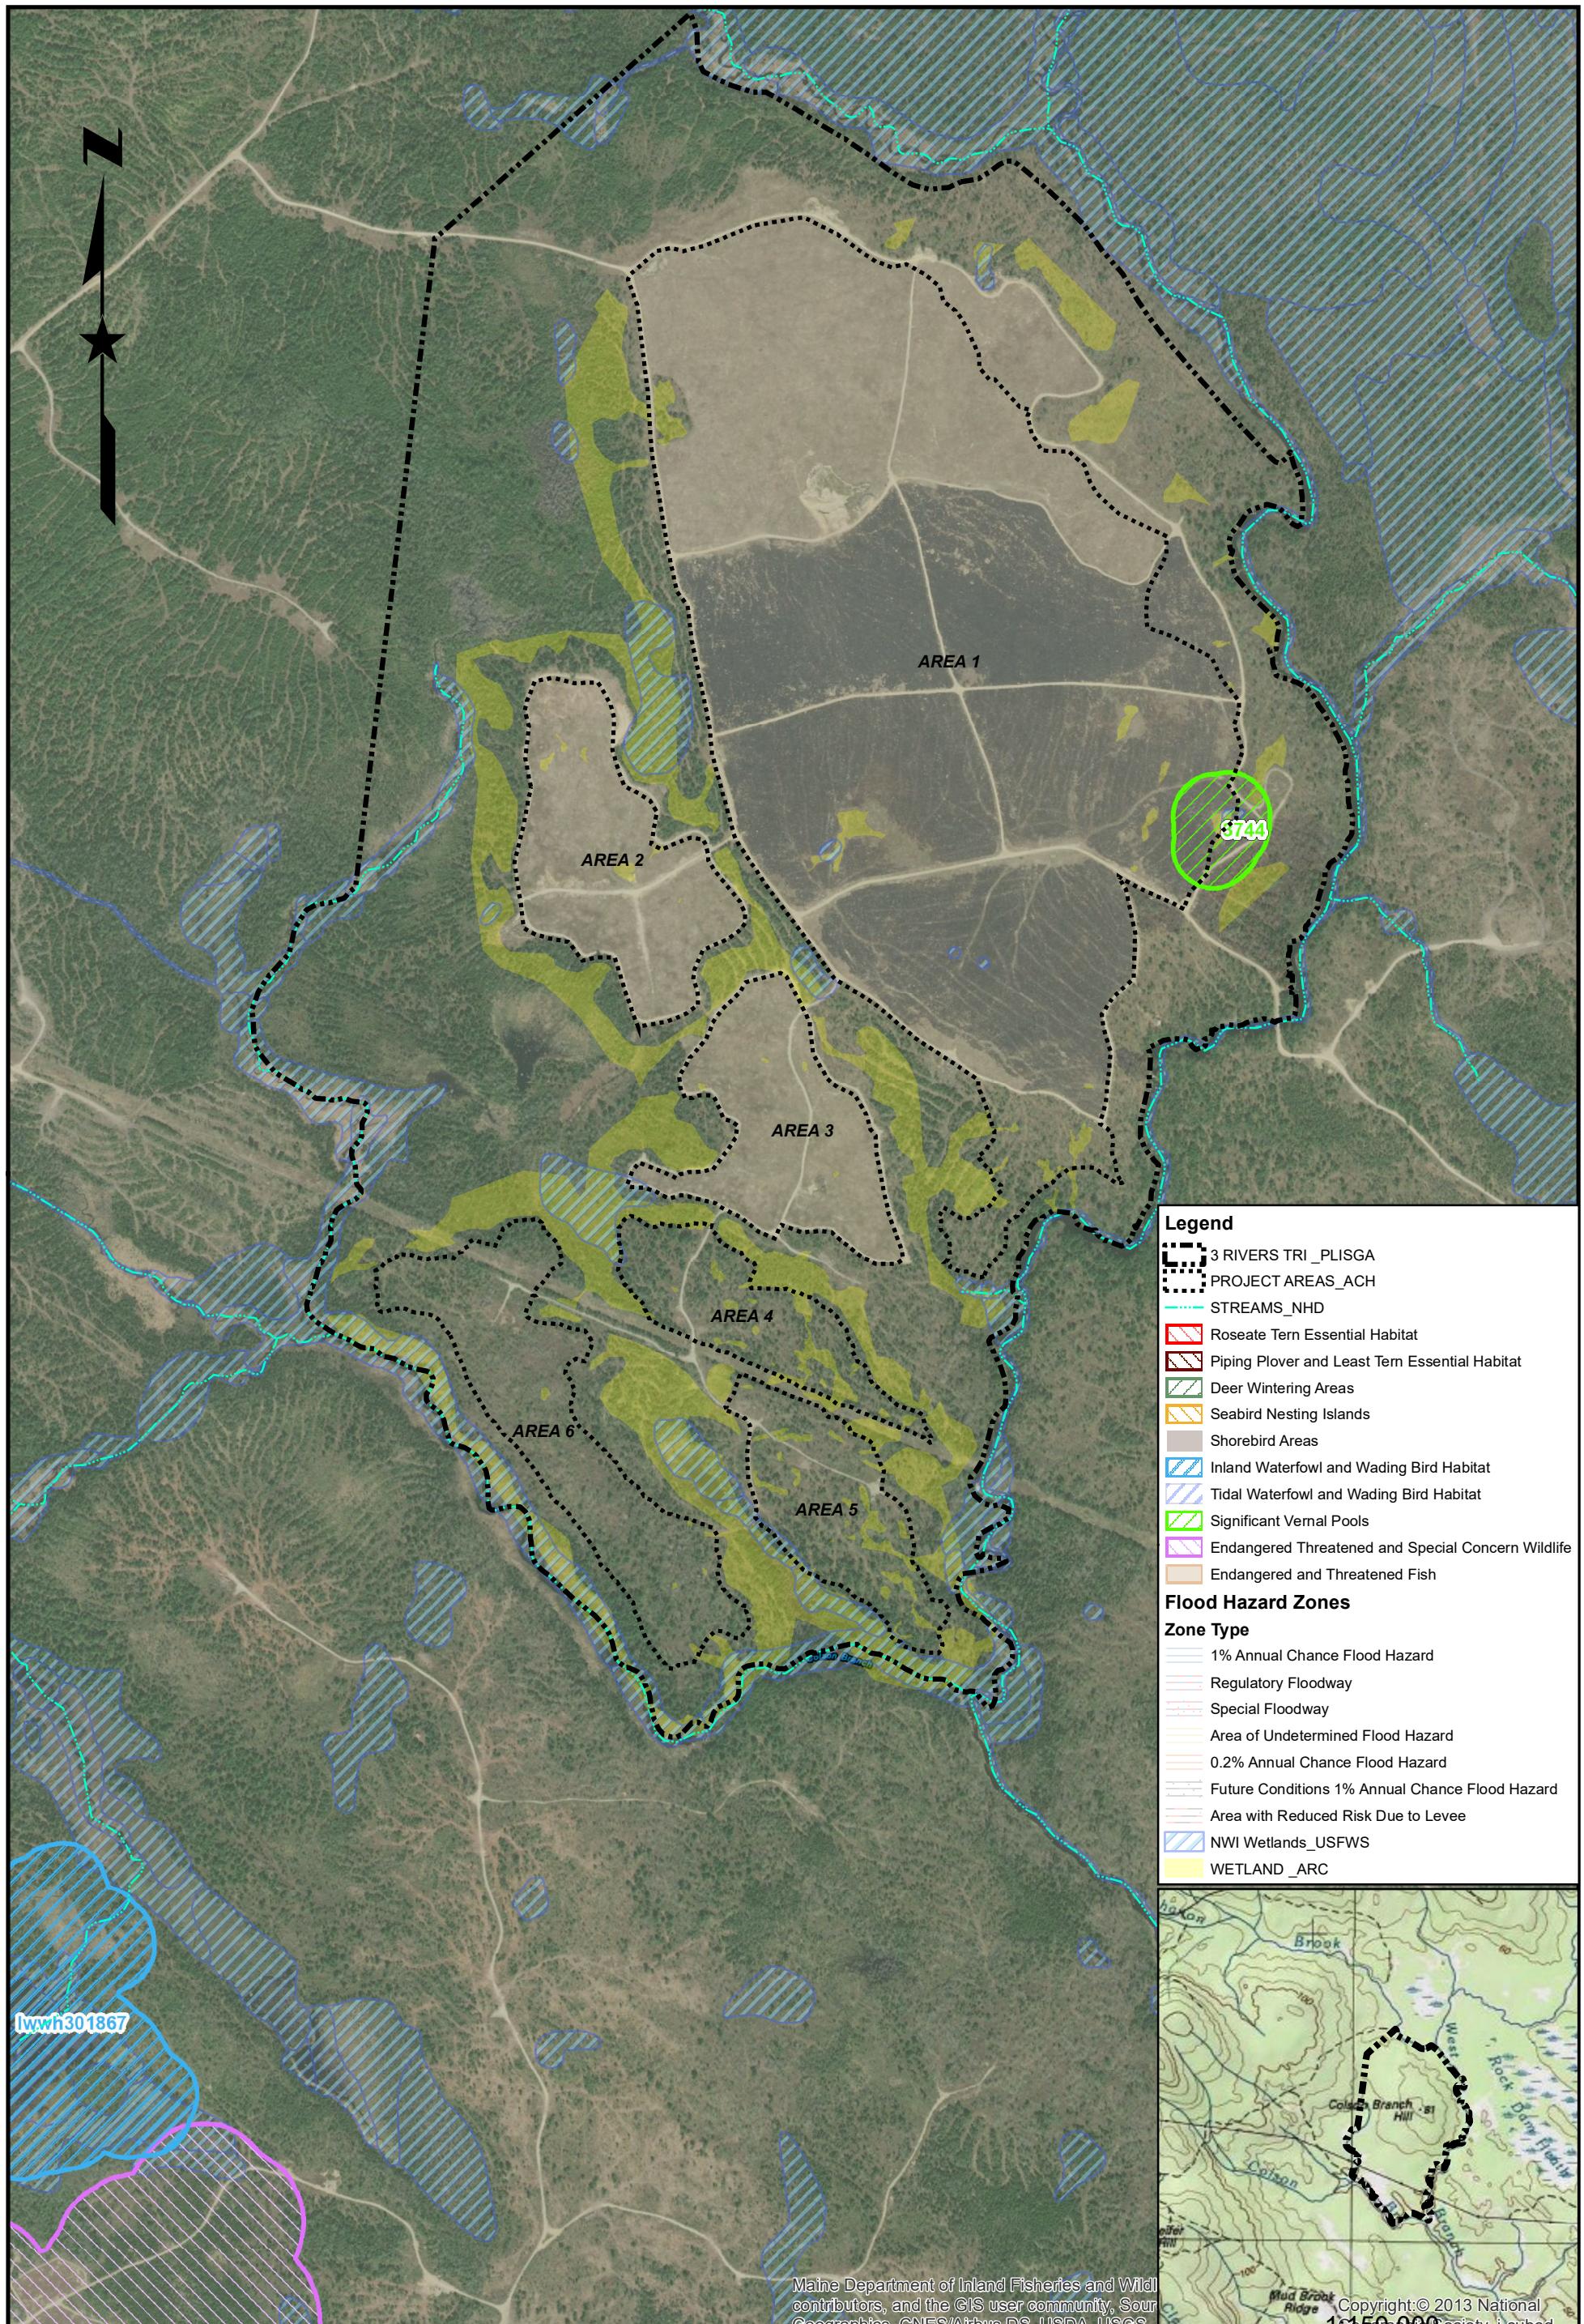
**SHEET B-3**  
**RESOURCE MAP OVERVIEW**  
**DATE: AUGUST 26, 2019**

1.) WETLAND AND VERNAL POOL SURVEYS COMPLETED DURING 2018 & 2019 BY ATLANTIC RESOURCE CO. LLC  
2.) BOUNDARIES LOCATED USING A TRIMBLE GEO/TOPCON GRS-1 GPS WITH POST PROCESSED SUBMETER ACCURACY AS STATED BY MANUFACTURER  
3.) RESOURCE DATA IN NAD83 UTM ZONE 19-US.FEET.  
SOURCE:  
1.) ORTHOIMAGERY-ESRI ARCGIS ONLINE  
2.) USGS TOPO QUADS- ESRI ARCGIS ONLINE USA TOPO MAPS  
3.) BASE SURVEY PROVIDED BY PLISGA & DAY

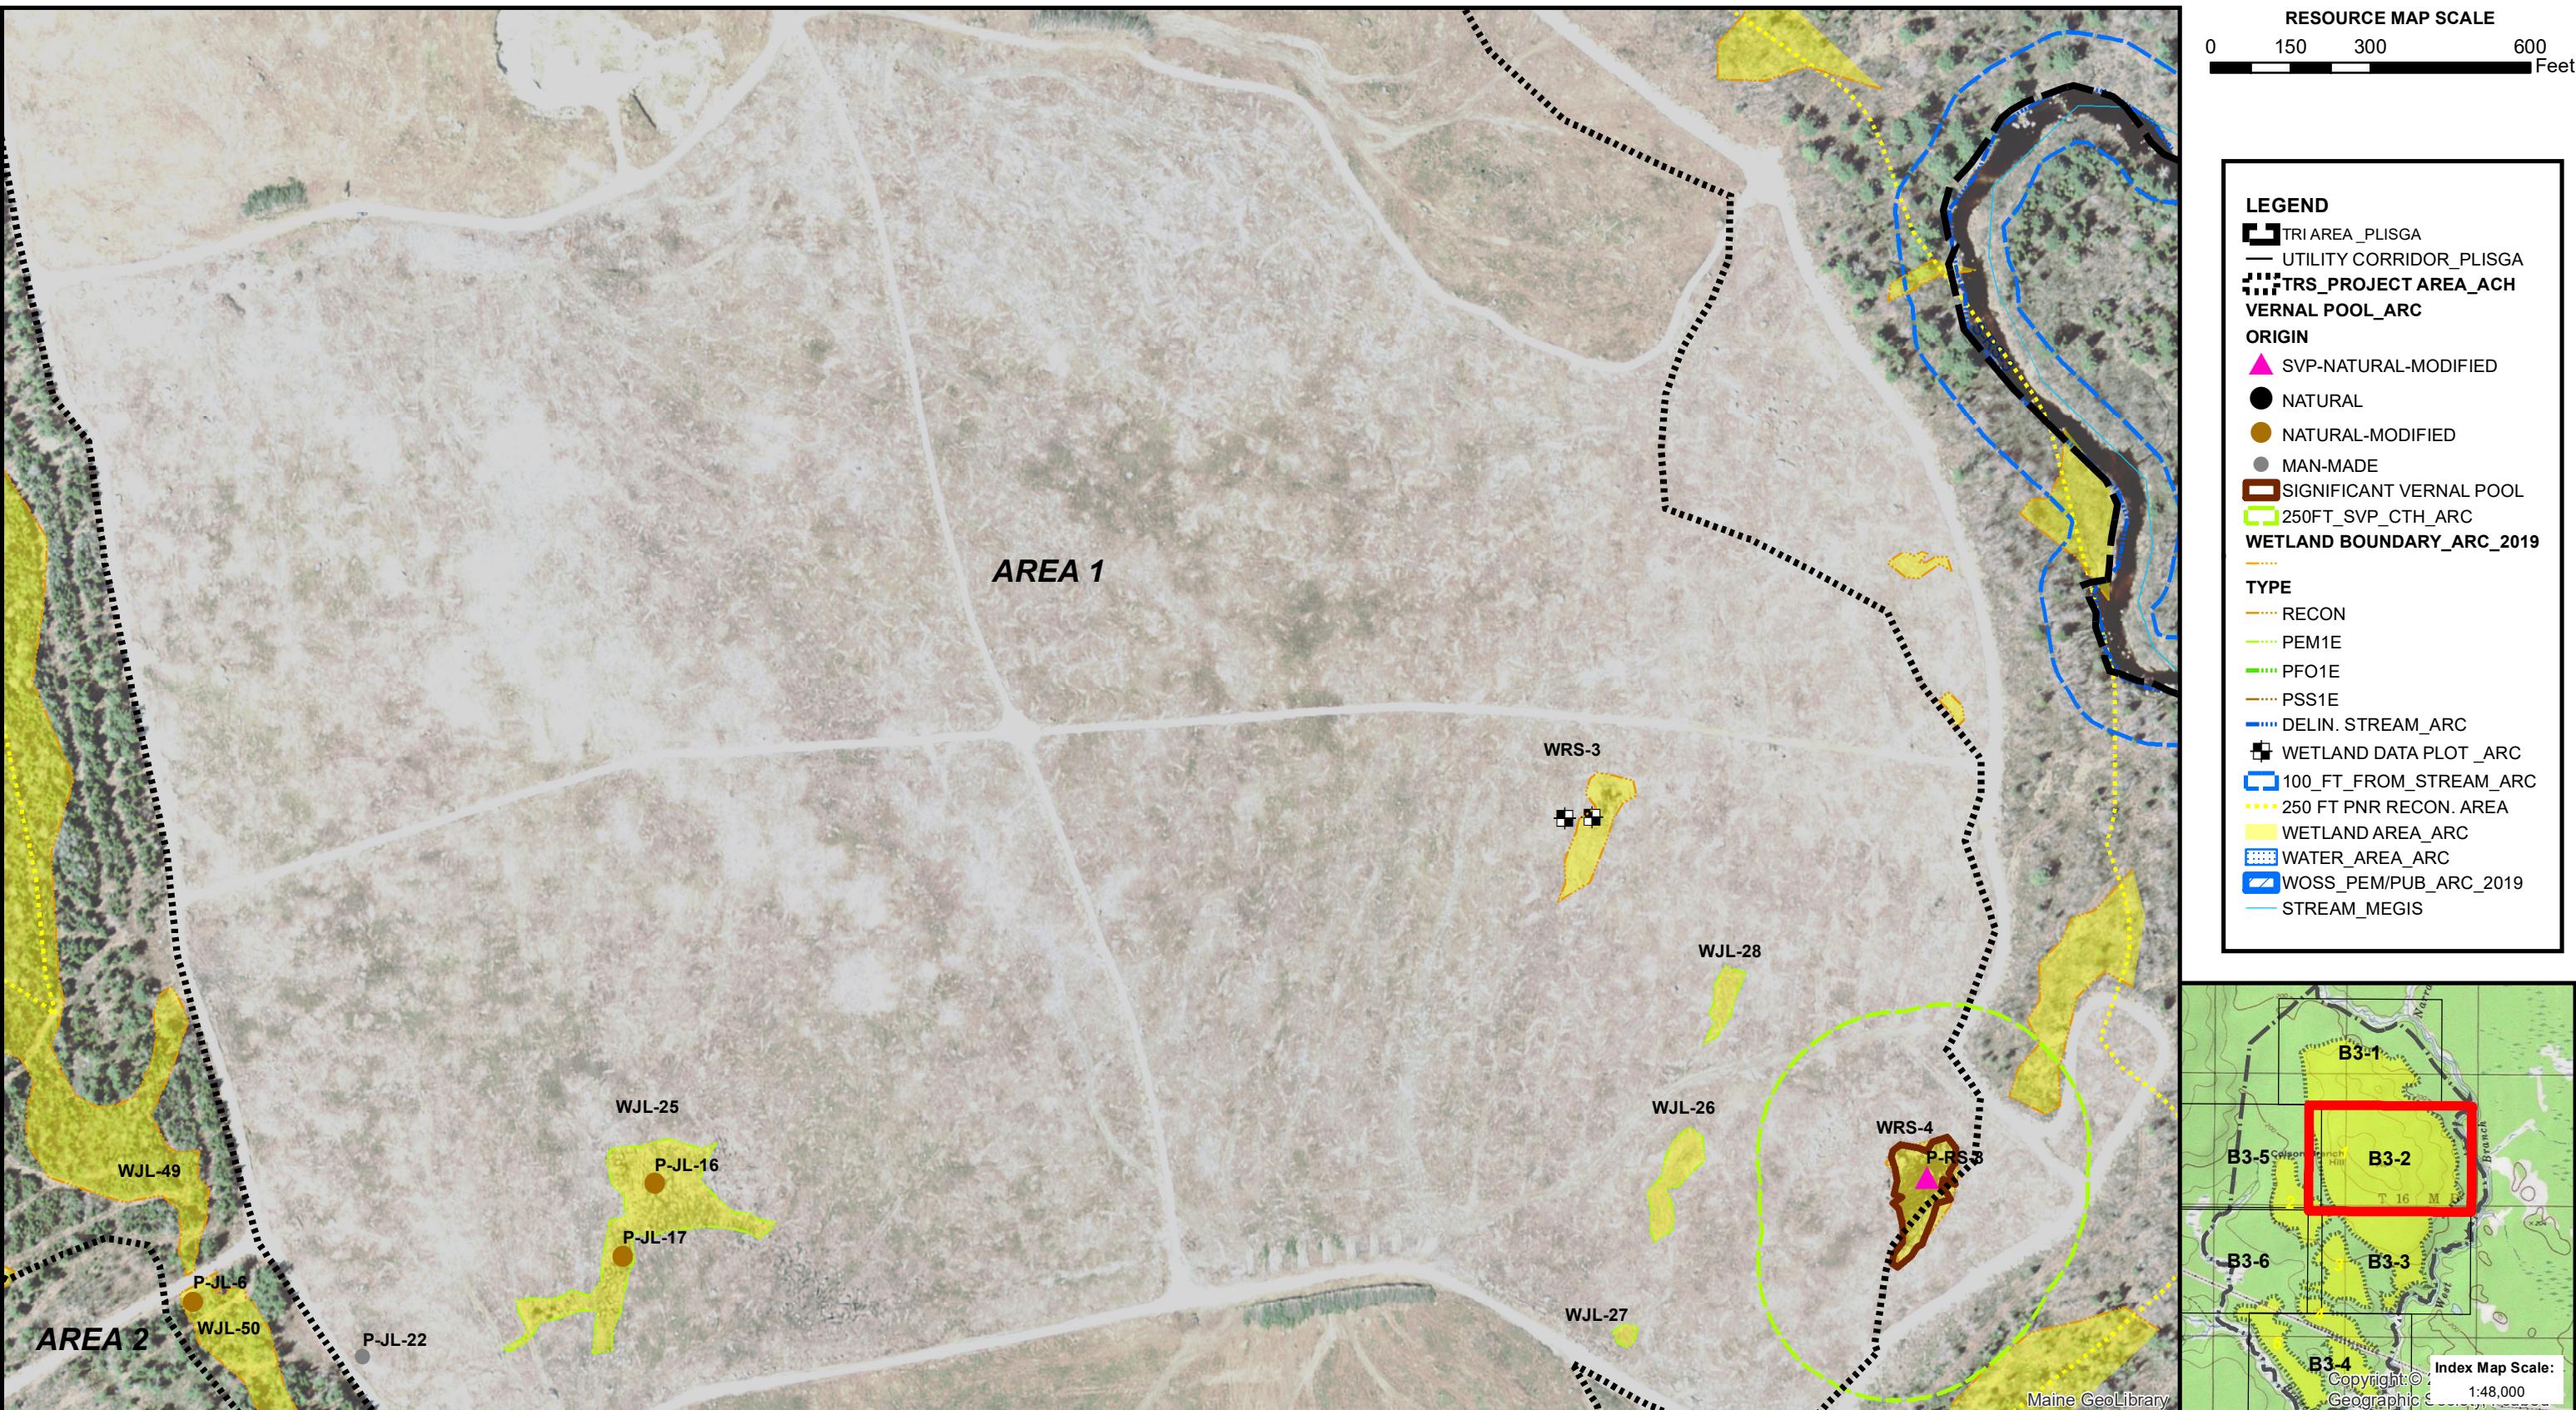
**B3-2 - RESOURCE MAP**  
**Page 2 of 6**

- NOTES**
1. This Protected Natural Resources Plan details the findings of Protected Natural Resources services conducted by Atlantic Resource Co, LLC in November and December of 2018 and May, June and July of 2019. Services included identification and delineation of protected natural resources (wetlands, streams, vernal pools) within the 6 proposed development areas, identification of vernal pools within 250' of the proposed development areas, identification of streams within 100' of the proposed development areas, and ground-truthing of wetlands and streams identified during the desktop review within 250' of the proposed development areas.

2. Protected Natural Resources were identified and delineated in general accordance with the Maine Department of Environmental Protection Natural Resources Protection Act definitions; the United States Department of the Army State of Maine General Permit (October 2015-2020), the Corps of Engineers Wetland Delineation Manual (1987), and the U.S. Army Corps of Engineers Regional Supplement to the Corps of Engineers Wetland Delineation Manual: Northcentral and Northeast Region (2012).

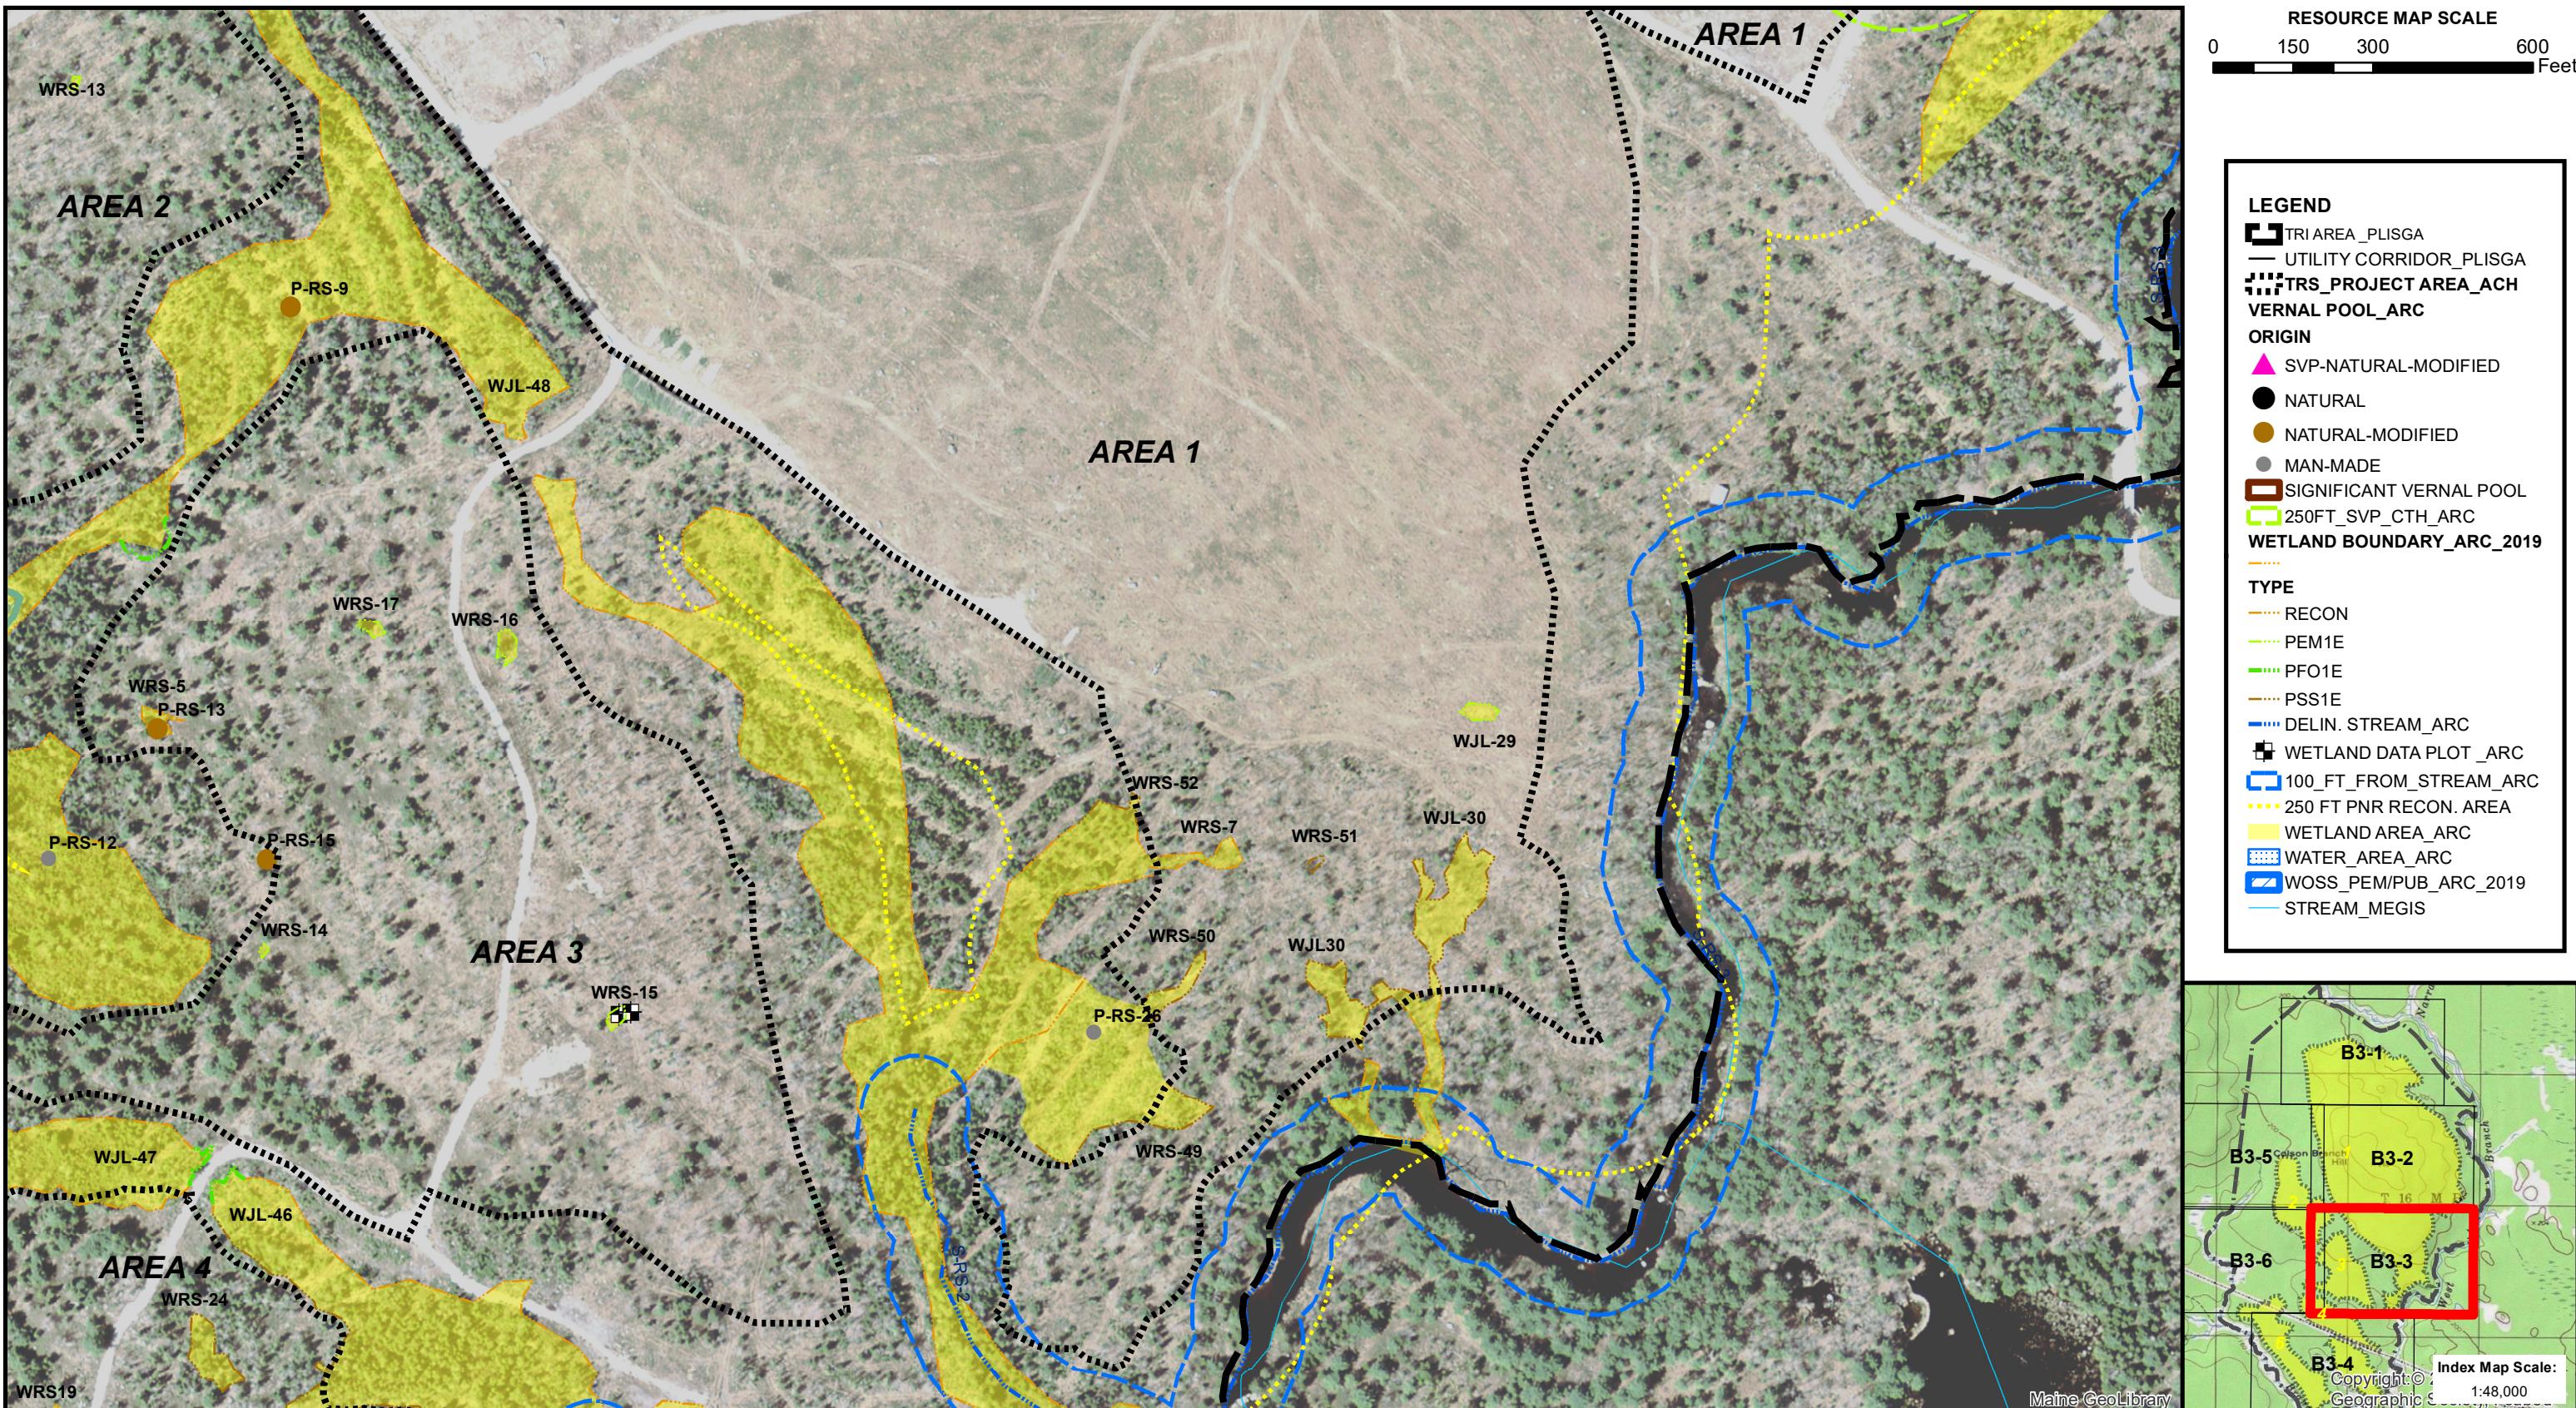
B3-3 - RESOURCE MAP  
Page 3 of 6  
DATE: AUGUST 26, 2019

- NOTES
1. This Protected Natural Resources Plan details the findings of Protected Natural Resources services conducted by Atlantic Resource Co, LLC in November and December of 2018 and May, June and July of 2019. Services included identification and delineation of protected natural resources (wetlands, streams, vernal pools) within the 6 proposed development areas, identification of vernal pools within 250' of the proposed development areas, identification of streams within 100' of the proposed development areas, and ground-truthing of wetlands and streams identified during the desktop review within 250' of the proposed development areas.

2. Protected Natural Resources were identified and delineated in general accordance with the Maine Department of Environmental Protection Natural Resources Protection Act definitions; the United States Department of the Army State of Maine General Permit (October 2015-2020), the Corps of Engineers Wetland Delineation Manual (1987), and the U.S. Army Corps of Engineers Regional Supplement to the Corps of Engineers Wetland Delineation Manual: Northcentral and Northeast Region (2012).

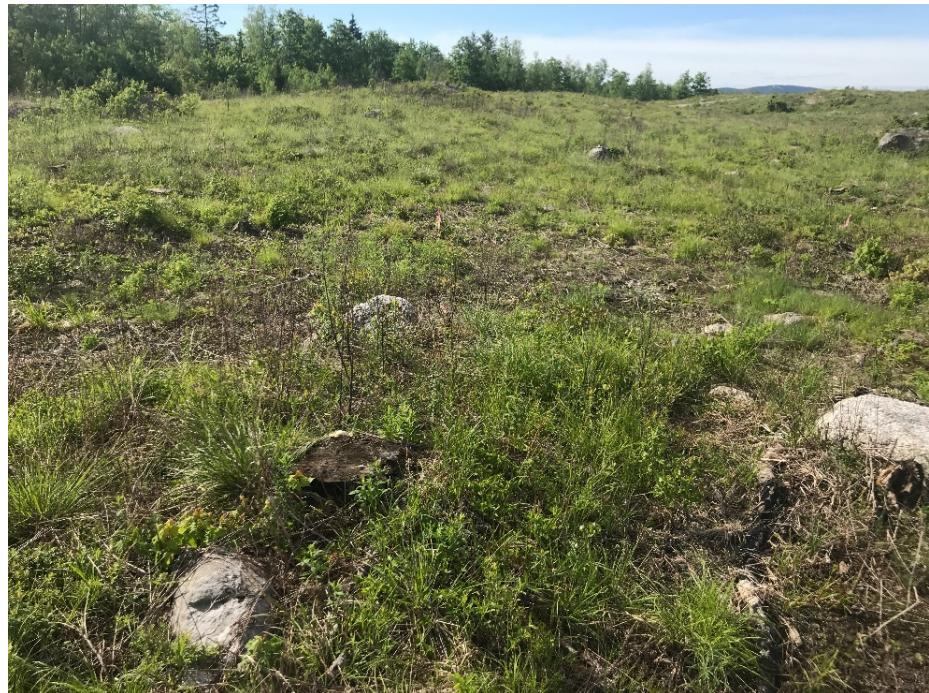
**Photo 2:** Wetland WRS-2: PEM1E (Area 1). Photograph taken 6/18/19.

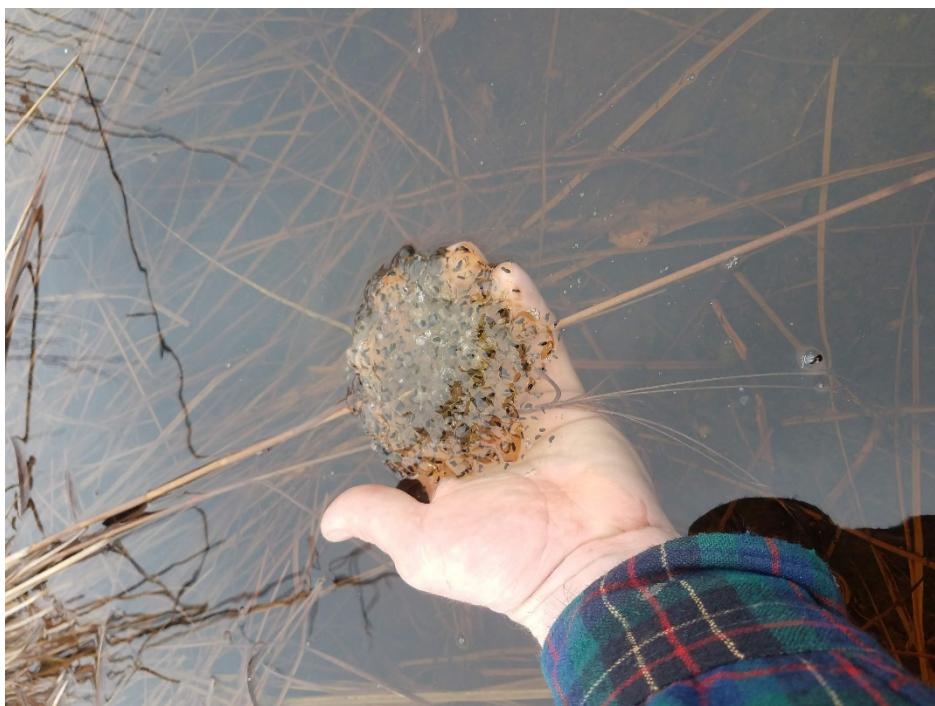
**Photo 4:** Vernal Pool: P-JL-16 (Area 1). Wood frog egg mass. Photograph taken 4/30/19.

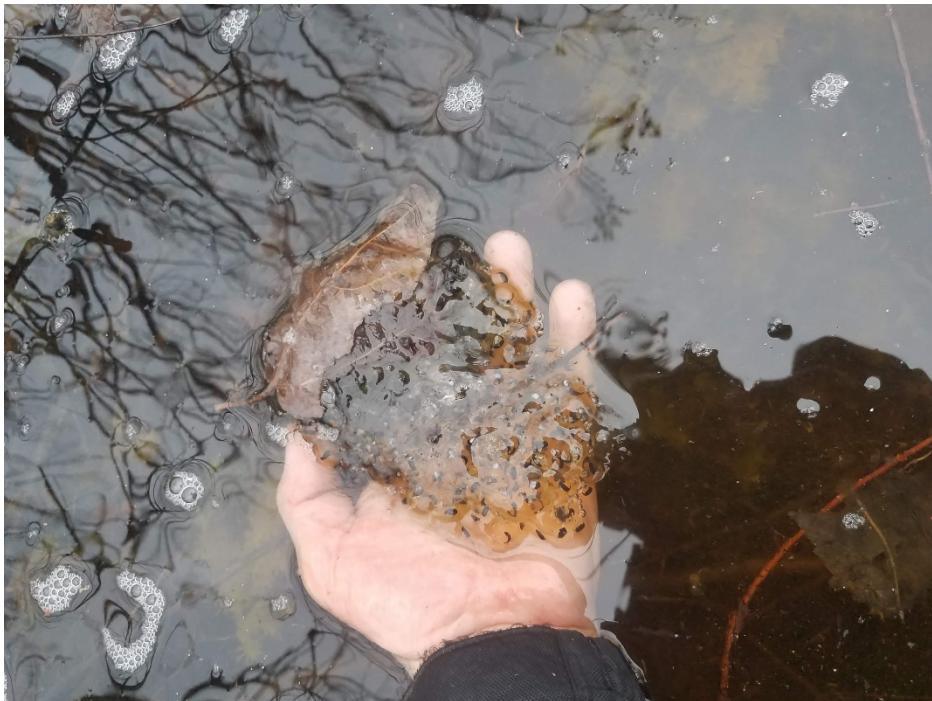
**Photo 15:** Vernal Pool: P-RS-25 (Area 4). Wood frog egg mass. Photograph taken 04/30/19.

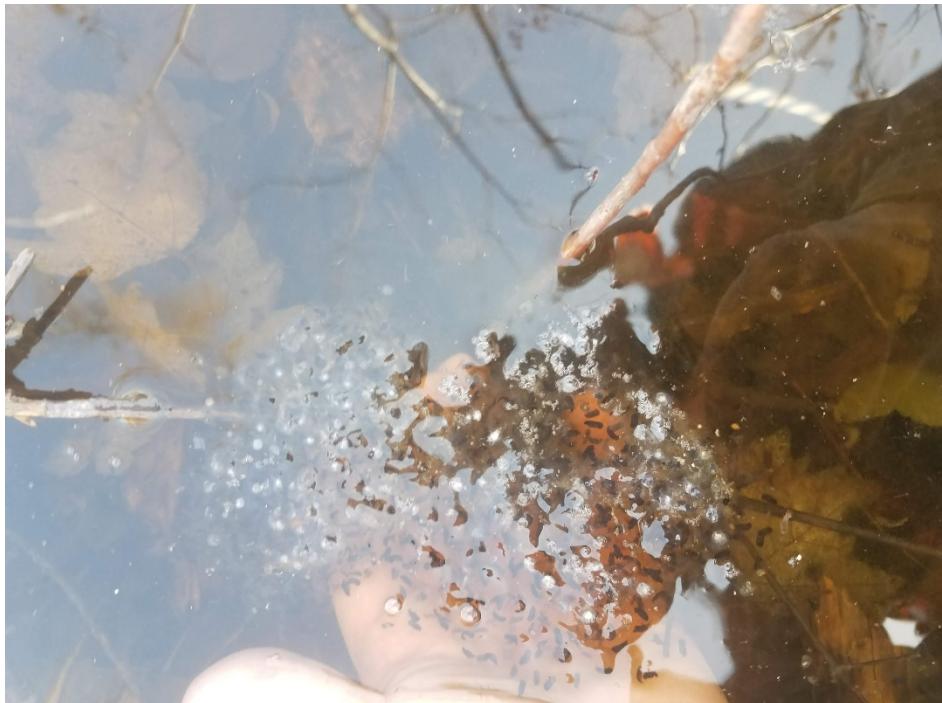
**Photo 35:** Vernal Pool: P-RS-22 (250' Buffer Area). Wood Frog egg masses. Photograph taken 04/30/19.

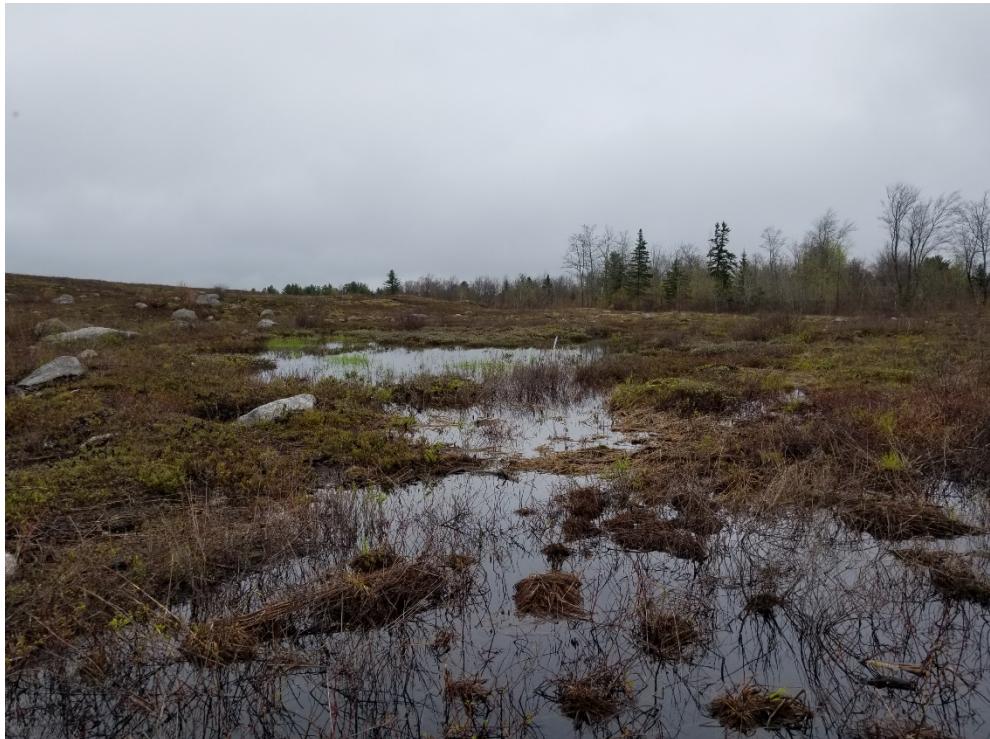
Photo 1: SVP P-RS-8. Photograph taken 05/22/19.

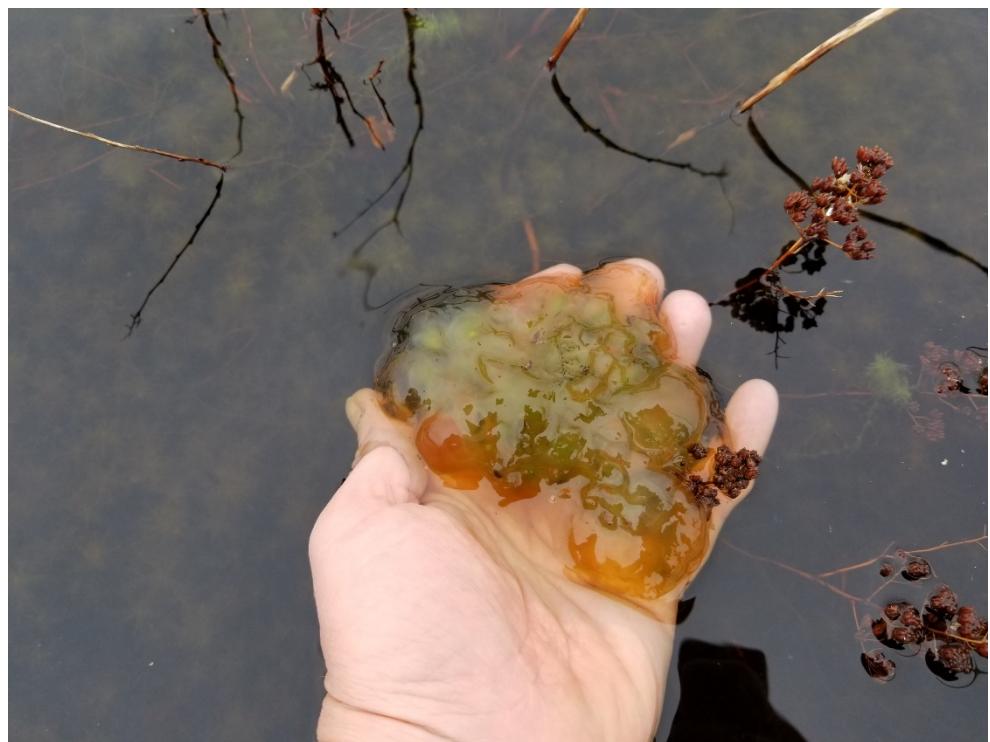
Photo 2: Spotted salamander egg mass in SVP P-RS-8. Photograph taken 05/22/19.
