## SECTION 10 BUFFERS

**EXHIBIT 10-1      POST-CONSTRUCTION VEGETATION MANAGEMENT PLAN**

# Post-Construction Vegetation Management Plan

**Western Maine Renewable Energy Project  
Somerset County, Maine**

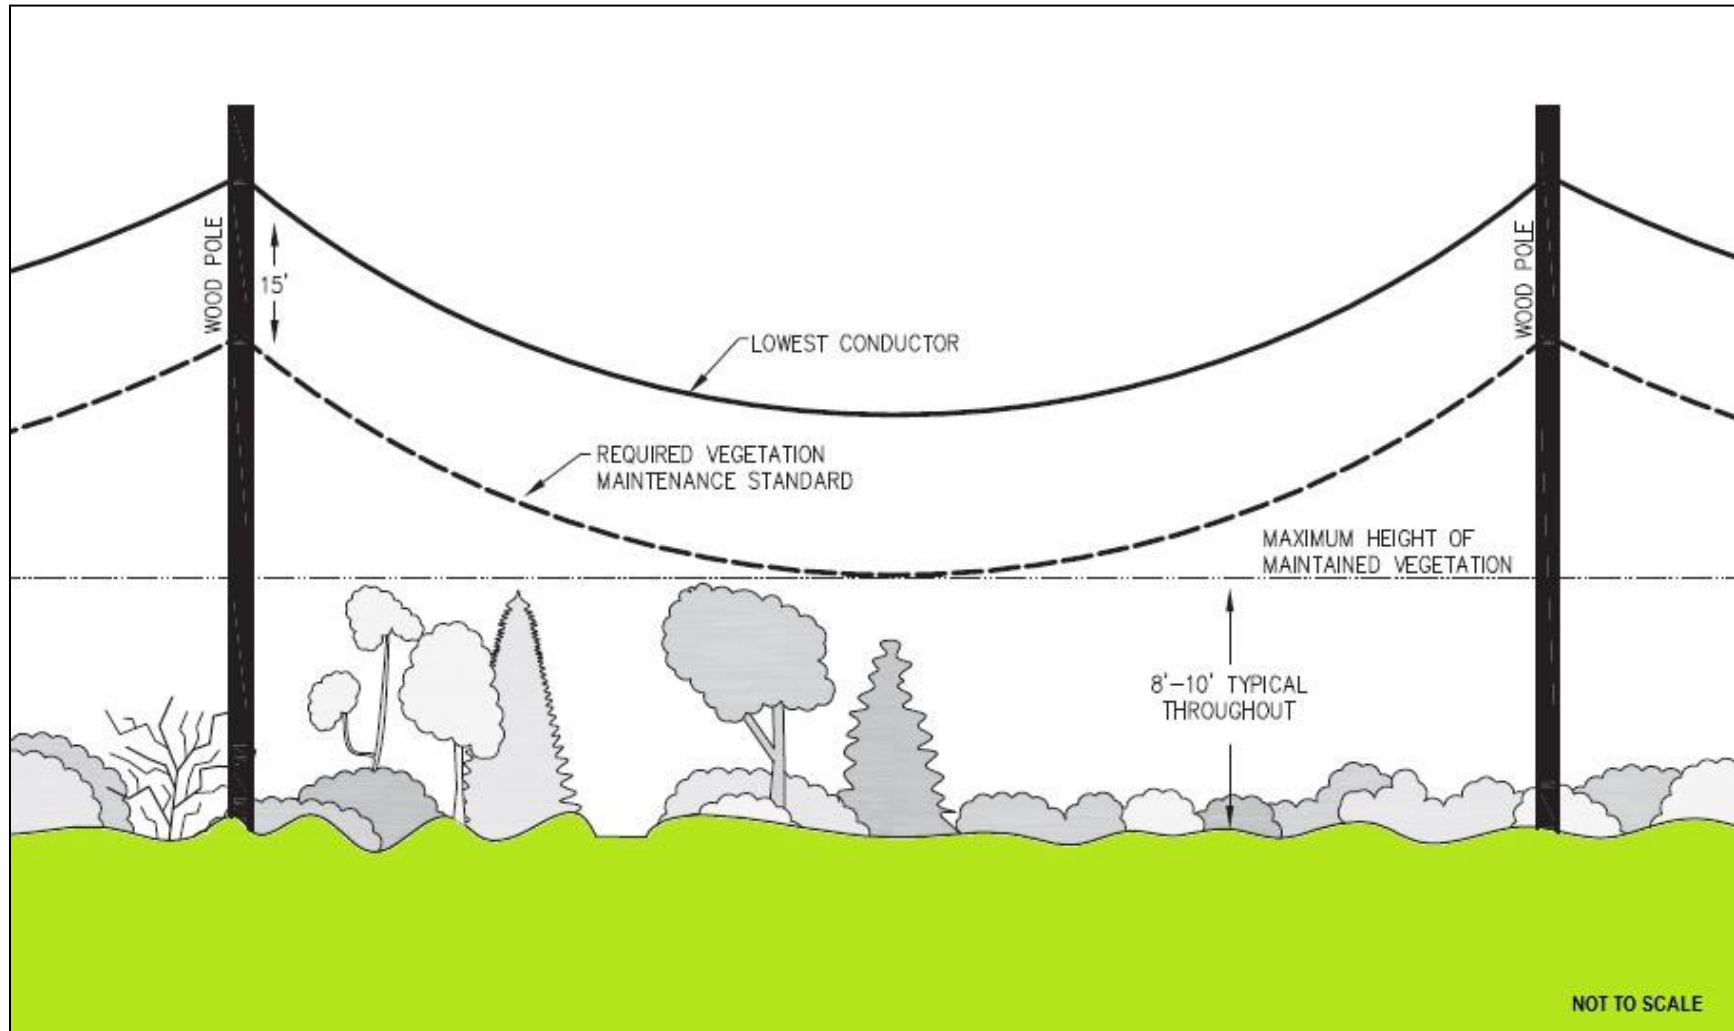
Figure 1. Diagram Illustrating Minimum Vegetation Maintained Between Vegetation and Conductors for the Western Maine Renewable Energy Project; Somerset County, Maine, 2020.

appropriate clearance is typically achieved by removing all capable species and topping other vegetation exceeding 8–10 feet in height (Figure 1).

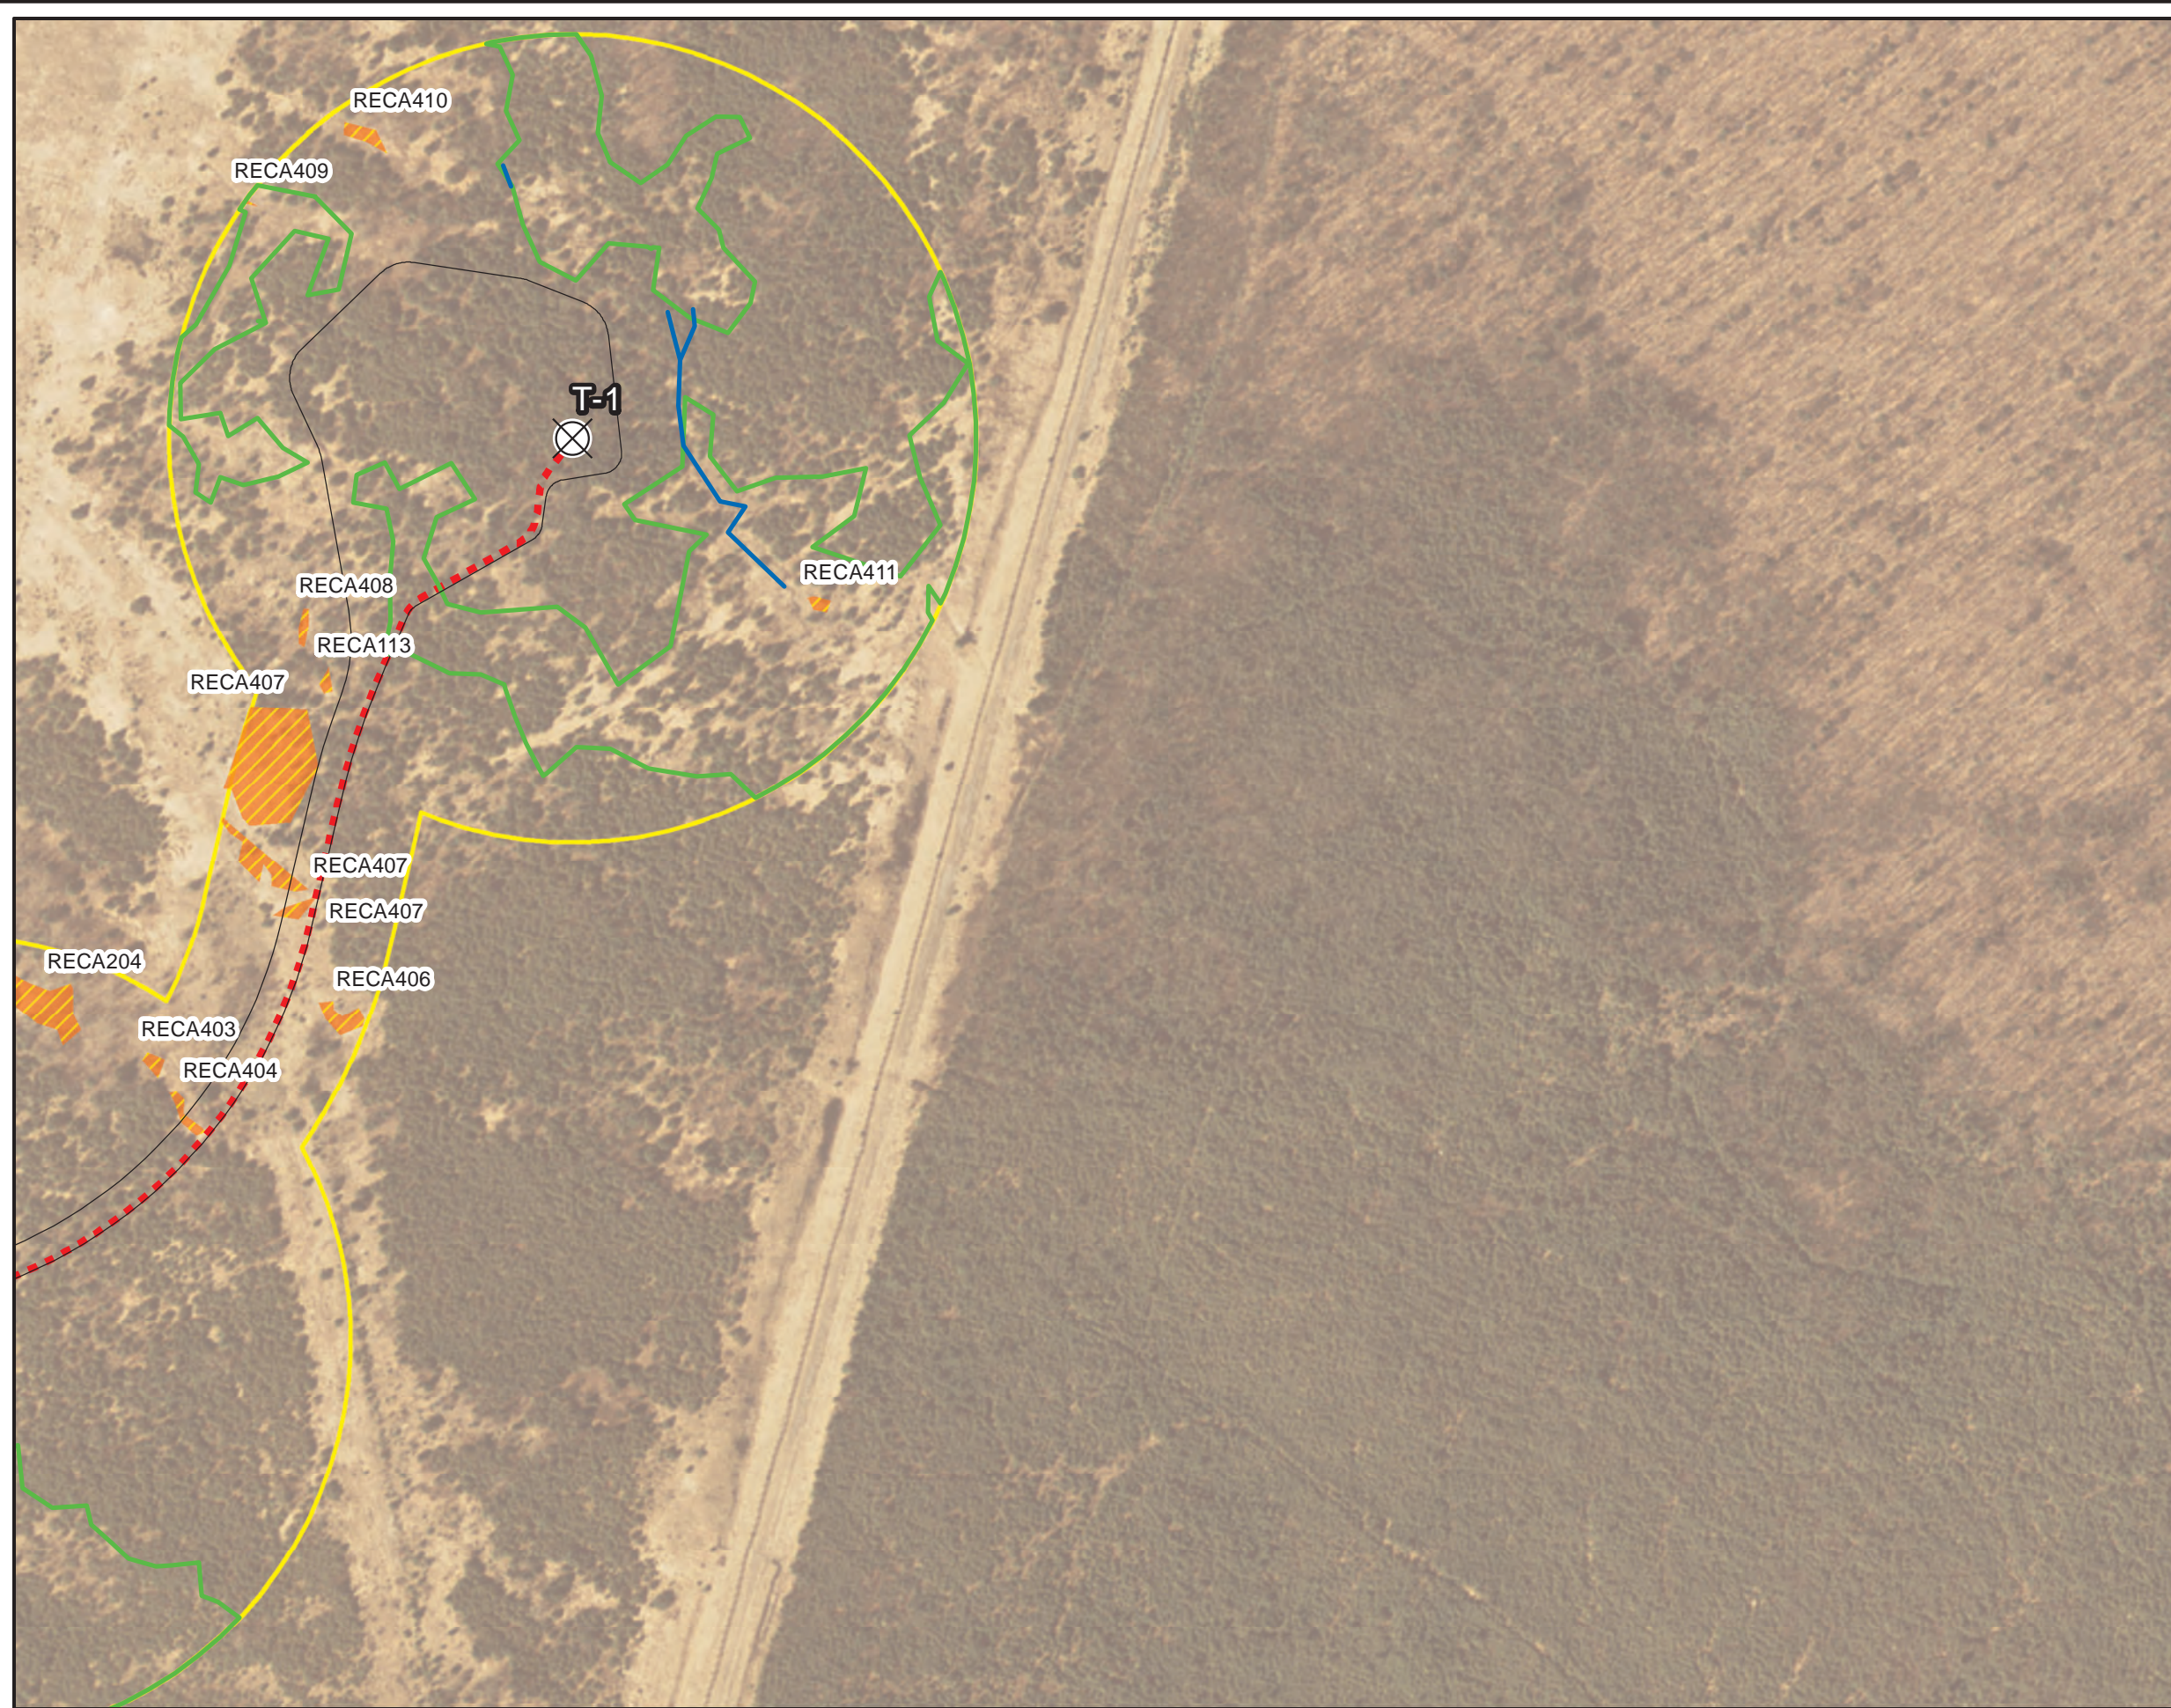
**Figure 2**  
**Invasive Species Survey Results**  
**Plate 7 of 14**  
**Western Maine Renewable Energy Project**

- Project Area
- Access Roads and Pads
- Turbine Location
- Delineated Wetland
- Delineated Stream
- Invasive Plant Group**
- Reed Canary Grass
- Connection System**
- 34.5kV Underground

Reed canary grass dominated the vegetation cover in many of the wetlands near disturbed areas during the late summer months. The species is present along the main travel roads and generally was found to cover upwards of 50 percent of open wetland areas near roads. The ROW in the southeast corner of the substation is dominated by over 1 acre that is predominantly reed canary grass, as is the smaller transmission-line ROW that continues northwest from this location.
