Re : RFP# 202008127 2021R1 Grant Application
East Ridge Road Crossing of Venture Brook – Cathance Twp, ME
St.Germain File No.: 4067-0005

On behalf of the Washington County Commissioner and The Nature Conservancy, St.Germain is pleased to submit the attached application for grant funding to upgrade the Venture Brook crossing on East Ridge Road – a municipal owned road maintained by the Washington County Commissioner.

Re: #51863 – East Ridge Road Culvert Replacement, Cathance
Twp, ME – Wetland Delineation Memorandum

Natural Resource Photographs – 10/7/2020
East Ridge Road Culvert Replacement Project, Cathance Twp – #51873, Maine

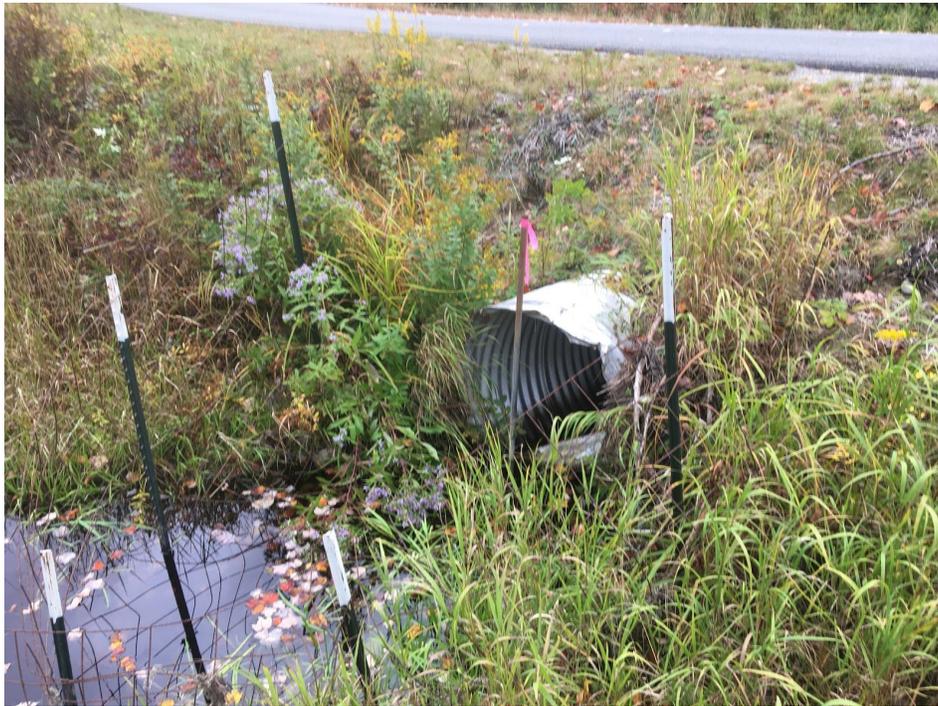
Photo 1: View looking east at the existing culvert inlet.

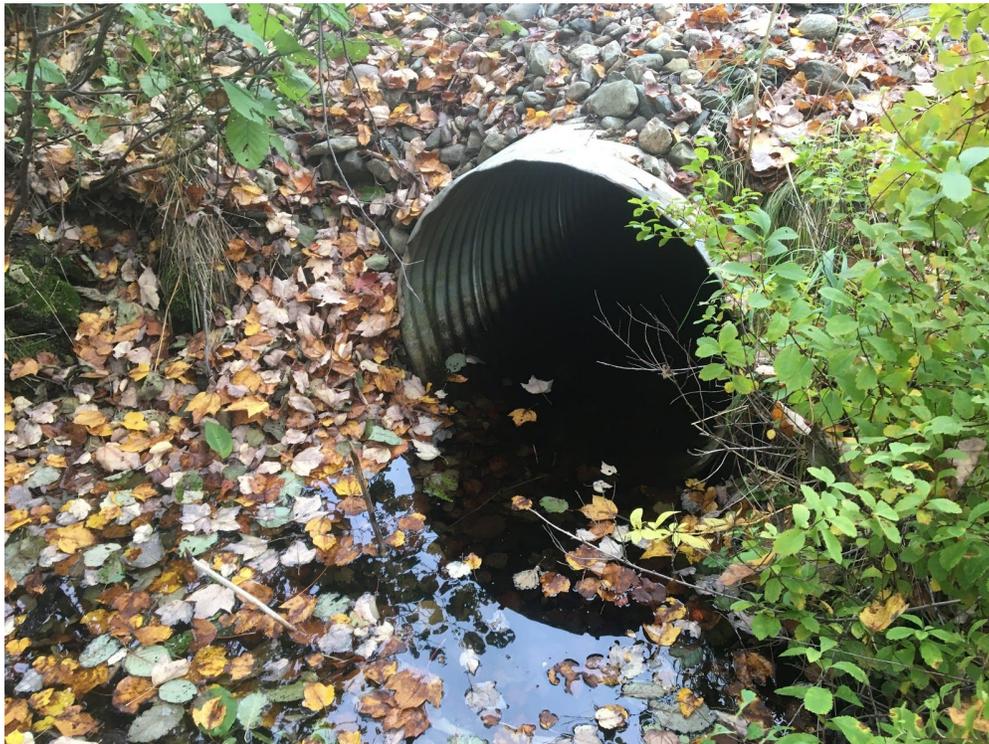
Photo 2: View looking east at the existing culvert outlet.

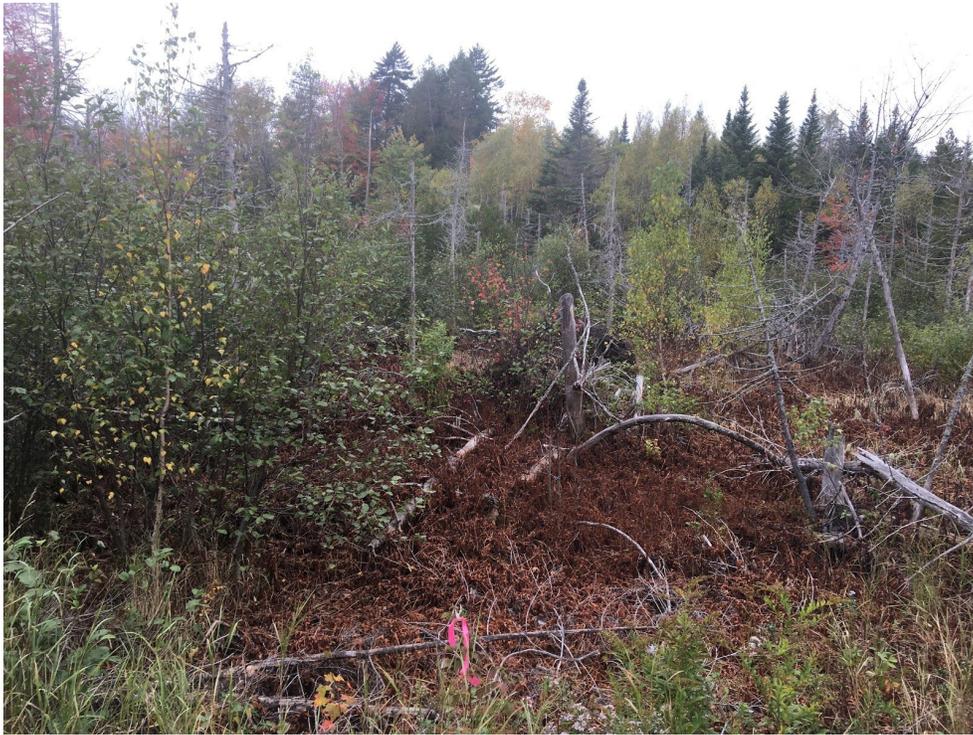
Photo 3: View looking upslope above the culvert inlet.

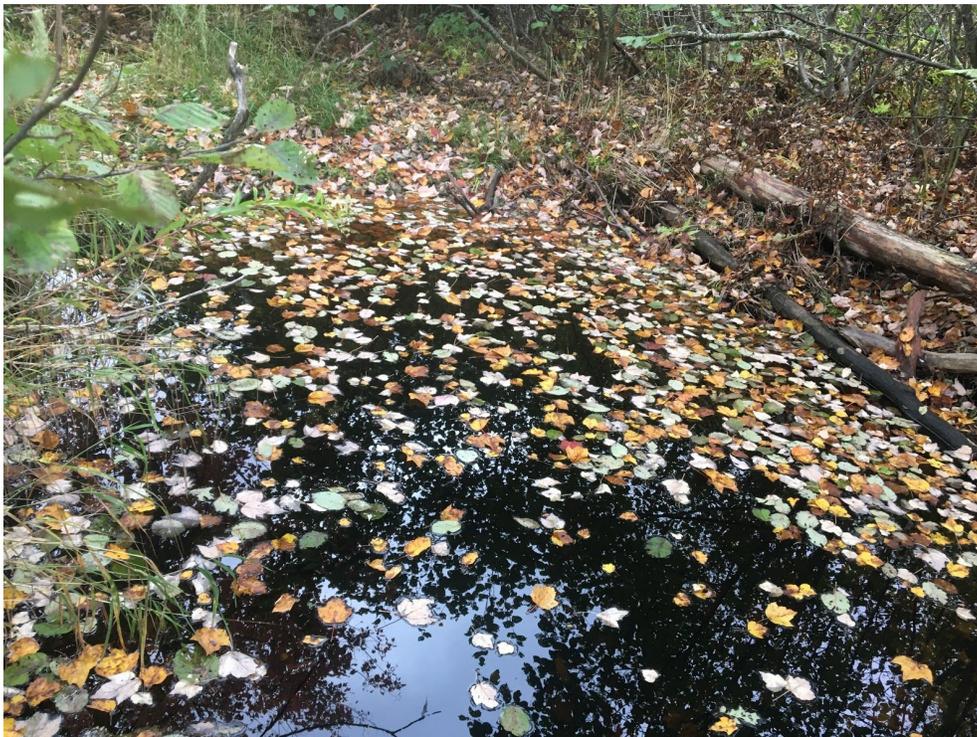
Photo 4: View looking downstream below the culvert outlet.

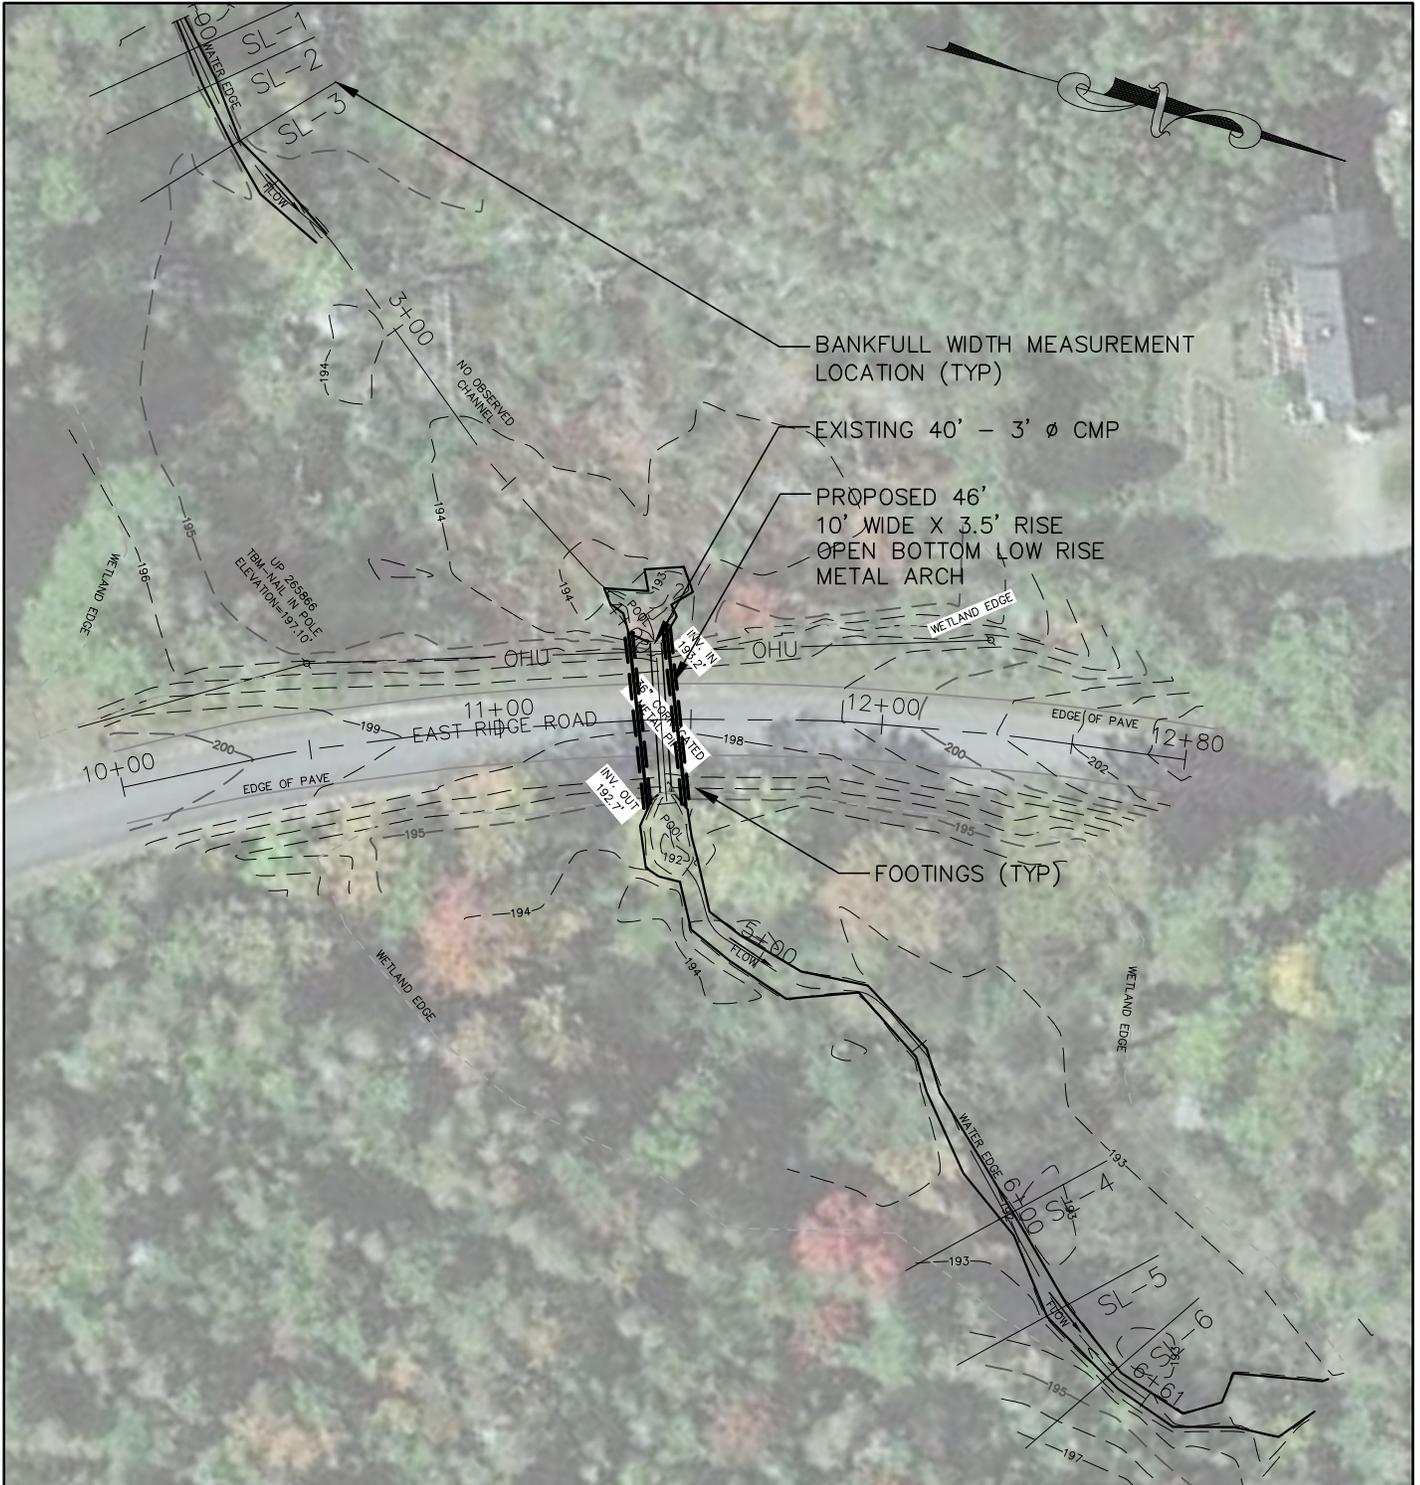
C-101

SITE PLAN

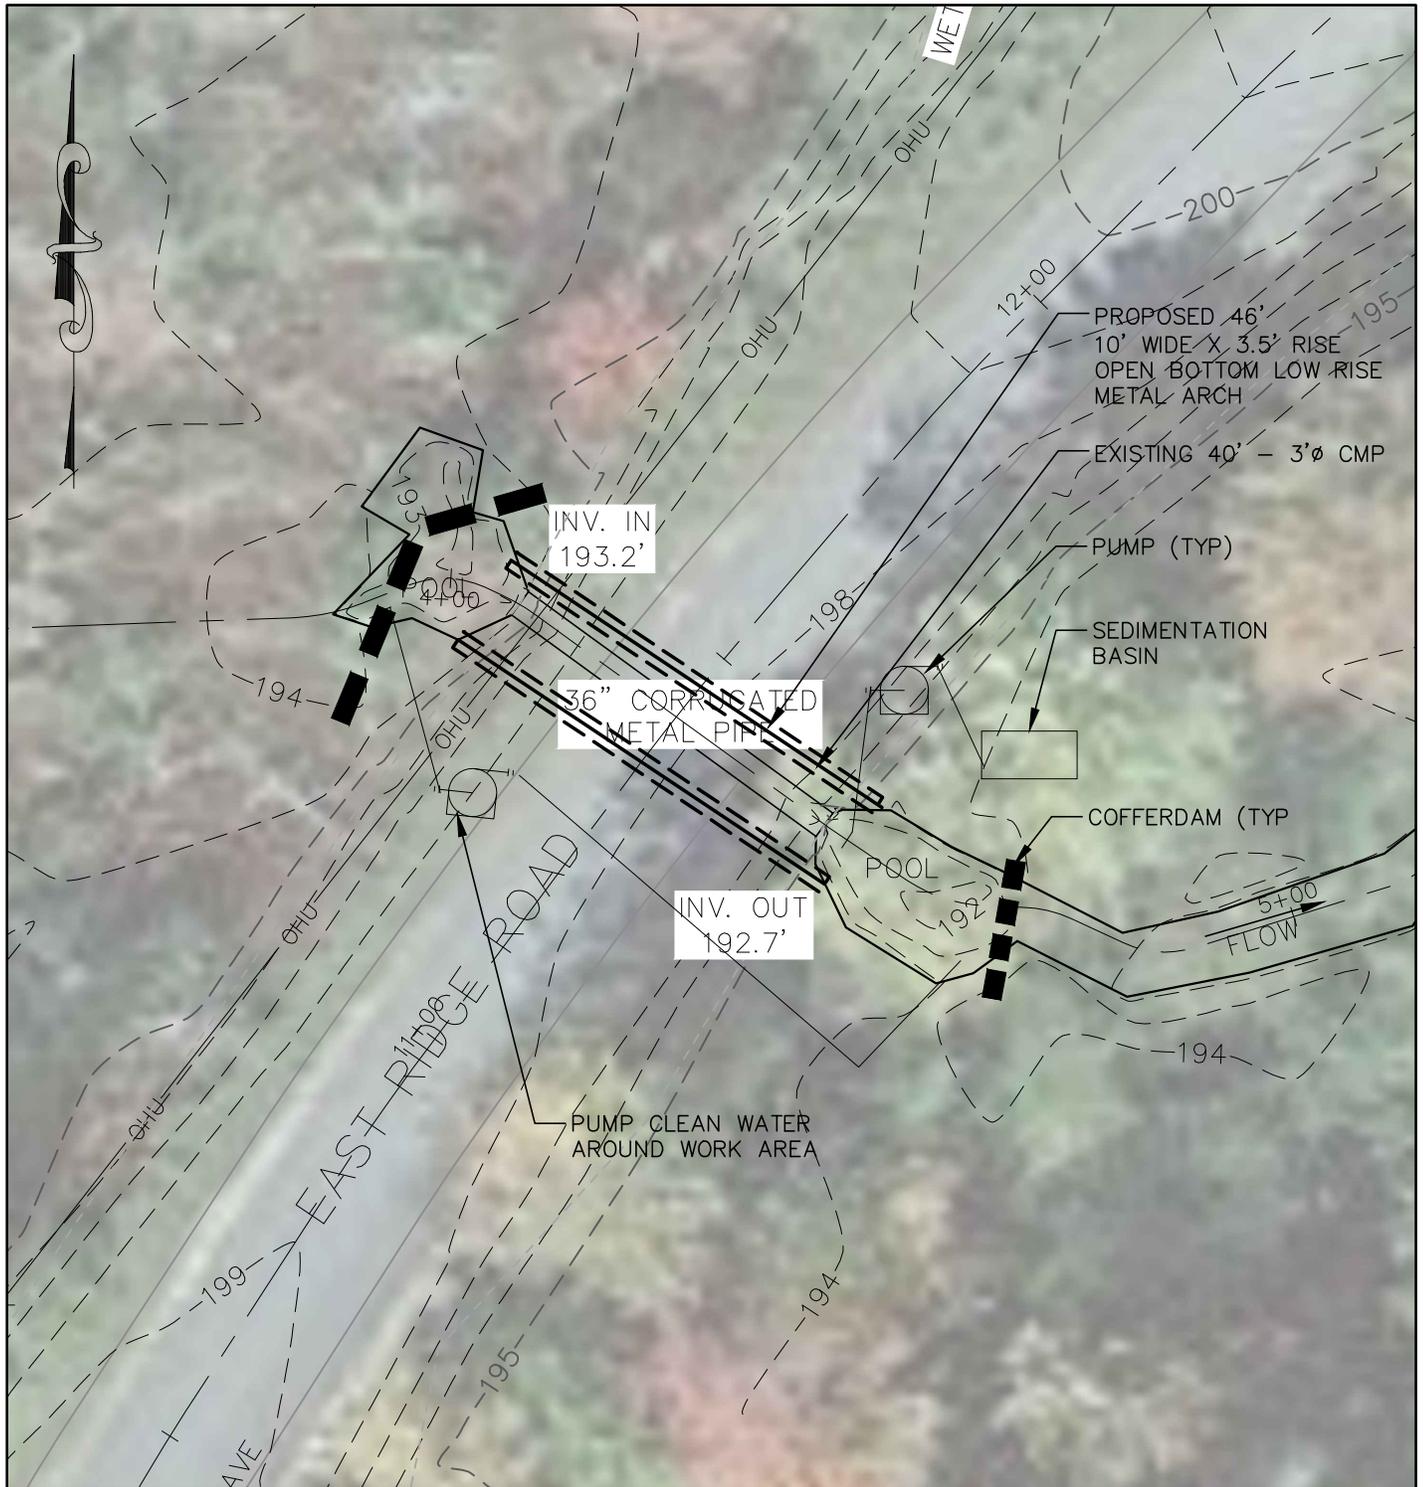
C-102

E&S CONTROL PLAN

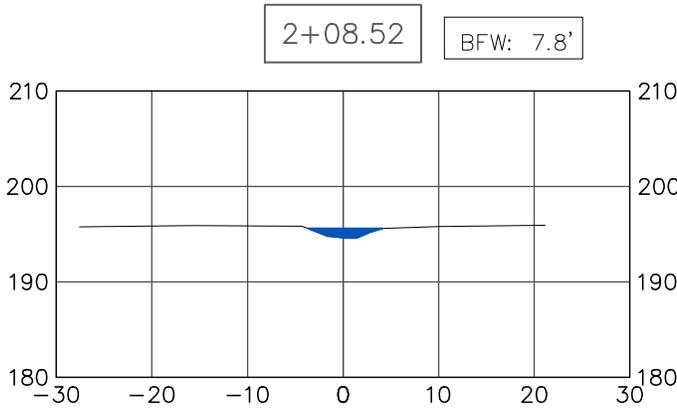
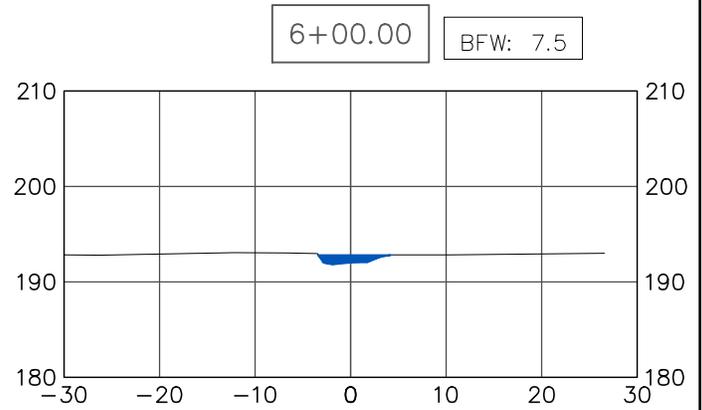
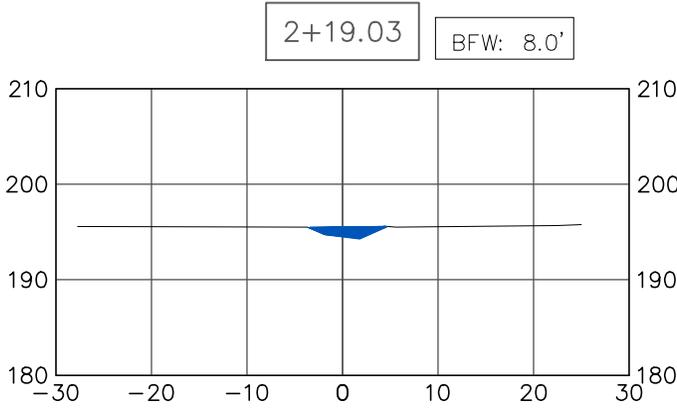
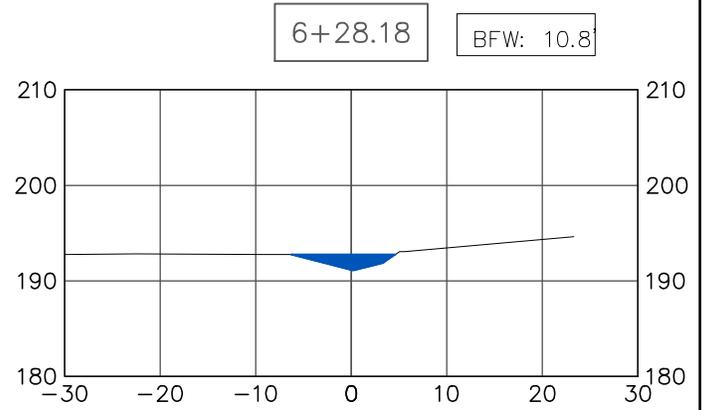
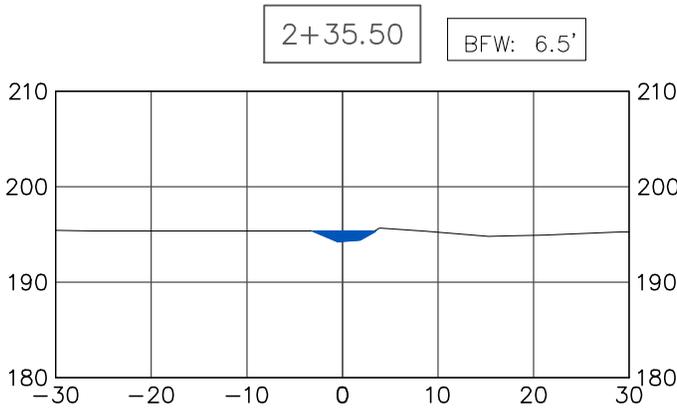
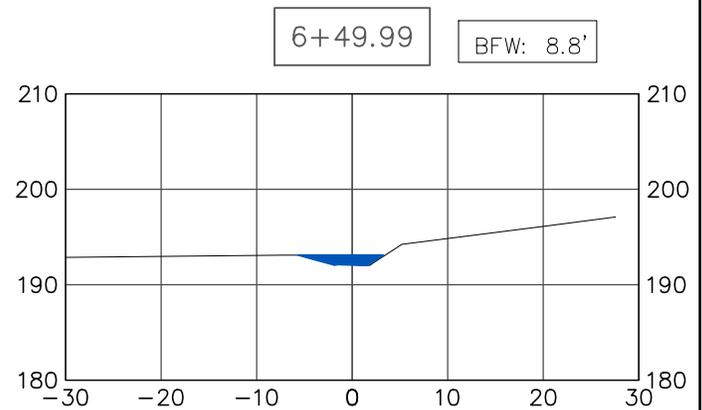
BANKFULL WIDTH SECTIONS

Measured Bankfull Width (beyond culvert influence, min. of 3 upstream and downstream measurements)	Upstream widths	1.	2.	3.	4.	5.	Average	Average value of upstream & downstream measurements

7.8'	8.0'	6.5'			7.4'	
	Downstream Widths	1.	2.	3.	4.	5.	Average	
		7.5'	10.8'	8.8'			9.0'	8.2'
Estimated Bankfull width (<i>measured average bankfull width values are the most accurate method</i>)	Maine Stream Habitat Viewer http://webapps2.cgis-solutions.com/MaineStreamViewer/						13.90 feet	
	StreamStats https://streamstats.usgs.gov/ss/						5.35 feet	
	Other Hydraulic & Hydrologic Analysis (if performed)						10.58xDA ^{0.43} =7.9 ft DA=0.5 square mile	
Has a Stream Bed Substrate analysis been performed?							<input checked="" type="checkbox"/> Yes	<input type="checkbox"/> No
Explain: JE Costa's Paleohydraulic Analysis and Field Confirmation								
Size of Downstream scour pool <input type="checkbox"/> N/A, No scour pool present		Width		Length		Max Depth		
		13'		22'		0.5'

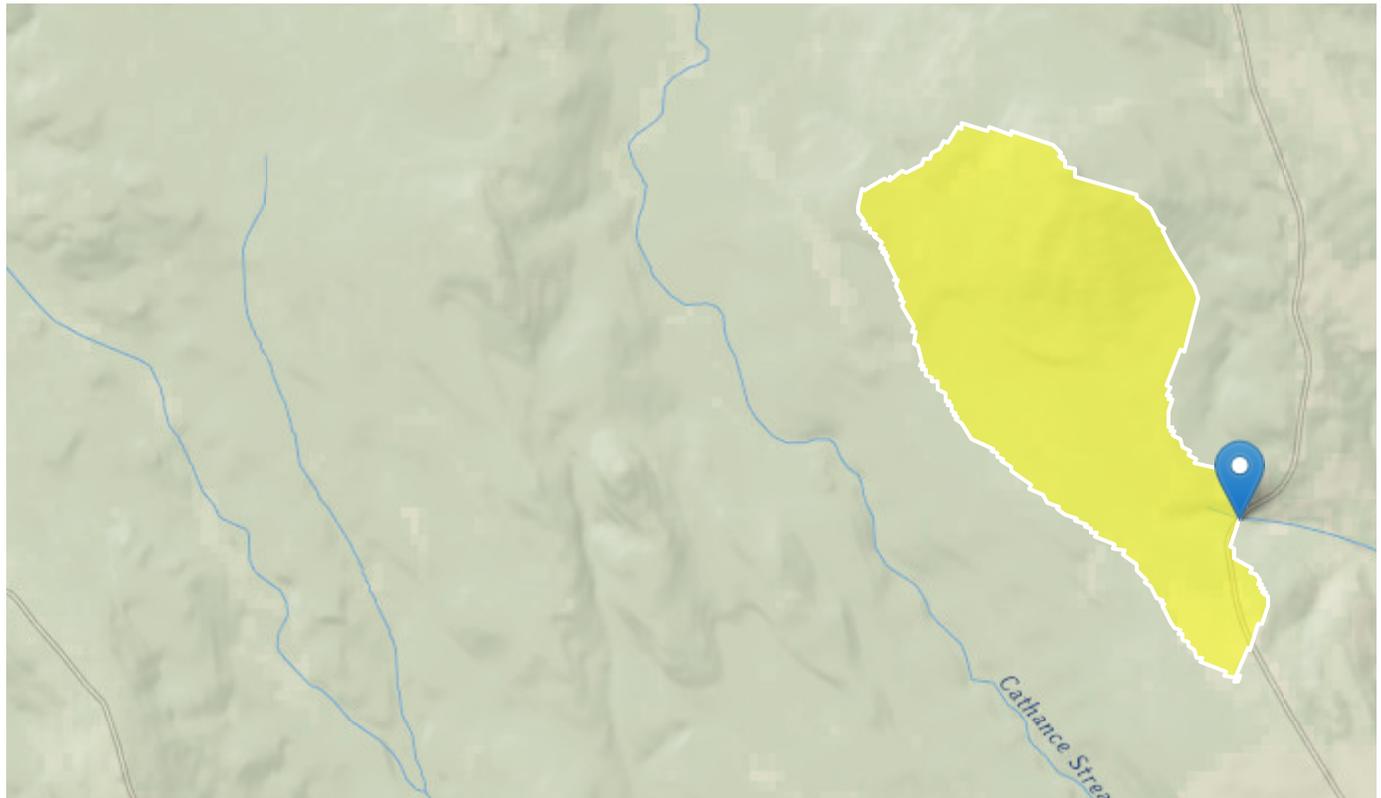
StreamStats Report for East Ridge Road crossing in Cathance Township, Maine.

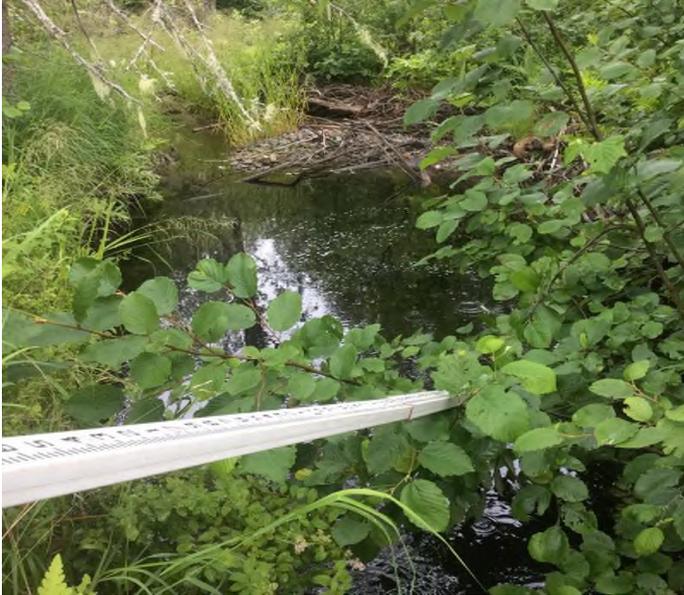
Downstream

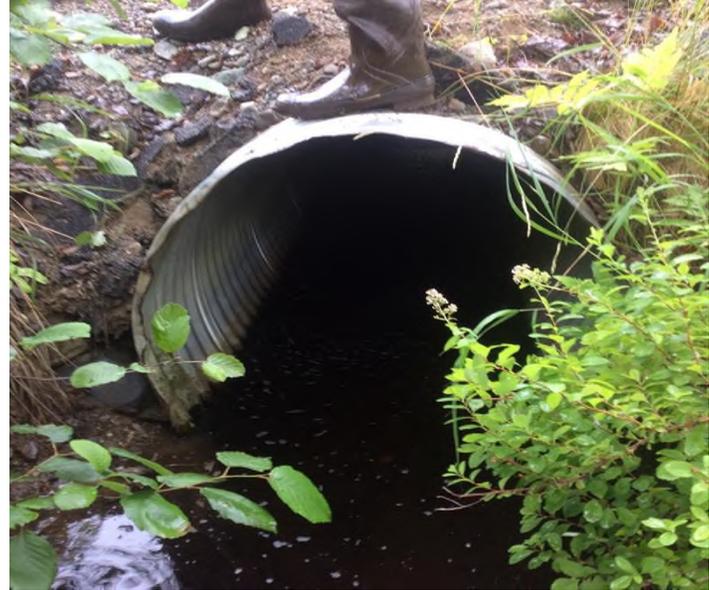
Outlet

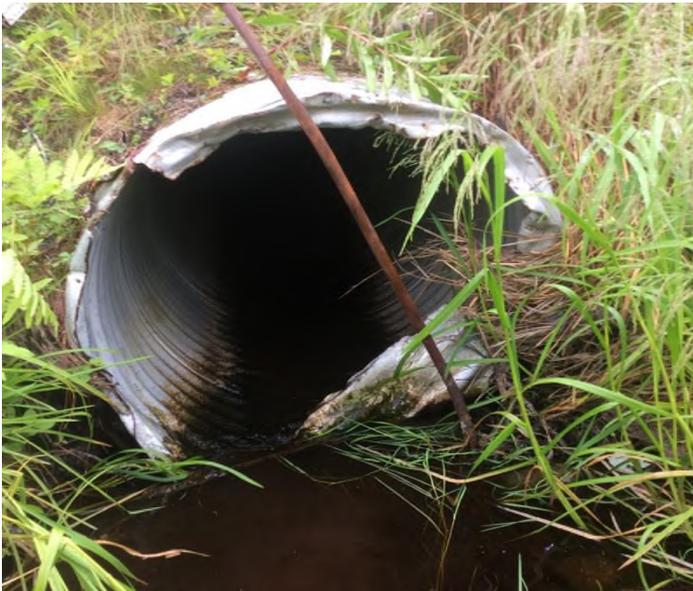
Inlet

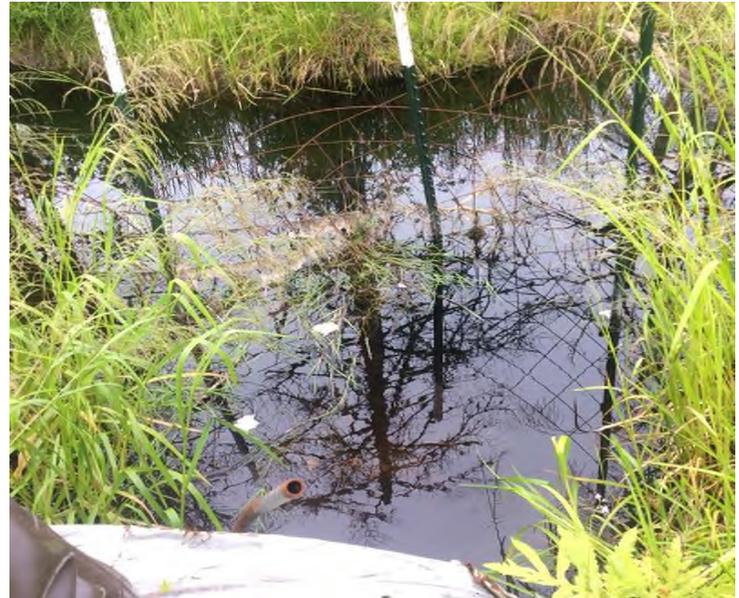
Upstream
